**Peace Project Water Use Plan**

**Reference: GMSMON-20**

**BC Hydro Williston Reservoir Recreation Use Monitoring  
Program, Data Report Year 3 (2011)**

**Synergy Applied Ecology**

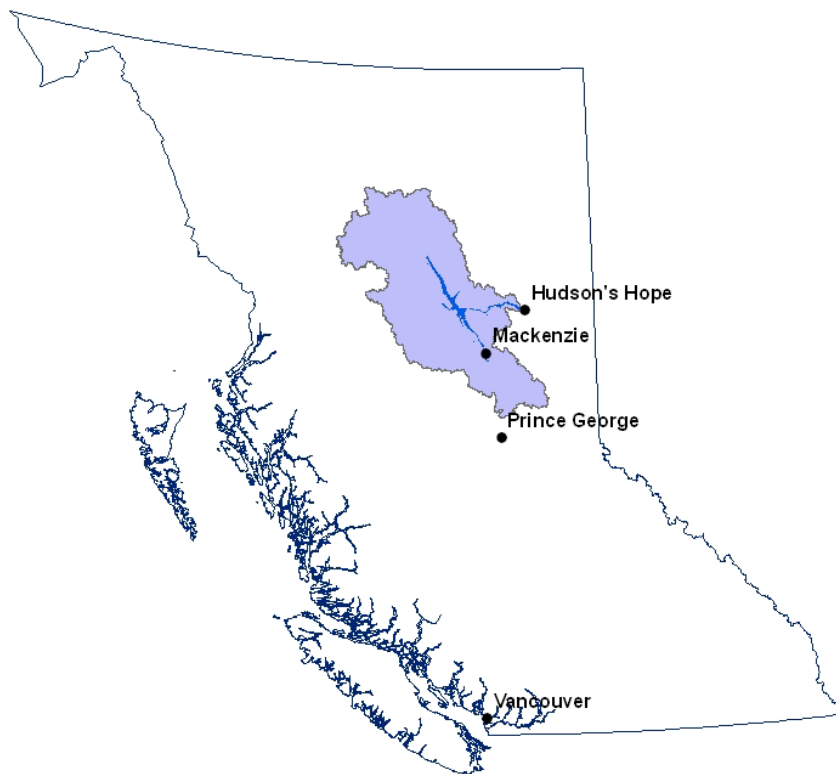
Figure 1. The Williston Reservoir and surrounding watershed boundary in northern British Columbia. The W.A.C. Bennett and Peace Canyon generation stations are on the Peace River adjacent to the community of Hudson's Hope.

The Williston Reservoir is the largest man-made, freshwater, hydroelectric reservoir in British Columbia with an area of 1,779 km<sup>2</sup> and a shoreline perimeter of 1,700 km (Figure 1). The reservoir offers considerable recreational fishing and wildlife viewing opportunities as boaters can access remote, undeveloped areas of the watershed with relative ease. The maximum licensed water level is 672 m asl and a minimum level of 640 m asl, with the lowest water levels typically reached in April annually before spring snow melt.

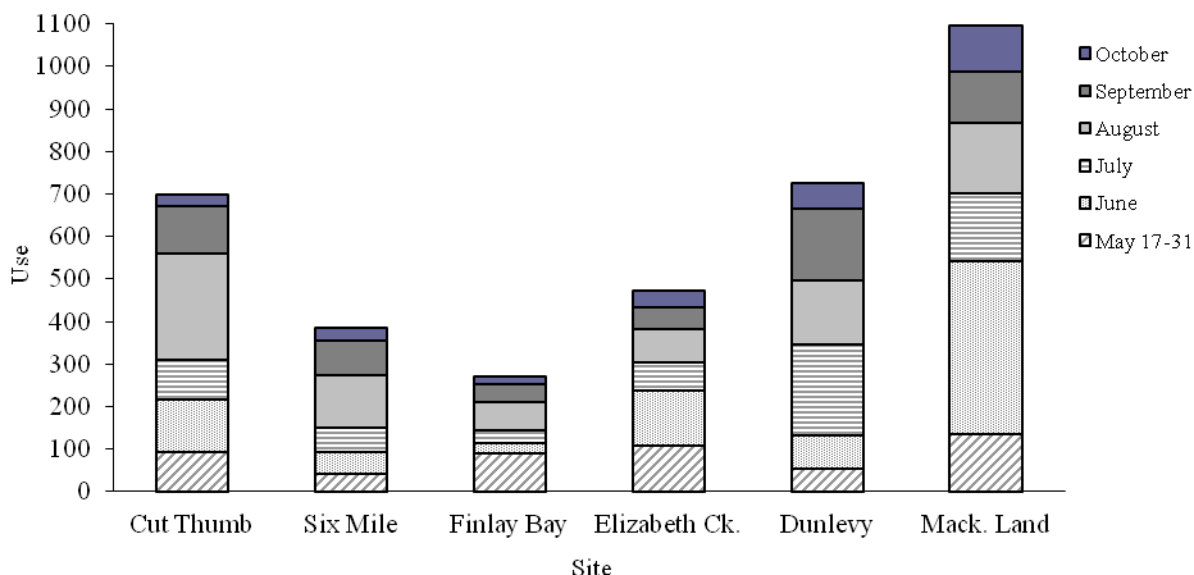
Figure 3. Monthly use by site estimated from photo-validated counter data corrected using photo success between May 17 and October 31 2011.

Total use by site estimated from photo-verified counter data varied from 272 visits at Finlay Bay to 1097 visits at Mackenzie Landing between May 17 and October 31 2011 (Figure 3). A large multi-year construction project at the W.A.C Bennett Dam commenced and required those wishing to use the Elizabeth Creek boat launch to be escorted by a pilot vehicle. Over 4100 events were logged by construction traffic using the boat launch during the Year 3 (2011) monitoring period. These data were

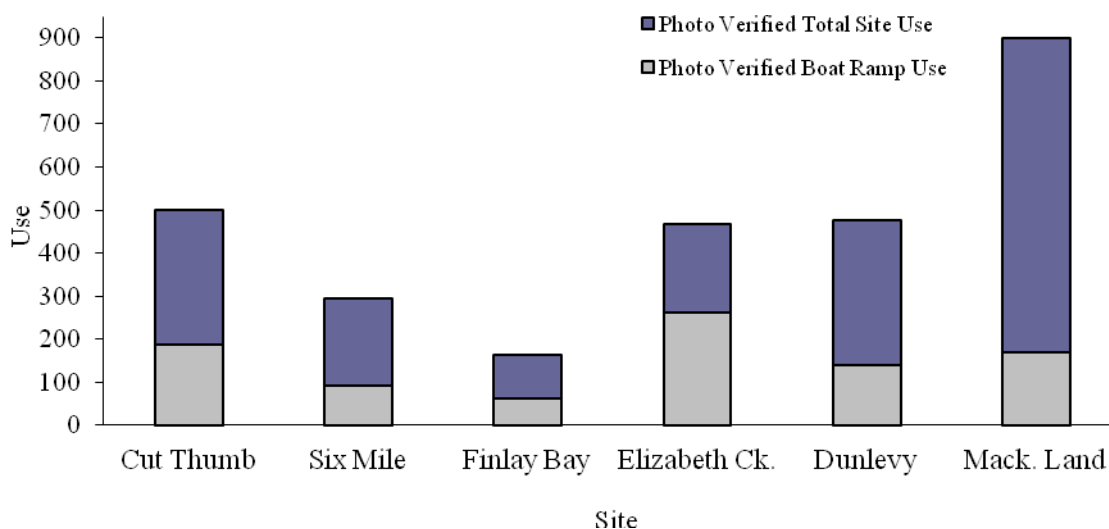
Figure 4. Proportion of photo-validated vehicles bringing boats to the recreation sites between May 17 and October 31 2011.

A total of 18,707 photos were collected with 9,981 corresponding to vehicle counter events. The proportion of photo-validated site users that brought boats varied from 18.7% at Mackenzie Landing to 55.8% at Elizabeth Creek (Figure 4, Table 5). Mean photo success was 64% and ranged from 32% at Finlay Bay to 99% at Elizabeth Creek. Boaters visited all sites throughout the monitoring period (Table 6). On average, visitors with boats stayed longer than 8 hours at all sites (Table 7). The number of easily recognized repeat visitors per site ranged from 11 (Finlay Bay) to 141 (Mackenzie Landing; Table 8). Cameras were removed at the end of season but camera lock boxes were left on site to facilitate re-deployment of monitoring equipment next spring.
