Kinbasket Reservoir Monitoring of the Valemount Peatland

Reference: CLBMON-08

Final Report

Kerr Wood Leidal Associates Ltd.
200 - 4185A Still Creek Drive
Burnaby BC V5C 6G9
604-294-2088

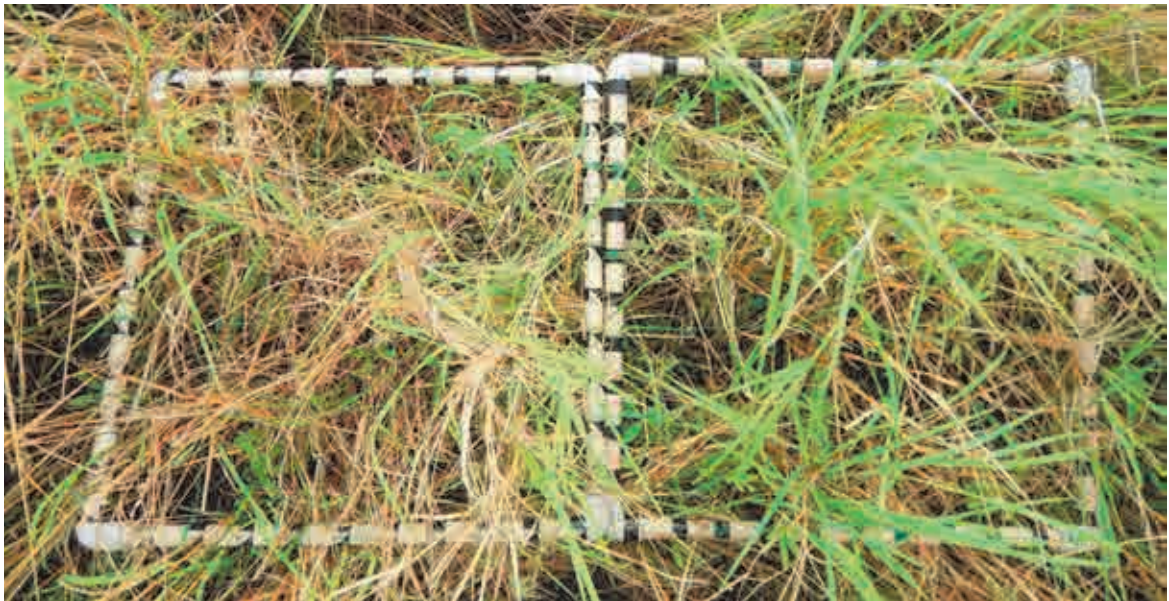
Rectangular 0.5 m² plots, consisting of two adjacent 0.5 x 0.5 m quadrats, were established at each transect point (Photo A). Percent ground covers, species composition and species vigour were recorded for each plot. Percent ground covers were estimated to the closest 0.1% for live vegetation, litter, bare ground, water, coarse woody debris, and rocks within each plot. Soil decomposition, pH, and electrical conductivity (EC) were measured for plots with moist or wet peat. The degree of soil decomposition was evaluated using the von Post Scale of Humification (Ekono 1981). Soil pH and EC (mS/m) were measured using an Oakton Instruments digital pH meter.

Photo A: Example of 0.5 m x 0.5 m quadrats placed for vegetation sampling. Percent cover of each layer was estimated at ground level (i.e., below vegetation canopy).

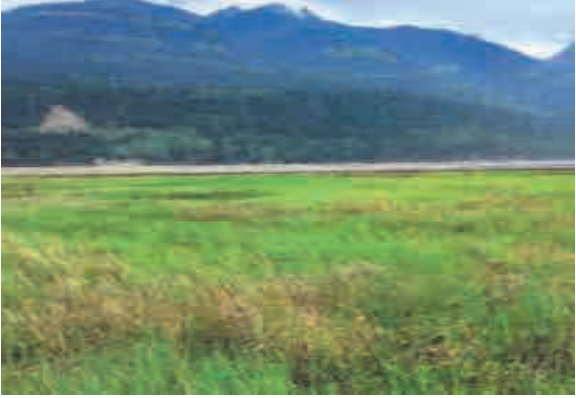
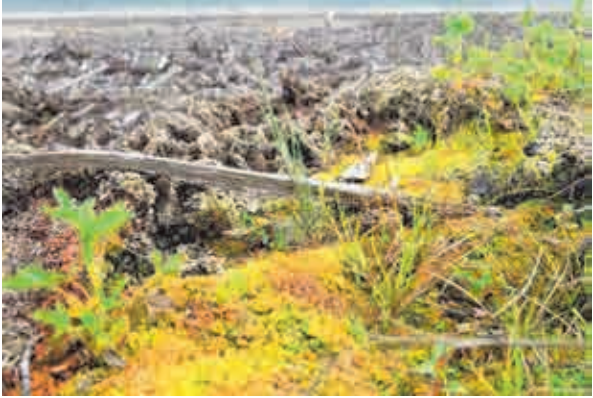
Terrain Feature	Vegetated Peatland
Photo Location (Figure 2-1)	1 (left), 2 (right)
Inferred Process	Deposition
Occurrence/Coverage	Limited to western edge of project area

Comment on Process Mechanism	A healthy peatland environment is typically a depositional environment in which vegetation accumulates in layers on top of older, decaying vegetation to eventually form peat (Photo 1). Photo 2 (right) shows the edge of living vegetation on the peatland.

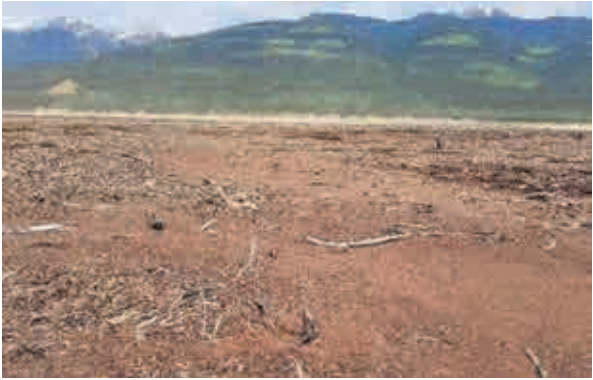
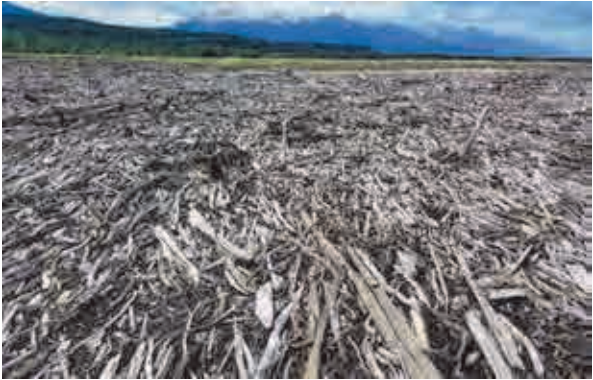
Terrain Feature	Wood Debris
Photo Location (Figure 2-1)	3 (left), 4 (right)
Inferred Process	Deposition
Occurrence/Coverage	Extensive coverage throughout non-vegetated section of peatland

Comment on Process Mechanism	When reservoir levels are high, floating wood debris is likely washed into this part of the reservoir. When reservoir water levels recede, wood debris is deposited onto the ground surface (Photo 3). Some fine wood debris may be windblown. In some areas, the woody debris deposits appeared to be imbricated: their position is aligned with the direction of receding water (Photo 4).

It is hypothesized that wood debris deposits observed in the non-vegetated portion of the peatland are related to reservoir operations and have contributed to the observed vegetation loss. The wood debris floats along the water surface when reservoir levels are high and is likely blown into the northern part of the Kinbasket Reservoir. This hypothesis is substantiated by the prevailing wind direction in the Valemount area (Figure 3-11). When reservoir levels recede, the wood debris is deposited on the ground surface. The deposition of wood debris buries existing vegetation and limits future growth of wetland plant species. The location and extent of the wood debris ground coverage can change notably from year to year (Figure 3-5), further limiting the colonization of wetland flora. The impacts of wood debris on the recolonization of natural vegetation in the Kinbasket Reservoir drawdown zone has been identified previously (Hawkes 2016), and a management program (CLBWORKS-16) has been in place since 2008 to remove wood debris from the Kinbasket Reservoir (BCH 2018).

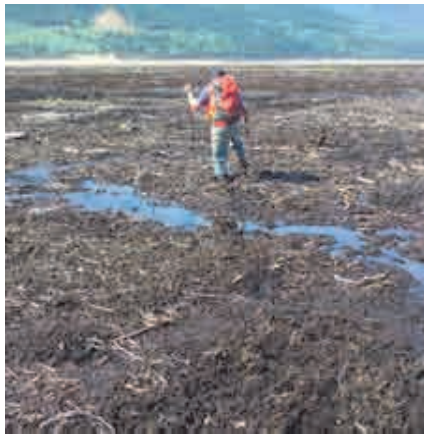
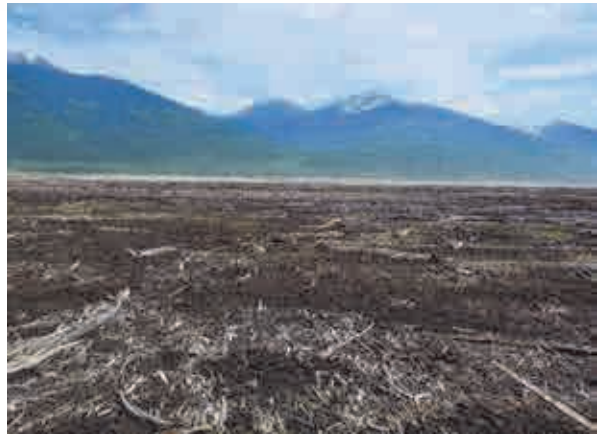
Terrain Feature	Exposed Peat
Photo Location (Figure 2-1)	5 (left), 6 (right)
Inferred Process	Erosion
Occurrence/Coverage	Extensive coverage throughout non-vegetated section of peatland
Comment on Process Mechanism	Exposed peat material is initiated by the loss of living peatland surface vegetation. This is likely occurring as a result of two concurrent processes: prolonged water inundation and deposition of wood debris on the peat surface. Once vegetation is absent from the peatland surface, desiccation, wind, and wave processes further expose and erode the peat material.

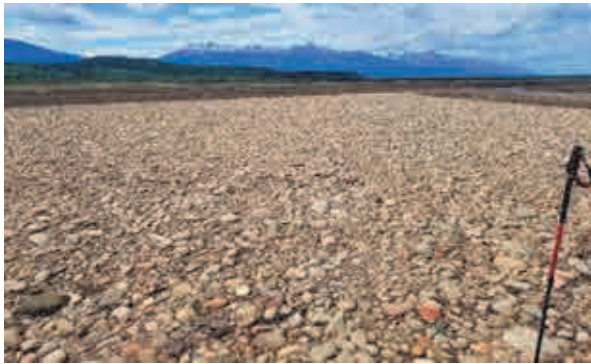
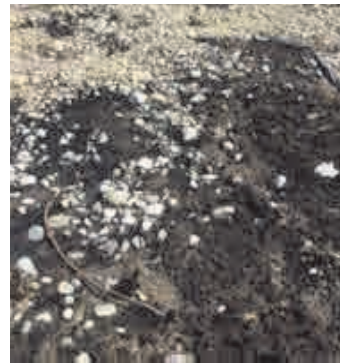
Terrain Feature	Cobble Terrace
Photo Location (Figure 2-1)	7 (left), 8 (right)
Inferred Process	Erosion (exposure of former fluvial depositional feature)
Occurrence/Coverage	A few isolated locations adjacent to the Canoe River
Comment on Process Mechanism	Originally formed by historic fluvial depositional processes, this terrace feature, which appears to underlay the peat material (Photo 8), is now being exposed by the erosion of the peat material via desiccation, wind, and wave processes (Photo 7).

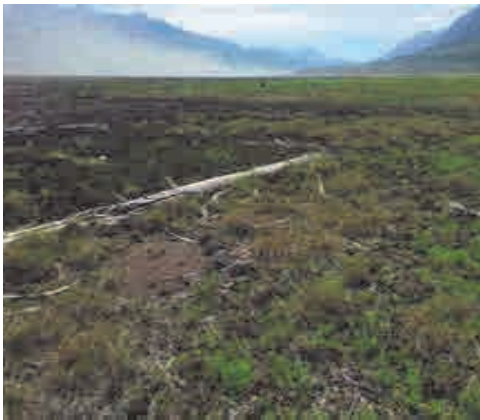
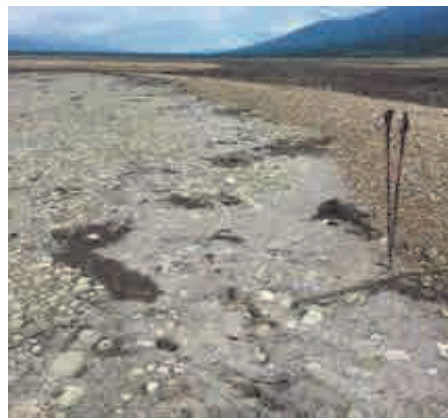
Terrain Feature	Scarp
Photo Location (Figure 2-1)	9 (left), 10 (right)
Inferred Process	Erosion
Occurrence/Coverage	Minor occurrences along a few isolated areas along the peatland vegetation boundary (Photo 9), and along the eastern edge of exposed cobble terrace feature (Photo 10).
Comment on Process Mechanism	This type of erosion is likely occurring from wave-related processes.

Wave related processes appear to be a secondary source of erosion within the project area. Wave erosion features were observed in the form of two scarps (Table 3-1): one along the cobble terrace and another at the southern edge of the peatland vegetation boundary. It is assumed that if wave processes were notably impacting the vegetated peatland, or other terrain types, it would have been more evident during the field visit. Although the prevailing winds are from the SE direction (Figure 3-11), wave activity may be limited since the average wind speeds tend to be lowest when the reservoir elevation is at and above the vegetation boundary (Figure 3-9). Wave activity may also be limited within the Kinbasket Reservoir due to shallow gradients and low water depths that limit wave height formation. However, further analysis would be needed to confirm this assumption.

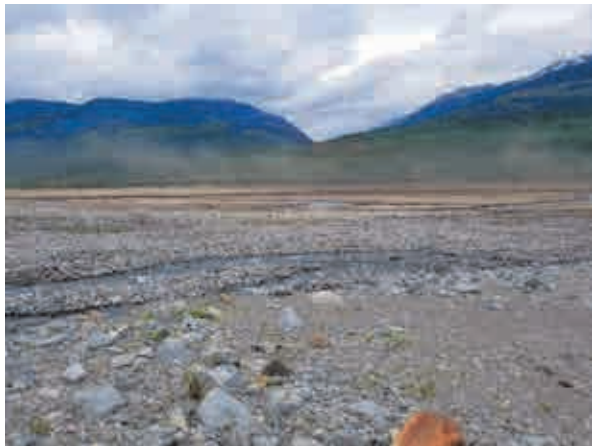
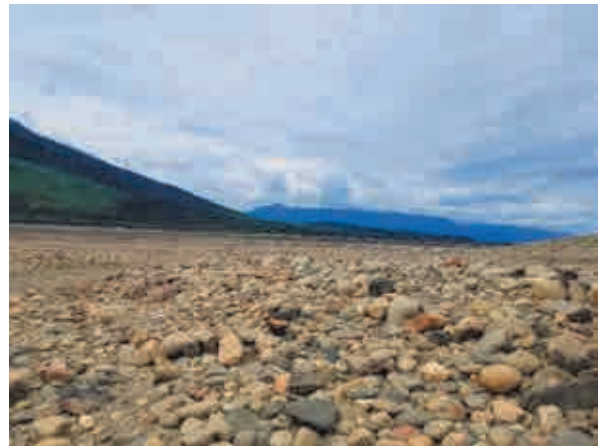
Terrain Feature	Alluvial Fans
Photo Location (Figure 2-1)	11 (left), 12 (right)
Inferred Process	Deposition
Occurrence/Coverage	There are two large alluvial fans within the project area: one at the outlet of David Henry Creek (Photo 12) and a second at an unnamed creek near the southwest corner of project area (Photo 11).
Comment on Process Mechanism	These are large depositional features that introduce a significant amount of sediment into the reservoir. It is not known if they cover peat material.

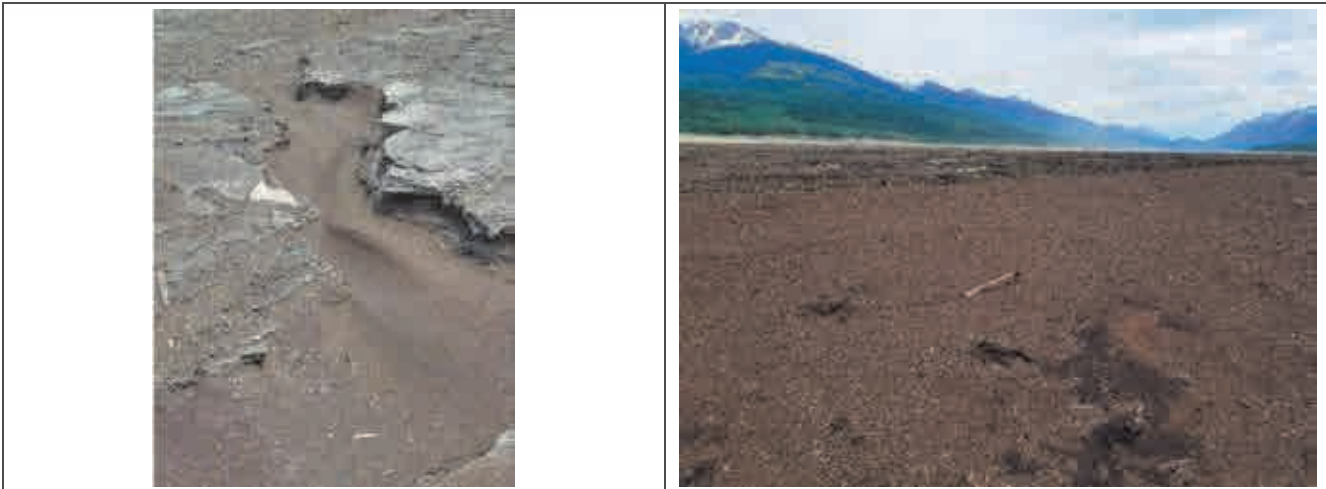
Terrain Feature	Dunes Comprised of Wood Debris
Photo Location (Figure 2-1)	13 (left), 14 (right)
Inferred Process	Deposition
Occurrence/Coverage	Moderate coverage throughout the non-vegetated section of the peatland
Comment on Process Mechanism	Wind-blown deposits of fine-grained wood debris subject to renewed erosion and redeposition (Photos 13 and 14).

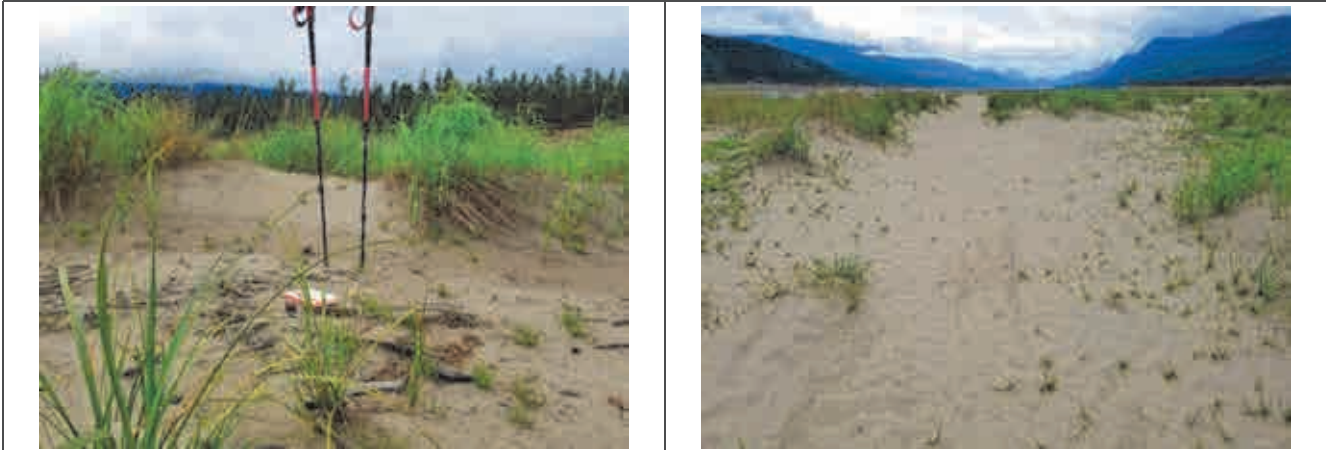
Terrain Feature	Dunes Comprised of Sand/silt
Photo Location (Figure 2-1)	15 (left), 16 (right)
Inferred Process	Deposition
Occurrence/Coverage	Concentrated occurrences in the north section of the project area.
Comment on Process Mechanism	Wind-blown deposits of sand/silt sized sediment (Photo 16) subject to ongoing erosion and redeposition (Photo 15).

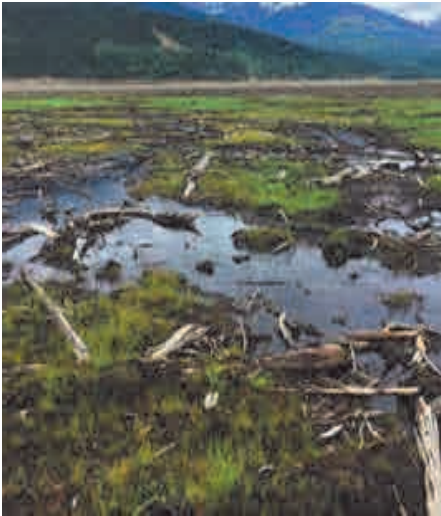
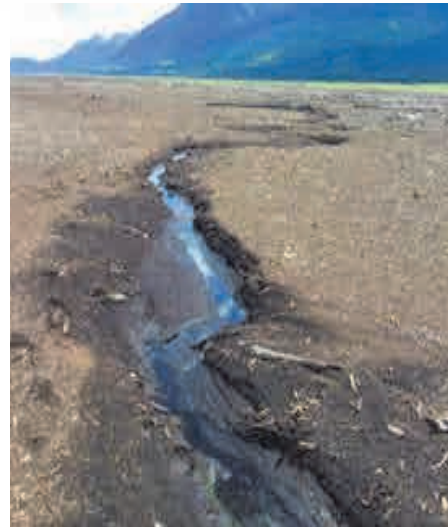
Terrain Feature	Rills
Photo Location (Figure 2-1)	17 (left), 18 (right)
Inferred Process	Erosion
Occurrence/Coverage	There are many rill channels across the project area; flowing from west to east into the Canoe River
Comment on Process Mechanism	These rill structures are fed by small ponds and poorly-defined drainage channels in the vegetated portion of the wetland (Photo 17). These rills transition into well defined, and incised, channels within the exposed peat and wood debris terrain (Photo 18).

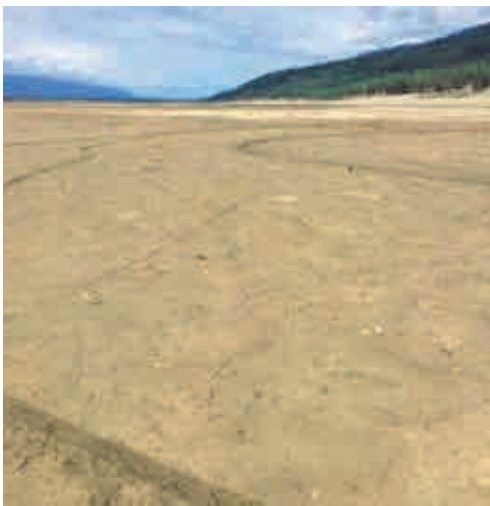
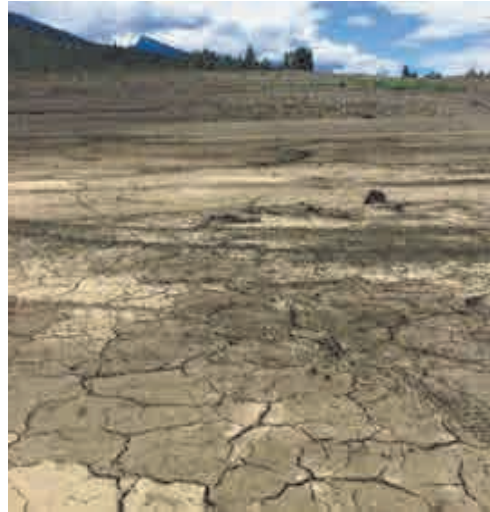
Terrain Feature	Lacustrine Deposits
Photo Location (Figure 2-1)	19 (left), 20 (right)

Inferred Process	Deposition
Occurrence/Coverage	Extensive coverage within the south and eastern portions of the project area
Comment on Process Mechanism	These deposits are primarily silt- and sand-sized sediments. Some of the lacustrine deposits appear darker in colour (Photo 20), which is a result of being moist compared to the lighter-coloured dry areas.

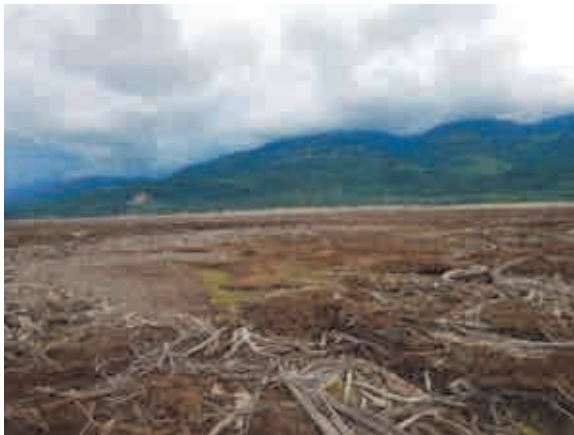
Photo B: View from the end of the living vegetation zone on Transect 7 facing North showing the absence of visible living vegetation.

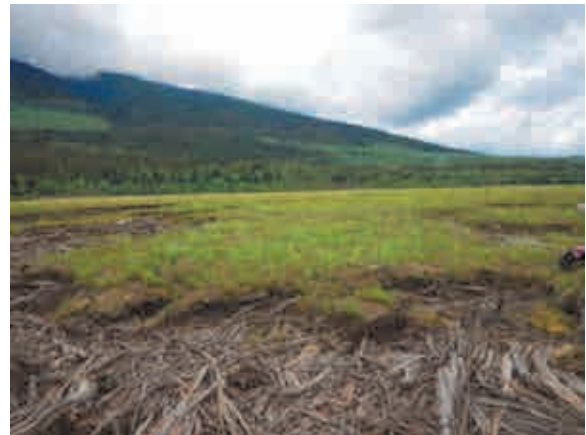
Photo C: View from the end of living vegetation zone on Transect 7 facing South showing the distinctive edge of living vegetation.

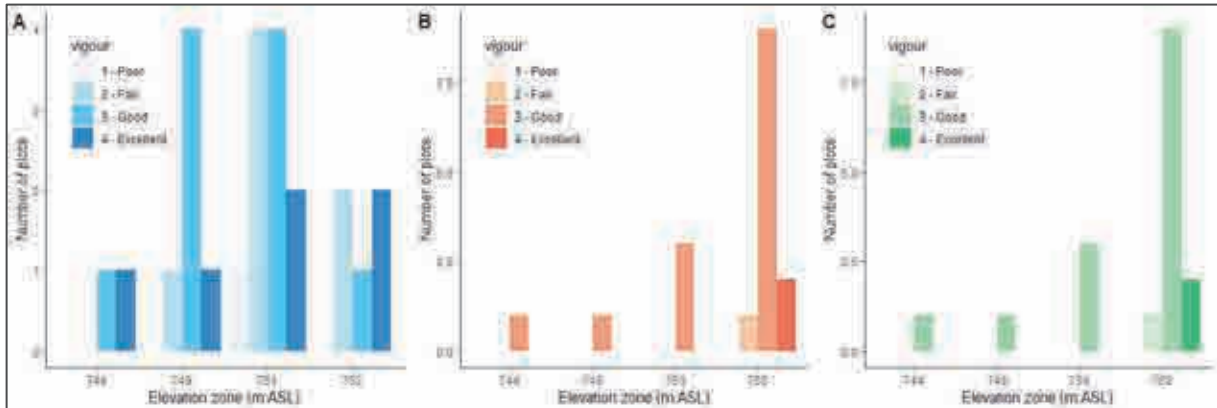
C. aquatilis, *C. palustre*, and *E. fluvitale* were found within plots at each elevation zone. While the number of occupied plots decreased with elevation (Figure 3-1B, Figure 3-2), the majority of plants exhibited Good to Excellent vigour in all elevation zones.

Figure 3-2: Vigour Exhibited by the Three Most Common and Widely Distributed Species (A = *Carex aquatilis*, B = *Comarum palustre*, C = *Equisetum fluvitale*) within surveyed Plots at Each Elevation Zone

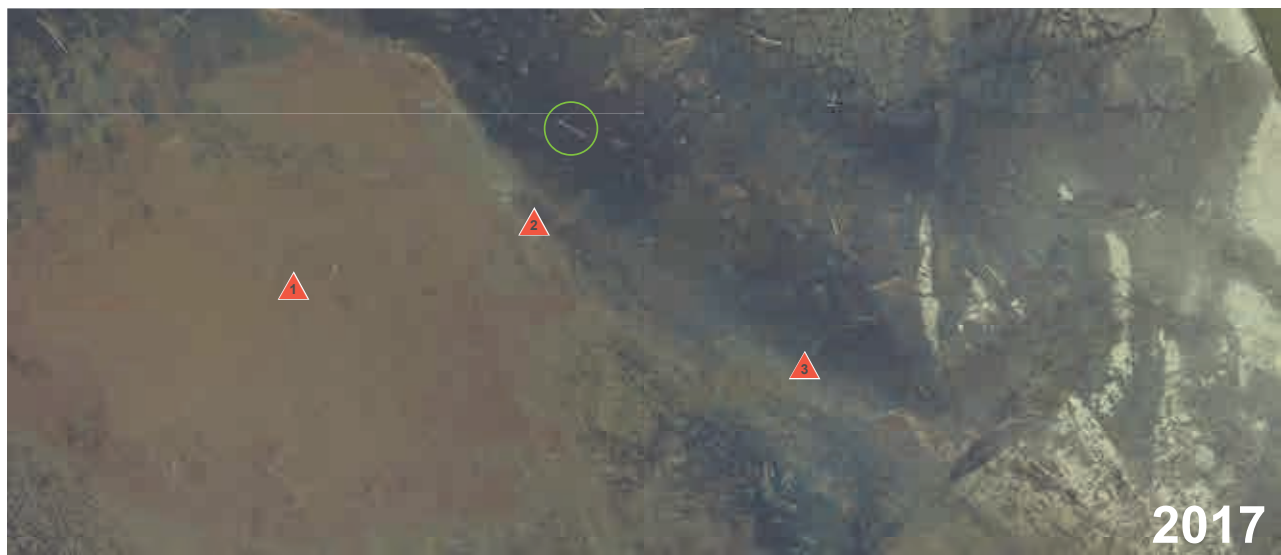
Figure 3-4

Changes in Cobble Terrace Exposure, 1993 to 2019

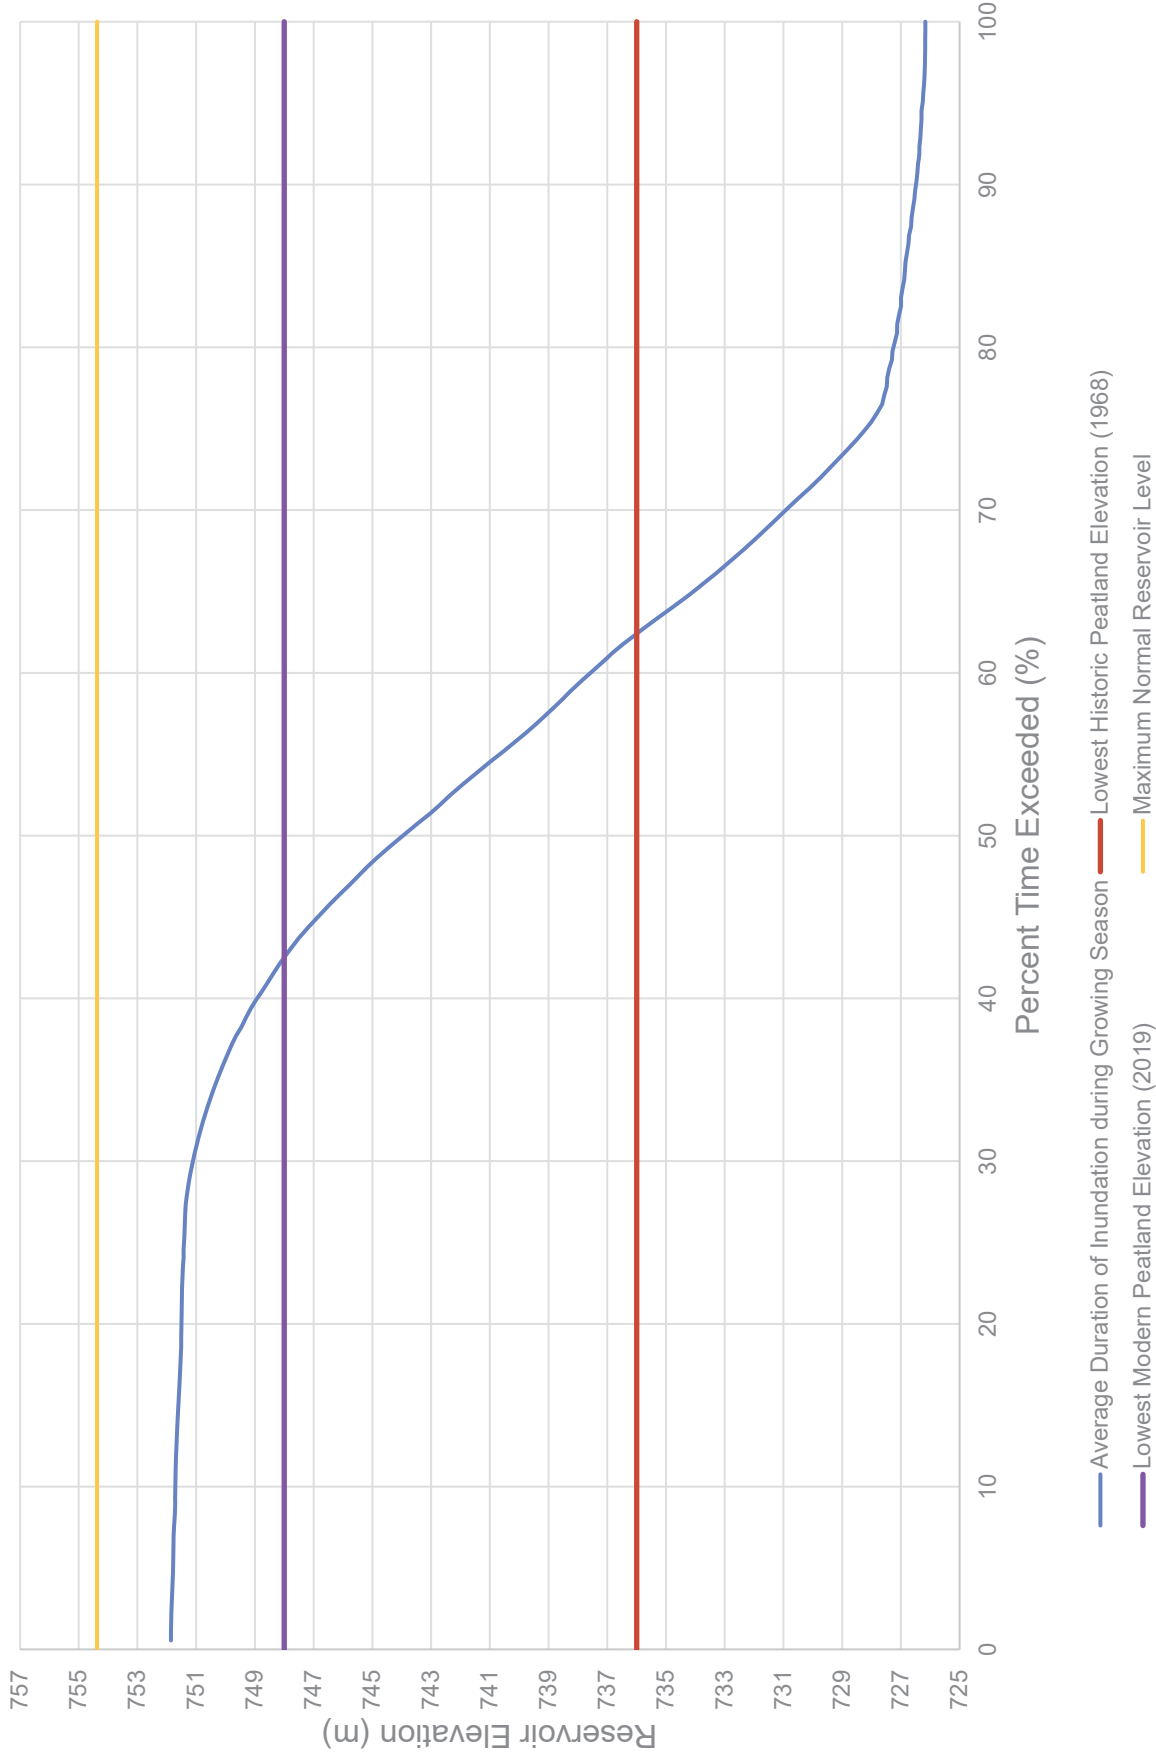
Figure 3-8: Average Duration of Reservoir Inundation During the Growing Season, 2007 to 2018

It is suspected that prolonged inundation of the peatland (Figure 3-8) is generally responsible for the reduction in the size of the vegetation peatland compared to pre-reservoir conditions due to water stress on the vegetation community (LGL 2017). However, it is not clear why the boundary of the vegetated portion of the peatland appears to be situated at ~749 m ASL and has stayed in this position since at least 2016 (Figure 3-3). Reservoir levels routinely exceed an elevation of 749 m ASL (Figure 3-7). However, inundation of this elevation of the vegetated peatland area occurs for 40% or less of the growing season (Figure 3-8). It is hypothesized that the effects of inundation at this elevation (and above) reflect a threshold at which peatland flora can withstand inundation the reservoir operations impose.

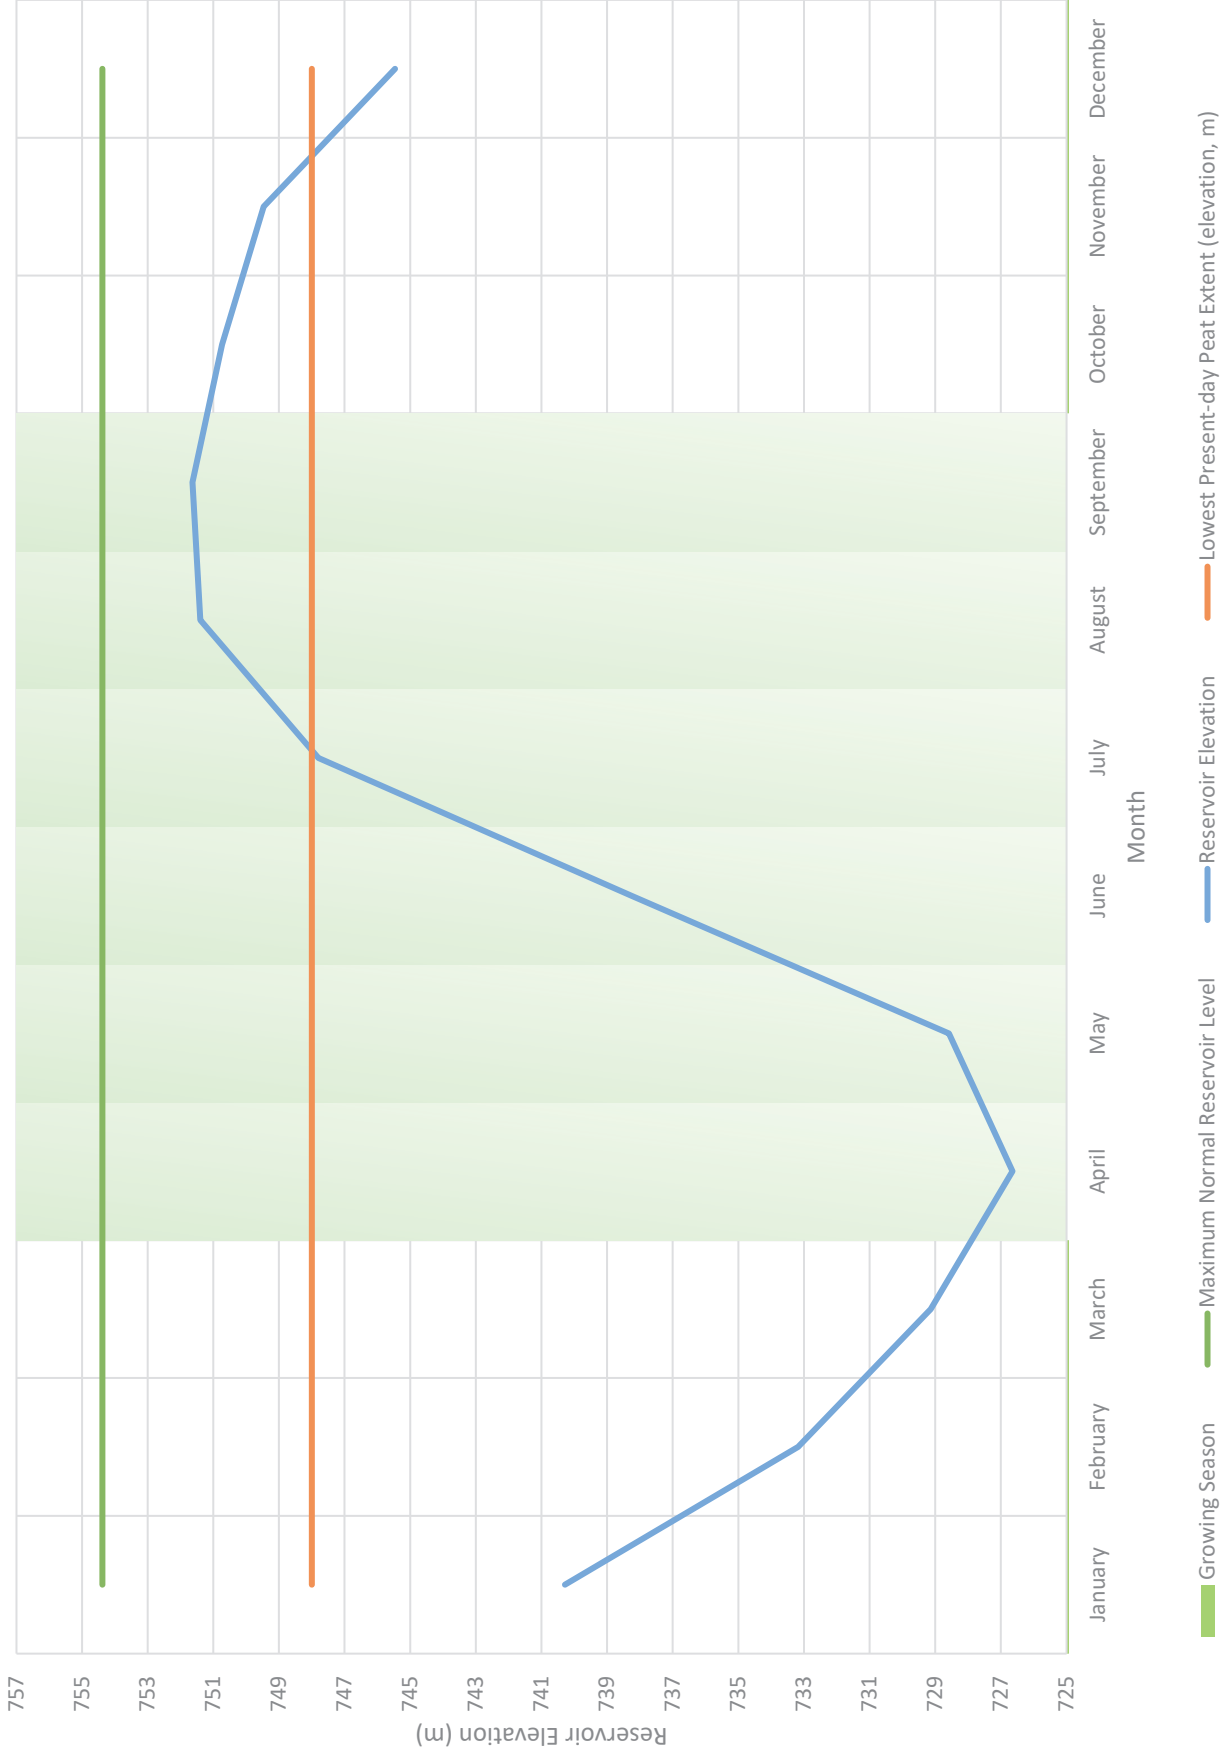
Figure 3-9: Mean Monthly Reservoir Elevation (2007 to 2019) throughout the Growing season
