## **Columbia River Project Water Use Plan**

**CLBWORKS-30B Wildlife Enhancement Program – Wetland Enhancement Program**

***CLBWORKS-30B Burton Flats Fish Stranding Assessment – Risk Analysis and Summary Report***

**Study Period: January 2018 to October 2018**

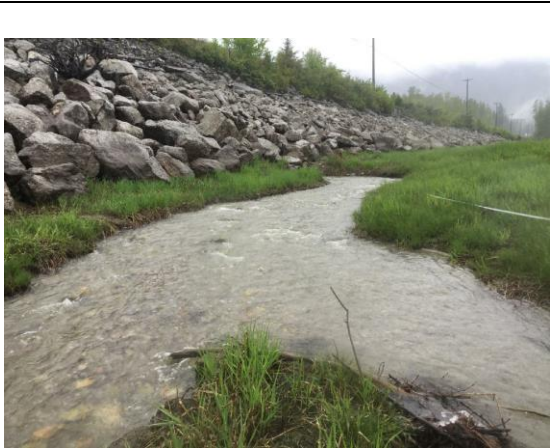
Photo 1: Upstream view at T5 (near culvert outlet) (May 8, 2018).

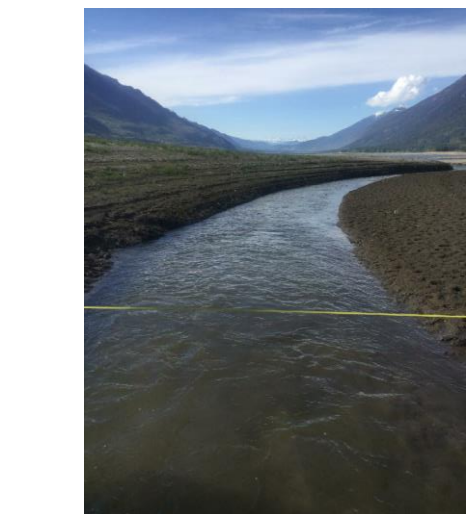
Photo 4: Downstream view at T1 (near outlet to Lower Arrow Lakes Reservoir) (May 9, 2018).

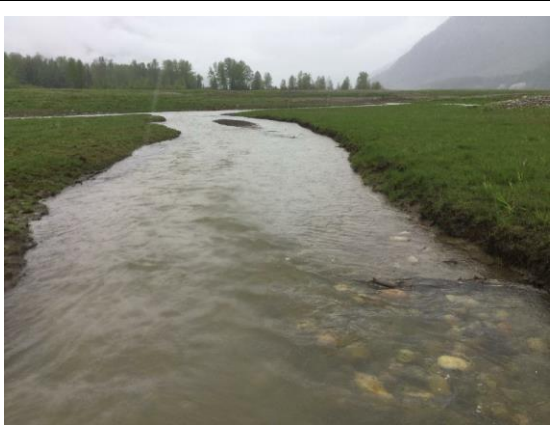
Photo 5: Downstream view at T4 (near confluence with Channel 2) (May 8, 2018)..

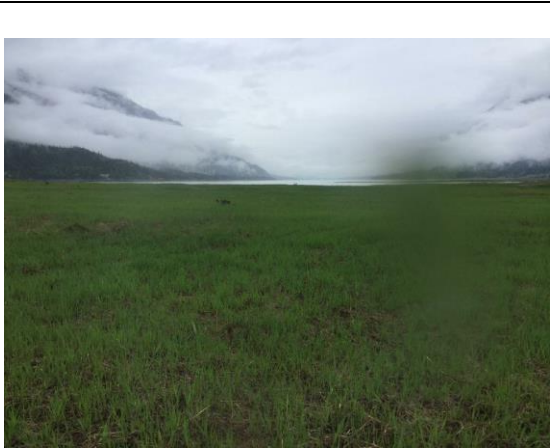
Photo 1: Downslope view upslope from section of non-defined channel (May 8, 2018).

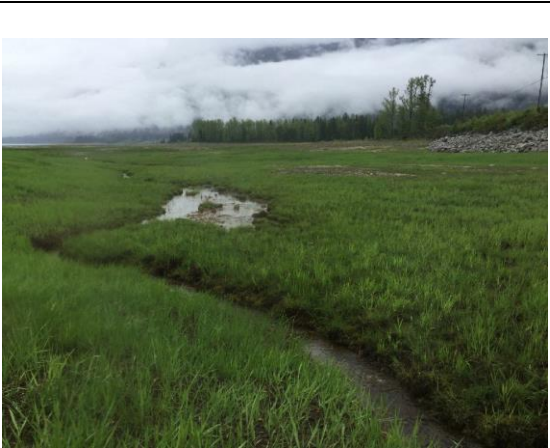
Photo 2: View of channelization downstream from culvert outlet (May 8, 2018).

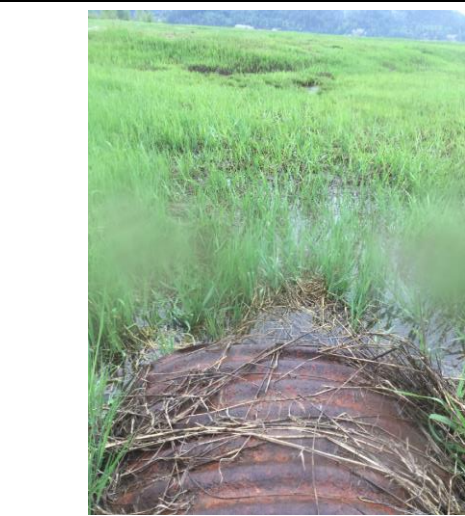
Photo 3: Downslope view of culvert outlet within non-defined channel section (May 8, 2018).

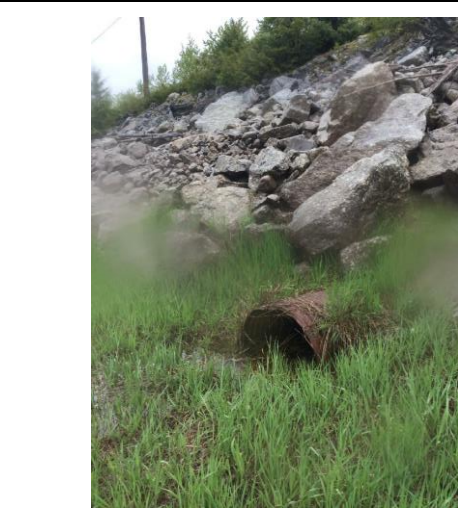
Photo 4: View of culvert outlet under Highway 6 (May 8, 2018).

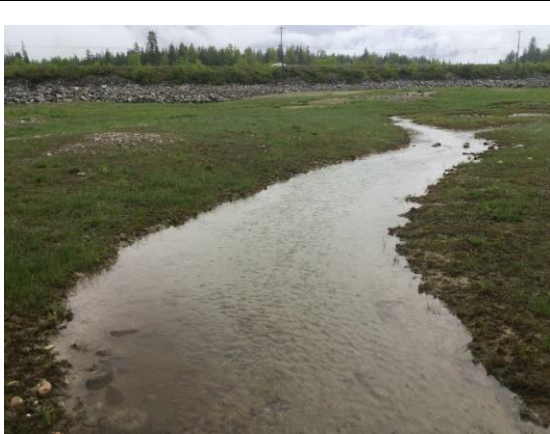
Photo 5: Upstream view at T6 (near confluence with Channel 1) (May 8, 2018).

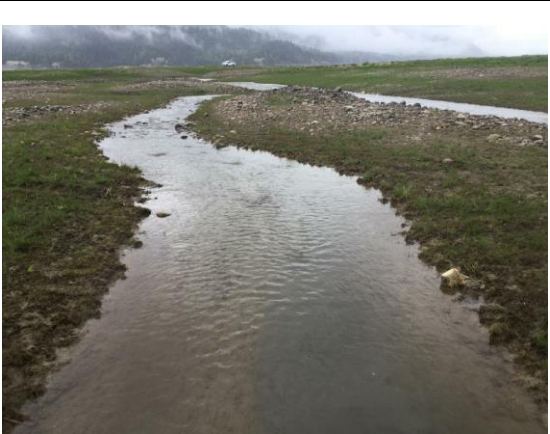
Photo 6: Downstream view at T6 (near confluence with Channel 1) (May 8, 2018).
