Aberfeldie Redevelopment Project Water Use Plan

Riparian Vegetation Monitoring

Reference: ABFMON-5 Task 2C

Q9-9576 Aberfeldie Dam Station Fisheries Habitat Compensation
Monitoring Project

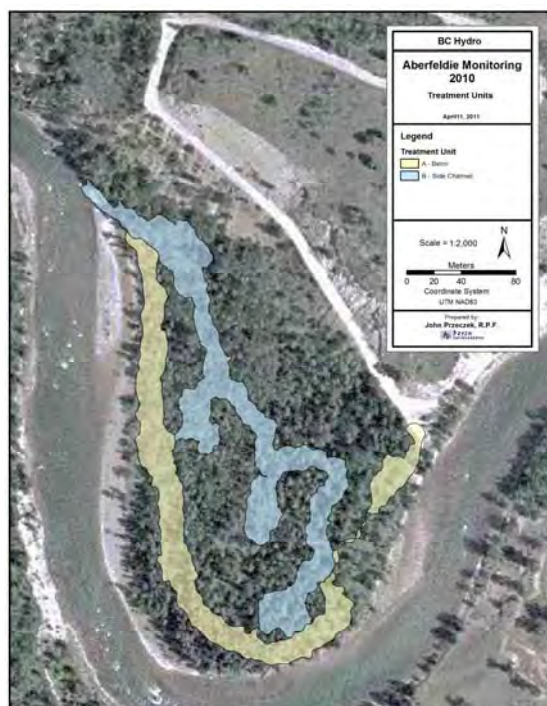
The study area was stratified into two treatment units (TU; Figure 2): the berm (TU A) and the sides of the side channel (TU B). These treatment units were stratified to reflect ecological differences that included variation in slope, aspect, and proximity to a stream channel. These two TUs also received different restoration combinations (Table 1). TU A was further stratified for the purpose of monitoring the development of seeded agronomic grasses and legumes into Berm Side (BS; west-facing slope of the constructed berm) and Berm Top (BT; flat top of the constructed berm) and all other disturbances were combined. TU B was further stratified for the purpose of monitoring the development of seeded agronomic grasses and legumes into River Side (RS; westerly side of the channel) and Plant Side (PS; easterly side of the channel) to capture potential differences in seeding success.

Figure 2. Treatment units identified at the Aberfeldie side channel study area (yellow=berm, TU A; blue=side channel, TU B).

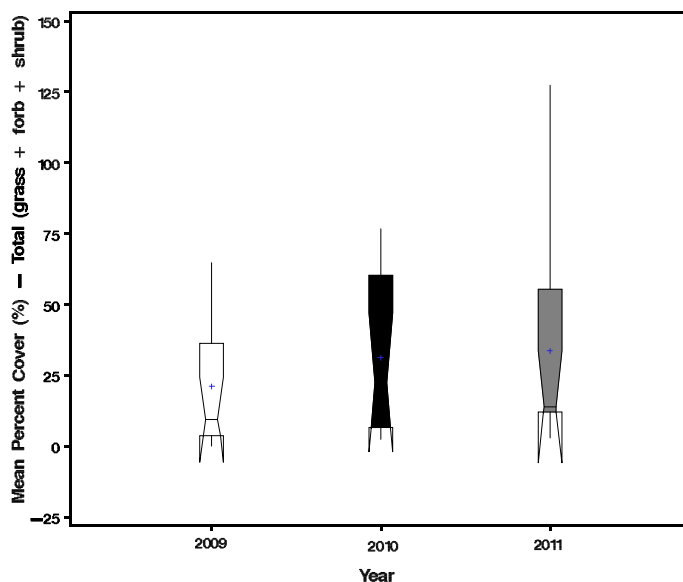
Overall, the amount of total vegetation cover has been holding constant between $20.9\% \pm 3.1$ (since 2009 when the compensation project was initiated to $33.6\% \pm 5.0$ in 2011 (Figure 5; Table 5).

Figure 5. Box plot of mean total percent cover (%) for grass, forb & shrubs from 2009 to 2011 combined across all areas (berm and side channel) at the Aberfeldie side channel study area. Boxes represent 50% of the data. Medians are indicated by notches and the mean is indicated by '+'. Tails extend to minimum and maximum values.

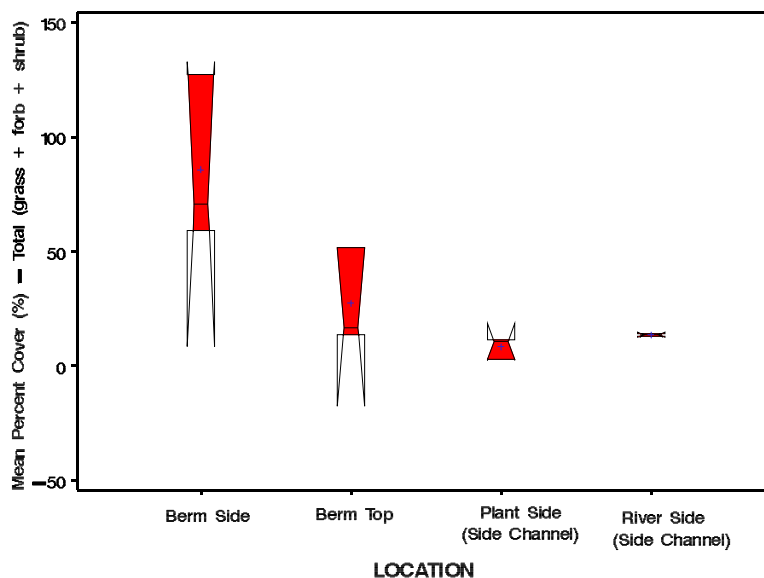
Although total plant cover appears to have remained constant from 2009 to 2011, it depends on site location (Table 5). Total plant cover was significantly greater on the berm-side (mean \pm SE: $85.5\% \pm 10.7$) than on the berm top ($27.2\% \pm 6.0$; Figure 6). Total percent cover was significantly lower in the side channel, both on the plant ($8.2\% \pm 1.6$) and the river side ($13.3\% \pm 1.83$).

Figure 6. . Box plot of mean total percent cover (%) for grass, forb & shrubs at the berm (side/top) and side channel (plant/river side) areas in 2011 at the Aberfeldie side channel study area. Boxes represent 50% of the data. Medians are indicated by notches and the mean is indicated by '+'. Tails extend to minimum and maximum values.

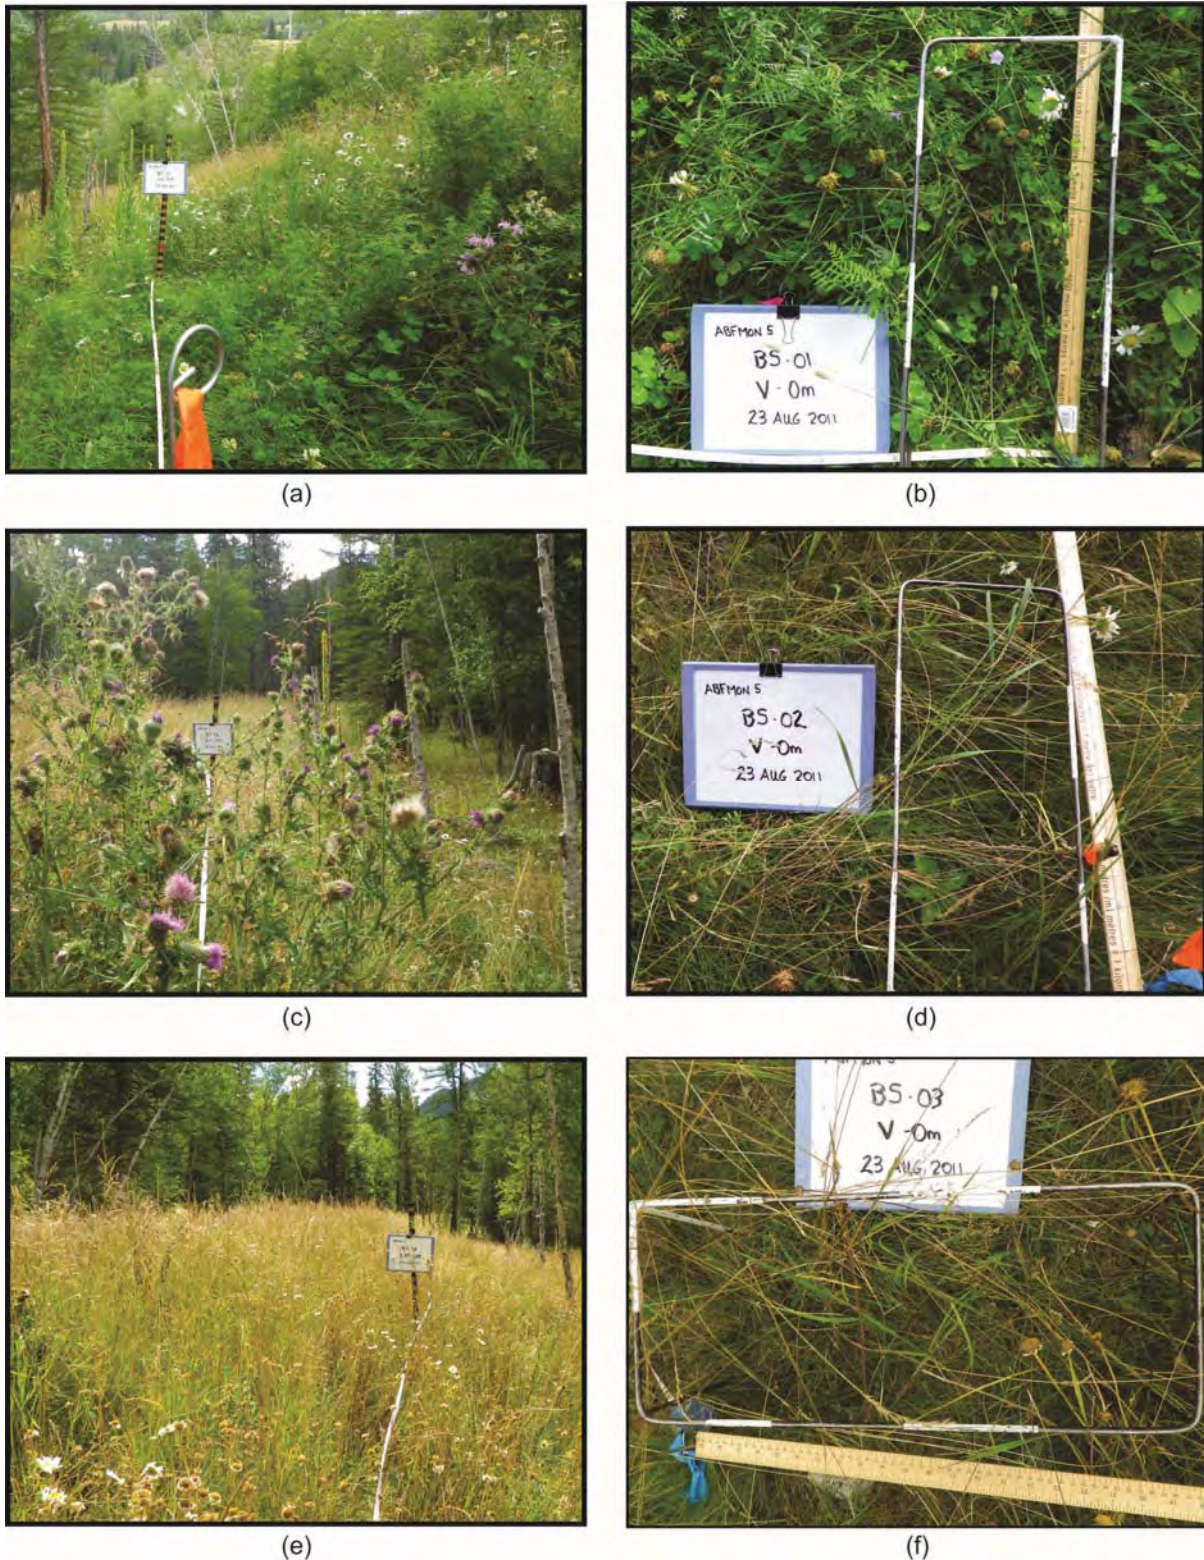
Plate 2. Various views of three permanent vegetation monitoring transects on the side of the berm:

(a) BS01 from EOT to SOT, (b) BS01 at 0 meters, (c) BS02 from EOT to SOT, (d) BS02 at 0 meters, (e) BS03 from EOT to SOT, and (f) BS03 at 0 meters.

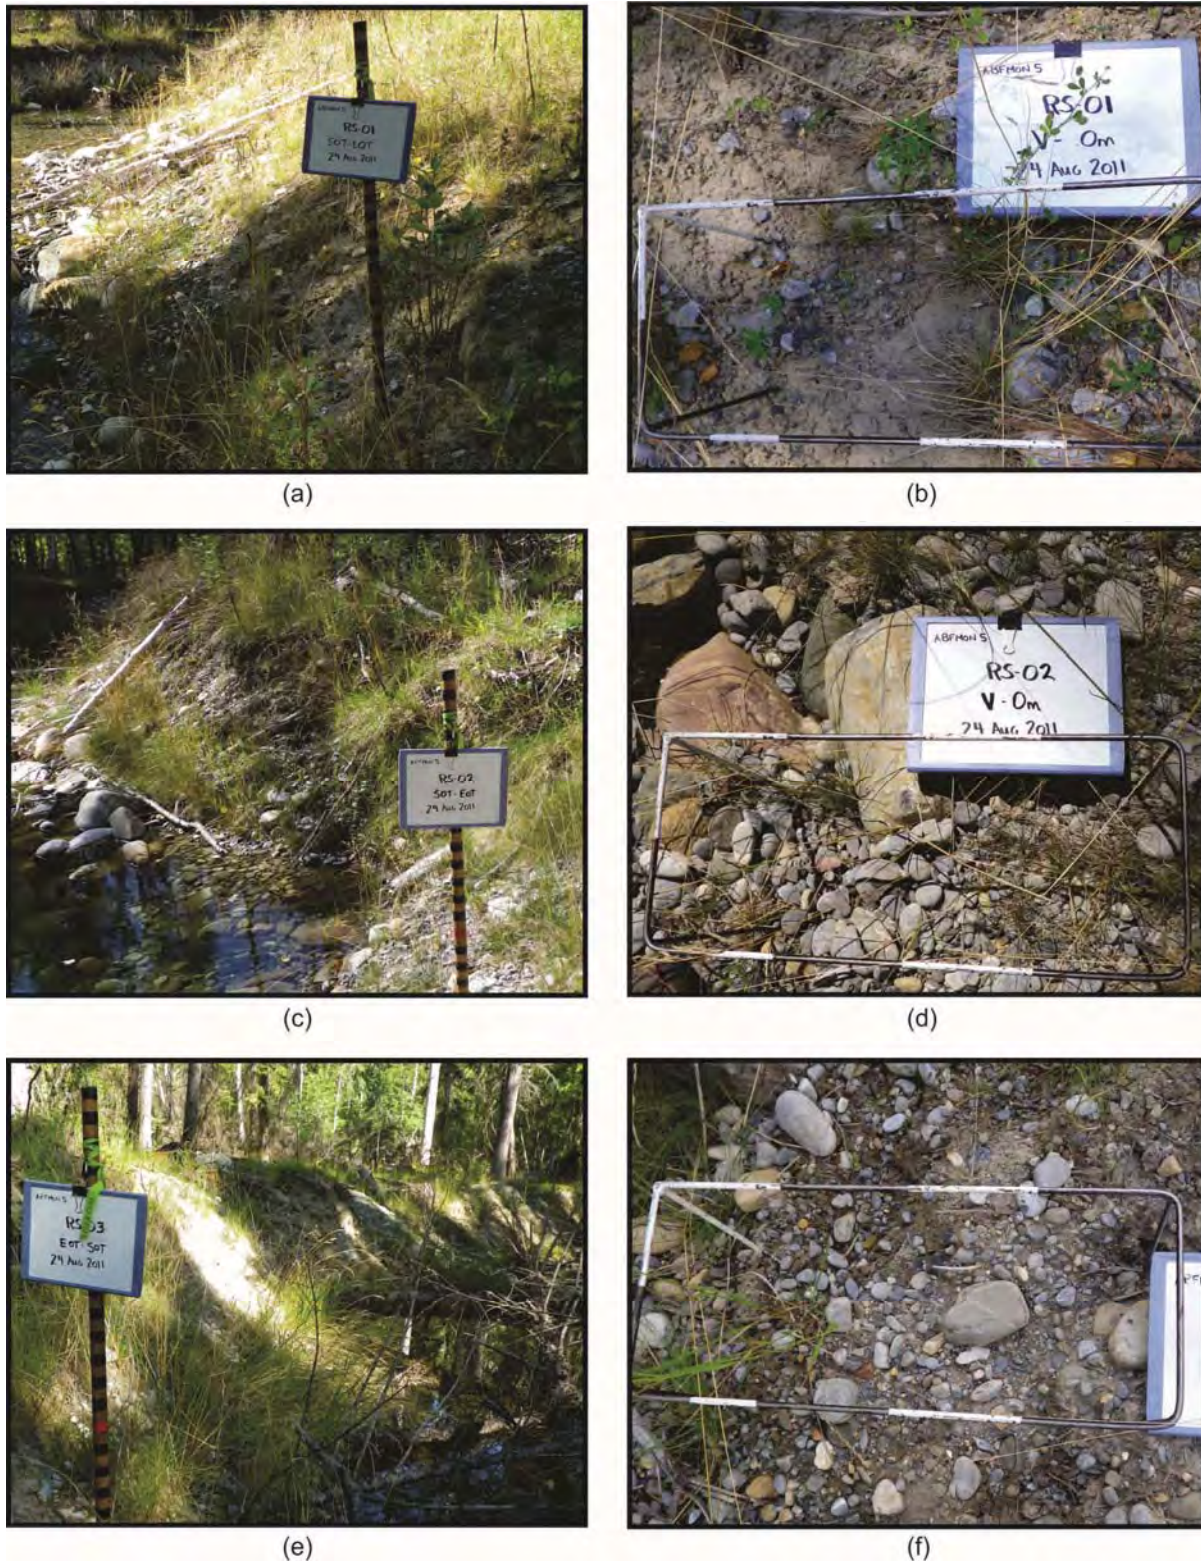
Plate 3. Various views of three temporary vegetation monitoring transects on the river side of the side channel: (a) RS01 from SOT to EOT, (b) RS01 at 0 meters, (c) RS02 from SOT to EOT, (d) RS02 at 0 meters, (e) RS03 from EOT to SOT, and (f) RS03 at 0 meters.
