Aberfeldie Redevelopment Project Water Use Plan

Riparian Vegetation Monitoring

Reference: ABFMON-5 Task 2C
Q9-9576 Aberfeldie Dam Station Fisheries Habitat Compensation
Monitoring Project

Implementation Year: 4

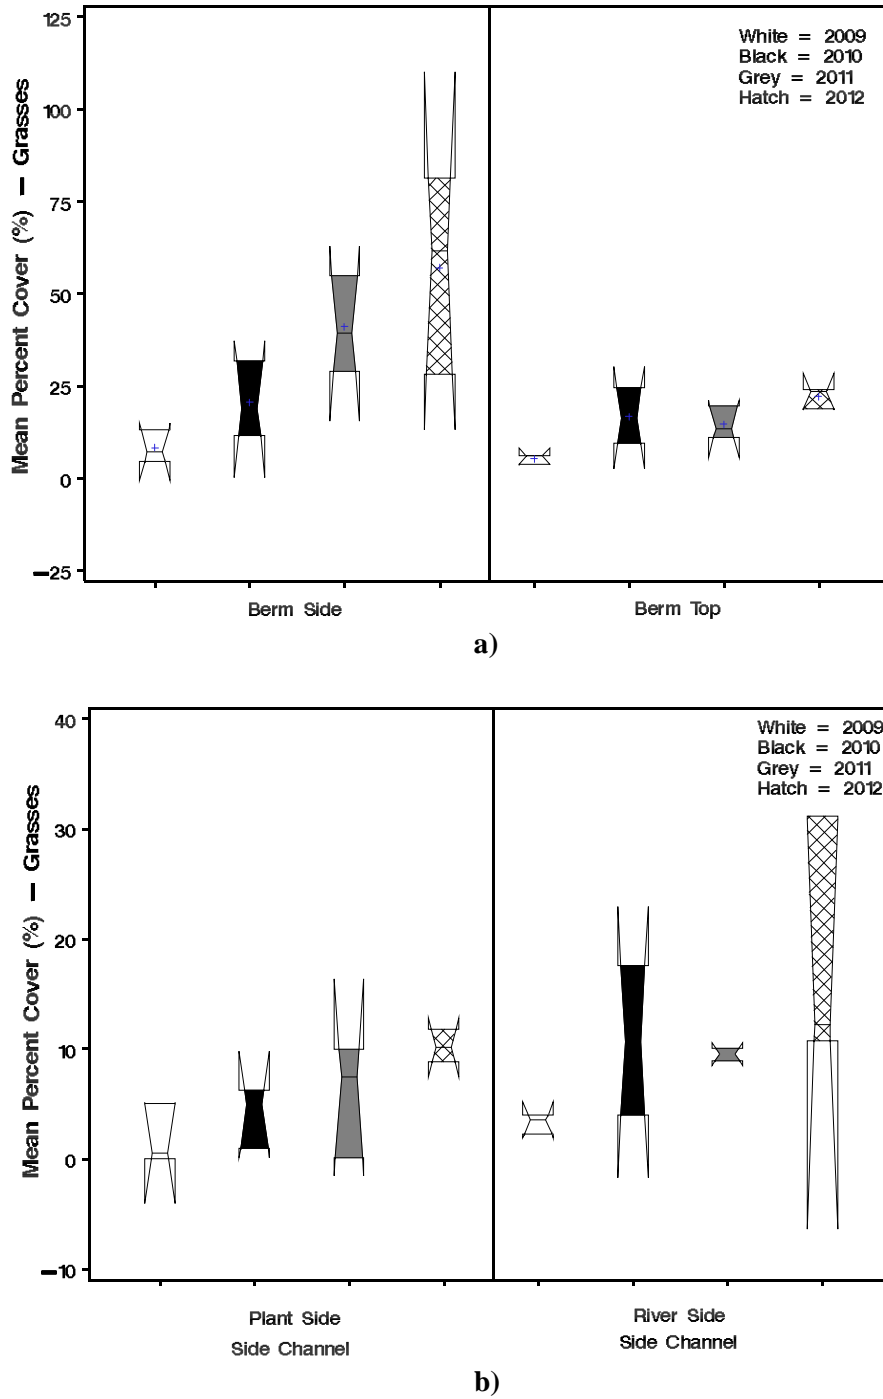
Grass coverage also varied significantly with the side channel areas (Table 5). Grass coverage was greatest on the berm, particularly on the berm side ($31.6\% \pm 3.4$), whereas the coverage of grass in the side channel was considerably lower (plant side: $5.3\% \pm 0.9$; river side: $10.4\% \pm 1.5$; Figure 4).

Figure 4. Box plot of mean percent cover (%) of grasses from 2009 to 2012 in the two side channel sections a) side/top of berm and b) plant /river side of the side channel at the Aberfeldie side channel compensation project. Boxes represent 50% of the data. Medians are indicated by notches and the mean is indicated by '+'. Tails extend to minimum and maximum values. Note different vertical axis labels in b).

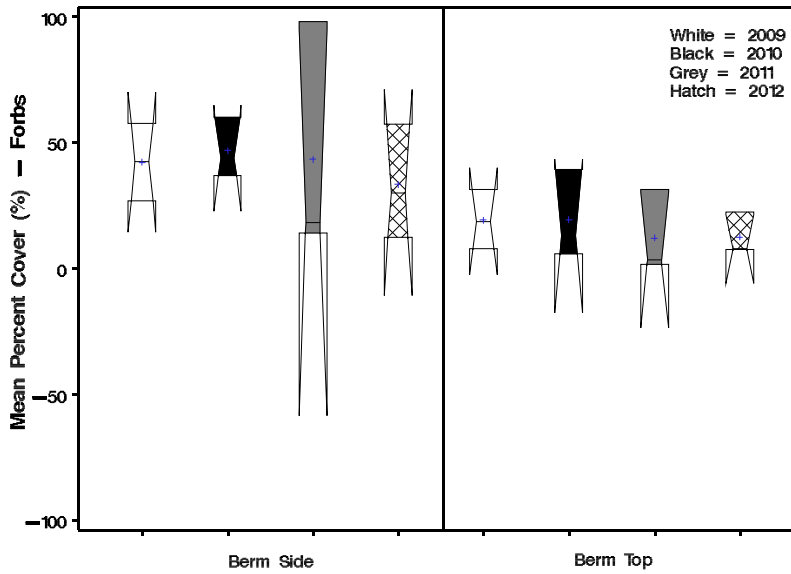
However, there continues to be significant differences in forb coverage depending on the section of the habitat compensation project. Forb cover was significantly greater on the berm side ($41.4\% \pm 4.0$) than on the berm top ($15.7\% \pm 2.5$; Figure 6a). Forb cover was significantly lower on both side channel locations compared to the berm locations (plant side: $2.0\% \pm 0.5$; river side: $3.9\% \pm 0.6$; Figure 6b).

Figure 6. Box plot of mean percent cover (%) of forbs from 2009 to 2012 in the two side channel sections a) side/top of berm and b) plant /river side of the side channel at the Aberfeldie side channel compensation project. Boxes represent 50% of the data. Medians are indicated by notches and the mean is indicated by '+'. Tails extend to minimum and maximum values. Note different vertical axis labels in b).

The cover levels of the two berm sites were higher than those of the two side channel sites (Figure 6). The main gate was left open and a number of cattle were found grazing in the side channel area. Wherever they crossed the side channel there was obvious disturbance to the side channel banks (Plate 8). The loose sandy/gravelly nature of the parent materials in the study area makes them particularly susceptible to disturbance which results in increased soil exposure, damage to developing plant communities, increased surface erosion, and introduction of invasive plants.

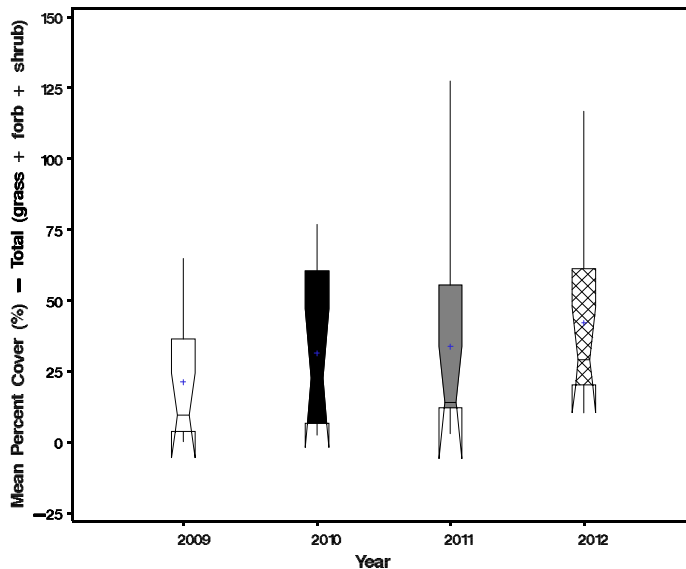
Overall, the amount of total vegetation cover has significantly increased over time ($20.9\% \pm 3.1$ in 2009 to $42.7\% \pm 4.8$ in 2012; Figure 7).

Figure 7. Box plot of mean percent total cover (%; grass, forb & shrubs) from 2009 to 2012 combined across all areas (berm and side channel) at the Aberfeldie side channel study area. Boxes represent 50% of the data. Medians are indicated by notches and the mean is indicated by '+'. Tails extend to minimum and maximum values.

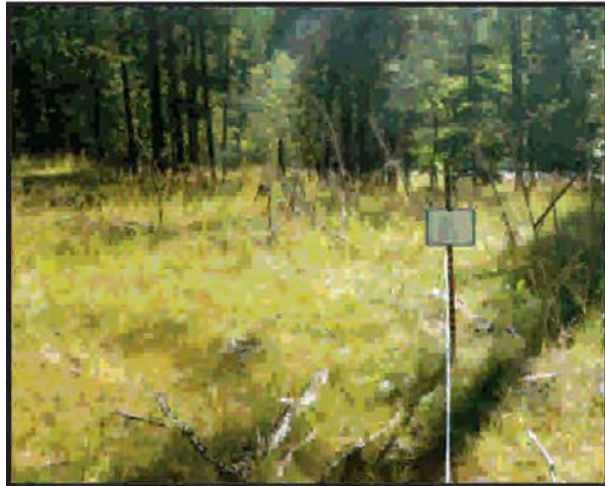
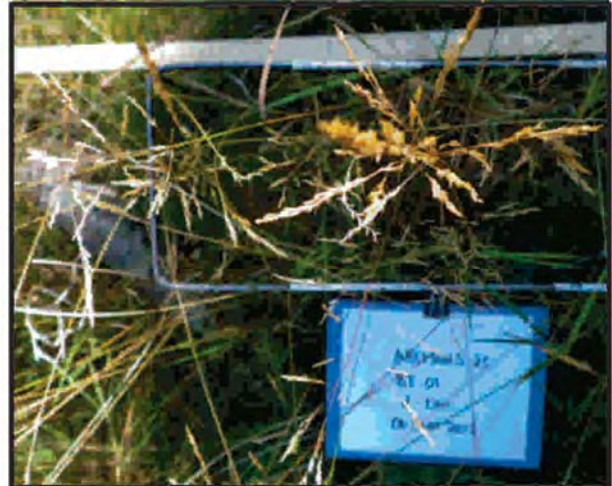
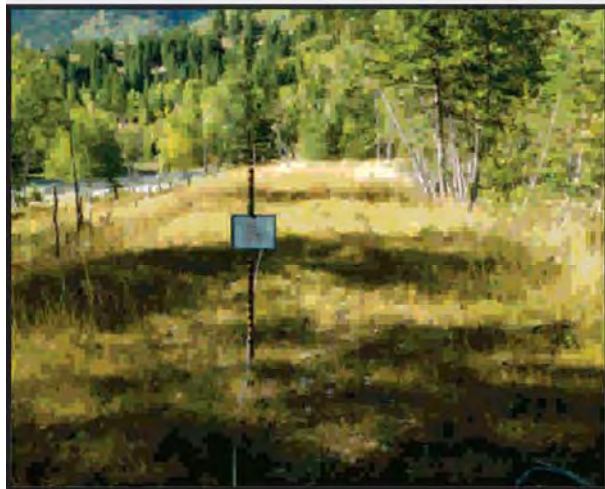
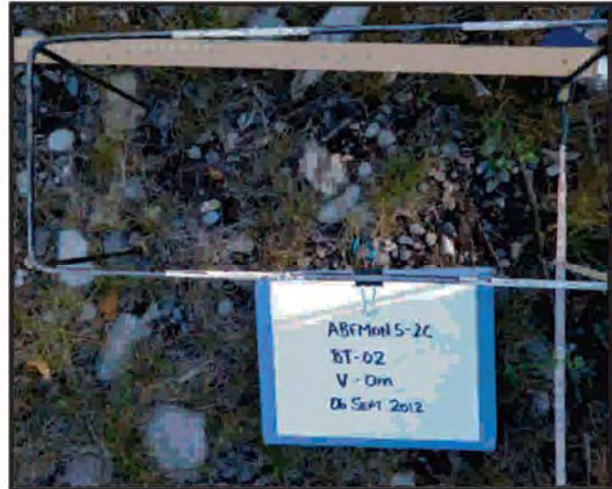
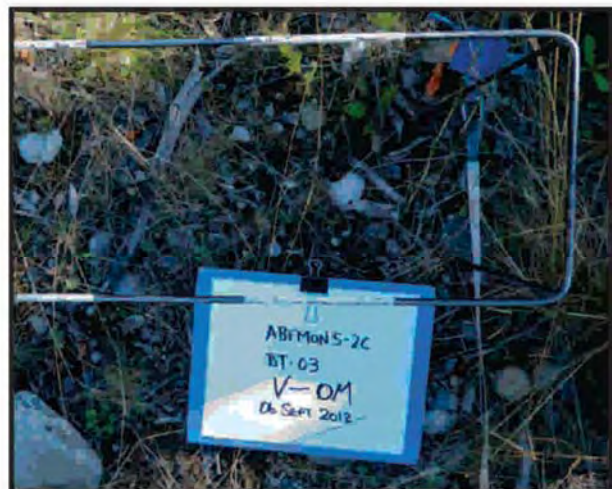
Plate 1. Various views of the three permanent vegetation monitoring transects on top of the berm: (a) BT01 from EOT to MOT, (b) BT01 at 0 meters, (c) BT02 from SOT to MOT, (d) BT02 at 0 meters, and (e) BT03 from SOT to EOT, (f) BT03 at 0 meters.

Seeded vegetation at the two berm sites (berm top and berm side) germinated consistently. Vegetation on the berm side is growing well and has considerable coverage (Figure 8). On the other hand, it is unlikely that the berm top location will meet the target of 60% cover set by Keefer (2006) (Table 6, Plate 1, Plate 2 and Plate 5). Seeded vegetation at the two side channel sites (river side and power plant side) germinated inconsistently and mean total cover for each site will not meet Keefer's (2006) target of 60% cover (Plate 3, Plate 4 and Plate 6). Vegetation cover at the two side channel sites continues to be very low and the likelihood of future plant establishment is low as long as slope instability continues to be an issue. Appendix 1 provides a summary of the vegetation data collected in 2009 - 2012.

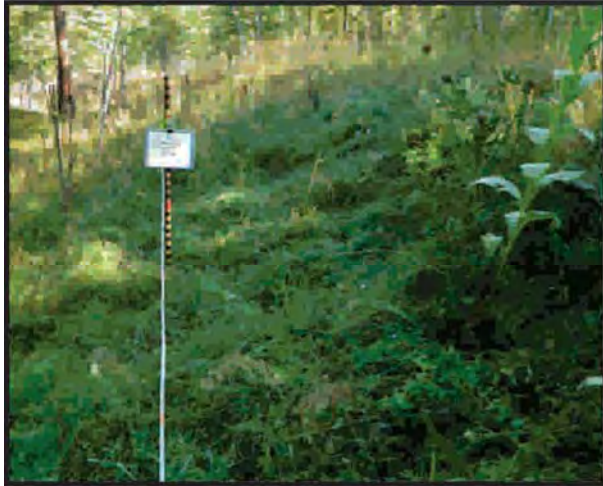
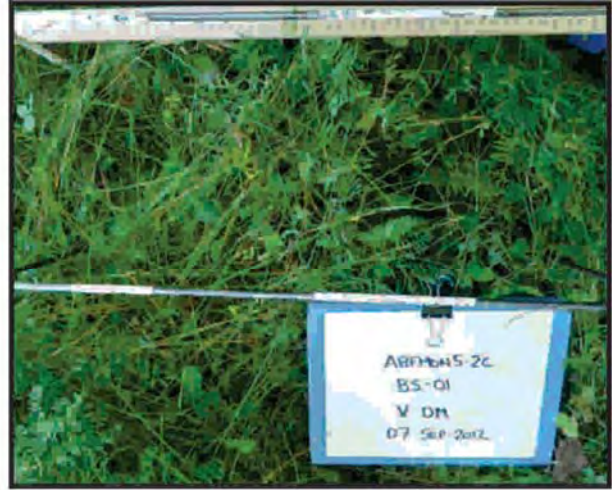
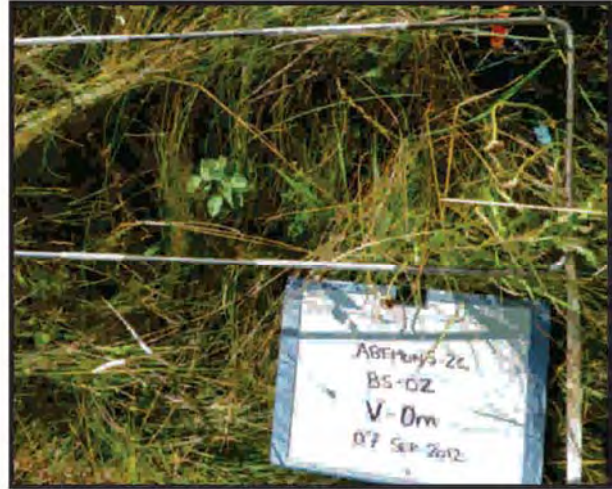
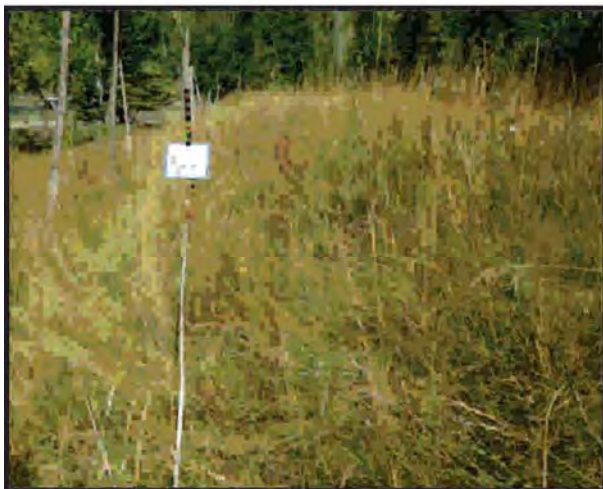
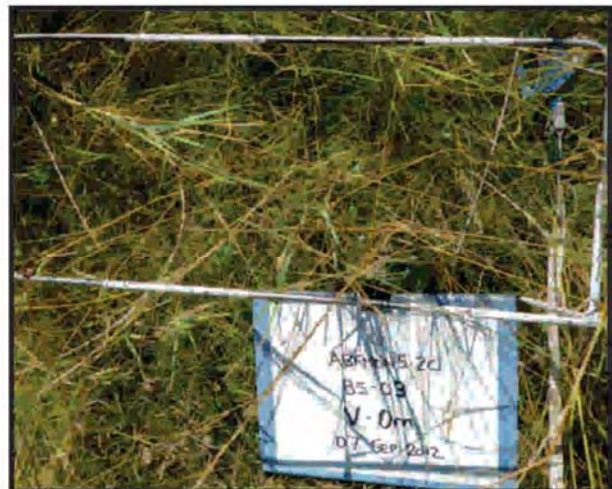
Plate 2. Various views of three permanent vegetation monitoring transects on the side of the berm: (a) BS01 from SOT to EOT, (b) BS01 at 0 meters, (c) BS02 from SOT to EOT, (d) BS02 at 0 meters, (e) BS03 from SOT to EOT, and (f) BS03 at 0 meters.

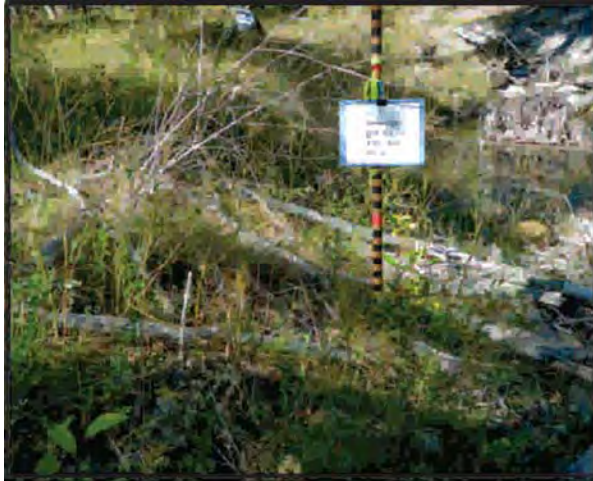
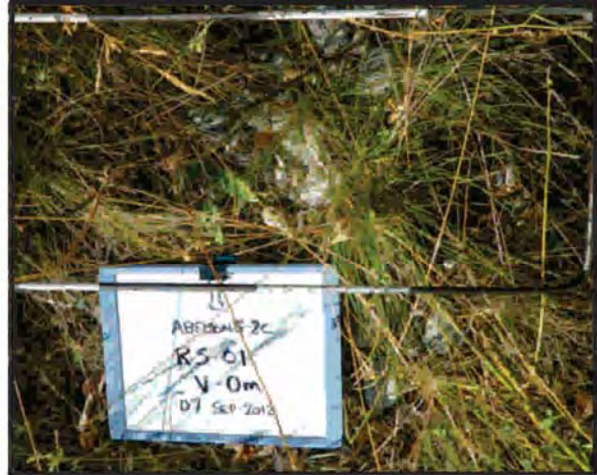
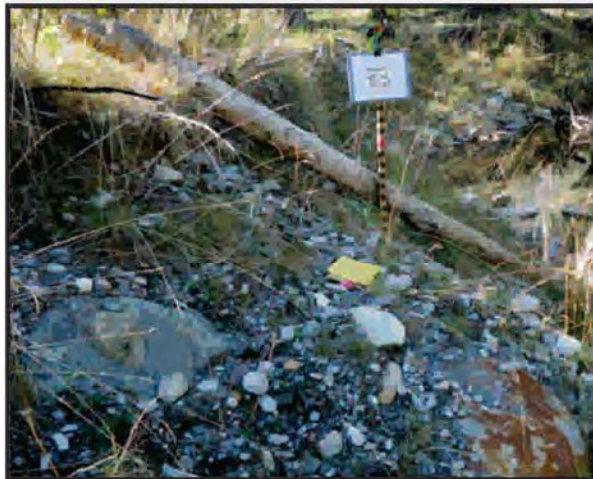
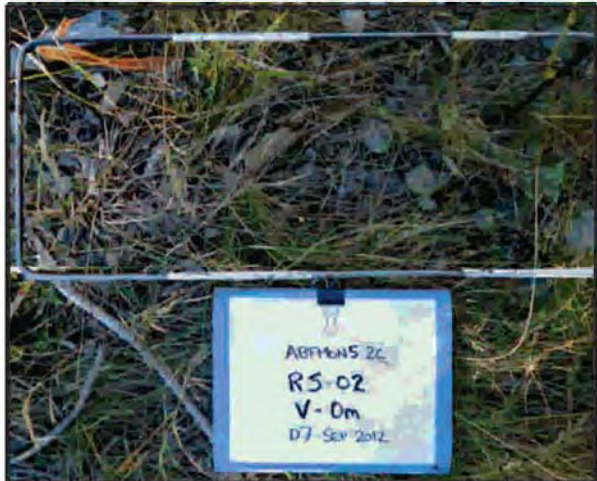
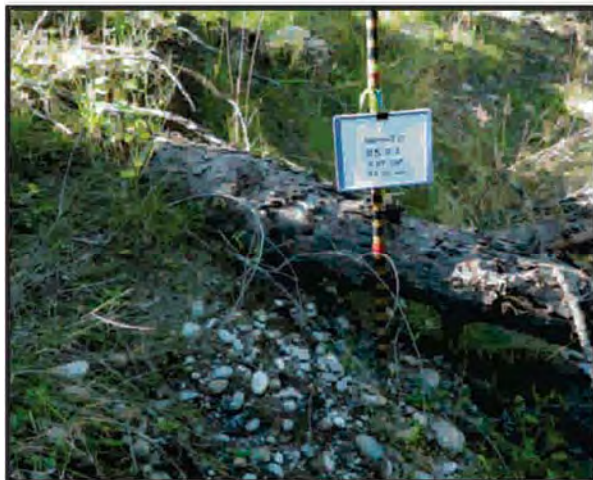
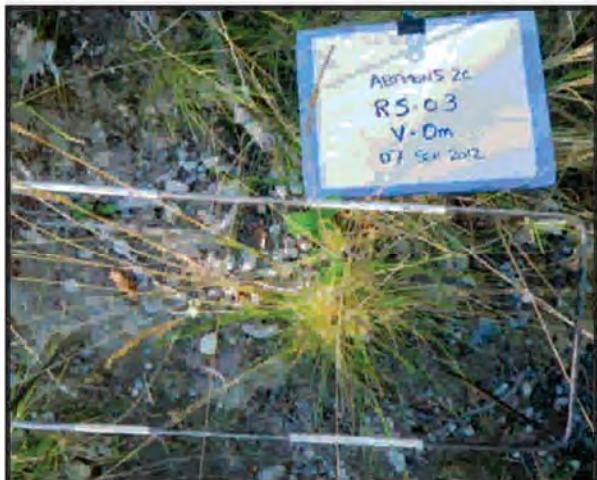
Plate 3. Various views of three temporary vegetation monitoring transects on the river side of the side channel: (a) RS01 from EOT to SOT, (b) RS01 at 0 meters, (c) RS02 from EOT to SOT, (d) RS02 at 0 meters, (e) RS03 from EOT to SOT, and (f) RS03 at 0 meters.

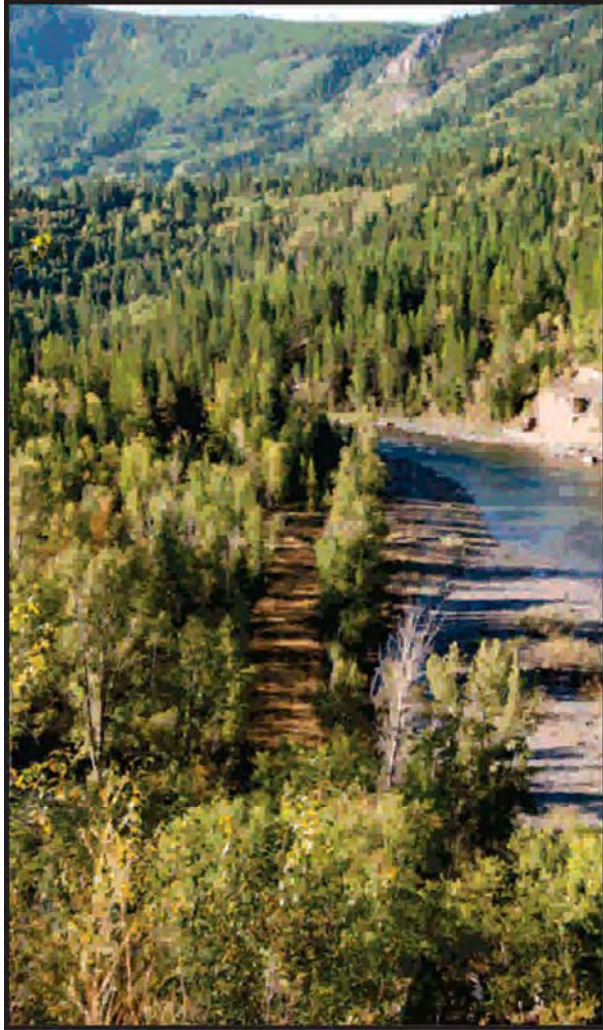
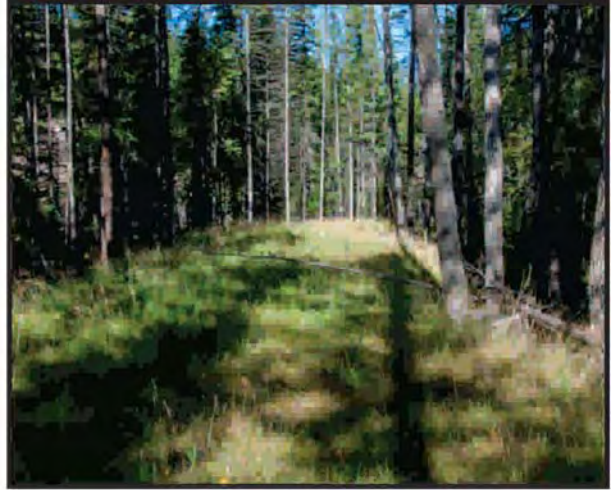
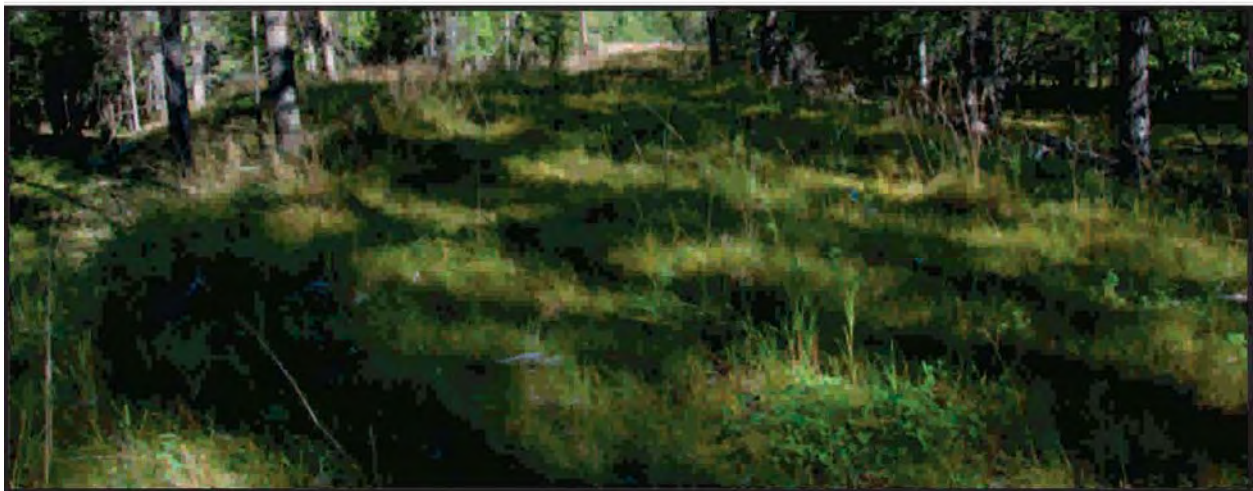
Plate 5. Selected photographs showing: (a) the berm looking south, (b) overview of the berm looking north west, (c) the berm looking west just below the parking area, and (d) the berm looking north.

Seeded vegetation on the side of the berm was distributed relatively evenly and after the fourth growing season the target objective of 60% cover is being met or exceeded. Vegetation on the top of the berm is growing adequately and the south end supports a larger forb component than the central and northern sections (Appendix 1). The top of the berm does not meet the target cover objective and supplemental seeding and fertilization treatments will be required to meet project targets. The relatively aggressive plant community that is developing has resulted in moisture competition and mechanical damage (snow press) issues for planted seedlings which has contributed to decreased seedling survival.

3. Consider supplemental seeding and fertilizing of the portion of the berm top TU that is not achieving 60% cover. This may provide the boost required to meet the target vegetation cover of 60%. The additional nutrients are not expected to affect either the side channel or the Bull River. Additional site preparation may be required to provide sufficient acceptable seedbed for improving the cover of seeded grasses and forbs. This recommendation needs to be considered in combination with recommendation 2.

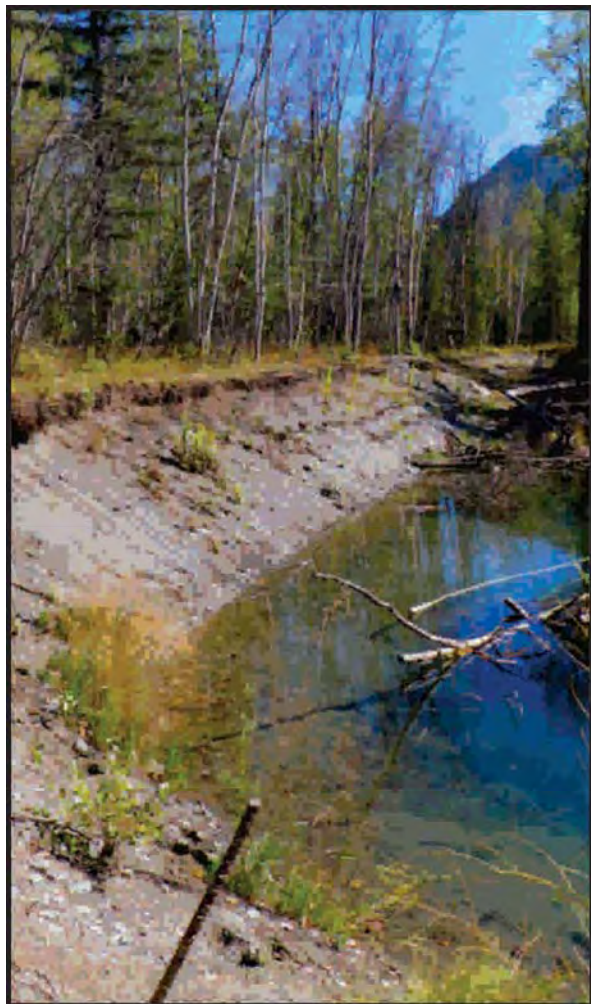
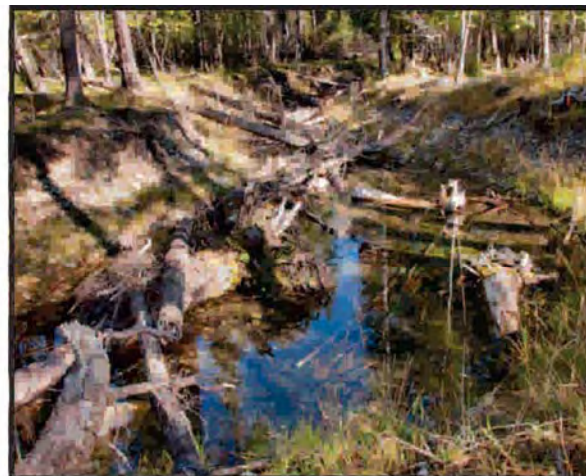
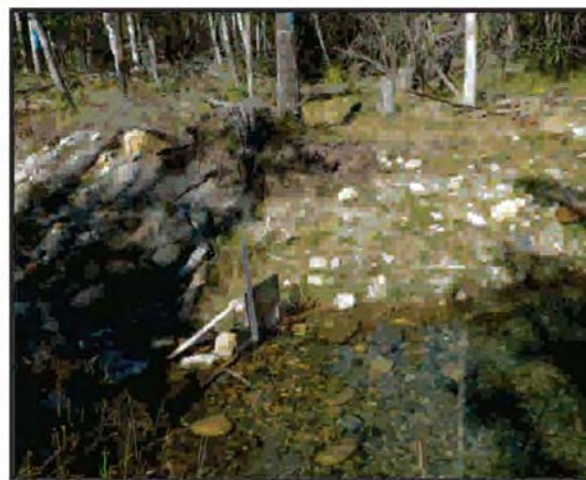
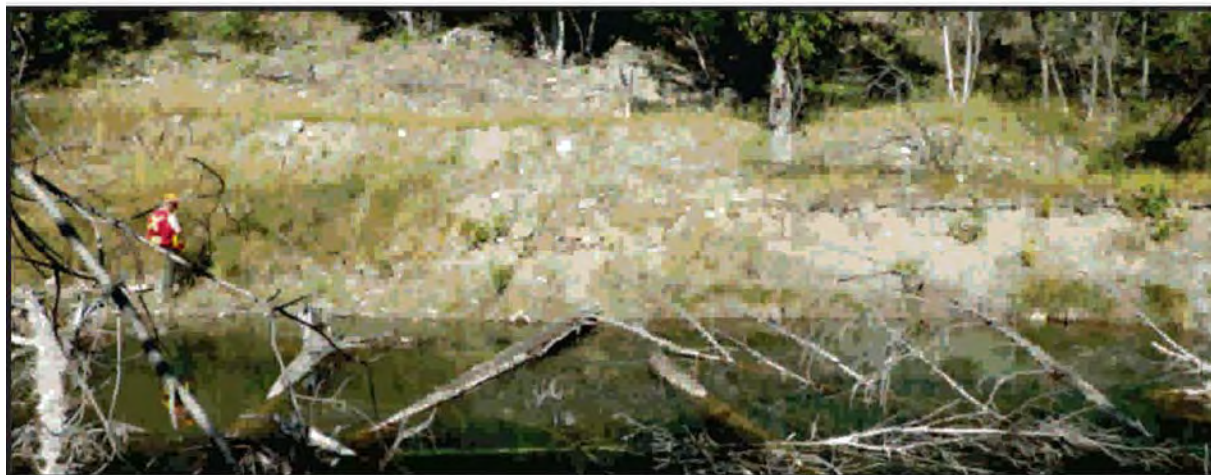
Seeded grass and legume plant communities did not perform as well on the side channel. This is due to the large proportion of the TU that consists of steep, coarse textured materials that are dry ravelling. The side channel will not meet target revegetation objectives without additional intervention.

Plate 6. Selected photographs showing: (a) unsuccessful revegetation efforts on a steep dry ravelling slope in TU B (side channel), (b) overview of a portion of the side channel, (c), a section of the side channel at the weir, and (d) unacceptable patchy vegetation development at the northern end of the side channel.

Resloping treatments may improve access for cattle that use the area and result in damage to streamside plant communities and introduction of soil into the side channel. Controlling cattle access may be the only way to prevent potential negative impacts from cattle grazing in the area and to ensure that project objectives are achieved. A detailed resloping, revegetation and cattle management plan should be prepared to provide direction for the implementation of any additional work.

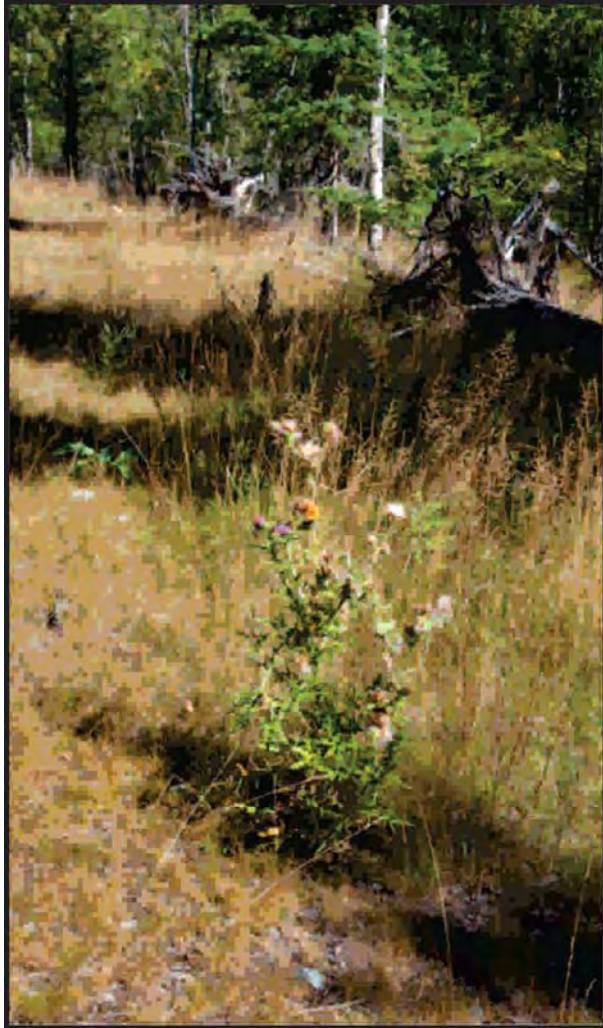
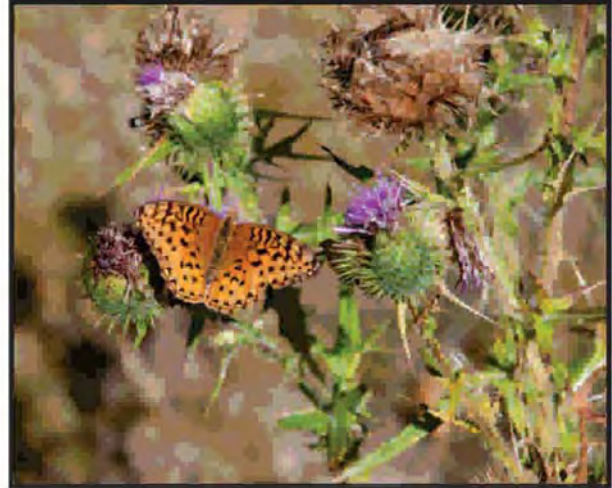
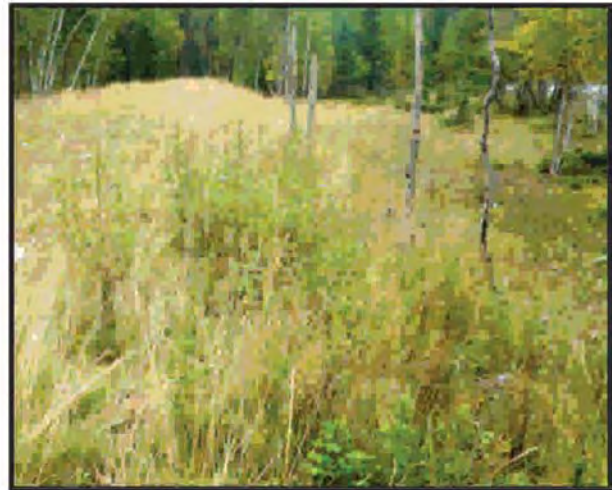
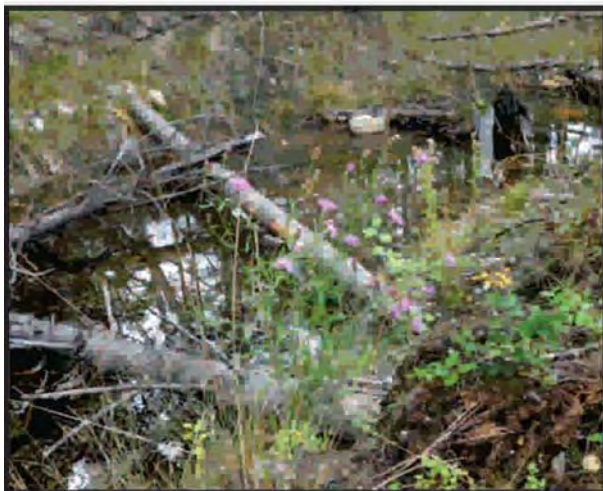
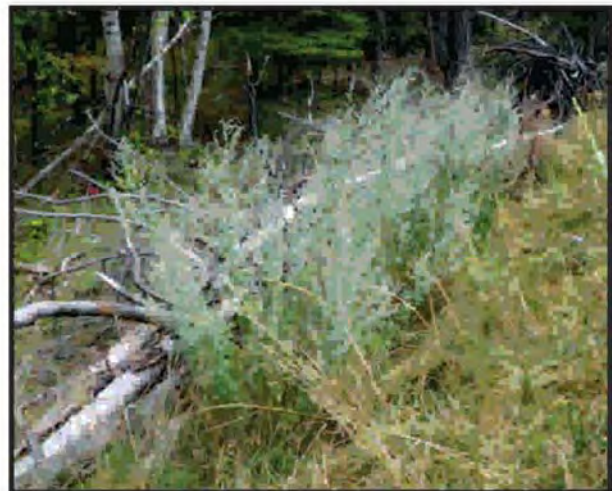
Keefer (2006) recommended a target of 0% cover for invasive plants. Invasive plants continue to be concentrated along the river side of both the side-channel and the berm. Overall it appears that the noxious weed population increased by 23% from 2011 to 2012. The patches of Canada thistle (*Cirsium arvense* (L.) Scop.) and bull thistle (BT, *Cirsium vulgare* (Savi) Ten.) have increased in number and size with the largest patch of CT extending 18x3m (0.005 ha, photo 1245). However the count of single plants had decreased. Distribution along the side-channel was mostly individual plants with densities ranging from 1 - 2 plants/m². A number of patches have formed along the berm with densities of 6 plants/m² and greater.

The presence of spotted knapweed (SK, *Centaurea biebersteinii* DC) has increased significantly. One patch with a density of 4 (>10 plants/ m²) was observed on the river side of the side channel and two plants were found on the berm. Sulphur cinquefoil plants (*Potentilla recta* L.) were found with the SK on the berm as well as distributed sporadically along the side-channel.

Plate 7. Selected photographs showing invasive species : (a) and (b) bull thistle, (c) Canada thistle(d) spotted knapweed, and (e) absinth wormwood.

5. Ensure that gates remain closed to reduce access by cattle and additional damage to sensitive banks at the side channel TU.
6. Hand-pulling and digging spotted knapweed, blueweed, sulphur cinquefoil and common burdock plants during the spring and throughout the year when the soil is moist is highly recommended to eradicate these species.

7. Repetitive mowing and/or herbicide treatment is recommended to control further spread of Canada thistle and bull thistle.

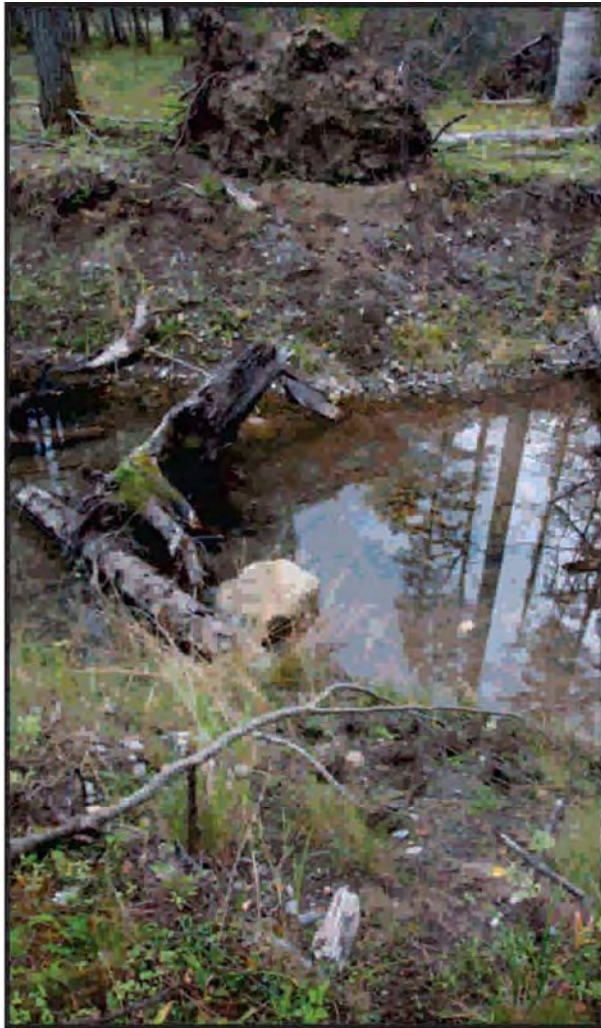
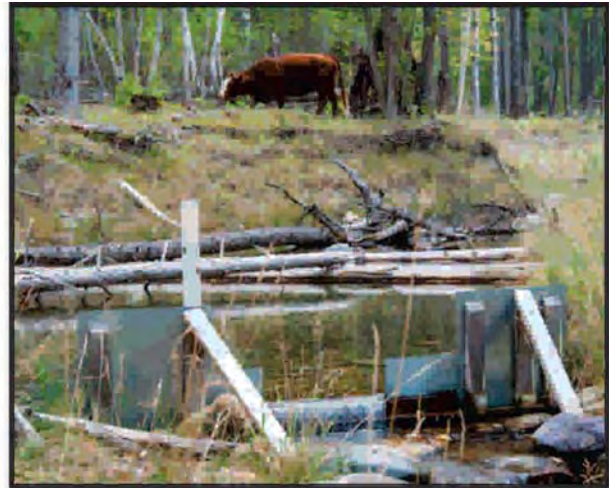
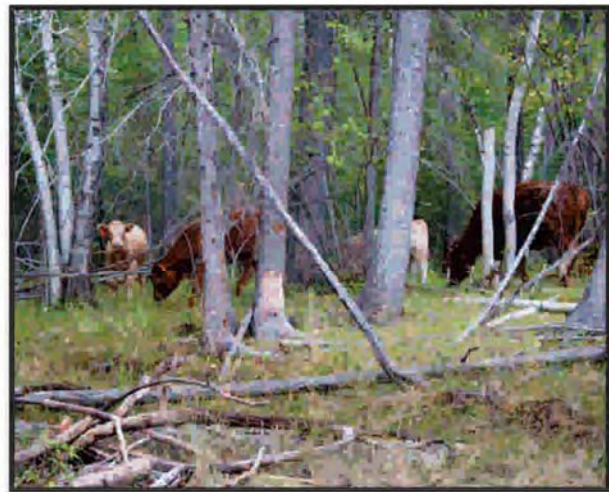
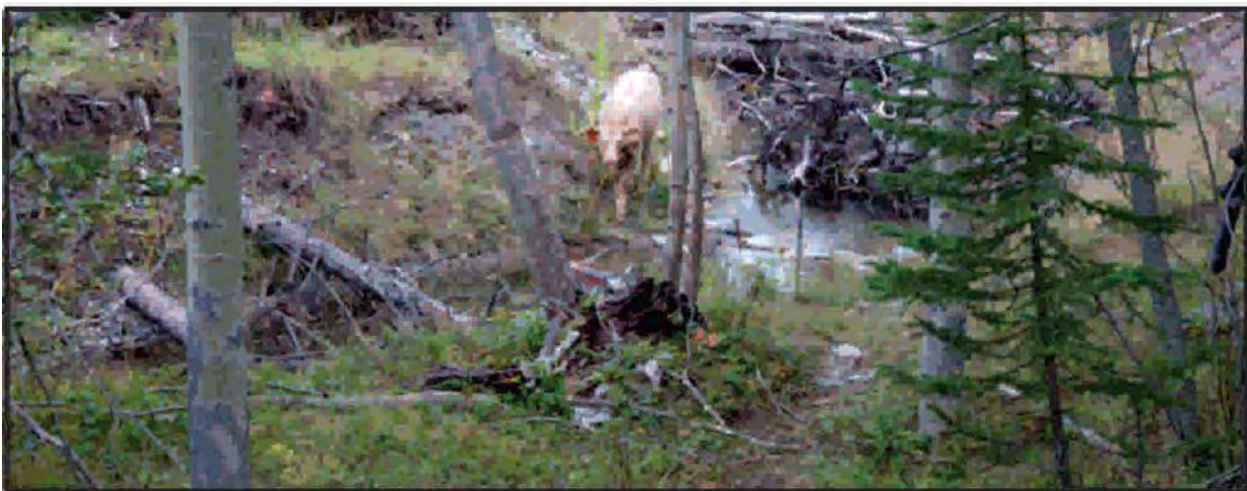
Plate 8. Selected photographs showing: (a) cattle crossing damage at the side channel, (b) + (c) +(d) cattle grazing at various locations along the side channel.

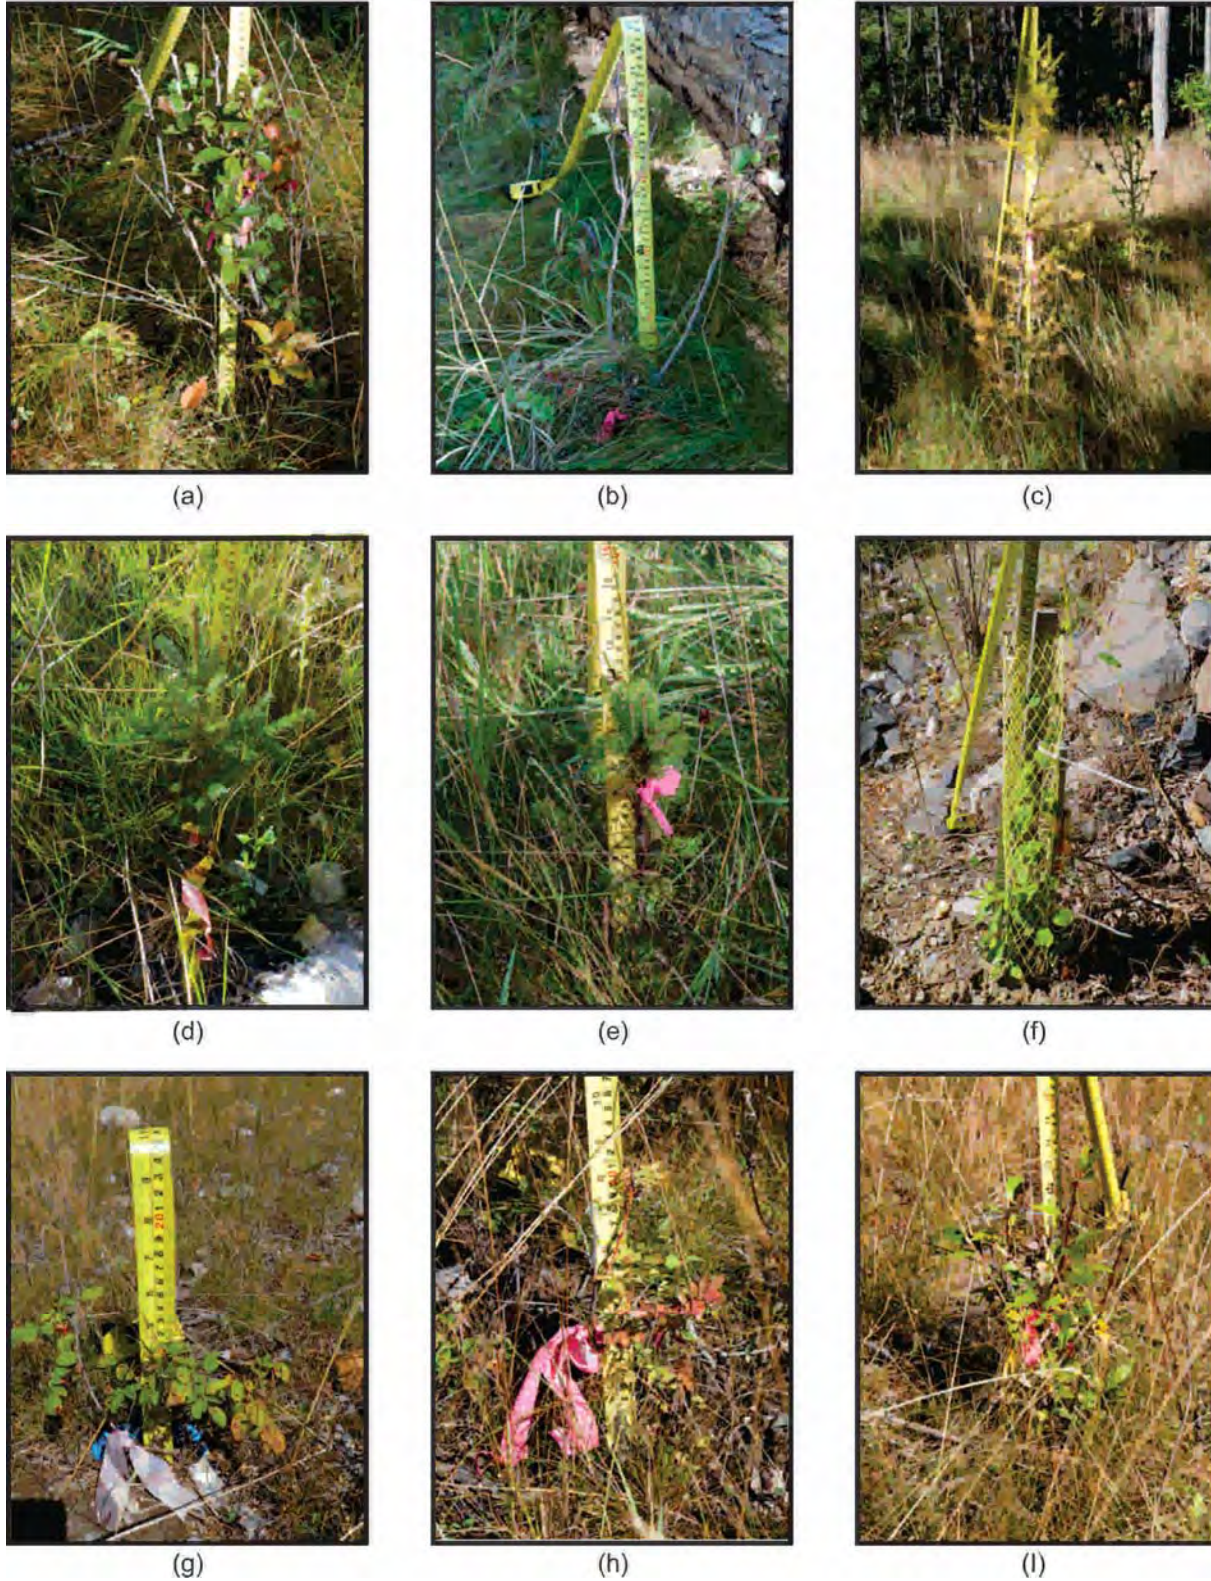
There was a general decline in seedling condition in all species in 2012 (Table 8) from previous years. The condition target (60% of plants must fall in good and/or fair category, Keefer 2006) was only met for hawthorn, prickly rose in lines and plots and hawthorn and Engelmann spruce in lines. Plate 9 shows seedlings of a variety of species and condition codes.

Plate 9. Selected photographs showing surviving seedlings: (a) good quality hawthorn, (b) poor quality hawthorn, (c) fair quality western larch, (d) good quality Engelmann spruce, (e) fair quality Engelmann spruce, (f) good quality Saskatoon, (g) + (h) good quality prickly rose, and (i) good quality cottonwood with browsing damage.

Survival is expected to decrease for most species as indicated by the increase in seedlings in the poor condition class. The continued development of the seeded grass and legume plant community at TU A (berm) is having a negative impact on seedling condition and seedling survival. Reduced moisture availability for trees and shrubs, due to the well-established grass/legume plant community, is probably the most important constraint on planting success. Planting operations need to consider the potential competing plant community and site preparation treatments should focus on minimizing expected limiting factors.

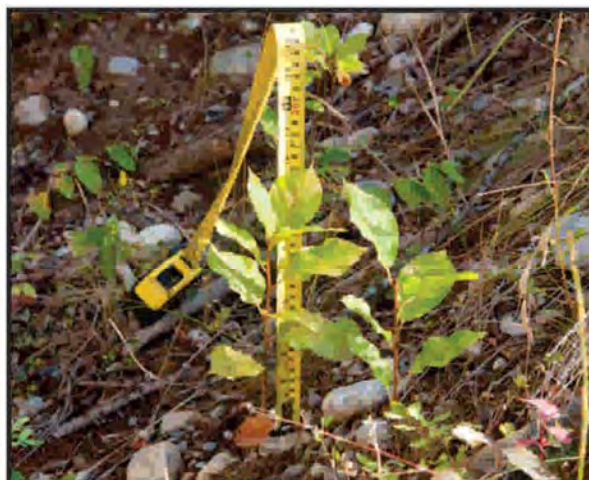
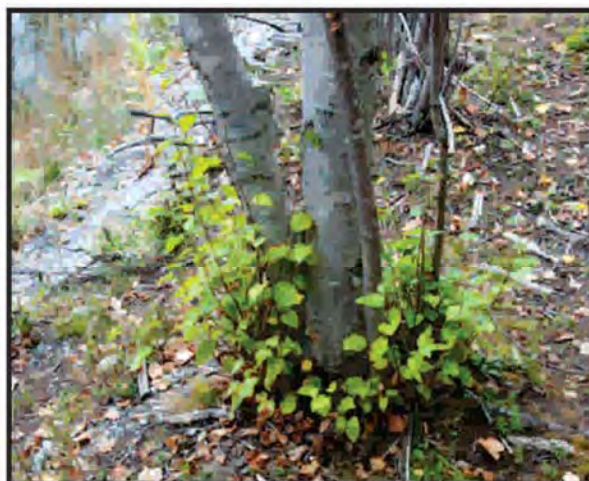
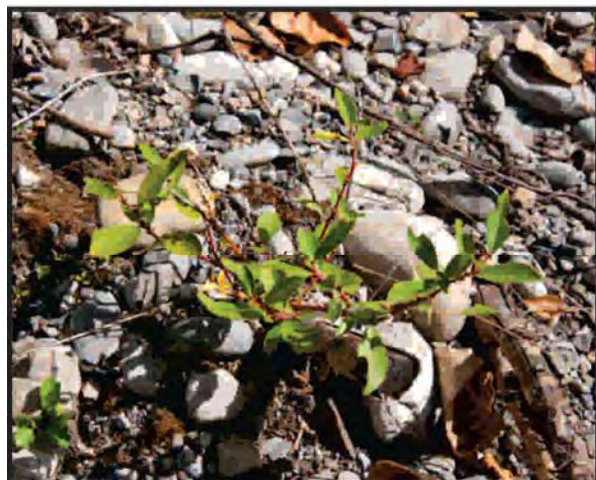
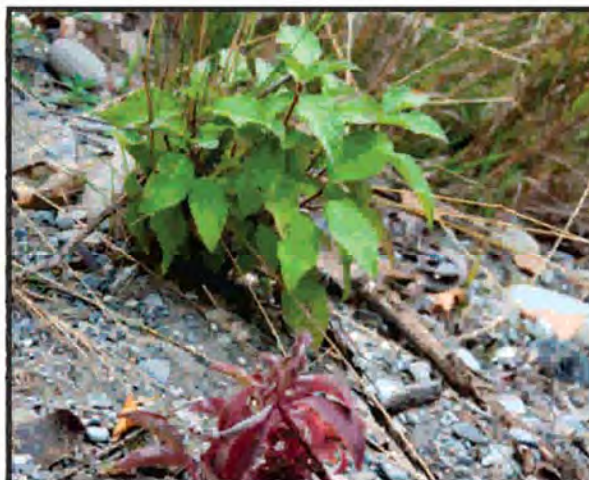
Plate 10. Selected photographs showing native species volunteers: (a) cottonwood at the side channel showing extensive root system, (b) chokecherry, (c) birch copse, and sprouted cuttings from modified brush layers (d) willow, and (e) red-osier dogwood.

The fourth growing season seedling survival ranged from unacceptable to excellent. Ponderosa pine suffered 100% mortality in 2009. Cottonwood, paper birch, western larch, Saskatoon and Engelmann spruce in plots do not meet the target of 75% survival. Native chokecherry, cottonwood, birch, and aspen disturbed during construction activities continue to sprout from rhizomes, roots, and stems which will contribute to the diversity of the riparian plant community in the study area (Plate 10).

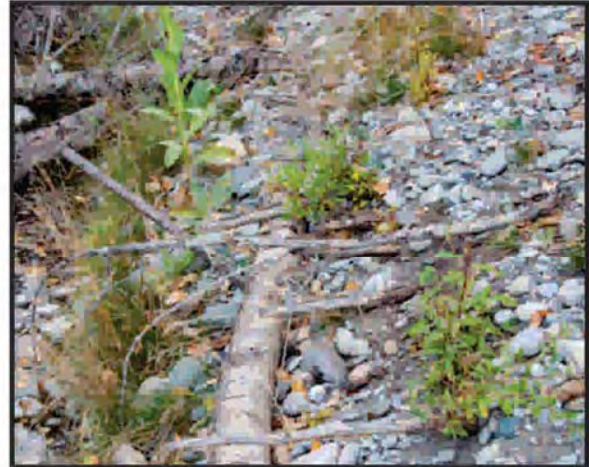
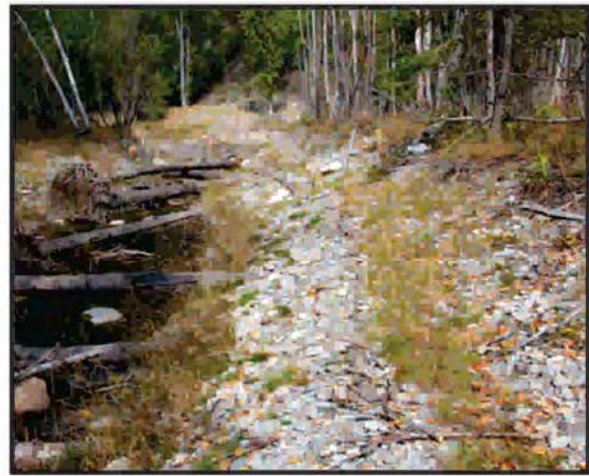
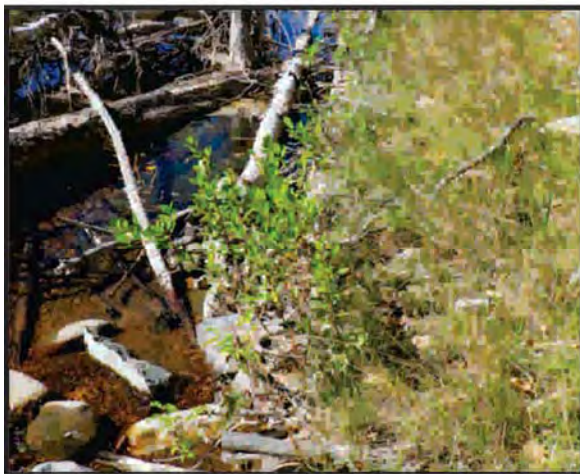
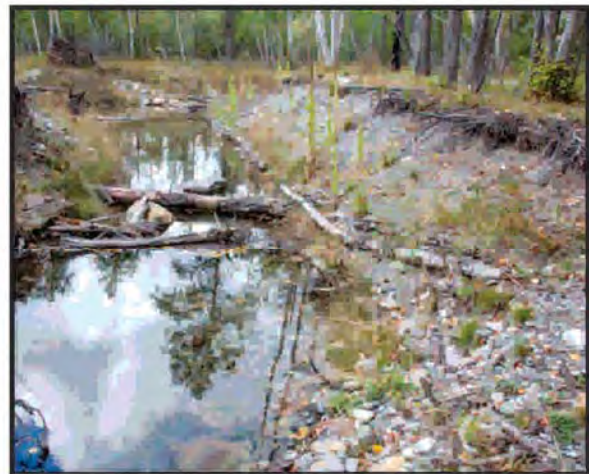
brush layers have failed. The most significant issues include: poor selection of species for sill logs, inadequate staking of sill logs, use of stakes and cuttings that were too small in diameter, and stakes/cuttings planted too shallow.

Only one of the assessed brush layers met the recommended criteria of at least 70% effective length. The poor performance of the modified brush layers was probably due to improper installation in 2009. Installation problems included poor choice of sill log species, inadequate staking of sill logs and shallow planting of cuttings for brush layers. Three of the brush layers (no. 6, 12, 16) had increased numbers of cuttings with leaves due to new sprouts forming since the last growing season. We do not expect the sprouting to be sufficient to significantly increase the effective length of any of the modified brush layers.

Plate 11. Selected photographs showing: (a) unsuccessful brush layer showing how the modified slope allows for the establishment of grasses and forbs, (b) improperly staked sill log with a few sprouted cuttings, (c) unsuccessful modified brush layers (d) a section of successful modified brush layer, and (e) unsuccessful modified brush layers.
