Columbia River Project Water Use Plan

Monitoring Wetland and Riparian Habitat in Revelstoke Reach in Response to Wildlife Physical Works

Year 6 Annual Report

Study Period: 2018

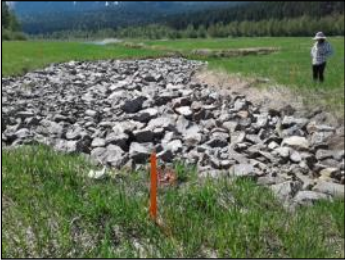
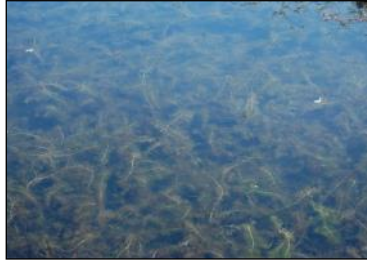
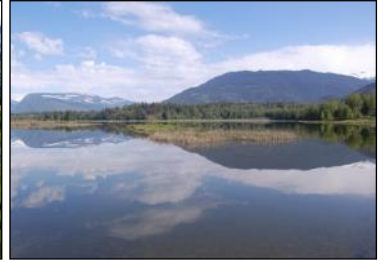
Cover photos

From left to right: Site 6A, Eurasian water-milfoil (*Myriophyllum spicatum*) in Cartier Bay, Site 15A, Airport Marsh. Photos © LGL Limited: Virgil Hawkes and Doug Adama.

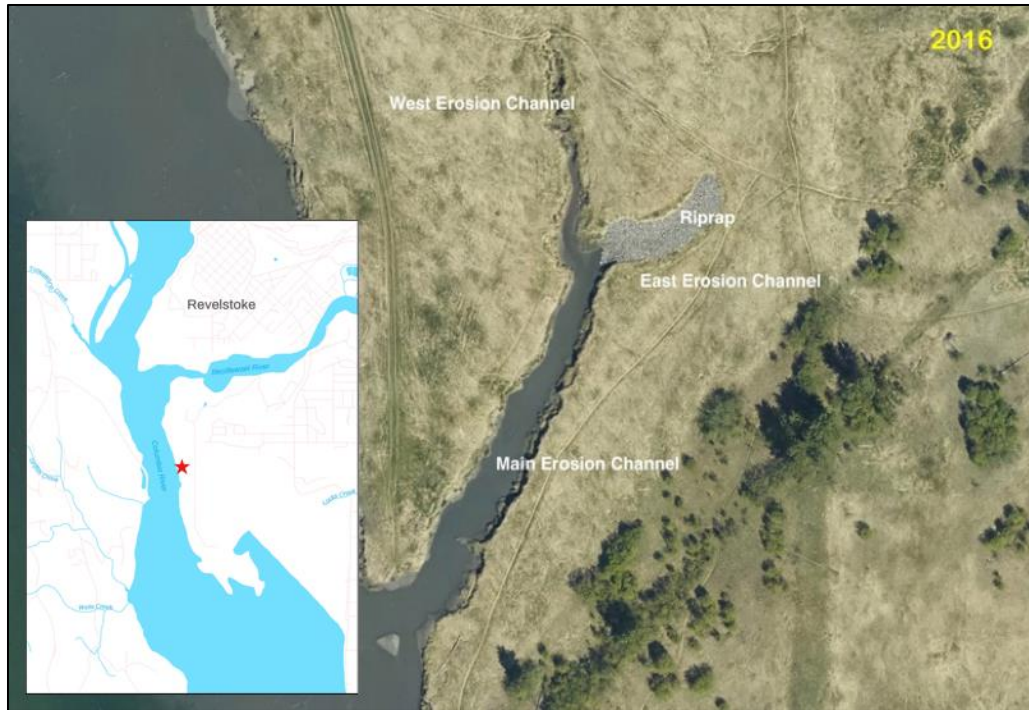
Figure 2-1: Aerial image of the WPW-6A “Y shaped” erosion channel. Scale 1:500. Inset show the location of the channel south of Revelstoke, BC. Image date May 2016.

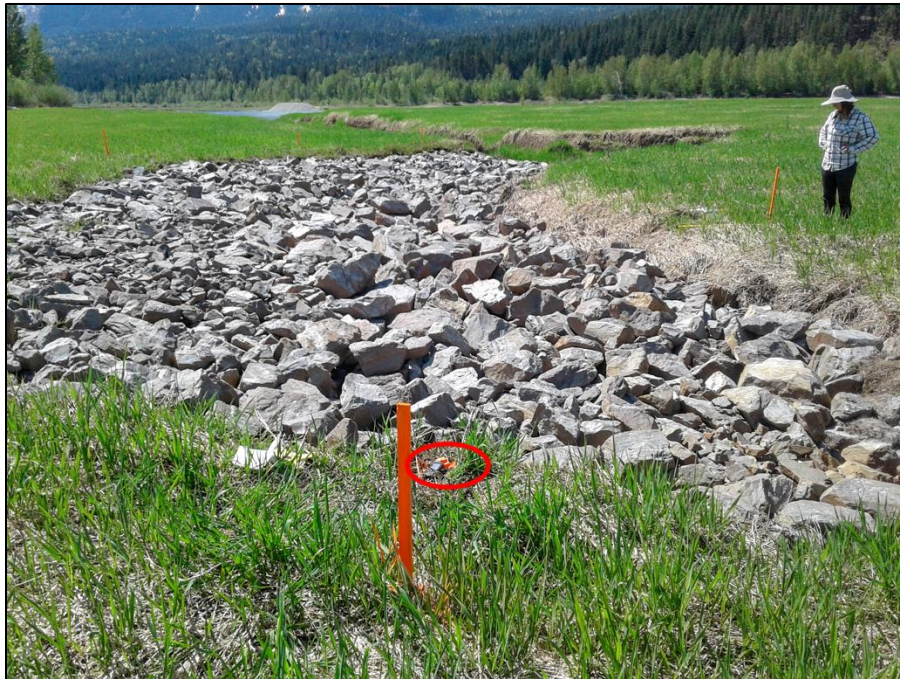
Figure 4-1: East erosion channel at WPW-6A, May 2018 The stake in the foreground is 122 cm behind pin 1-5 located at the margin of the riprap – channel bank interface (circle).

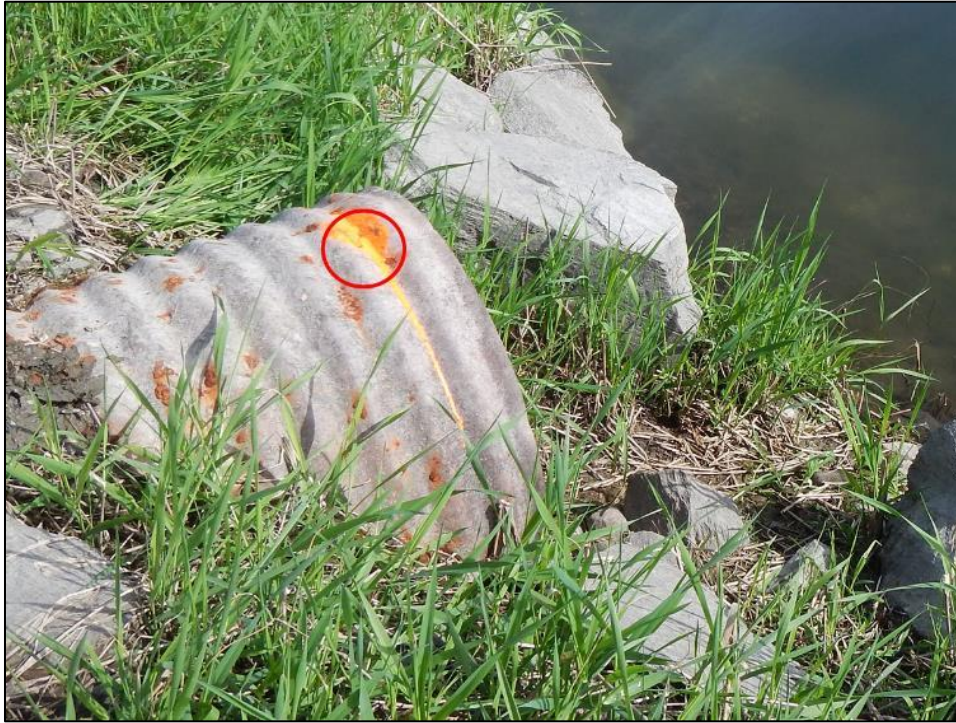
Figure 4-3: Location of survey reference point CS15A established by Waston Engineering on a culvert near Site 15A.

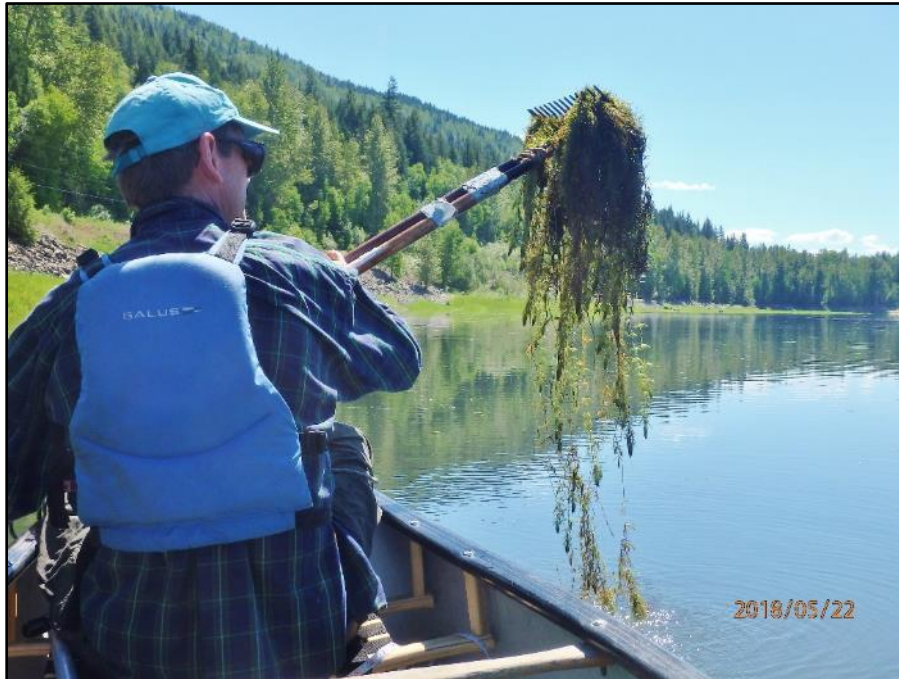
Figure 4-4: Rake sample of aquatic macrophytes, Cartier Bay wetland, May 22, 2018.

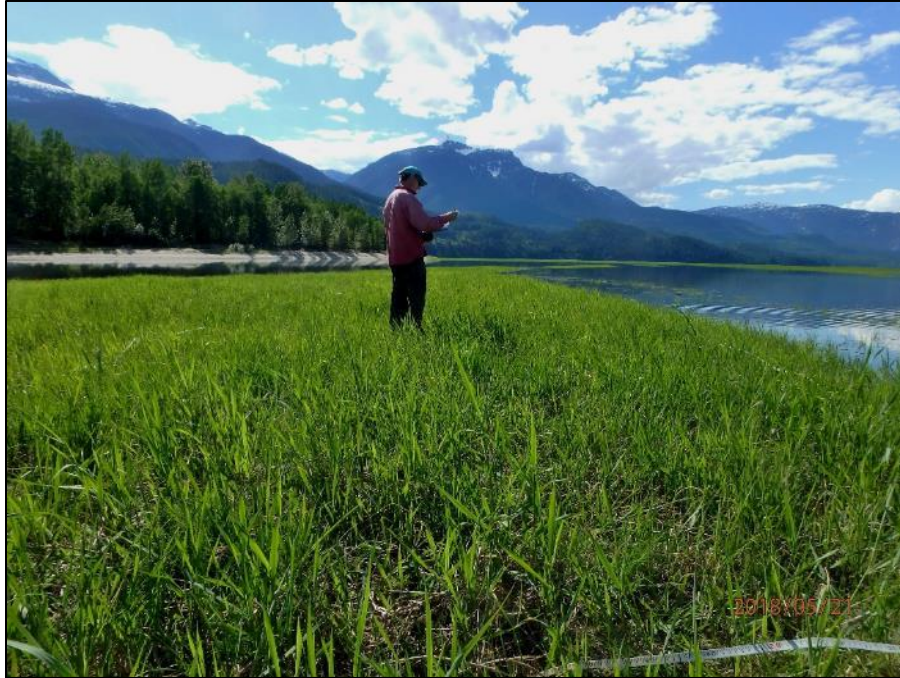
Figure 4-5: Supplemental riparian vegetation plot in a reed canarygrass-dominated community, Cartier Bay, May 21, 2018.

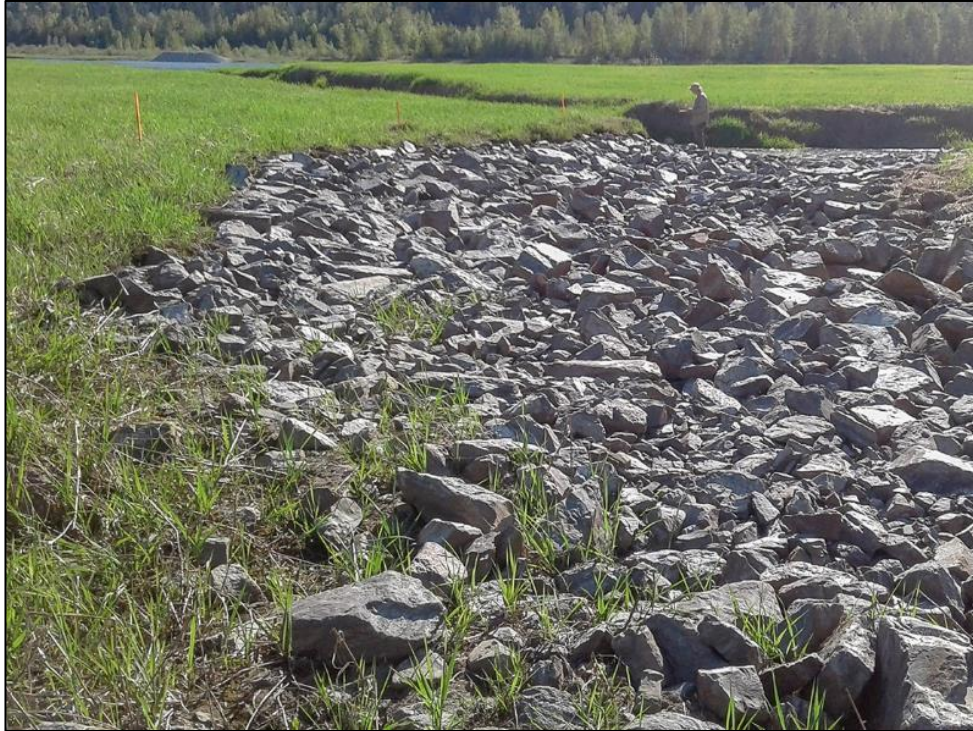
A visual inspection of the east channel indicated that the riprap has become well integrated into the surrounding soils. In places, sediment has accumulated along the margin of the riprap, and reed canarygrass has ingressed into the channel riprap (Figure 5-1). As observed in 2016, active erosion was evident at the southwest terminus of the east channel (Figure 5-2). Fresh clumps of sod that had broken off the overhanging bank were observed on the floor of the channel indicating active bank undercutting. No other signs of erosion were observed along the perimeter of the east channel.

Figure 5-1: Reed canarygrass (in the foreground) ingressing into the riprap along the margin of the WPW-6A east erosion channel, May 2018.

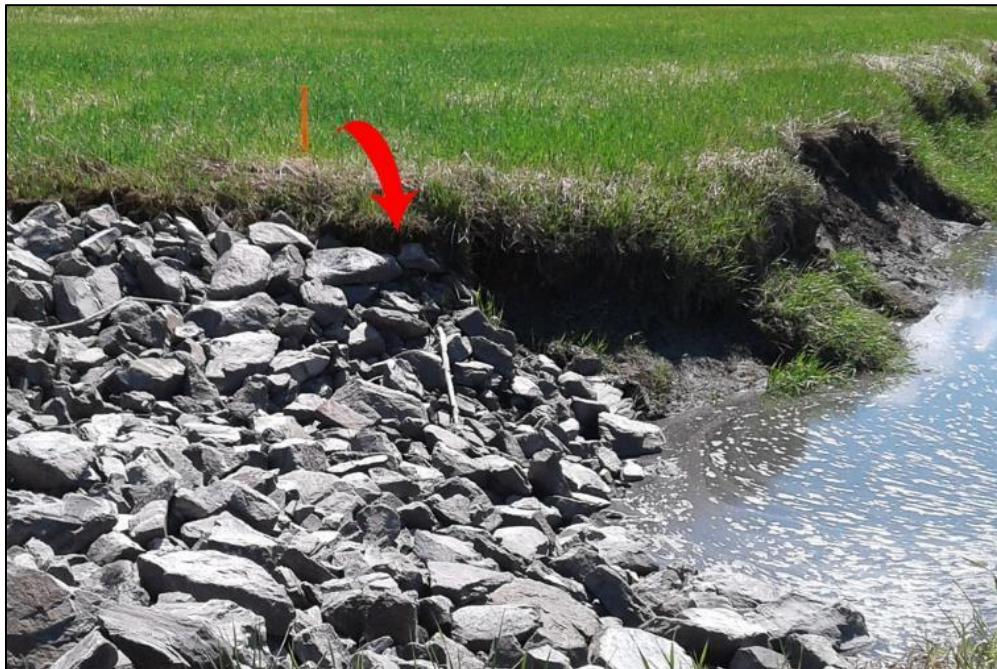
Figure 5-2: Soil movement, slumping, and bank undercutting at the mouth of the east channel of WPW-6A, May 2018. The arrow indicates the location and direction of soil movement and slumping.

Table 5-1) with distances increasing by 7 cm and 4.5 cm, respectively, over two years. Soil movement at pin 1.1 was due to slumping at the mouth of the east channel (Figure 5-2). Soil movement at pin 1.2 did not appear to be due to erosion and was likely a result of bank settlement along the margin of the channel. Little to no soil movement (≤ 1 cm) was observed at the remainder of the pins along the bank of the east channel (

3. Continue erosion monitoring at WPW-6A following the methods described in this report. This includes visual assessment, survey measurements, and image interpretation. We recommend particular attention be paid to the undercut bank at the mouth of the east erosion channel as well as expanding the surveys to include the main erosion channel. We also recommend using a drone to capture

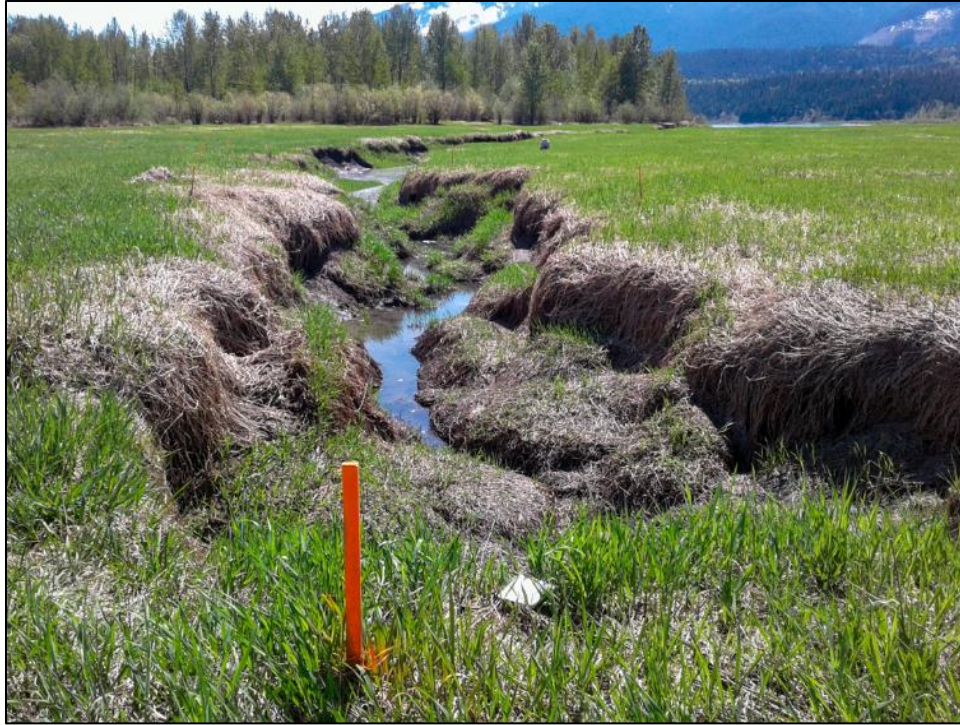
Extensive slumping was observed in the untreated west channel (Figure 5-3). Again, fresh clumps of sod were observed on the floor of the channel indicating ongoing active erosion and undercutting of the channel banks.

Figure 5-3: Extensive slumping and mass wasting in the WPW-6A west erosion channel, May 2018.

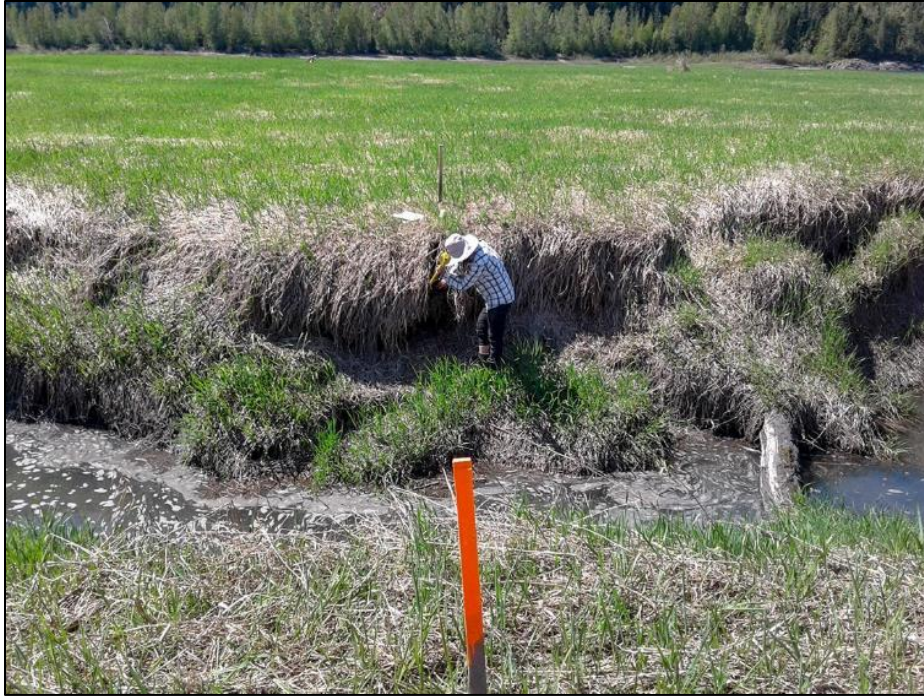
Table 5-1). Pins 2.5, 2.6, 2.7, and 2.9 had slumped down the bank from undercutting and mass failure (Figure 5-4). Pin 2.5, located at the head of the channel, was found on the floor of the channel, indicating aggressive head cutting had occurred over the two years.

Figure 5-4: Autumn Solomon (ONA) searching for erosion pin 2.7 on an undercut bank in the west erosion channel at WPW-6A, May 2018.

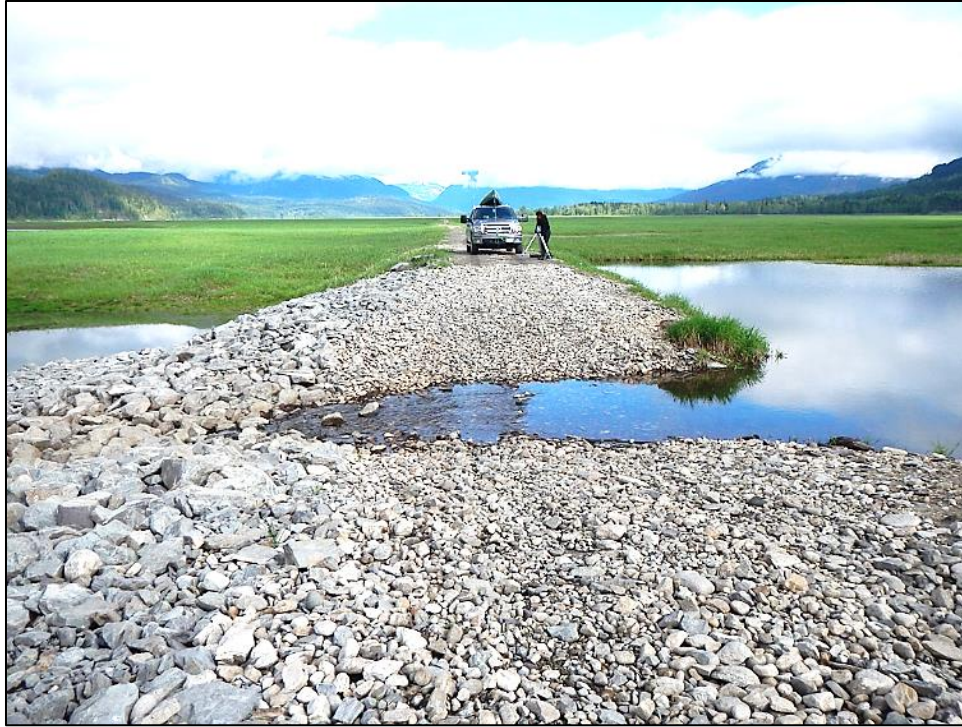
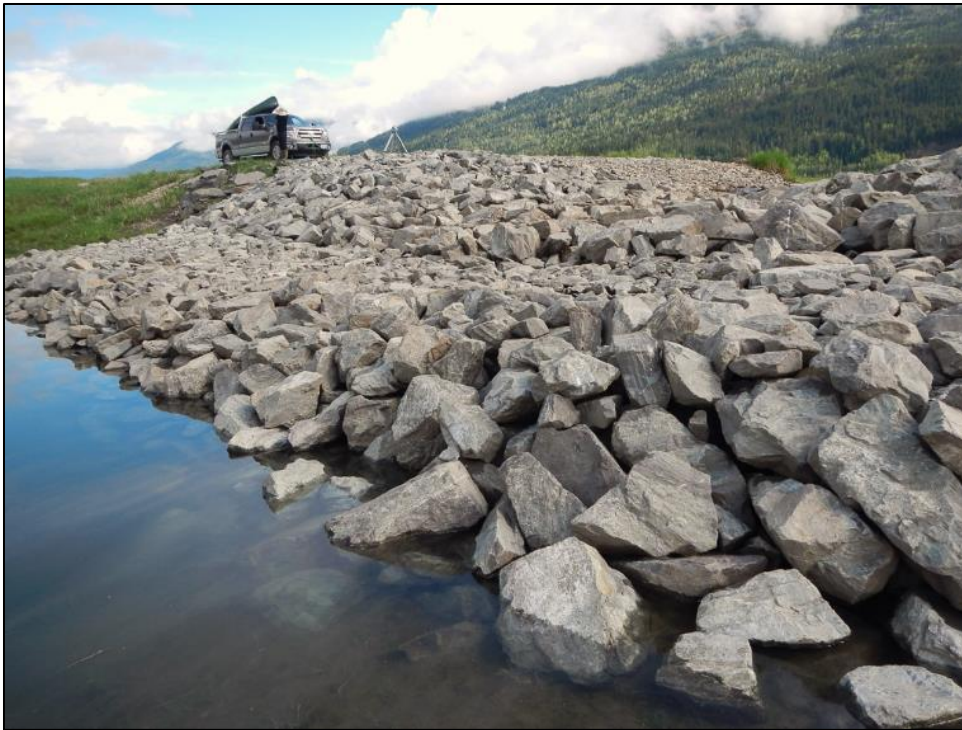
We found no evidence of erosion during our visual assessment of site WPW-15A (Figure 5-7). Average elevation of the swale was estimated to be 434.051 m based on survey measurements referenced to permanent reference points established on the old culvert (Figure 4-3). This compares favourably with the values reported by Watson Engineering (2016) of 434.045 m, indicating that no measurable amount of erosion has occurred in the swale since construction.

Figure 5-7: Images of the WPW-15A wildlife physical works at Cartier Bay, May 2018.

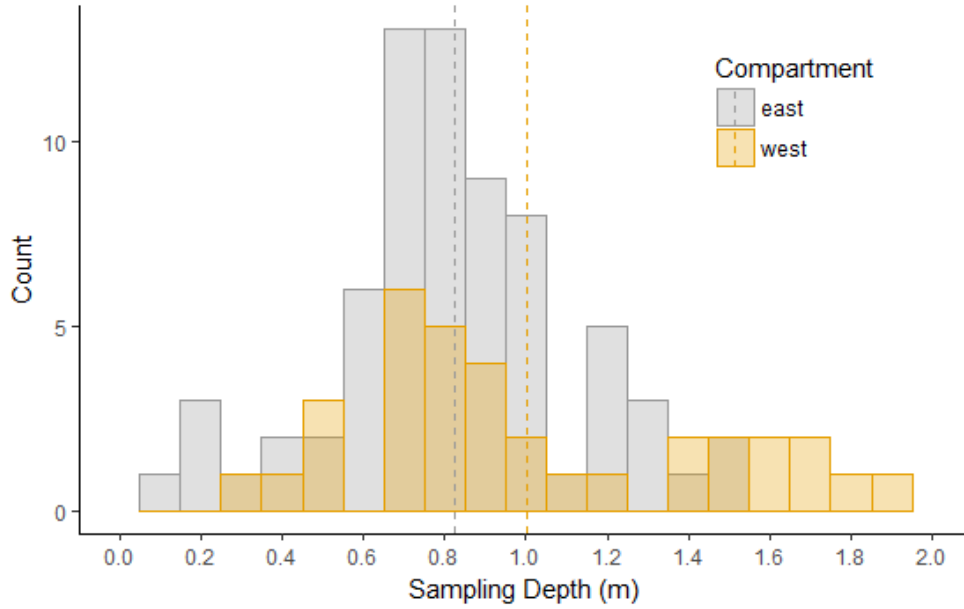
Figure 5-8. Sampling depth distributions for the east and west compartments of Cartier Bay wetland in 2018. “East” compartment refers to the area east of the eroded roadbed bisecting the wetland; “west” compartment refers to the area west of the roadbed and east of WPW-6A (Figure 2-2). Dashed lines represent the average sampled depths.
