Columbia River Project Water Use Plan

**Kinbasket and Arrow Reservoirs Revegetation
Management Plan**

**Monitoring Wetland and Riparian Habitat in Revelstoke
Reach in Response to Wildlife Physical Works**

Final Comprehensive Report

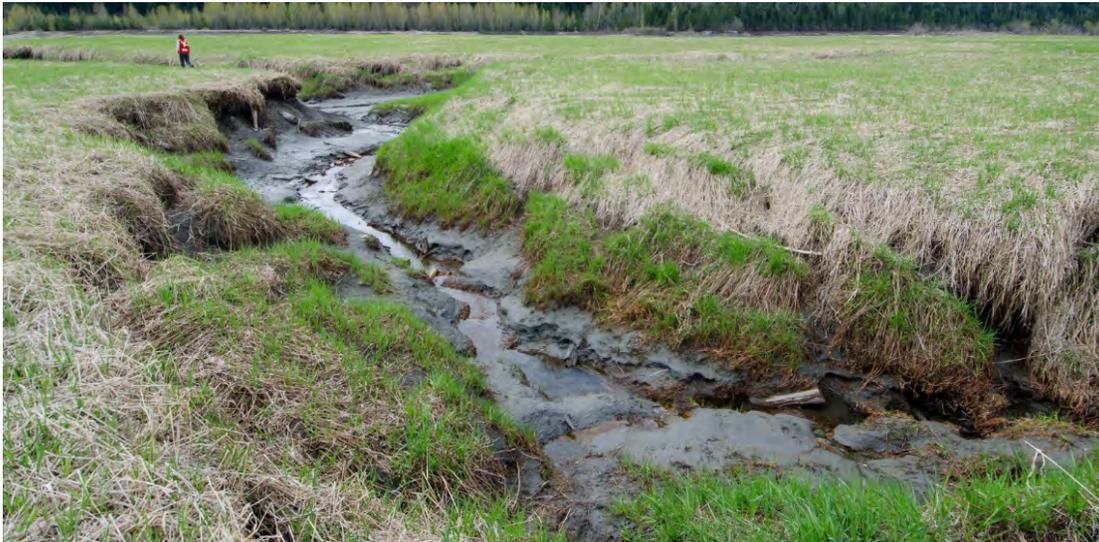
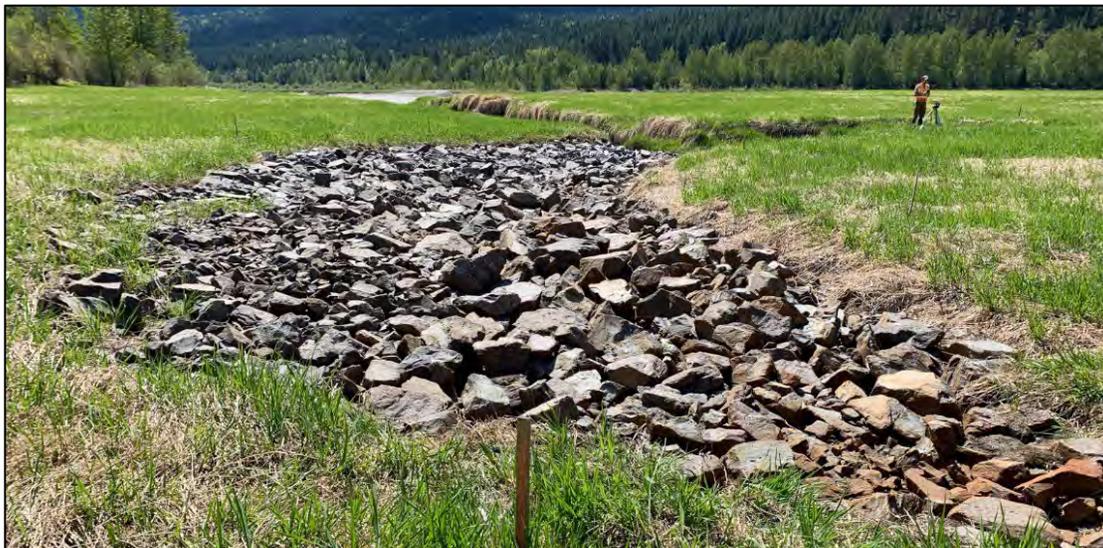
Figure 2-2: Before and after images of the east erosion channel. Image dates April 25, 2013 (above) and May 13, 2020 (below).

The WPW-6A project was implemented in 2013 by Landmark Solutions Ltd under BC Hydro's supervision, and LGL Limited was retained for environmental monitoring during construction. In 2014, Golder Associates (2014) provided recommendations for monitoring WPW-6A. LGL Limited monitored the site in 2016, 2018, 2019, and 2020 (Hawkes and Adama 2020; Miller *et al.* 2020a; b).

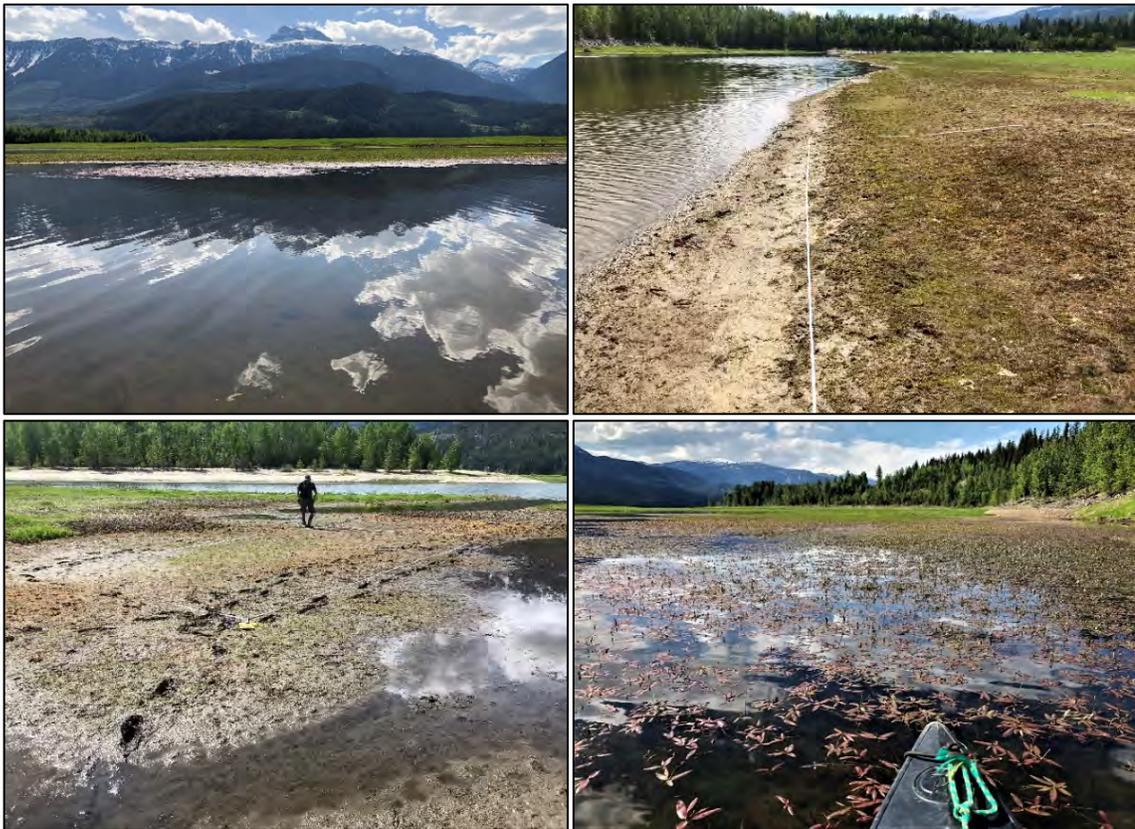
The Cartier Bay wetland consists of an existing slough/shallow open water complex that historically may have been an oxbow of the Columbia River. The main wetland consists of two compartments separated by a gap in an old roadbed (Old Arrowhead Highway) that bisects a large 24.3 ha pond. The outflow of this wetland is through a gap in the old rail grade. Prior to WPW-15A, water retention in the lower pond compartment was improved when a wooden box culvert under the disused rail bed collapsed, causing water to flow over the resulting swale in the rail grade (WPW-15A; Figure 2-4). The persistence of water in the pond was deemed to be uncertain due to considerable erosion occurring on the downstream side of this swale (Figure 2-6, upper photo).

Figure 2-3. Cartier Bay wetland, Revelstoke Reach (Arrow Lakes Reservoir).

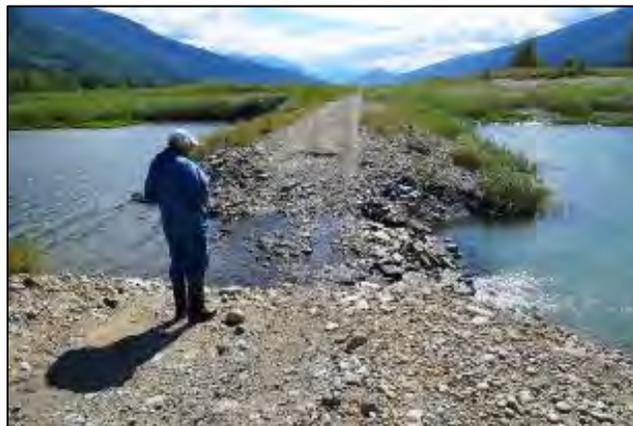
Figure 2-5. Eroding Cartier Bay box culvert and swale outlet (September 8, 2014). Observer: David Polster.

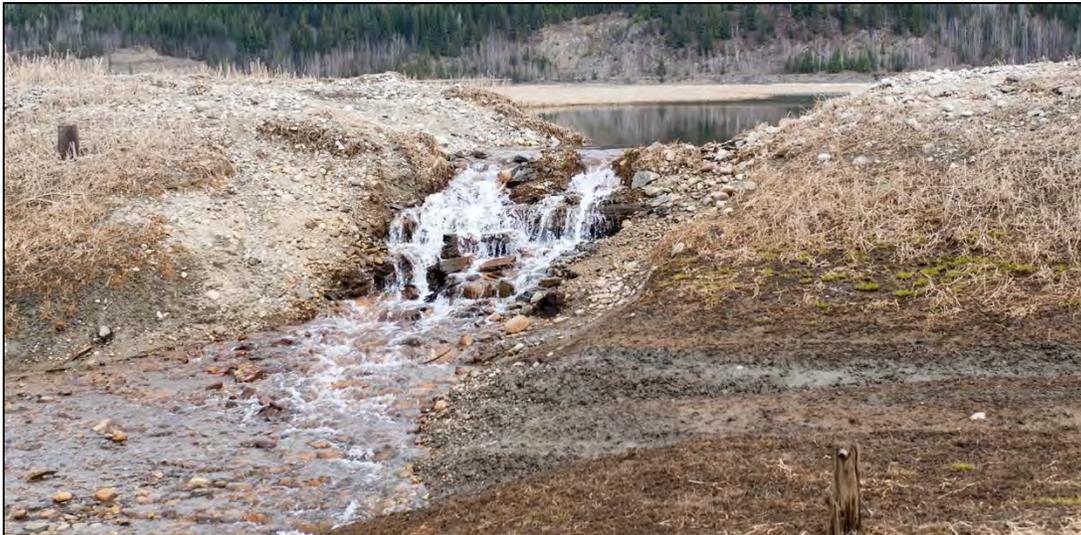
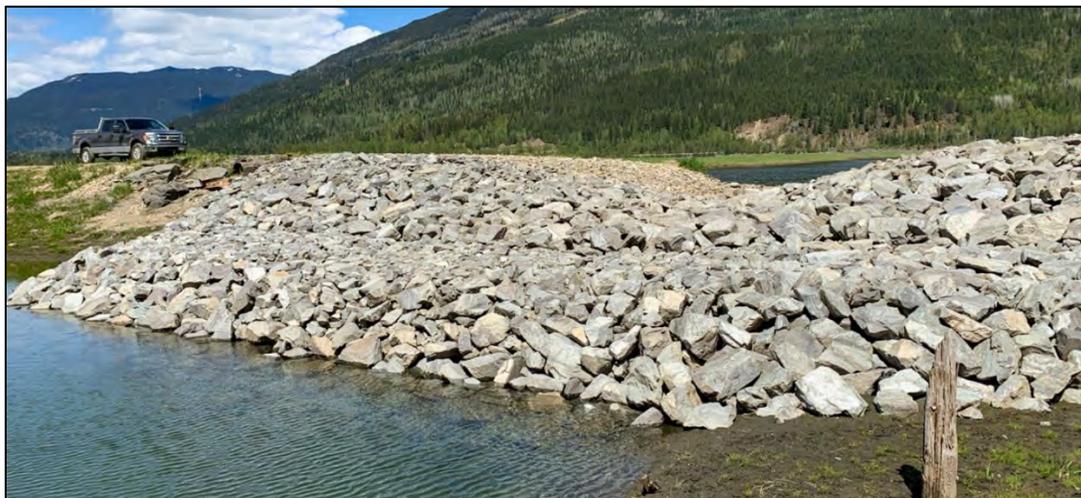
Figure 2-6: Images of the box culvert and swale at WPW 15A before treatment (above, taken in 2009) and after treatment (below, taken in 2020).

WPW-15A was designed to protect the wetland and wildlife values in Cartier Bay by reinforcing the swale and armouring the downstream face (Figure 2-6, lower photo). After careful consideration (Hawkes *et al.* 2014), the final design opted for stabilization of the swale at its existing elevation. This was accomplished via the addition of riprap and filter blanket on the downstream side of the impoundment at the box culvert. Construction began on October 17 and was completed on October 22, 2016 (Figure 2-6). The swale elevation, original box culvert, and adjacent steel culvert were left essentially unchanged; however, changes to the porosity of the swale could not be assessed, and the swale invert was measured to be raised by ~10-20 cm [pre-works the invert was estimated to be 433.962 m ASL; post-works, it was measured to be 434.045 m ASL (Watson Engineering 2016), and in 2021 it was measured to be 433.92 m ASL (BC Hydro unpublished data)].

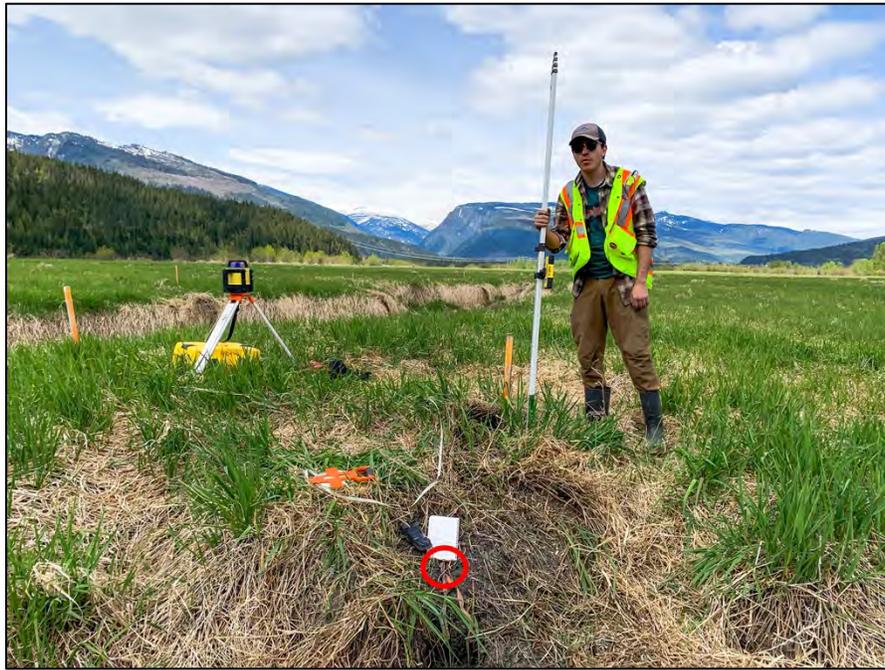
Figure 4-2: Image showing survey measurements taken at WPW Site 6-A. Environmental technician Addison Fosbery (Okanagan Nation Alliance) is standing above an erosion pin located in the red circle. Behind is the survey stake located 122 cm behind the erosion pin.

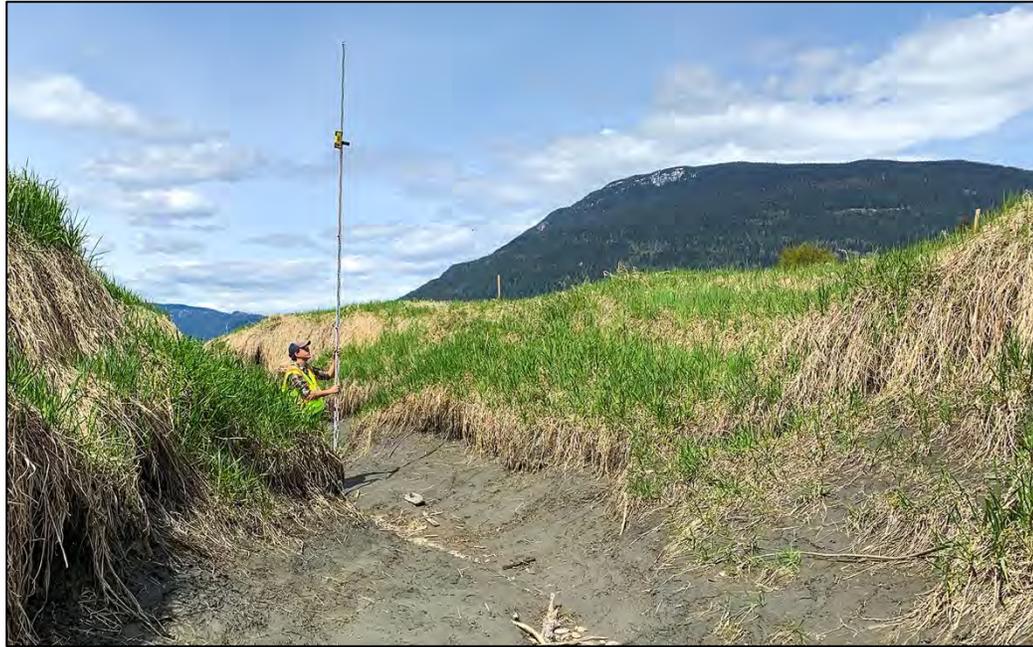
¹ Thalweg is the lowest elevation within a valley or watercourse in a given cross-section between two points (Figure 4-4).

Figure 4-4: Image showing thalweg measurement being taken by Addison Fosbery between erosion pins in the west erosion channel at WPW Site 6-A. Note the bank failure that has occurred in the foreground (right hand bank).

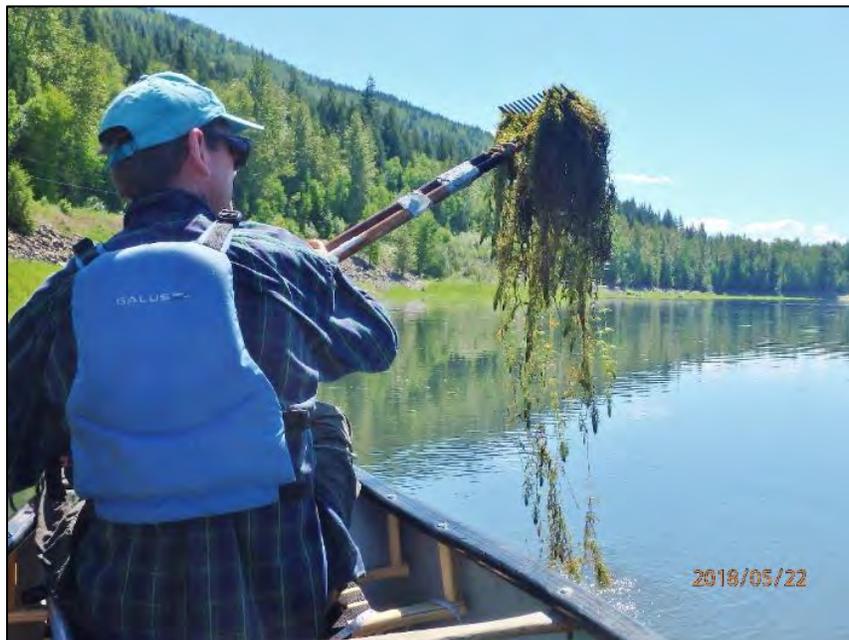
Two benthic rake drags were made, one on each side of the canoe. Following each rake drag, the contents of the rake were examined (Figure 4-5) and the species composition of the macrophyte sample was recorded.

Figure 4-5: Rake sample of aquatic macrophytes, Cartier Bay wetland, May 2019. Surveyor: Mike Miller.

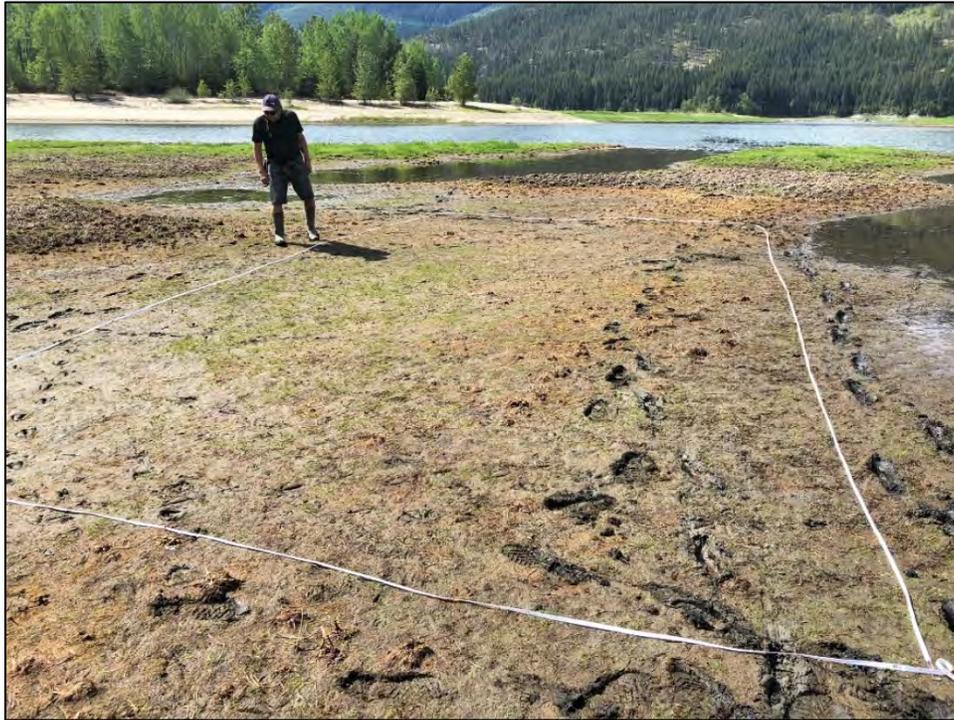
In 2019, sampling was conducted to assess riparian vegetation conditions at the terrestrial-aquatic interface (Miller *et al.* 2020b). For completeness, those methods (and results) are repeated here. Vegetation was sampled on the shoreline immediately above the permanently wetted zone within 15 semi-random, 10-m x 5-m (50-m²) plots (Figure 2-4, Figure 4-6). Substrates at this elevation were characterized by high clay content. This shoreline sample was designed to complement the set of terrestrial plots sampled in 2018

Figure 4-6: Supplemental riparian vegetation plot just above permanently wetted zone, Cartier Bay. Photographed May 14, 2019. Surveyor: Dixon Terbasket.

Per cent covers, measured as the percentage of the ground surface covered when the crowns are projected vertically, were visually estimated and rounded as follows: traces = 0.1%; <1% rounded to 0.5%; 1-10% rounded to nearest 1%; 11-30% rounded to nearest 5%; 31-100% rounded to nearest 10%. Vegetation within plots was assessed for plant species composition/cover and vegetation community type, or VCT. Community typing followed that used for CLBMON-33 (Miller *et al.* 2018a).

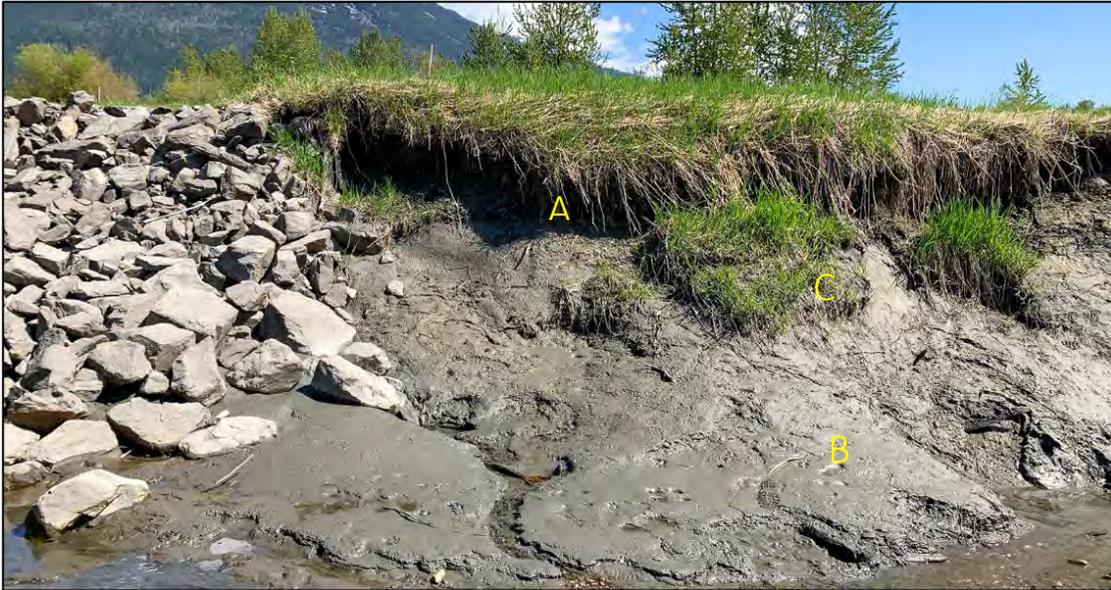
Little evidence of erosion was observed at the riprap-floodplain interface in the east channel. As in prior years, surveys conducted in 2020 found the riprap has integrated nicely into the floodplain (Figure 2-2), and again, no evidence of channelling was observed. However, as reported previously (Miller et al. 2020 and 2020b), bank undercutting, slumping, and bank failure of the fine-textured soil are an ongoing concern at the confluence of the east and main erosion channels (Figure 5-1).

Figure 5-1: Bank undercutting (A), slumping (B), and bank failure (C) at the mouth of the east channel of WPW-6A. May 13, 2020.

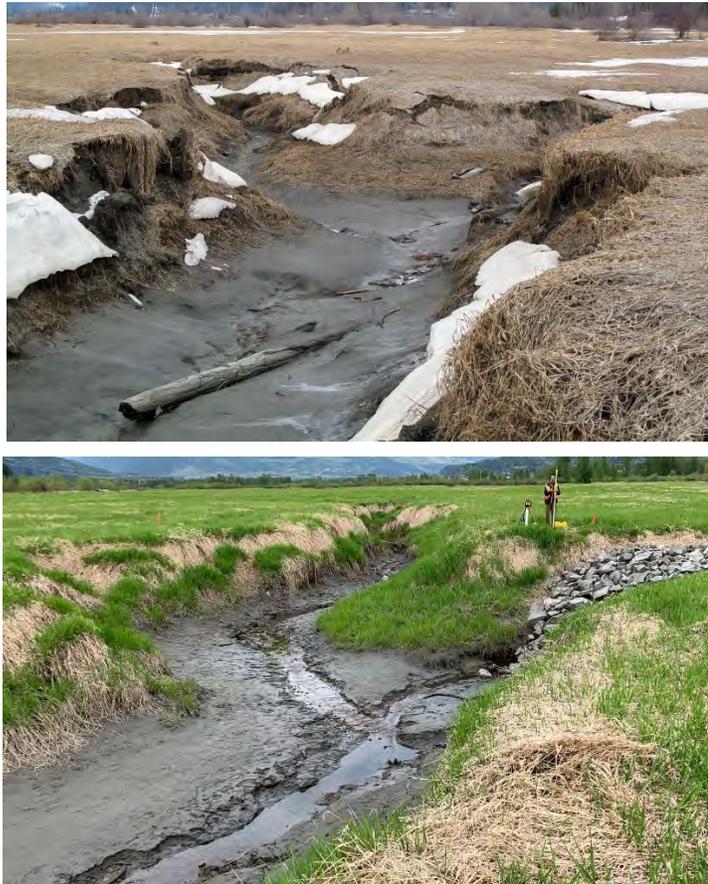
Figure 5-2: Before and after images taken at the confluence of the east and west erosion channels. Image dates April 09, 2009 (above) and May 13, 2020 (below). The west channel is noticeably wider, longer, and deeper in the lower image.

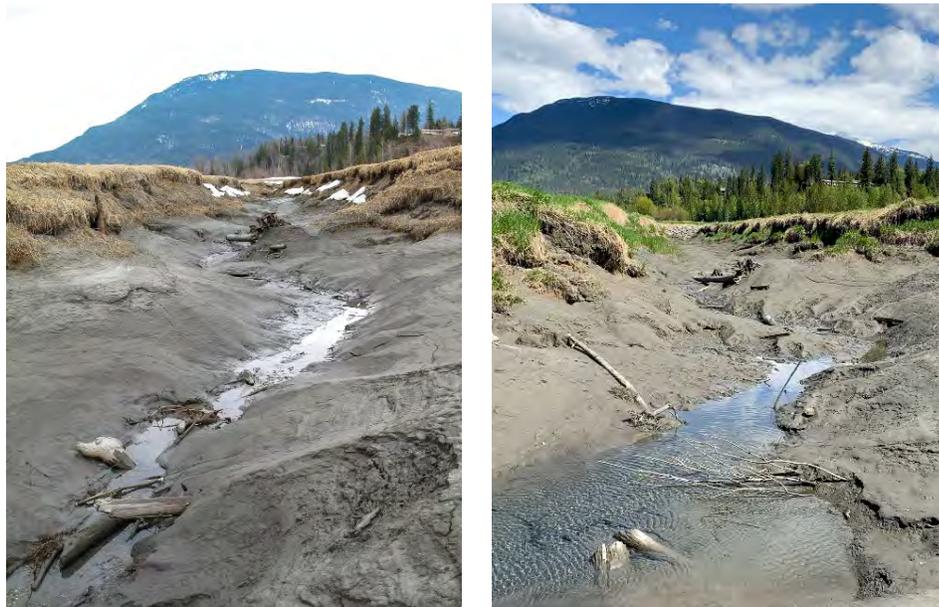
Figure 5-3: Before and after images taken at the confluence of the main erosion channel. Image dates April 09, 2009 (left) and May 13, 2020 (right). The main channel is noticeably wider and deeper in the image taken in 2020.

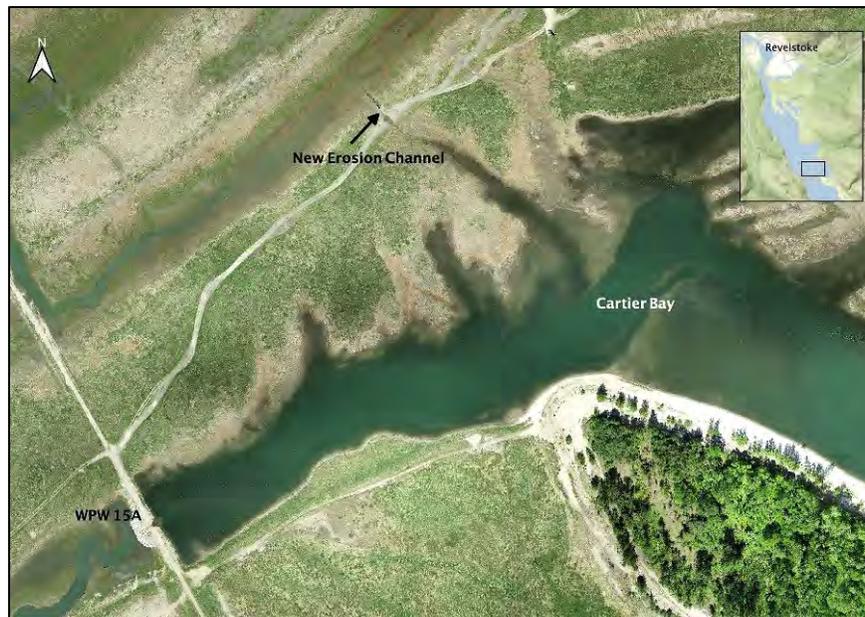
Figure 5-7. Location of recent erosion channel and head-cut (indicated by yellow arrow) caused by overflow from the west compartment of Cartier Bay wetland.

It is likely that the physical works are responsible for the fact that the pond has begun to overflow its northern bank. Prior to physical works implementation, the elevation of the ad hoc dike and wooden box culvert was 433.962 m ASL. The final elevation of the swale after improvements (addition of riprap and filter blanket) was 434.045 m ASL (Watson Engineering 2016). The possibility that the impoundment may now be retaining slightly more water (~10 cm) in the west compartment during spring run-off, resulting in higher back filling of the compartment, raises other concerns. One is that increased water depth could affect utilization of the compartment by waterfowl such as dabbling and diving ducks. A map of waterfowl distributions (Figure 6-2) shows that when reservoir elevations were between 433.8 m and 434.75 m, dabbling ducks continued to concentrate in the permanent wetland area, but their distribution within the wetland shifted away from the deepest parts of the pond (i.e., the west compartment) towards the shallower east compartment. Diving ducks were uncommonly observed in either location when the wetland was impounded (Hawkes *et al.* 2015).

These observations and concerns were relayed to BC Hydro and, in early October of 2020, BC Hydro installed a temporary (sandbag) dike at the overflow point to reduce the escapement of water and stem the erosion process. That work is not detailed in the present report. However, an assessment of this mitigation effort is currently underway.

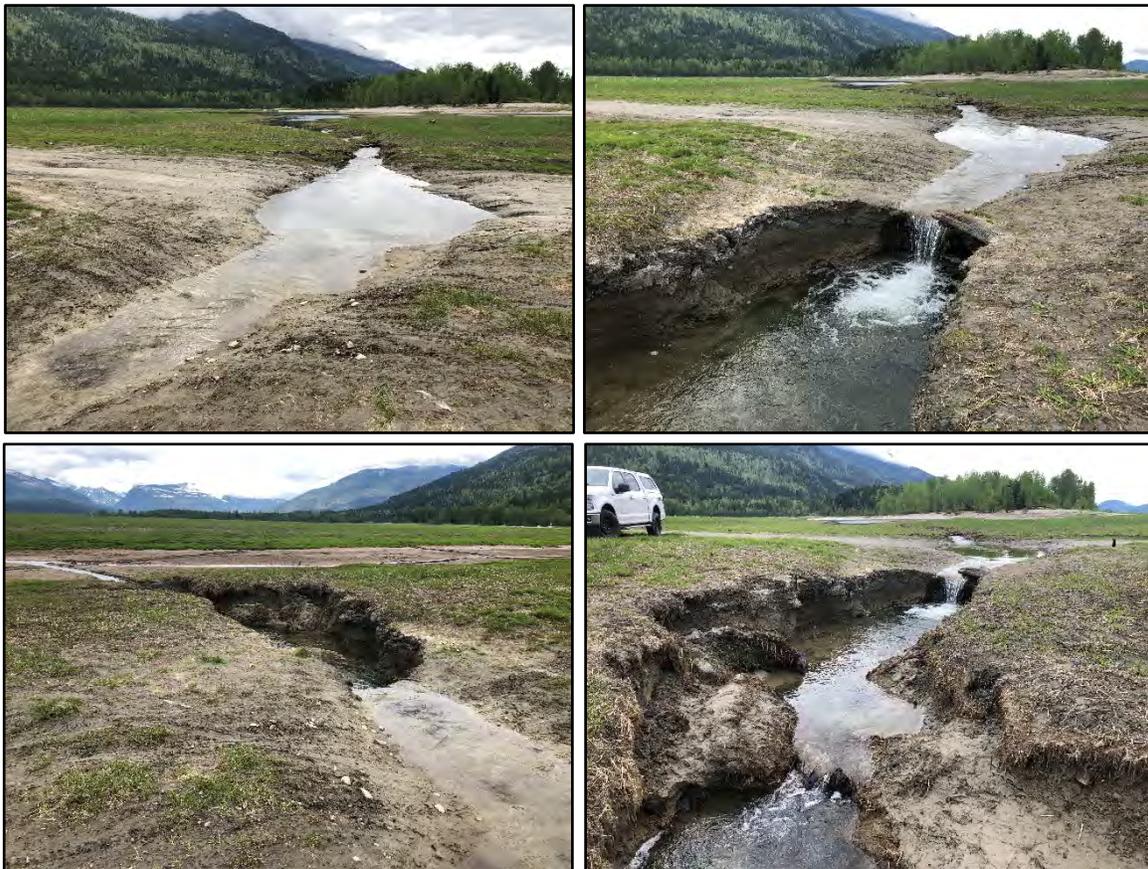
Figure 5-8. Overflow from the west compartment of Cartier Bay wetland where it crosses an access road near WPW-15A, with associated erosion channel and head-cut adjacent to the road. Photographed 15 May 2020.

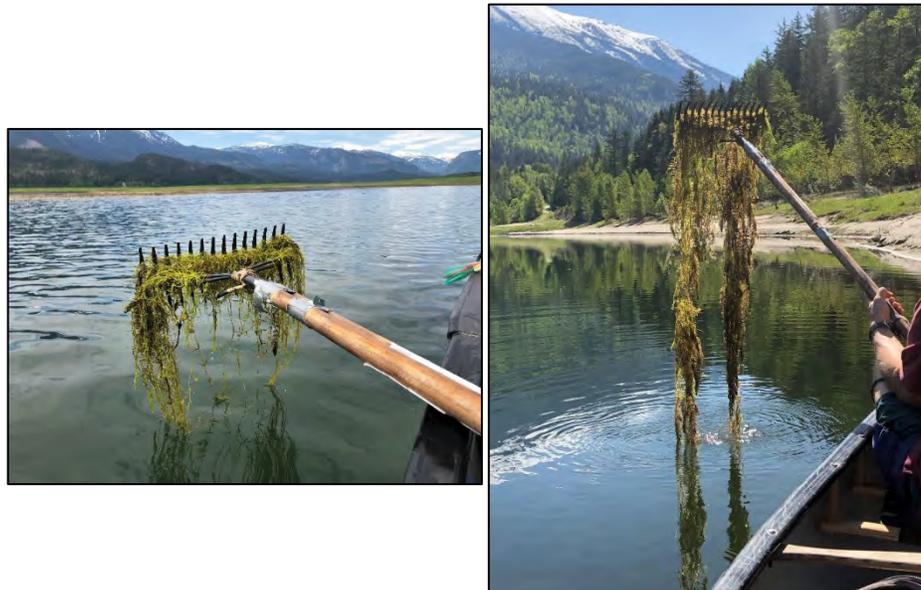
Figure 5-14. Rake samples illustrating concentrations of stonewort (left) and Eurasian water-milfoil (right) in the lower (western) compartment of Cartier Bay wetland, May 2019.

Despite the relatively low number of aquatic macrophyte species in Cartier Bay, these species tend to form distinct associations across regions within the two wetland compartments. Macrophyte cover in the western portion of the lower (west) compartment (i.e., the area closest to WPW-15A and the river) is primarily composed of stonewort (green algae) and the invasive Eurasian water-milfoil (Figure 5-15). The eastern portion of the west compartment continues to be dominated by those species, but also supports modest

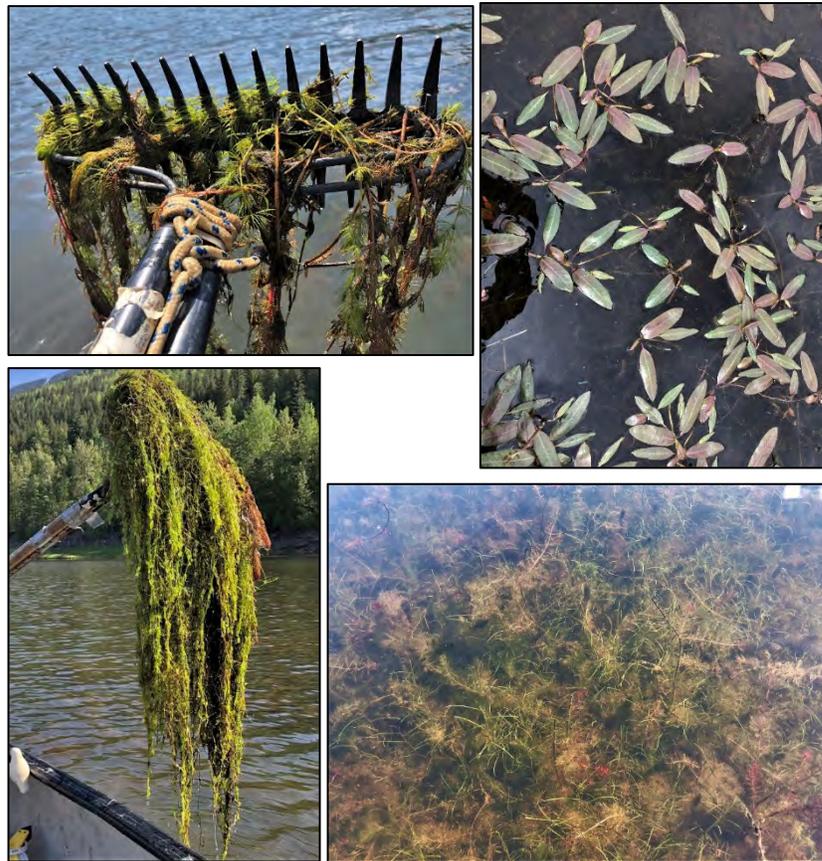
Figure 5-15: Macrophyte assemblages, east compartment of Cartier Bay wetland, May 2019. Clockwise from top left: rake sample illustrating mixed association of common hornwort, Eurasian water-milfoil, and stonewort; floating bed of water smartweed; submerged bed of small pondweed; and rake sample illustrating dense cover of stonewort.

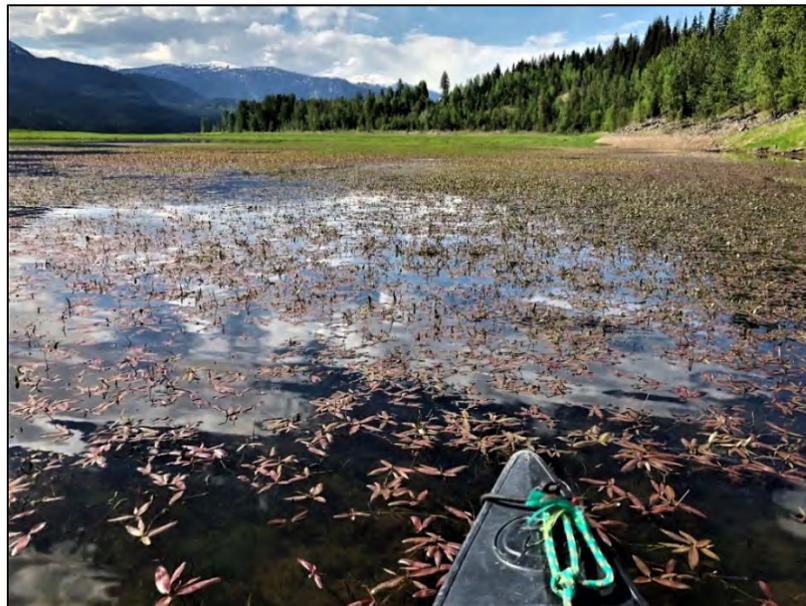
Figure 5-16: Floating mats of water smartweed, north end of Cartier Bay wetland (upper, east compartment), May 2019.

covers of common hornwort and three pondweed species, mainly eel-grass pondweed. In the southwest portion of the upper (east) compartment (i.e., east of the old roadbed), cover is co-dominated by stonewort, Eurasian water-milfoil, and common hornwort (Figure 5-16), but here small pondweed represents a significant subcomponent as well along with scattered floating beds of water smartweed (an amphibious species that also appears in terrestrial form on the adjacent shoreline). Moving northward along the east compartment, common hornwort and Eurasian milfoil alternately form dense patches, or co-occur in dense patches, while stonewort becomes less common overall and floating beds of water smartweed become more frequent (Figure 5-17). In the northernmost section of the east compartment, small pondweed forms frequent monospecific stands (or mixed stands with Eurasian water-milfoil), particularly in areas of shallower (< 0.5 m) water (Figure 5-16).

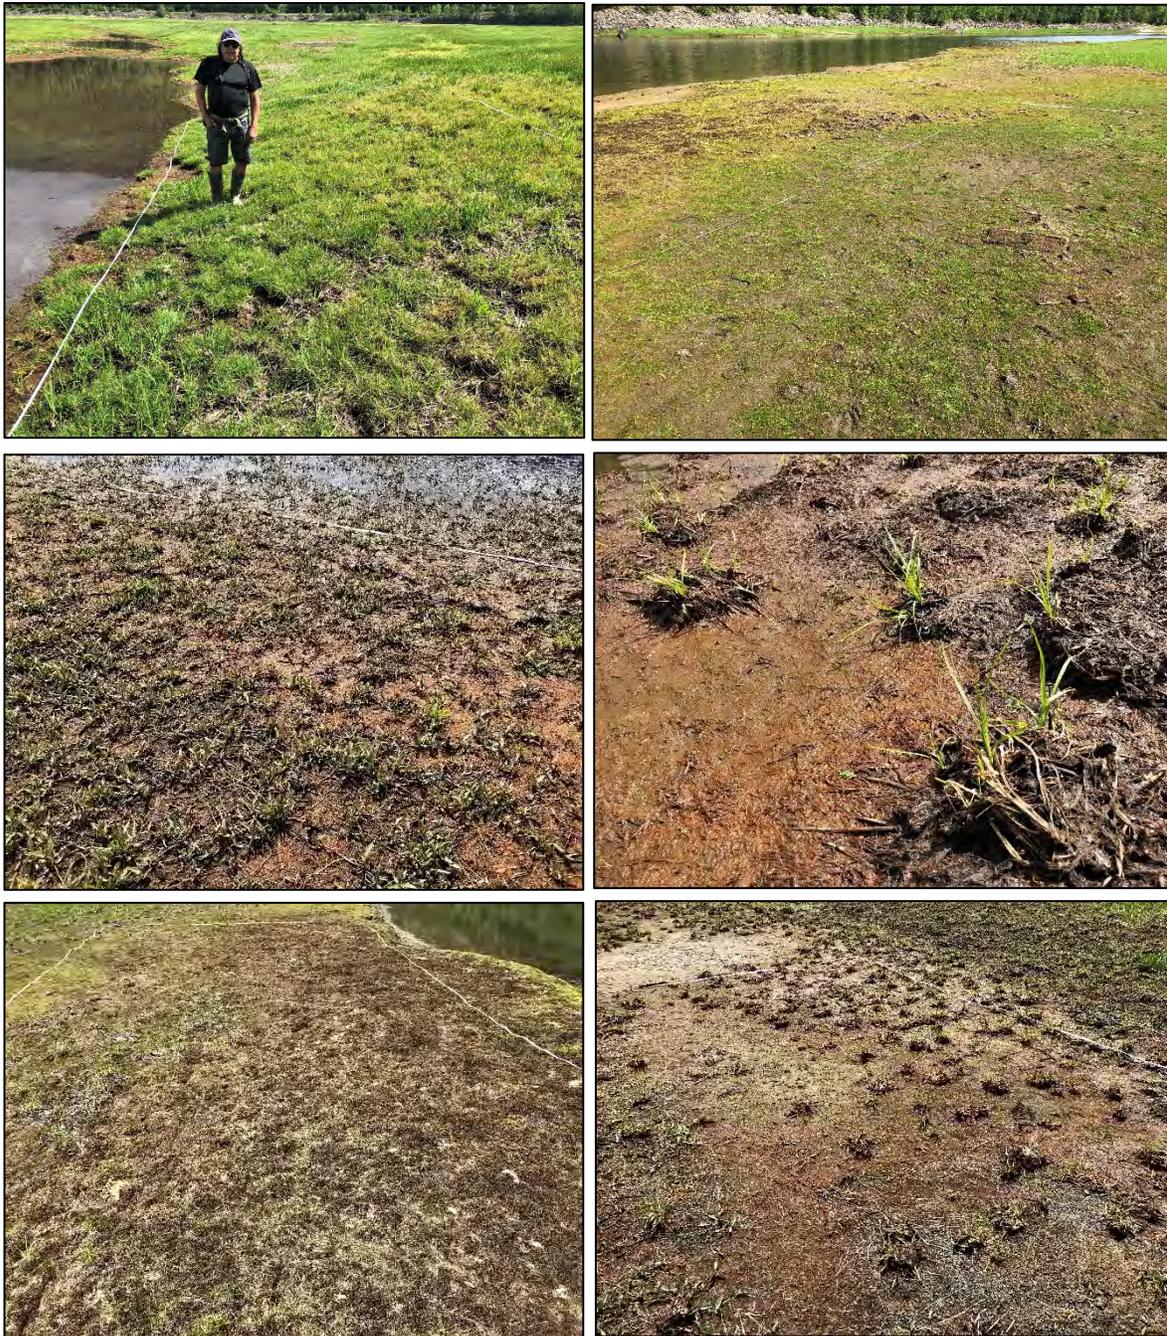
Figure 5-17: Examples of low-elevation, riparian plant associations recorded at the terrestrial/aquatic interface of Cartier Bay wetland in May 2019, prior to spring reservoir inundation. Clockwise from top left: Kellogg's sedge – Columbia sedge association; spring water-starwort – toad rush association; wool-grass stand (close-up); wool-grass stand (overview); moss cover; water smartweed association. Surveyor: Dixon Terbasket (ONA).
