Columbia River Project Water Use Plan

Monitoring Wetland and Riparian Habitat in Revelstoke Reach in Response to Wildlife Physical Works

Data Report

Study Period: 2019

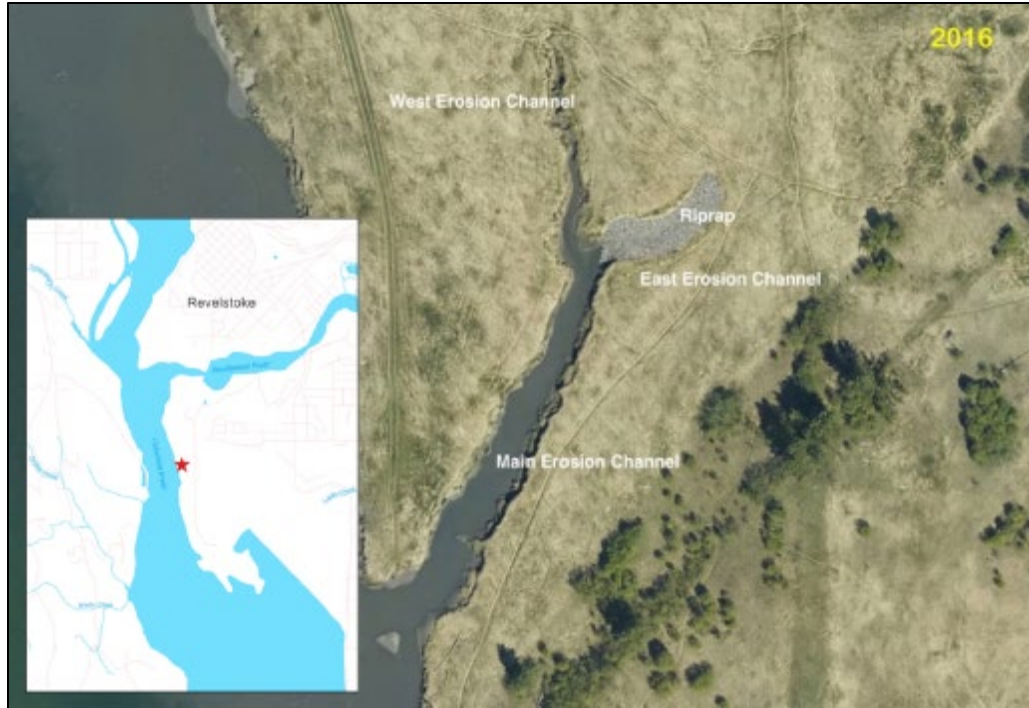
Figure 2-1: Aerial image of the WPW-6A “Y shaped” erosion channel. Scale 1:500. Inset show the location of the channel south of Revelstoke, BC. Image date May 2016.

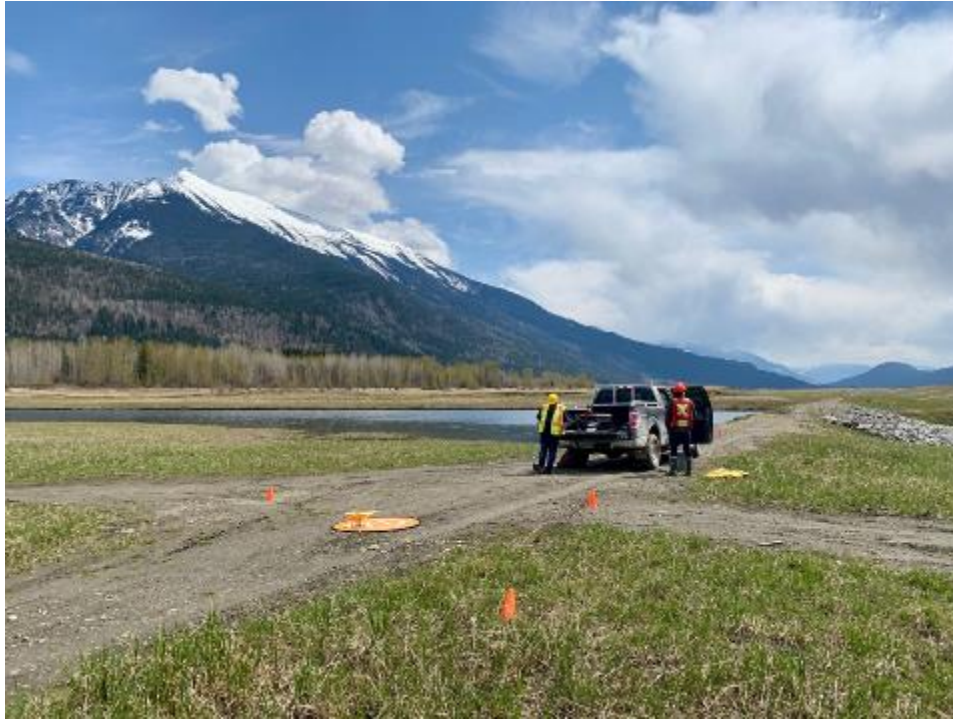
Figure 4-1: Image showing the safe deployment of a drone by Scott Waterfield (Osprey Aerial Intelligence Ltd) to capture high resolution imagery and elevation data at Cartier Bay on April 26, 2019.

A DJI Phantom (model 3-advanced) drone piloted by Scott Waterfield of Osprey Aerial Intelligence Ltd acquired bare ground elevation data and high-resolution imagery of WPW-Sites 6A and 15 on April 26th, 2019 (Figure 4-1). The drone was equipped with a 12.8 MP sensor and GPS/GLONASS satellite navigation systems and was flown at an average altitude of 31 meters along flight lines to attain 70% overlap of adjacent flight lines. Eight Propeller AeroPoint™ ground control points were positioned to allow for post-processing of the georeferenced images. Images were processed using the Propeller software platform,

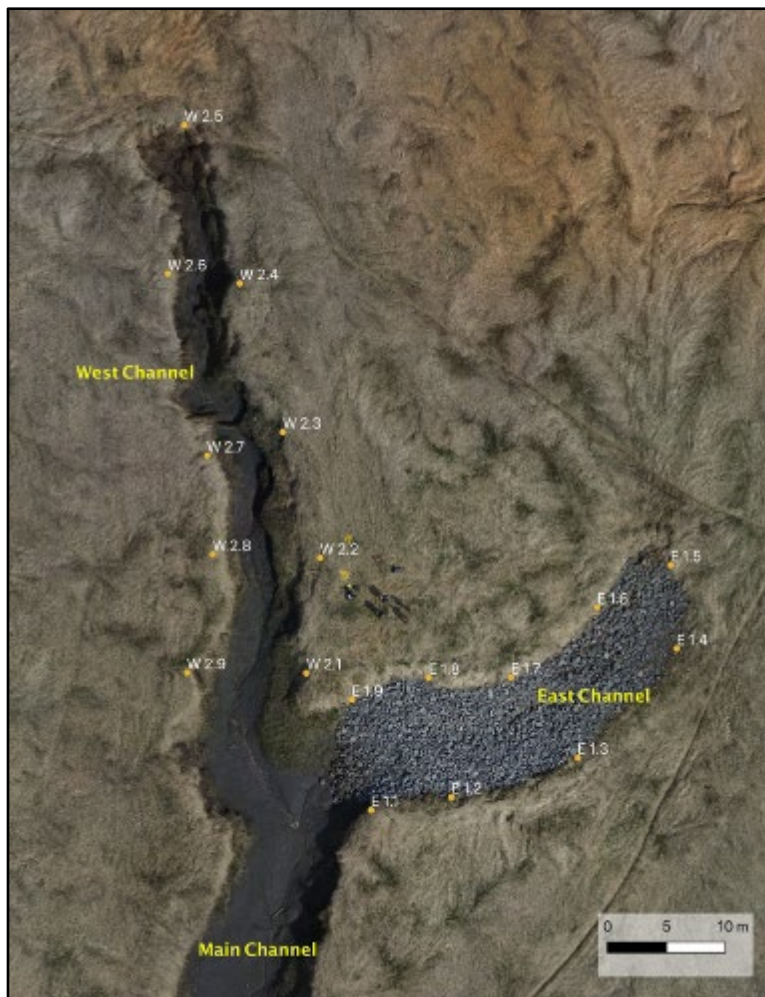
Figure 4-2: Image showing the arrangement of survey pins around the perimeter of the erosion channels. Thalweg measurements were taken between adjacent pins. Image date April 26, 2019

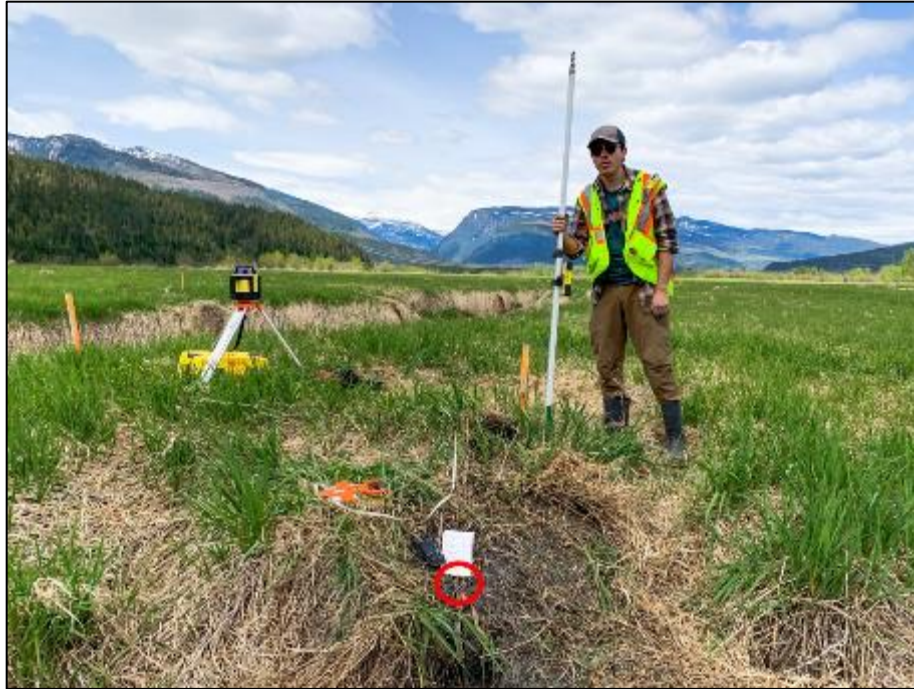
Figure 4-3: Image showing survey measurements taken at WPW Site 6-A, May 9, 2019. The erosion pin is located in red circle; behind is the survey originally located 122 cm behind the erosion pin. Environmental technician Addison Fosbery from Okanagan Nation Alliance is holding survey pole.

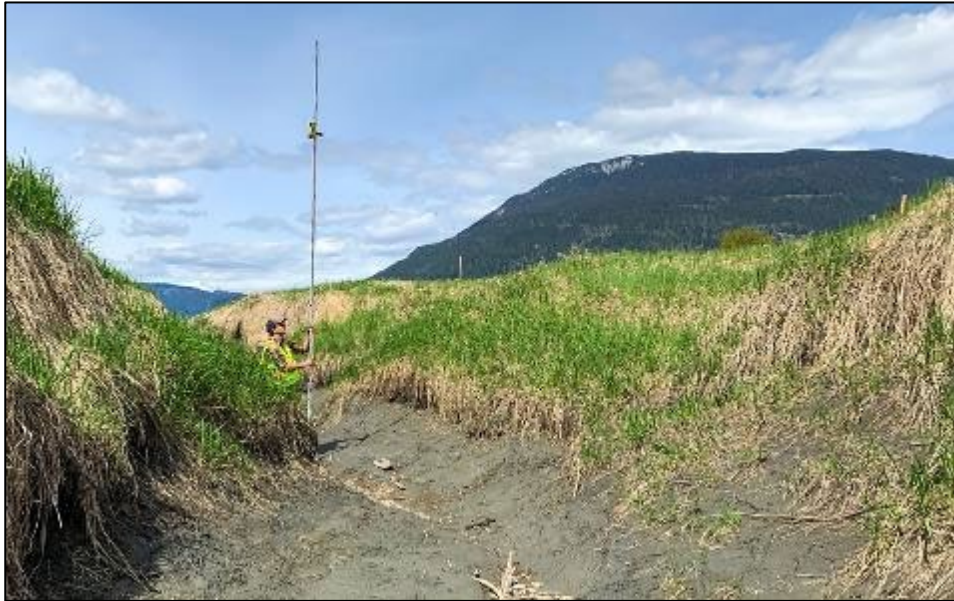
Figure 4-5: Image showing thalweg measurement being taken by ONG technician Addison Fosbery between erosion pins in the west erosion channel at WPW Site 6-A on May 9, 2019.

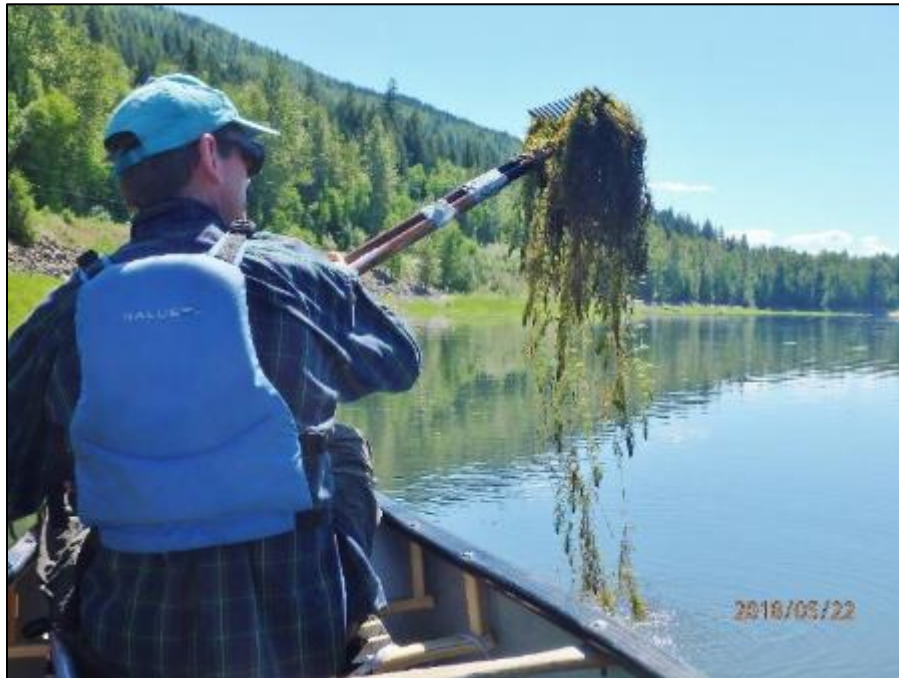
Figure 4-6: Rake sample of aquatic macrophytes, Cartier Bay wetland, May 2019.

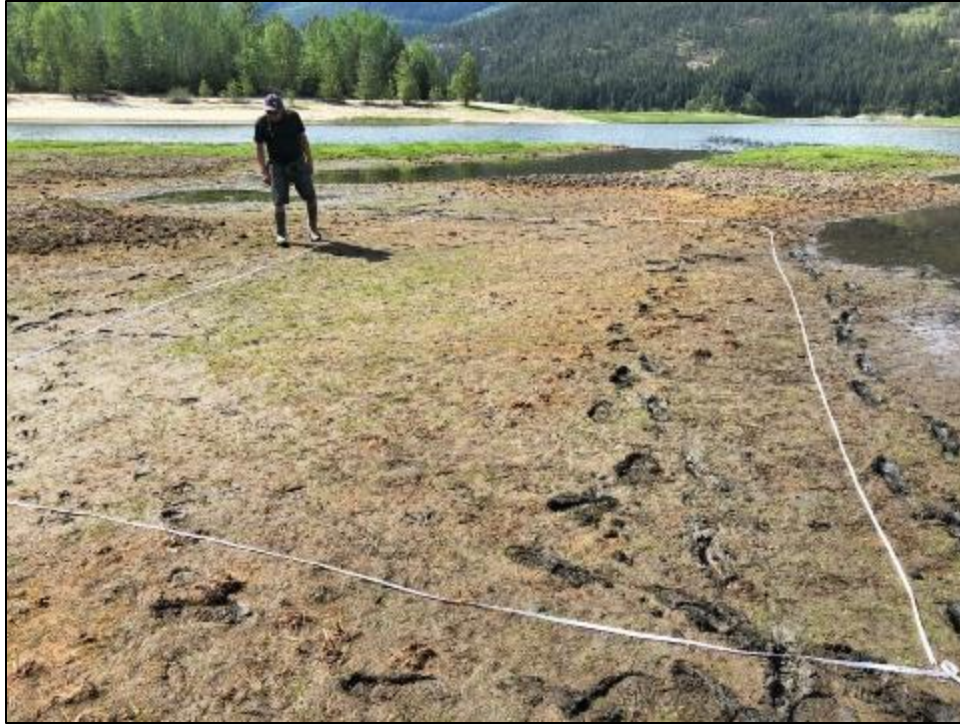
Figure 4-7: Supplemental riparian vegetation plot just above permanently wetted zone, Cartier Bay. Photographed May 14, 2019. Model: Dixon Terbasket (ONA).

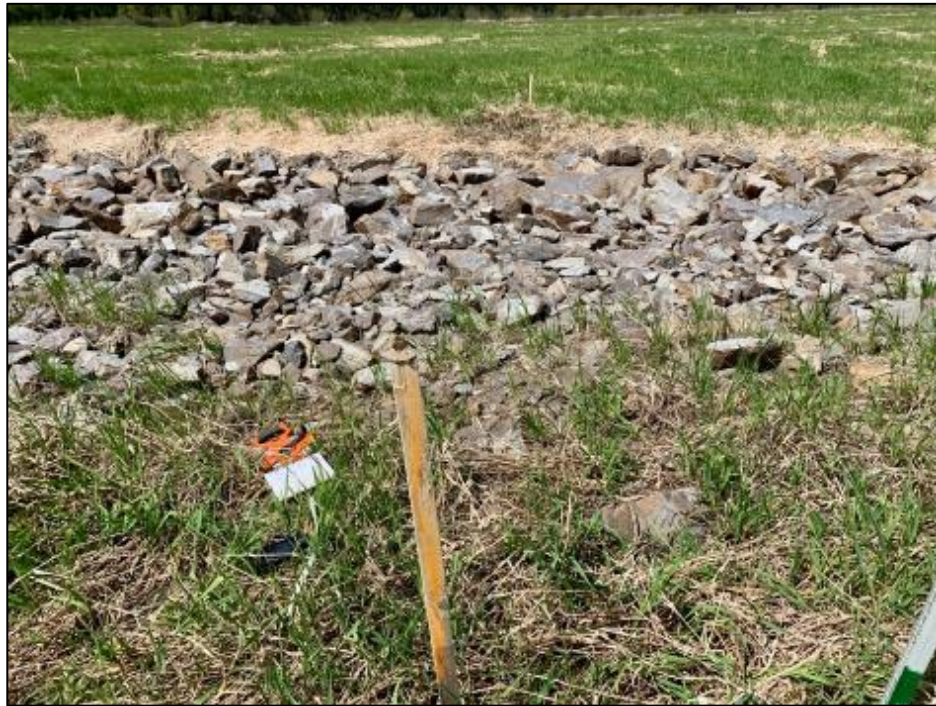
As reported previously (Miller *et al.* 2020), the riprap in the east channel continues to become well integrated into the surrounding soils. Fines are accumulating and reed canarygrass is showing ingress along the margin of the riprap (Figure 5-1). Bank erosion and mass wasting continues to be evident on the southwest terminus of the east channel (Figure 5-2; (Hawkes and Adama 2020; Miller *et al.* 2020).

Figure 5-1: Reed canarygrass (in the foreground) ingressing into the riprap along the margin of the WPW-6A east erosion channel. Image Date May 9, 2019.

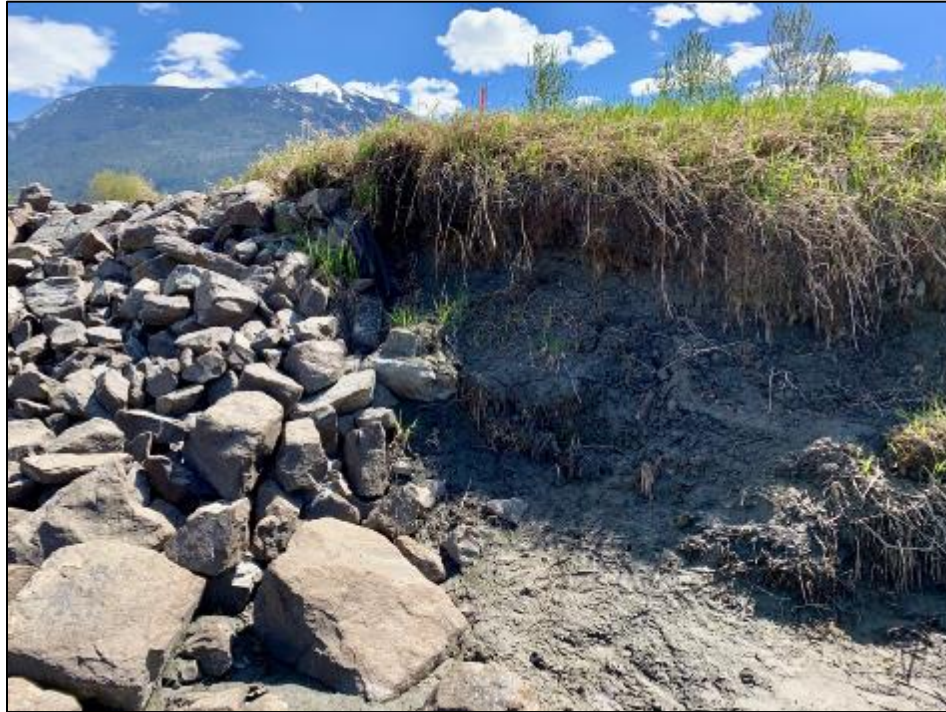
Figure 5-2: Undercutting of the bank at the mouth of the east channel of WPW-6A. May 9, 2019.

1. Continue visual assessments, survey measurements, and aerial image interpretation to monitoring erosion at WPW-6A. Particular attention should be paid to the undercut bank at the mouth of the east erosion channel. We recommend using a drone again to capture higher resolution imagery and DEM at WPW-6A. Drone acquired photogrammetry was a cost-effective approach for monitoring changes in channel size and volume. The higher resolution imagery and DEM acquired by the drone provided more reliable data for delineating channel perimeters and estimating channel area (m²) than airplane acquired digital orthophotos.

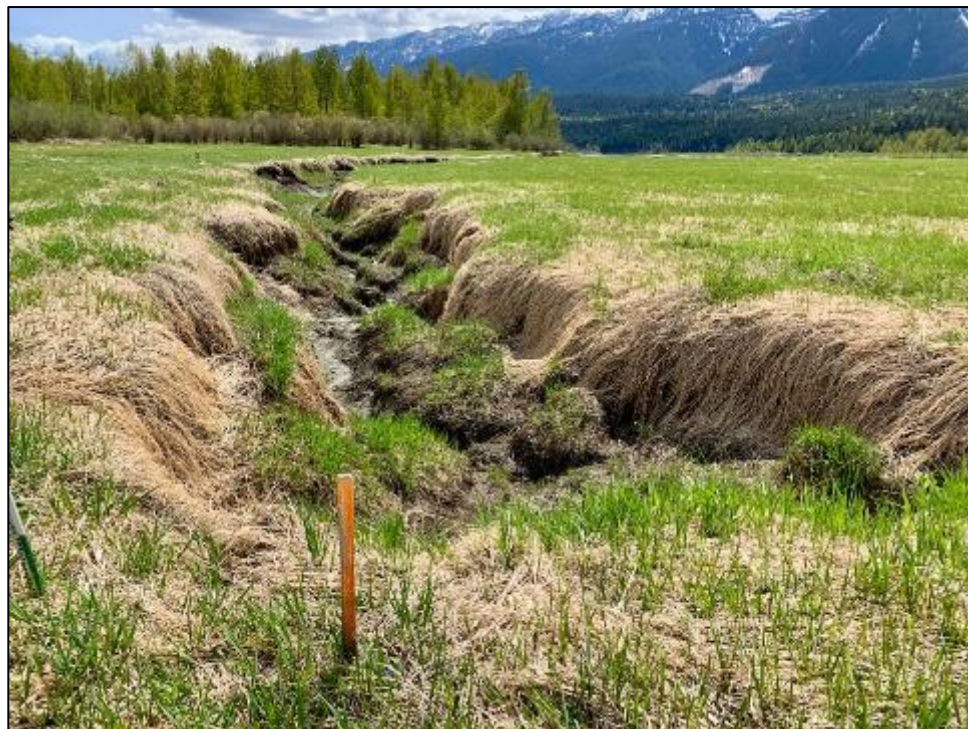
As observed in previous years (Hawkes and Adama, 2020; and Miller *et al.* 2020), extensive slumping and mass wasting was observed in the untreated west and main channels (Figure 5-3; Figure 5-4). While visual inspection and photo documentation are useful for identifying obvious signs of erosion, more quantitative methods were more reliable for assessing erosion in the two channels.

Figure 5-3: Extensive slumping and mass wasting in the WPW-6A west erosion channel. May 9, 2019.

4. Given the success of the WPW in arresting erosion in the east channel, we recommend that preliminary scoping of the west and main channels at Site 6 be undertaken in year three of this project (2020/21) to assess the utility of applying a similar approach there.

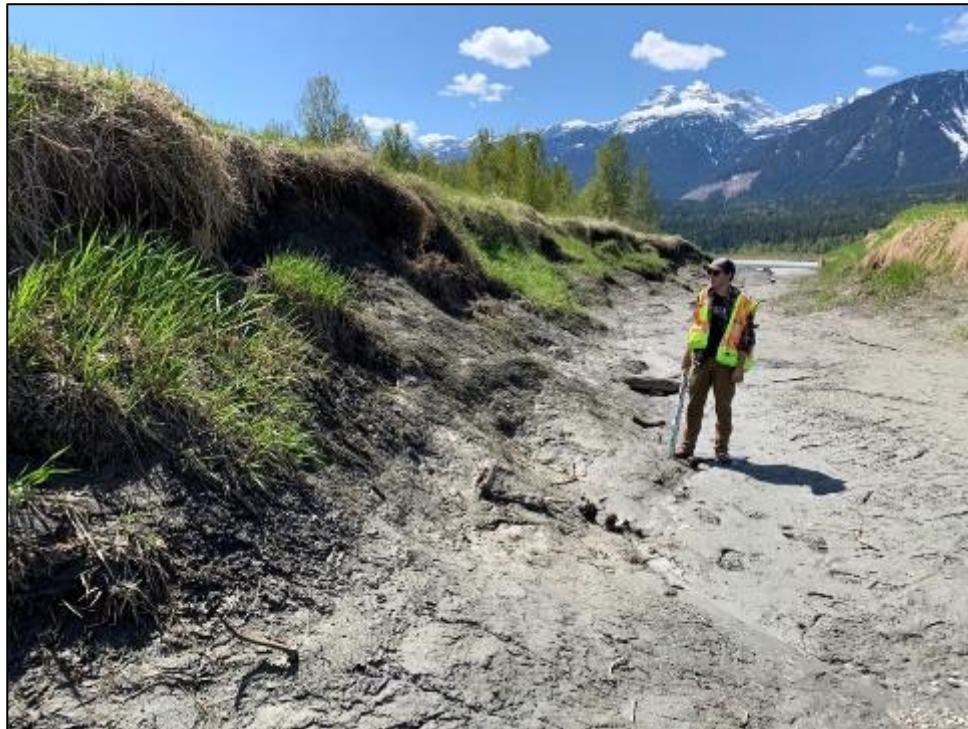
Figure 5-4: ONA field technician Addison Fosberry examining slumping and mass wasting in the main erosion channel at Site 6A. May 9, 2019.

2. We recommend expanding the erosion monitoring to include the main erosion channel at WPW-6A. Survey efforts to date have focused on monitoring and comparing erosion between the east and west channels. The main channel is closer to Machete Island and is immediately threatened by the enlargement of this portion of the erosion channel.

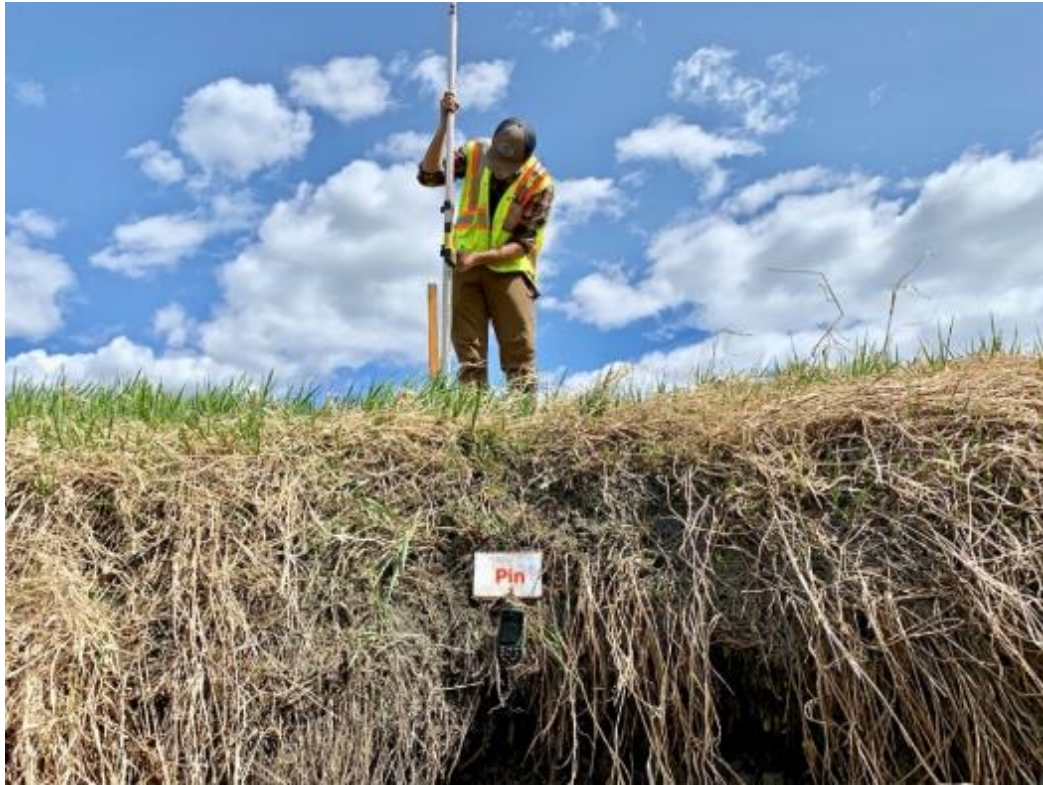
The rate of slumping in the west channel was higher in 2019 than the rate observed between 2016 and 2018 (Table 8-1; $t_{(df = 7)} = 2.53, p = 0.04$). This indicates that the rate of soil movement caused by bank undercutting may have accelerated, likely as a result of

lateral erosion below the upper sod layer causing it to cantilever and slump into the channel increasing the distance between the stake and the pin (Figure 4-4; Figure 5-5). Since their placement in 2016, five of the nine pins have moved > 10 cm from their original position from the stake (Table 8-1).

Figure 5-5: Photo of pin 2-4 located in the now overhanging (cantilevered) sod of the undercut bank of the west erosion channel. May 9, 2019.

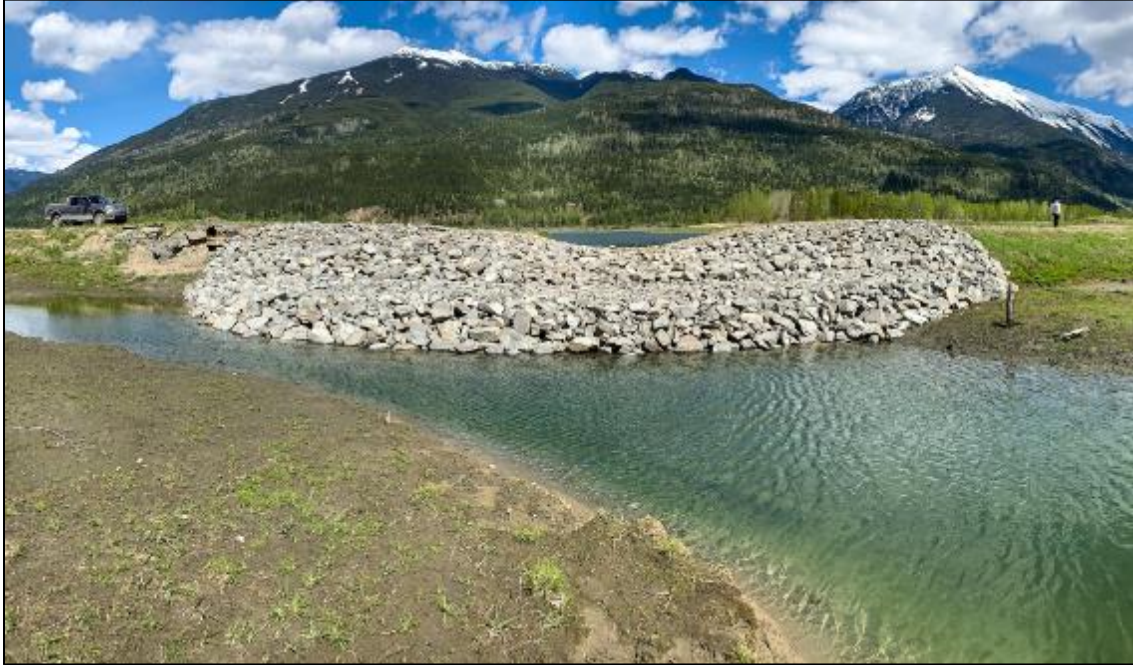
No sign of erosion was observed along the margin of the riprap or at the swale invert during our visual assessment of WPW-15A (Figure 5-8). The elevation of the swale invert was similar between years (434.05 m in 2018 and 434.04 m in 2019). These values compare favourably with the values reported by Watson Engineering (2016) of 434.045 m, confirming that no erosion has occurred on the surface of the swale invert since construction.

Figure 5-8: Image of the WPW-15A wildlife physical works at Cartier Bay. May 10, 2019.

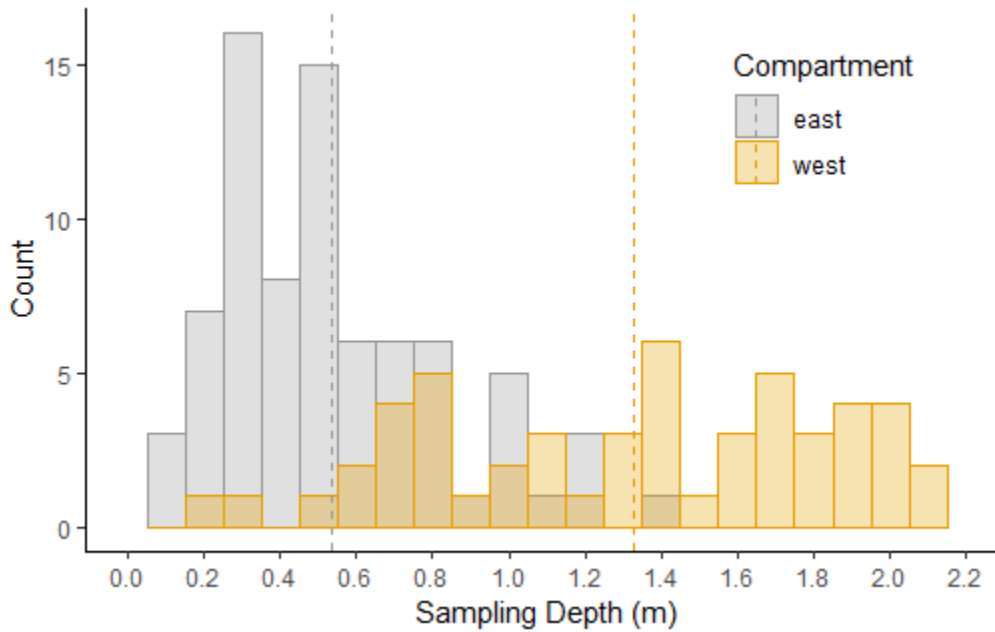
Figure 5-9. Sampling depth distributions for the east and west compartments of Cartier Bay wetland in 2019. “East” compartment refers to the area east of the eroded roadbed bisecting the wetland; “west” compartment refers to the area west of the roadbed and east of WPW-6A (Figure 2-2). Dashed lines represent the average sampled depths.

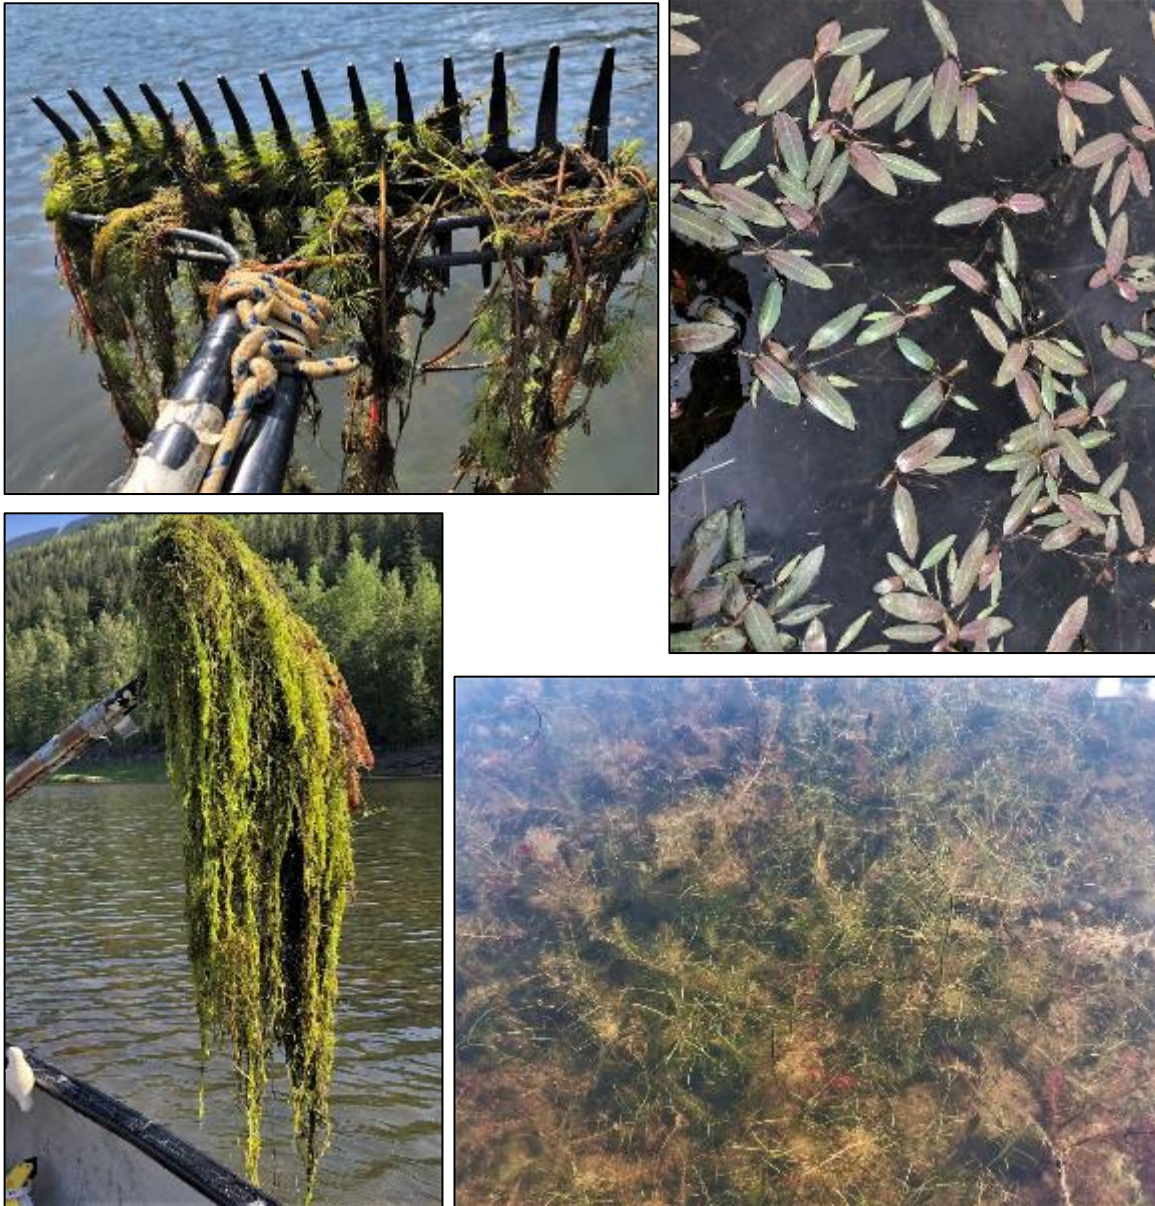
mixed stands with Eurasian water-milfoil), particularly in areas of shallower (< 0.5 m) water (Figure 5-14).

Figure 5-14: Macrophyte assemblages, east compartment of Cartier Bay wetland, May 2019. Clockwise from top left: rake sample illustrating mixed association of common hornwort, Eurasian water-milfoil, and stonewort; floating bed of water smartweed; submerged bed of small pondweed; and rake sample illustrating dense cover of stonewort.

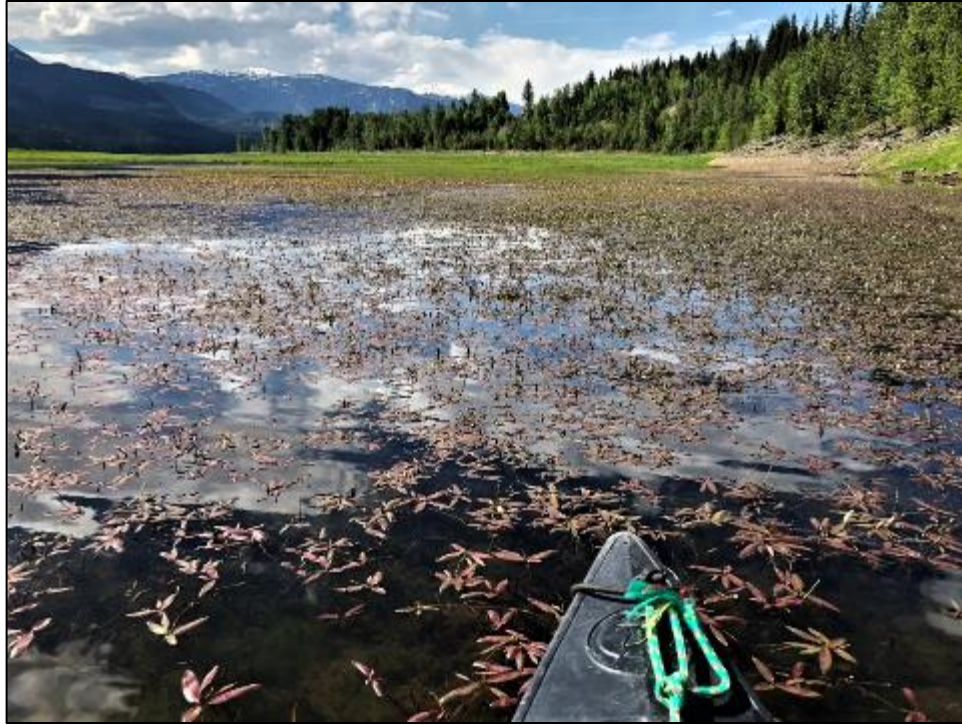
Figure 5-15: Floating mats of water smartweed, north end of Cartier Bay wetland (east compartment), May 2019.

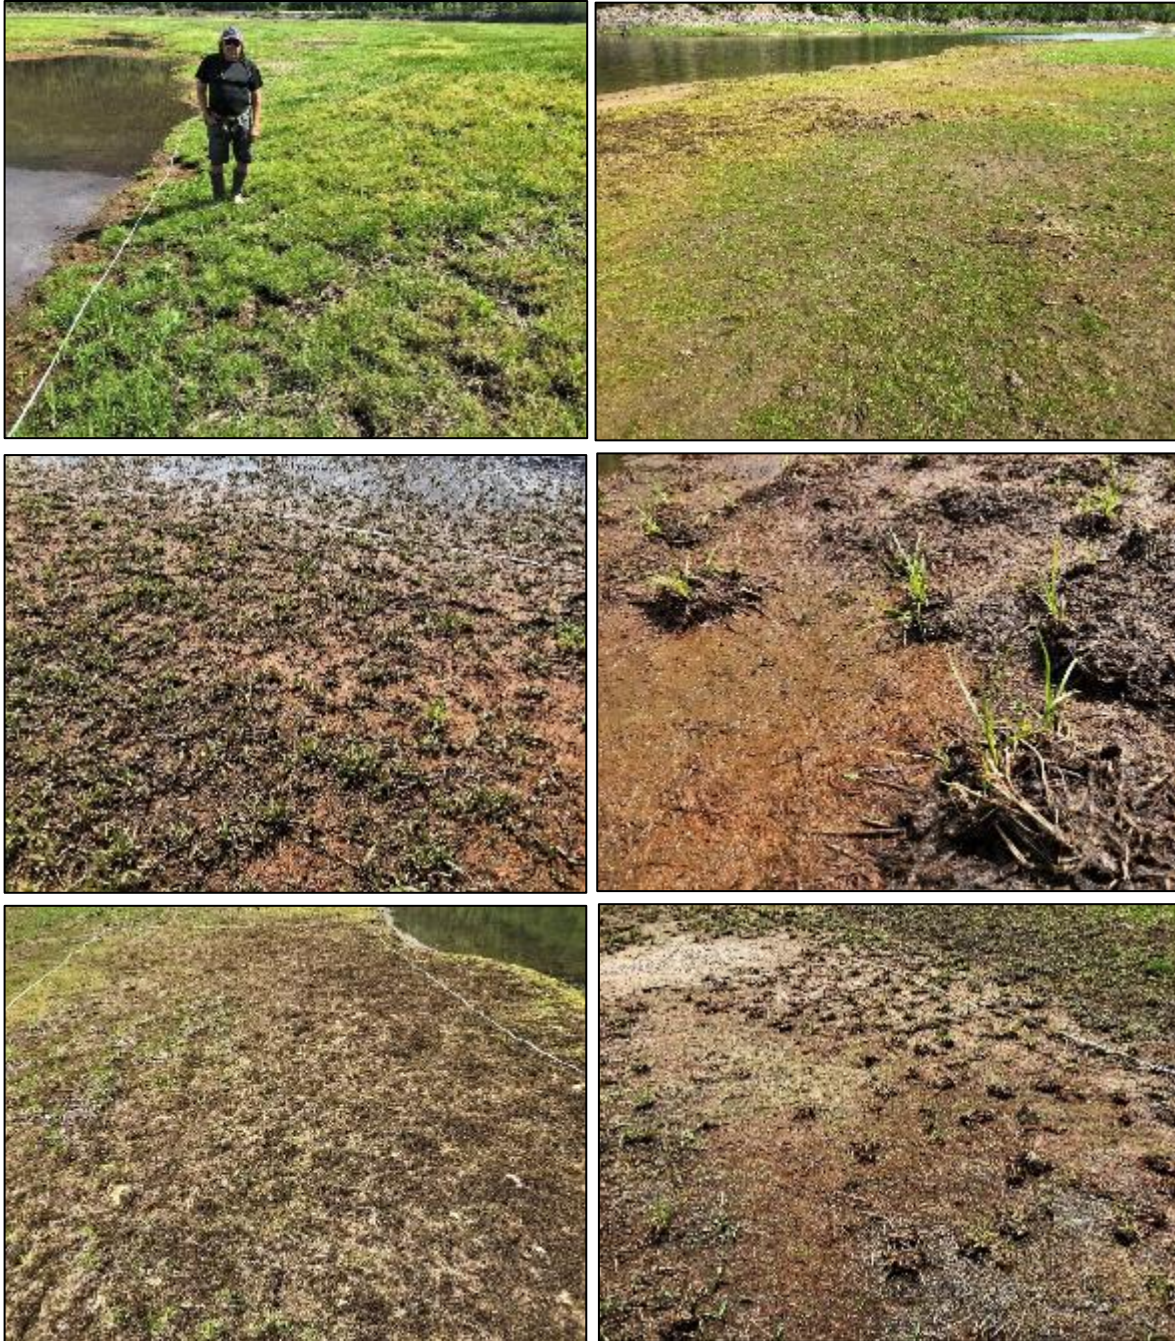
Figure 5-16: Examples of low-elevation, riparian plant associations recorded at the terrestrial/aquatic interface of Cartier Bay wetland in May 2019, prior to spring reservoir inundation. Clockwise from top left: Kellogg's sedge – Columbia sedge association; spring water-starwort – toad rush association; woolgrass stand (close-up); woolgrass stand (overview); moss cover; water smartweed association.
