Columbia River Project Water Use Plan

Revelstoke Reservoir Macrophyte Assessment

Reference: CLBMON-55

Revelstoke Reservoir Macrophyte Assessment – Phase 2

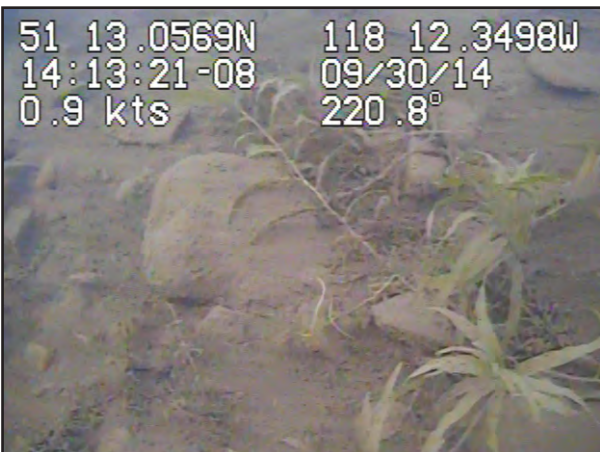
Photo 11: *P. alpinus* observed using drop
camera at Site 2 (September 30, 2014)

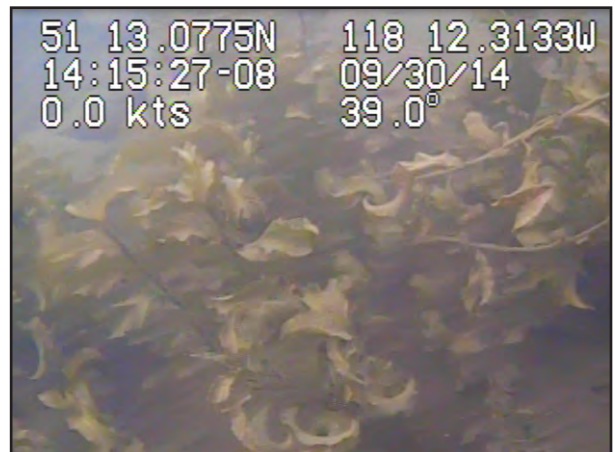
Photo 12: *P. amplifolius* observed using drop
camera at Site 2 (September 30, 2014)

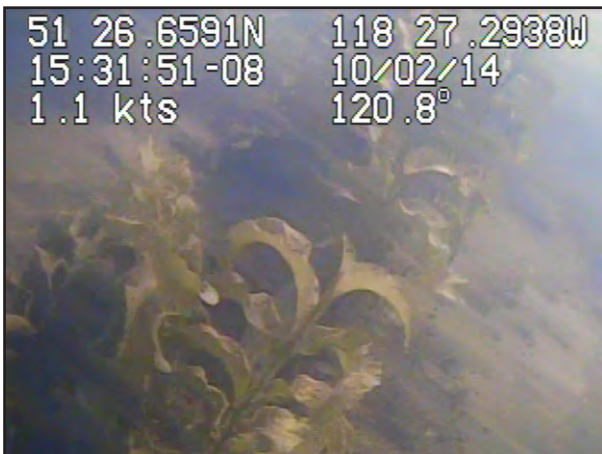
Photo 29: *P. amplifolius* observed using drop camera at Site 5 (October 4, 2014)

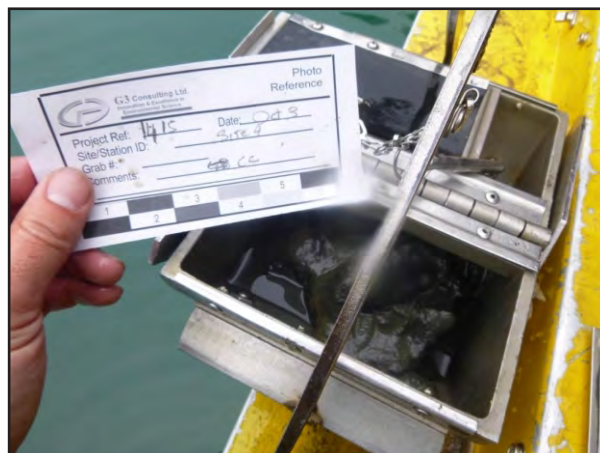
Photo 66: Stainless steel Ponar used for collecting sediment

A stainless steel 15 cm Ponar was used to collect sediment samples from each study area (Photo 66, Appendix 2). Samples were collected within each zone of the centre transect and deposited on in a white bucket for visual assessment and photographic documentation.
