Columbia River Projects Water Use Plan

Feasibility Study for Boat Launch Ramps at Nakusp on the Arrow Lakes Reservoir

July 11, 2017

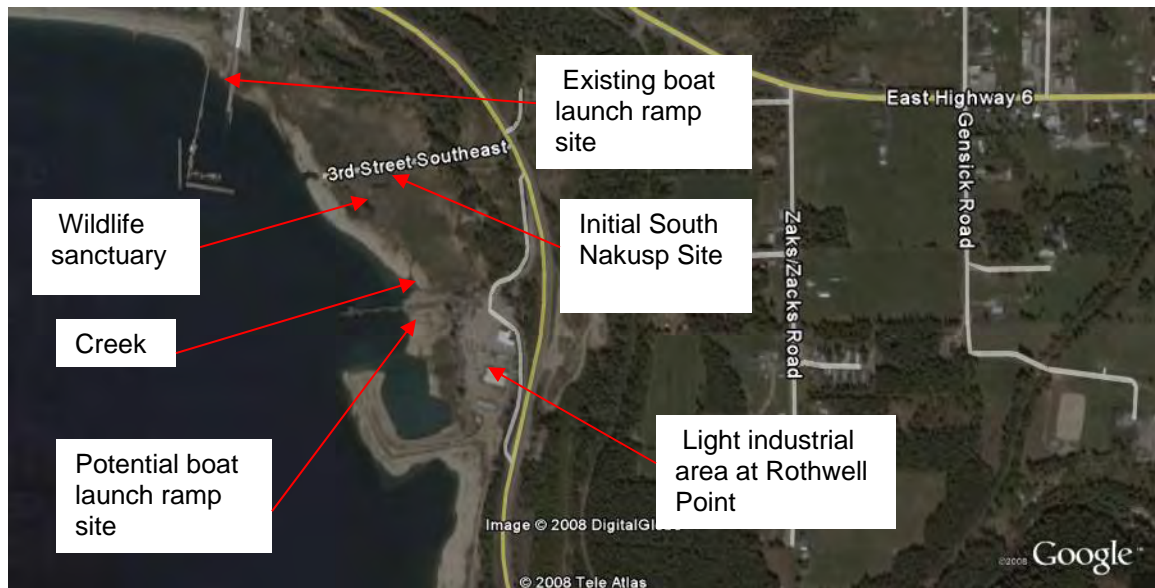
Figure 3.4 – Aerial View of Potential South Nakusp Boat Launch Ramp Site

The potential boat launch area is also bounded by a creek to the north and earth berm to the south as shown on Figure 3.4.

The project team also observed that the adjacent light industrial site at Rothwell Point and the upland area could be a potential site for a boat launch ramp. This site is located south of the marsh area and is currently occupied by several light industrial businesses. We understand that the property is privately owned by the Waterfield family.

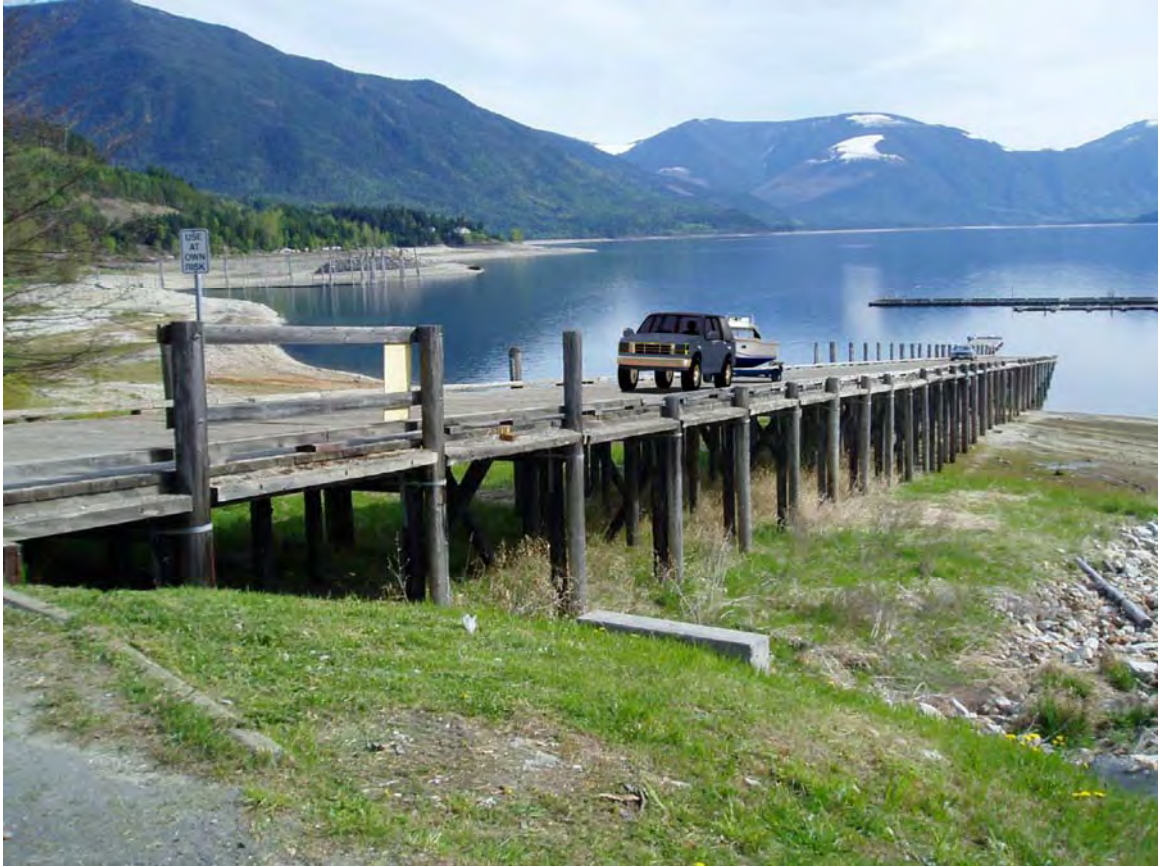
Figure 4.1 – Existing Timber Trestle Boat Launch Ramp

This concept considers the retention of the existing timber trestle assuming that the ramp will be kept functional with routine maintenance and replacement of structural members. In order to relieve some of the congestion currently experienced by users of the ramp, Option 1 considers providing a proposed turnaround to reduce the distance and effort required to reverse a vehicle and boat trailer when launching a boat.

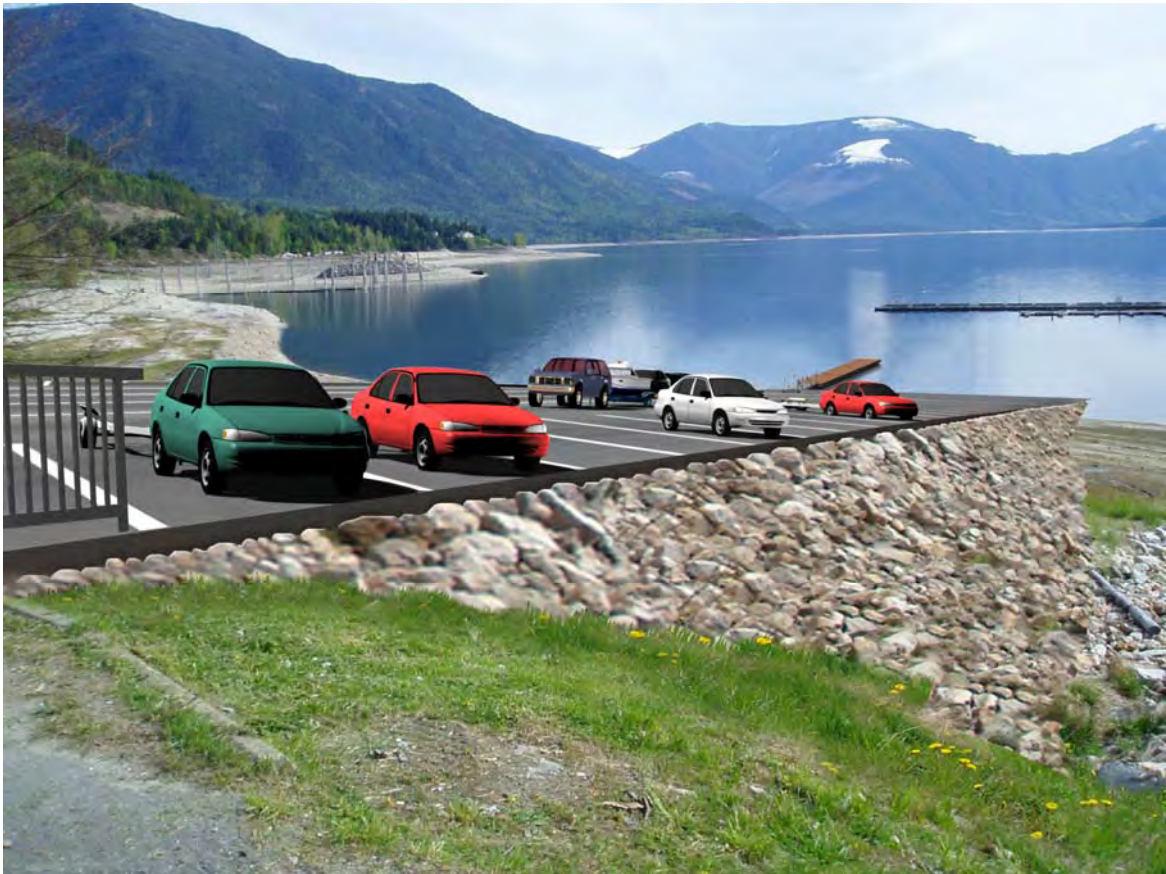
Figure 4.2 – Photo-simulation of Option 4 – Rock-filled Boat Launch Ramp

- A three lane ramp with access lane and parking area approximately 180 m long and 34 m wide. The core of the ramp will be constructed with general fill graded and sloped to 13% and the sides of ramp will be protected from erosion due to waves with armour rock. For Option 3 the ramp will have an all weather gravel surface, and for Option 4 the ramp surface will be a concrete slab with a grooved pattern for improved traction. The steeper slope of the ramp (13% versus 10% for the original timber ramp) provides a shorter ramp length and creates a larger area for the marina in front of the ramp; and,
- A floating walkway to allow people access to their boats when launching and retrieving.

Expansion of the existing parking area is dependent on whether privately owned properties along Nelson Avenue will be available for use. However, some minor improvements to enlarge the parking area are: the relocation of the existing washroom building and reconfiguration of the traffic pattern at the end of Nelson Avenue. A comparison of the existing boat launch ramp versus a photo-simulation of Option 4 is shown in Figures 4.1 and 4.2.

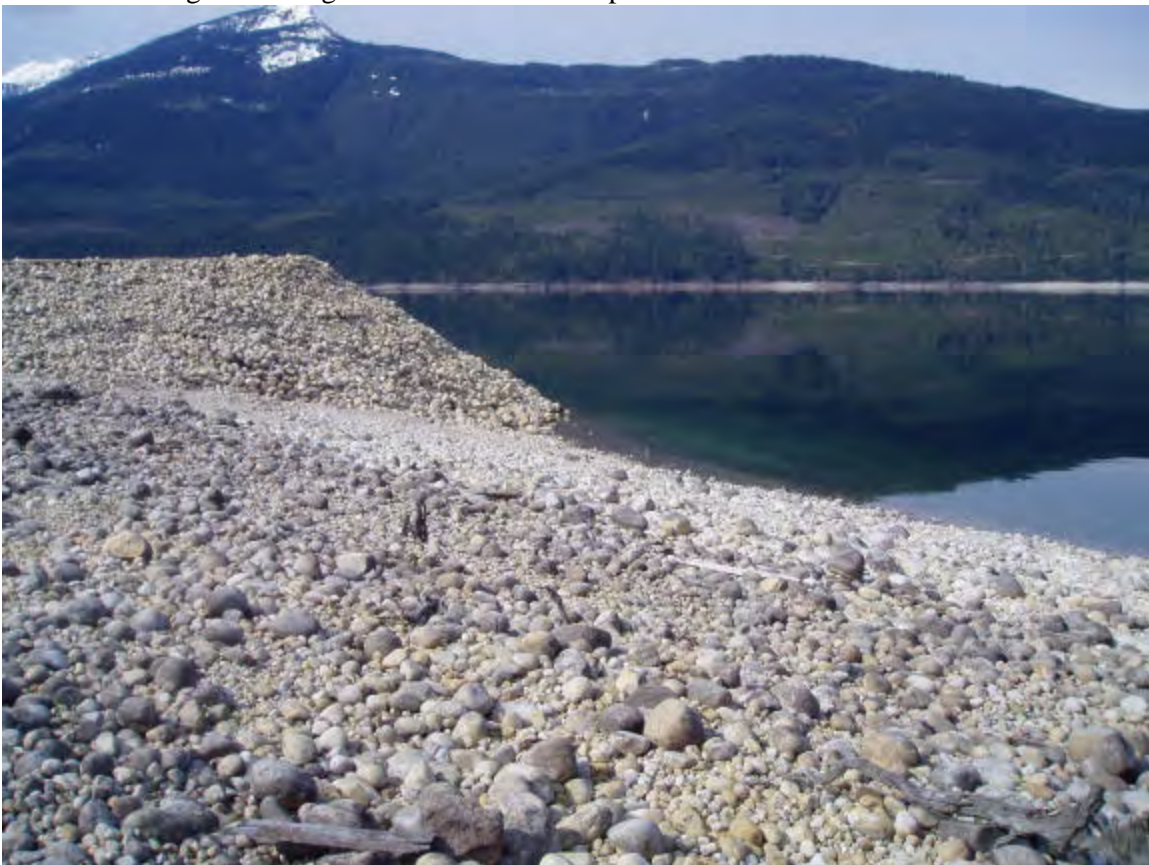
Plate 2. Looking west towards end of berm. Substrate here is larger and provides fish habitat.

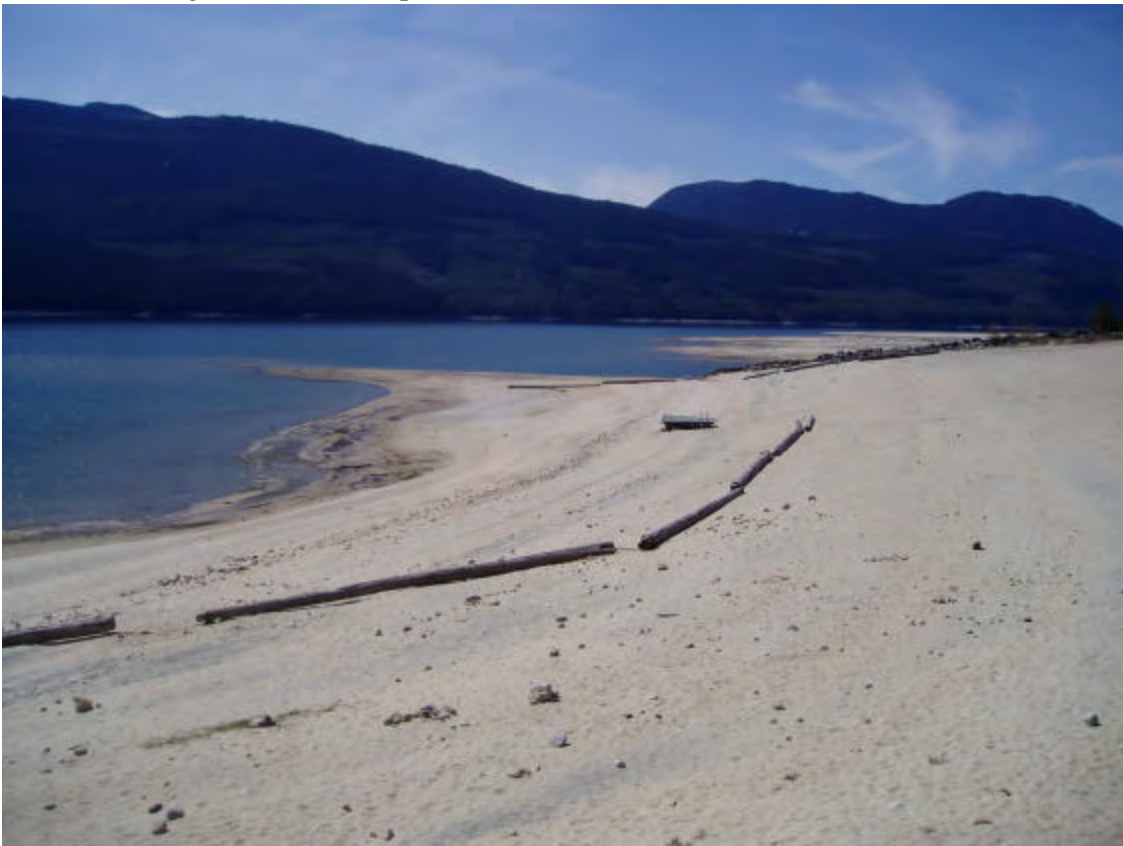
Plate 8. View of substrate at public beach site. Note shallow water depths extending from shoreline.

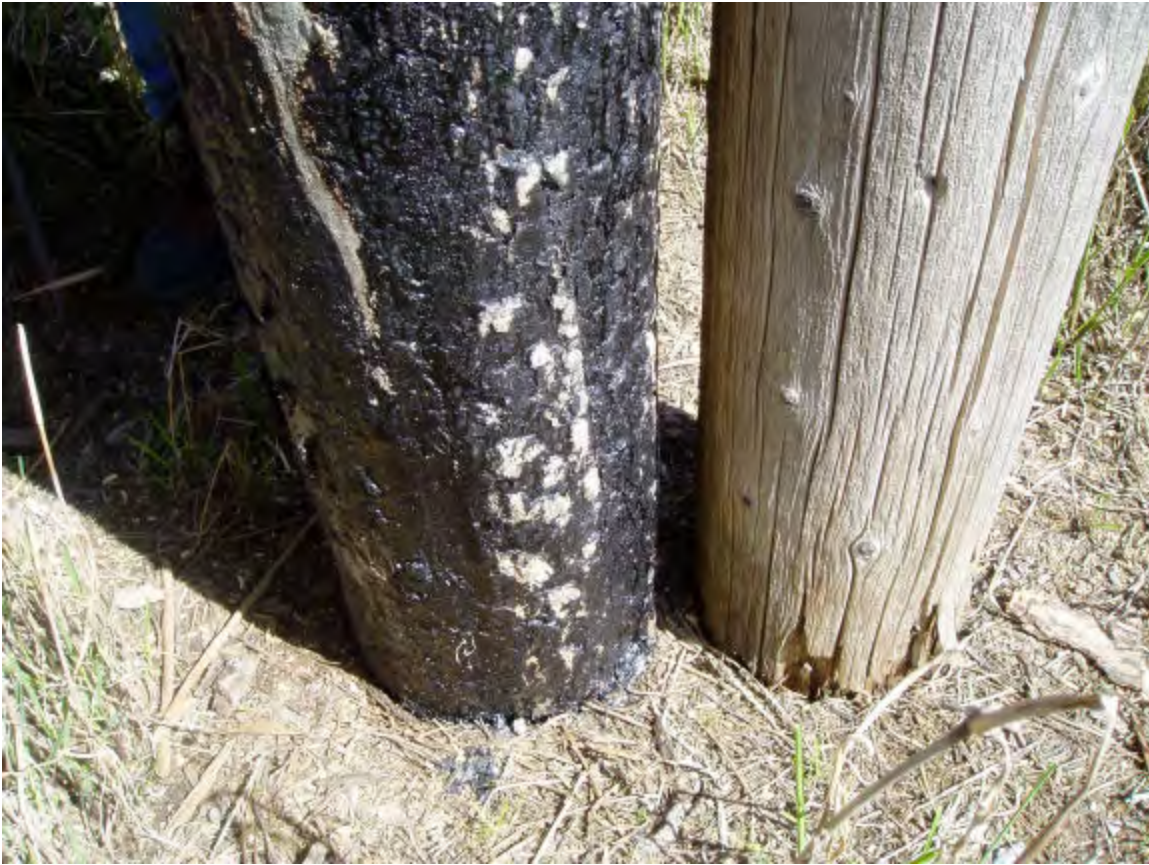
Plate 12. Treated timber piles used on inside of bridge but outside edge piles are untreated.

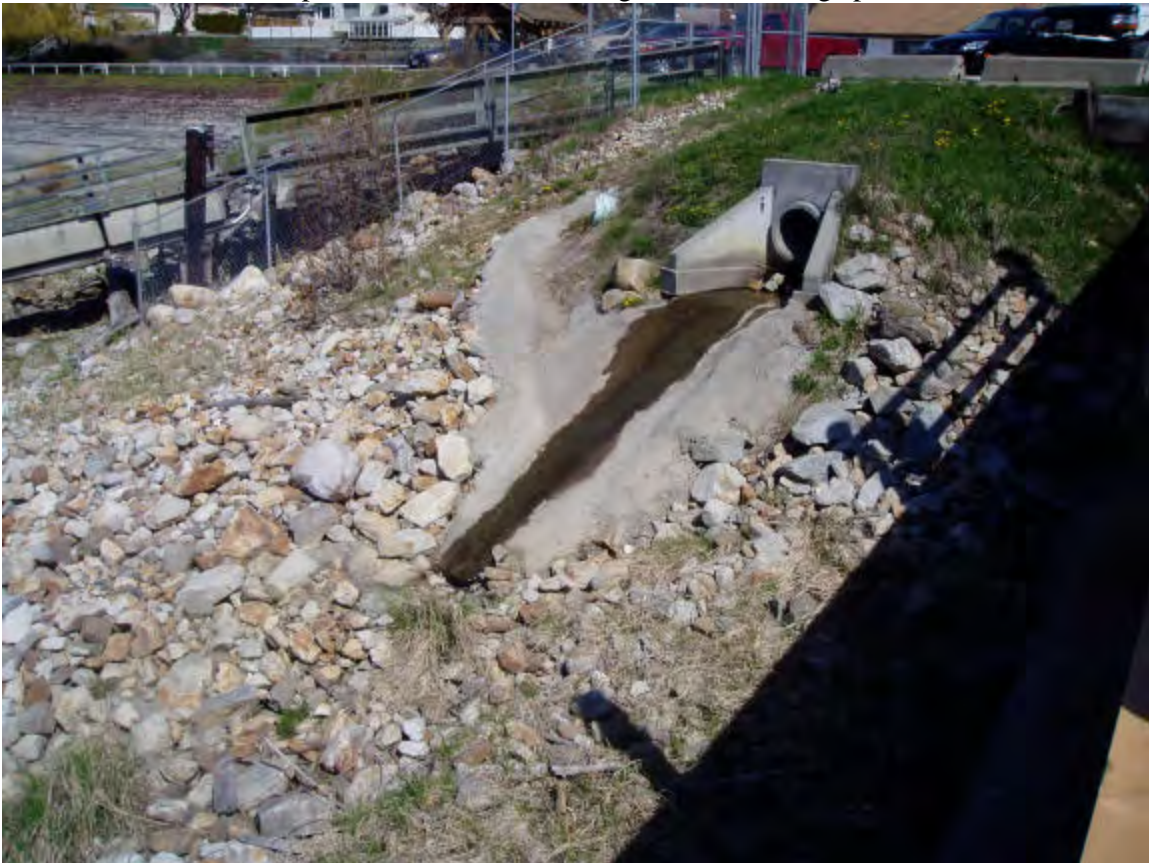
Plate 13. View of the storm drain outlet at existing Nakusp boat ramp.

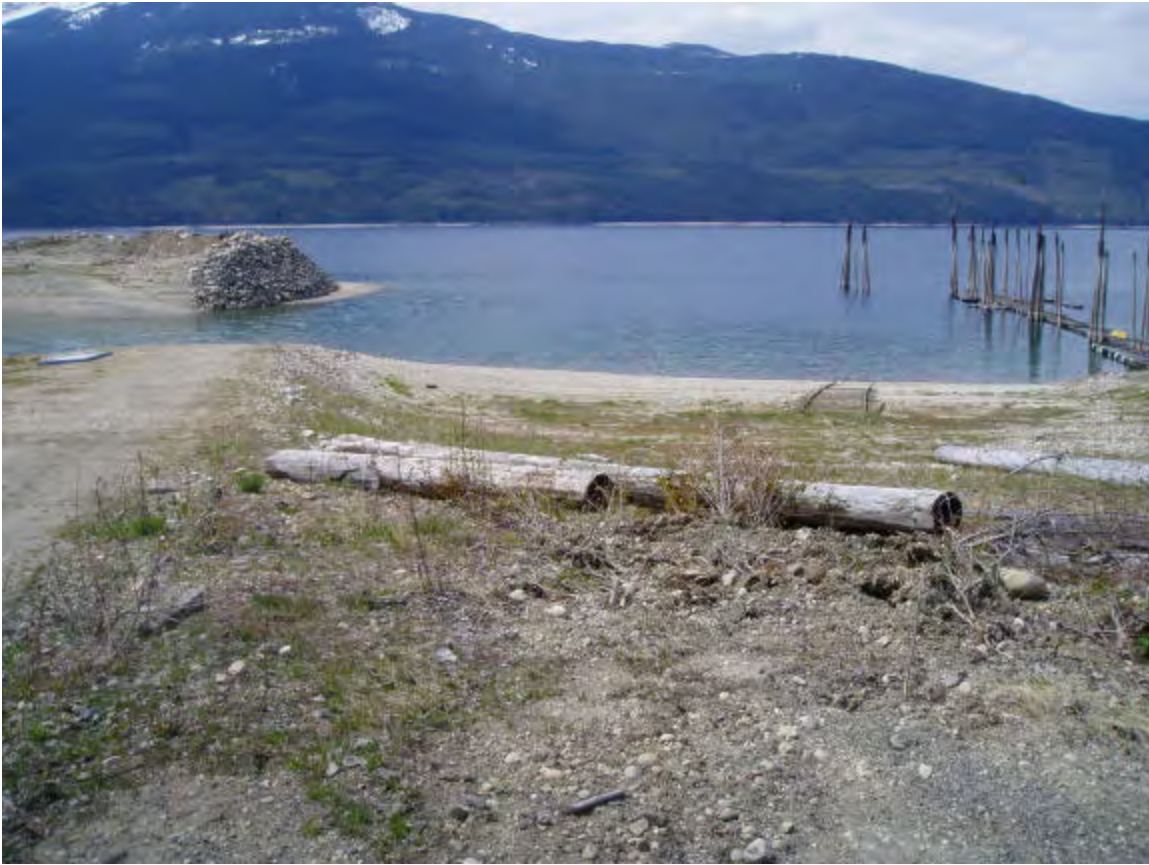
Plate 24. Downslope view of existing walkway floats and piles.
