Duncan Dam Project Water Use Plan

Lower Duncan River Riparian Cottonwood Monitoring

Year 4 Report

**DDMMON#8-1 Lower Duncan River
Riparian Cottonwood Monitoring
Year 4 Annual Report (2013)**

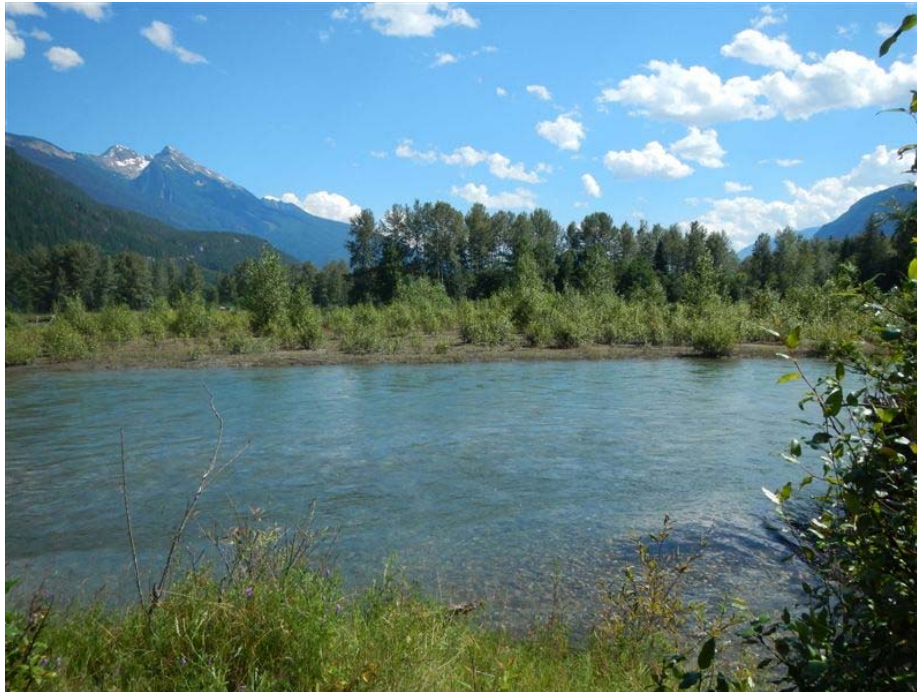
Cover photo

Lower Duncan River, Segment 3, transect line 11 looking at the mid-channel bar that is sampled as part of D3T11, July 22, 2013. Photo © Mary Louise Polzin, Vast Resource Solutions Inc.

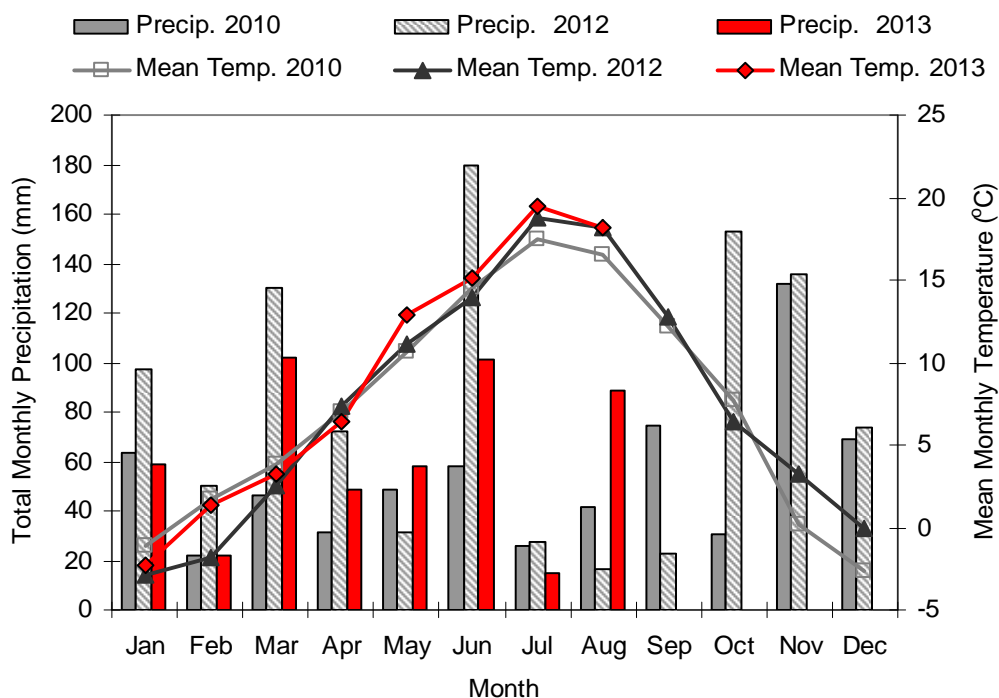
Figure 3-1: Duncan Lake Dam weather station at Meadow Creek monthly mean temperature and monthly total precipitation for 2010, 2012, and 2013 (sampling years). Available records ended August 30, 2013.

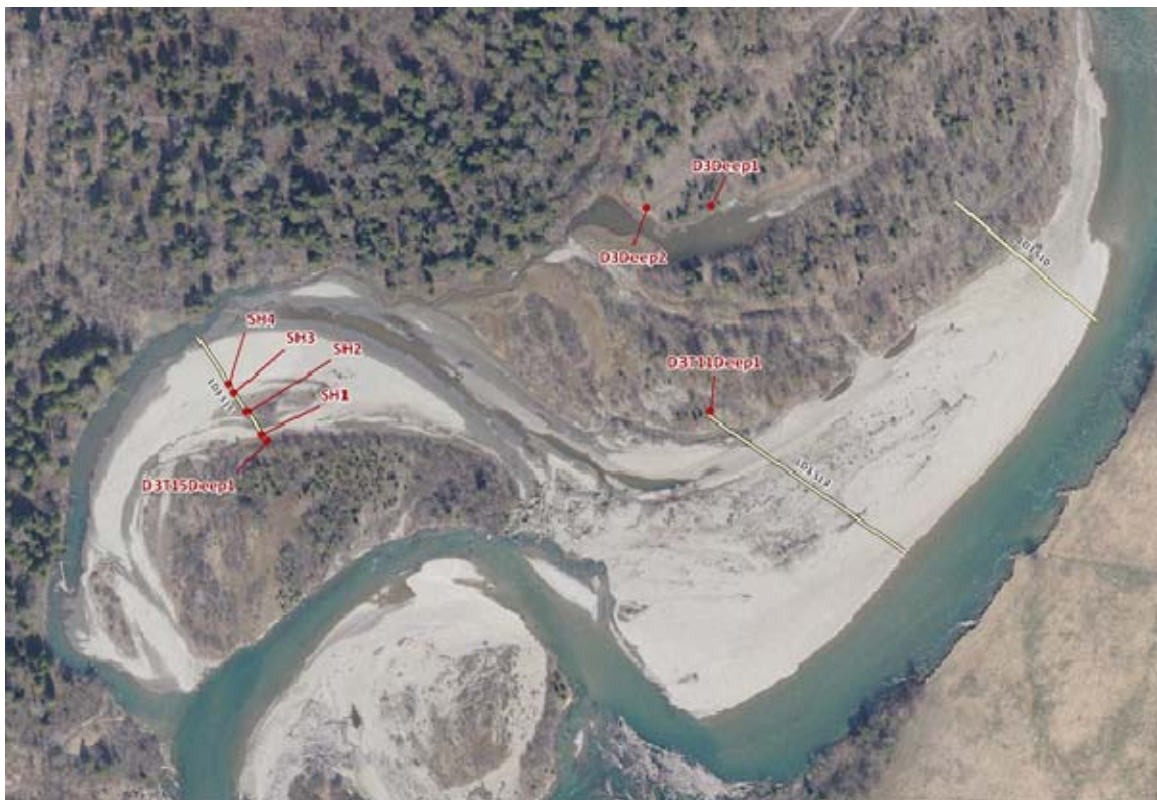
Figure 3-9: Well locations for segment D3Deep1, Deep2, D3T11_DE1, D3T15_DE1, SH1, and SH2.

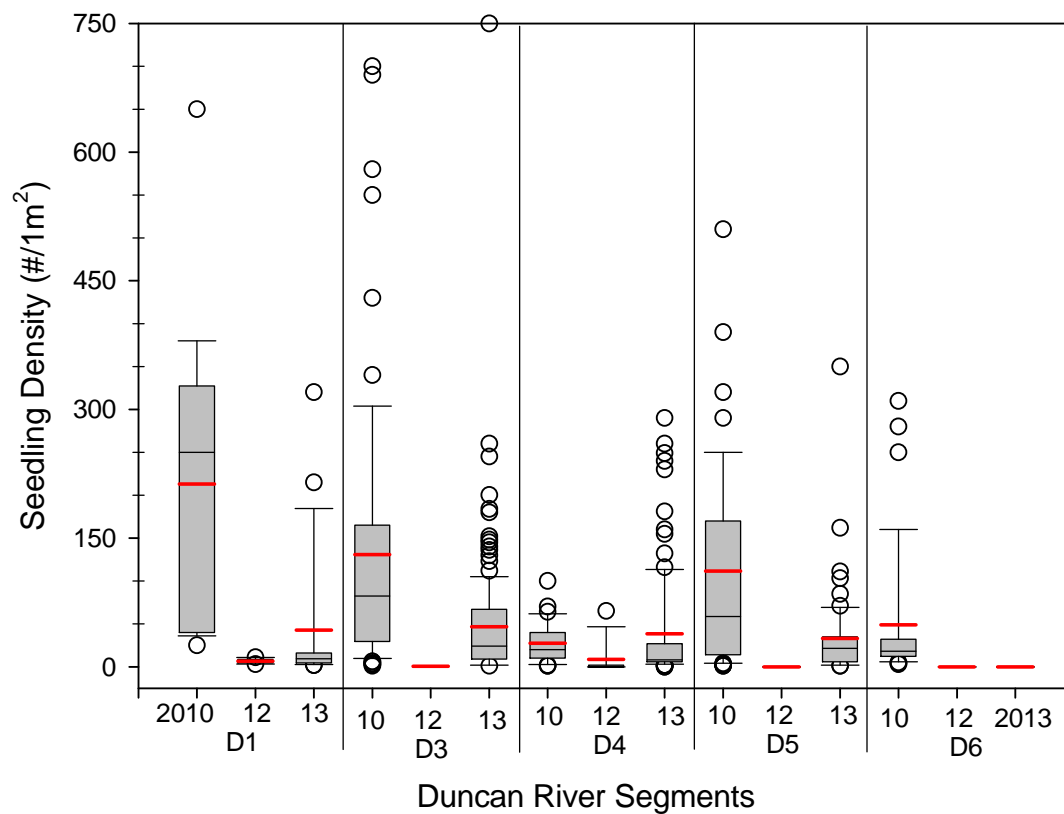
Figure 3-14: Germinant densities for 2013 compared to 2012 and 2010 for each segment along the lower Duncan (D) River. Segment D5, 2010 has an outlier of 900 stems per m² but was cut off to increase detail for the box plots.

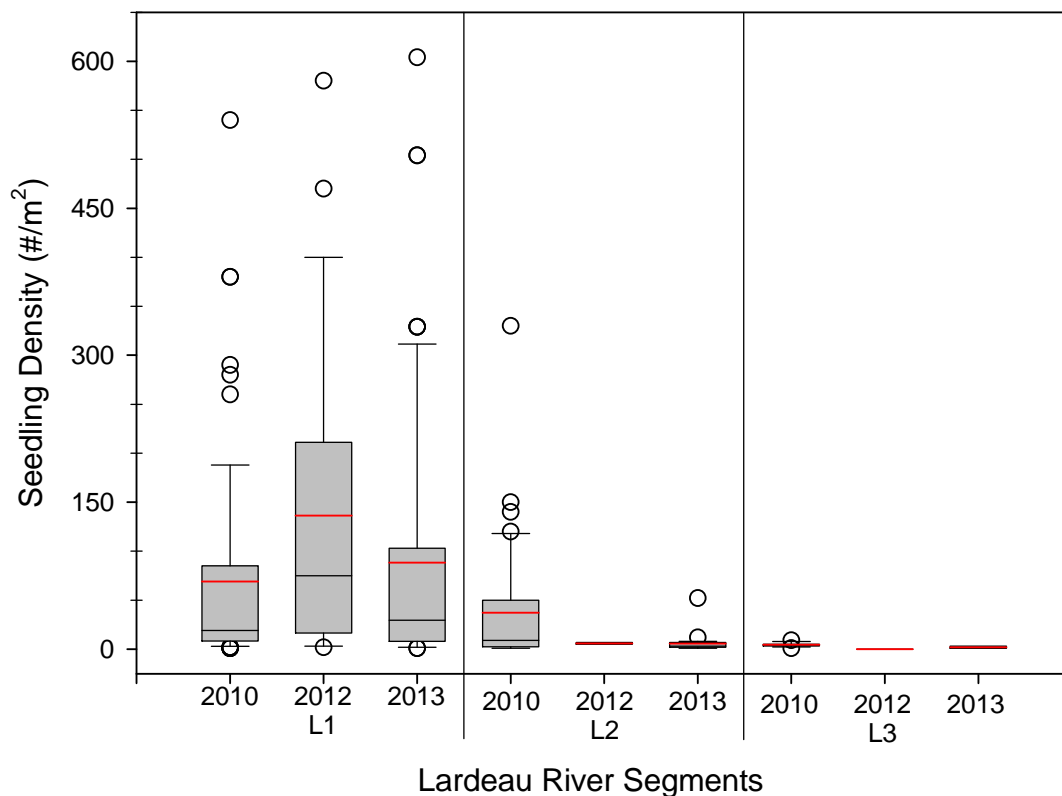
Figure 3-15: Seedling establishment densities (germinants) for 2010, 2012, and 2013 for each segment along the Lardeau (L) River.

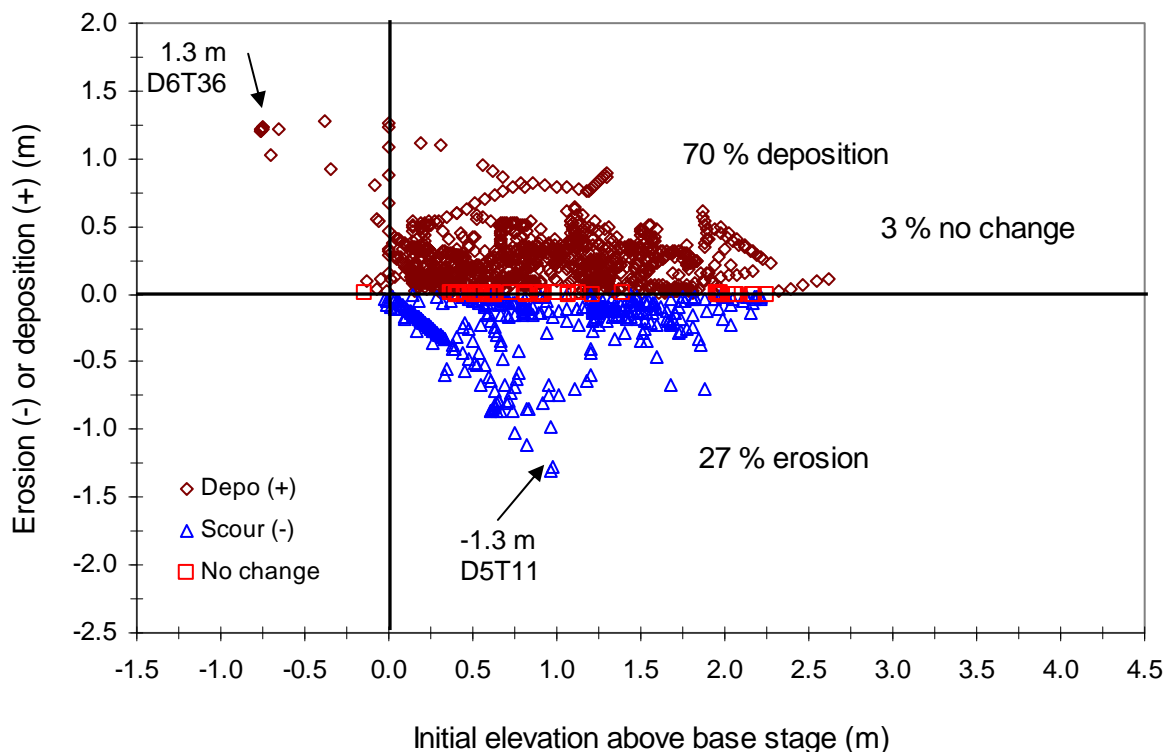
Figure 3-17: Erosion and deposition along the Duncan reach since 2009. The red squares indicate no change which bracketed 0.9 cm to -0.9 cm of change.

Following the receding waters of the 2012 flood in late September, extensive deposition and erosion was noted along the majority of the transect lines for the Duncan reach. The majority, 70 per cent of change observed along the lower Duncan reach since 2009 was from deposition, while 27 per cent was from erosion (Figure 3-17) and 3 per cent had no change greater than ± 0.9 cm. The highest amount of deposition occurred along D6T36 with 1.28 m of deposition from the expansion of the point bar compared to 2009. The greatest amount of erosion occurred along D5T11 with -1.30 m of erosion where a previous high water back channel was widened and deepened during 2012 high water. The average deposition level was 0.26 m and average erosion level was 0.21 m with a wide range of variation occurring along individual transect lines.

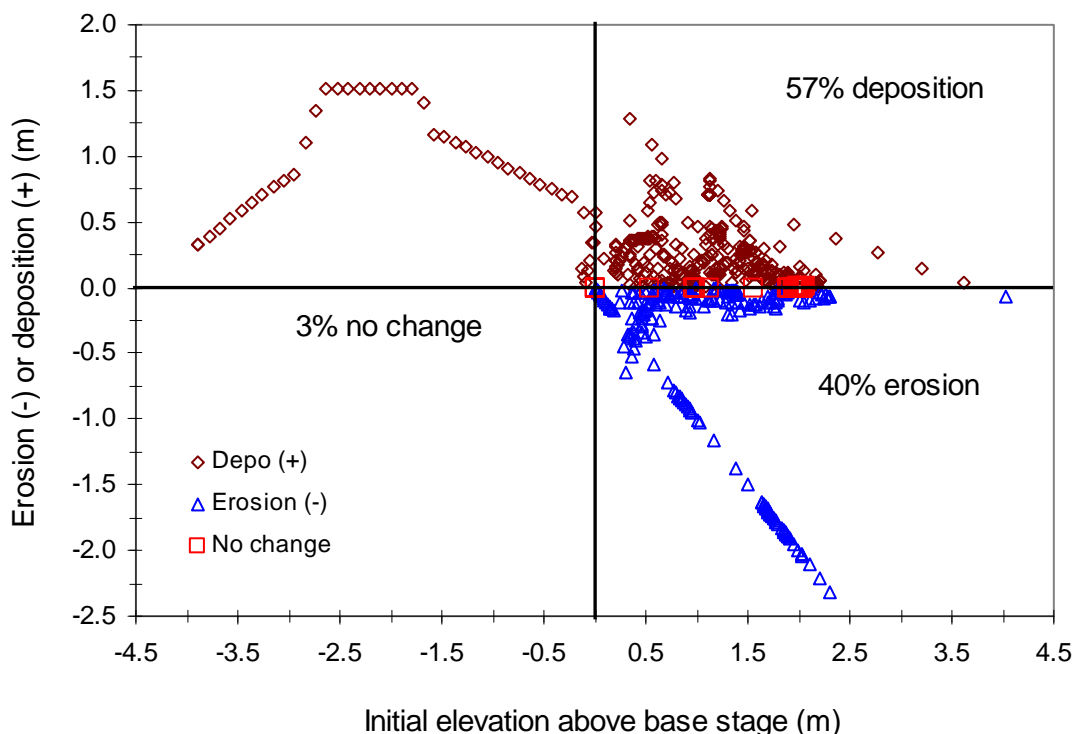
Figure 3-18: Erosion and deposition along the Lardeau reach since 2009. The red squares indicate 'no change' width from +0.9 cm to -0.9 cm of actual measured change.

the Lardeau reach had a range of -2.3 m to 1.5 m. The high deposition below 0 initial elevation was due to expansion of a point bar and the high erosion was due to the complete erosion of a transect line and an almost complete erosion of a second line with only 6 m of transect line remaining in 2012.

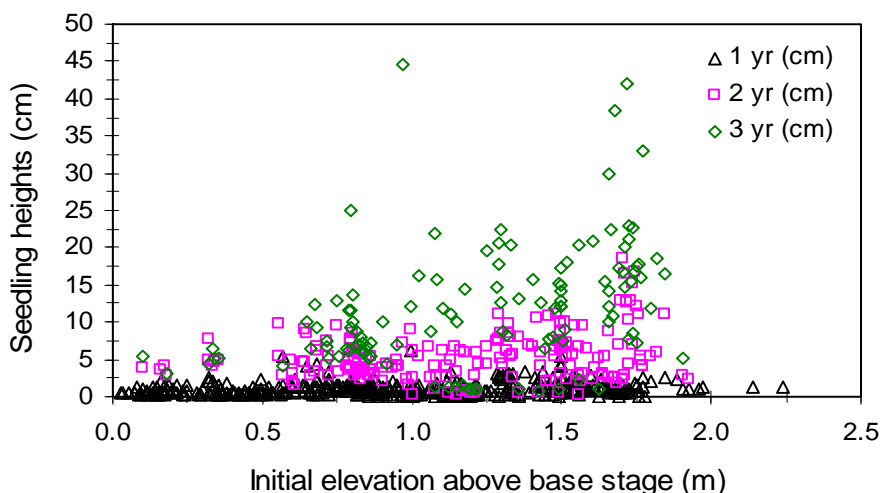
Figure 3-21: The lower Duncan River sampling reach average seedling heights (cm) grouped by year at initial elevation. The maximum elevation that occurred along transect lines was 2.3 m.

Seedlings established at a broad range of elevations along the Duncan River, from 0.03 m to 2.3 m (Figure 3-21). In contrast, along the Lardeau seedling establishment occurred from 0.5 m to 2.2 m initial elevation (Figure 3-22). Second and third year seedlings occurred mainly between 0.5 m to 2.0 m for the Duncan and the Lardeau.

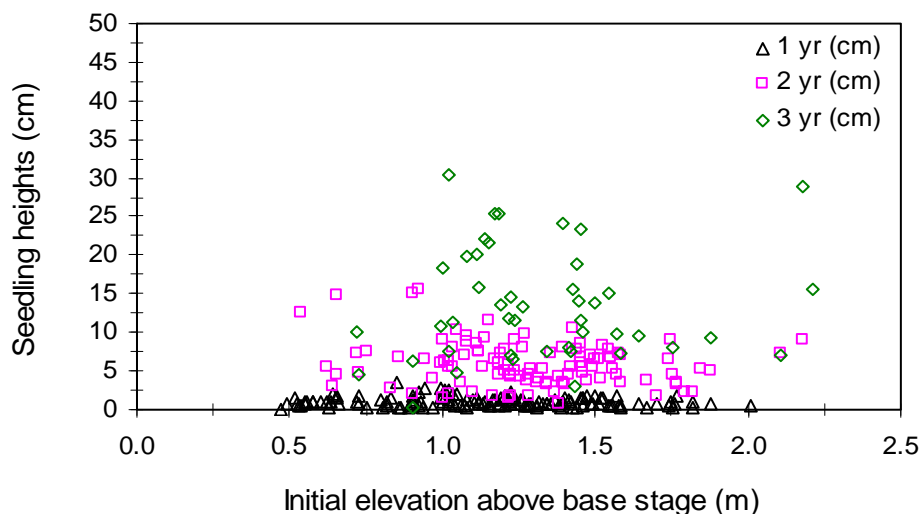
Figure 3-22: The Lardeau sampling reach average seedling heights (cm) grouped by year at initial elevation. The maximum elevation that occurred along transect lines was 4.0 m at one location. The next maximum elevation was 2.3 m similar to the Duncan reach.

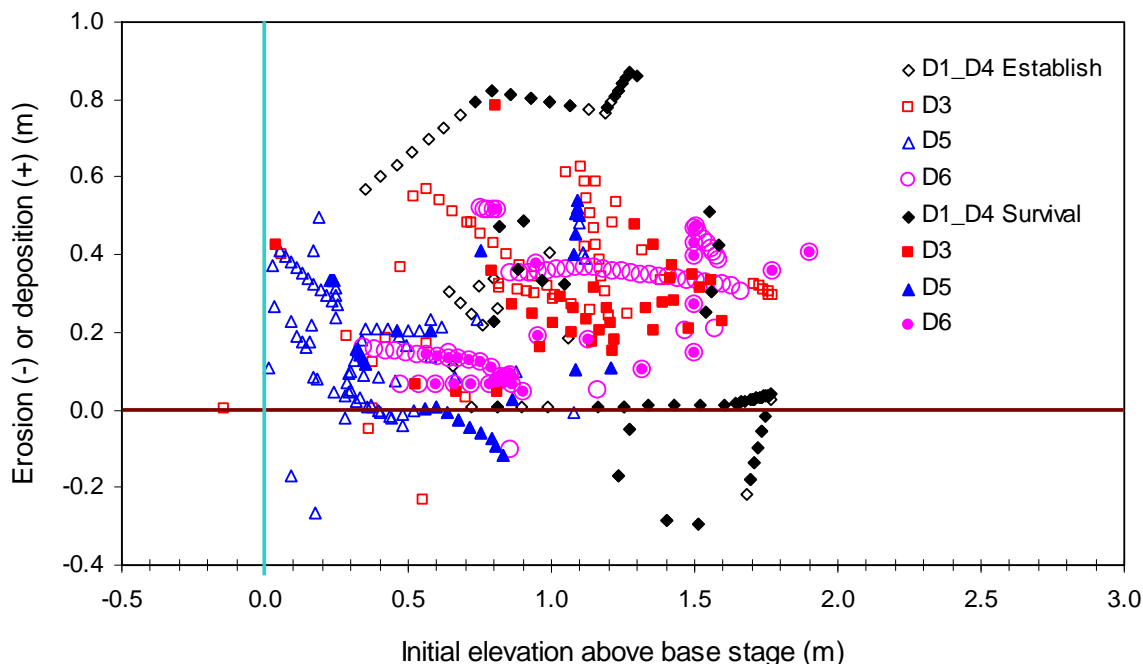
Figure 3-23: Occurrence of cottonwood seedlings in relation to erosion and deposition at various elevations above base stage for the lower Duncan river segments. Establishment year (open symbols) represent sampling quadrats with first year seedling. Survival (filled symbols) represent sampling quadrats with two year old seedling.

profiles. The 'Survival' seedlings are 2 years old and survived to the end of the growing season of 2010. Four and five year old seedlings were not tracked and no 2010 seedlings survived deposition/erosion along transect lines when surveyed in 2012. Therefore, this graph does not show seedlings that survived the erosion and deposition, but rather it represents where seedlings occurred before the 2012 flood and the level of deposition and erosion that occurred at these elevations above base stage since 2009.
