Duncan Dam Project Water Use Plan

**Lower Duncan River
Riparian Cottonwood Monitoring**

Reference: DDMMON#8-1

Year 5 Report

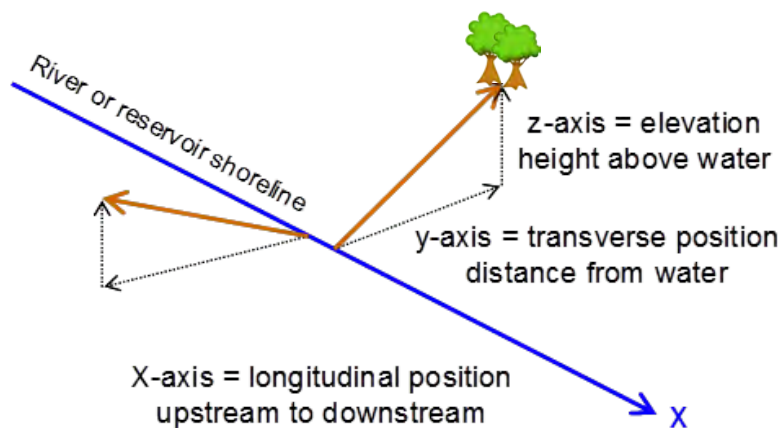
Figure 2-3. Riparian plant occurrence along three spatial dimensions.

The sampling designed (set up in 2009) incorporated the basic concept of a hydrogeomorphic framework, where the relationships between riparian vegetation, elevation and substrate conditions, as well as river flow, stage patterns and groundwater patterns can be analyzed and modelled. We implemented a composite study design within this framework, which included both temporal and spatial comparisons, as employed by Braatne et al. (2008). The use of a surveyed (elevational profile) belt transect lines allowed for the collection of riparian plant occurrence along three spatial dimensions (Cartesian coordinated x, y, z) (Figure 2-3). The x-axis represents the longitudinal axis, the position along the upstream-to-downstream corridor of a river. The y-axis represents the distance away from the river edge. The banks rise up from the river and this elevational rise provides the third spatial dimension, the z-axis. Long-term monitoring to analyze responses to human alterations, such as changes in river flow regime requires a study system that facilitates repetitive observations relative to the three spatial dimensions which adds the fourth dimension, temporal (time) comparisons.

Cartesian coordinate (x,y,z) = spatial position

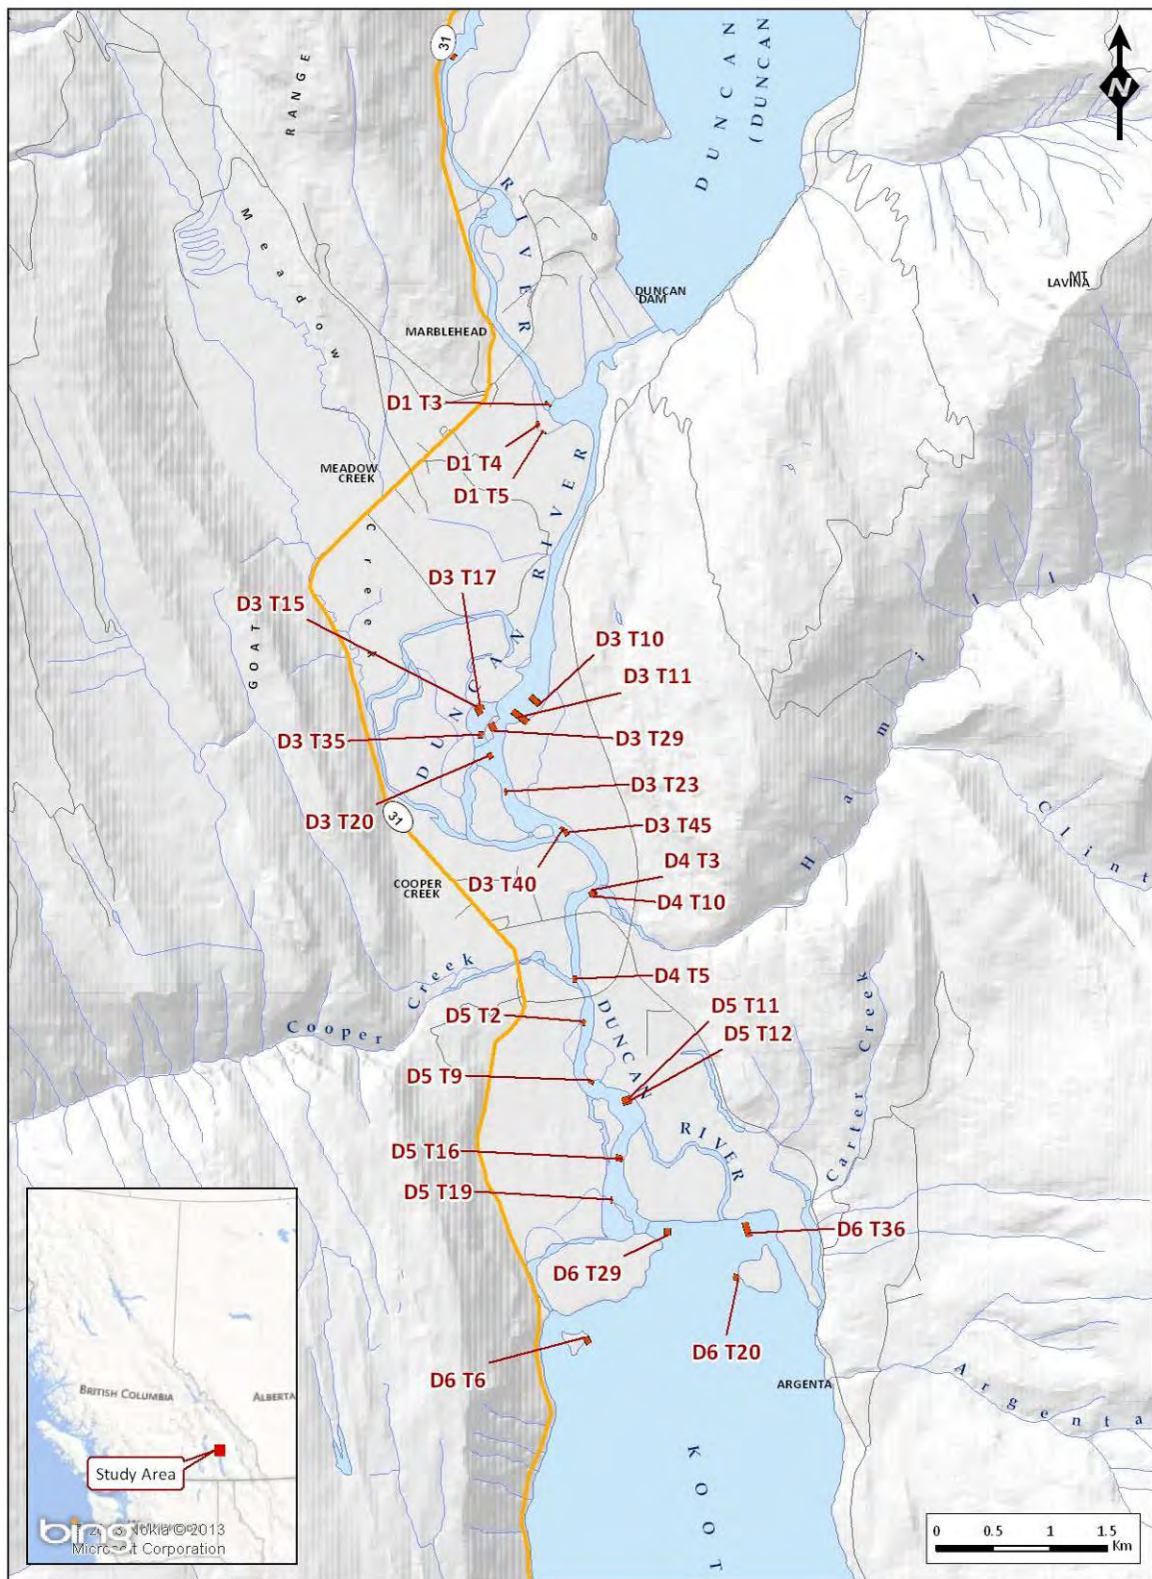
Figure 2-4: Lower Duncan River study transects in 2013. Segments are indicated by the number following D (Duncan), and transect numbers are indicated after the T (transect).

All transect lines were surveyed in April/May of 2013 and new transect lines were established. Duncan River Segment 4 (D4) transect lines are located along the Duncan River but are influenced by the Hamill Creek (two transect lines) and Cooper Creek (one transect line) confluences with the Duncan River. Both of these creeks experienced large flash flood events triggered by an extreme rain event (mainly Hamill Cr.) during spring high flows, resulting in the adjacent floodplain being altered considerably from erosion and deposition. The changes in the transect line profiles were major and would impact the interpretation of elevation profiles for seedling recruitment and specific stage measurements for D4. Therefore, the three transect lines were resurveyed in spring of 2014 to record the extent of change that occurred from the high water event. A total station was used and bench marks were resurveyed as well as points from last year and new deposition and scour patches. D4 is an important segment as it allows us to assess the influence of creek confluences with the Duncan River on black cottonwood recruitment and riparian vegetation.

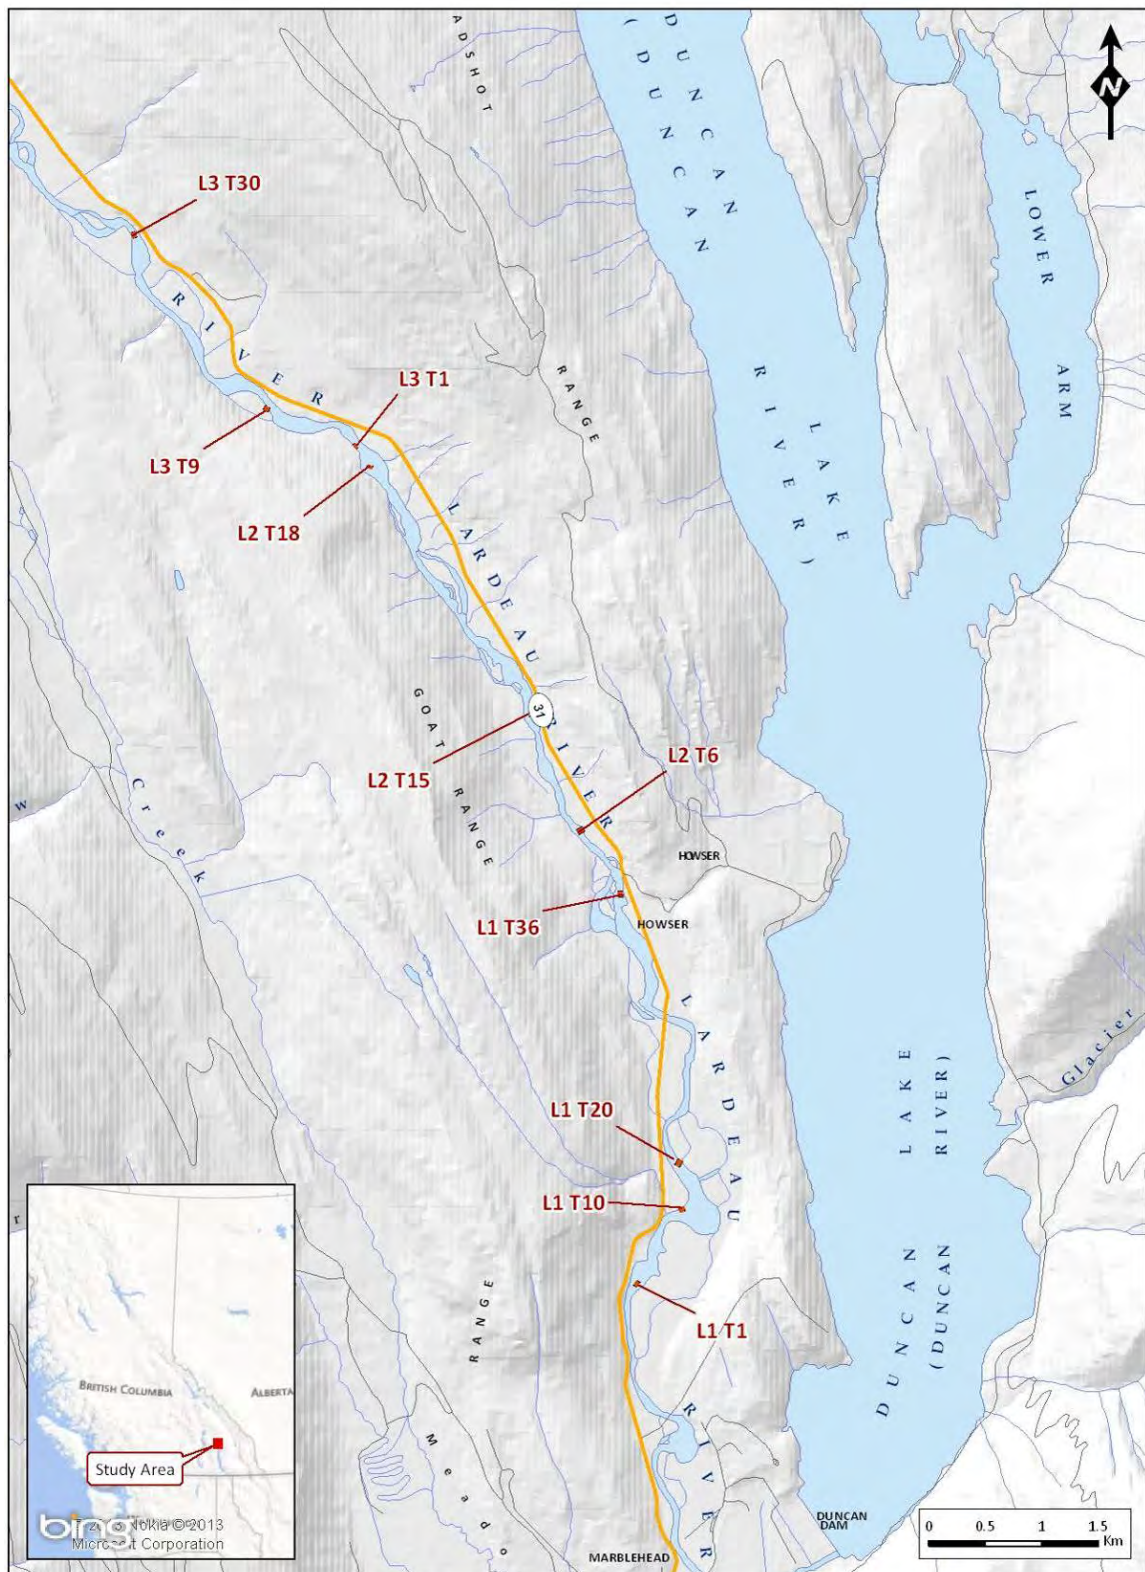
Figure 2-5: Lardeau River study transects in 2013. Segments are indicated by the number following L (Lardeau), and transect numbers are indicated after the T (transect).

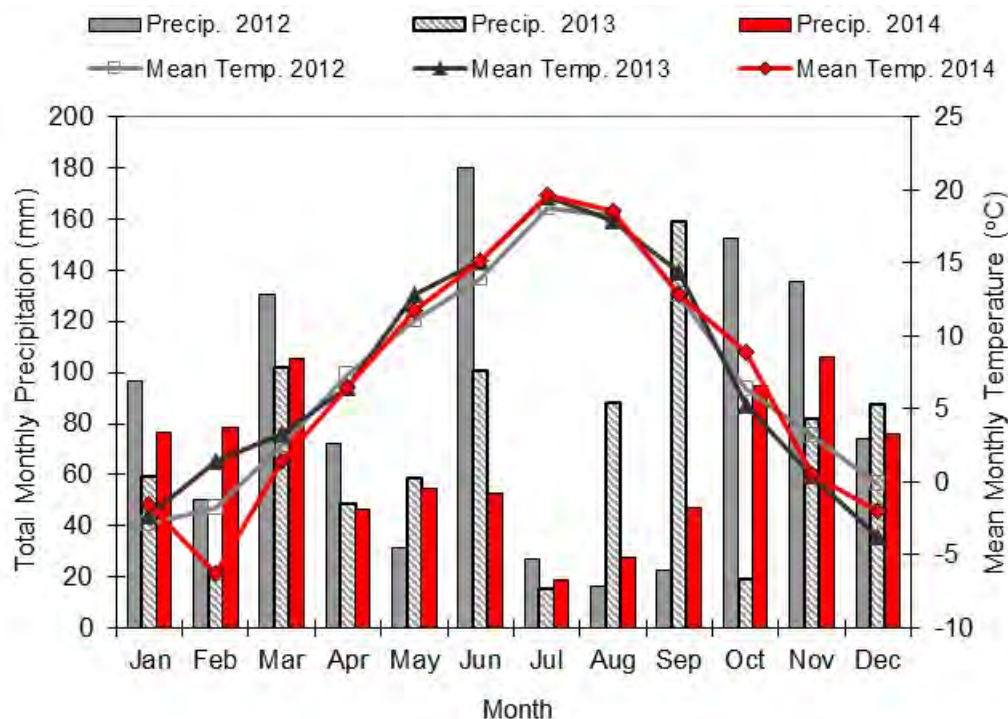
Figure 3-1: Duncan Lake Dam weather station at Meadow Creek monthly mean temperature and monthly total precipitation for 2012, 2013, and 2014.

The past sampling year (2014) experienced generally similar mean temperatures through the growing season but a colder February compared to 2012 and 2013 (Figure 3-1). The mean daily temperature for the growing season (May to end of September) was similar to previous years; 2012 (15.0 °C), 2013 (16.0 °C), and 2014 (16.1 °C) with the 2014 season slightly warmer (monthly mean) than the past sampling years.

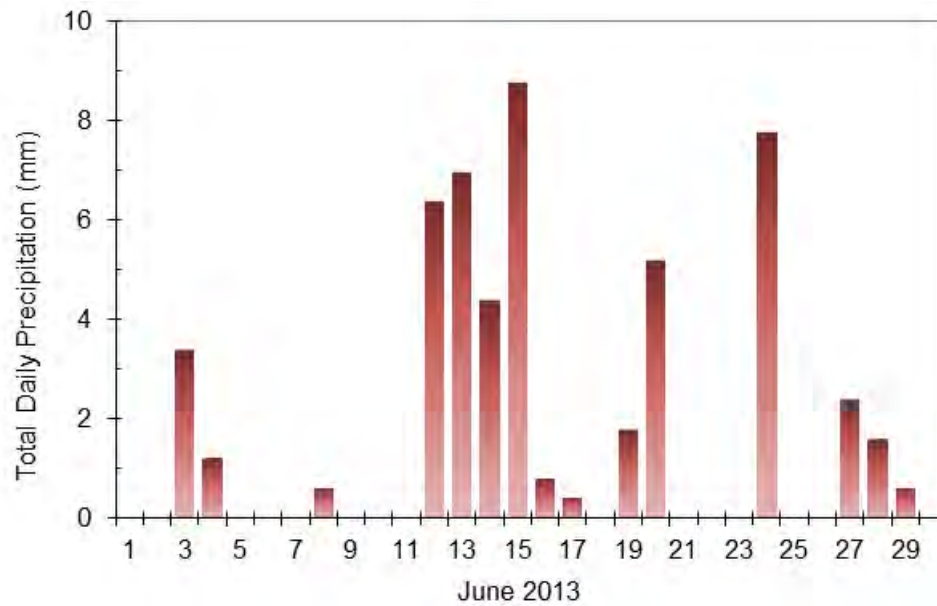
Figure 3-2: Precipitation (mm) for the month of June 2014 at Duncan Lake Dam weather station. Total precipitation for the month of June was 52.4 mm.

The month of June, 2014, did not experience any heavy precipitation event and the total precipitation for June (52.4 mm) was less than in one day of the extreme event of the prior year when 57 mm was recorded June 19, 2013 (Figure 3-2). There was slight difference between total precipitation for 2012, 2013, and 2014 (Figure 3-3;). However, the weather for the summer months, June, July, and August 2014 experienced slightly warmer conditions than previous sampling years, and with reduced precipitation (Figure 3-4 and Table 3-1). The total precipitation for each month was not the lowest recorded for each month over the study interval but the combination was a reduced precipitation pattern, coupled with the higher mean temperature for each month. June, 2009 had the lowest precipitation for the month but it was followed by higher precipitation for July and August. July, 2013 had the lowest precipitation for the month but it had higher June and August precipitation levels. August, 2013 had the lowest precipitation for the month but it was preceded by the highest June precipitation level and higher July precipitation than 2014 during the same period (Figure 3-4). The lowest mean monthly precipitation and slightly higher temperature for this period of time occurred in 2014 (Table 3-1) resulting in a warm dry summer for 2014 compared to previous sampling years.

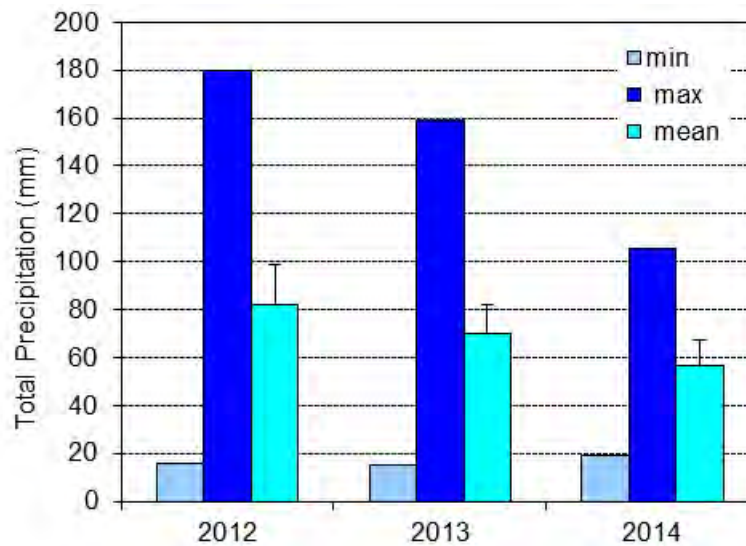
Figure 3-3: The minimum, maximum and mean total precipitation for 2012, 2013, and 2014. Standard error bars are marked for the mean total precipitation.

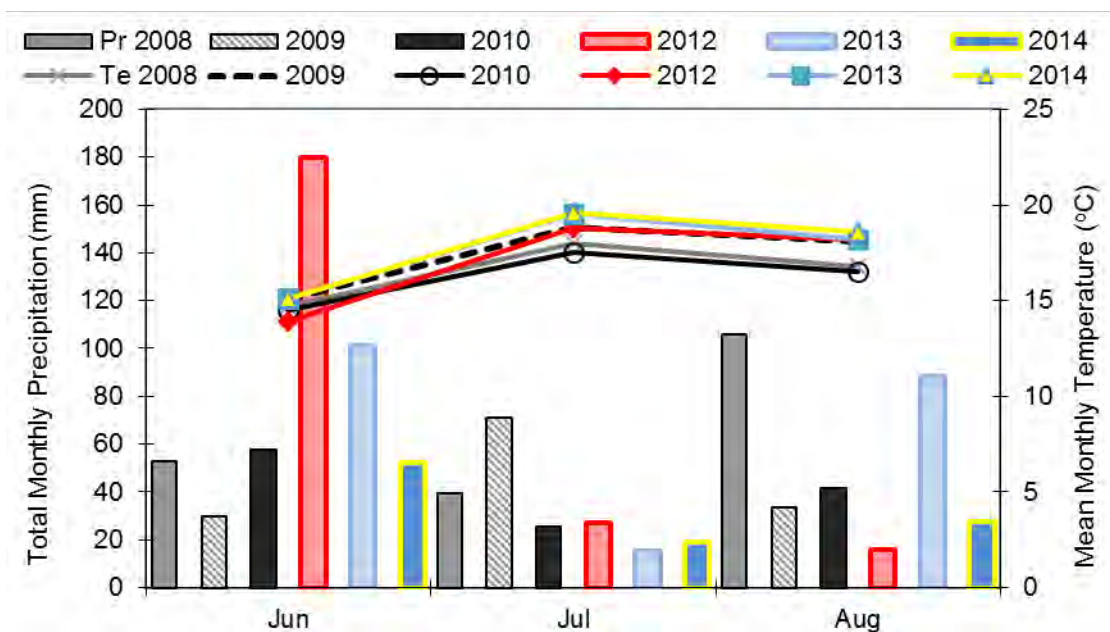
Figure 3-4: Comparison of total precipitation and average temperatures for the summer months; June, July, and August during the study period (Pr = precipitation and Te = temperature).

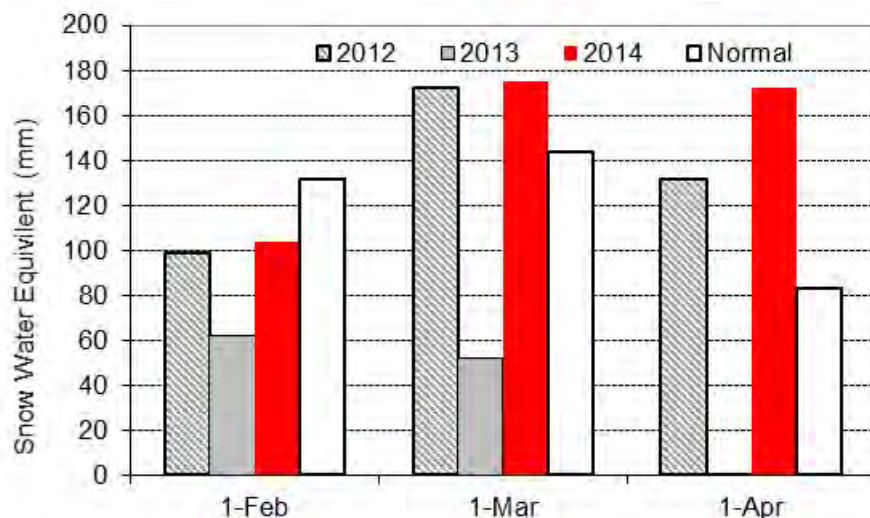
Figure 3-5: Snow water equivalent totals for the months February, March, and April at the station 2D07A Duncan Lake No. 2 at 662 m elevation at Marble Head weather station for 2012, 2013, and 2014. Normal values for each month are illustrated as well taken from 2D07A Duncan Lake No. 2 station.

Both the Duncan and Lardeau rivers are snowmelt-dominated systems. As such, seasonal snow pack levels play a role in the extent of freshet flooding. However, weather determines the rate of snow melt and subsequently contributes to whether or not flood conditions occur. The Snow Water Equivalent (SWE) for 2012, 2013, and 2014 were obtained from Duncan Lake watershed station 2D07A (archive manual snow survey data), which is at 662 m elevation at the Marble Head Weather station. This shows that 2014 was similar to 2012 and did not have the low snow pack levels of 2013, at least at this low elevation site (Figure 3-5).

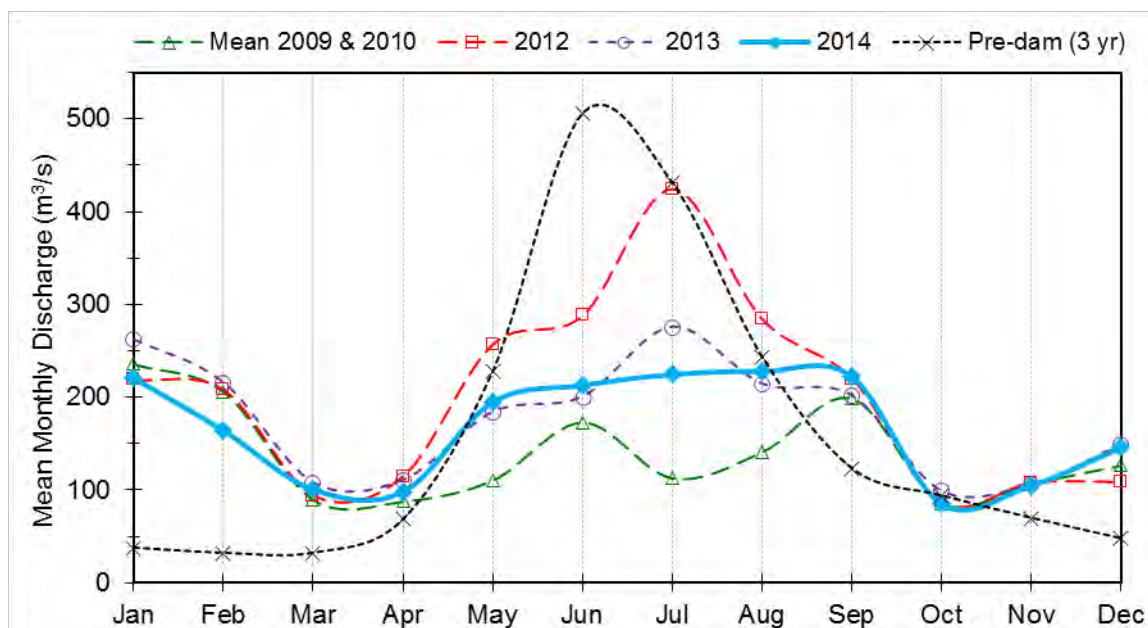
Figure 3-6: Mean monthly hydrographs for the lower Duncan River for sampling years 2009 and 2010 combined, 2012, 2013, 2014, and pre-dam (3 years of data) discharges plotted with smoothed lines.

Mean monthly discharges for 2009 to 2014 (2009 and 2010 were combined as these provided similar patterns as demonstrated in Polzin and Rood 2014), are shown in Figure 3-6. The sampling year of 2012 was an exception with the regular Alt S73 flow regime preempted by high snowmelt and rainfall in the Duncan Basin (see Polzin and Rood 2013). The past sampling year, 2014, had similar flows during the start of the growing season compared to 2013. However, 2014 did not have a similar peak in July and this is important to the study since this is when the major seed establishment primarily commences. The flow regimes for 2013 and 2014 were dissimilar to those of 2009 and 2010. There was a gradual increase in the mean discharge rate from May (195 m³/s) to August, 2014 (228 m³/s) with September flows being only slightly lower, around 222 m³/s, which was slightly higher than all previous years of the study.

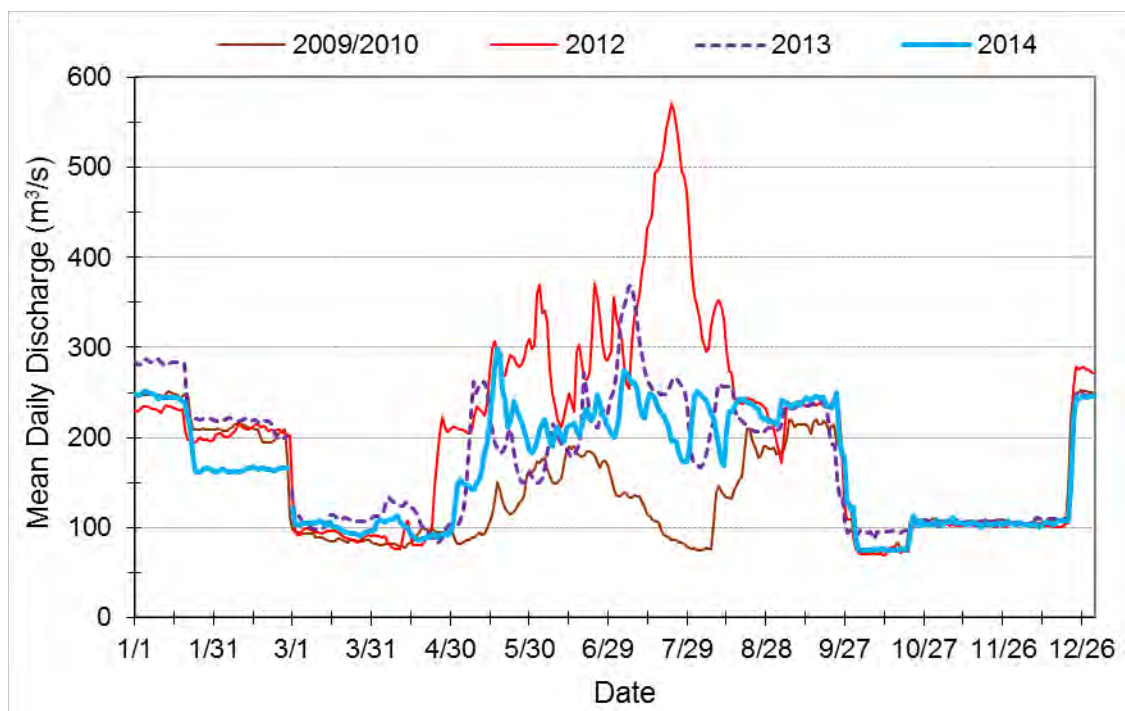
Figure 3-7: Mean daily discharge (m^3/s) for 2009 and 2010 (combined), 2012, 2013, and 2014 (provisional) for the lower Duncan River at Station 08NH118.

The daily mean data shows the variation that occurs during the month (Figure 3-7) which is smoothed out by monthly means. The sampling years 2009 and 2010 both had two extended periods of peak flows, one during June and a second during August and September. The discharges in May were slightly higher in 2014 compared to 2013 and from June to September 5, 2014 discharge was lower than 2013 with some variation. The peak occurring July 6, 2014 (271 m³/s) and was smaller than that of July 8, 2013 (369 m³/s). Discharges were similar for September for 2013 and 2014 with flows slightly higher for 2014 (Figure 3-7). From May 1 to the end of September 2014, daily flows were higher than 2009 and 2010.

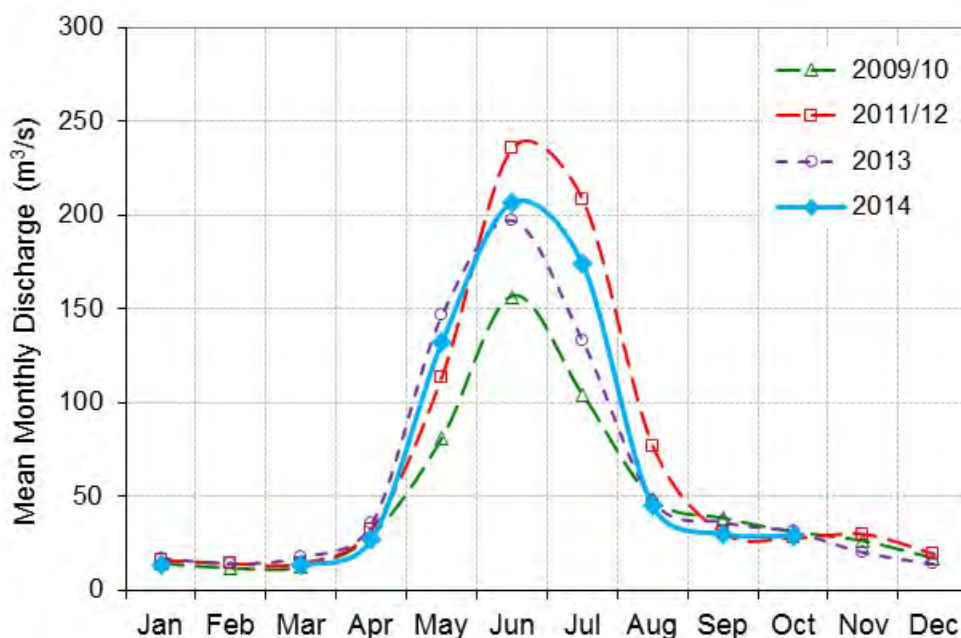
Figure 3-8: Mean monthly discharge (m³/s) for the Lardeau River for 2014, 2013 and the average for years 2009 and 2010 and the average of 2011 and 2012 (because very similar flows for the paired years (Polzin and Rood 2013)).

In 2014, the Lardeau River (reference reach for the study) experienced an average spring freshet with a peak discharge of $243 \text{ m}^3/\text{s}$ that was slightly below the 2 year recurrence peak ($Q_{\text{max}2} = 269.2 \text{ m}^3/\text{s}$) in 2014. The mean monthly discharges for 2014 were very similar to 2013 (Figure 3-8). There was a slight drop in the average discharge for August in 2014 compared to previous year flows. Flow records for the Lardeau River consisted of 70 years of records starting in 1917, with a period of missing records from 1920 through 1945. Flow records from two hydrometric sites were coordinated by regression analysis for the period of overlap for the missing years of 1997 through 2002 (Q_{max} at 08NH007 = Q_{max} at 08NH118 $\times 0.37$, $R^2 = 0.96$, linear regression forced through origin). Recurrence analysis indicated that the 2014 spring freshet along the Lardeau River was below the 1-in-2 year flood event ($Q_{\text{max}2}$) see Polzin and Rood (2013) for detailed log Pearson Type III analysis.

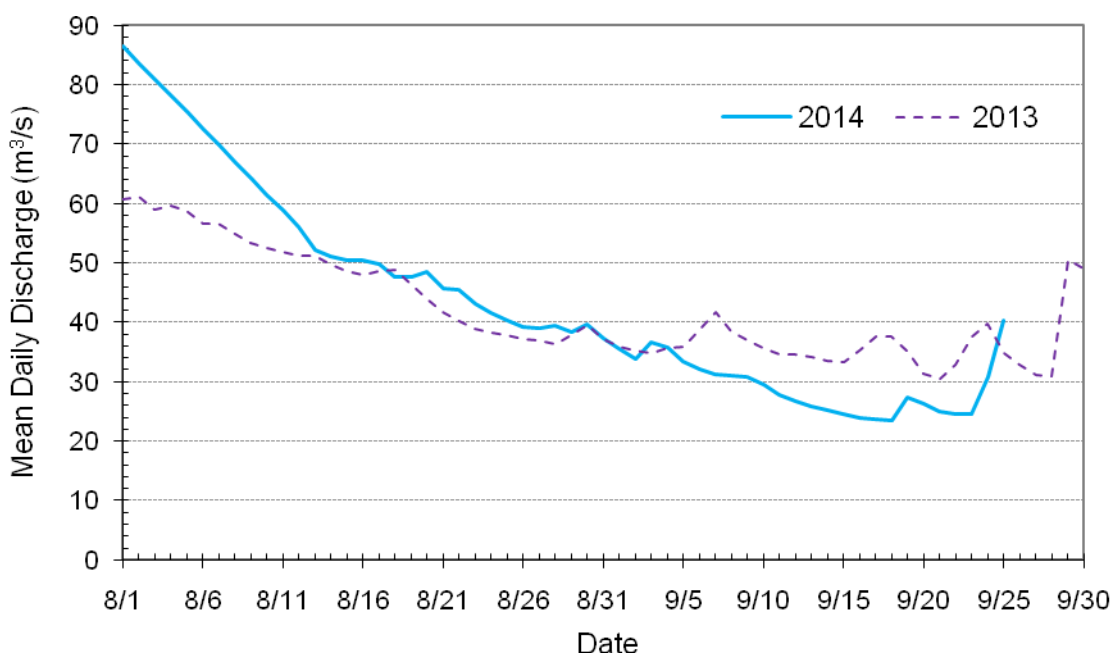
Figure 3-9: Mean daily discharge (m³/s) for 2013 and 2014 (provisional) for the lower Lardeau River at Station 08NH007 for August and September.

The 2014 peak flow occurred on June 25, which was typical timing for the Lardeau River. Historically, 71 per cent of annual peaks have occurred within June. During the research years of this project, spring freshet occurred mid to late June (Table 3-2). The discharge gradually declined from June 20 to September as it approached base flow with the slight dip in August compared to previous years. There was a decline in the mean monthly discharge for August and September with Figure 3-9 showing the daily discharge pattern with discharge higher in 2014 at the start of August, similar during mid-to the end-August, and a drop in discharge in September compared to the 2013 discharge.

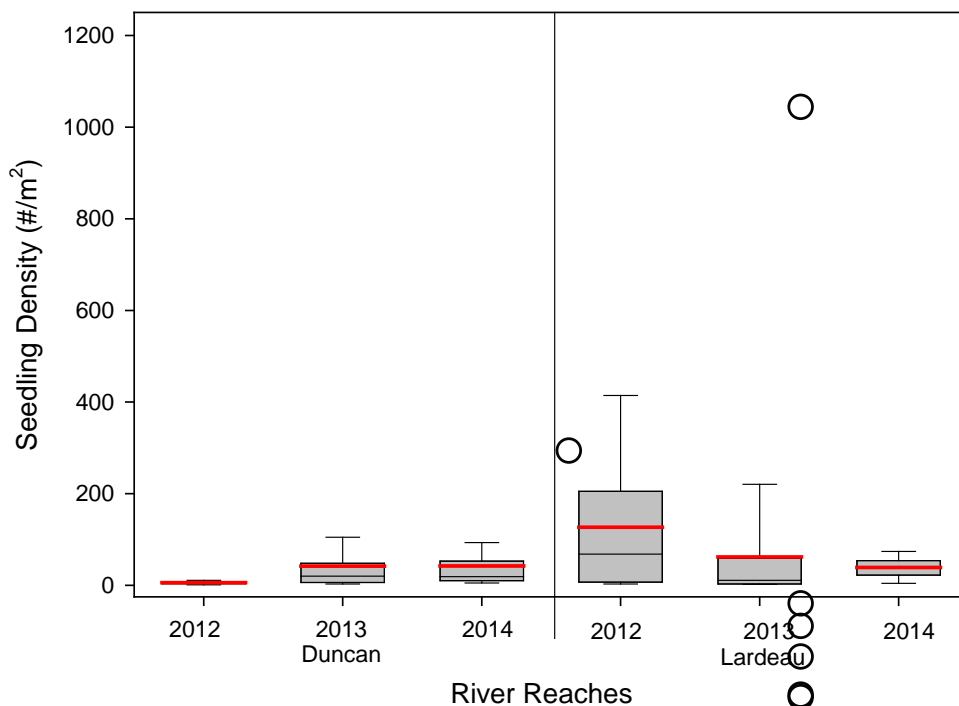
Figure 3-10: The 2012, 2013, and 2014 black cottonwood germinant densities for the Duncan and Lardeau study reaches.

[*For box plots, the lower boundary of the box indicates the 25th percentile, the black line within the box marks the median, the wider red line marks the mean and the upper boundary indicates the 75th percentile. Whiskers above and below the box indicate the 90th and 10th percentiles. Outliers are indicated with an open circle.]

In 2014, black cottonwood seedling densities ('densities' will be used to refer to the germinant densities and does not include 2013 and/or 2012 seedling densities in 2014) along the lower Duncan River were significantly higher than in 2012 with higher densities in 2014 ($P < 0.001$) and tended to be different from 2013 densities ($P = 0.096$) (See Appendix 4 for statistical results). The difference in the median value comparisons for 2014 to 2012 densities indicated that seedling densities were greater than would be expected by chance. Seedling density comparison between the Duncan and the Lardeau reaches for 2014 were also significantly different in the median values ($P = < 0.001$, see Appendix 4). Box plot comparisons between densities for 2012, 2013, and 2014 illustrate the magnitude of differences for the Duncan Reach across years and between the Lardeau and Duncan Reaches (Figure 3-10) as well as across the Duncan River segments (Figure 3-11).

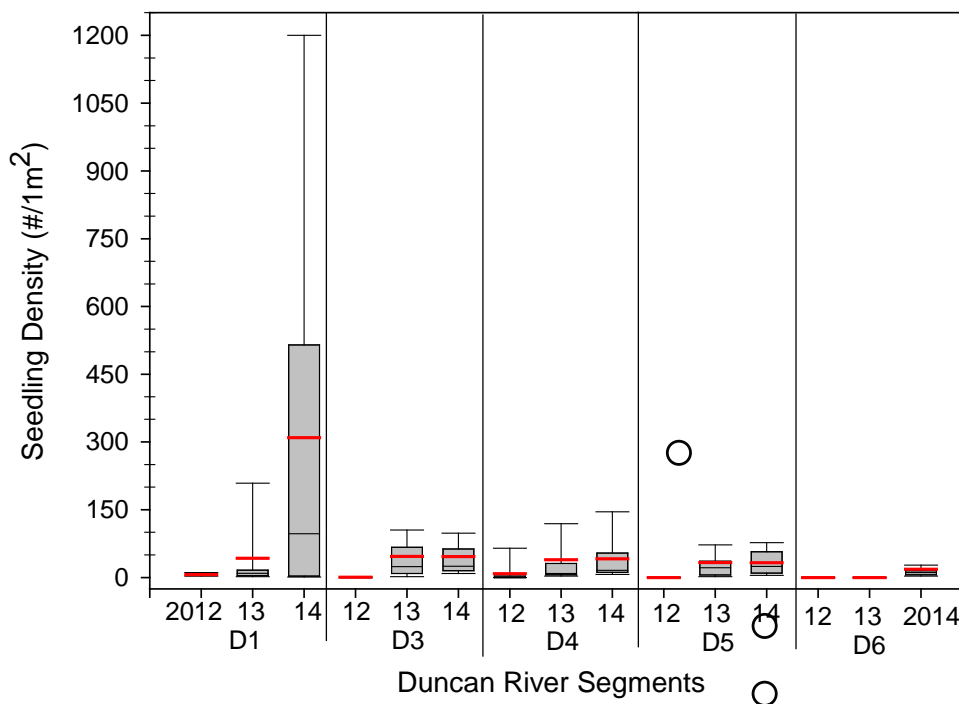
Figure 3-11: Germinant densities for 2012, 2013, and 2014 for each segment along the lower Duncan (D) River.

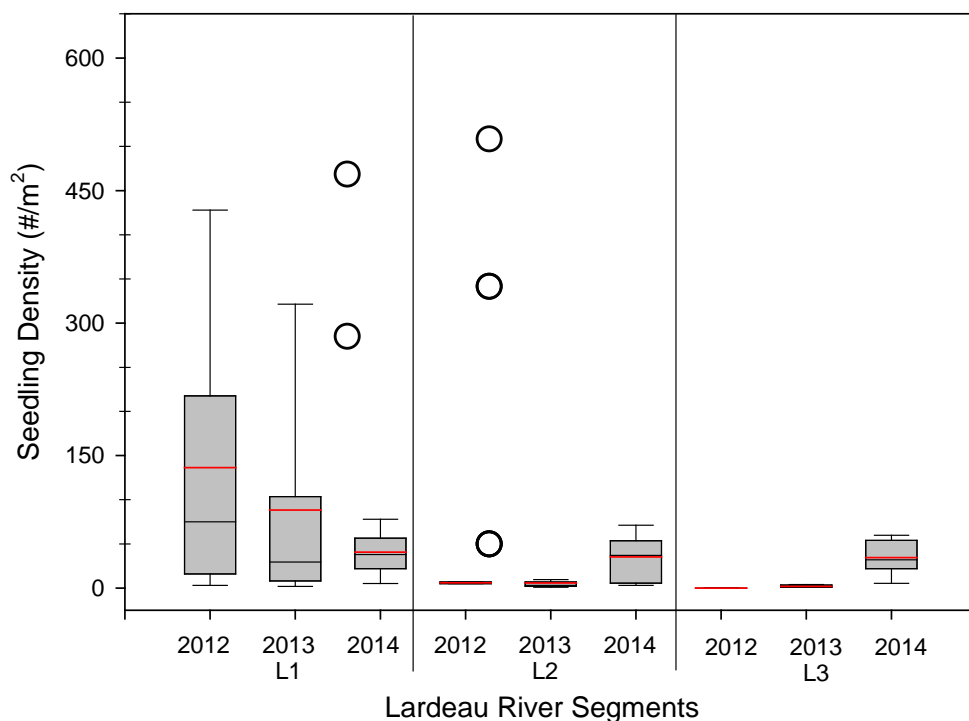
Figure 3-12: Seedling establishment densities (germinants) for 2012, 2013, and 2014 for each segment along the Lardeau (L) River.

The Lardeau River also had significant difference in the median values for seedling densities in 2014 compared to 2013 ($P = 0.002$) and 2012 ($P = 0.045$ Appendix 4). However, unlike the Duncan reach, the seedling densities were highest in 2012 (Figure 3-10). Comparisons between segments show that Segment 1 (L1) had a reduction of seedling establishment in 2014 compared to 2013 and 2012 but not great enough to exclude the possibility that the difference was due to random sampling variability. There were significant increases in seedling densities for L2 and L3 in 2014 compared to 2012 and 2013 densities ($P = < 0.001$ for L2 and L3 Appendix 4) (Figure 3-12).

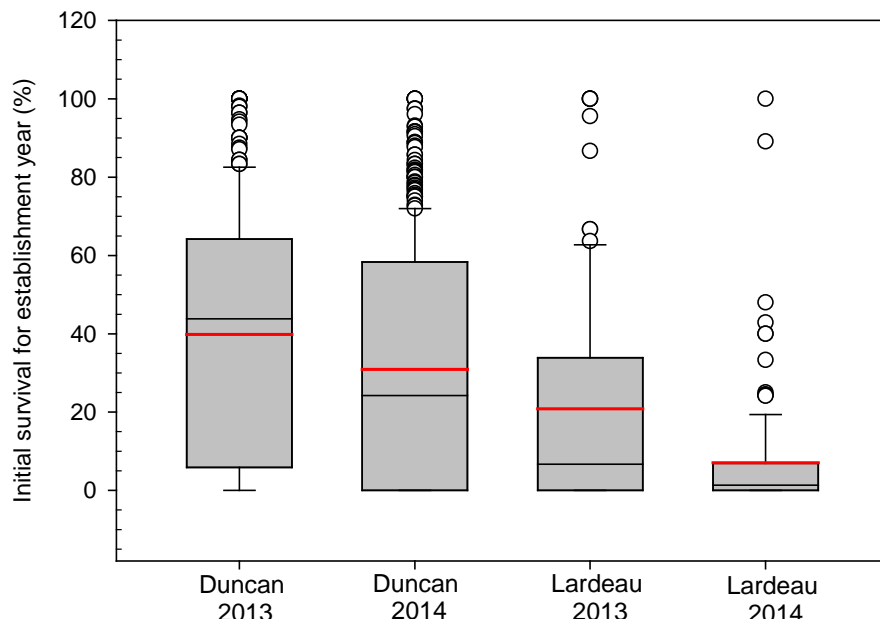
Figure 3-13: Survival percentages (for each quadrat) for 2013 and 2014 germinants for the Duncan and Lardeau reaches.

Along the Lardeau reach the 2014 survival of germinants through the summer was significantly reduced compared to 2013 (7.0, Std Dev 15.0 and 20.8, Std Dev 28.0 respectively) with $P = <0.001$, $F = 13.0$ (Appendix 4). The average first season survival rate was 23.6 percent (2009 to 2013). This includes the reduced survival rate of 19.0 percent for 2012 (2009 and 2010 had an average survival rate of 31.0 percent).

Recruitment of 2012 seedlings was above average for both reaches. The Duncan reach had 82.4 percent survival for their third summer but initial establishment was very low and the survival rate involved only seven quadrats with 2012 seedlings. The average for the Duncan recruitment was 75.0 percent. The Lardeau reach had 86.1 percent survival for the third summer. Initial establishment abundance was above average in 2012. The Lardeau reach averaged 75.9 percent for recruitment (3rd year) with 21 quadrats in 2014 which had 2012 seedlings. Survival rates for the third year were consistent with previous monitoring years with the Lardeau reach consistently having slightly higher rates (Polzin and Rood 2013).

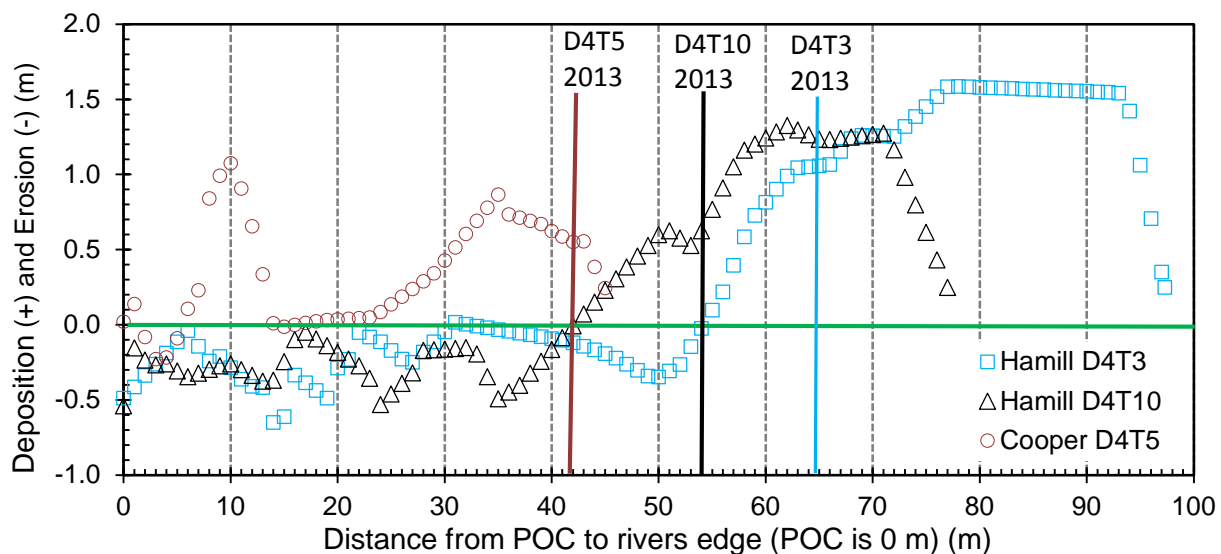
Figure 3-14: Erosion and deposition along D4. The POC is at 0 m and vertical lines indicate rivers' edge when surveyed May 1, 2013.

Duncan Segment 4 (D4) transects 3, 5 and 10 (T3, T5 and T10 respectively) experienced erosion and deposition especially in the extension of the transect lines adjacent to Hamill Creek (T3 and T10). This effect is revealed with comparison to the spring 2013 profiles (Figure 3-14 and Appendix 1). Base stage levels at the time of the surveys were similar for both years (2013 – 0.32 m and 2014 – 0.25 m above base stage). Because of the influence of Hamill Creek, D4T3 and T10 had changes in elevation profiles due to 54.2 per cent erosion and 45.8 per cent from deposition. D4T5 was also influenced by Cooper Creek and experienced more change due to deposition (87.2 per cent) with limited erosion (12.8 per cent). D4T5 had greater amount of deposition near the POC compared to D4T3 and T10 (Figure 3-14) and less expansion of the point bar (2 m compared to 23 m for D4T10 and 32 m for D4T3) due to deposition beyond rivers edge.

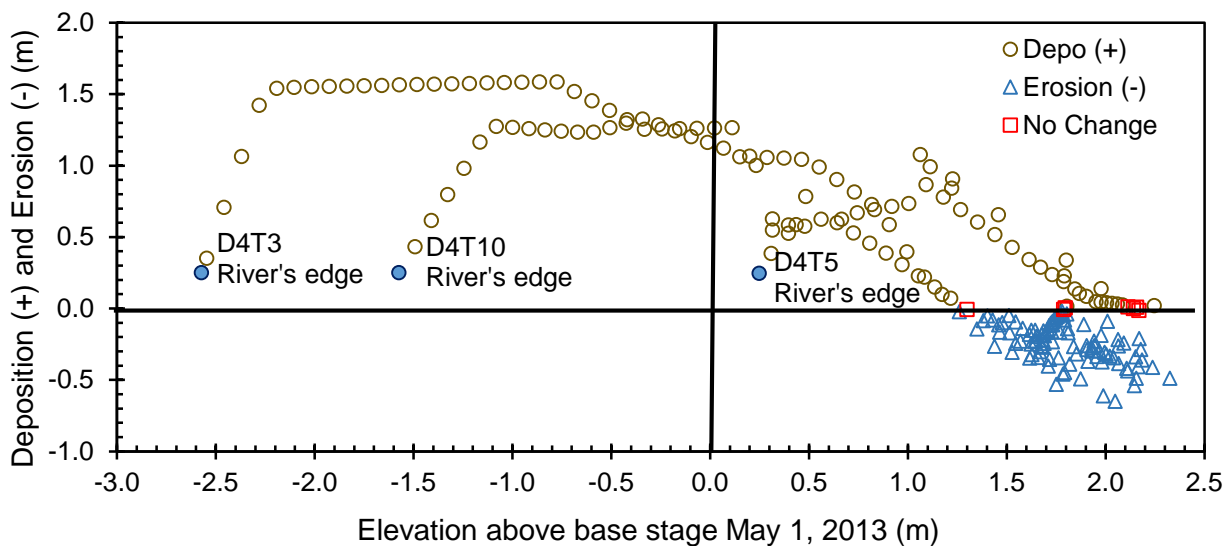
Figure 3-15: Erosion and deposition along D 4 following spring freshet of Hamill and Cooper creeks. The red squares indicate 'no change'. The 0 m on X axis is rivers' edge April 2013.

The theoretical slope was used in Figure 3-15 so the points would not be superimposed at the zero elevation and to illustrate the apparent deposition that may have occurred in this zone due to the extension of the point bar beyond the river's edge in the early spring of 2013. The Duncan River's edge level above base stage is marked for each transect line in Figure 3-15 at the time of the survey.

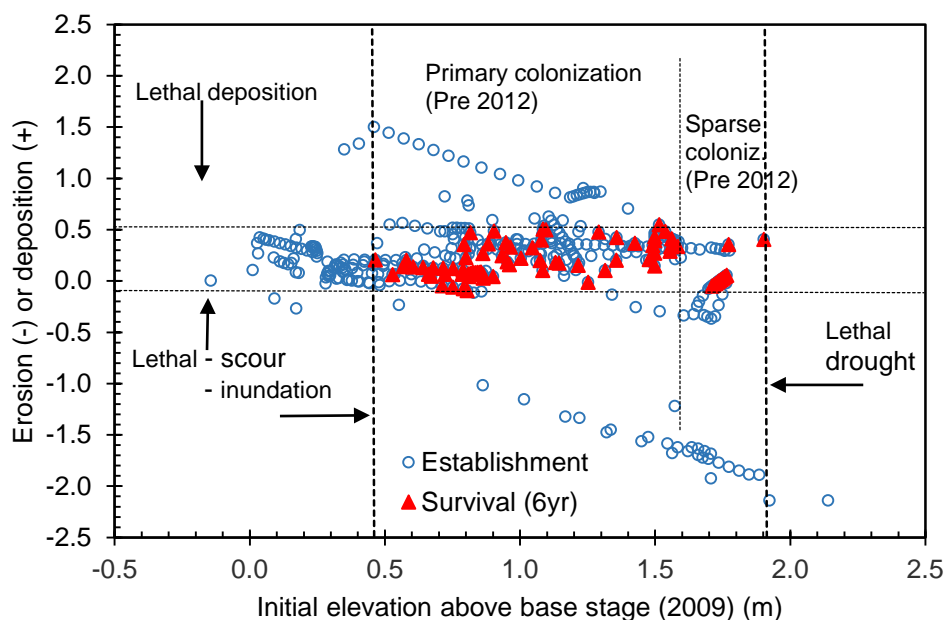
Figure 3-16: Seedling safe sites for the Duncan reach for seedling data from 2008 to 2013. Change in elevation (erosion and deposition) is for 2012.

Preliminary results show similar seedling safe zones for both rivers when all data for all segments were analyzed (Figure 3-16 and Figure 3-17). Lethal drought and/or drought stress did not occur along the Duncan reach but did to a small degree along the Lardeau reach for data up to 2013. The Duncan reach has only six year-olds (established in 2008) and no seedlings from 2010 or 2011 survived the inundation duration, scour, and deposition that occurred in 2012. There was no re-surveys of transect lines in 2010 to quantify what level of scour or deposition that the 2008 seedlings actually survived. However, riparian vegetation monitoring in 2012 confirmed the loss of some of the 2008 seedlings. The older black cottonwoods were not excavated to determine age, so the presence of young black cottonwoods in the same location might have included pre-2008 germinants during 2012 riparian monitoring surveys. These data show the elevation of the 2008 seedlings in 2009 but not the extent of erosion or deposition that they may have survived to be classified as recruited seedlings in 2010. Instead, the analyses represent only the amount of scour and deposition that occurred at those positions in 2012. Most of the 2008 seedlings counted and measured for height had some level of deposition since growth scars were observed below the ground surface level when some seedlings were excavated in 2009 and in subsequent years. Additionally, measuring scour and deposition that occurred at rebar stakes (measuring height of rebar from ground surface level) along transect lines and the embedded piezometer pipes (2013 and 2014) indicates that localized scour and deposition is occurring annually but at a reduced rate compared to 2012. Rebar measurements along the Duncan reach had 53 percent no change (<1 cm) and a range from 1 to 16.5 cm deposition and 1 to 5.1 cm erosion. The Lardeau had 45 percent no change with 1 to 6 cm deposition and 1 to 13.5 cm erosion. This suggests that slight deposition or scour had occurred from 2008 to 2010 similar to 2013 and 2014 results. We will derive more accurate analyses of the seedling safe zones if re-surveys occur in 2015 and 2017.

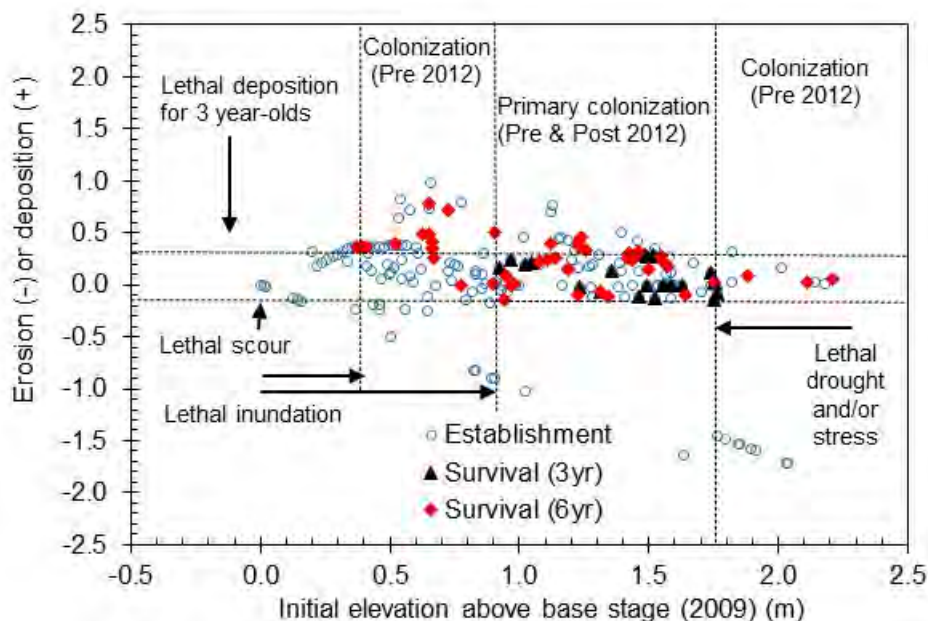
Figure 3-17: Seedling safe sites for the Lardeau reach for seedling data from 2008 to 2013. Change in elevation (erosion and deposition) is for 2012.

The Lardeau had seedlings survive from 2010 through to 2013 so there is a slightly more accurate picture of three year old seedlings surviving the levels of scour and deposition following the 2012 flood ($< Q_{\max 10}$) event. However, with only 2009 and 2012 elevation profiles it is not known at what elevations the 2008, 2010, and 2011 seedlings actually established or the amount of erosion and deposition they survived. The primary recruitment (colonization) safe zone for three year-olds is reduced in area if the older seedlings are removed from the data set (Figure 3-17). This reduces the area from 0.4 to 2.25 m for initial elevation to 0.9 to 1.75 m with the survival of 0.3 m deposition for three year-olds to 0.8 m of deposition survival by older seedlings.

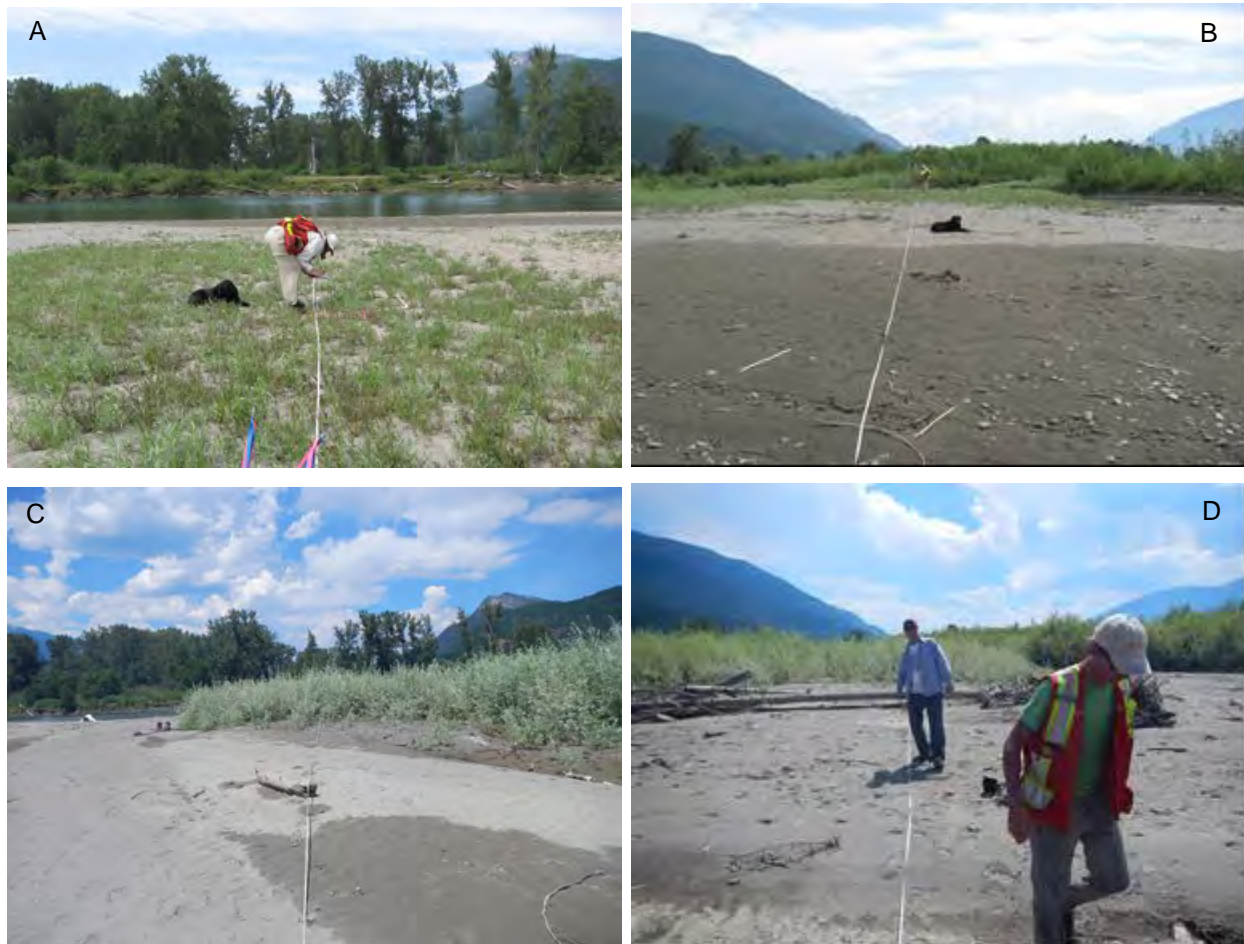
Figure 4-1: Photographs showing a section along D6T36 in 2009 (A) and (B). The same section in 2014 (C) and (D).

To quantify the hydrogeomorphic conditions that define the seedling safe sites and the successful elevation zone for black cottonwood recruitment along the Duncan, elevation surveys should be completed at least every 3 years. This will reveal the extent of deposition and scour that young seedlings are able to survive. This will also allow for average scour and deposition rates to be calculated for the Alt S73 new flow regime since the extreme 2012 flood event effectively reset the riparian recruitment zones along the lower Duncan River. The next survey in 2015 will thus contribute important information for the seedling recruitment modeling.
