Duncan Dam Project Water Use Plan

**Lower Duncan River
Riparian Cottonwood Monitoring**

Year 6 Report

**DDMMON#8-1 Lower Duncan River
Riparian Cottonwood Monitoring
Year 6 Annual Report (2015)**

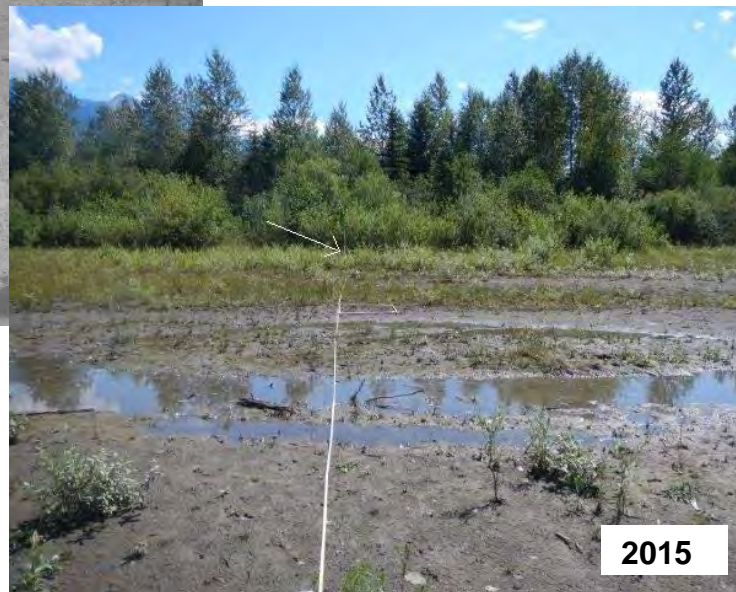
Cover photo

Lower Duncan River, Segment 3, Transect line 15, July 23, 2009 and the same transect line August 8, 2015. Arrow is pointing at the same piezometer in each photo. Photos © Mary Louise Polzin, VAST Resource Solutions Inc.

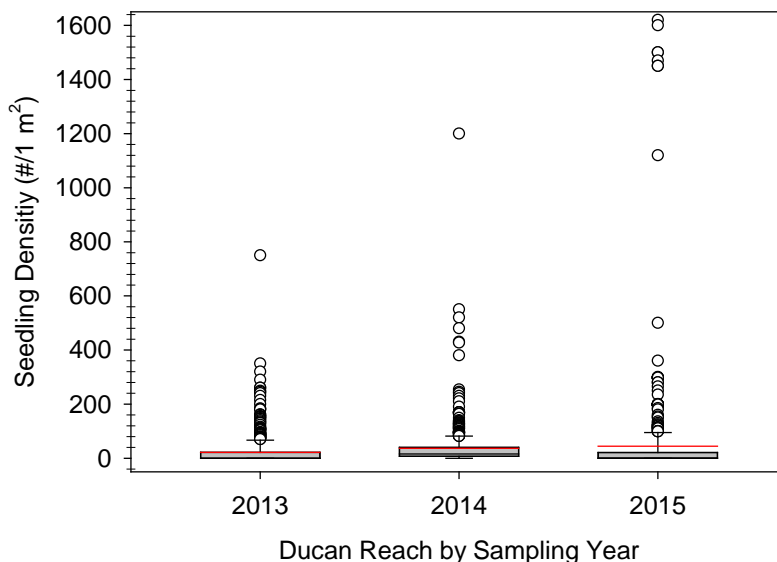
Figure 3-9: The 2013, 2014, and 2015 black cottonwood germinant densities paired between years (zeros when no germinants occurred where they were recorded in one of the other years) for statistical analysis.

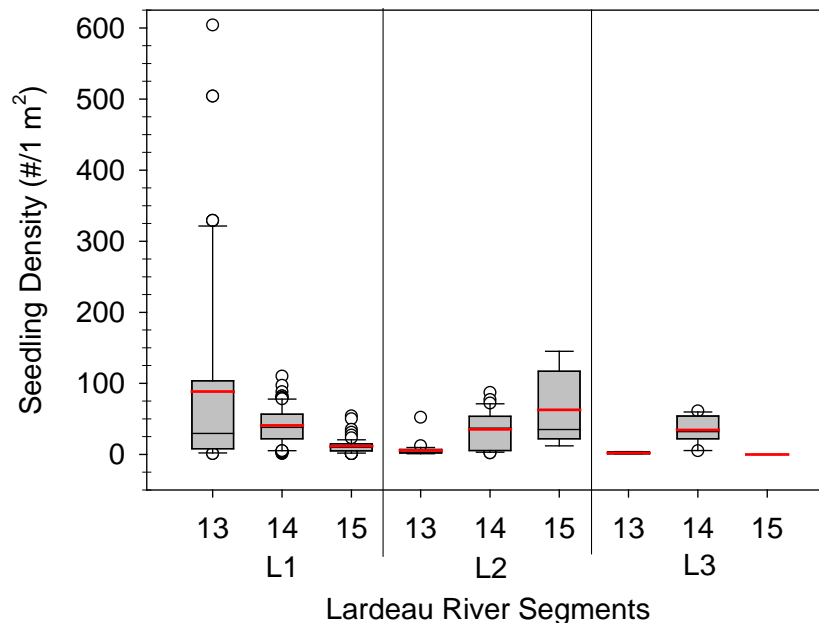
Figure 3-13: Seedling establishment densities (germinants) for 2013, 2014, and 2015 for each segment along the Lardeau (L) River.

Comparisons between segments show that Lardeau Segments 1 (L1) and 3 (L3) had a reduction of seedling establishment in 2015 compared to 2013 and 2014. Lardeau Segment 2 (L2) did have an increase in seedling densities and accounts for most of the outliers for 2015 reach graph (Figure 3-13).

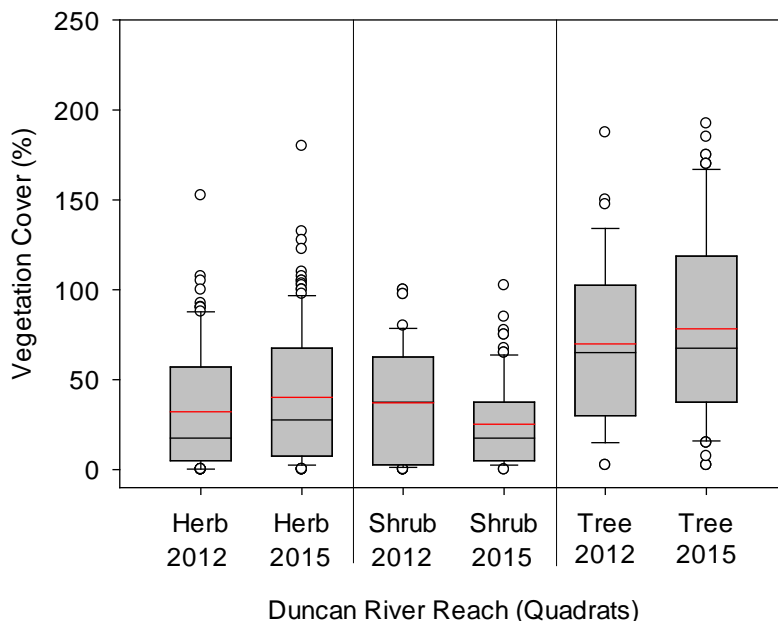
Figure 3-15: Vegetation per cent cover for the Duncan River by quadrat size comparing 2012 versus 2015. Vegetation cover can be greater than 100 per cent when multiple layers of vegetation occur.

Vegetation cover (per cent) for the Duncan reach was similar between 2012 and 2015 for each sampling quadrat size (herb 1 m², shrub 8 m², and tree 50 m²) with no significant differences when comparing 2012 to 2015 (Figure 3-15). There was also no significant difference between years for species richness occurring within quadrats. Richness within each size of quadrat was very similar between 2012 and 2015 (Figure 3-16).

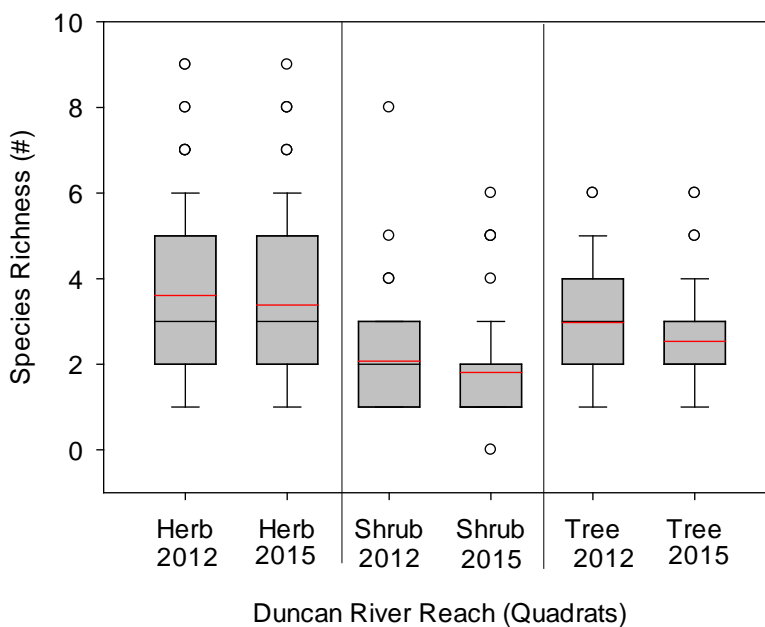
Figure 3-16: Species richness (number of species) for the Duncan River by quadrat size for 2012 versus 2015.

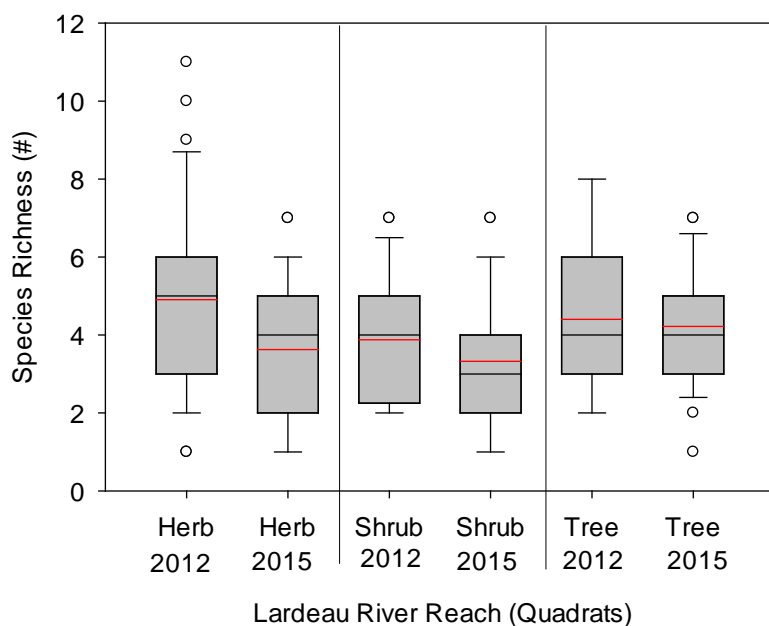
Figure 3-18: Species richness (number of species) for the Lardeau Reach by quadrat size for 2012 versus 2015.

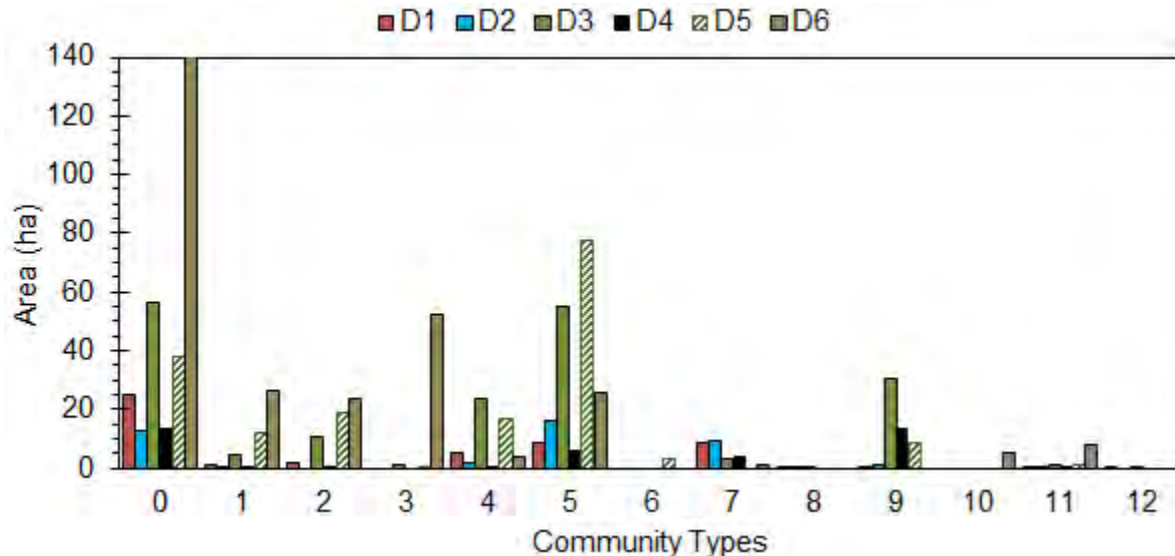
Figure 3-22: Community Type areas (ha) along the Duncan River for each segment for 2015.

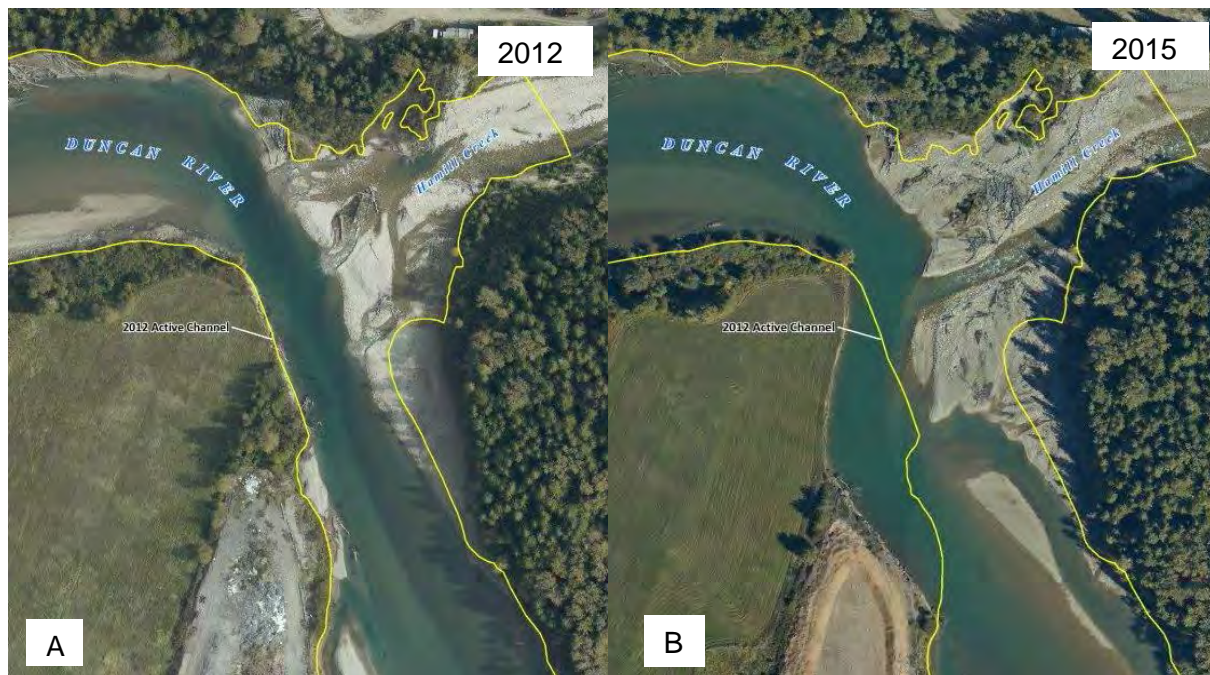
Figure 3-24: Air photos of Duncan Segment 4, Hamill Creek area in October 2012 (A) and the same area in September 2015 (B). The active channel delineation is for 2012.
