Duncan Dam Project Water Use Plan

Duncan Reservoir Riparian Vegetation Monitoring

Year 3 Report

DDMMON#8-2 Duncan Reservoir Riparian Vegetation Monitoring Study Year 3 Annual Report (2015)

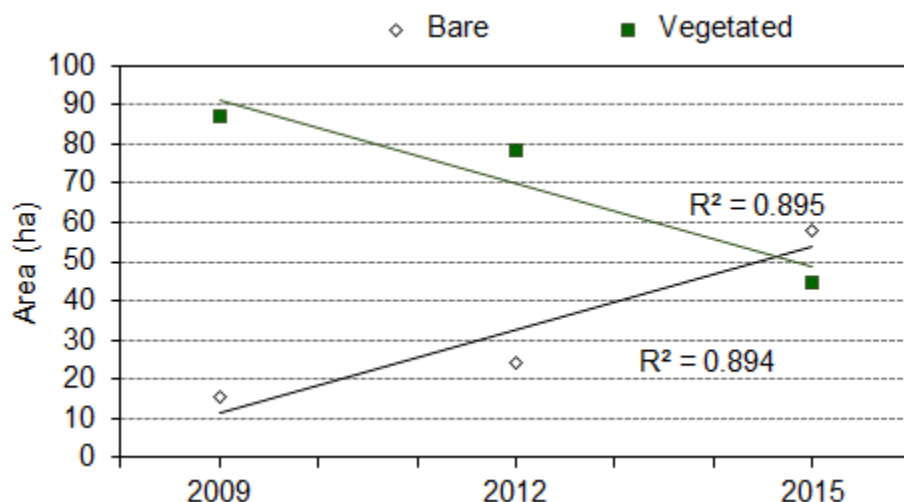
Figure 3-2: Comparison of area of bare and vegetated ground cover for the reservoir (total area 102.59 ha) for 2009, 2012, and 2015 sampling years.

There was a significant decrease in vegetated ground by area in 2015, as compared to 2009 (Linear regression for the vegetated area between 2009 and 2015 was $P = 0.02$, $F = 6.3$ and $df = 15$ $R^2 = 0.31$). The trendline $R^2 = 0.89$ for both the vegetated and the bare ground. The percentage of bare area (ha) was 56.4 per cent of the total area in the study in 2015 compared to 15.3 per cent bare in 2009. The per cent of vegetated area (all vegetation types) decreased from 84.7 per cent of area in 2009 to 43.5 per cent area in 2015 (Figure 3-2).

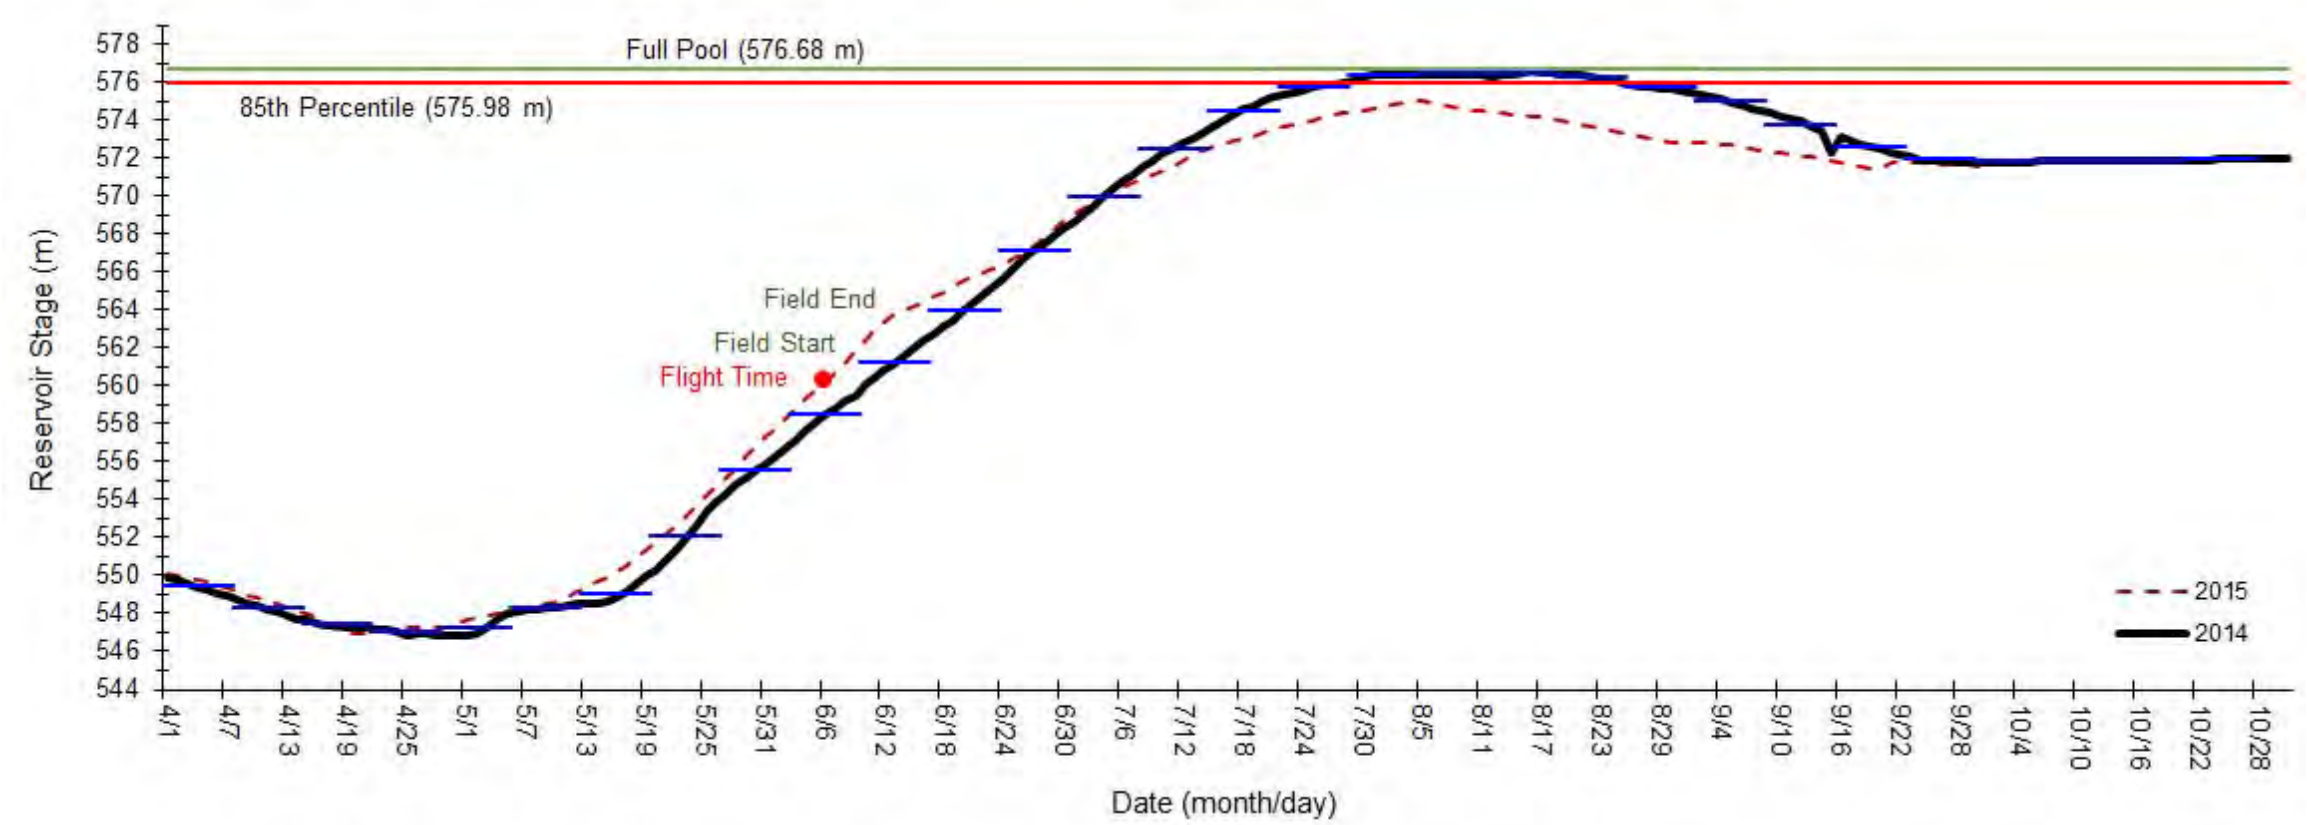
Figure 3-4: 2014 reservoir stage during the growing season (April to September 29) (solid black line) with the average weekly stage (26 weeks; short blue line) and the 85th percentile level (red line). Flight times relative to reservoir stage, as well as field data collection times are indicated as red and green marks, respectively and correspond to the 2015 reservoir stage (dashed line). Full-pool, which is upper limit of the reservoir water level and the start of the study area, is shown as a green line.

The areas for each site exposed for 85 to 100 per cent of the growing season for the high riparian potential for enhancement sites were compared between year's and shows that the area exposed at the 85th percentile has been decreasing for each site for each year sampled (Figure 3-3). Site 6 experienced the smallest decrease but Site 6 has had almost no vegetation cover since 2009. Data for each week and site is located in Appendix 2. The decrease in area for the 85th percentile has significantly decreased from 2009 and from 2011 ($P < 0.00$, $t = 7.3$, $df = 8$; and $P < 0.00$, $t = 13.9$, $df = 8$ respectively). The reservoir mean weekly levels have been graphed to show the timing and duration of inundation related to the reservoir drawdown zone elevations (Figure 3-4).

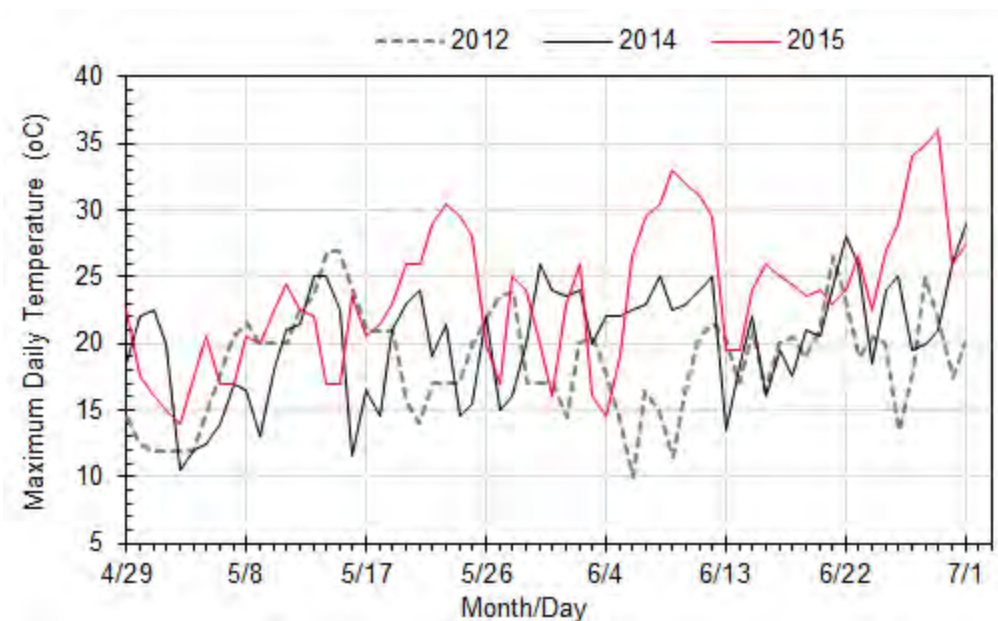
Figure 3-7: Daily maximum temperatures for May and June for 2012, 2014, and 2015 (Duncan Lake Dam station 1142574).

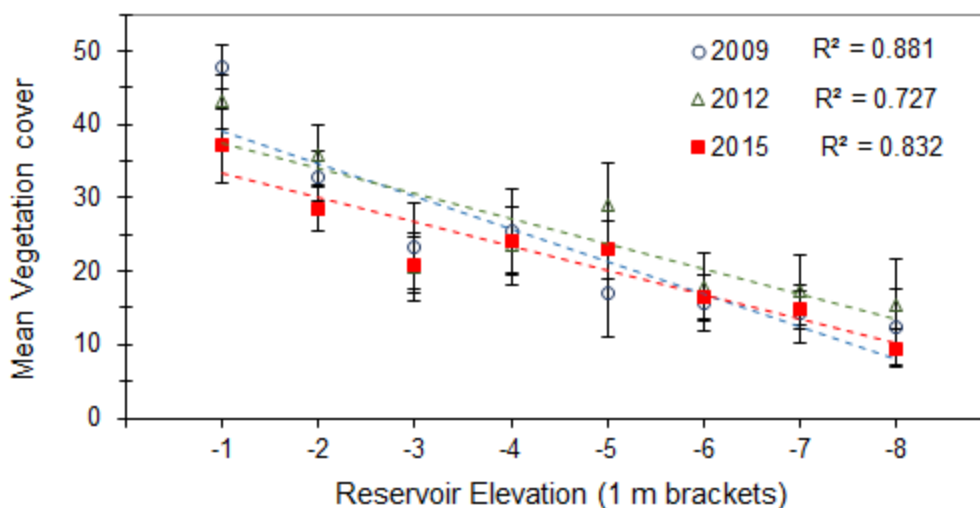
Figure 3-10: Mean (\pm s.e.) vegetation per cent (cumulative) *versus* elevation for quadrat data grouped in 1 m elevational intervals for 2009, 2012 and 2015. Trendlines correspond with marker colour.

Increased vegetation cover was noted with progress up the transect elevations to 576.7 m. Per cent cover was highest in 2009 at the -1 m bracket (576.7 m to 575.7 m (-1)) compared to 2012 and 2015 with a gradual decrease in cover between years (Figure 3-10). All sampling years show a gradual decrease in cover from full-pool down to -8 m into the drawdown zone, with similar trend lines across the years.

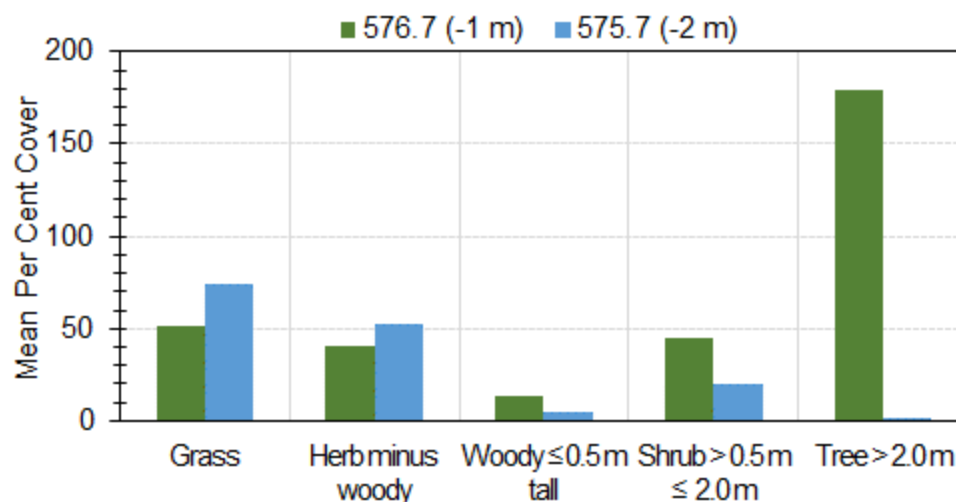
Figure 3-11: Mean per cent cover of herbaceous plants, grasses, shrubs, and trees from full-pool down 2 m decrease in elevation for 2015. Grass, herb, and seedlings or small saplings of woody species (≤ 0.5 m tall) were sampled in a 1 m^2 quadrat, shrubs in an 8 m^2 quadrat, and trees were sampled in 50 m^2 quadrat.

The 85th percentile was 576.0 m, with 0.68 m change in elevation from full-pool being exposed for 85 to 100 per cent of the growing season. Therefore, the first -1 m change in elevation is greater than the 85th percentile range that is exposed. This elevation band is where the majority of the shrub and tree species occurred. There were some woody species occurring at low density cover in the -2 m elevation band at the herb and shrub size quadrats, but no trees (> 2.0 m tall) (Figure 3-11). When woody species occurred in the -2 m band, they generally occurred at the upper end of the metre band in elevation. Woody species that were less than or equal to 0.5 m tall were assessed in the herb quadrats but separated out for this analysis, in order to investigate the level of inundation that limits woody species recruitment and survival. No woody species were recorded in the -3 m bracket or lower in the drawdown zone. Both grass and herbaceous species had slightly lower vegetation cover at the -1 m elevation drop as compared to the -2 m band.

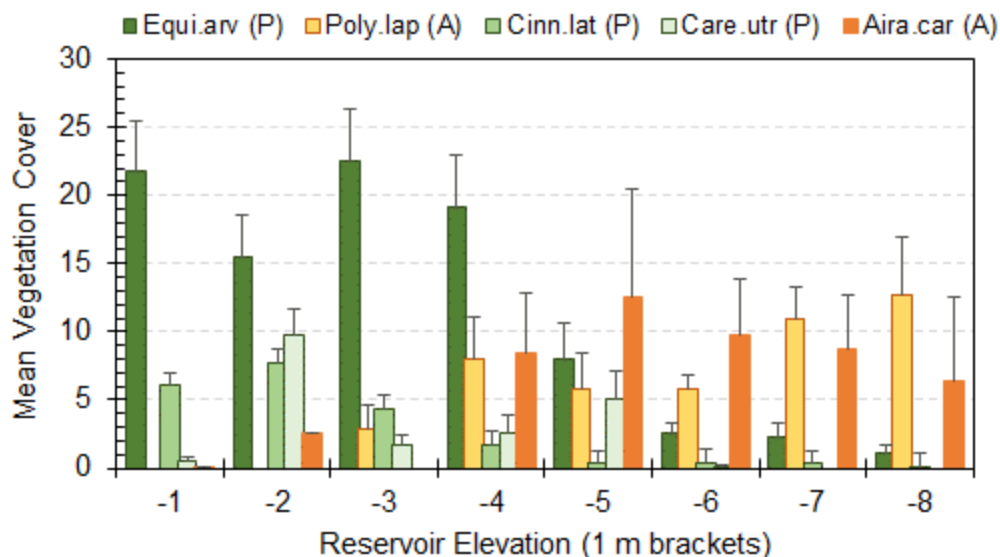
Figure 3-13: Mean (+ s.e.) per cent cover for the five dominant plant species *versus* elevation brackets within the drawdown zone of Duncan Reservoir in 2015.

For the five dominant species, it appears that perennials decrease as elevation decreases from full-pool while the two annual species have a reverse gradient with cover decreasing as elevation increases toward full-pool. Figure 3-13 shows these species listed in their ranked order from highest to lowest *versus* the elevation gradient. Common horsetail and nodding wood-reed perennial species were found as first year seedlings below the two metre change in elevation. Above the two metre change in elevation they were in mixtures of perennial and first year seedling growths depending on the site where they occurred.

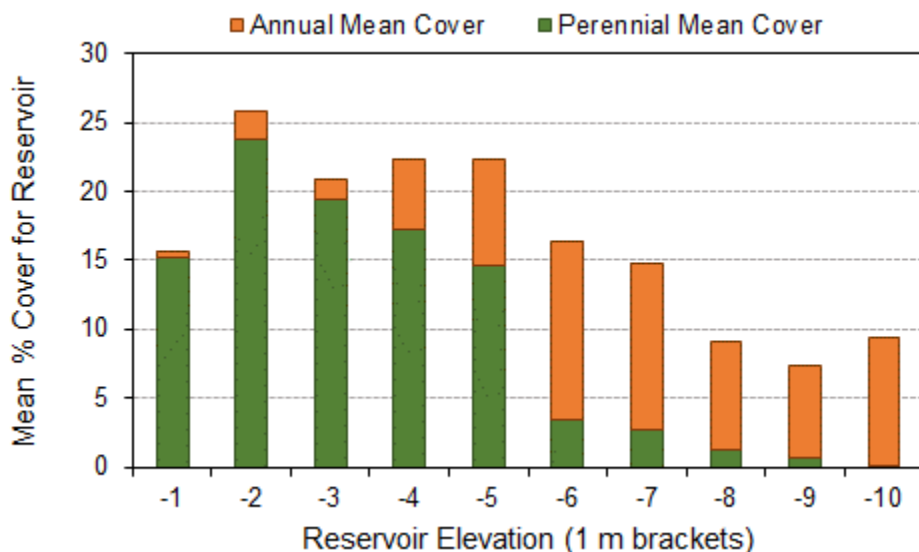
Figure 3-14: The mean per cent cover for annual and perennial plants and the elevation brackets at which they occurred within the Duncan Reservoir drawdown zone in 2015.

When all of the annual species are plotted next to the perennials, a clear trend emerges similar to the findings in 2012. Annual species dominated the lower elevations of the drawdown zone and perennials were predominant in the upper elevations (Figure 3-14).

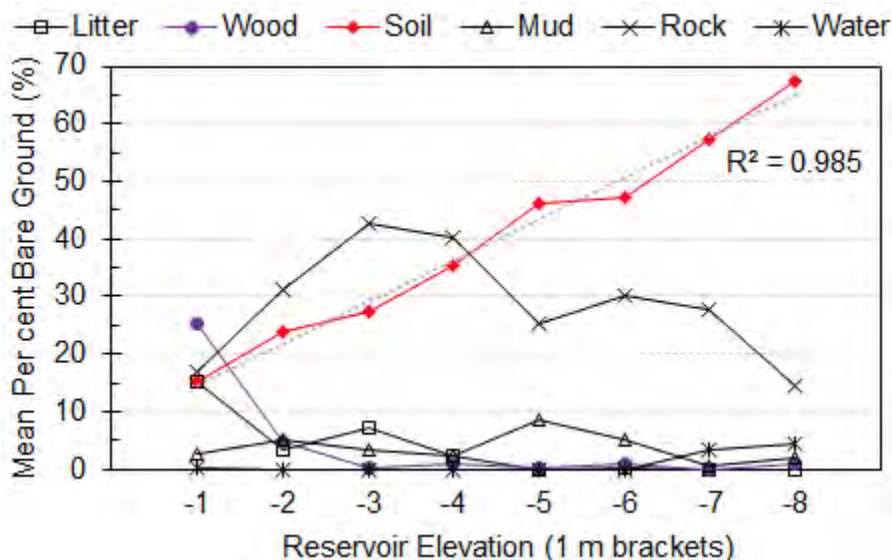
Figure 3-17: Mean bare ground and litter covers by elevation for all sites combined.

Bare ground was broken into five categories: wood, soil, mud, rock, and water. Litter cover was assessed but not included in bare ground totals. Woody debris (Wood) mainly occurred at the 1 m bracket below full-pool. Bare ground (Soil) had a steady increase in cover as elevation dropped in the drawdown zone (Figure 3-17). Litter was highest at the 1 m bracket with low levels at the 2 and 3 metre brackets and close to zero at the lower elevations.

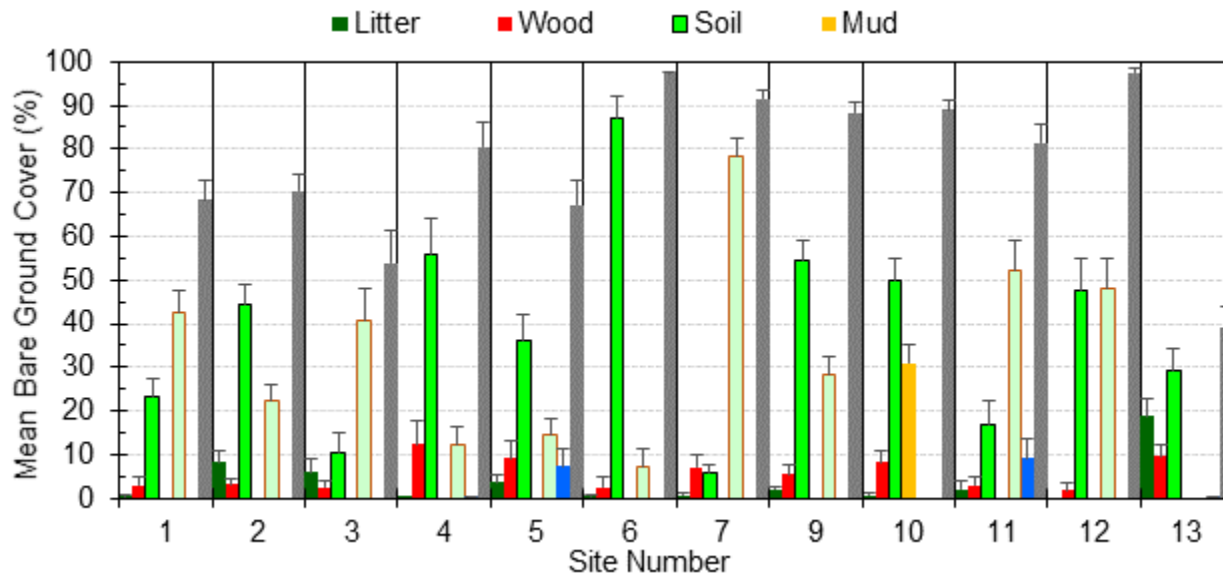
Figure 3-20: Mean (\pm s.e.) bare ground and litter covers by sites.

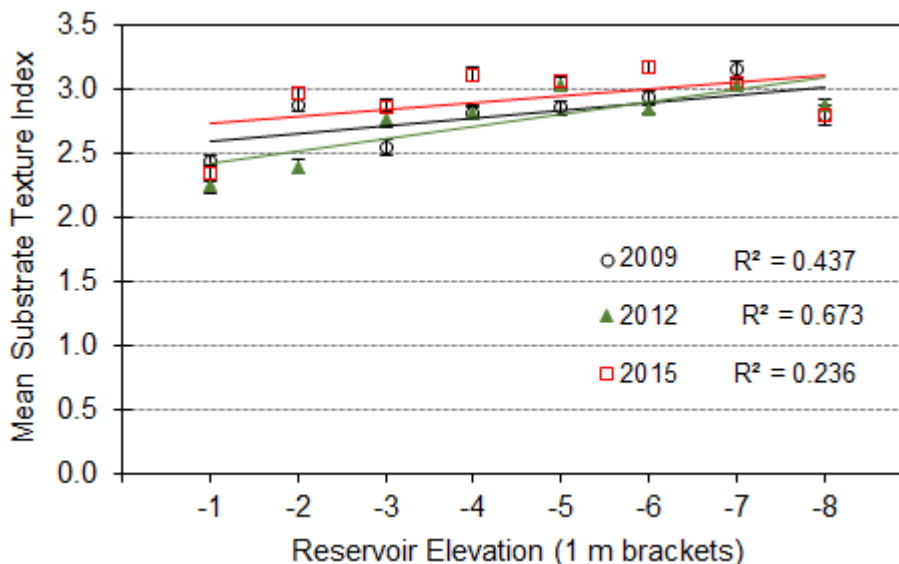
Figure 3-21: Mean (\pm s.e.) substrate texture index *versus* elevation grouped into 1 m elevational intervals for 2009, 12, and 15. Substrate texture index (1 = silt (very fine) to 5 = bolder (very coarse)).

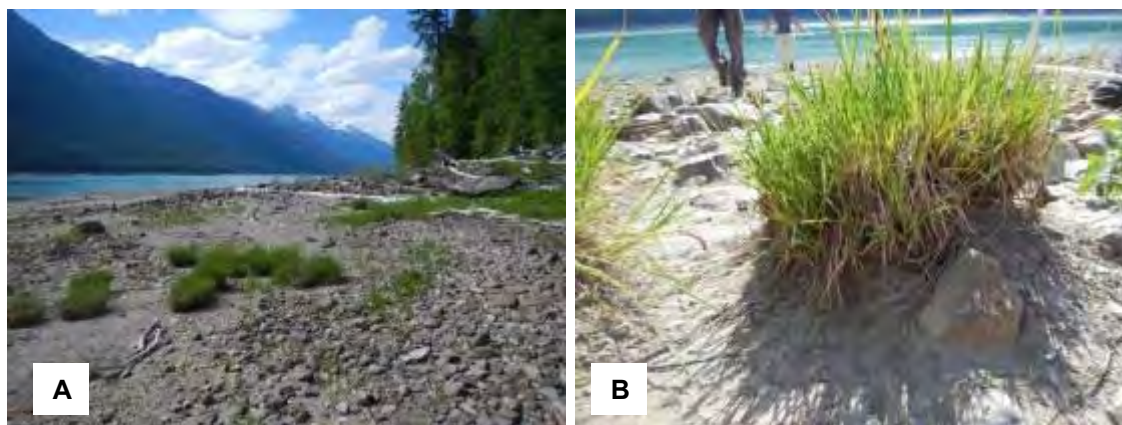
Figure 4-1: Sedge clumps looking up reservoir from Site 9, Transect 709 (A) (-2 m elevation bracket) and a close up of a sedge and grass clump (B) (-1 m elevation bracket).
