# Walter Hardman Project Water Use Plan

Lower Cranberry Creek: Rainbow Trout Biology/Abundance Monitoring

**Implementation Year 2**

**Reference: WHNMON-5**

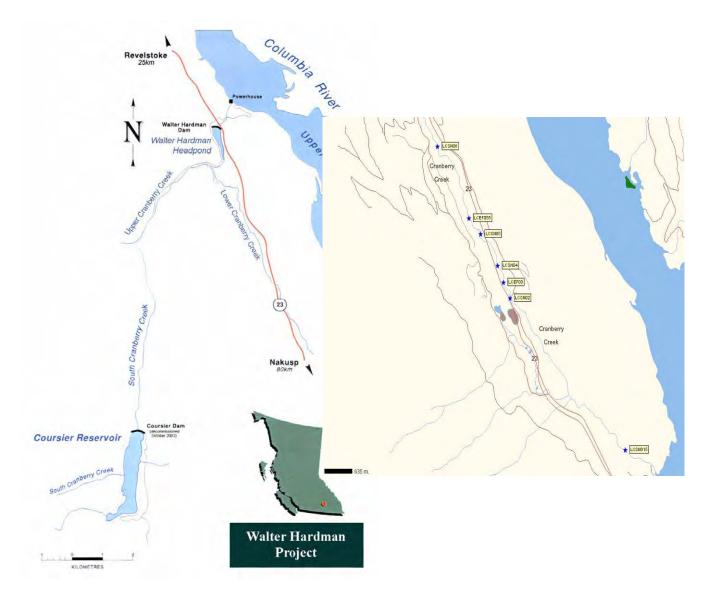
Figure 1 Map of Walter Hardman project and site locations used for fish and habitat surveys in Lower Cranberry Creek in 2008. (Source: Walter Hardman Project Use Plan, Monitoring Program Terms of Reference, 2006)

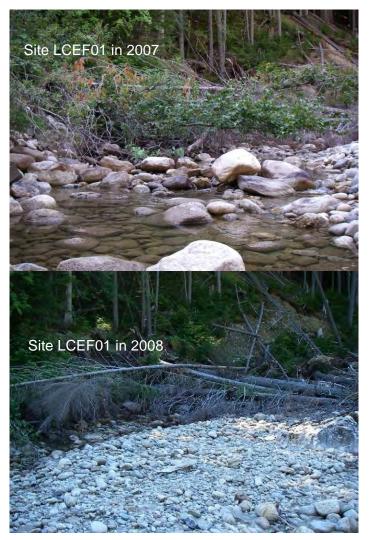
Figure 2 Site LCEF01 was used in 2007 and not in 2008 due to the large number of trees which fell into the channel. The area was dewatered and not accessible to fish.

During the 2007 survey seven sites were chosen and permanently marked with rebar / t-bar for future sampling years (see Davis and LeBourdais 2007). Due to alterations in river flow pattern several sites had to be changed in the 2008 sampling season (Table 1). At site LCEF01 the stream bank collapsed into the side channel used in 2007 (Figure 2). This effectively eliminated the side channel originally sampled in 2007. To replace this site we identified a site approximately 0.5 km downstream with habitat features that better represented the features of this particular section of the creek. Site features included bedrock and large boulders with a large pool bounded by riffles (Figure 3). This site was labeled as site LCSN01.5.

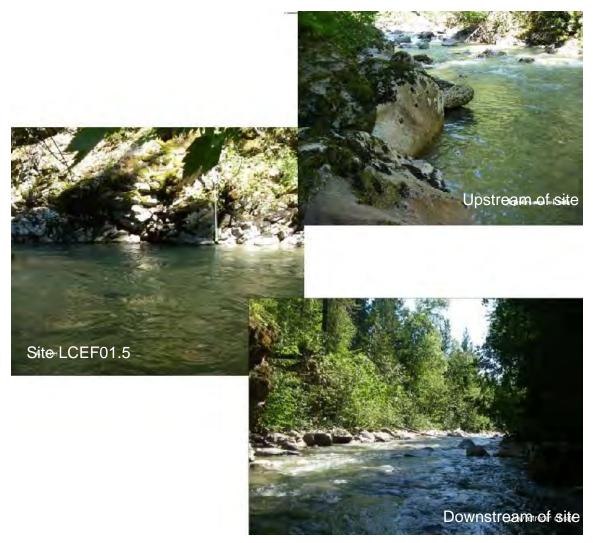
Figure 3 Lower Cranberry Creek, site LCEF01.5, showing habitat features such as the large boulders (bottom picture) and a deep pool (middle picture). The top picture is upstream of the site. The middle picture is at the site, while the bottom picture is the downstream section of the site.

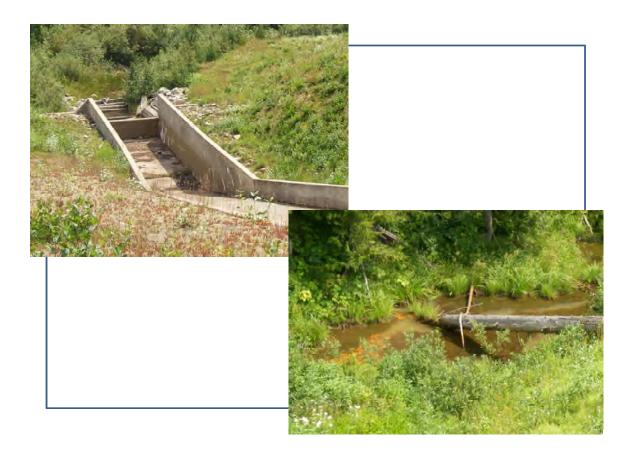
Figure 4 Site LCEF07 was generally inaccessible to fishes due to the spillway on the headpond (top picture) and contained extremely stagnant water with high growth of grass and algae (orange and dark green brown water in lower picture).

We also replaced site LCEF07 with site LCEF05. The original site was located in the overflow area of the Walter Hardman headpond. This section of the creek was overgrown with algae and inaccessible to fishes due to the diversion channel (Figure 4).

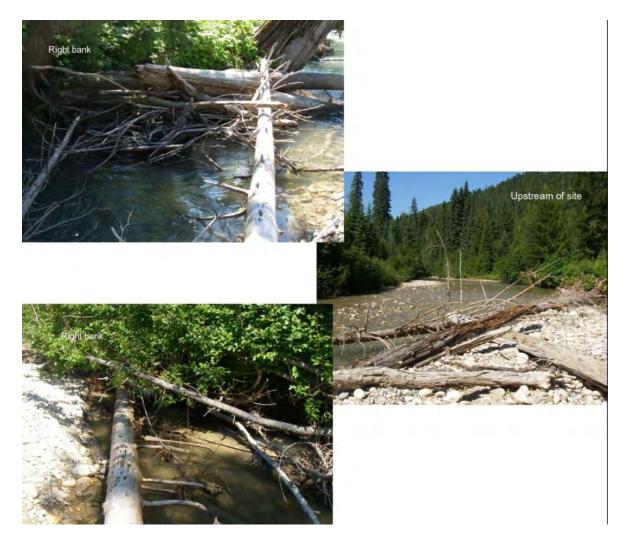
Figure 5 Site LCEF03 showing the large woody debris over the stream site along the right bank facing downstream (top), upstream of site (middle right) and the right bank facing upstream (bottom).

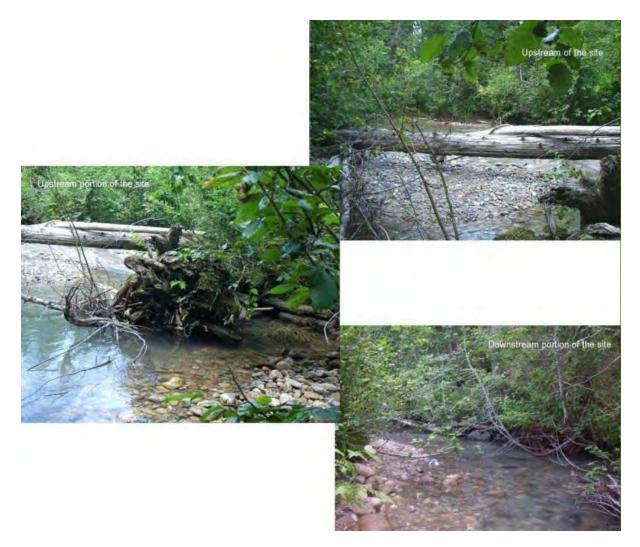
Figure 6 Large woody debris (LWD) and overhanging vegetation at site LCSN05.5 during the 2008 sampling season. The top photo is the LWD upstream of the site, while the middle photo is the upstream section the site. The bottom photo shows the overhanging vegetation facing downstream of the site.
