Walter Hardman Project Water Use Plan

**Lower Cranberry Creek: Rainbow Trout Biology/Abundance
Monitoring**

Reference: WHNMON-5

Study Period: 2009-2010

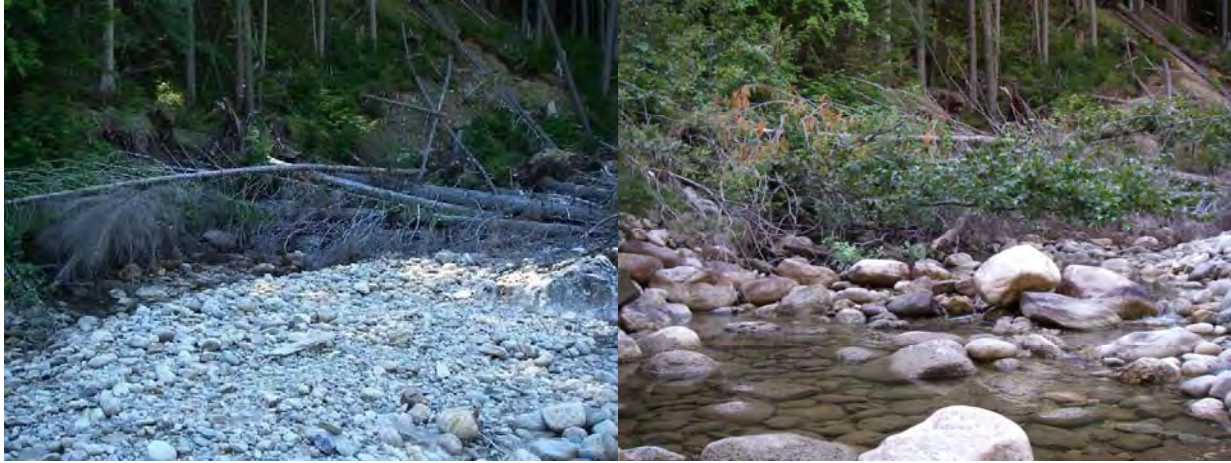
Photo 1. Site LCEF01 was used in 2007 and not in 2008 or 2009 due to the large number of trees which fell into the channel. The area was dewatered and not accessible to fish.

During the three years of assessment a number of unavoidable circumstances have resulted in changes to the study design. One of the original seven survey sites (LCEFO1) selected in 2007 had to be revised in 2008 due to a stream bank failure that eliminated a side channel that was included in the sample site. As a result, a new site 0.5 km downstream (site LCSN01.5) had to be chosen in 2008. One further adjustment in site location was made in 2009 with the exclusion of Site LCEFO7, located in the overflow area of the Walter Hardman Headpond that had become overgrown with algae and was deemed inaccessible to fish. Site LCEFO7 was replaced with site LCEFO5 (Photo 3). Habitat assessments were conducted at all sites in 2009 but continuous poor weather events limited the field crew's ability to electrofish sites LCEFO3 and LCEFO6.

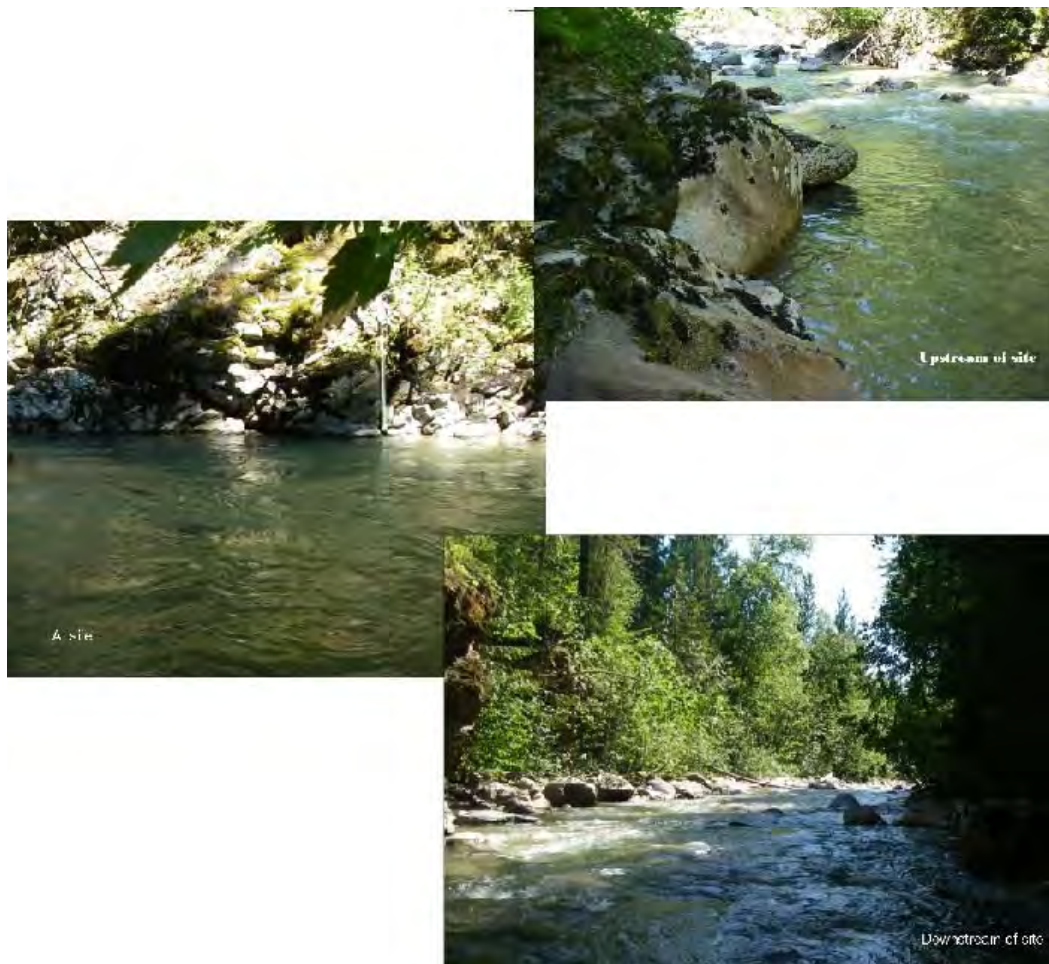
Photo 2. Lower Cranberry Creek, site LCEF01.5, showing habitat features including large boulders (bottom picture) and a deep pool (middle picture). The top picture is upstream of the site. The middle picture is at the site, and the bottom picture is the downstream section of the site.

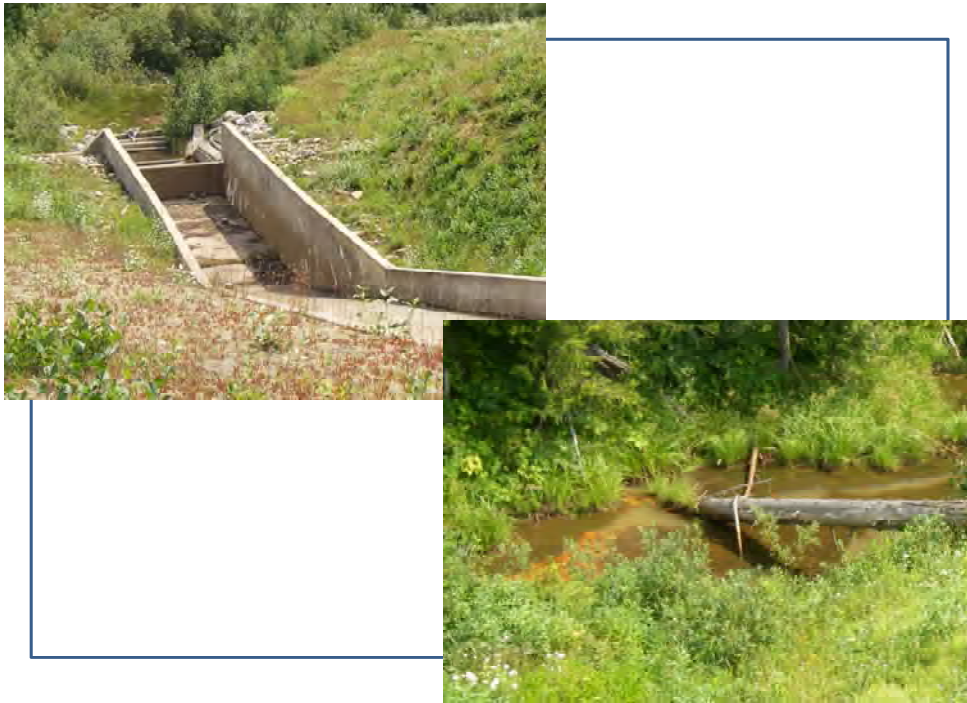
Photo 3. Site LCEF07 was generally inaccessible to fish due to the spillway on the headpond (top picture) and contained extremely stagnant water with high growth of grass and algae (orange and dark green brown water in lower picture).

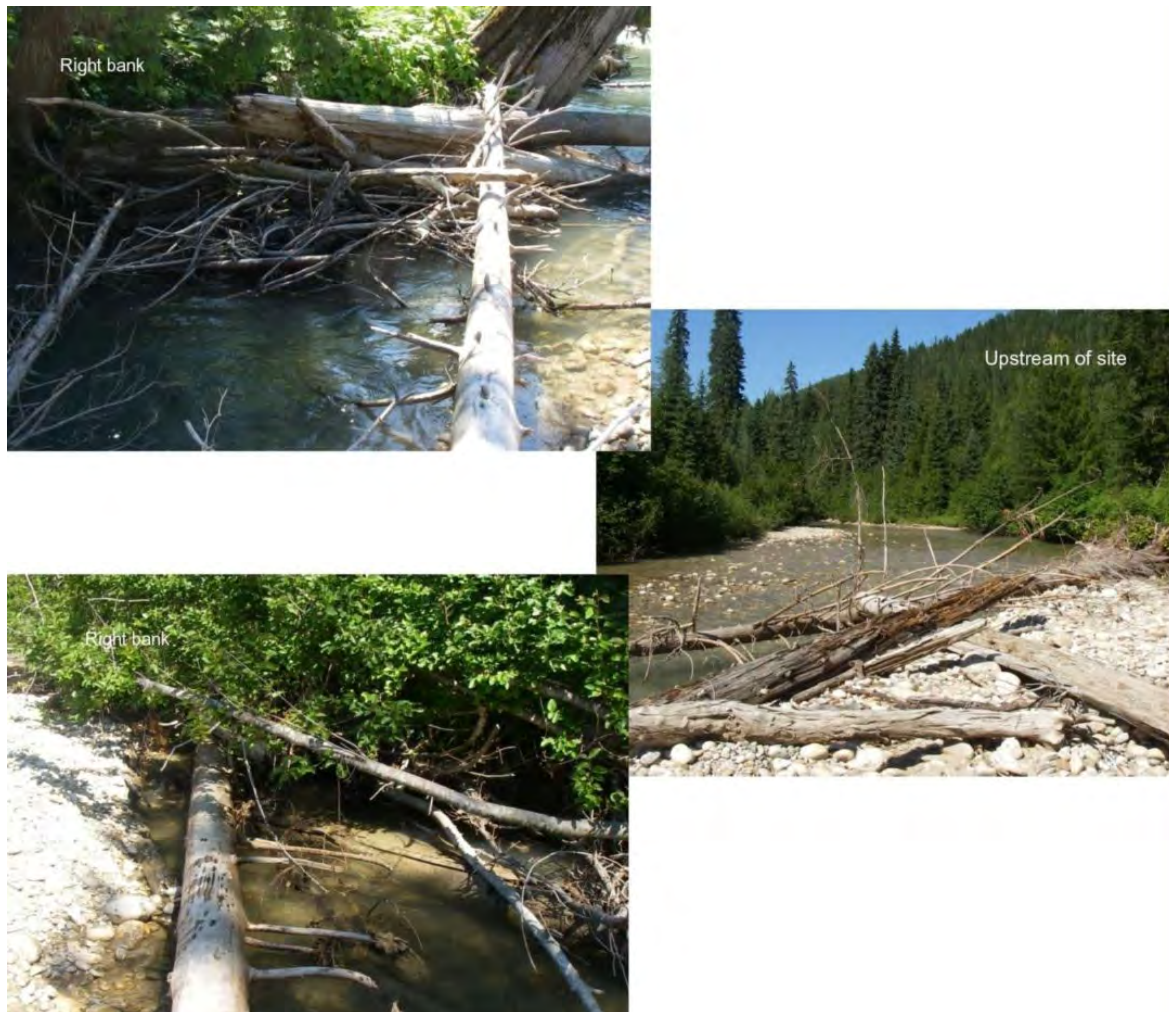
Photo 4. Site LCEF03 showing the large woody debris over the stream site along the right bank facing downstream (top), upstream of site (middle right) and the right bank facing upstream (bottom).

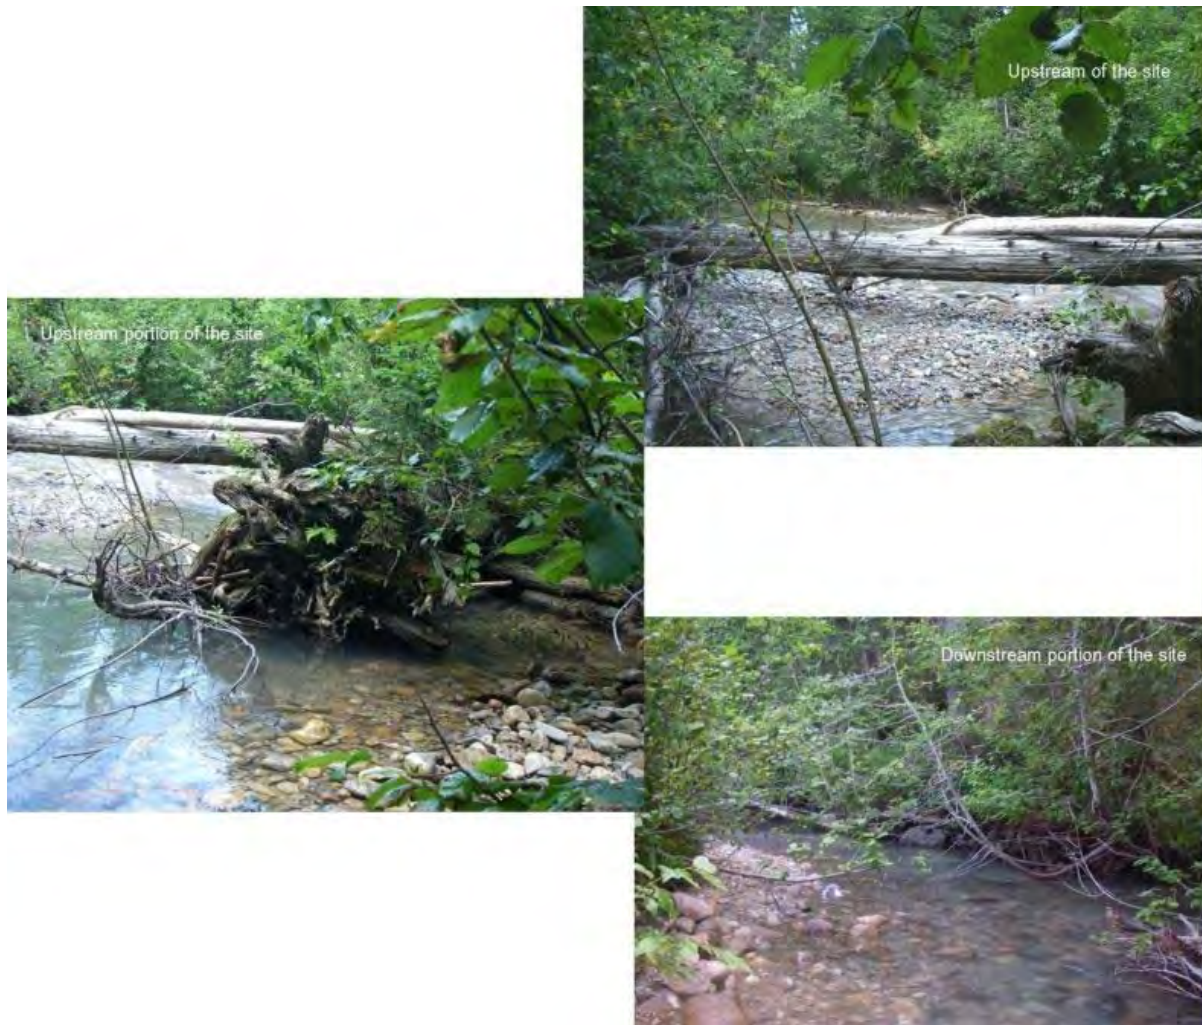
Photo 5. Large woody debris (LWD) and overhanging vegetation at site LCSN05.5. The top photo is the LWD upstream of the site, while the middle photo is the upstream section the site. The bottom photo shows the overhanging vegetation facing downstream of the site.

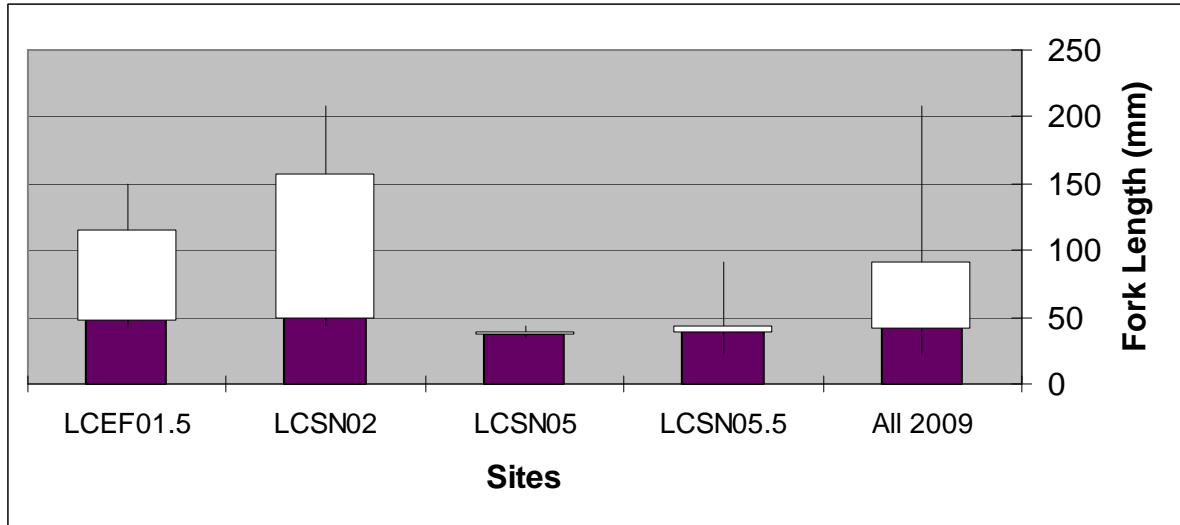
median, quartiles, maximum and minimum fork lengths, wetted weight and condition factor by site, total for 2009 (Figures 2-4).

Figure 2. Box plot of rainbow trout fork length (mm) captured at Cranberry Creek, 2009.

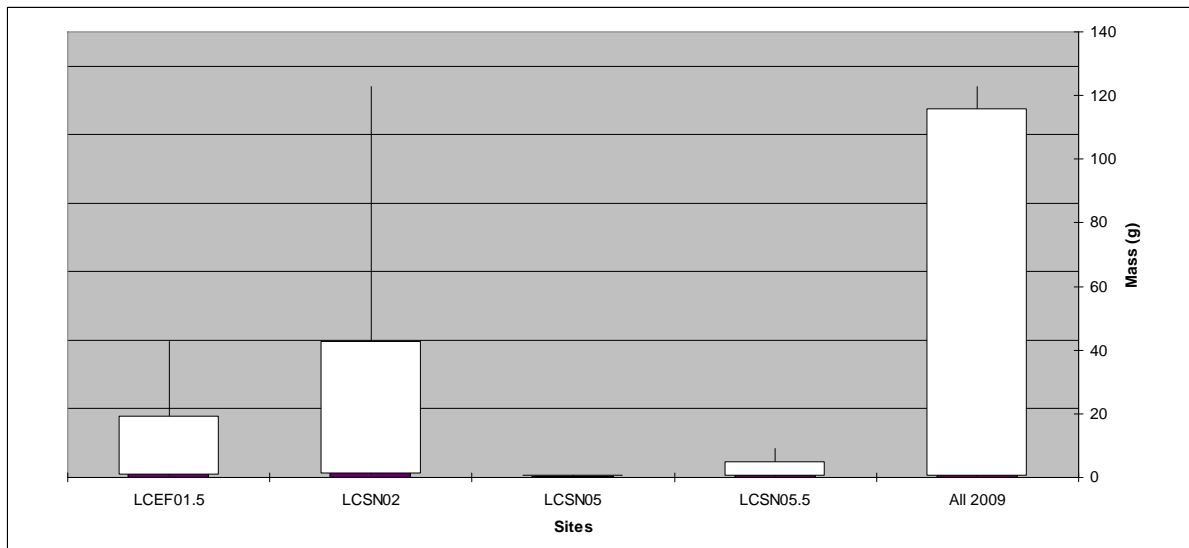
Figure 3. Box plot of rainbow trout wet weights (g) captured at Cranberry Creek, 2009.

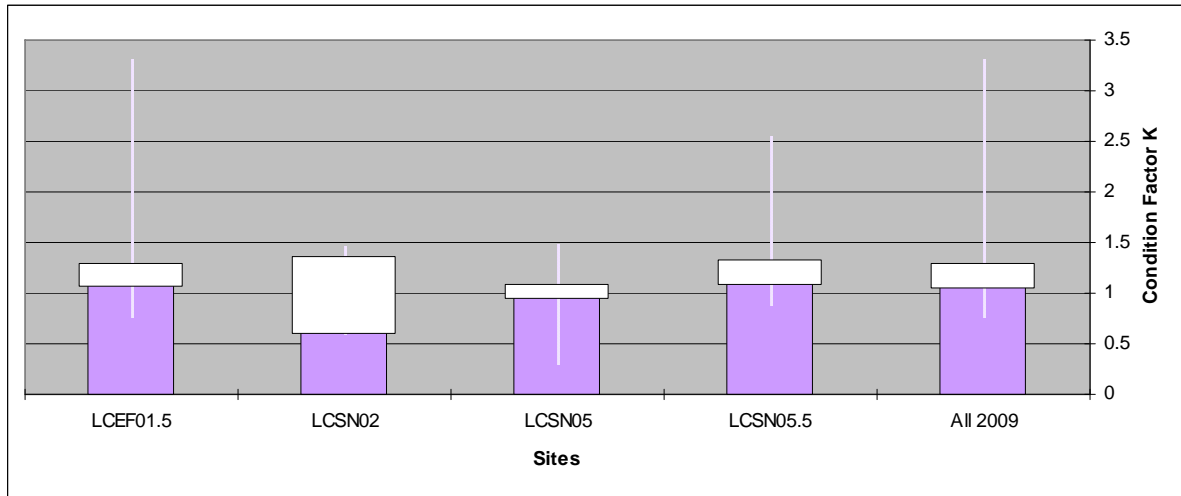
Figure 4. Box plot of rainbow trout condition indices (K) captured at Cranberry Creek, 2009.

The data were analyzed for condition factor (K). For salmonids, the K values usually fall in the range of 1.20 to 1.60 for fair to excellent condition fish (Barnham and Baxter 1998). The condition factor of the four sites in 2009 was fair with an average of 1.21, standard deviation of 0.42. Site LCEF05 had the lowest condition factor of 1.03 (N=11) and standard deviation 0.19. All rainbow trout observed at LCEF05 in 2009 were fry with an average fork length of 37 mm and average weight of 0.55g. Site LCEF05.5 had the highest average condition factor of 1.31 (N=8), standard deviation 0.52. The highest number of rainbow trout were observed at site LCSN01.5 (N=21) standard deviation 0.52. Site LCSN01.5 had 43% of the captured rainbow trout in 2009 and a K value of 1.23. Overall, the 2009 fork length and weight observations provide some indications that the population is in fair condition
