Walter Hardman Project Water Use Plan

Walter Hardman Generating Station Tailrace Habitat Monitoring

Walter Hardman Generating Station Tailrace Habitat Monitoring Final Report

Study Period: 2007 - 2012

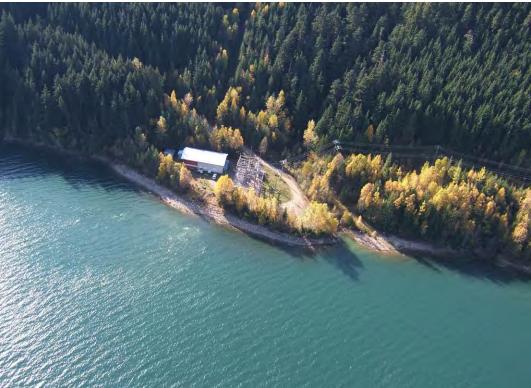
Walter Hardman Generating Station located on the west shore of Arrow Lakes Reservoir (October 10, 2008, ALR elevation 437.95m)

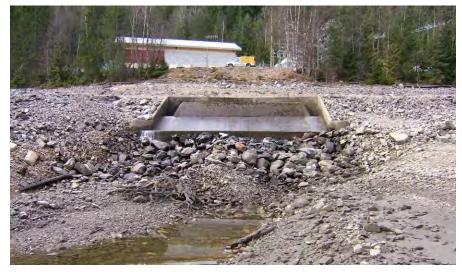
Figure 2. Outlet structure with no turbine outflow. The small amount of discharge from the HVAC system can be seen at the far left of the structure (April 17, 2012). Walter Hardman Generating Station is in the background.

Observations of the channel during a planned plant outage on April 17, 2012, demonstrate that even with cessation of plant discharge, most of the channel remains wetted (Figure 9). ALR elevation at the time was 427 m, therefore, the channel was not backwatered by the reservoir. A small amount of water from the plant's HVAC system is continuously discharged independent of any turbine flow (Figure 2).

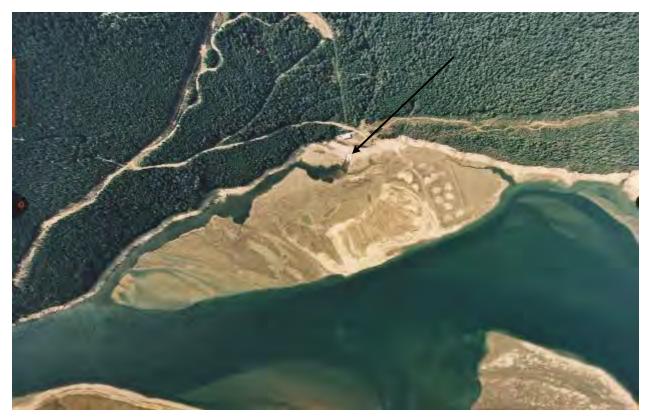
Figure 3. Aerial photograph of WHN generating station and back channel area April 28, 1996. Arrow Reservoir elevation was 428.6 m. Arrow points to outlet structure. Flow from the upstream Mid Columbia River to ALR goes from right to left in the photo.

Once discharged from the facility, water then passes into a back channel that is approximately 100 m long and can be from 3-5 m wide depending on the influence of ALR backwatering (Figure 3). At ALR elevations between 429 m and 430 m a.s.l., the backchannel begins to emerge as a distinct channel, albeit still influenced by reservoir levels at the higher elevations.

Existence of a channel at the WHN tailrace is determined predominantly by ALR elevation. At ALR elevations near or above 430 m, the channel is completely inundated to the base of the outlet structure. At about 427 m to 428 m, the channel is no longer influenced by ALR elevations (Figure 3 and Figure 5).

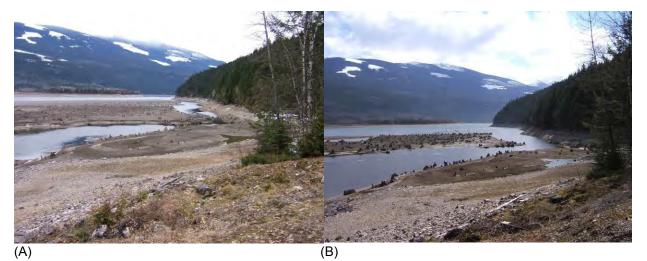
Figure 5. View of the back channel at ALR elevations (A) 427.7 m April 16, 2012, and (B) 429.5 m April 23, 2009.

differentiating channel habitat from ALR backwatering (Figure 5). As this elevation did not occur during the kokanee spawning season (September-October) of any year throughout the study period it was not possible to determine use of the back channel by spawning kokanee.
