**Appendix A. 2014 Summary of Water Level Data for Brewster Lake, and the Upper and Lower Campbell Lake Reservoirs.**

**RE:** 2014 summary of water level data for Brewster Lake, and the Upper and Lower Campbell Reservoirs.

**Appendix C. Year 1 Vegetation Transect Data.**

**Appendix D. Vegetation Community Mapbook.**

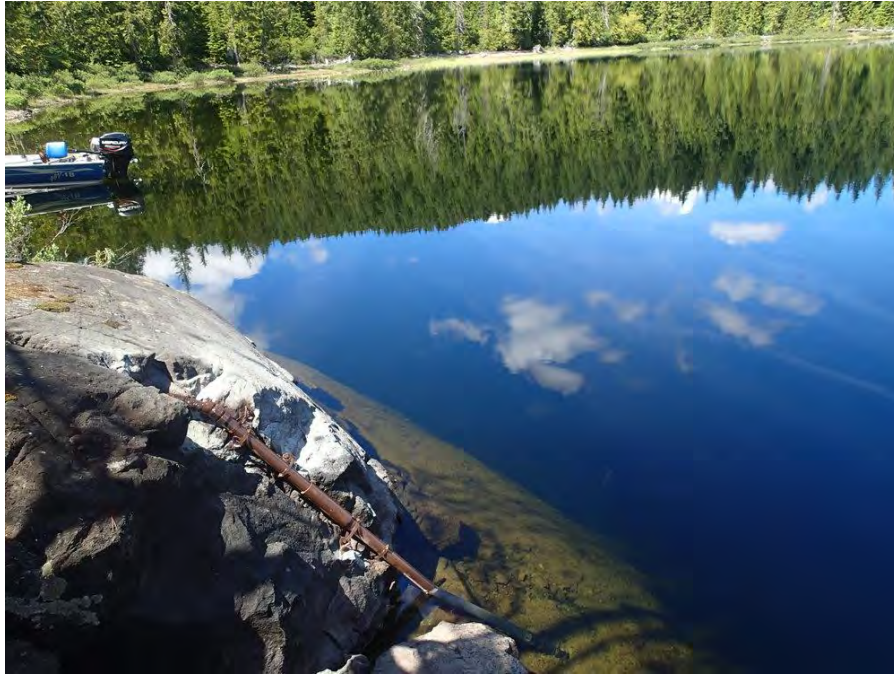
**Figure 1.** Brewster Lake Gauging Station (BRE-LG01): Submerged water level transducer in standpipe housing fastened to shoreline bedrock, as installed on June 30, 2014.

A hydrometric gauging station was installed in Brewster Lake on June 30, 2014 to record lake water levels. The gauge (BRE-LG01), was installed and is being monitored to provincial standards (9RISC 2009). The gauge is comprised of a KPSI Series 500 SDI-12 pressure transducer connected to a Unidata Neon C data logger. The gauge was installed on the west shore approximately 1.5 km north of the lake outlet. A standpipe fastened to shoreline bedrock provided a protective housing for the submerged pressure transducer (Figure 1). The pressure transducer has a depth range of 0 to 4 m, and is programmed to log average water depth and temperature every 2 minutes calculated from scans taken at a 15 second interval. The 2 minute average data records are stored on the logger and transmitted via satellite every 4 hours. A 12 VDC sealed lead acid battery charged via a solar panel powers the data logger. The data logger and battery are installed in waterproof housings mounted to a nearby tree (Figure 2).

Three permanent benchmarks were installed in the bedrock in the proximity of the transducer. Each benchmark was numbered, photo documented, and a relative level survey was completed to permit future quality assurance checks on the gauged water level data. A field team will re-visit the Brewster Lake Gauging Station in upcoming years to establish coordinates for the benchmarks and transducers with a GPS unit. Upon establishing coordinates for the transducer water depths will be converted to water surface elevations in metres above sea level (masl). On-going maintenance to the gauging station will be performed as needed.

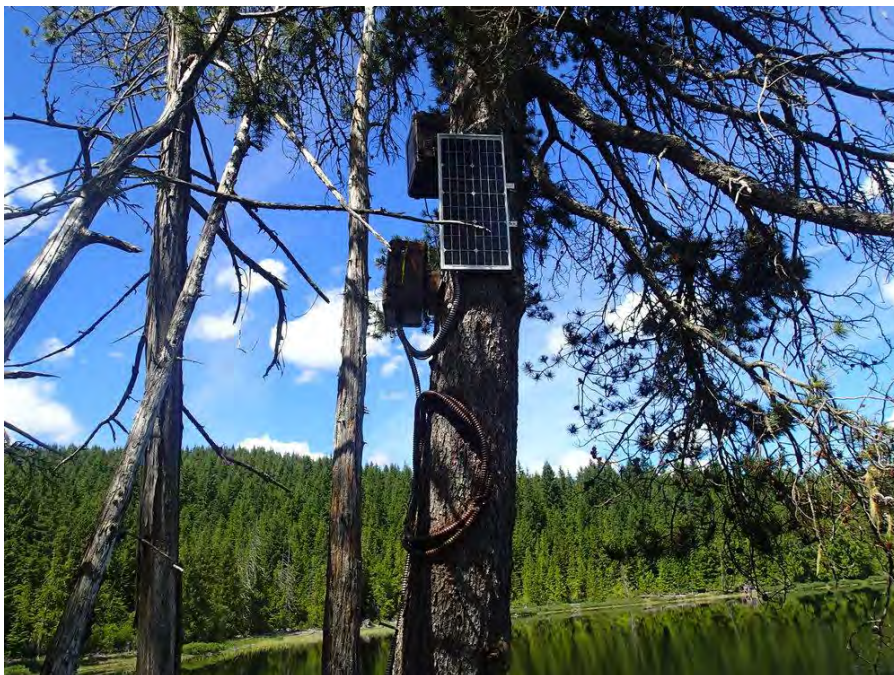
**Figure 2.** Brewster Lake Gauging Station (BRE-LG01): Data logger, solar panel, and battery box tree mounted, as installed on June 30, 2014.

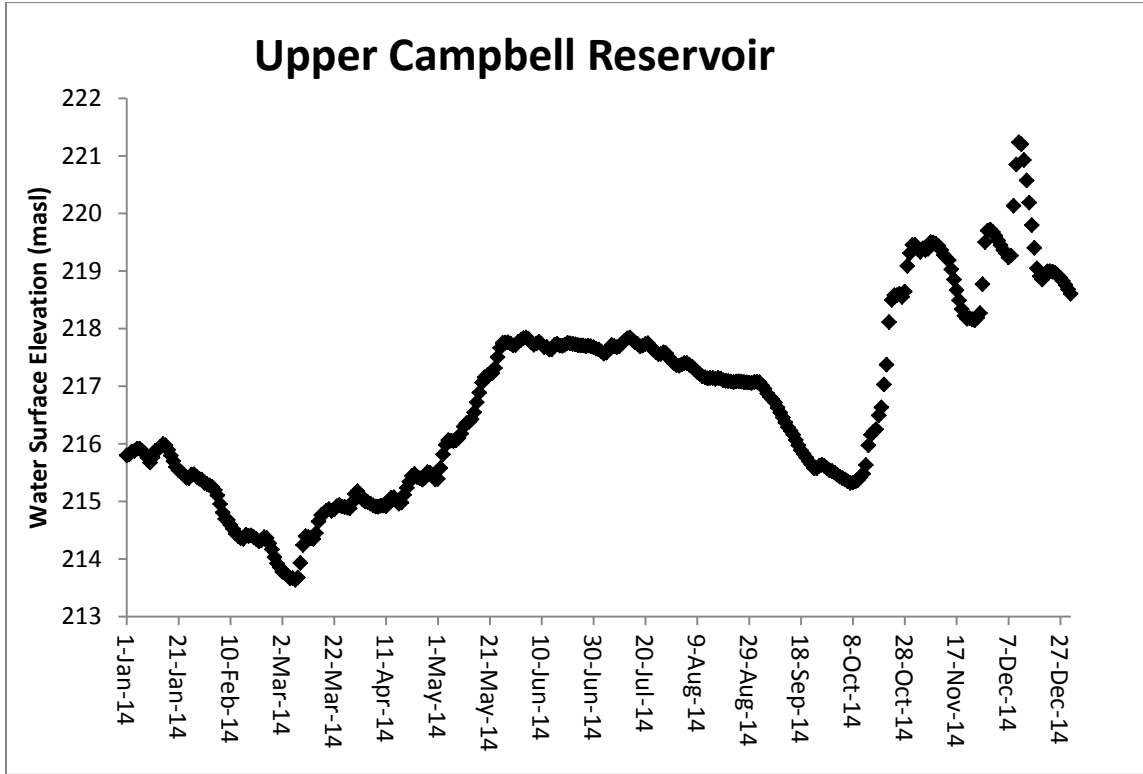
Figure 3. Daily average water surface elevations in the Upper Campbell Reservoir, January 1 to December 31, 2014.

Daily average water surface elevations in the Upper and Lower Campbell Reservoirs as recorded by BC Hydro and the daily average water depths measured at the Brewster Lake gauging station are reported here. Data in the Upper and Lower Campbell Reservoirs are presented from January 1 to December 31, 2014; while Brewster Lake data is presented from July 1 to December 31, 2014 because the gauge station was installed on June 30, 2014. The mean, minimum, and maximum values are summarized in Table 1. The daily average water levels in the Upper Campbell Reservoir, Lower Campbell Reservoir, and Brewster Lake are shown in Figure 3, Figure 4, and Figure 5 respectively; and are summarized in Table 2.

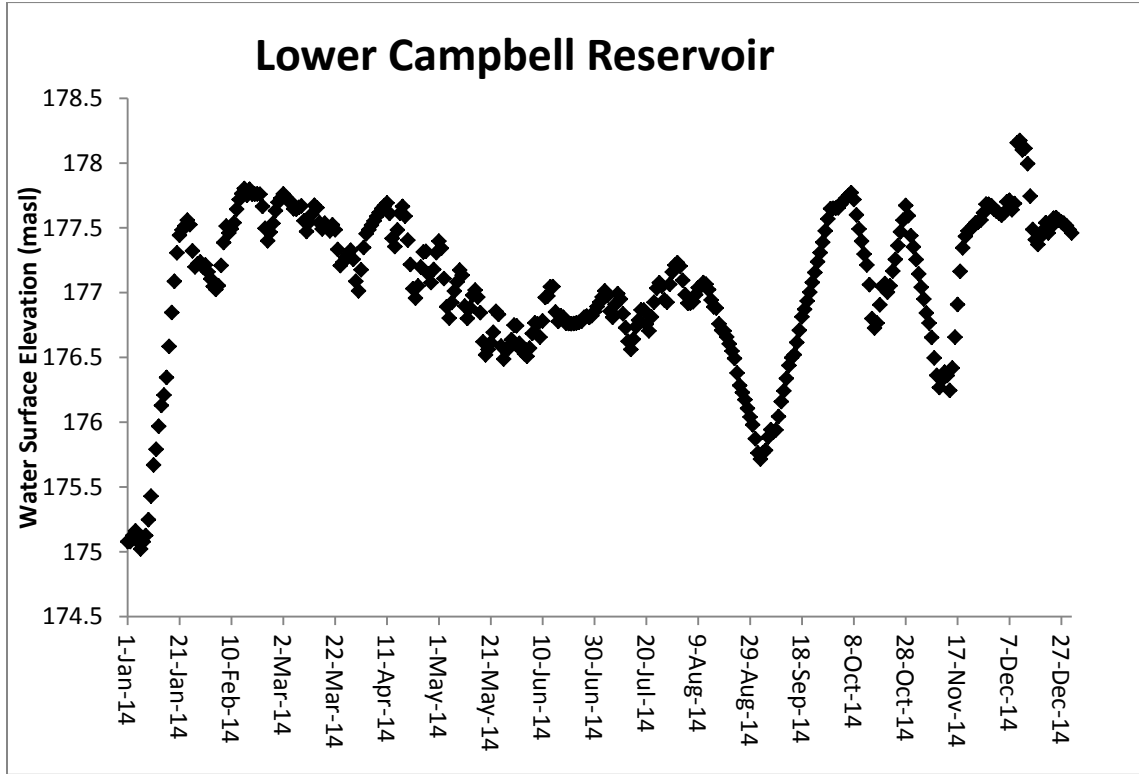
Figure 4. Daily average water surface elevations in the Lower Campbell Reservoir, August 10 to December 31, 2014.

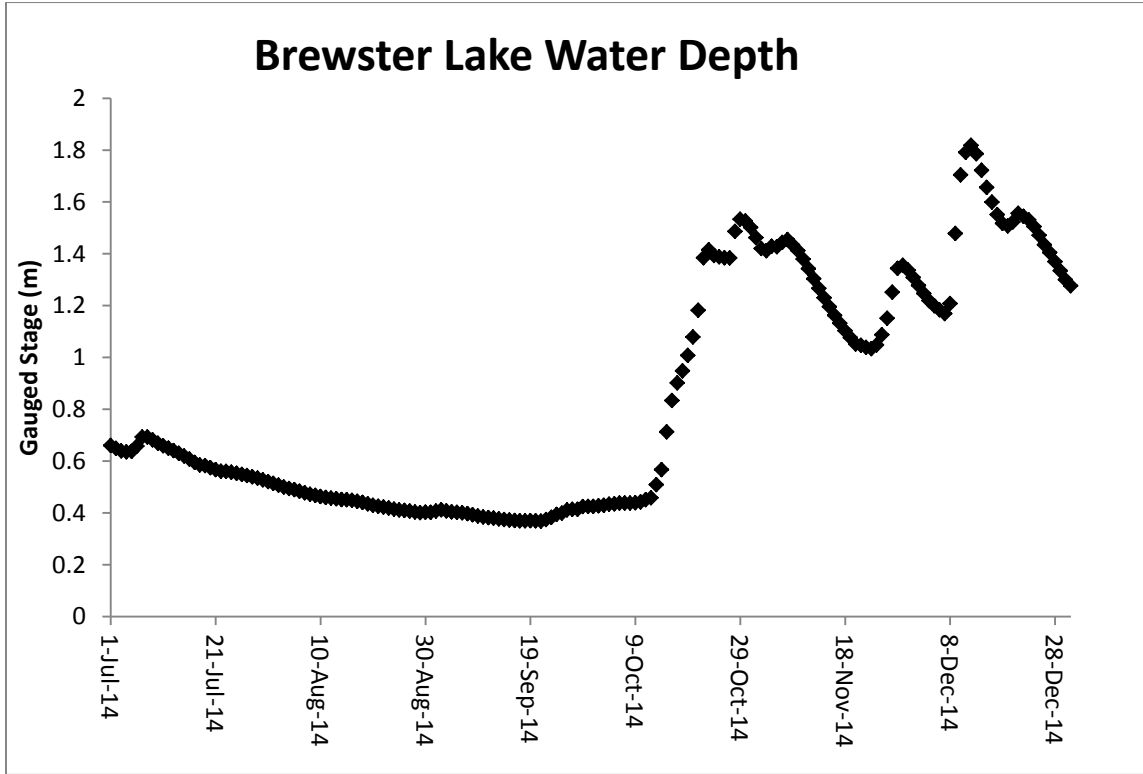
Figure 5. Daily average water surface levels at the Brewster Gauge Station in Brewster Lake, July 1 – December 31, 2014.
