Campbell River Project Water Use Plan

JHTMON-6 Campbell Watershed Riverine Fish Production

JHTMON-6: Campbell Watershed Riverine Fish Production Assessment – Component 2 Fish Passage Study

Year 2 (2016) Annual Report

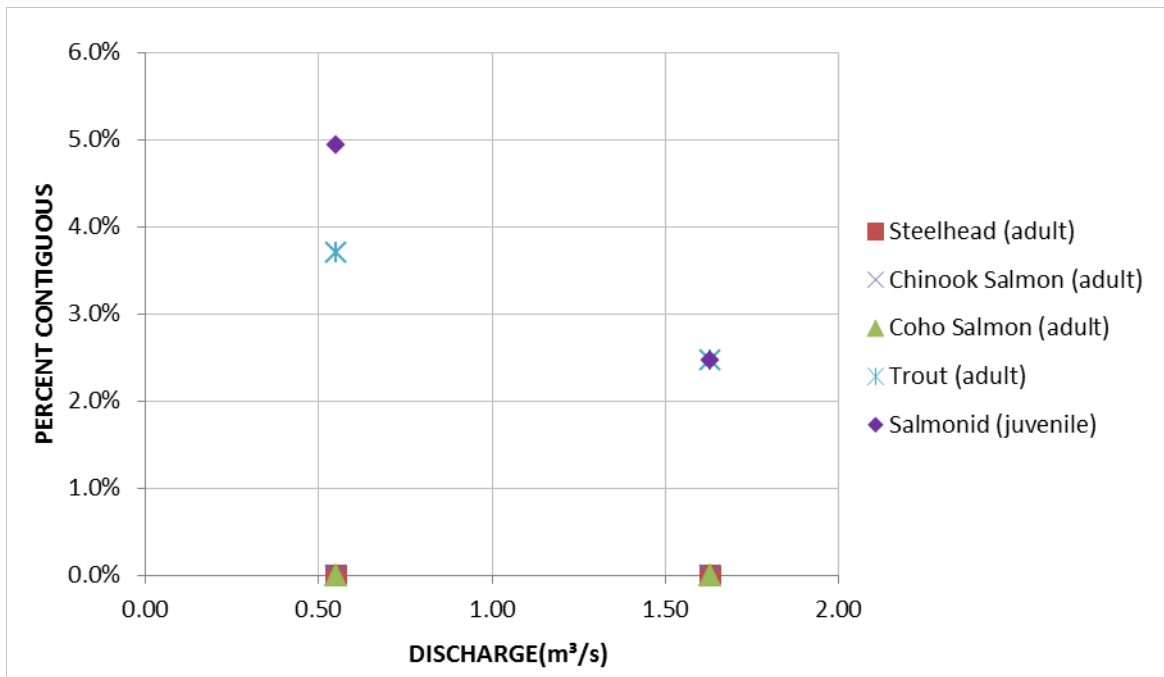
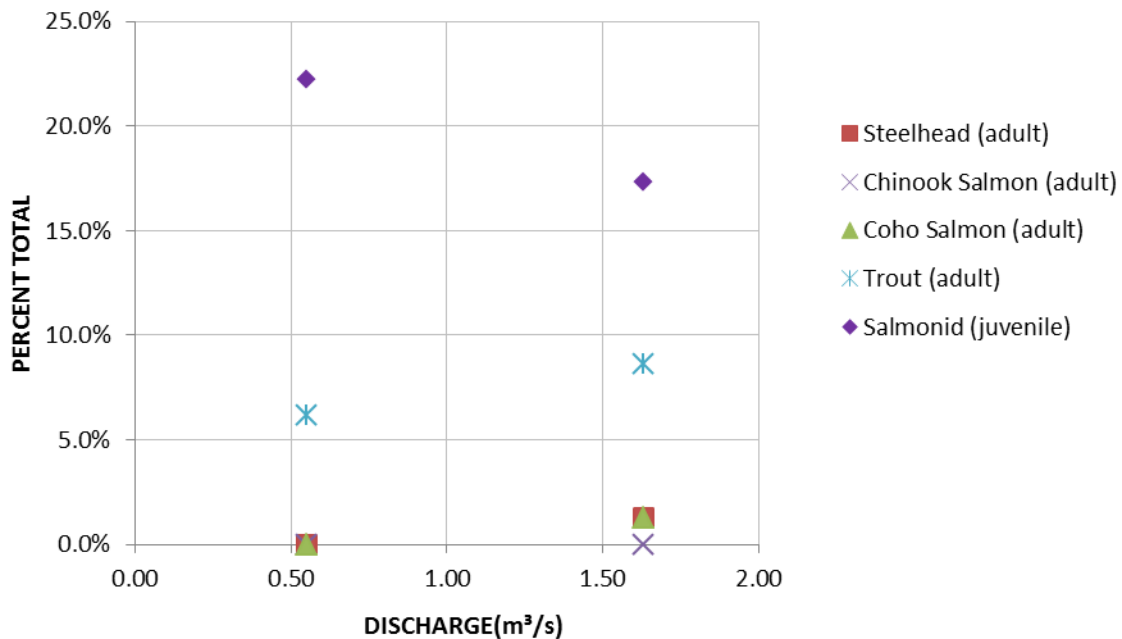
Figure 4. Percentage of a) contiguous passable transect length and b) of total passable transect length at SAM-BAR05 during Surveys 1 and 2.

Discharge was plotted against the percent contiguous and percent total passable transect lengths for adult Steelhead, adult Coho Salmon, adult Chinook Salmon, adult trout, and juvenile salmonids for SAM-BAR05 (Figure 4). SAM-BAR05 was found not passable for any of the species assessed, under the percent contiguous or total criteria at the flows observed in Surveys 1 and 2. Although this relationship was not presented for SAM-BAR07 or SAM-BAR11, these barriers were also demonstrated to be not passable under the percent contiguous or total criteria at the flows observed in Surveys 1 and 2.

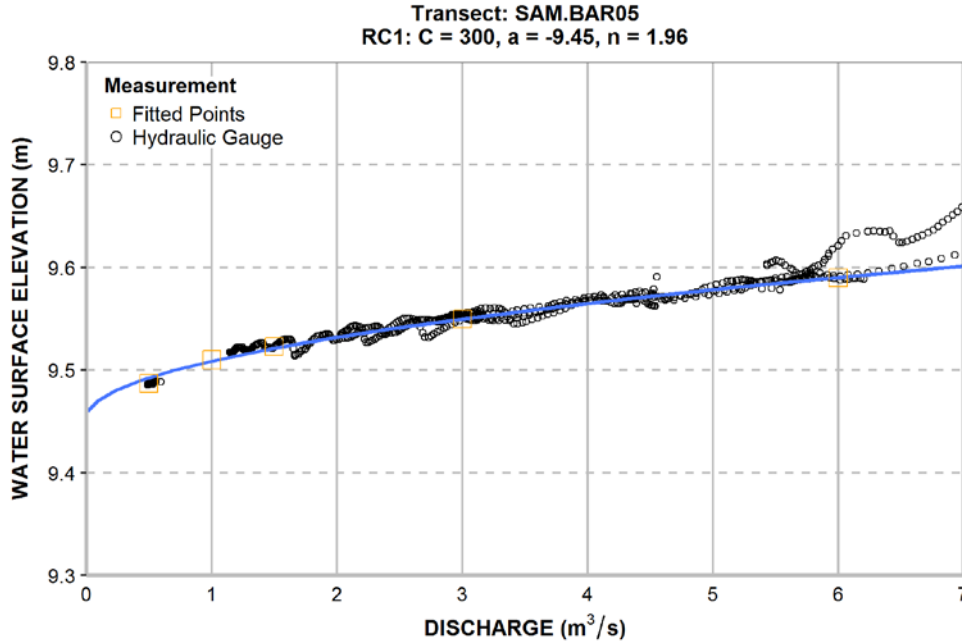
Figure 6. Stage-Discharge relationships measured at riffle barriers on the Salmon River (a) SAM-BAR05, (b) SAM-BAR07, and (c) SAM-BAR11.

Between August 1 and October 31, 2016, flow at the WSC gauge 08HD032 ranged from approximately 0.51 m³/s to 107.53 m³/s (Figure 5). The stage-discharge relationships generated from stage data from each barrier site and discharge from WSC gauge 08HD032 are presented in Figure 6. Rating parameters and flow ranges for stage-discharge curves, which were obtained from the stage-discharge curves for each of the three barriers to describe each of the stage-discharge relationships are provided in Table 11.

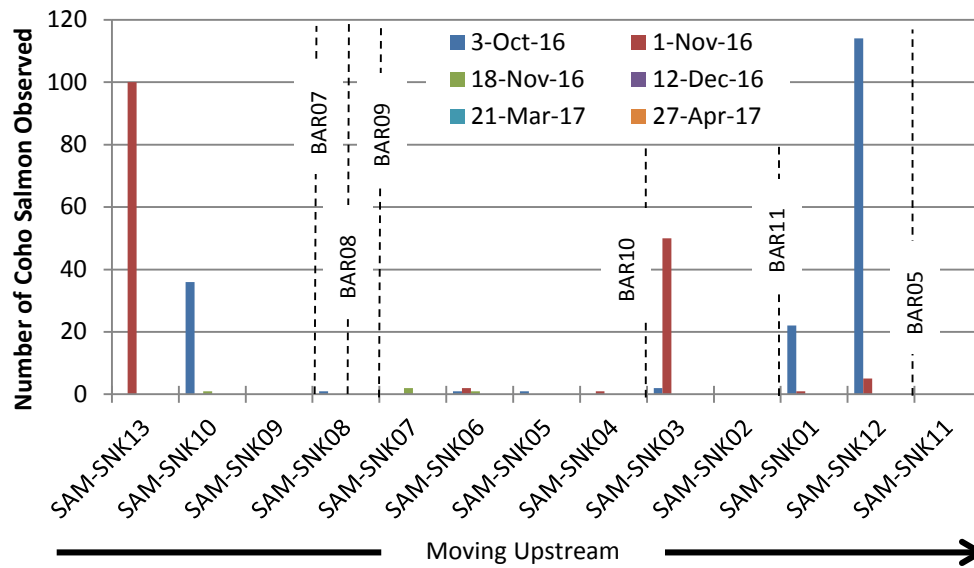
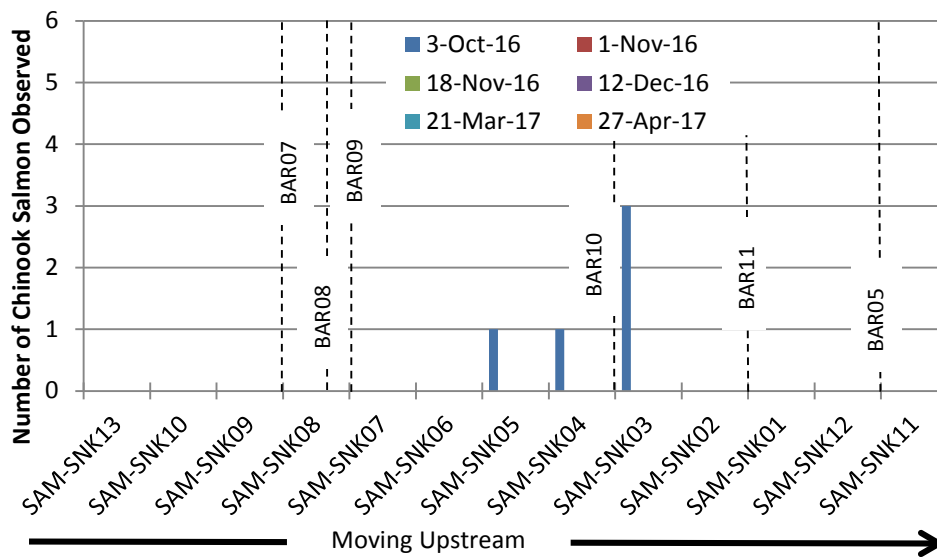
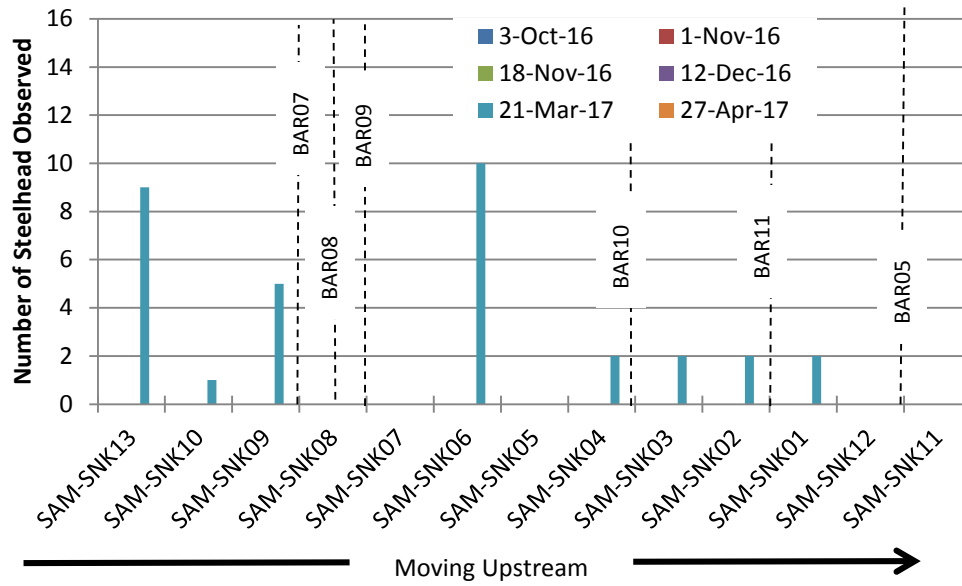
Figure 7. Observations within snorkel sites in relation to barriers for a) Coho Salmon, b) Chinook Salmon, and c) Steelhead. Representative barrier locations are presented with dashed lines, note that x-axis distances are not to scale.

In total, 340 Coho and five Chinook Salmon were observed during snorkel surveys (Figure 7). Coho Salmon were observed during surveys conducted in October and November while Chinook Salmon were only observed during the survey conducted on October 3, 2016. Coho Salmon were observed upstream of all barriers except for SAM-BAR05, while Chinook were observed upstream of all barriers except for SAM-BAR11 and SAM-BAR05. Cumulative plots of Coho and Chinook Salmon at barriers SAM-BAR05, SAM-BAR11, and SAM-BAR07 are provided in Figure 8 and Figure 9, respectively.

In total, 33 Steelhead were observed during snorkel surveys (Figure 7), all on March 21, 2017. Steelhead were found throughout the river and were observed upstream of all barriers except for SAM-BAR05. Cumulative plots of Steelhead at barriers SAM-BAR05, SAM-BAR11, and SAM-BAR07 are provided in Figure 10.

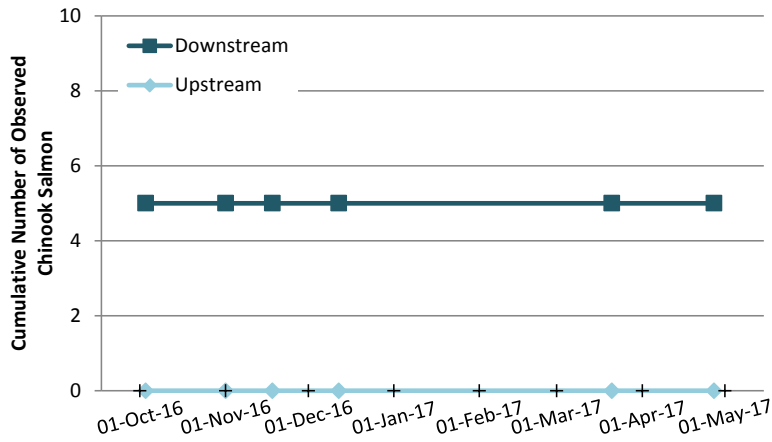
Figure 9. Cumulative plots for Chinook Salmon displaying fish observed upstream and downstream of a) SAM-BAR05, b) SAM-BAR11, and c) SAM-BAR07.

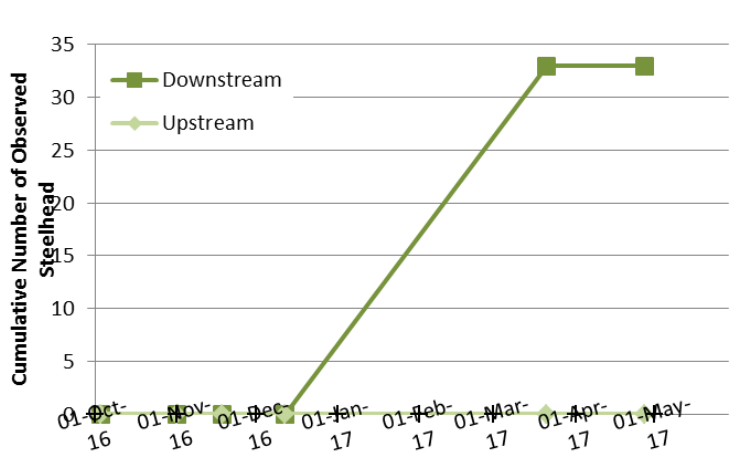
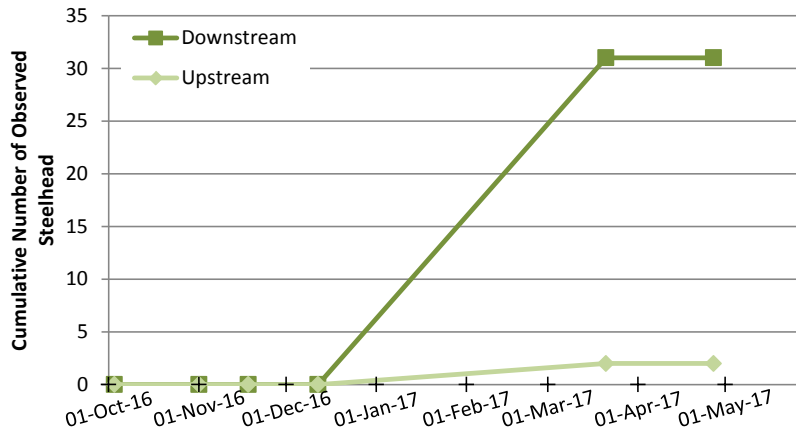
Figure 10. Cumulative plots for Steelhead observed upstream and downstream of a) SAM-BAR05, b) SAM-BAR11, and c) SAM-BAR17.
