Campbell River Project Water Use Plan

Campbell Watershed Riverine Fish Production Assessment

Component 2 Fish Passage Study Final Program

Final Program Summary Report

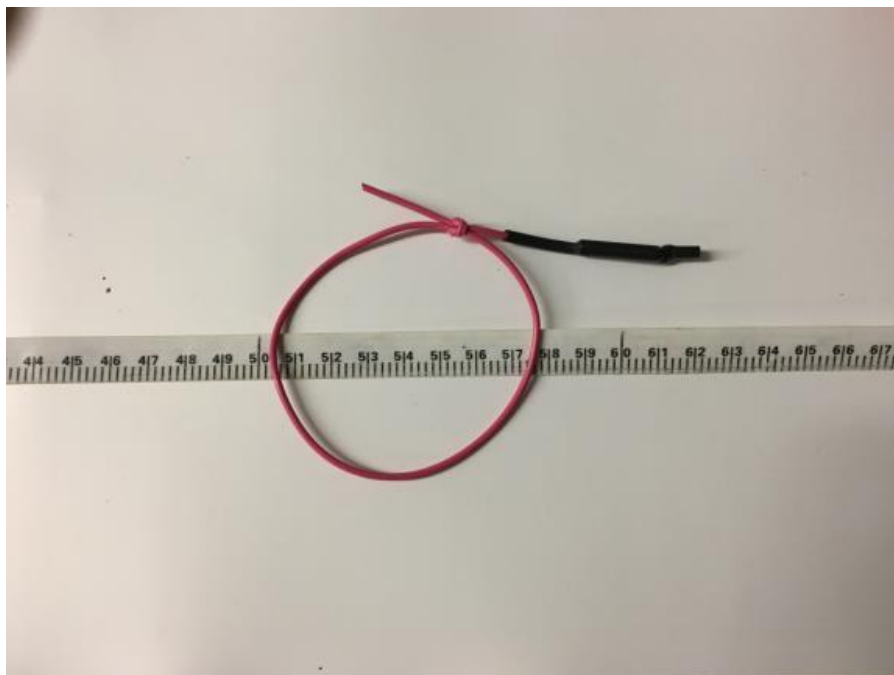
Figure 3. Example PIT tag assembly shown on a transect tape for scale (cm). Assembly is composed of a 23 mm HDX PIT tag shrink wrapped to a 30 cm piece of bright pink Floy FT-4 spaghetti tag with a wire core, then knotted to form a closed loop.

The PIT tagging method was adopted from FLNRO and BCCF protocols for Steelhead and Coho Salmon. The method offers efficient tagging, high tag retention, and good external visibility (McCulloch pers. comm. 2016). The tags were premade by attaching a 23 mm HDX PIT tag to a 30 cm piece of Floy FT-4 spaghetti tag. In Years 3 and 4, a 0.03 inch diameter welding wire core was inserted inside each spaghetti tag. The wire core minimized tag loss by increasing the strength of the tags and reducing knot failure. The spaghetti tags were inserted through the base of the dorsal fin of captured fish using a stainless steel needle, and were then knotted to form a closed loop (Figure 3 and Figure 4).

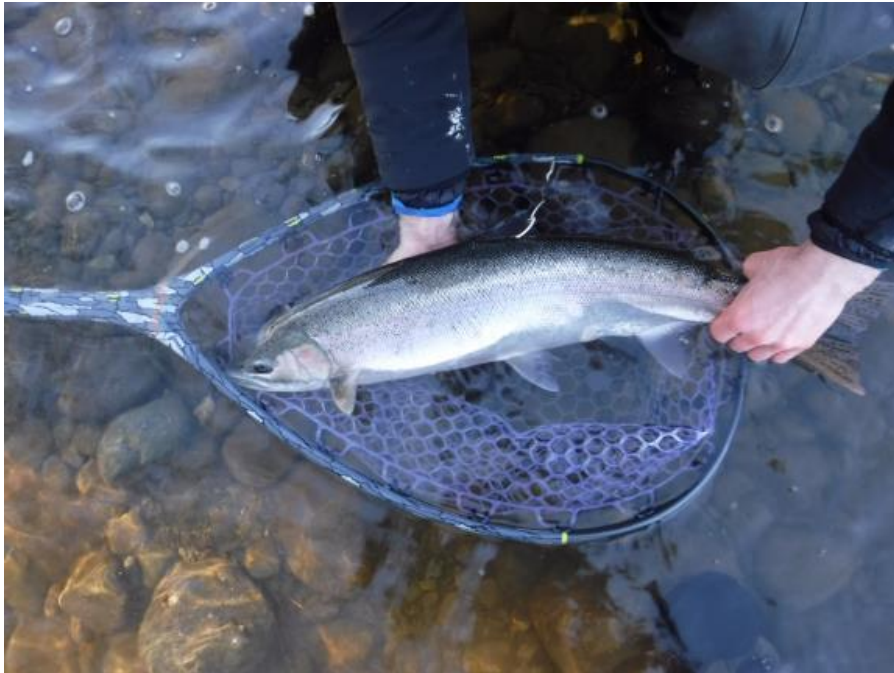
Figure 4. PIT tagged (white) adult Steelhead caught on December 23, 2017. Field staff is preparing to release the fish.

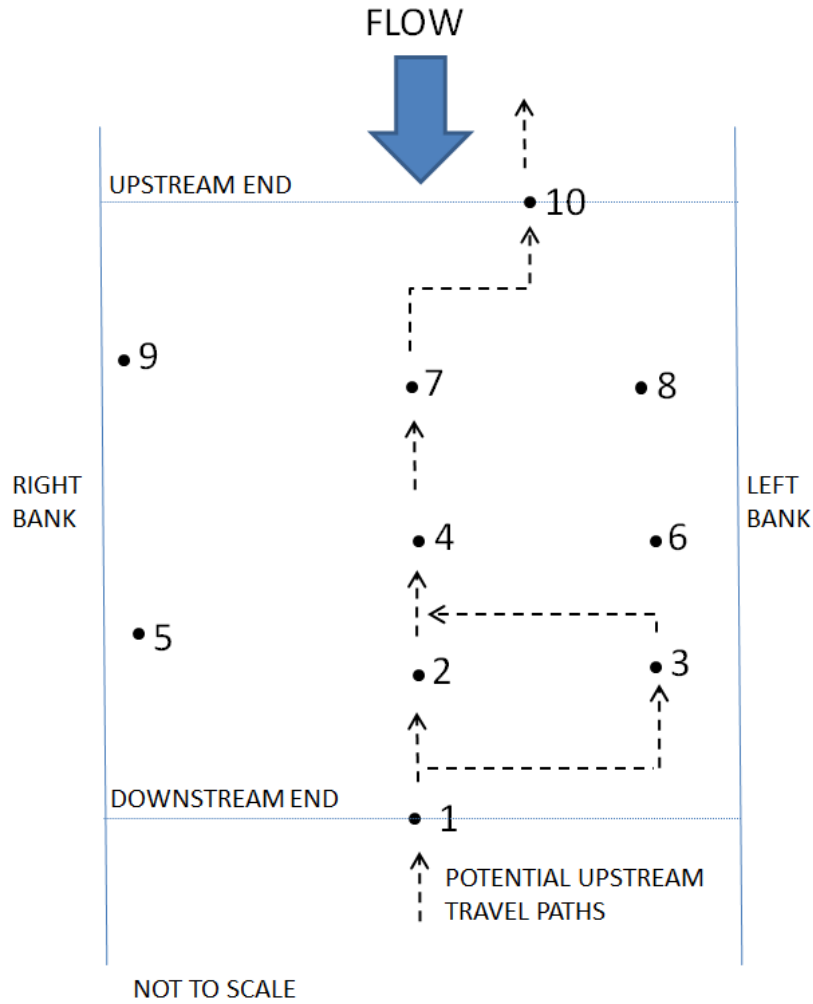
Figure 5. Plan view schematic of QUN-BAR01 and the respective potential passage routes for upstream migrating fish.

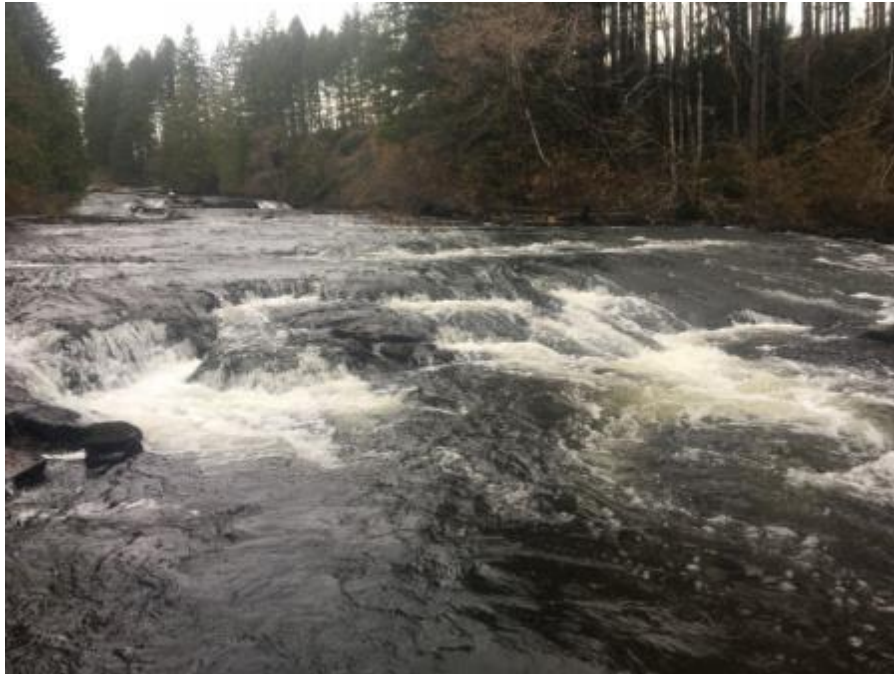
The first potential passage route was a wide chute, spanning the river channel, at the downstream end of QUN-BAR01 (Figure 6). At a flow of 1.66 m³/s, the route was 4 m long, with a gradient of 6% (Table 8). This route was considered passable at flows of 2.36 m³/s and above, but not passable at flows 1.66 m³/s and less.

Figure 6. Looking upstream at QUN-BAR01 passage Route 1, a wide chute spanning the river channel, assessed on November 8, 2017.

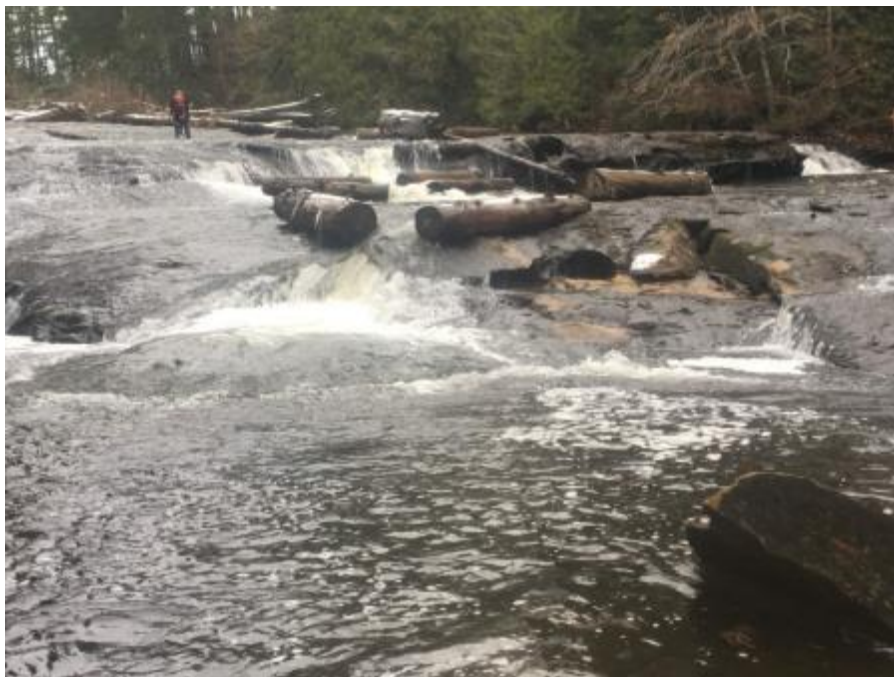
The second potential passage route was within a falls section of the barrier where a man-made slotted fish ladder was situated in the center of the channel at the lower end of QUN-BAR01, downstream of Route 4 (Figure 7). The ladder was constructed of large logs, fastened to the river bed, that funnel flow through a single pool. At a flow of $1.66 \text{ m}^3/\text{s}$, the route had a 1.2 m high drop and a depth of 0.14 m at the crest (Table 8). This route was considered passable at flows of 0.99, 2.36 and $2.64 \text{ m}^3/\text{s}$, and not passable at a flow of $1.66 \text{ m}^3/\text{s}$. At higher flows, it was anticipated this route will be used, as well as Route 3, to pass the downstream part of the barrier.

Figure 7. Looking upstream at QUN-BAR01 passage Route 2, a falls on river left, assessed on November 8, 2017.

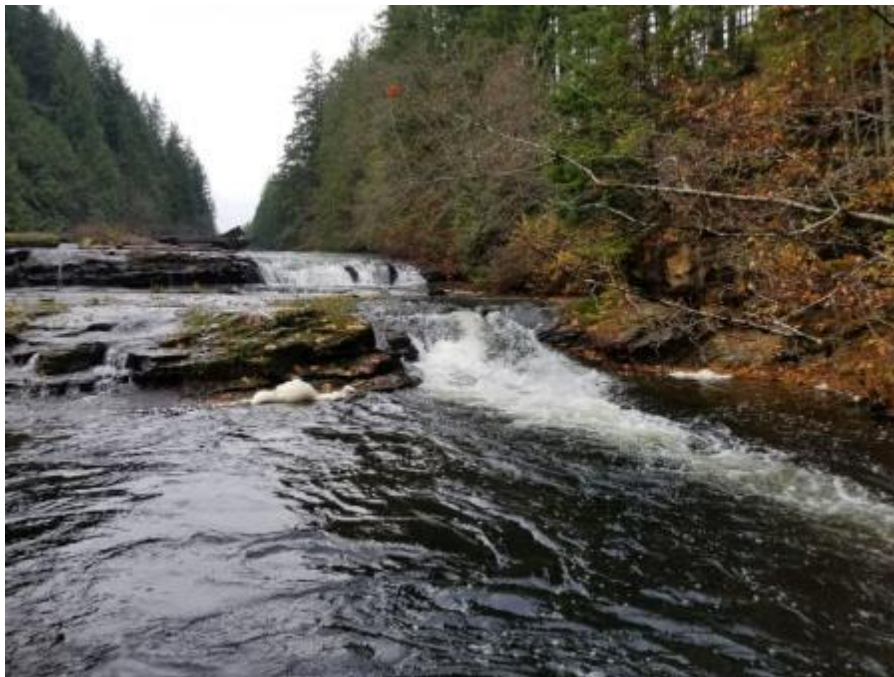
The third potential passage route was a chute situated along the river left of the channel at the lower end of QUN-BAR01, downstream of Route 6 (Figure 8). It appeared as though this chute may have been previously deepened to increase fish passage through it. At a flow of 1.66 m³/s, the route was 10.0 m long, with a gradient of 16% (Table 8). This route was considered passable at flows of 1.66 and 2.64 m³/s and not a passable at flows of 0.99 and 2.36 m³/s. The variance in passability between 1.66 and 2.36 m³/s may be the result of the barrier measurements collected at slightly different positions along the route. However, it was anticipated that this route was passable above 2.64 m³/s. This route and Route 2 were likely the two passage route options for the downstream end of the barrier.

Figure 8. Looking upstream at QUN-BAR01 passage Route 3, a chute on river left, assessed on November 8, 2017.

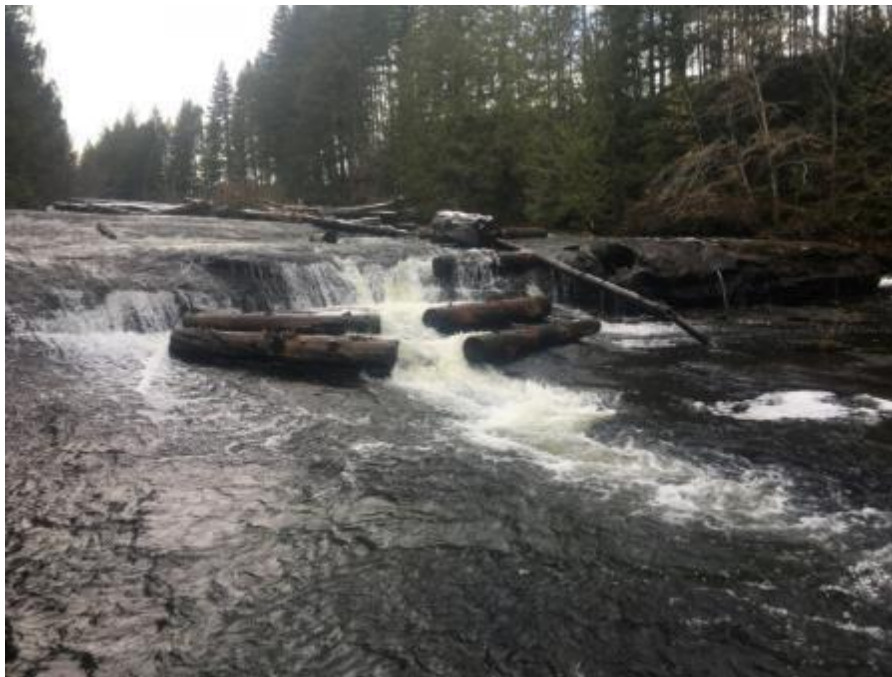
The fourth potential passage route was located in the middle of QUN-BAR01 within a section of chute where there was another man-made slotted fish ladder situated in the center of the channel (Figure 9). The ladder was constructed of large logs, fastened to the river bed, that funnel flow through a series of two pools. At a flow of 1.66 m³/s, the route was 9.0 m long, with a gradient of 20% (Table 8). This route was considered not passable at a flow of 1.66 m³/s, and passable at flows of 0.99, 2.36, and 2.64 m³/s. This route was likely the main passage route past the barrier's middle section at higher flows. Fish were expected to swim through Route 4 and travel upstream to Route 7.

Figure 9. Looking upstream at QUN-BAR01 passage Route 4, assessed on November 8, 2017, which contains a man-made slotted fish ladder in the centre of the channel.

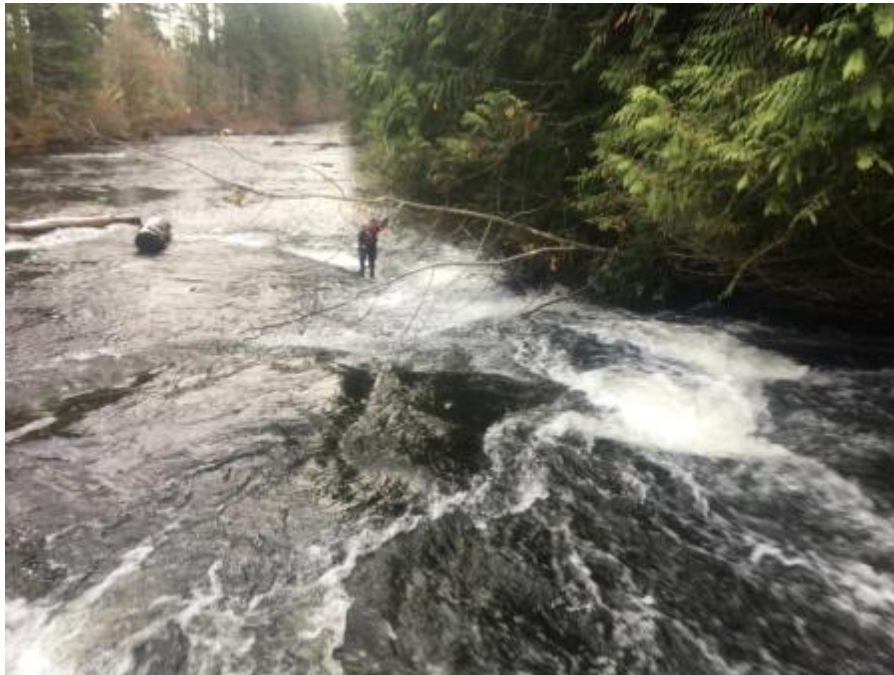
The fifth potential passage route was a natural bedrock chute situated along the river right of the channel in the middle of QUN-BAR01 (Figure 10). At a flow of 1.66 m³/s, this route was 20.2 m long, with a gradient of 18% (Table 8). This route was considered not passable at any of the flows observed. This was not likely a limiting barrier because fish would likely travel up Route 4 on their way to Route 7 at the upper end of the barrier.

Figure 10. Looking downstream at QUN-BAR01 passage Route 5, natural bedrock chute on river right, assessed on November 8, 2017.

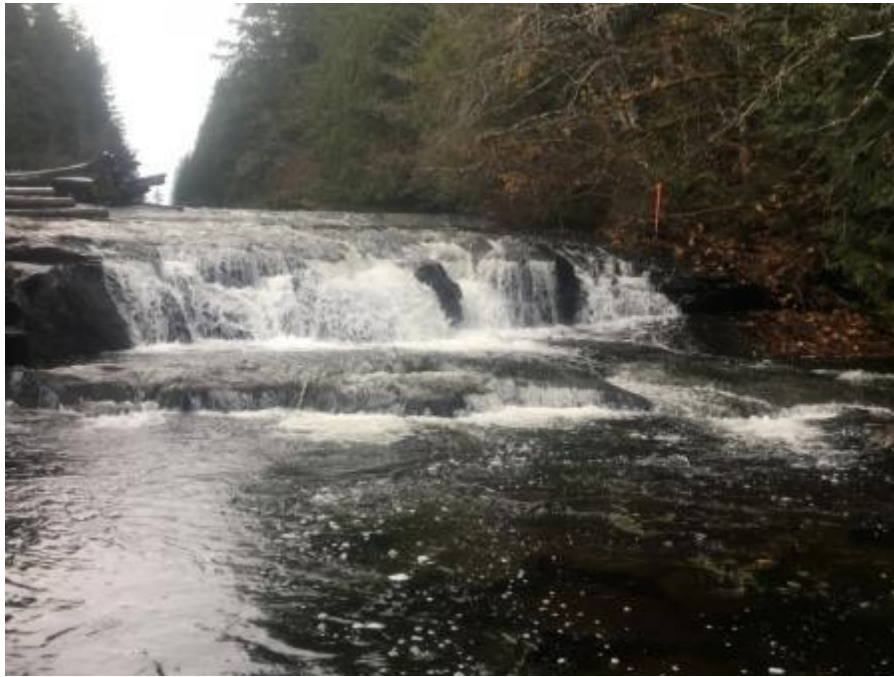
The sixth potential passage route was a natural falls situated along the river left of the channel in the middle of QUN-BAR01, adjacent to Route 4 (Figure 11). At a flow of 1.66 m³/s, the route had a 1.6 m high drop and a depth of 0.05 m at the crest (Table 8). This route was considered not passable under all of the observed flow conditions but was not likely a limiting barrier because fish would likely travel up Route 4 on their way to Route 7 at the upper end of the barrier at higher flows.

Figure 11. Looking upstream at QUN-BAR01 passage Route 6, a natural falls on river left, assessed on November 8, 2017.

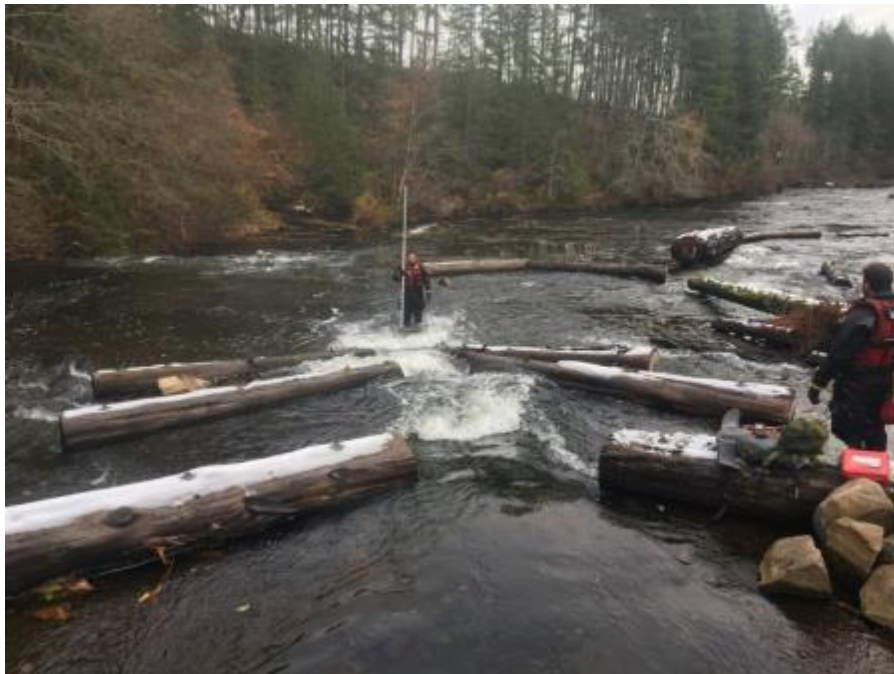
The seventh potential passage route was within a chute section of the barrier where a man-made slotted fish ladder was situated in the center of the channel at the upper end of QUN-BAR01 (Figure 12). The ladder was constructed of large logs, fastened to the river bed that funnels flow through a series of three pools. At a flow of $1.66 \text{ m}^3/\text{s}$, this route was 10.4 m long, with a gradient of 14% (Table 8). The route was considered not passable under flows of 0.99, 1.66, and $2.36 \text{ m}^3/\text{s}$, and passable at $2.64 \text{ m}^3/\text{s}$. This was likely the main passage route past the barrier's upper section at higher flows.

Figure 12. Looking downstream at QUN-BAR01 passage Route 7, assessed on November 7, 2017, which contains a man-made slotted fish ladder in the centre of the channel.

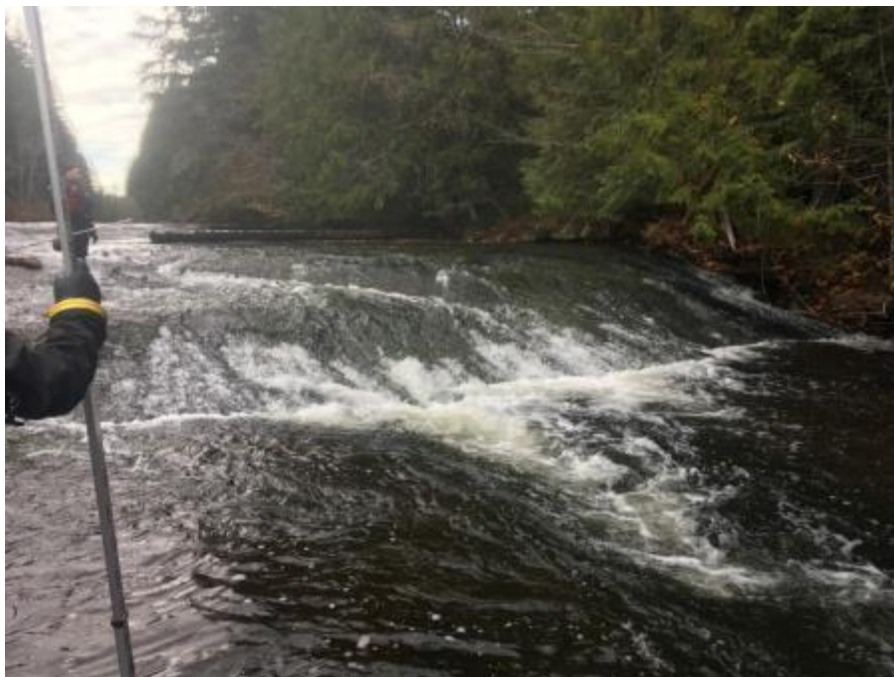
The eighth potential passage route was a natural bedrock chute situated along the river left of the channel at the upper end of QUN-BAR01 adjacent to Route 1 (Figure 13). At a flow of 1.66 m³/s, the route was 7.50 m long, with a gradient of 15% (Table 8). The route was considered not passable under all of the observed flow conditions and based on the relatively lower depth, it was considered less passable than Route 7. Thus, this route was not likely to be a limiting barrier because fish would likely travel up Route 7 instead of Route 8 to get past the upper section of the barrier (Figure 14) at higher flows.

Figure 13. Looking upstream at QUN-BAR01 passage Route 8, assessed on November 7, 2017, which is a natural bedrock chute on river left.

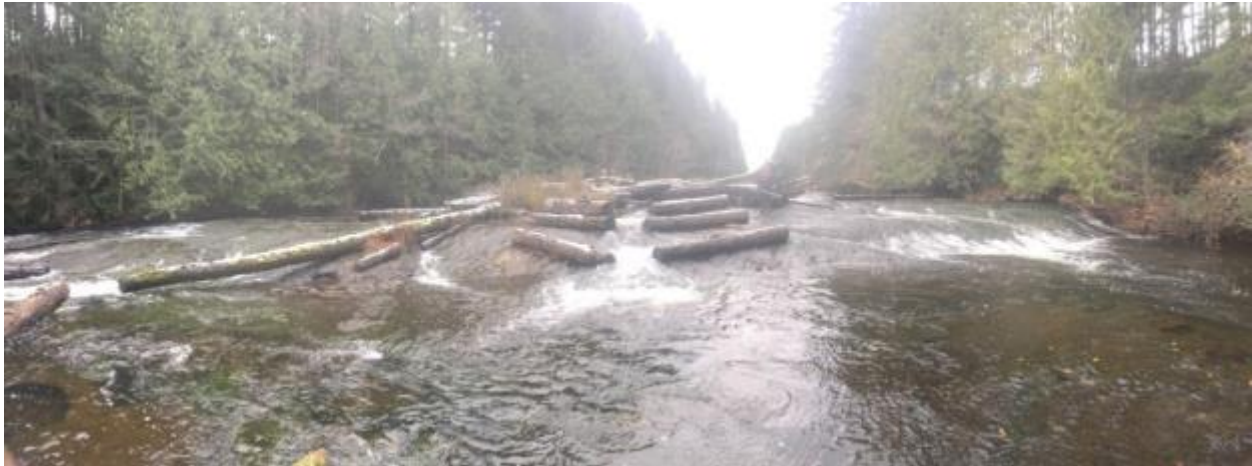
Figure 14. Looking upstream at QUN-BAR01 passage Route 7 (centre of channel), Route 8 (on river left), and Route 9 (on river right), on November 7, 2017.

The ninth potential passage route was a natural bedrock chute situated along river right of the channel at the upper end of QUN-BAR01 (Figure 15). At a flow of 1.66 m³/s, the route was 3.6 m long, with a gradient of 15% (Table 8). This route was considered not passable under all of the observed flow conditions. This was not likely a limiting barrier because fish would likely travel up Route 7 instead of Route 9 to get past the upper section of the barrier (Figure 14) because Route 7 had a greater flow depth than Route 9.

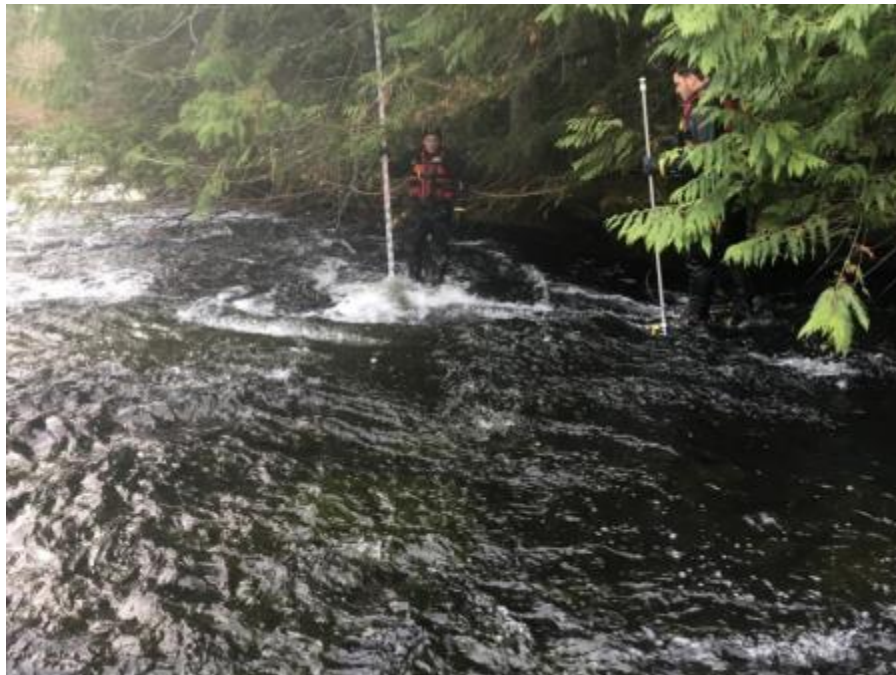
Figure 15. Looking downstream at QUN-BAR01 passage Route 9, a natural bedrock chute on river right, assessed on November 7, 2017.

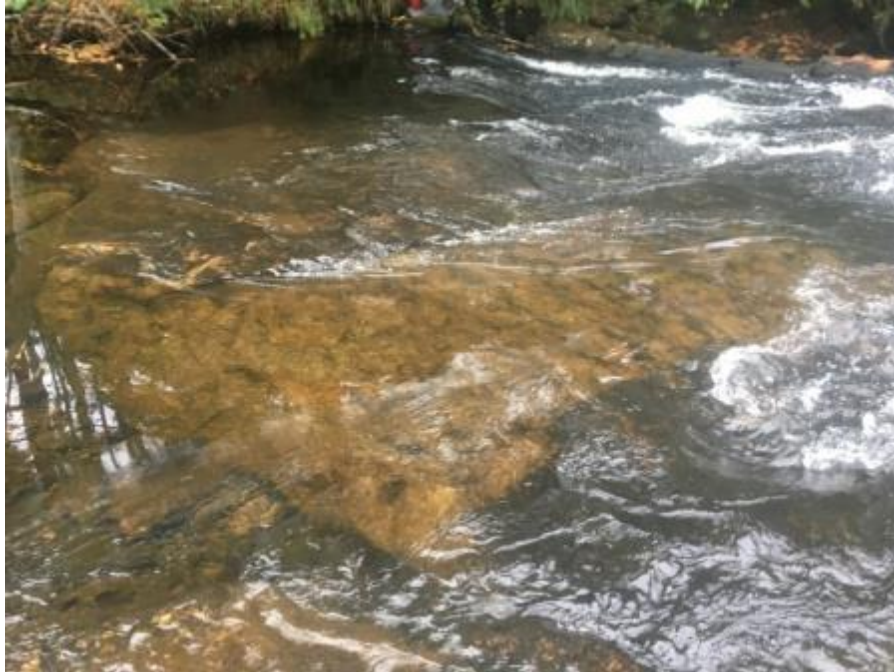
The tenth potential passage route was the upstream crest of QUN-BAR01. A portion of the crest along the river left bank has been previously deepened by rock removal (Figure 16). At a flow of 1.66 m³/s, the route is 25 m long, with a gradient of 8% (Table 8). This route was considered passable at flows of 1.66 m³/s and above.

Figure 16. Looking river right to river left at QUN-BAR01 passage Route 10, a chute at the upstream crest of QUN-BAR01, assessed on November 8, 2017.

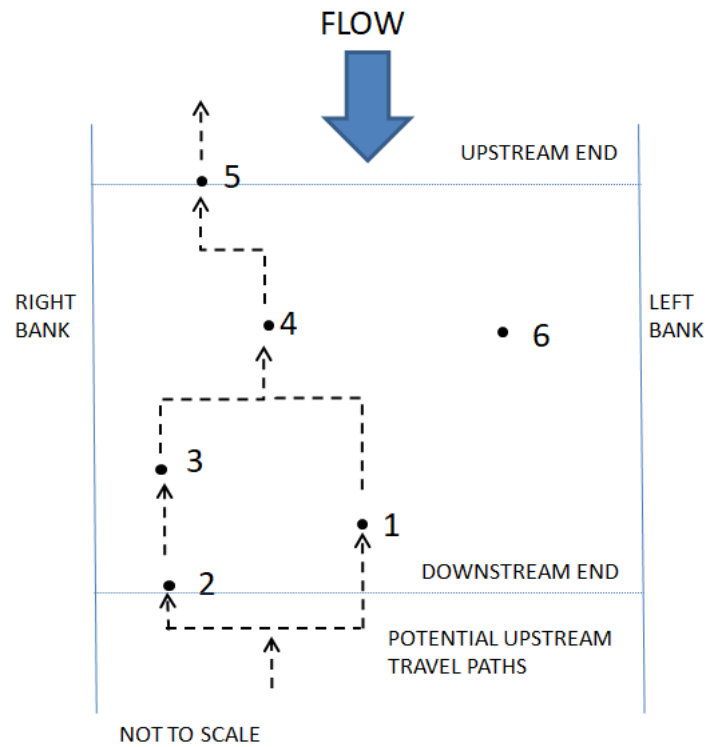
Figure 17. Plan view schematic of QUN-BAR05 and the respective potential passage routes for upstream migrating fish.

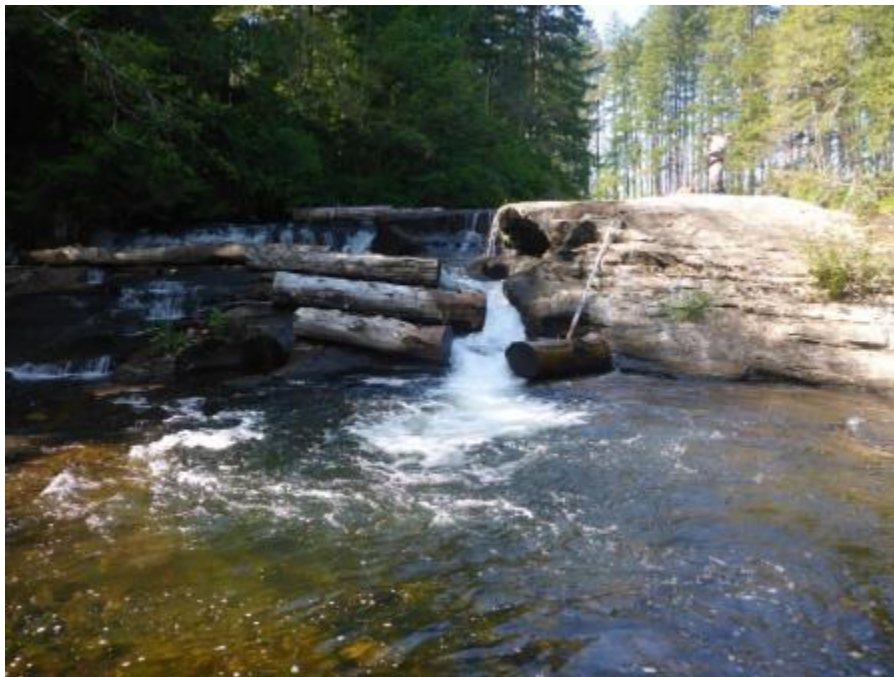
The first potential passage route was a chute with manmade passage augmentation, to the right of the channel's center, at the downstream end of QUN-BAR05 (Figure 18). At a flow of 1.02 m³/s, the route was 7.08 m long with a gradient of 23.7% (Table 9). This route was considered passable at a flow of 2.64 m³/s, but not passable at flows of 2.36 m³/s and less. One potential upstream path was for fish to swim through Route 1, then upstream to Routes 4 and 5 to pass the barrier (Figure 17).

Figure 18. Looking upstream at the river right portion of QUN-BAR05 on August 18, 2018. Route 1, a chute with manmade passage augmentation shown is in the foreground.

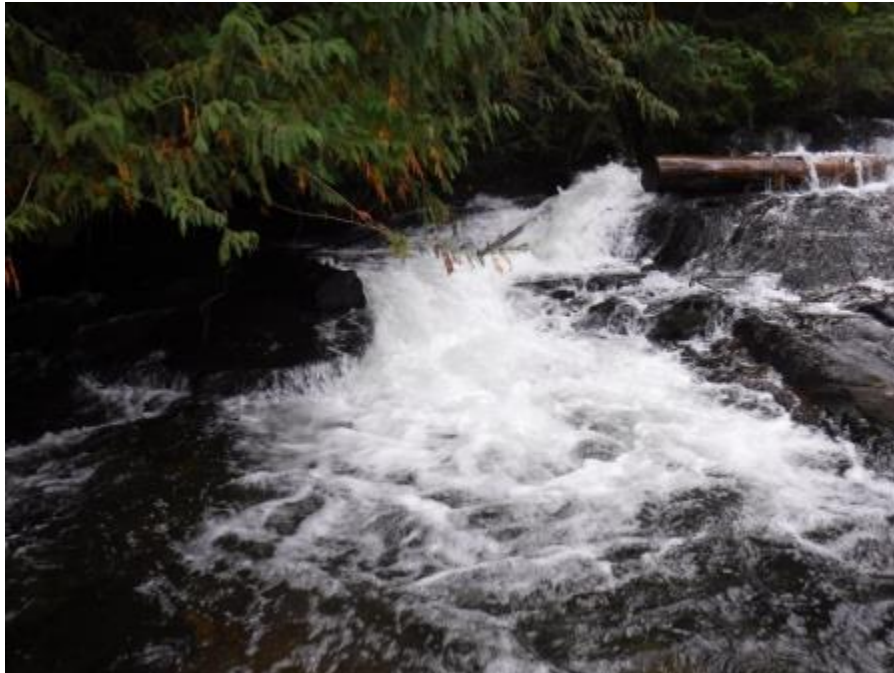
The second potential passage route was a falls, along the channel's river right, at the downstream end of QUN-BAR05 (Figure 19). At a flow of $1.02 \text{ m}^3/\text{s}$, the route had a 0.25 m high drop and a crest depth of 1.6 m (Table 9). This route was considered passable at all three flows surveyed. One potential upstream path was for fish to swim upstream through Routes 2, 3, 4 and 5 to pass the barrier (Figure 17).

Figure 19. Looking upstream at the river right bank of QUN-BAR05 on September 17, 2018. Route 2, a smaller falls seen is in the foreground; and Route 3, a larger falls seen is in the background.

The third potential passage route was a falls, along the channel's river right, at the lower end of QUN-BAR05 (Figure 19). At a flow of $1.02 \text{ m}^3/\text{s}$, the route had a 0.5 m high drop and a crest depth of 0.23 m (Table 9). This route was considered passable at flows of 2.36 and $2.64 \text{ m}^3/\text{s}$ and not passable at $1.02 \text{ m}^3/\text{s}$.

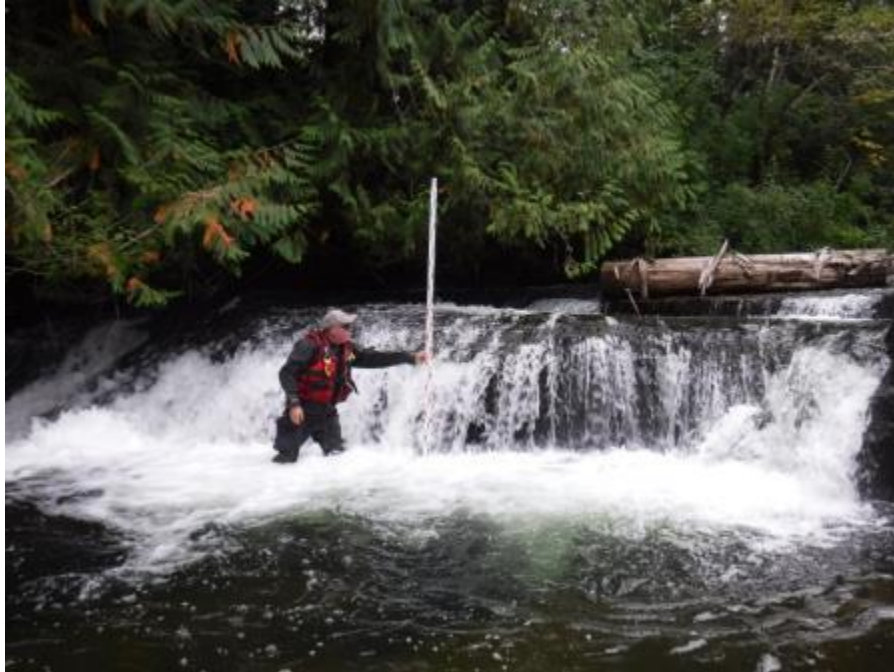
Figure 20. Looking upstream at the river right bank of QUN-BAR05 on September 17, 2018. Route 4, a large falls is shown.

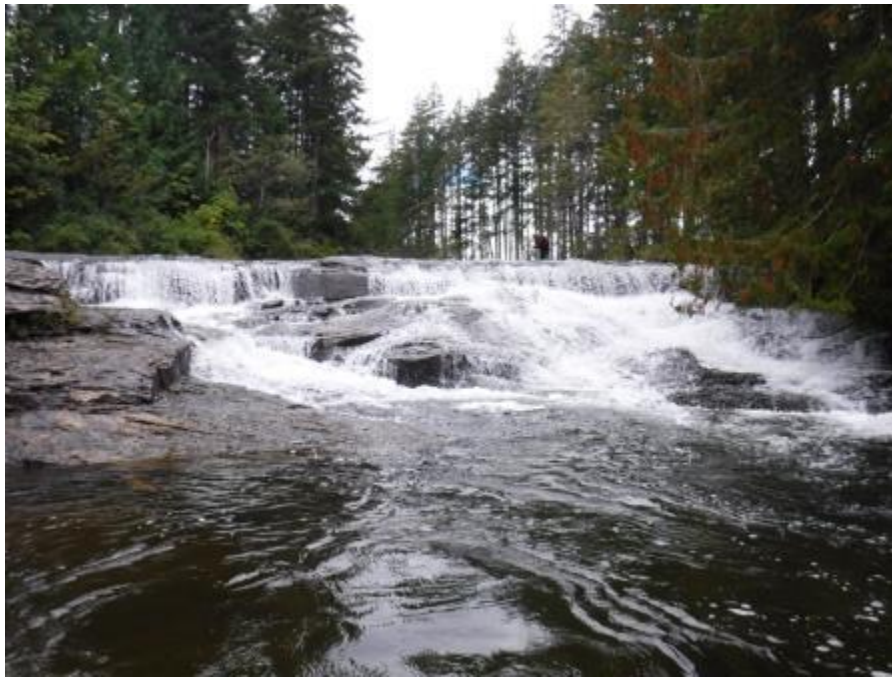
The sixth potential passage route was a large falls, spanning the river left portion of the channel at QUN-BAR05 (Figure 21). This route was not surveyed under any flow conditions as it was considered not passable and unlikely to be used for upstream migration.

Figure 21. Looking upstream at the river left portion of QUN-BAR05 on September 17, 2018. Route 6, a large falls is shown.

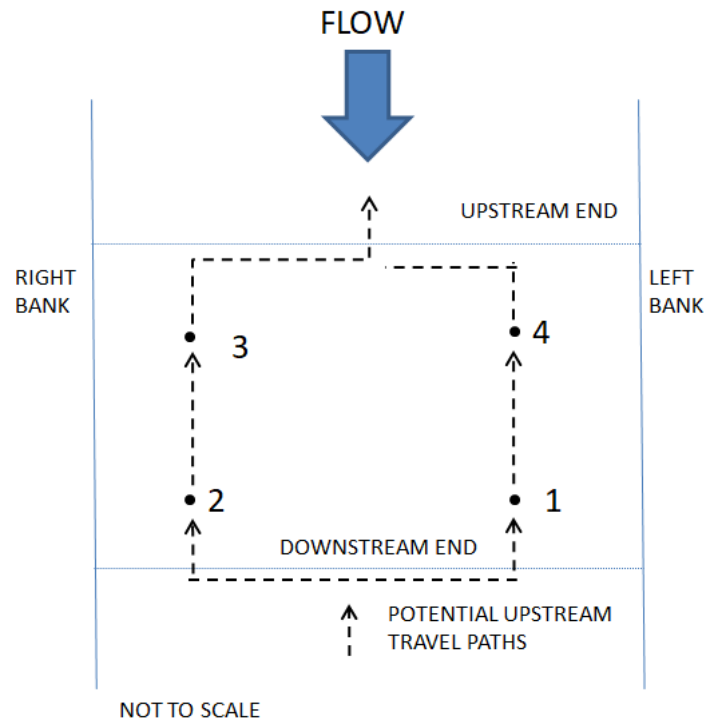
Figure 22. Plan view schematic of QUN-BAR07 and the respective potential passage routes for upstream migrating fish.

The three barrier assessment surveys at QUN-BAR07 were conducted at flows of 1.02, 2.36, and 2.6 m³/s (Table 10). During the initial barrier survey, a total of 4 potential passage routes were identified and assessed within QUN-BAR07, see Figure 22. The first survey also identified two potential upstream paths of travel for fish to swim past the overall barrier. Subsequent surveys assessed these two potential passage routes (Figure 22).

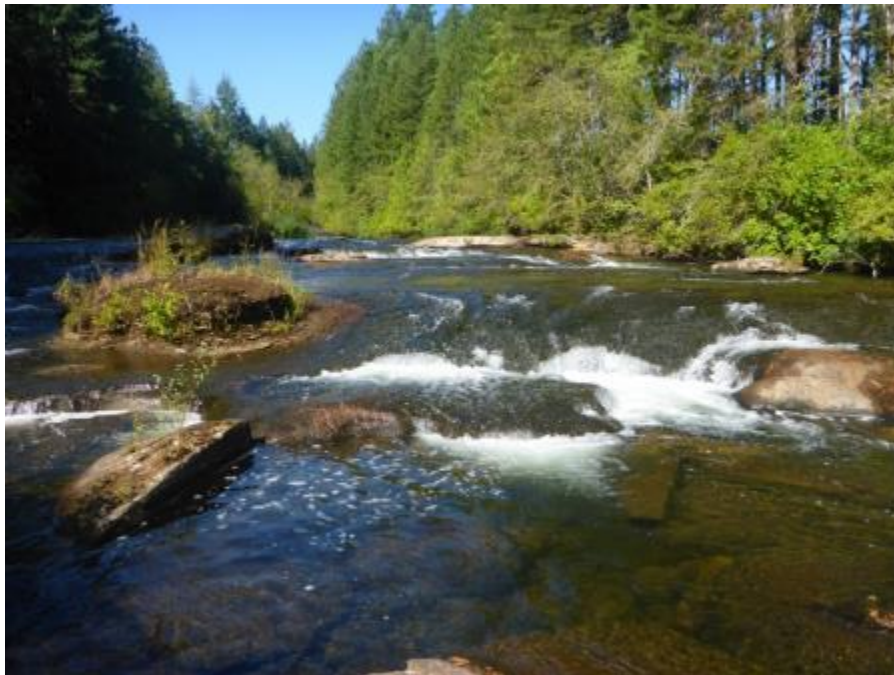
The first potential passage route was a chute, along the channel's river left, at the downstream end of QUN-BAR07 (Figure 23). At a flow of 1.02 m³/s, the route was 5.4 m long with a gradient of 7% (Table 10). This route was considered passable at a flow of 2.64 m³/s, but not passable at flows of 2.36 m³/s and less. One potential upstream path was for fish to swim through Route 1 and upstream to Route 4 to pass the barrier (Figure 22).

Figure 23. Looking upstream at the river left portion of QUN-BAR07 on August 18, 2018. Route 1, a chute is in the foreground; and Route 4, a chute is in the background.

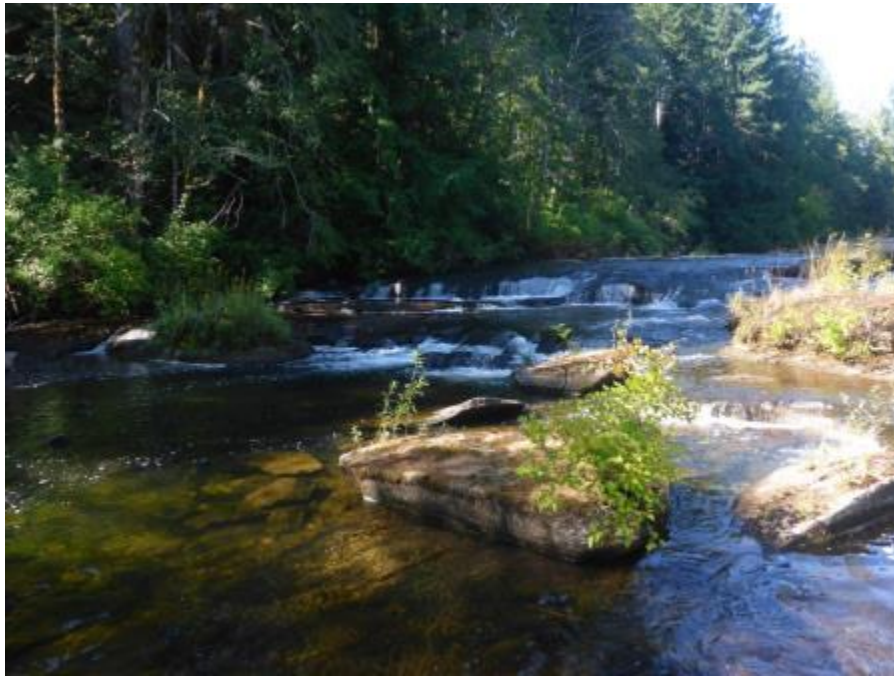
The second potential passage route was a falls, along the channel's river right, at the downstream end of QUN-BAR07 (Figure 24). At a flow of 1.02 m³/s, the route had a 0.25 m high drop and a crest depth of 1.6 m (Table 10). This route was considered passable at all three flows surveyed. One potential upstream path was for fish to swim through Route 2 and upstream to Route 3 to pass the barrier (Figure 22).

Figure 24. Looking upstream at the river right side of QUN-BAR07 on August 18, 2018. Route 2, a falls is in the foreground; and Route 3, a falls is in the background.

The third potential passage route was a falls, along the channel's river right, at the upstream end of QUN-BAR07 (Figure 24). At a flow of 1.02 m³/s, this route had a 0.77 m high drop and a crest depth of 0.09 m (Table 10). This route was considered not passable at all three flows surveyed. However, at higher flows fish would likely be able to swim through Routes 2 and 3 in sequence to pass the barrier.

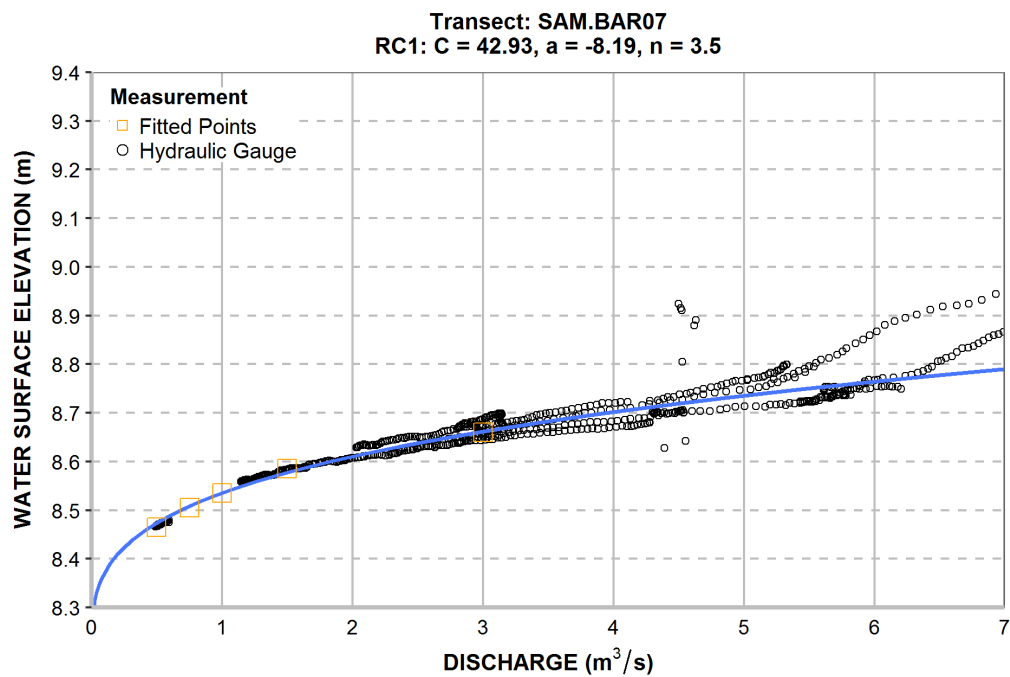
Figure 31. Stage-Discharge relationships measured at riffle barriers on the Salmon River
 (a) SAM-BAR05, (b) SAM-BAR07, and (c) SAM-BAR11.

Table 24. Rating parameters and flow ranges for stage-discharge curves at SAM-BAR05, SAM-BAR07, and SAM-BAR11 on the Salmon River.

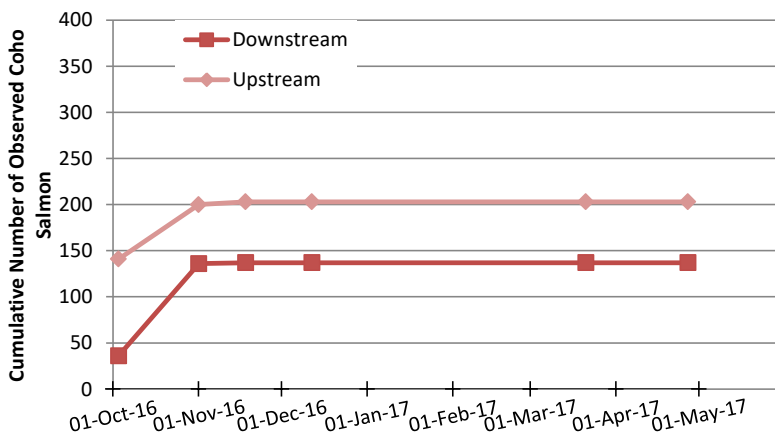
Figure 33. Cumulative plots for Coho Salmon displaying fish observed upstream and downstream of a) SAM-BAR05, b) SAM-BAR11, and c) SAM-BAR07.

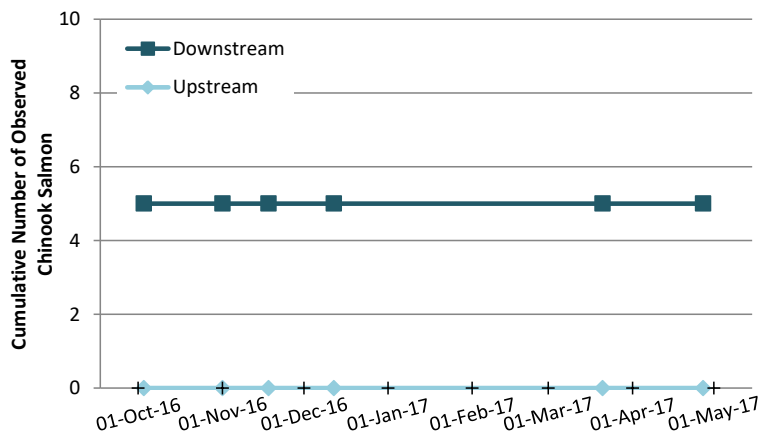
Figure 34. Cumulative plots for Chinook Salmon displaying fish observed upstream and downstream of a) SAM-BAR05, b) SAM-BAR11, and c) SAM-BAR07.
