RE: Project No. 3698623
British Columbia Utilities Commission (BCUC or Commission)
British Columbia Hydro and Power Authority (BC Hydro)
PUBLIC Ruskin Dam and Powerhouse Upgrade Project
Semi-Annual Progress Report No. 16 - October 2019 to March 2020 - Final
Completion Report (Report (Report))

Ruskin Dam and Powerhouse Upgrade Project

Final Completion Report

January 2020

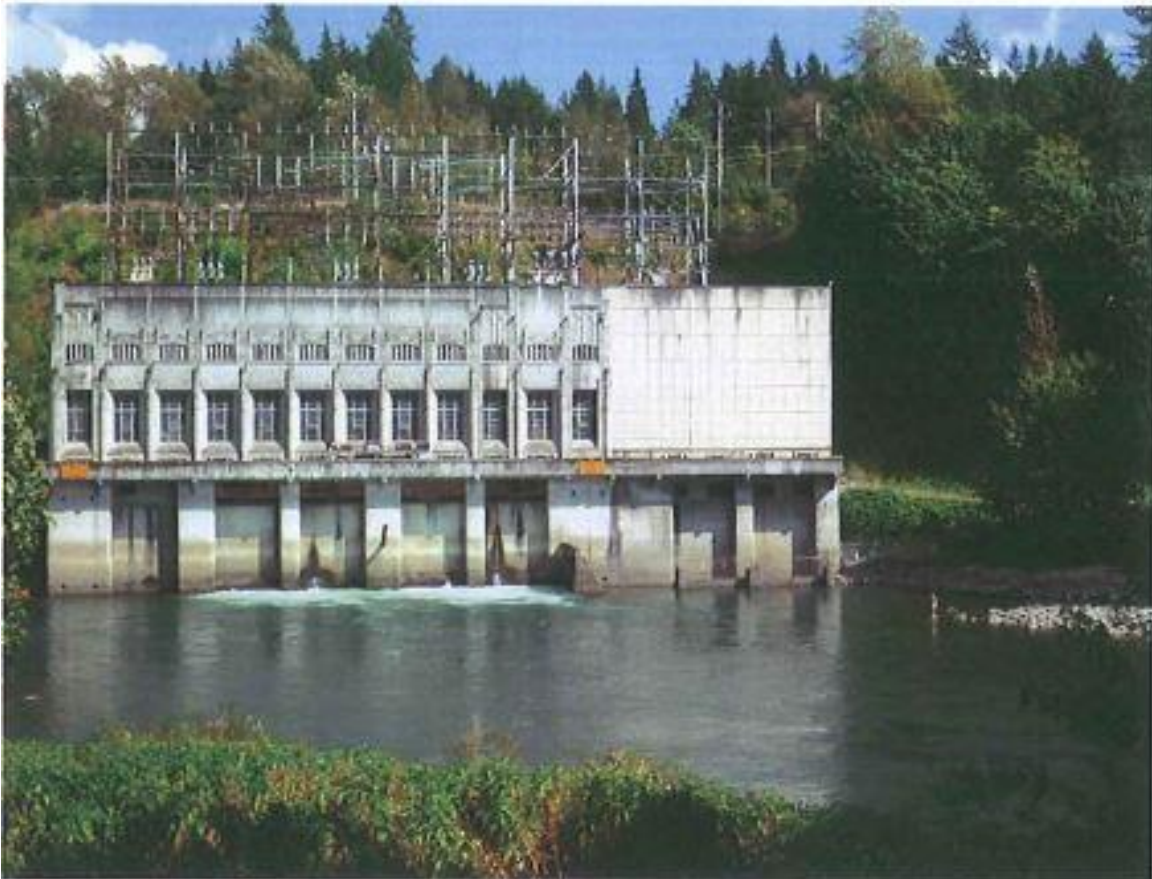
Figure 5 Powerhouse Roof Switchyard (Before)

The switchyard work consisted of upgrading and relocating the switchyard from the roof of the existing powerhouse (Worker Safety and Limits of Approach constraints) to a new location atop of the hill above the Left Abutment and Hayward Avenue.

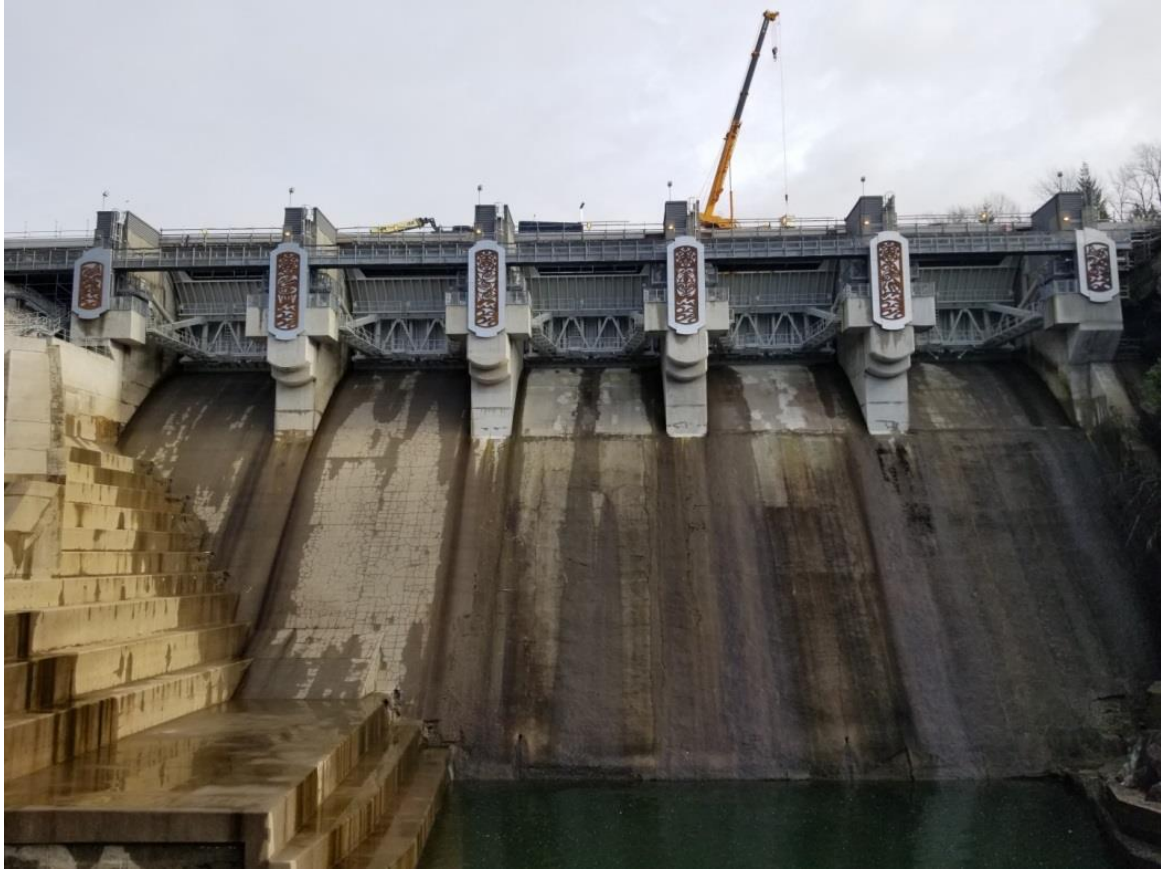
Figure 8 **Upper Dam with New Spillway Piers and Gates**

The dam work addressed seismic deficiencies in the upper dam, right abutment, and left abutment. This component of the Project included a new seepage cut-off wall, replacement of the spillway piers and spillway gates, installation of new unit intake gates, left bank slope re-grading, and replacement of the roadway crossing the top of the dam. The reliability of the Spillway Gate System was improved significantly by installing adequate redundancy in equipment and control systems.
