**RE: Project No. 1598907
British Columbia Utilities Commission (BCUC or Commission)
British Columbia Hydro and Power Authority (BC Hydro)
Salmon River Diversion Ceasing of Operations Project (Project)
Compliance with Commission Order No. G-96-17 Directive 3
PUBLIC Completion Report**

**Salmon River Diversion Ceasing of Operations
Project**

Project Completion and Evaluation Report

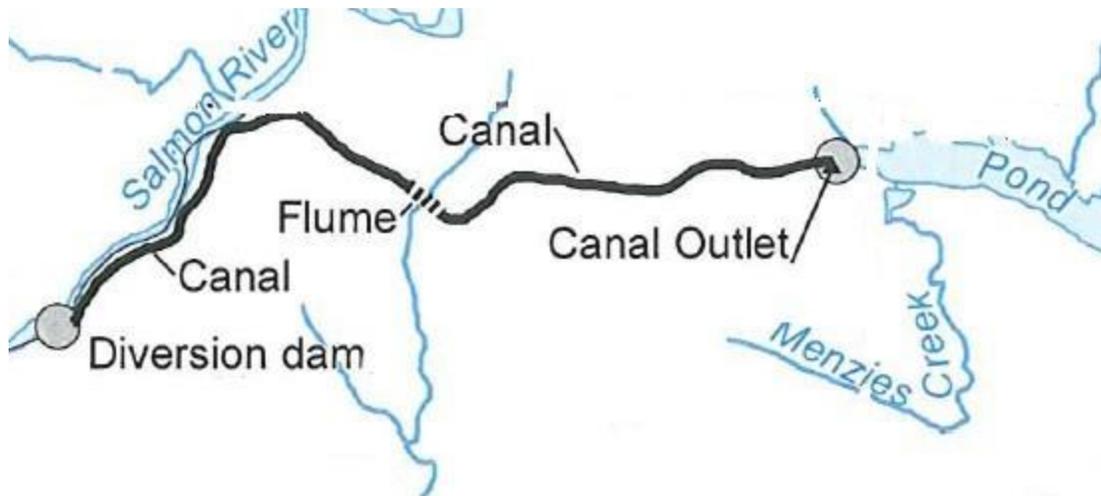
Figure 1 Map of Former Salmon River Diversion

The Salmon River Diversion (**Diversion**) was a run-of-river diversion facility located on eastern Vancouver Island about 30 km west of Campbell River, which diverted water from the Salmon River into the Lower Campbell Reservoir where it augmented water flows through the Ladore and John Hart Generating Stations. The diversion consisted of a rock-filled timber crib diversion dam (Dam) and canal between the Dam and Brewster Lake (**Canal**) built in 1957-1958. BC Hydro considered an investment to refurbish the Diversion, including improvements to fish passage, which would have allowed continuing operation, but determined in April 2016 that the economic case was marginal, and did not weigh favourably in comparison to ceasing operations and the associated safety, ecological and social benefits.

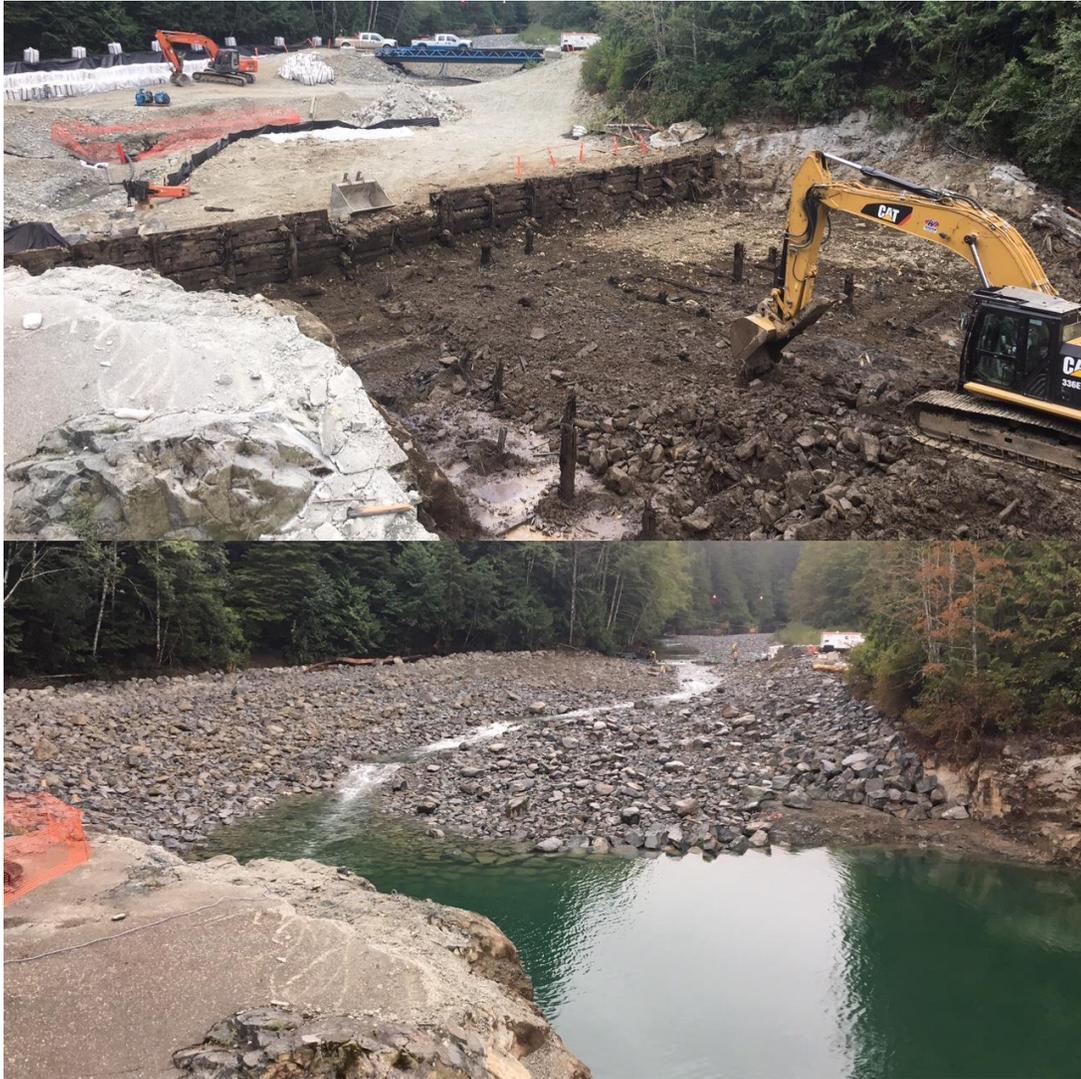
Figure 2 Salmon River Diversion Dam
Decommissioning Site during
Construction and Following Restoration
of River Channel (Looking Downstream)

10 **Contaminated Soil Remediation and Replacement** - During removal of
11 the dam, river bed soils were found to be contaminated much further
12 upstream than had been expected, resulting in the need to remove, store,
13 treat and backfill higher than expected quantities of contaminated soil. As
14 described in the Substantial Completion Report, this factor increased direct
15 Implementation Phase Project costs by [REDACTED].

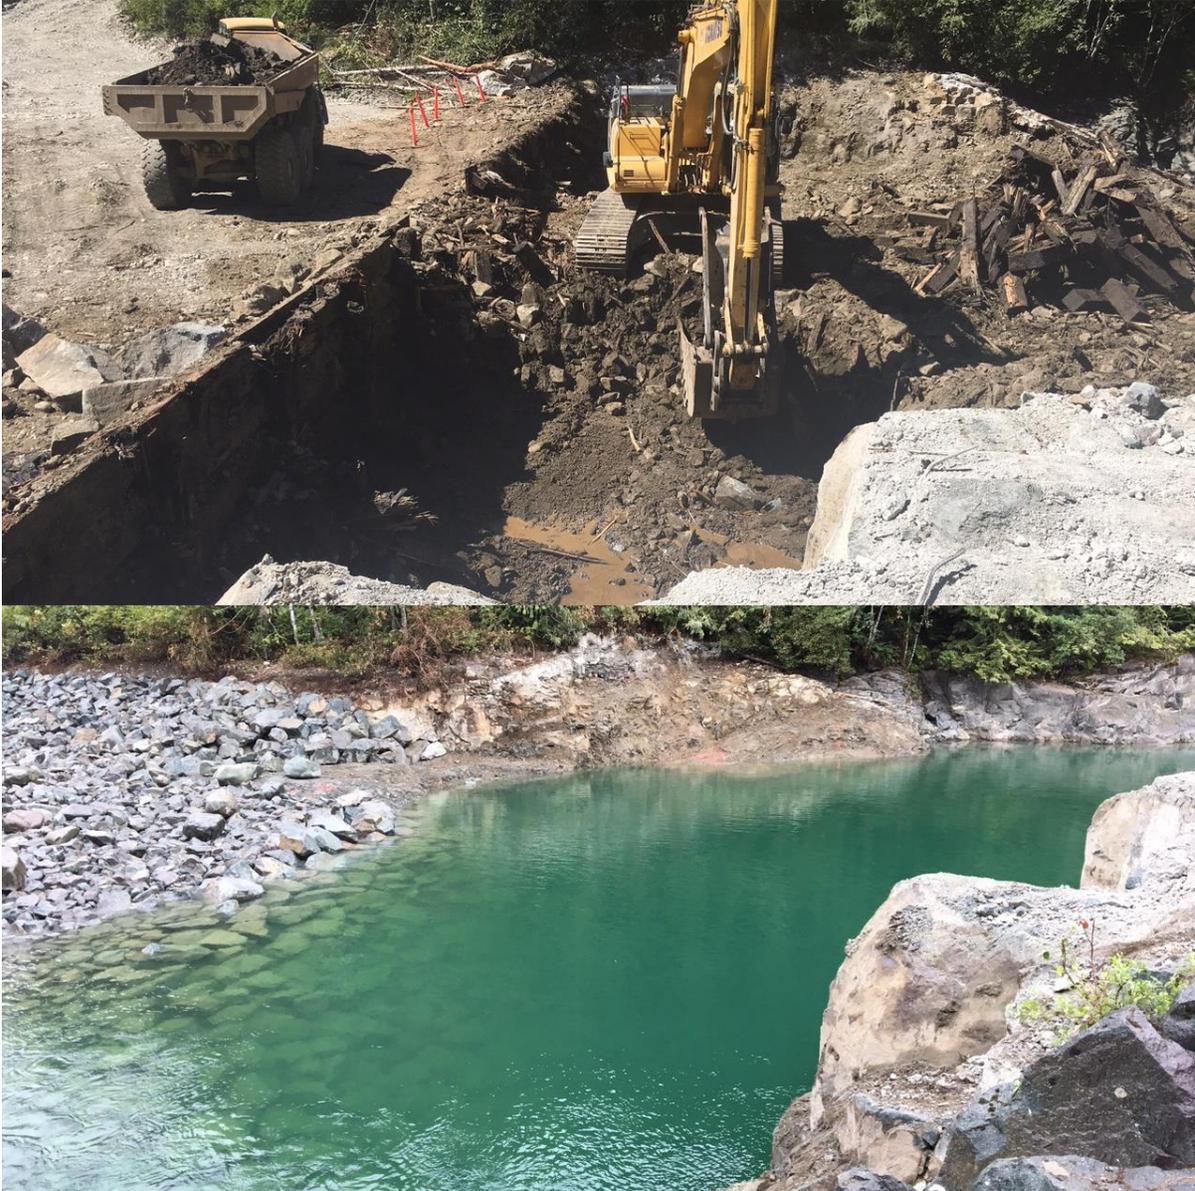
Figure 3 Salmon River Diversion Dam
Decommissioning Site during
Construction and Following Restoration
of River Channel (Side Profile)

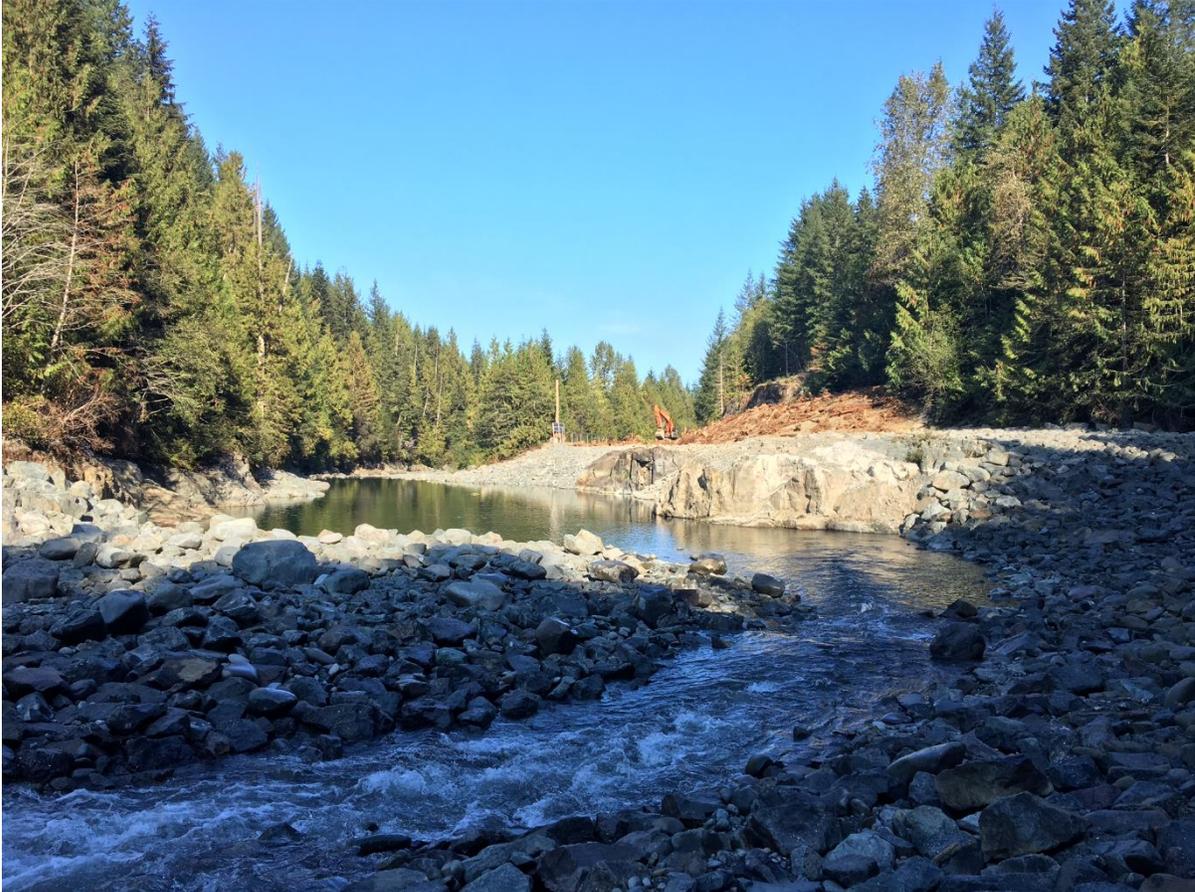
Figure 4 Salmon River Diversion Dam
Decommissioning Site Following
Restoration of River Channel (Looking
Upstream)

1 **Post-Construction Fish Passage Monitoring** - Following completion of the
2 decommissioning work, in September 2017, Ecofish and the A-Tlegay Fisheries
3 Society⁷ completed a short-duration fish passage monitoring program. Fish were
4 observed within the remediated channel, and no impedances were recorded.
