Victoria to Esquimalt Cable Replacement Project – Community Construction Report #3

July 2025

Project status

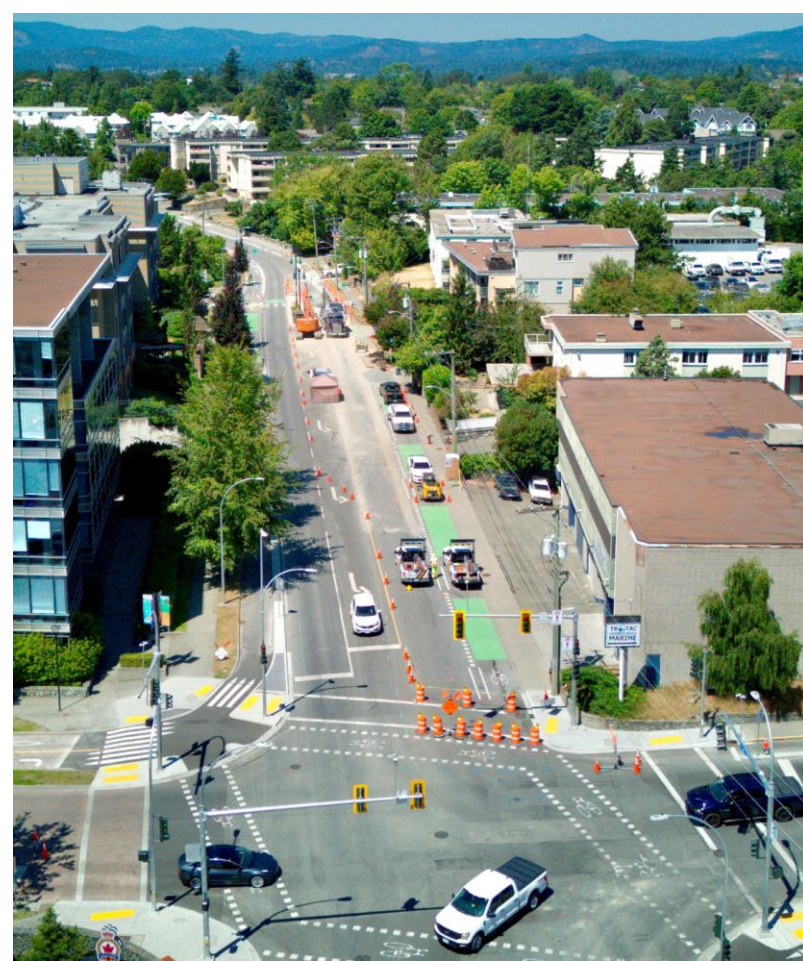
July 16 drone view of the duct bank work along Gorge Road, looking west, with the Jutland Road intersection in the foreground.

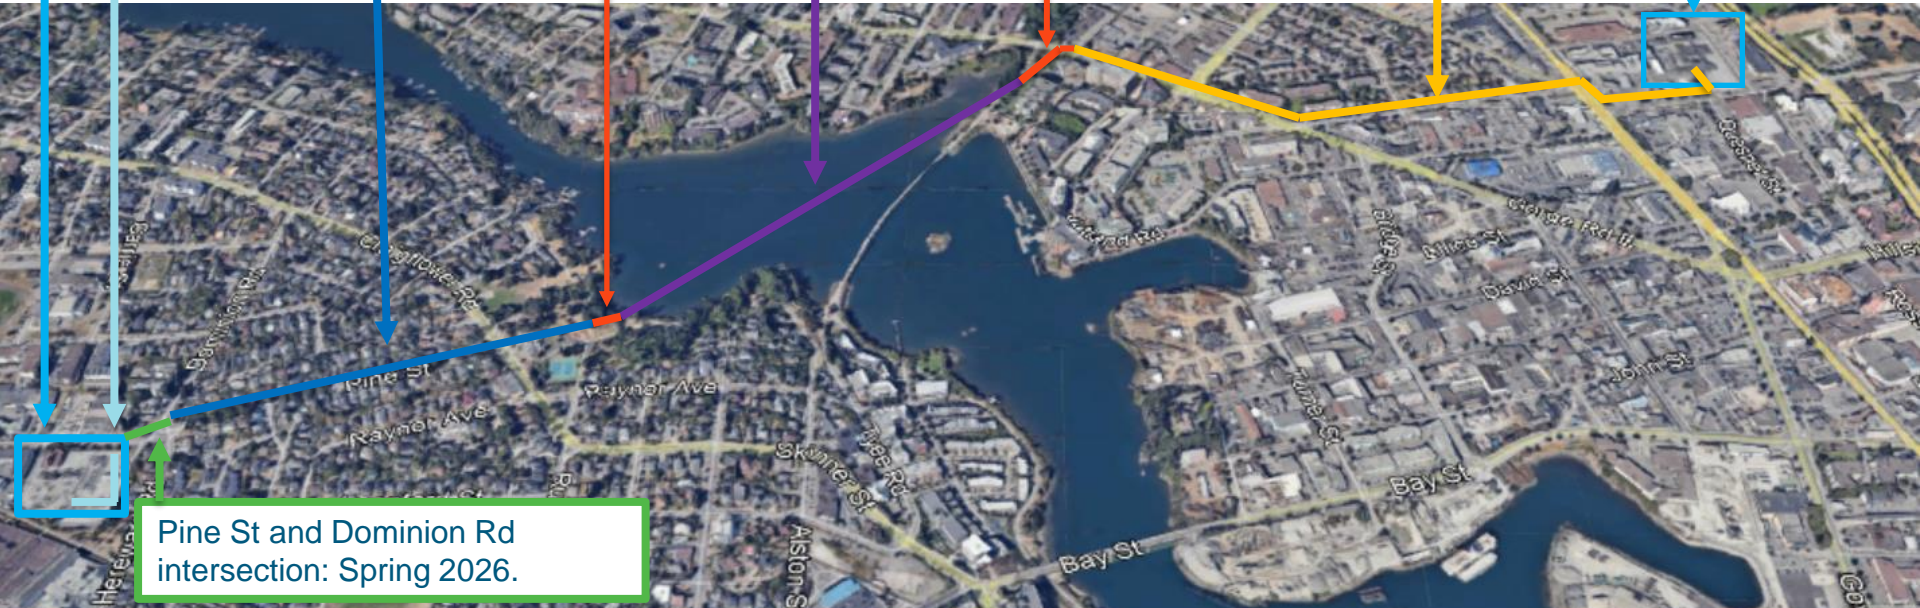
Planning the cable route – construction timing

Esquimalt Substation (left) and Horsey Substation work February 2025 to July 2026.

Esquimalt Substation work completed February to March 2025

Pine St and a section of Banfield Park completed June 2025

Banfield Park work in November 2025

Gorge Waterway shallow burial and adjacent parks: December 1, 2025 to February 15, 2026 (fisheries work window)

Viaduct Park work in November to March 2025

Streets include Gorge Rd, Dunedin St, Douglas St, and Topaz Ave: Crews will work eastward from Gorge Rd from early July to November 2025.

Pine St and Dominion Rd intersection: Spring 2026.

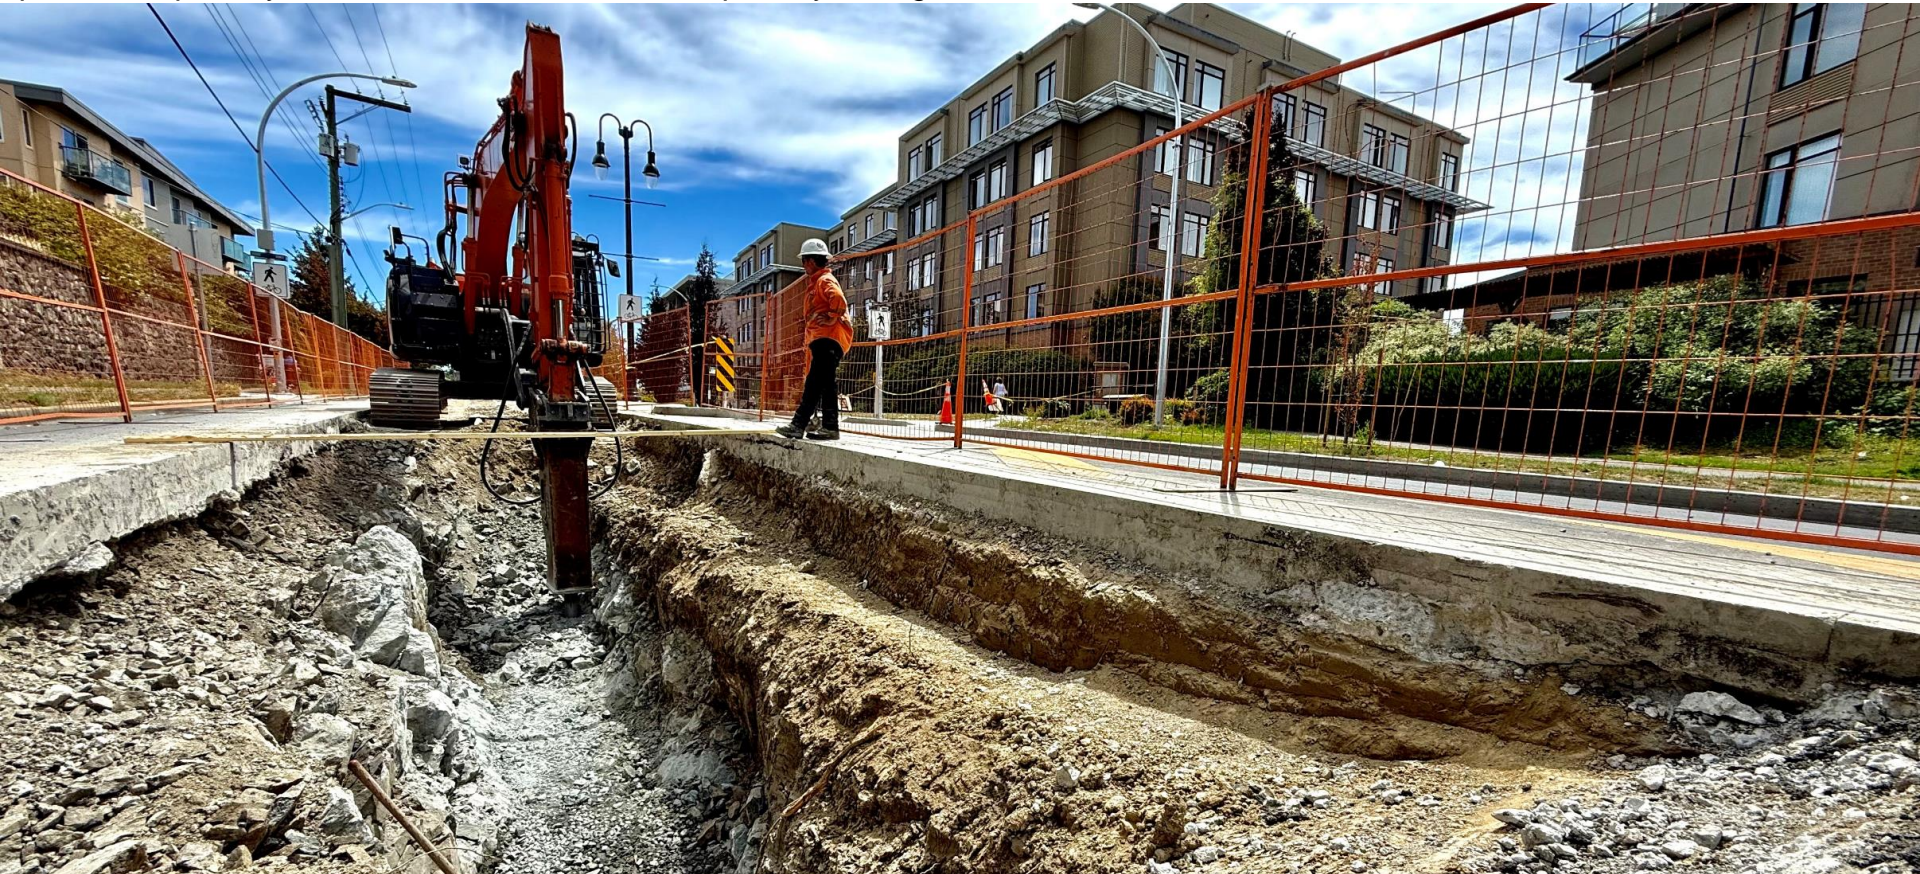
Construction photos: Gorge Road construction

July 8: The duct bank excavation on Gorge Road started on July 7. Rock was encountered at a shallow depth and rock chipping was required for about a 50-metre length. The excavation is about 2.5 metres deep. Typical progress of about 10-15 metres of duct bank placement per day was slowed to about 5 metres per day through the rock zone.

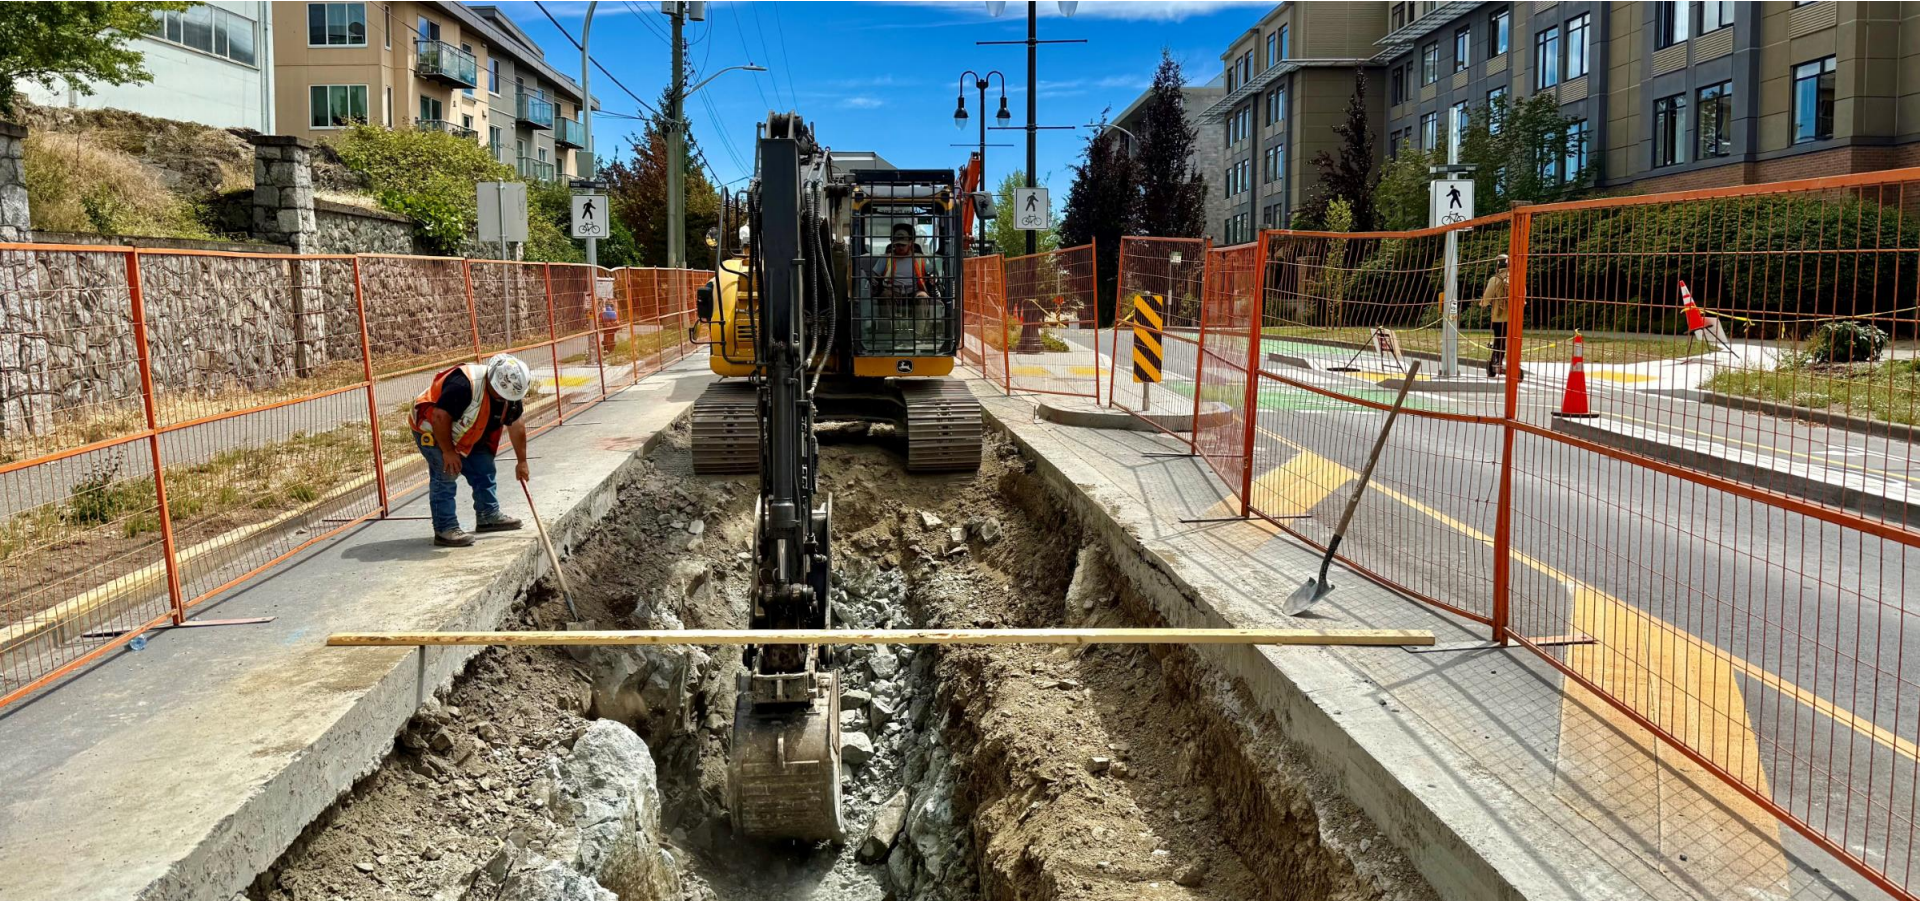
Construction photos: Gorge Road construction

July 8: A second excavator was used to remove the chipped rock material from the trench into a dump truck. The excavators switched positions multiple times per day. The wood 2x4 going across the trench is used to measure depth.

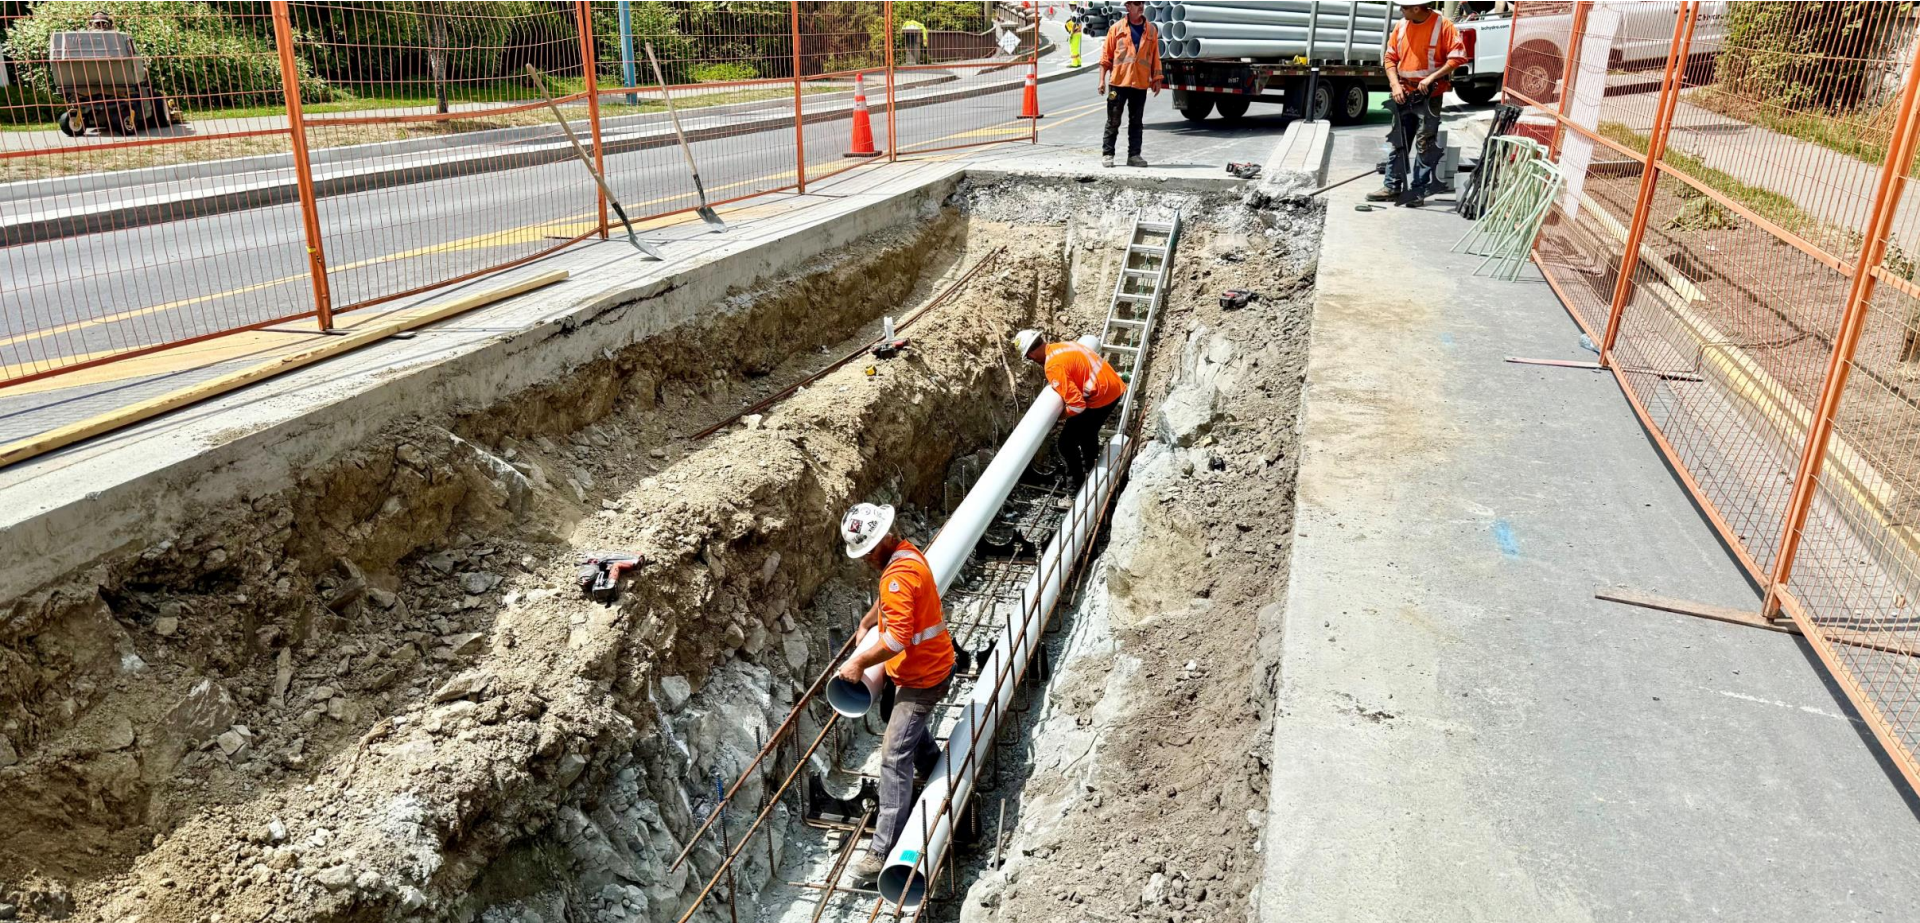
Construction photos: Gorge Road construction

July 8: With the first row of spacers and rebar in place, crews place the conduit.

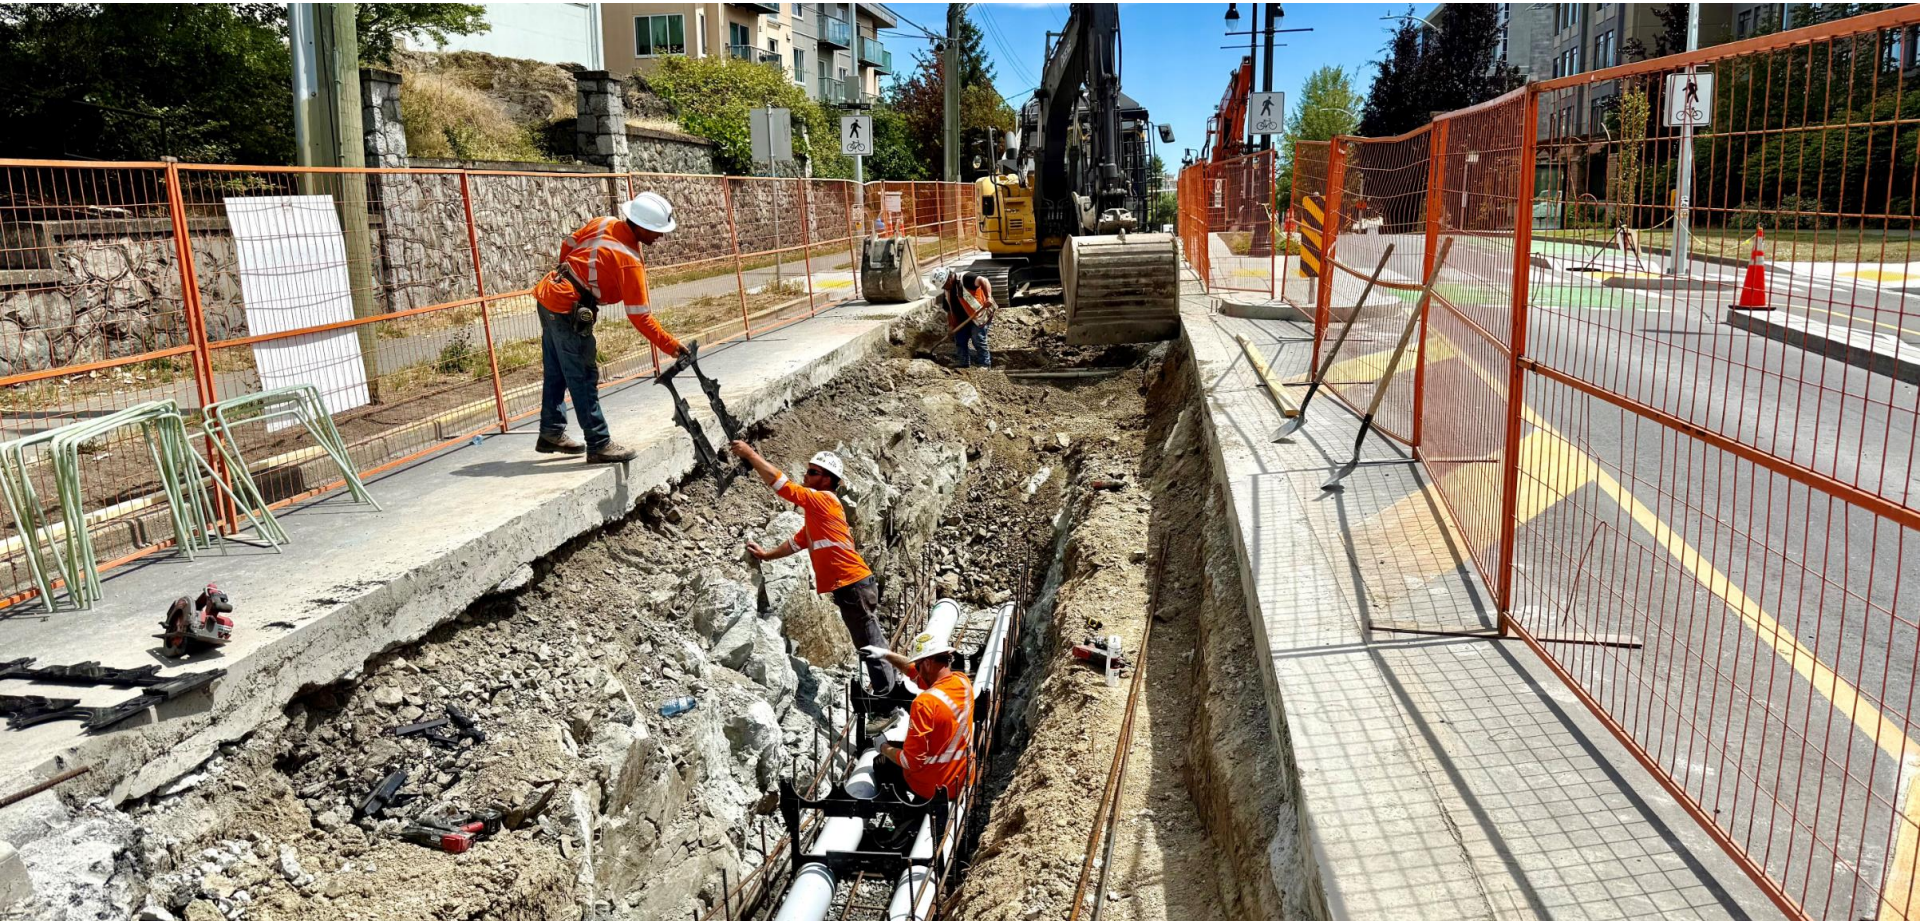
Construction photos: Gorge Road construction

July 8: More spacers added to provide for another level of conduit placement.

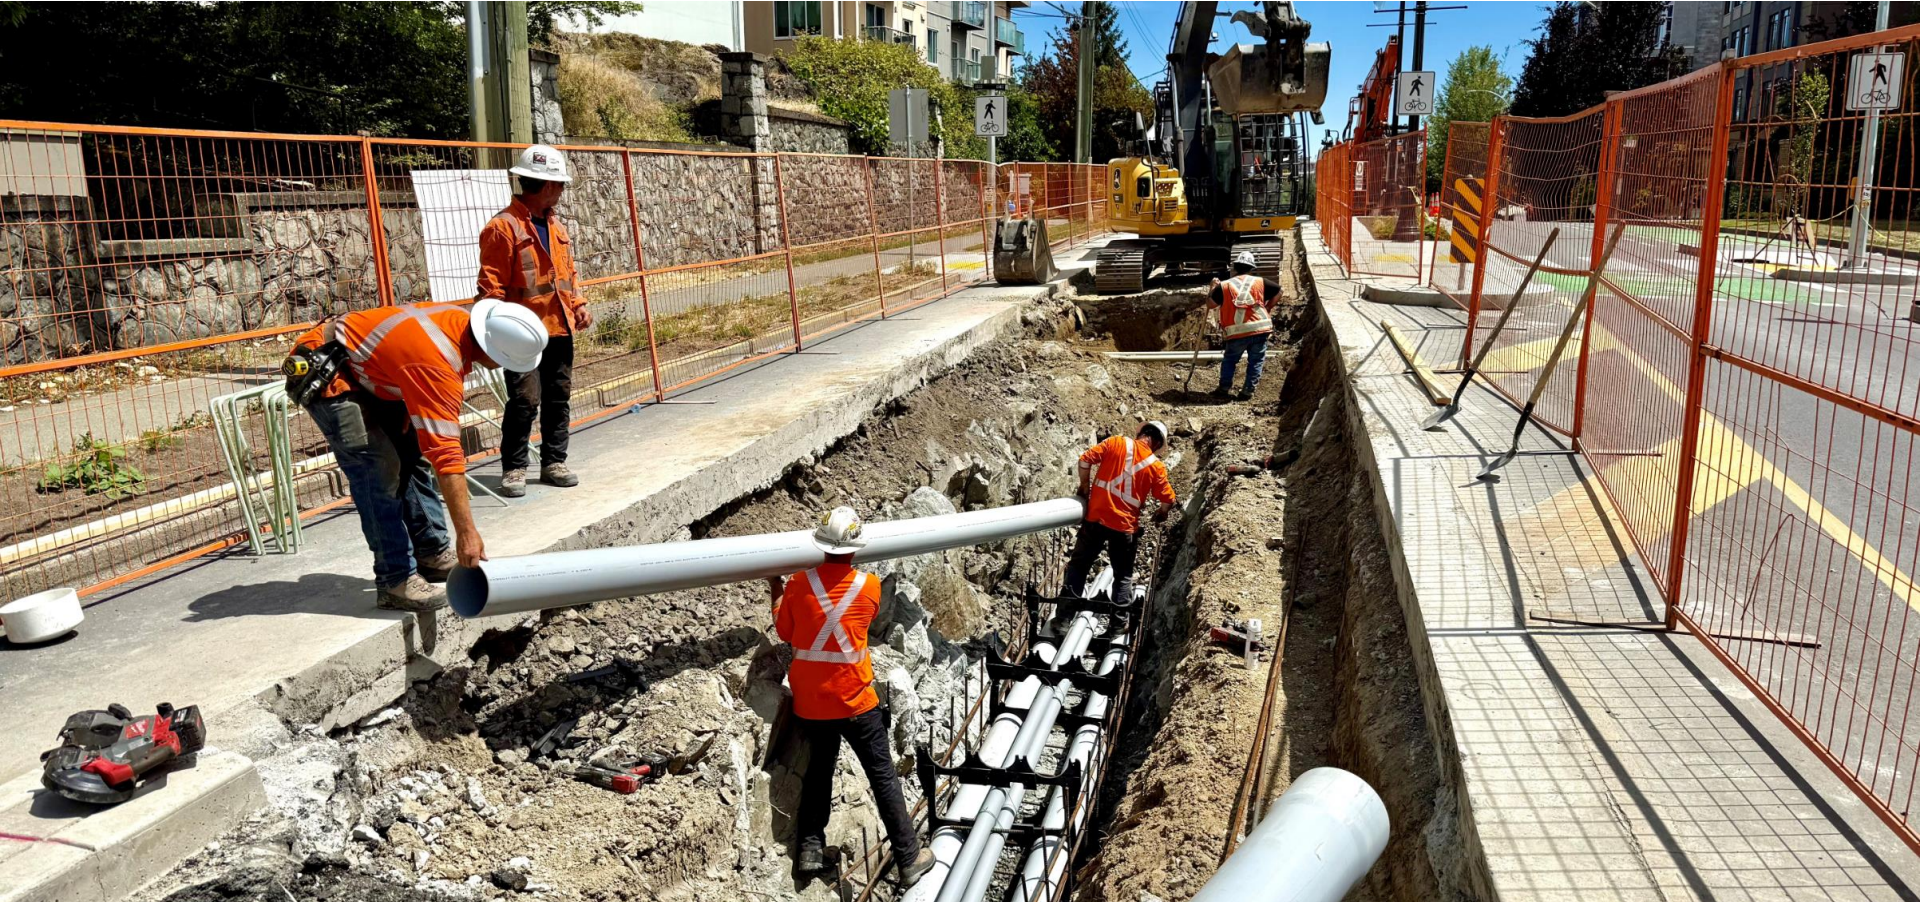
Construction photos: Gorge Road construction

July 8: The second level of conduit placement. There are four conduits that will house the cable, with one conduit used as a spare in the event of an emergency.

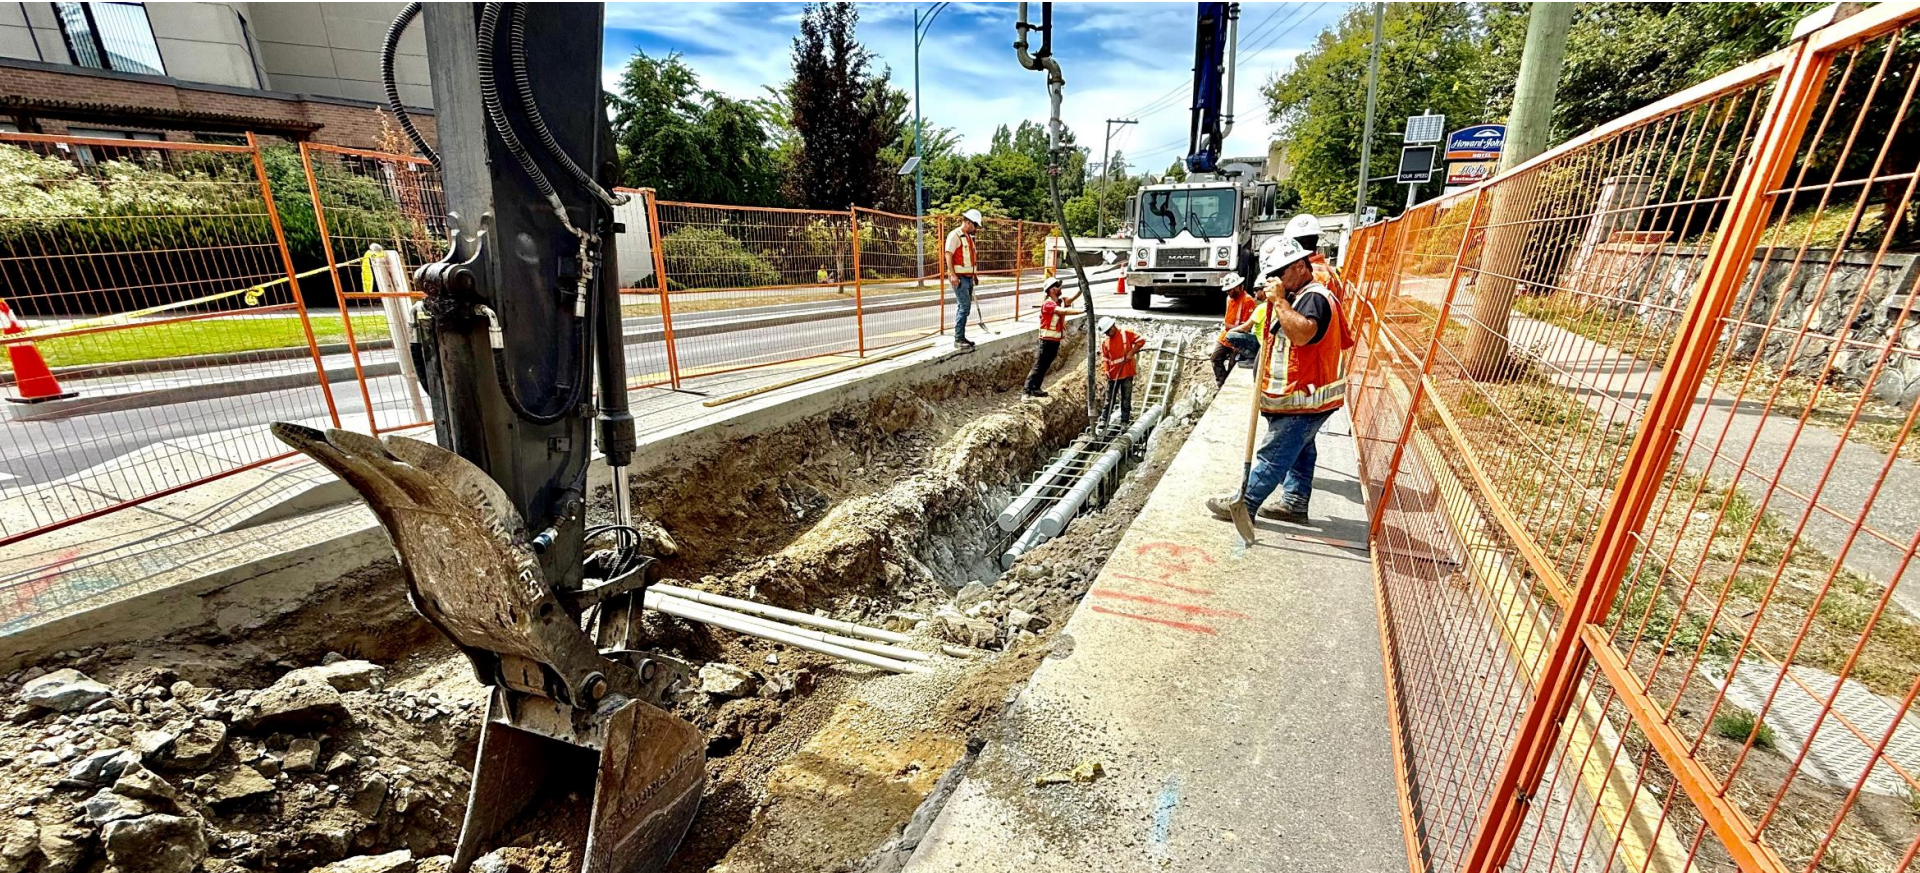
Construction photos: Gorge Road construction

July 8: In the background, concrete is placed along the conduit. In the foreground, material continues to be removed to progress down Gorge Road. The three red lines on the road show the location of the streetlight electric conduit and the careful excavation around them.

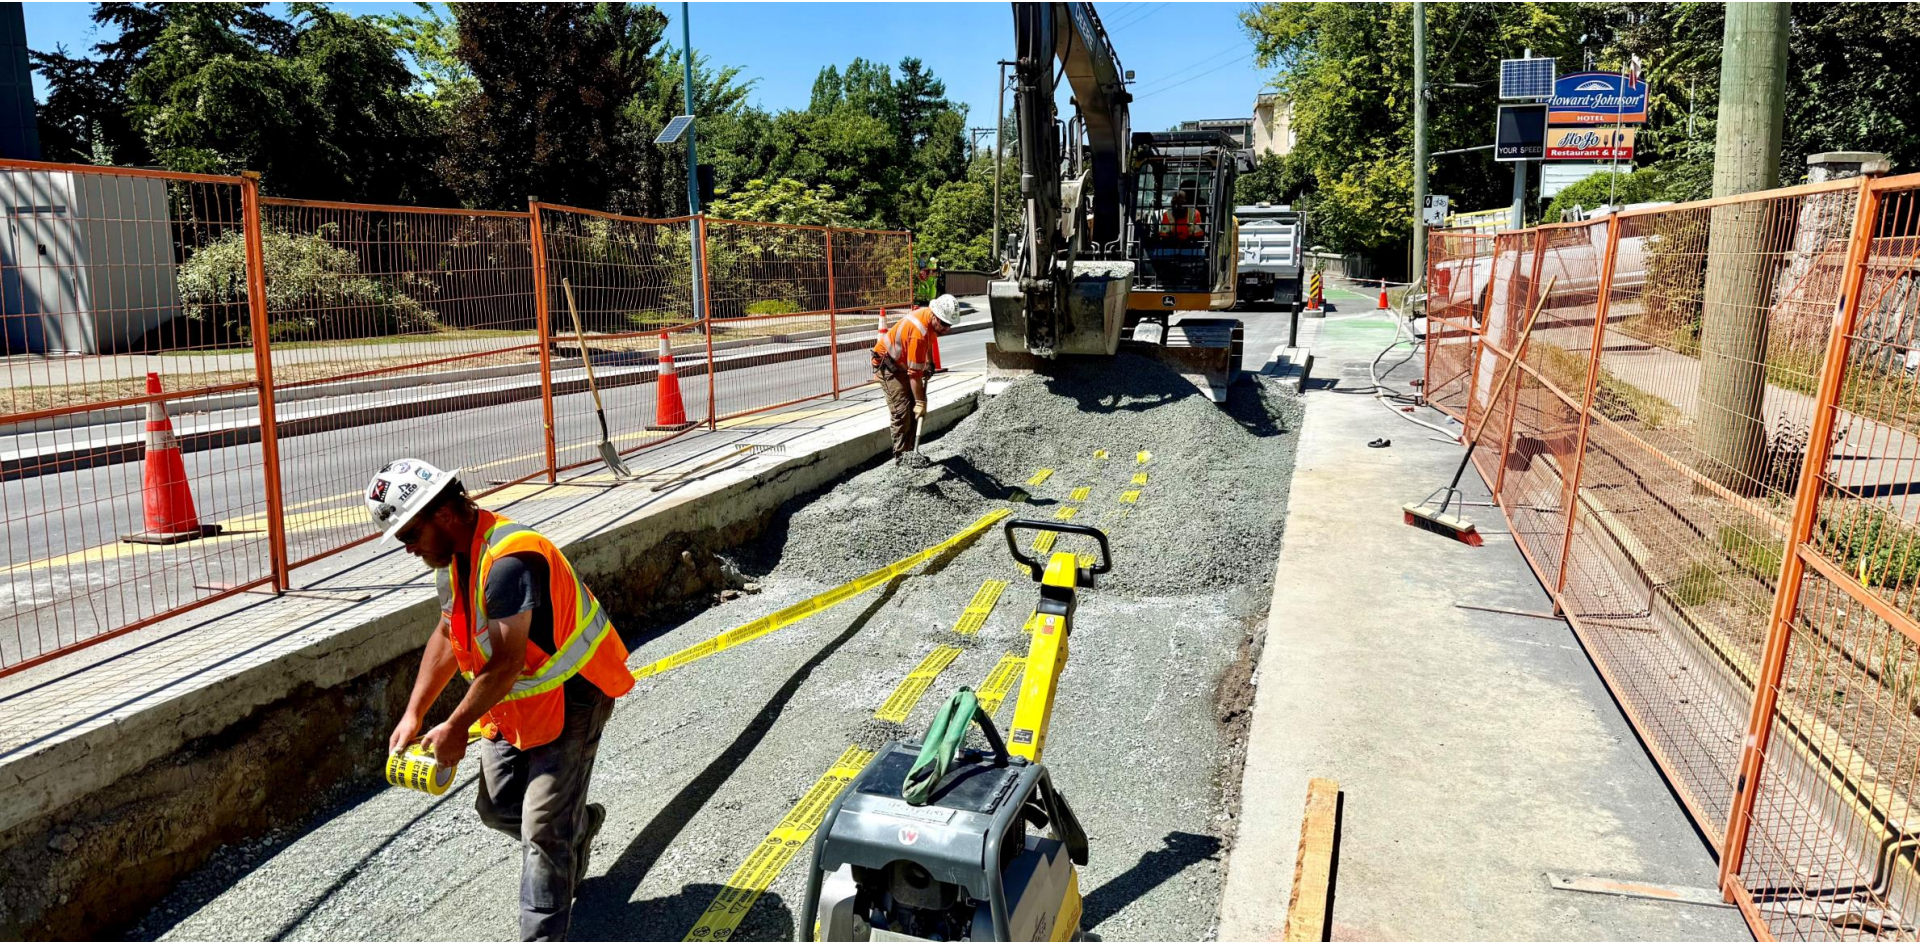
Construction photos: Gorge Road construction

July 16: Electrical caution tape is placed above the duct bank to prevent future excavation in the same location.

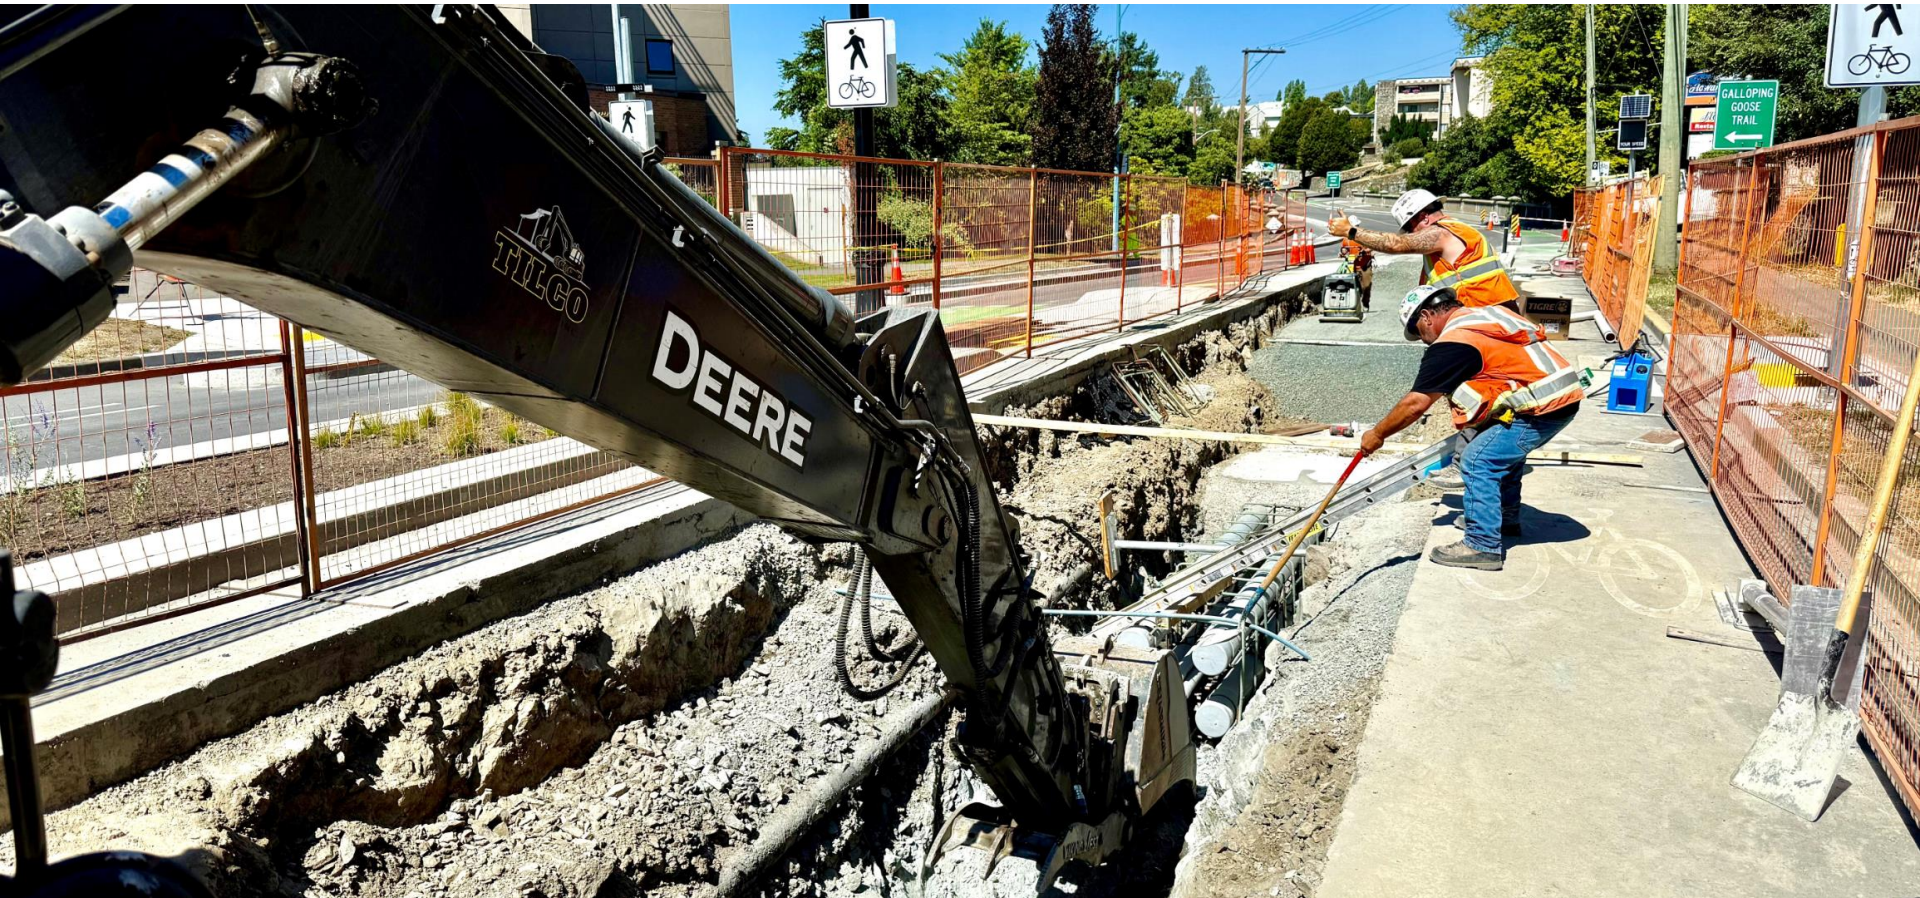
Construction photos: Gorge Road construction

July 16: Removing loose rock from the trench while protecting an irrigation line. The pipe to the left of the excavator bucket is an abandoned water main.

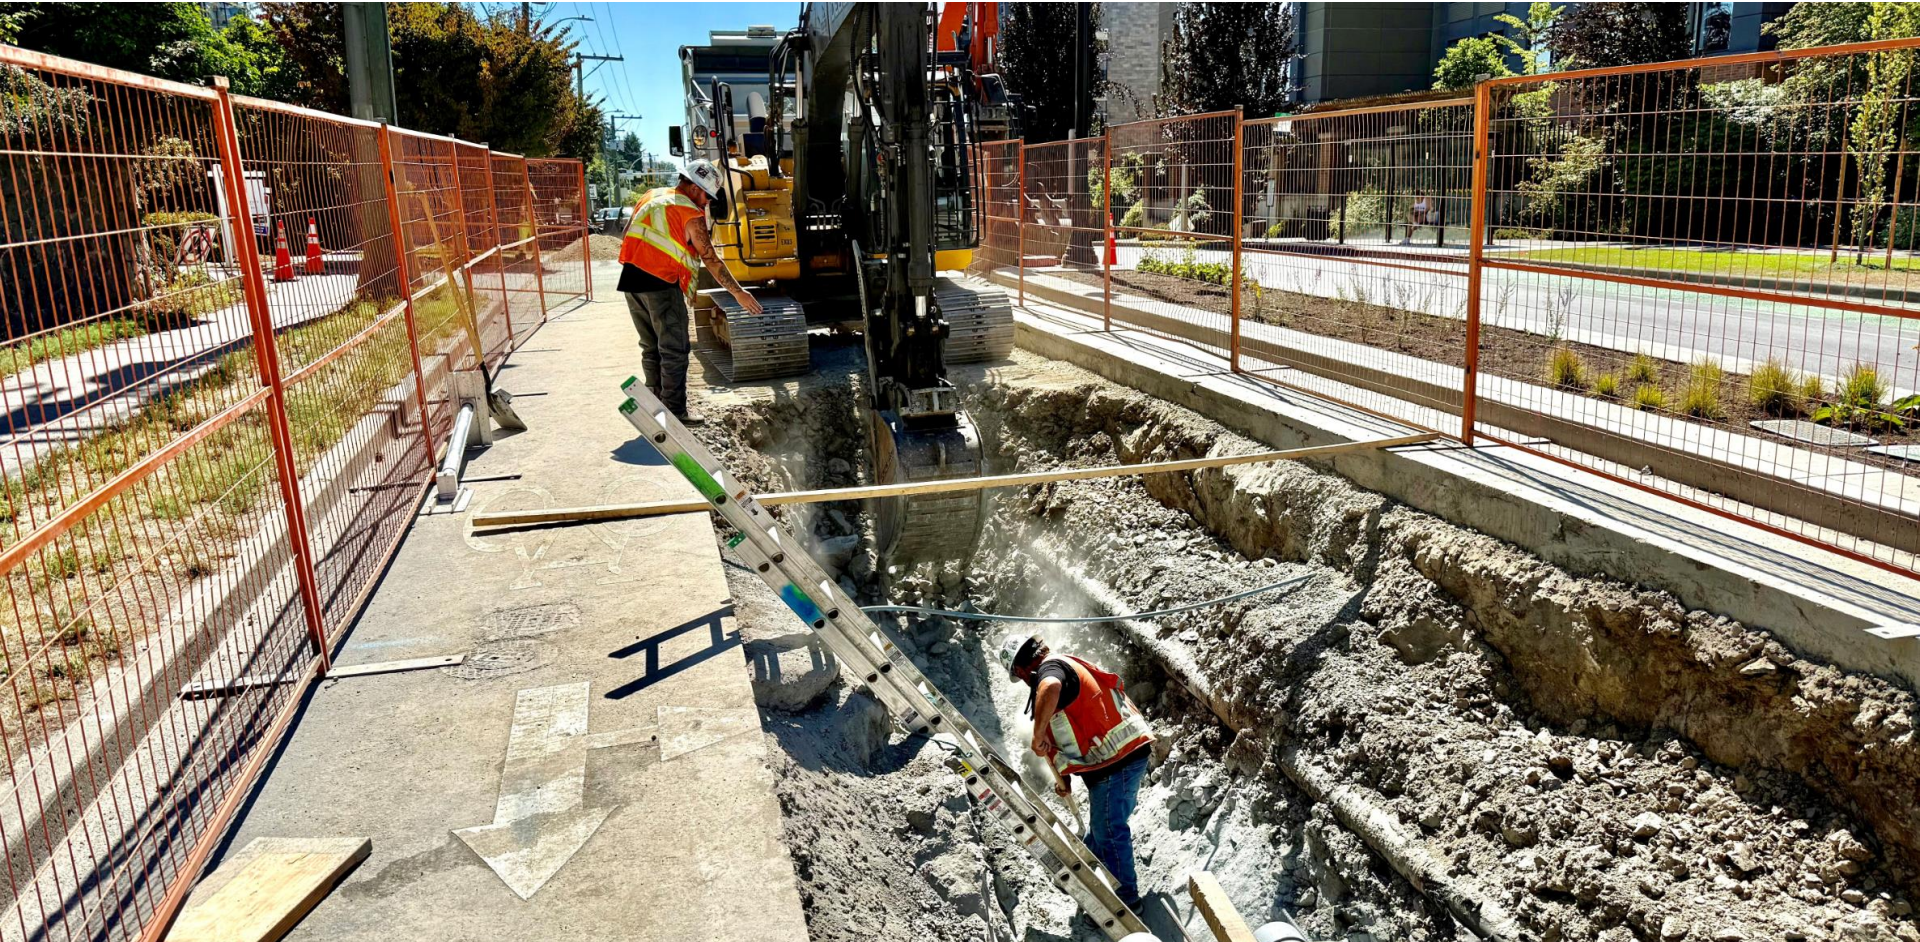
Construction photos: Gorge Road construction

July 16: Rock removal along the duct bank route and confirming the 2.5-metre depth.

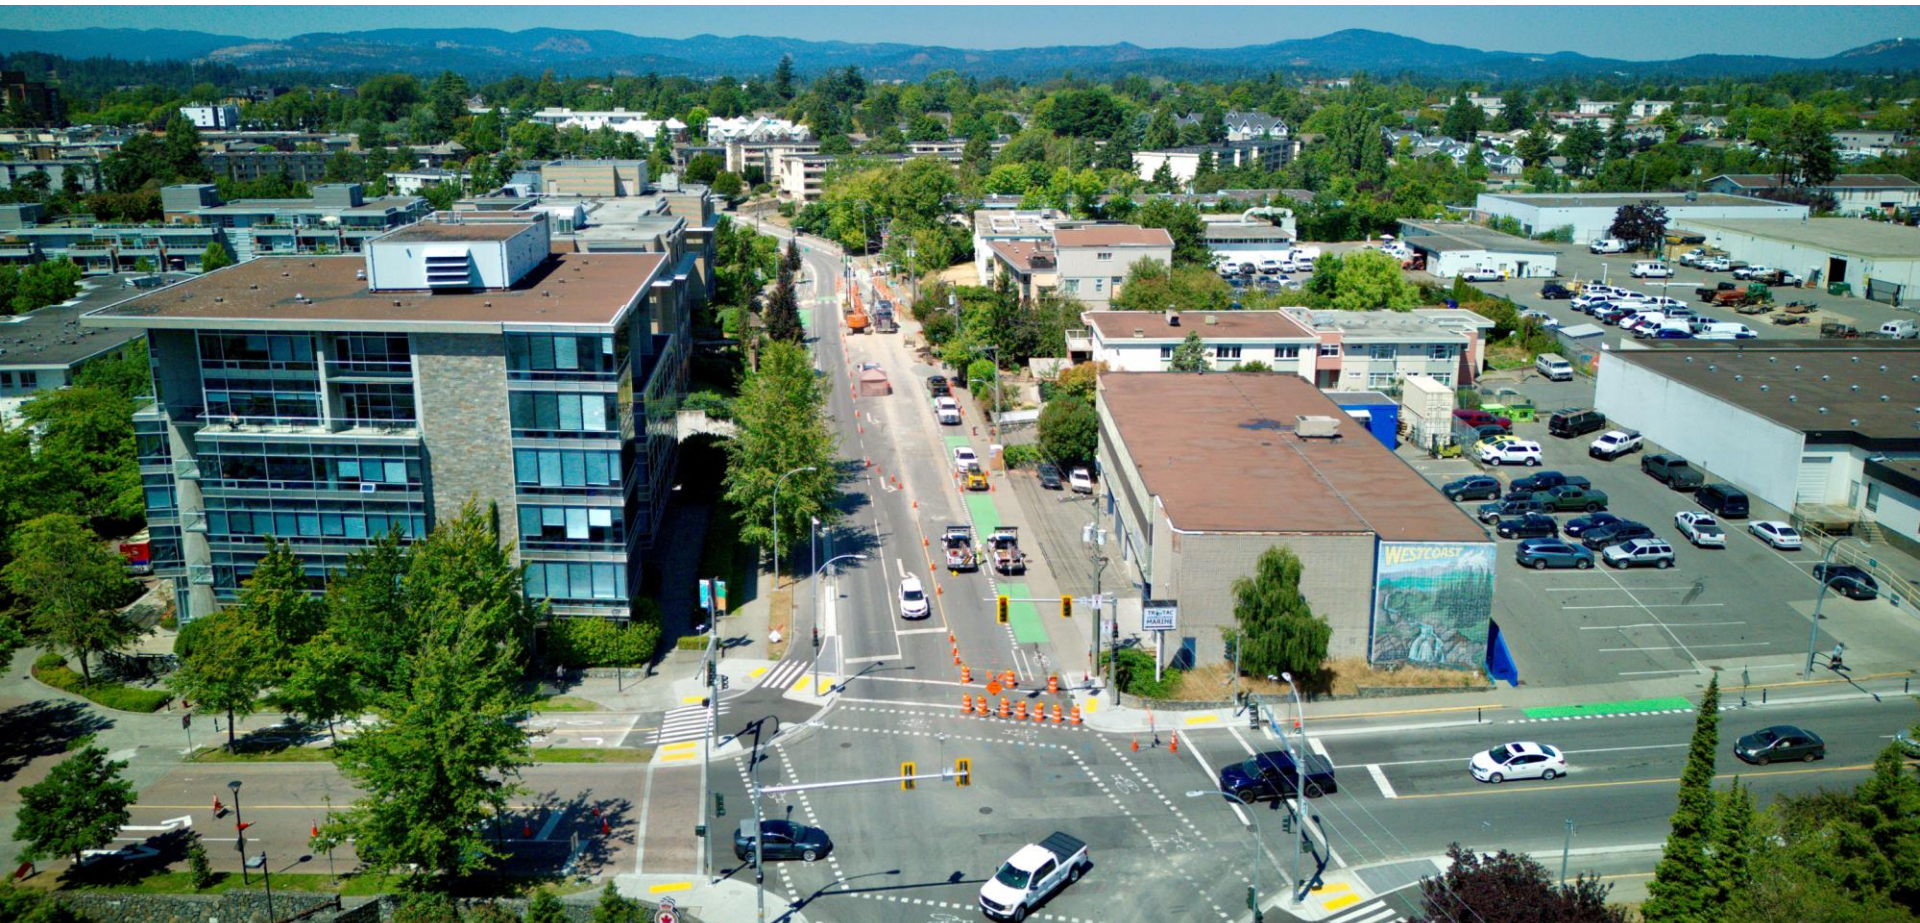
Construction photos: Gorge Road construction

July 16: Drone view looking west down Gorge Road and the construction area, with the Jutland Road intersection in the foreground.

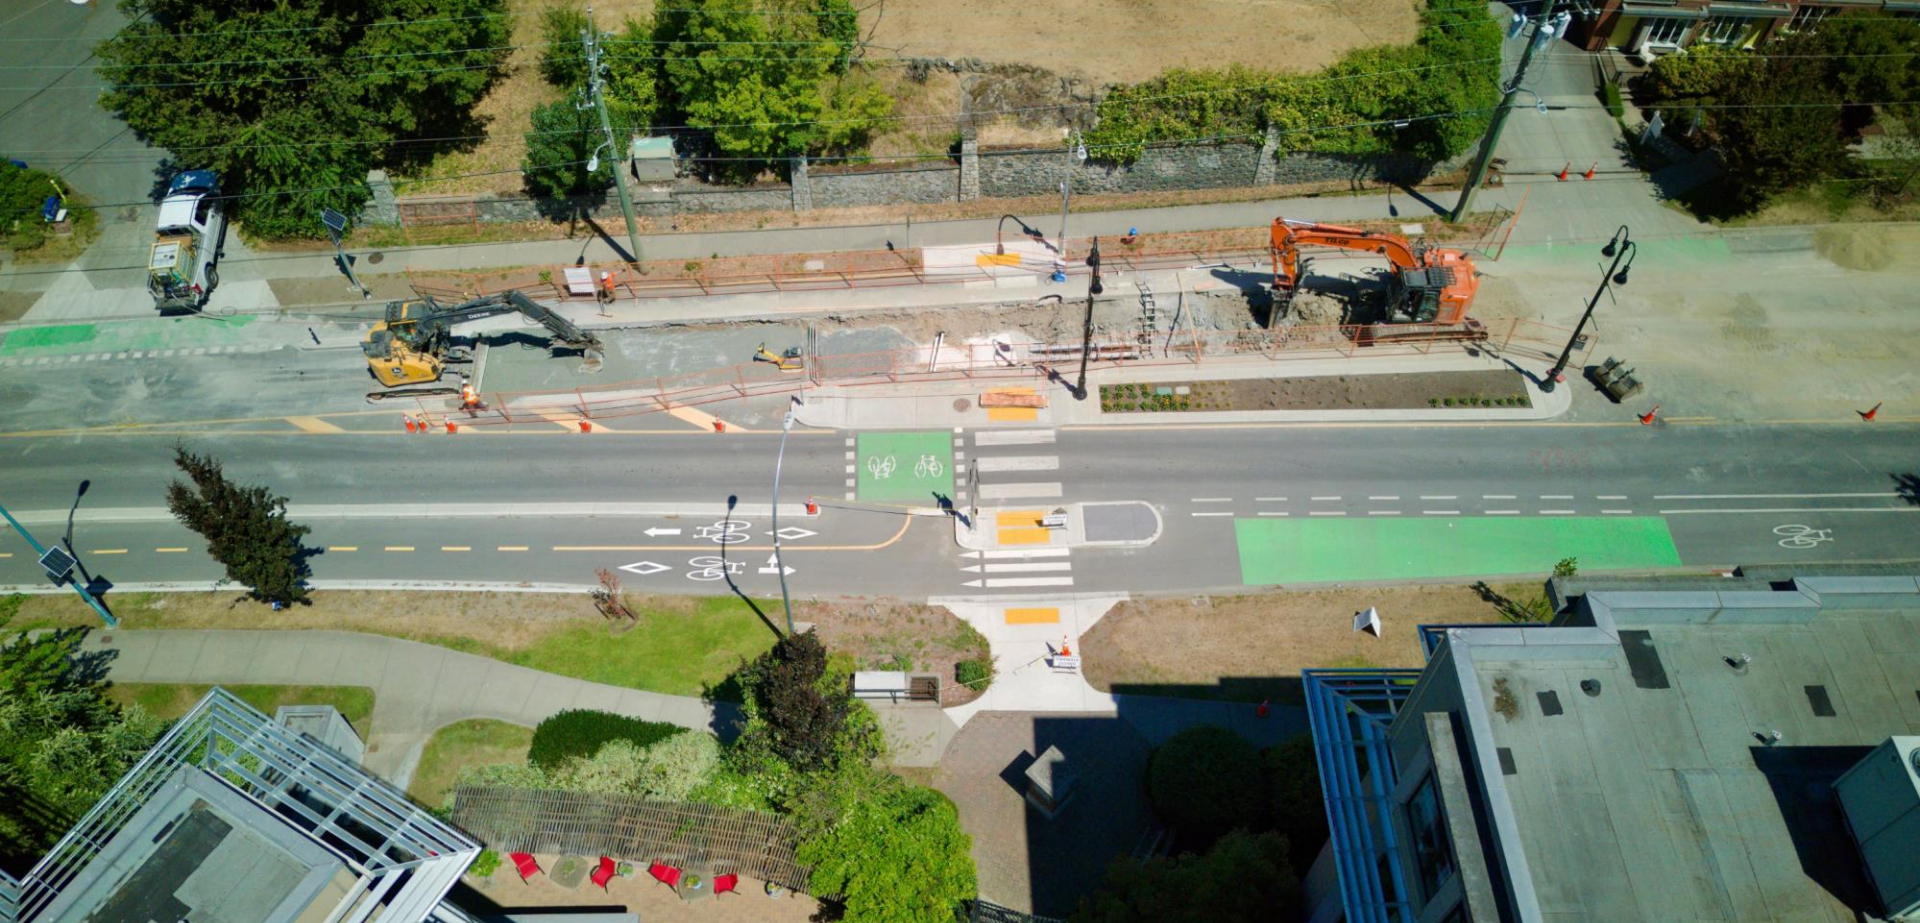
Construction photos: Gorge Road construction

July 16: Drone view of the duct bank excavation and work area.
