Victoria to Esquimalt Cable Replacement Project – Community Construction Report #3

July 2025

Project status

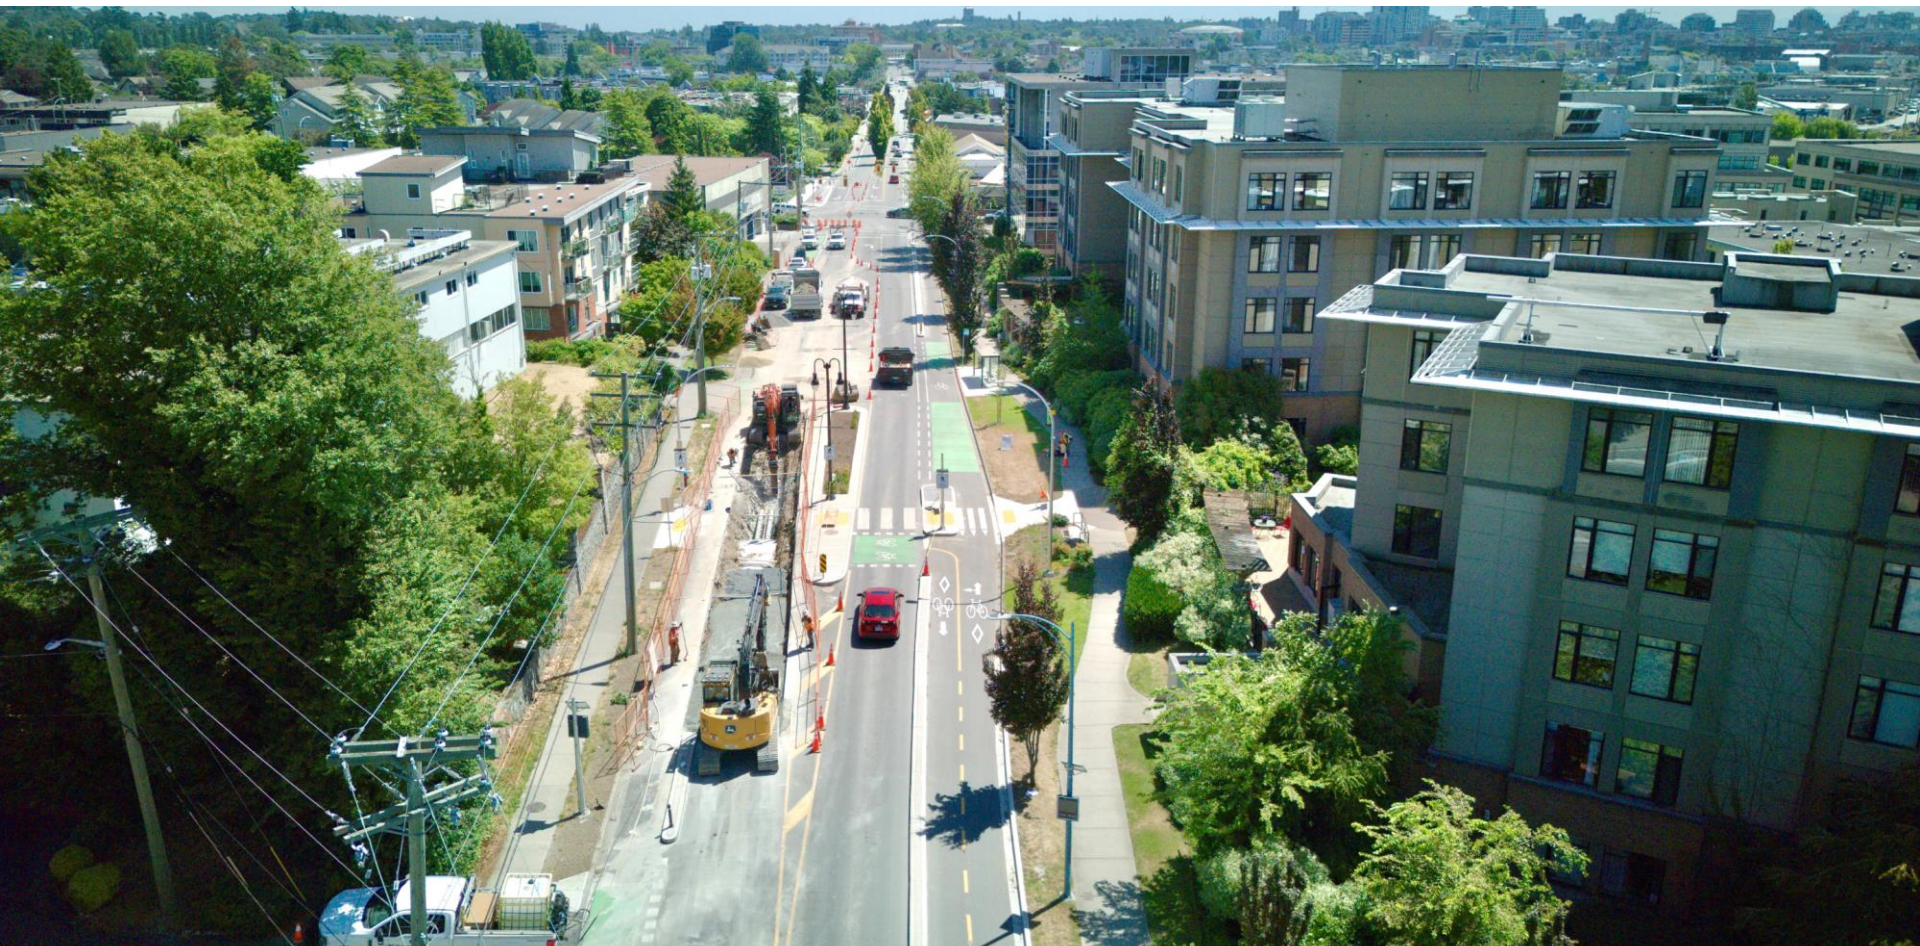
Construction photos: Gorge Road construction

July 16: Drone view from a different vantage looking east down Gorge Road.

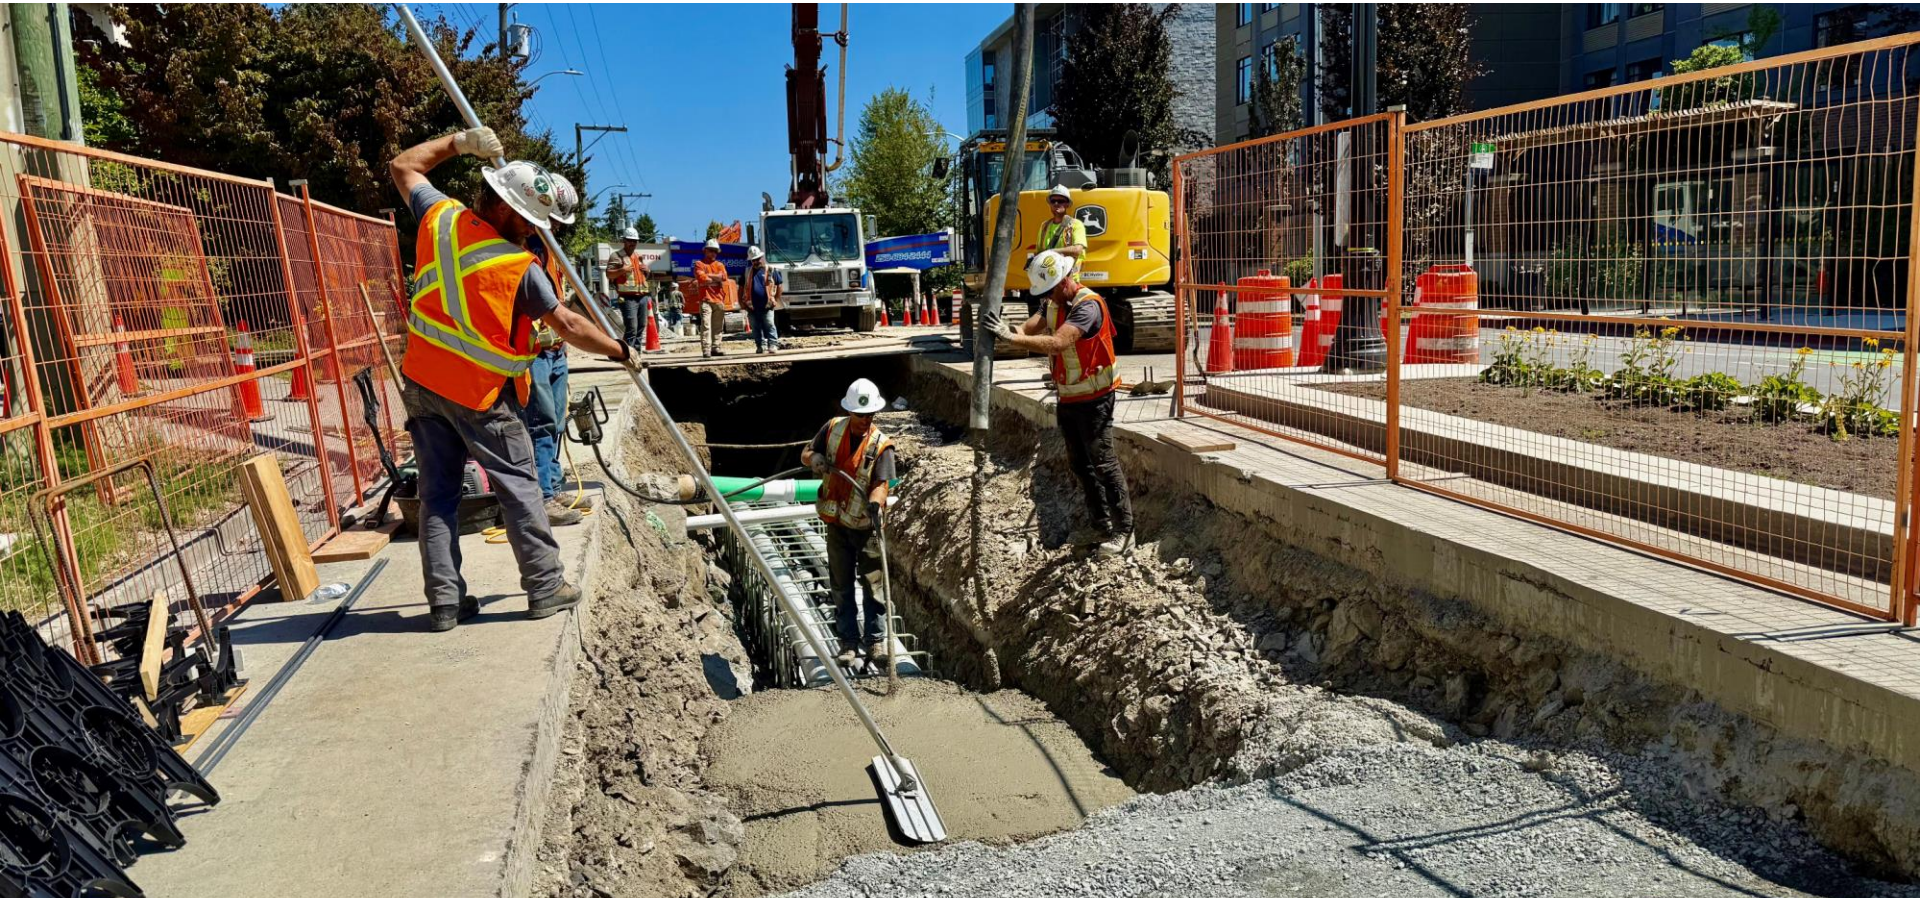
Construction photos: Gorge Road construction

July 23: Placement of concrete over the conduit. The duct bank excavation work finally moved out of the bedrock on July 23 with the trench work now moving through Victoria clay.

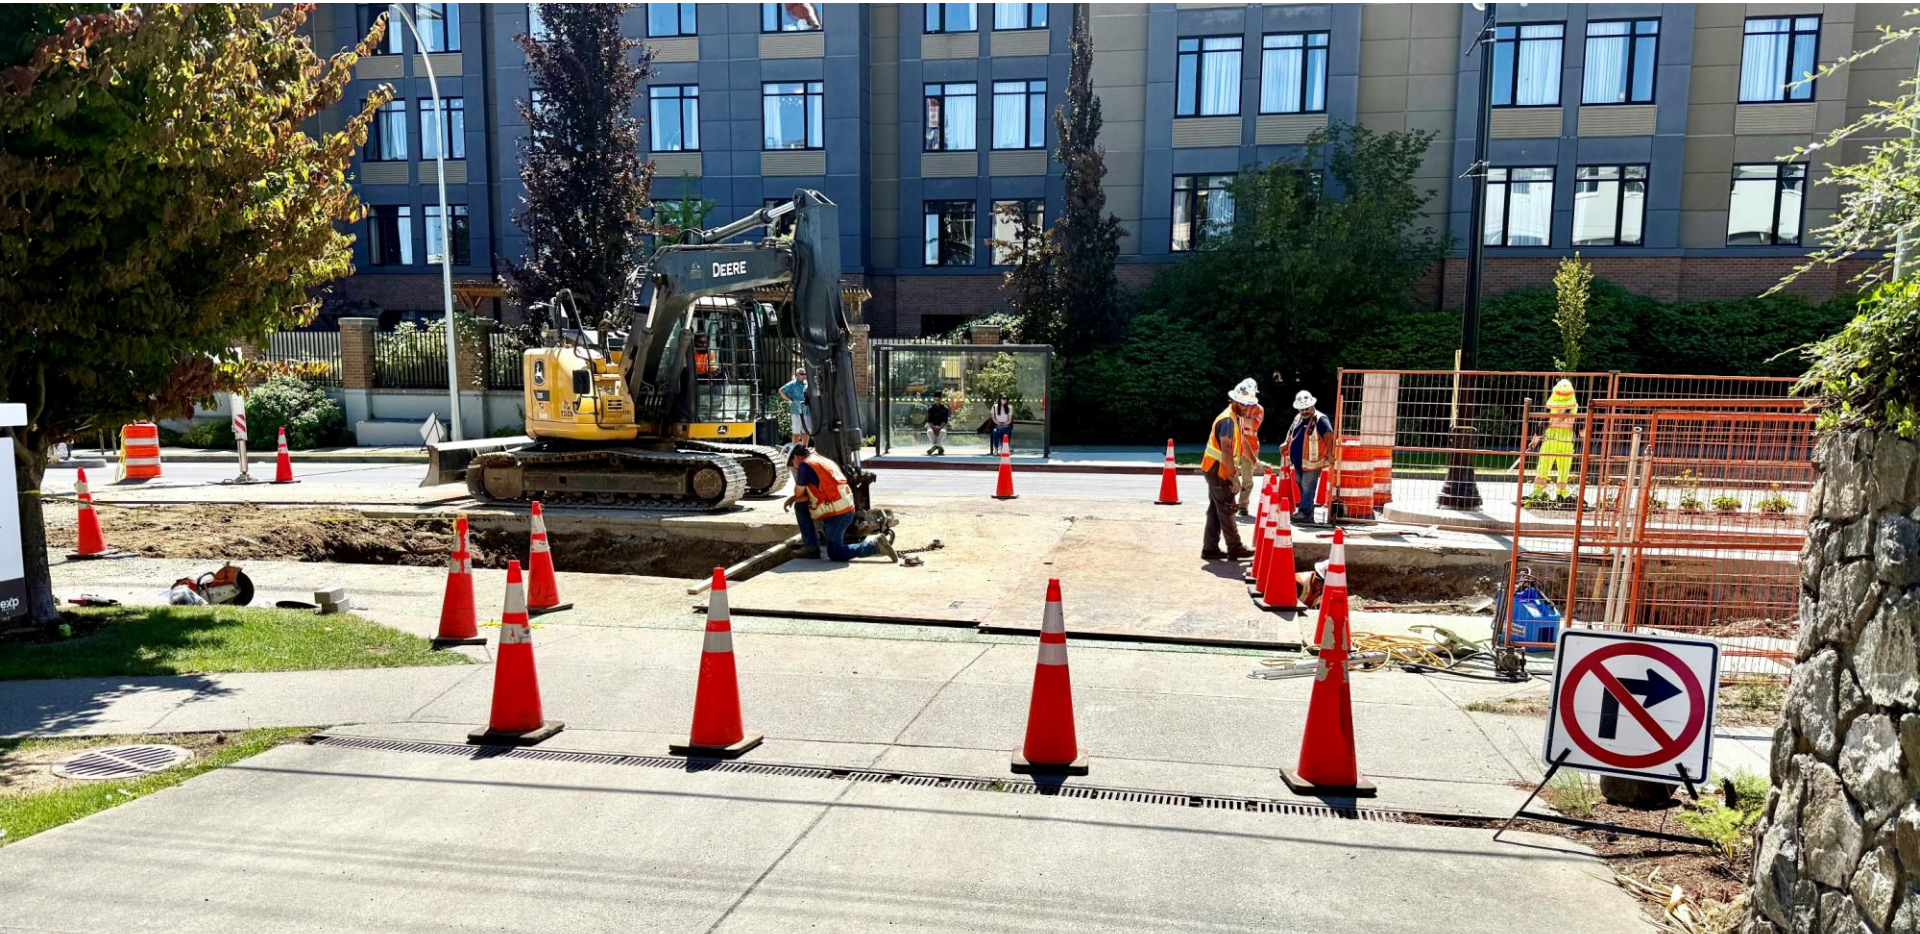
Construction photos: Gorge Road construction

July 23: Duct bank work area and two steel plates that were put in place to provide access to 356 Gorge Road.

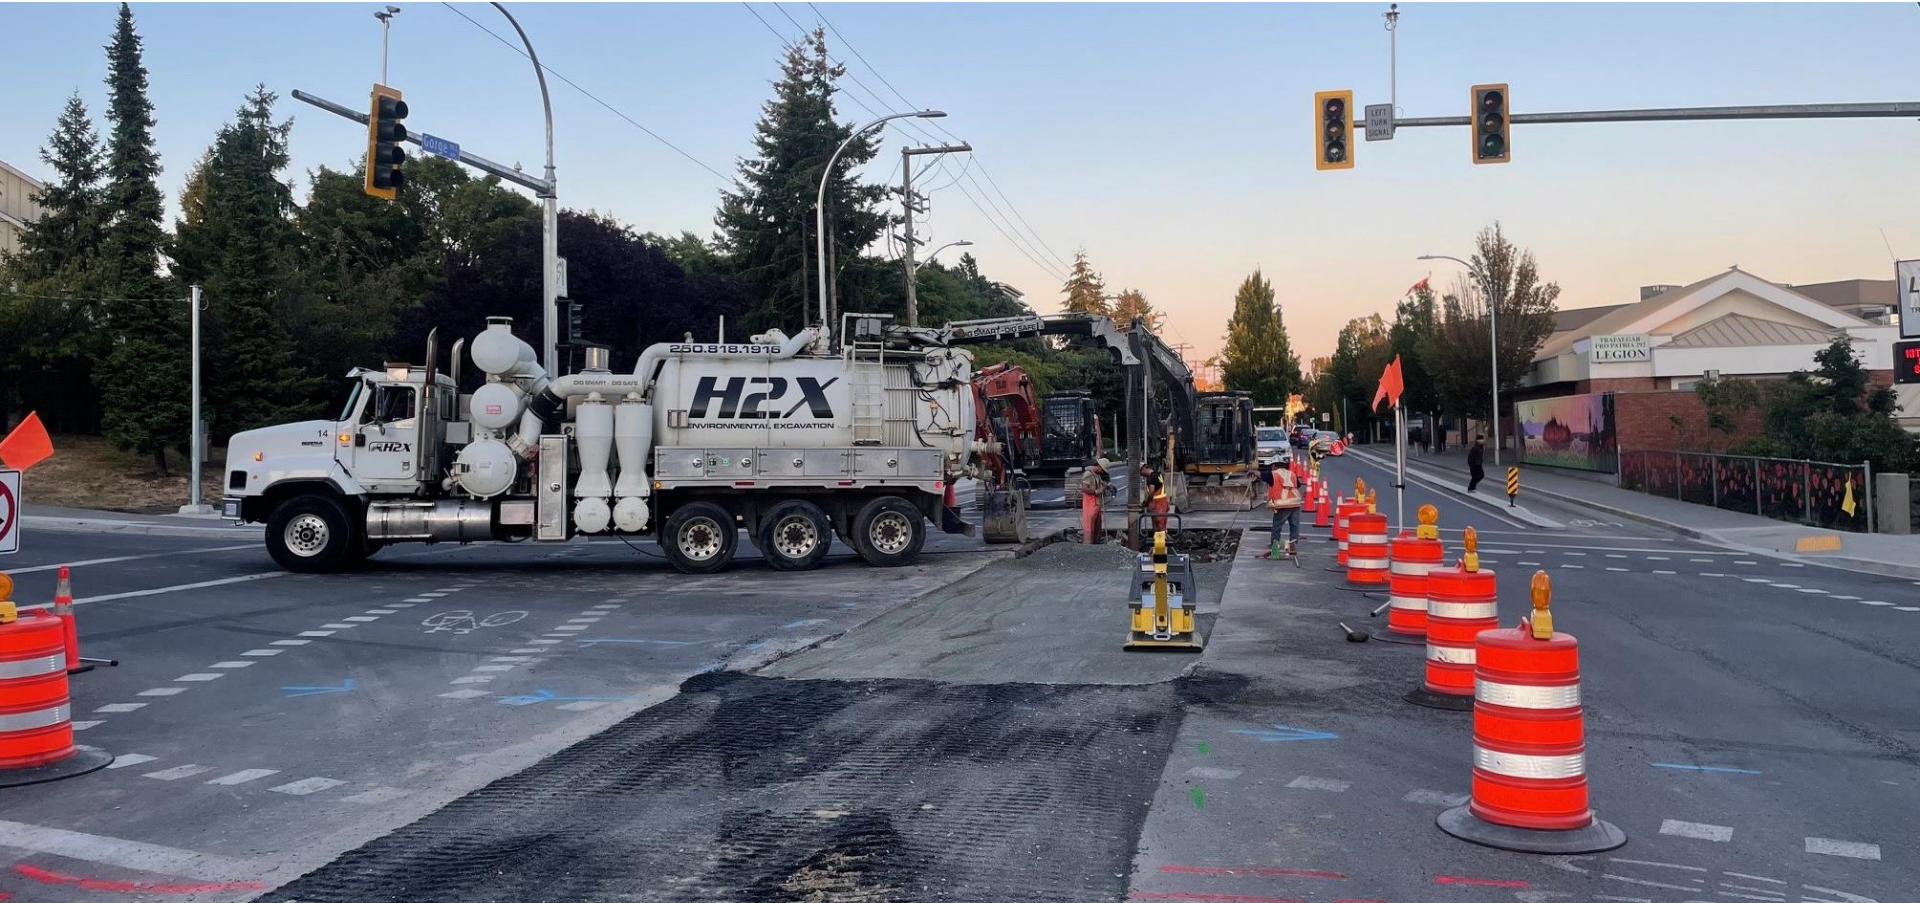
Construction photos: Gorge Road construction

July 23 (evening): Daylighting work to determine underground utilities at the Jutland Road intersection. This investigative work helps to limit any potential delays when the duct bank is built through the intersection in mid-August.

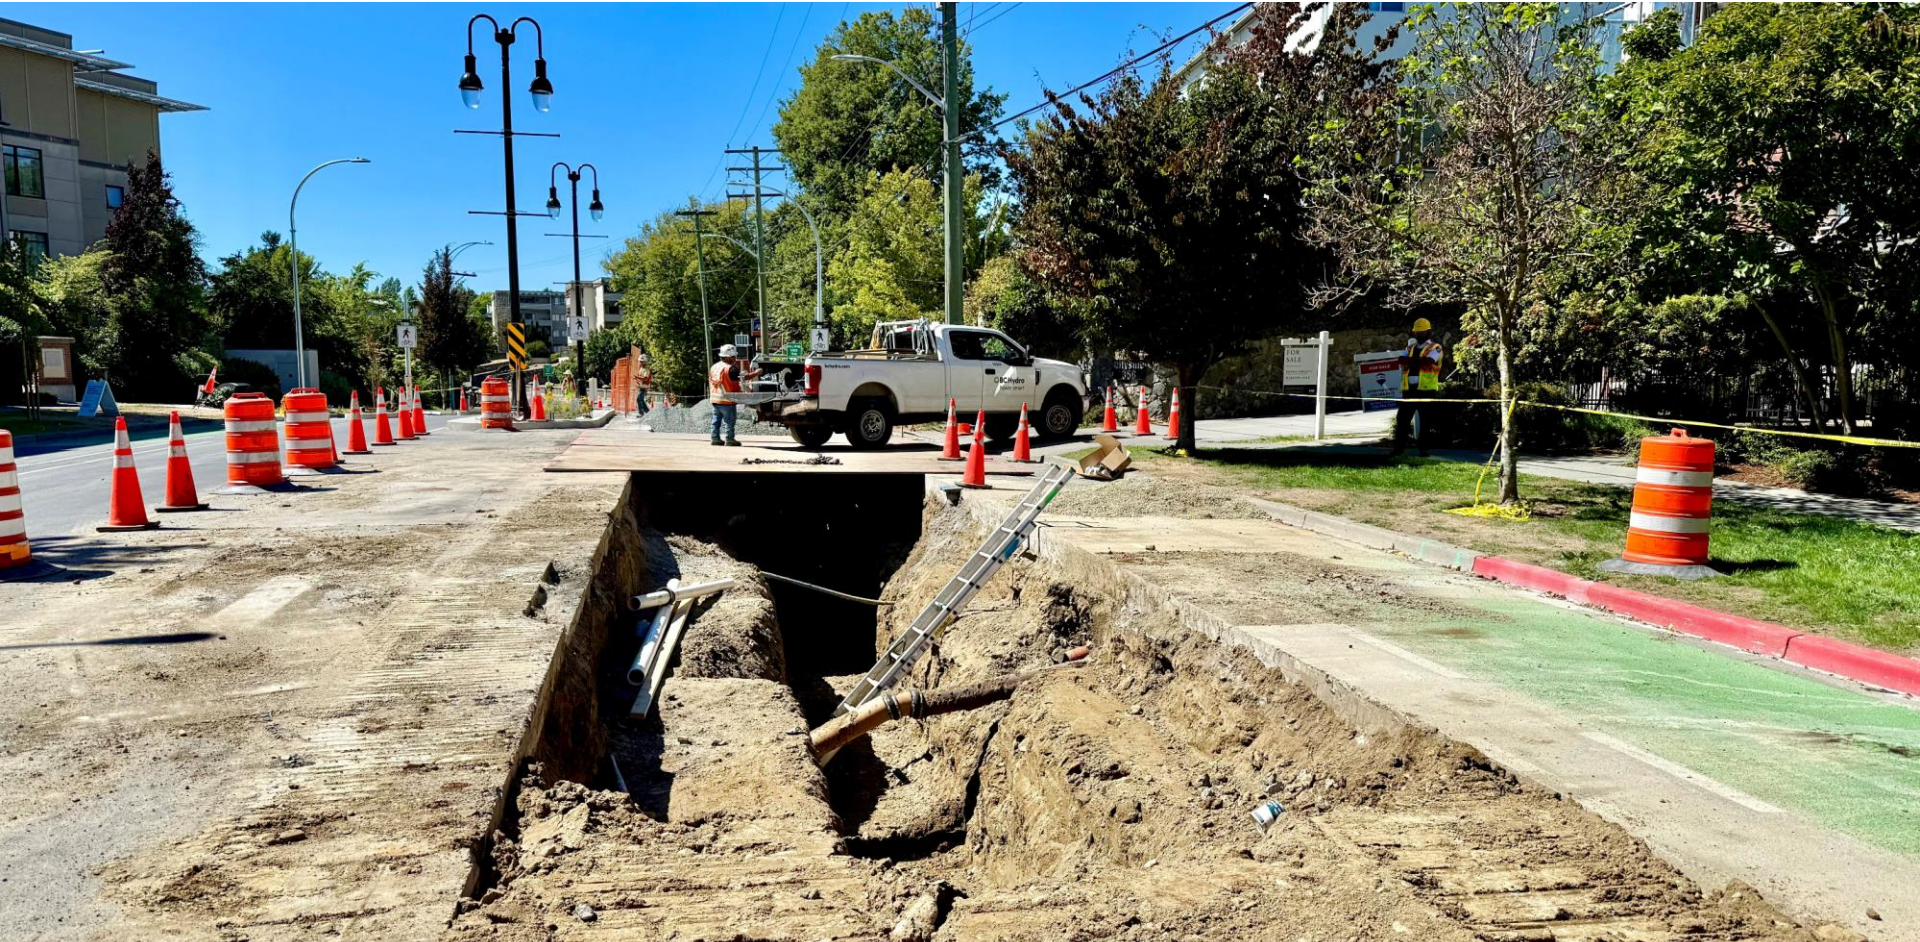
Construction photos: Gorge Road construction

July 24: Duct bank work with the new section of trench in the foreground fully excavated in clay/soil.

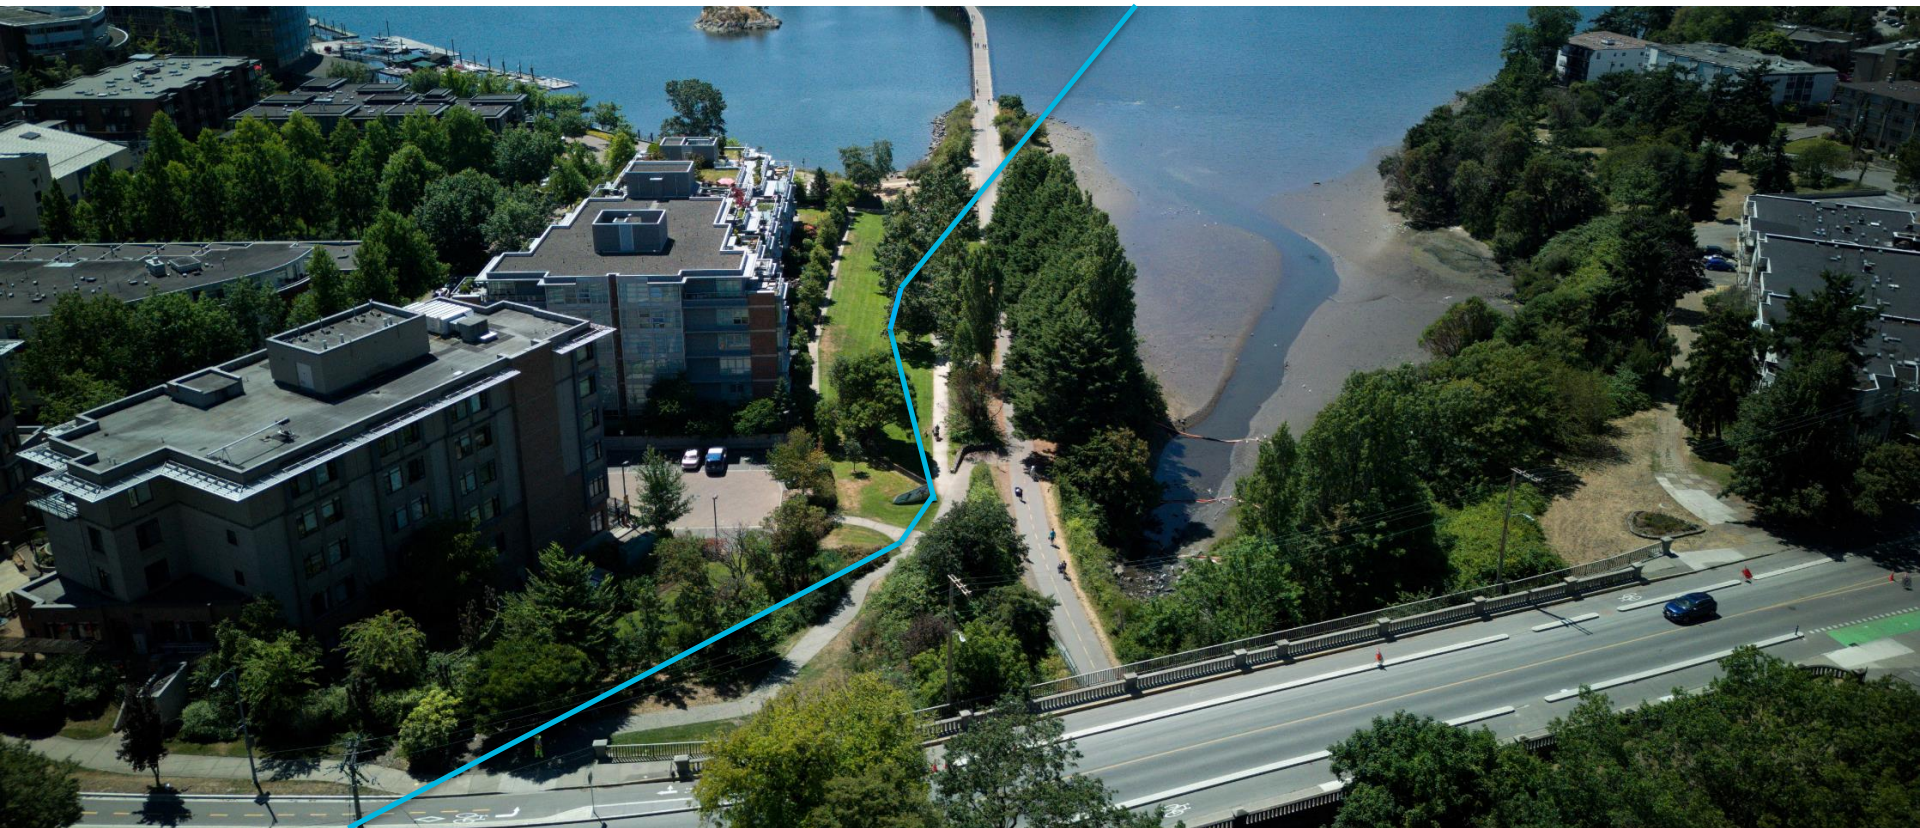
Viaduct Park construction timing

July 16: Panoramic view of the Gorge Waterway, Cecelia Creek Park and Viaduct Park, and Gorge Road where the current cable duct bank work is located at bottom left. The blue line shows the location of the new cable route, with the planned work within the Gorge Waterway and within the parks to take place from November 2025 to March 2026. The schedule also accounts for trail improvement work up to Gorge Road.
