# Victoria to Esquimalt Cable Replacement Project – Community Construction Report #10

**February 2026**

# Project status

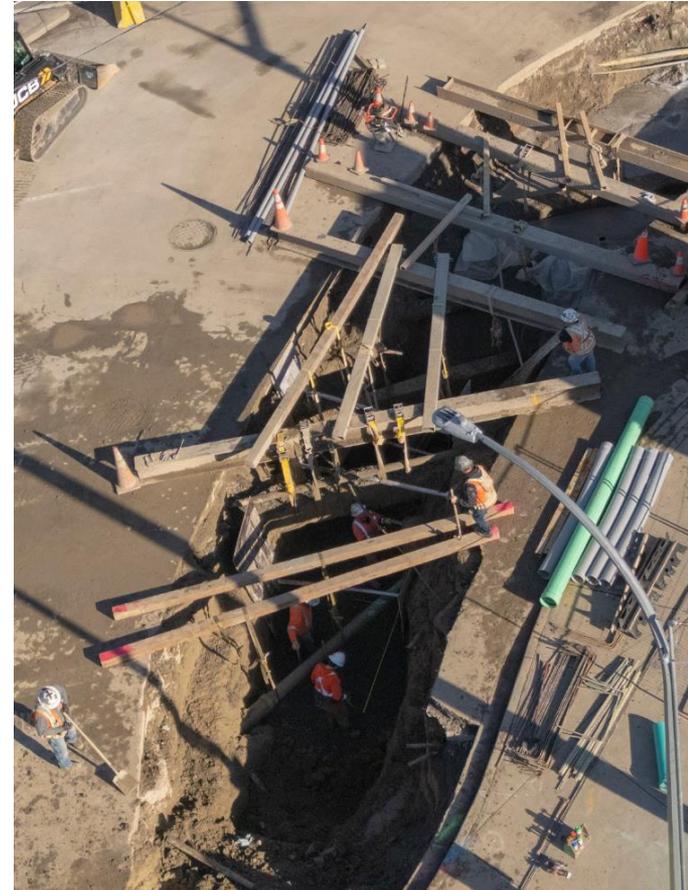
February 11: Duct bank work on Douglas Street and the bracing and protection of numerous utilities.

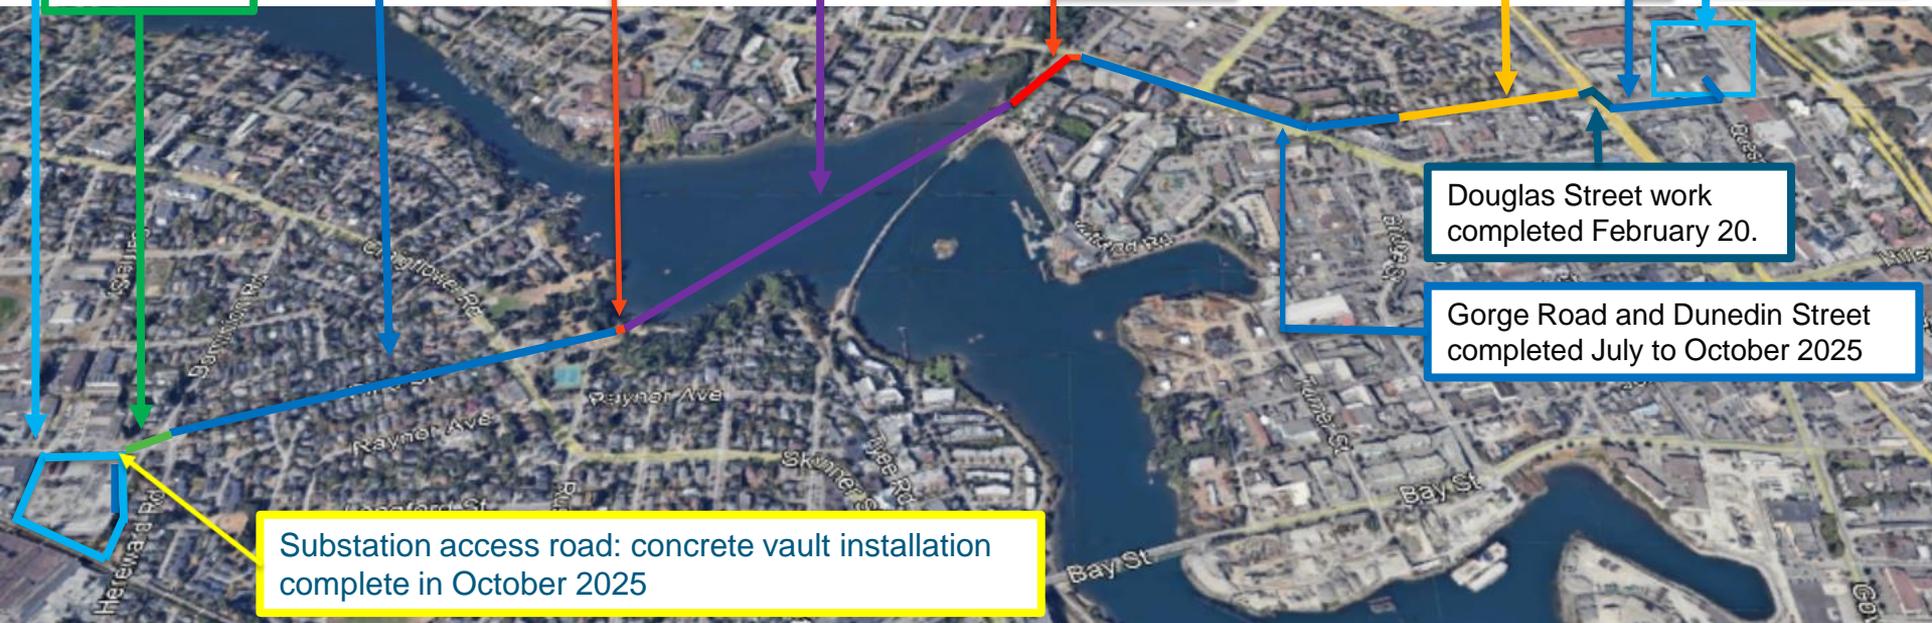
# Planning the cable route – construction timing

Esquimalt Substation (left) and Horsey Substation work February 2025 to November 2026.

Pine/ Hereward/ Dominion/ Devonshire intersection: April-May 2026.

Pine St and a section of Banfield Park completed June 2025

Banfield Park: work to November 2026

Gorge Waterway shallow burial and adjacent parks: Summer 2026 fisheries work window – July 1 to October 1

Gorge Road and Viaduct Park: work in November 2025 to November 2026

Dunedin Street: Crews will work westward mid-February through March 2026

Topaz Avenue: completed December 2025

Douglas Street work completed February 20.

Gorge Road and Dunedin Street completed July to October 2025

Substation access road: concrete vault installation complete in October 2025

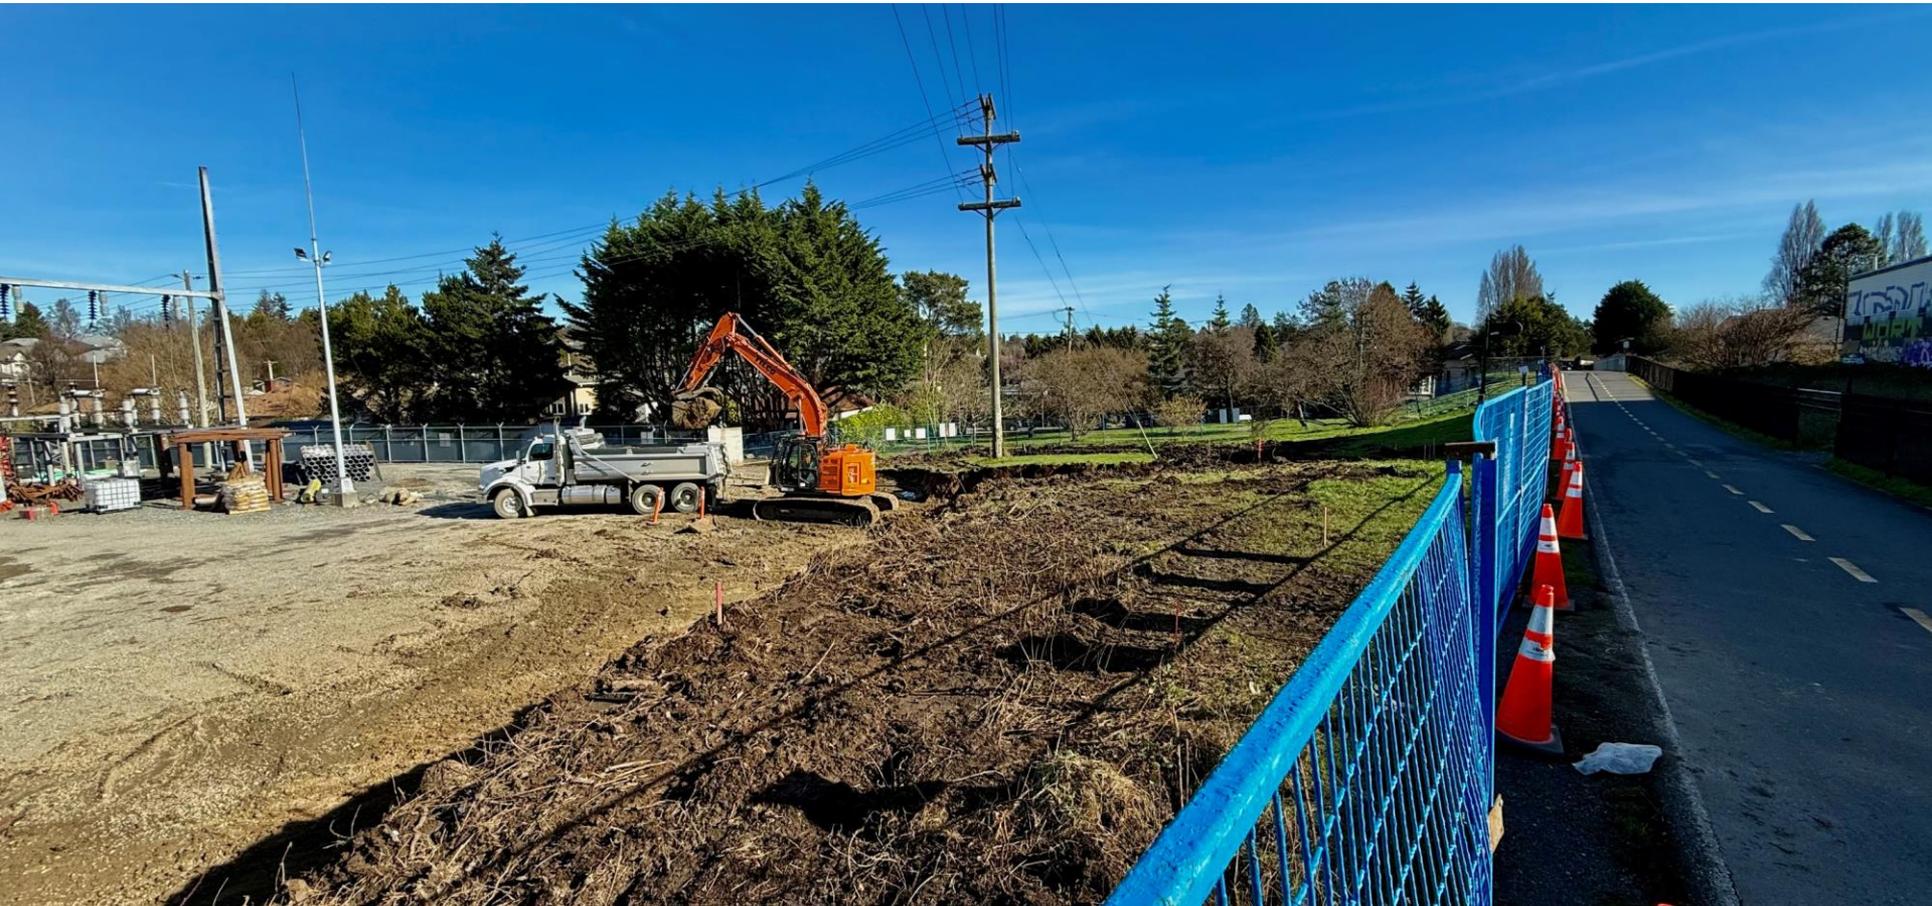
February 11: Earthworks construction work to expand the substation footprint and enable the placement of the cable duct bank. E&N Trail on the right.

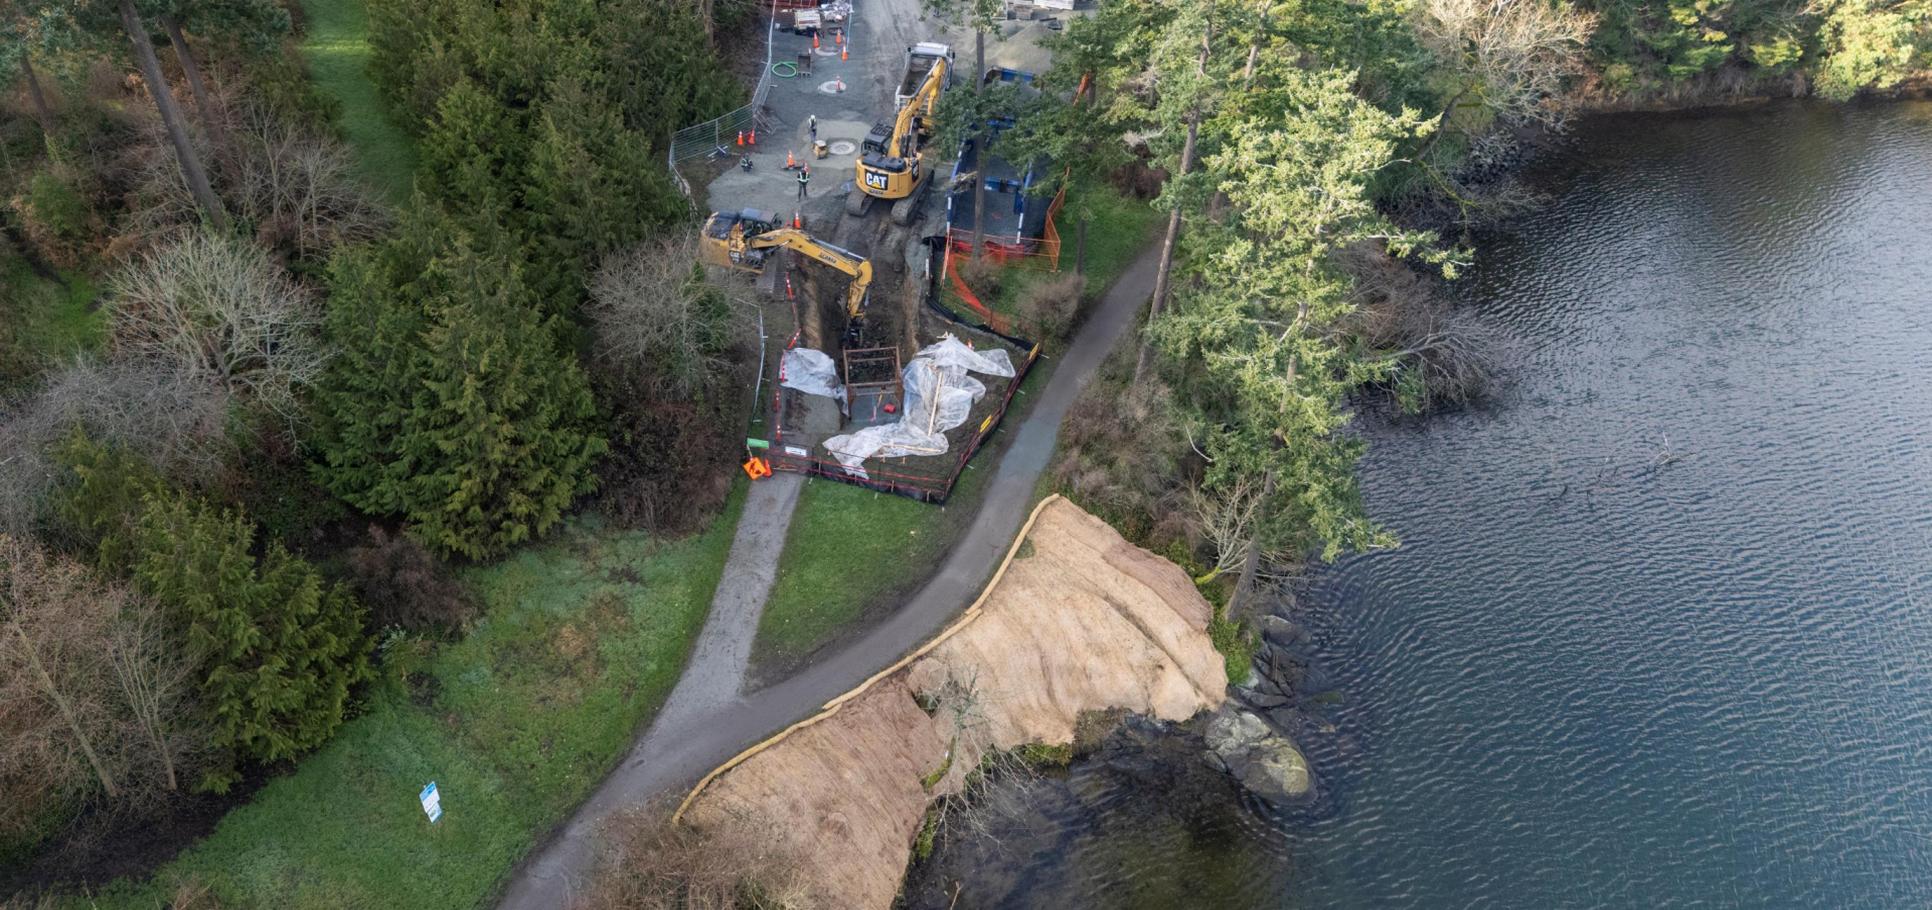
February 11: View of the construction work area. To prepare for marine work this summer, vegetation was removed within the foreshore area prior to the bird nesting season.

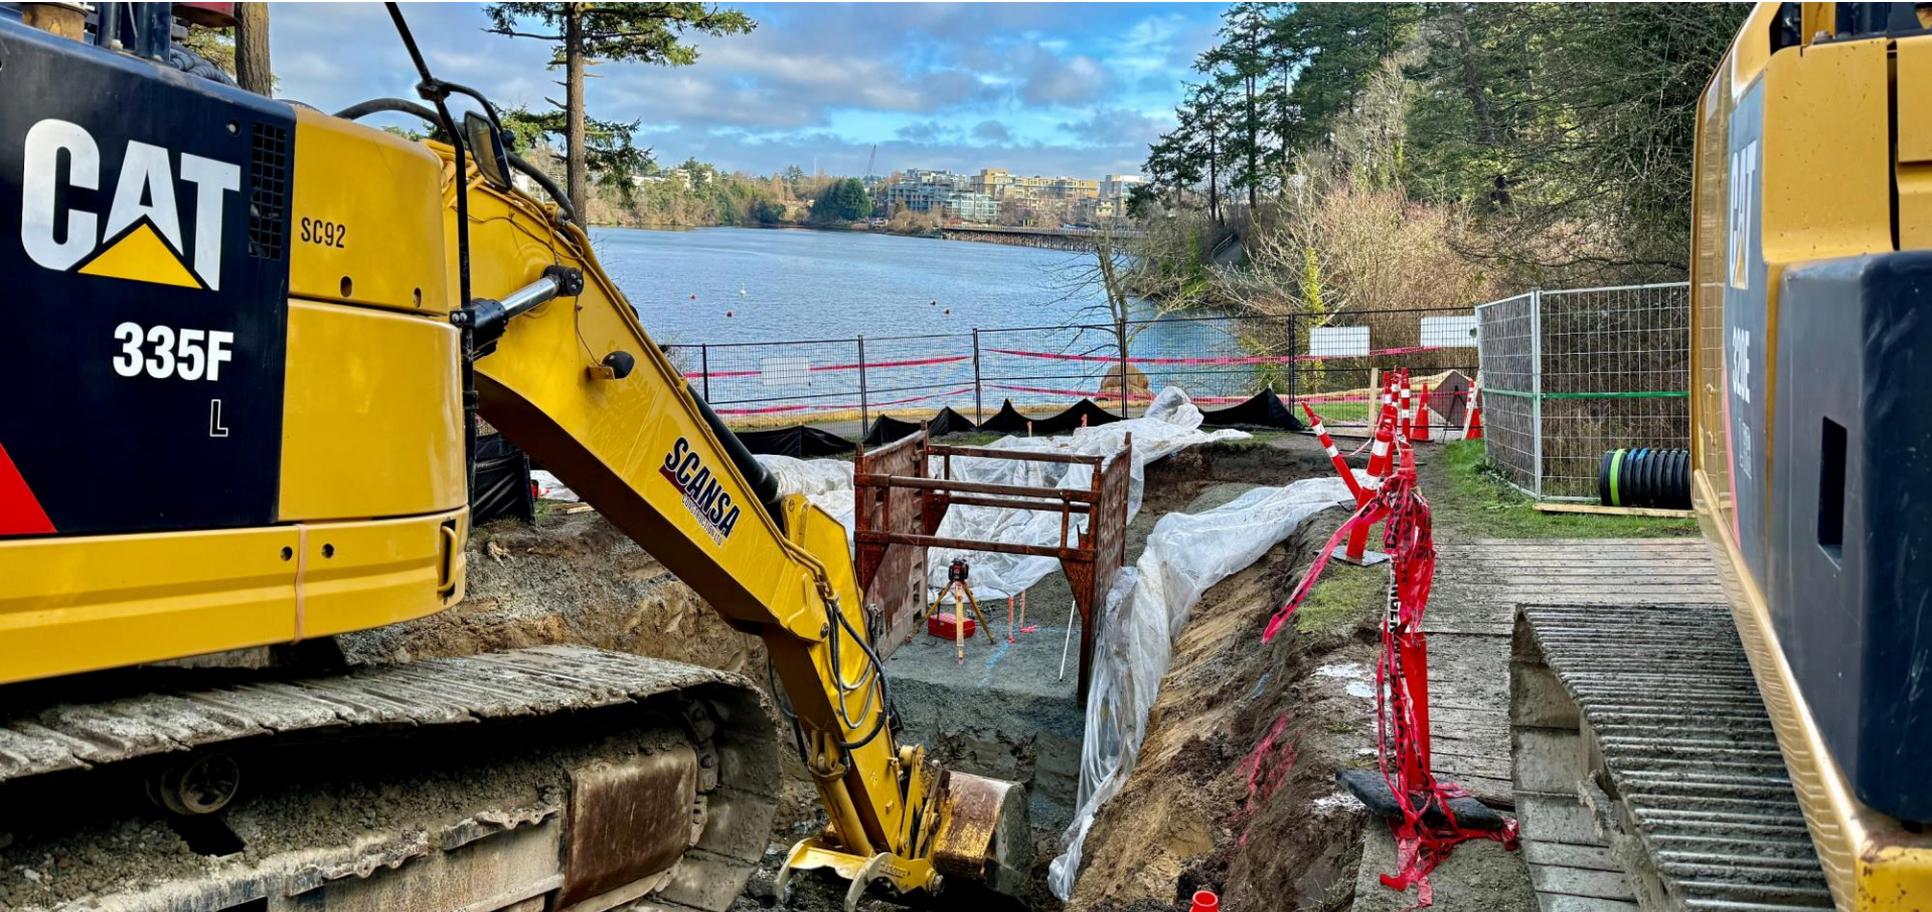
February 11: Work area for a section of duct bank from the concrete vault to near the foreshore area. The lower trail by the foreshore remains open for pedestrians and bikes. Scansa Construction Ltd is our contractor for this short section of the duct bank work.

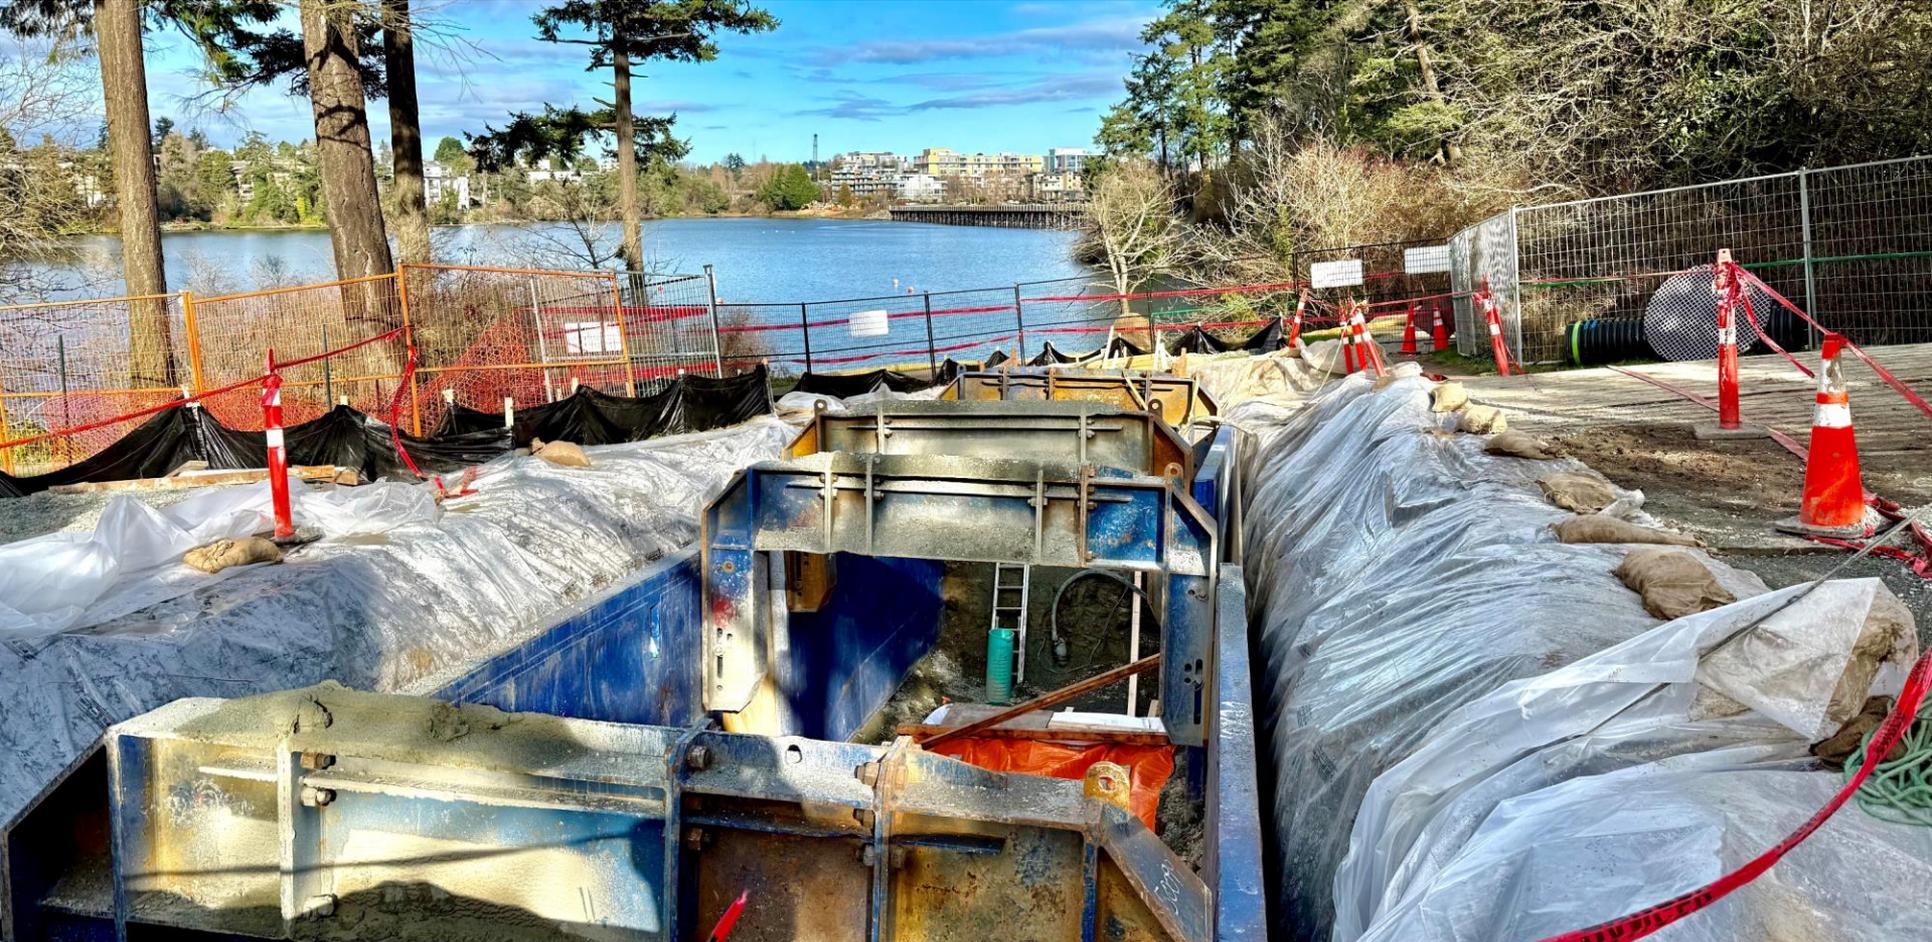
February 19: Vantage from above the concrete vault showing the fully excavated area and shoring.

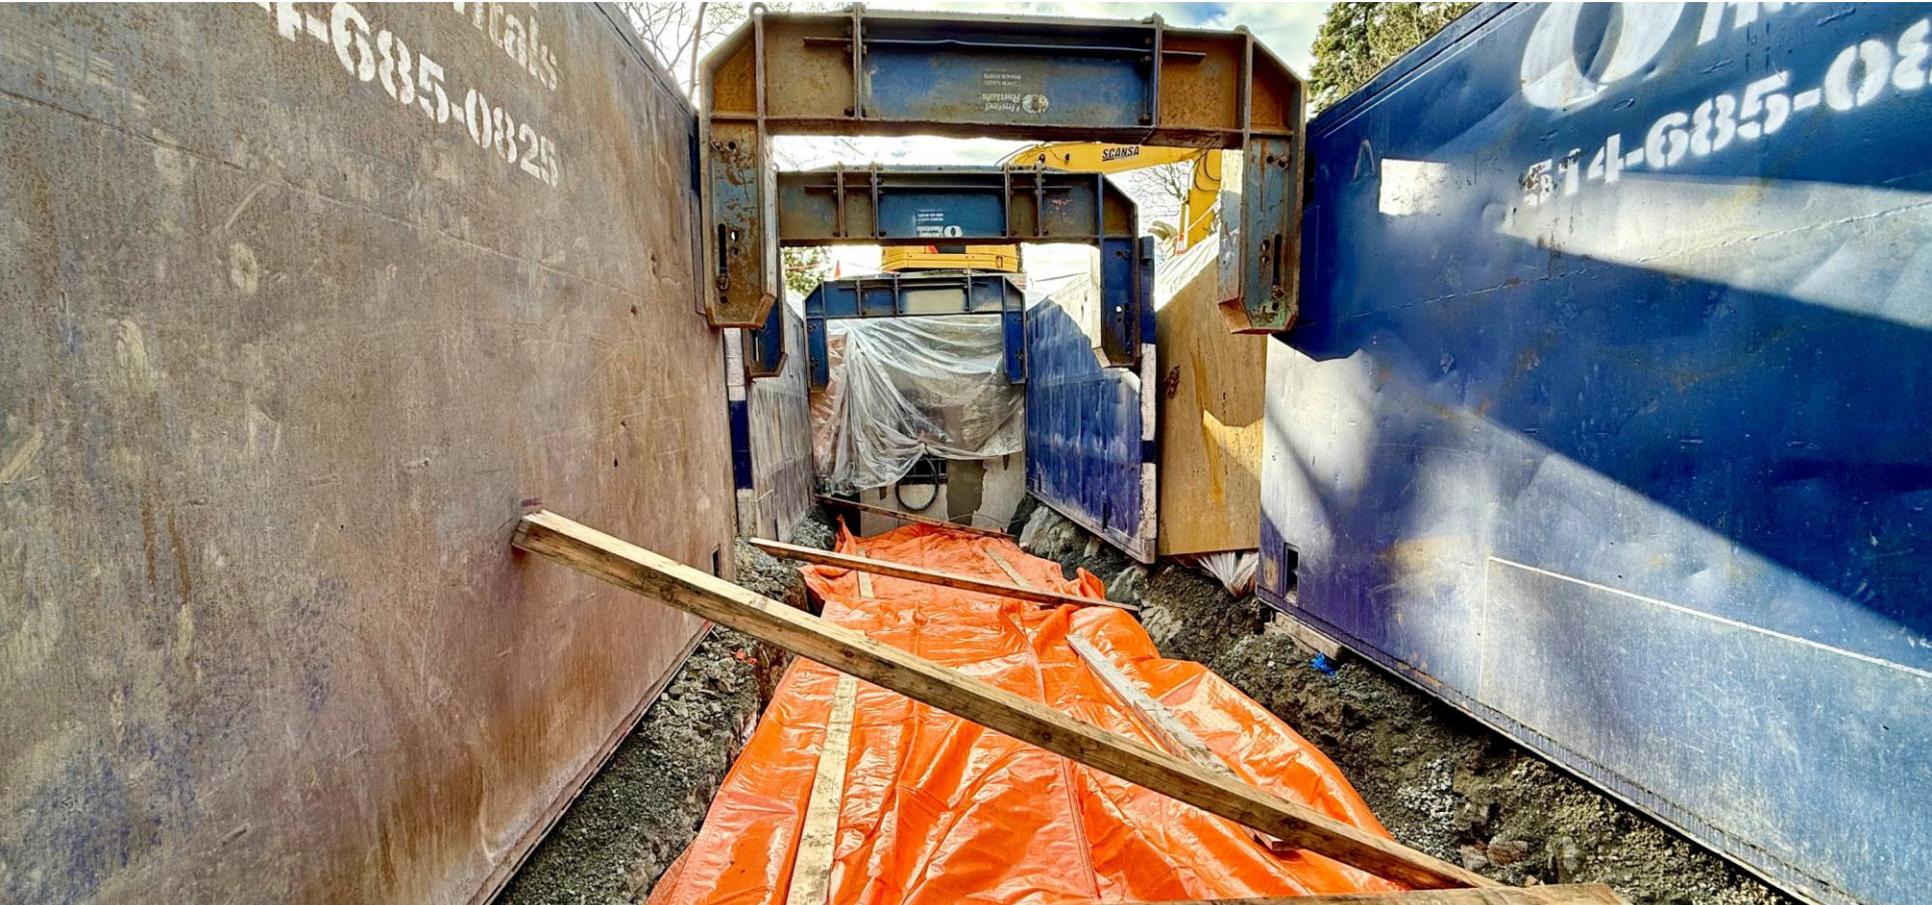
February 19: The excavated area looking back towards the concrete vault. The concrete foundation for the concrete anchor base is under the orange tarp.

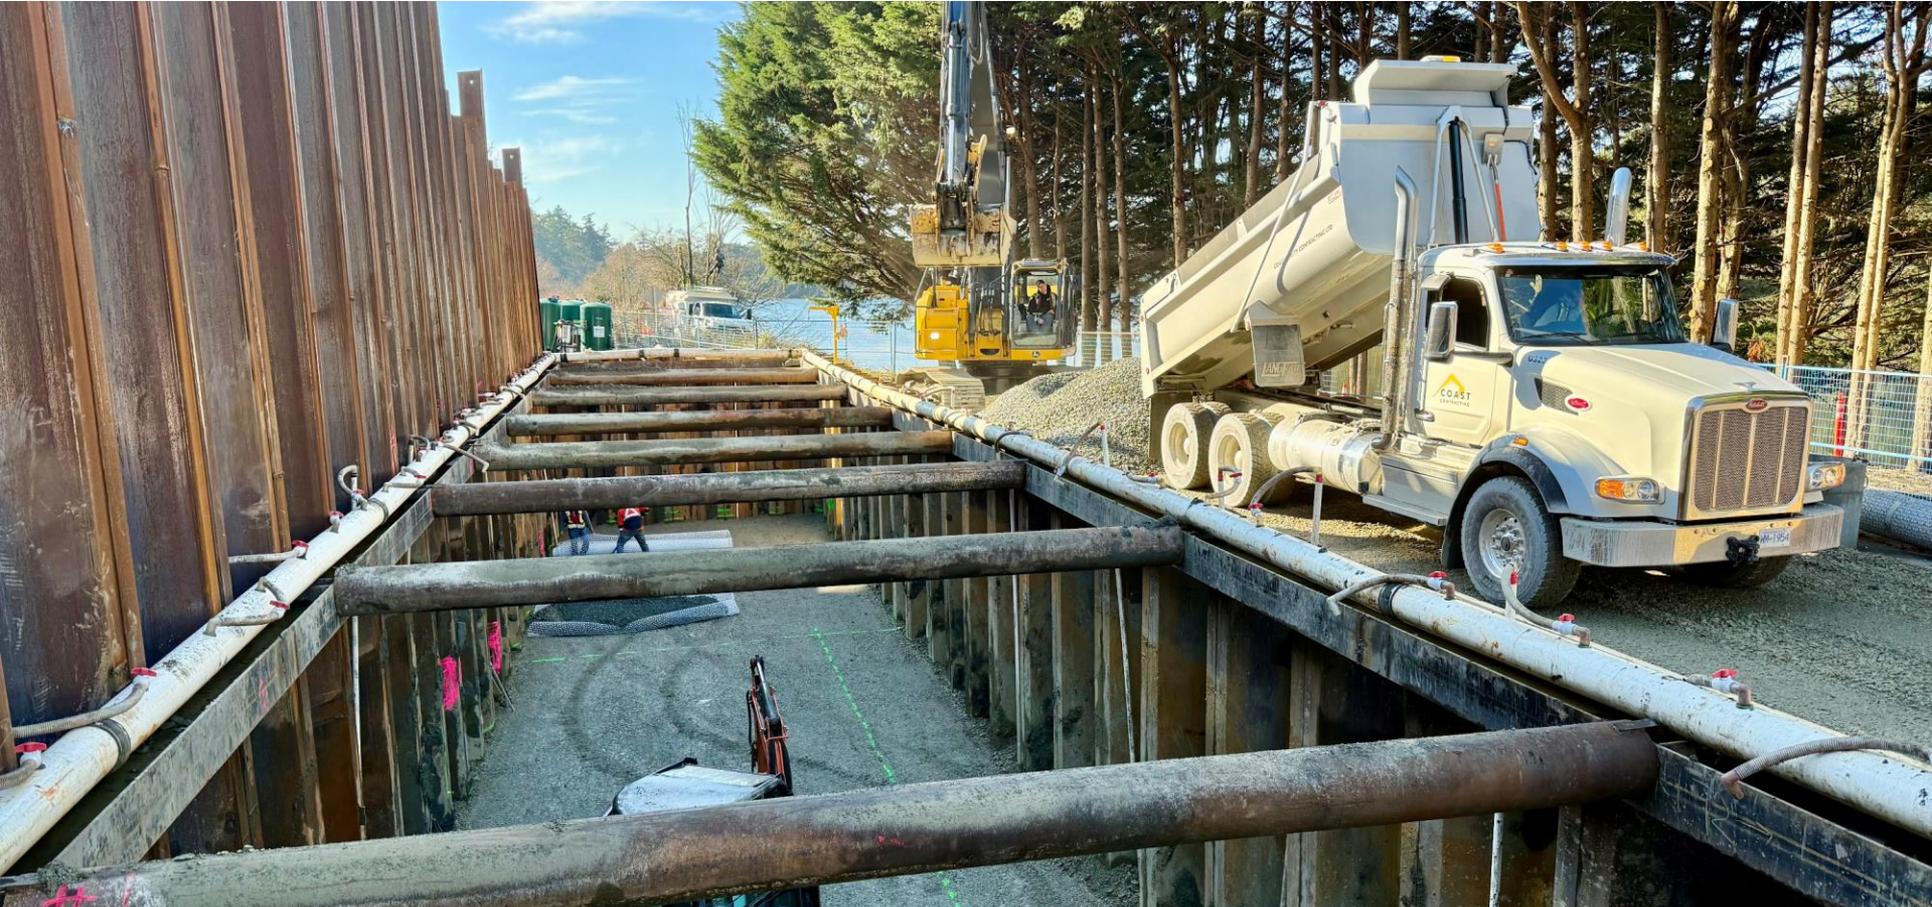
February 5: Completed excavation for the concrete vault and the placement of the gravel base. Green dashed lines are being placed to outline the placement of the 20-metre-long vault. In the background, removal of vegetation adjacent to the Gorge Waterway.

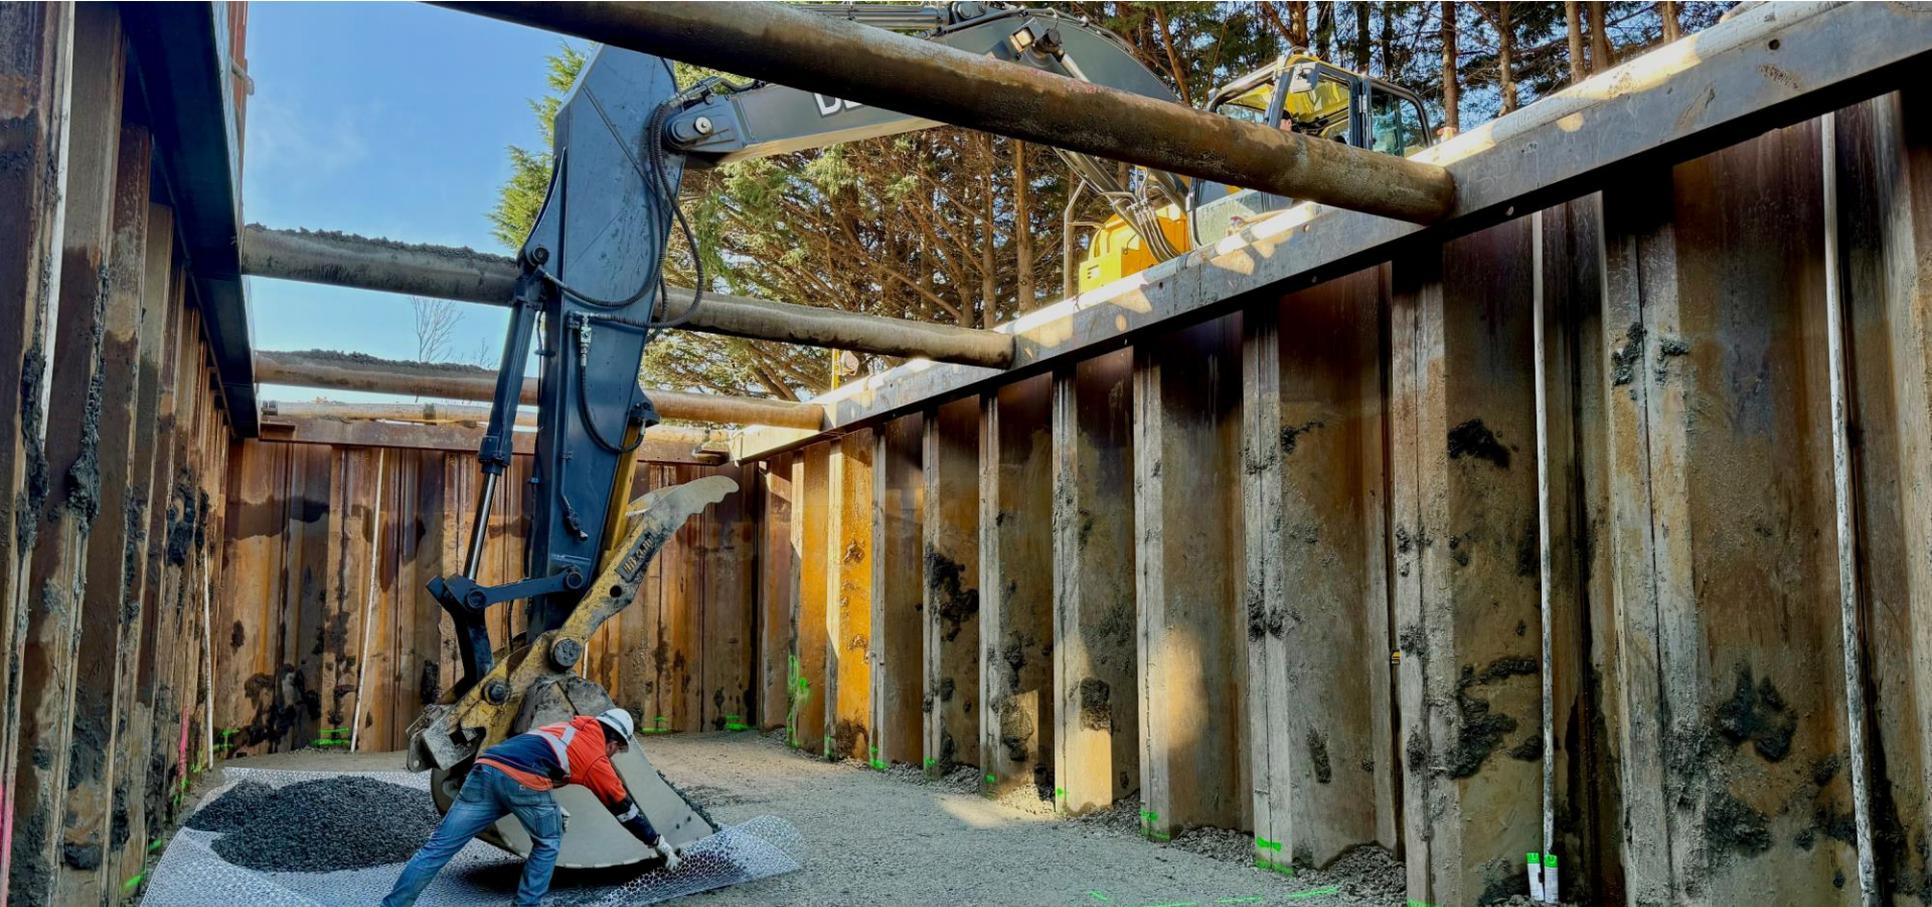
February 5: Within the excavated area for the vault looking westward, crews placing geo-tech mesh every 30 cm to maintain a good gravel base. The excavator above lowers the gravel into place.

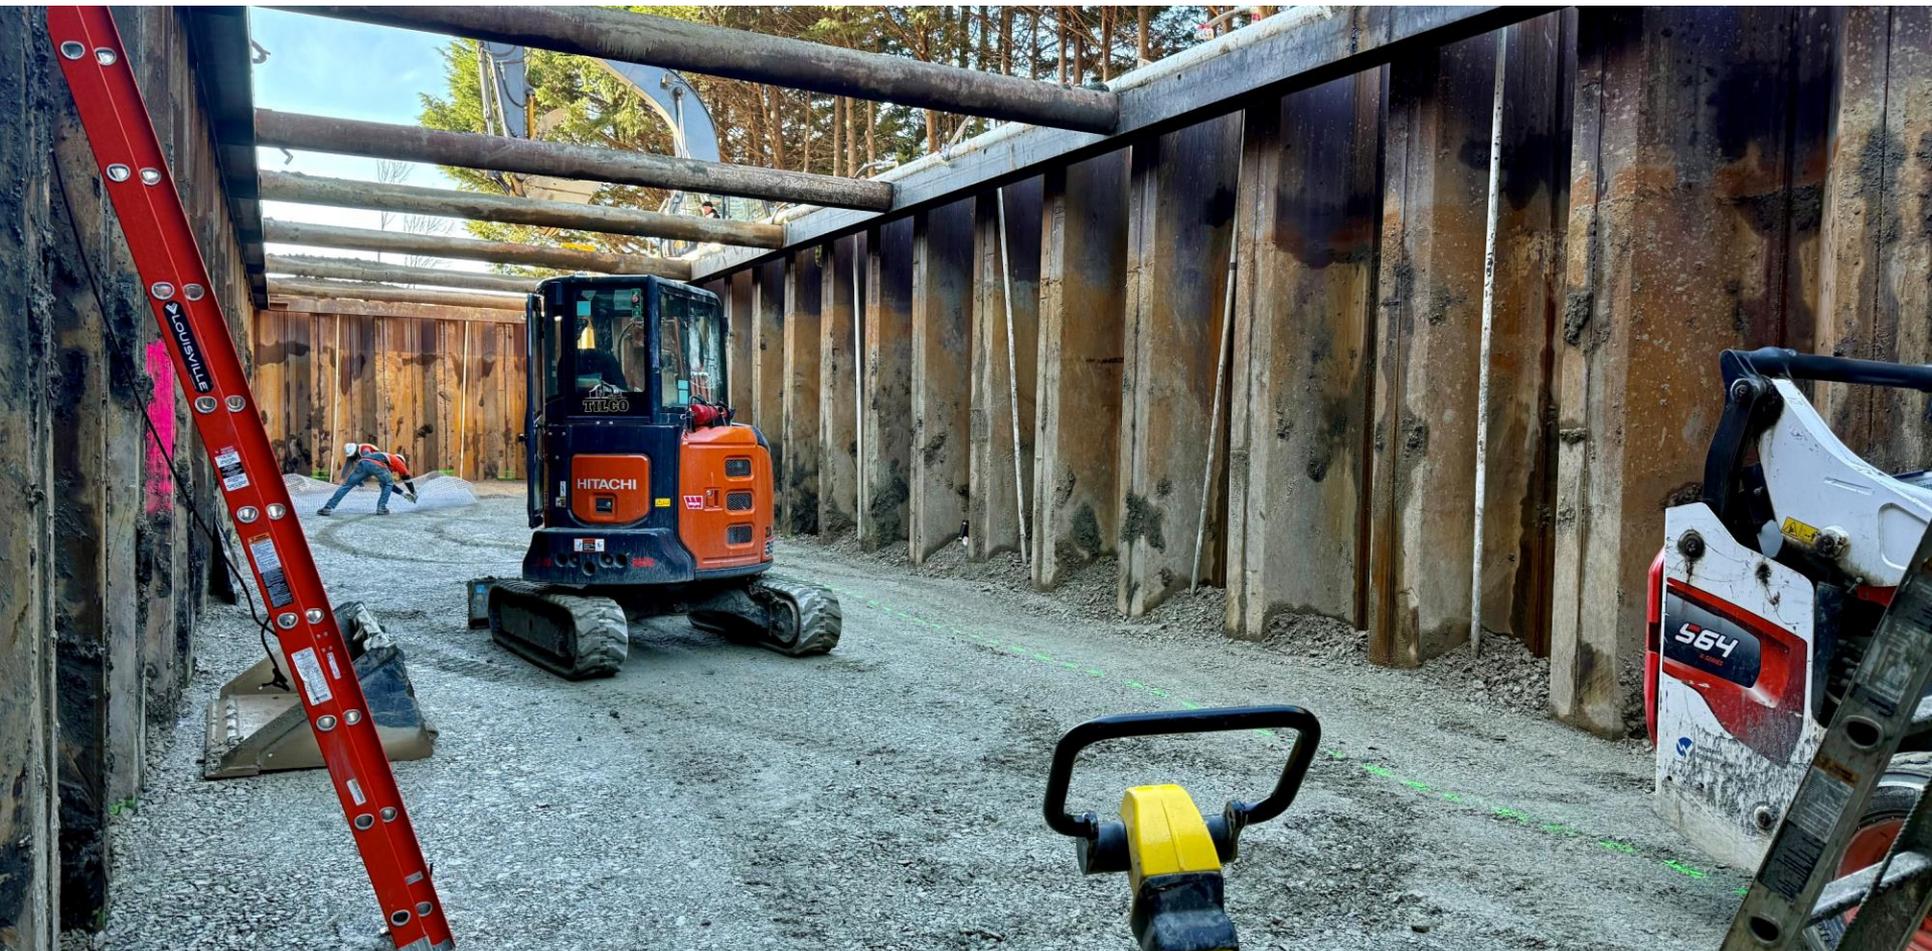
February 5: Inside the bottom of the excavated area looking westward.

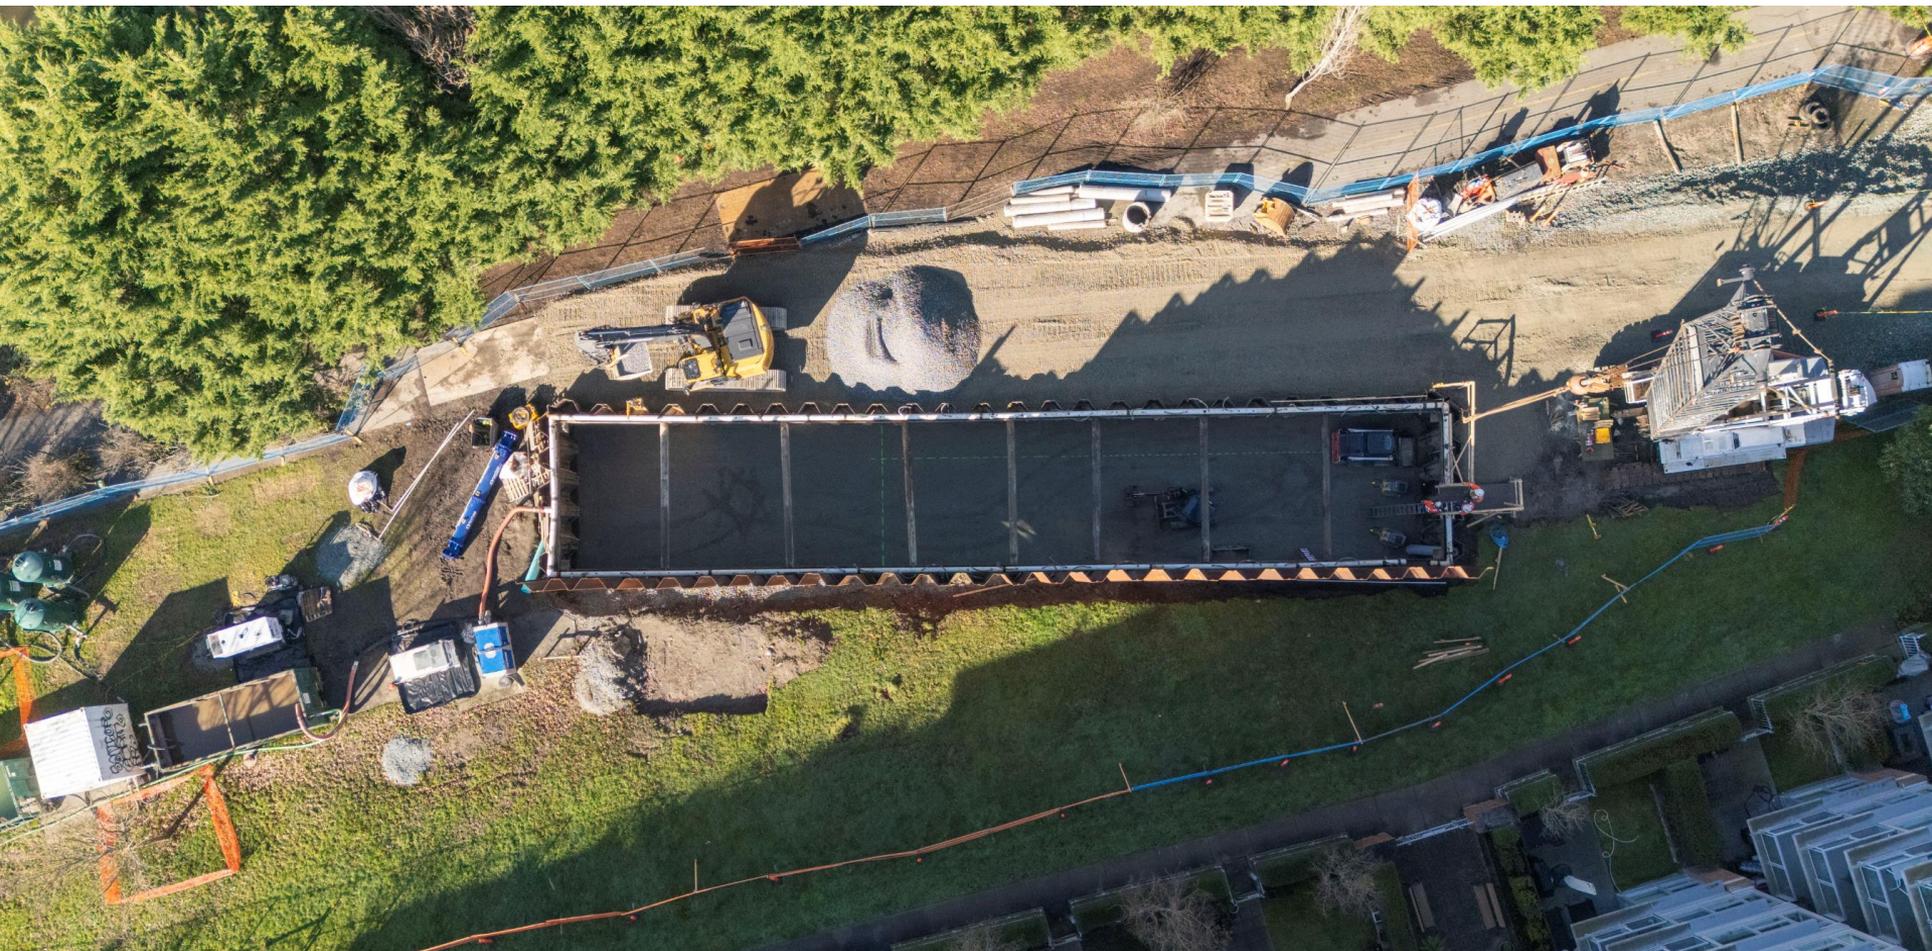
February 5: View of the sheet pile work area for the vault.

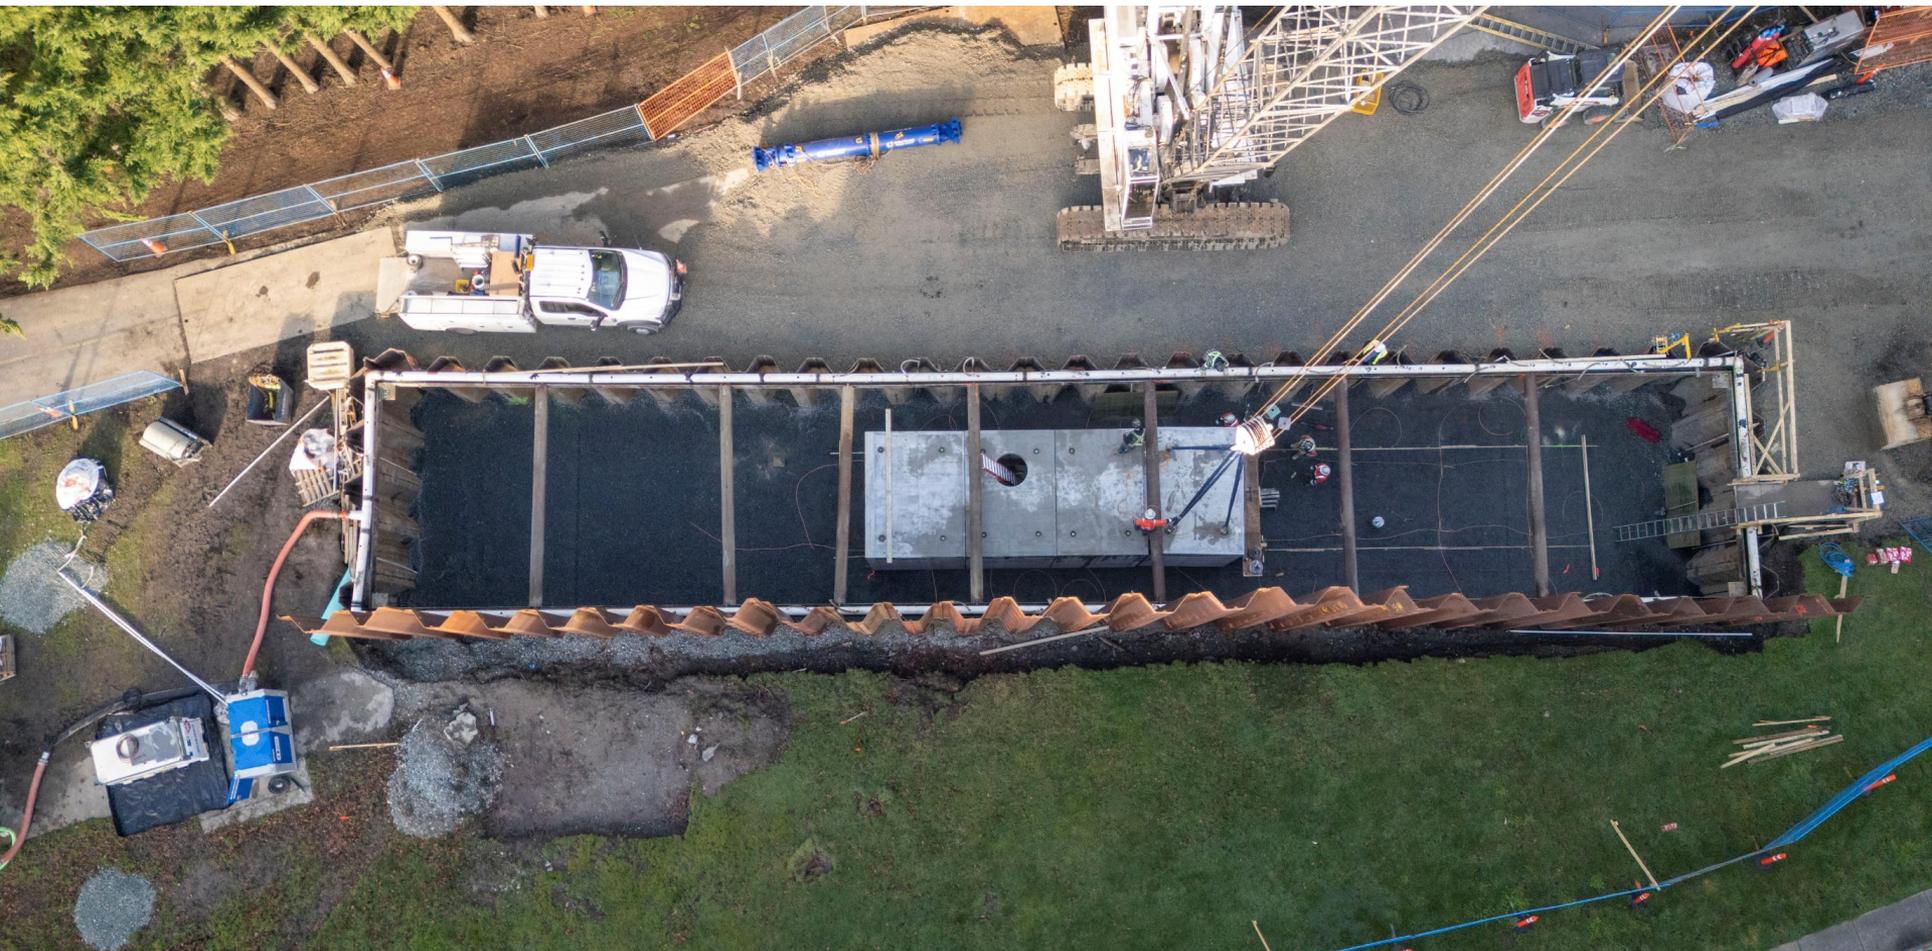
February 11: Placing the fourth of eight sections of the concrete vault. The vault was installed over a three-day period.

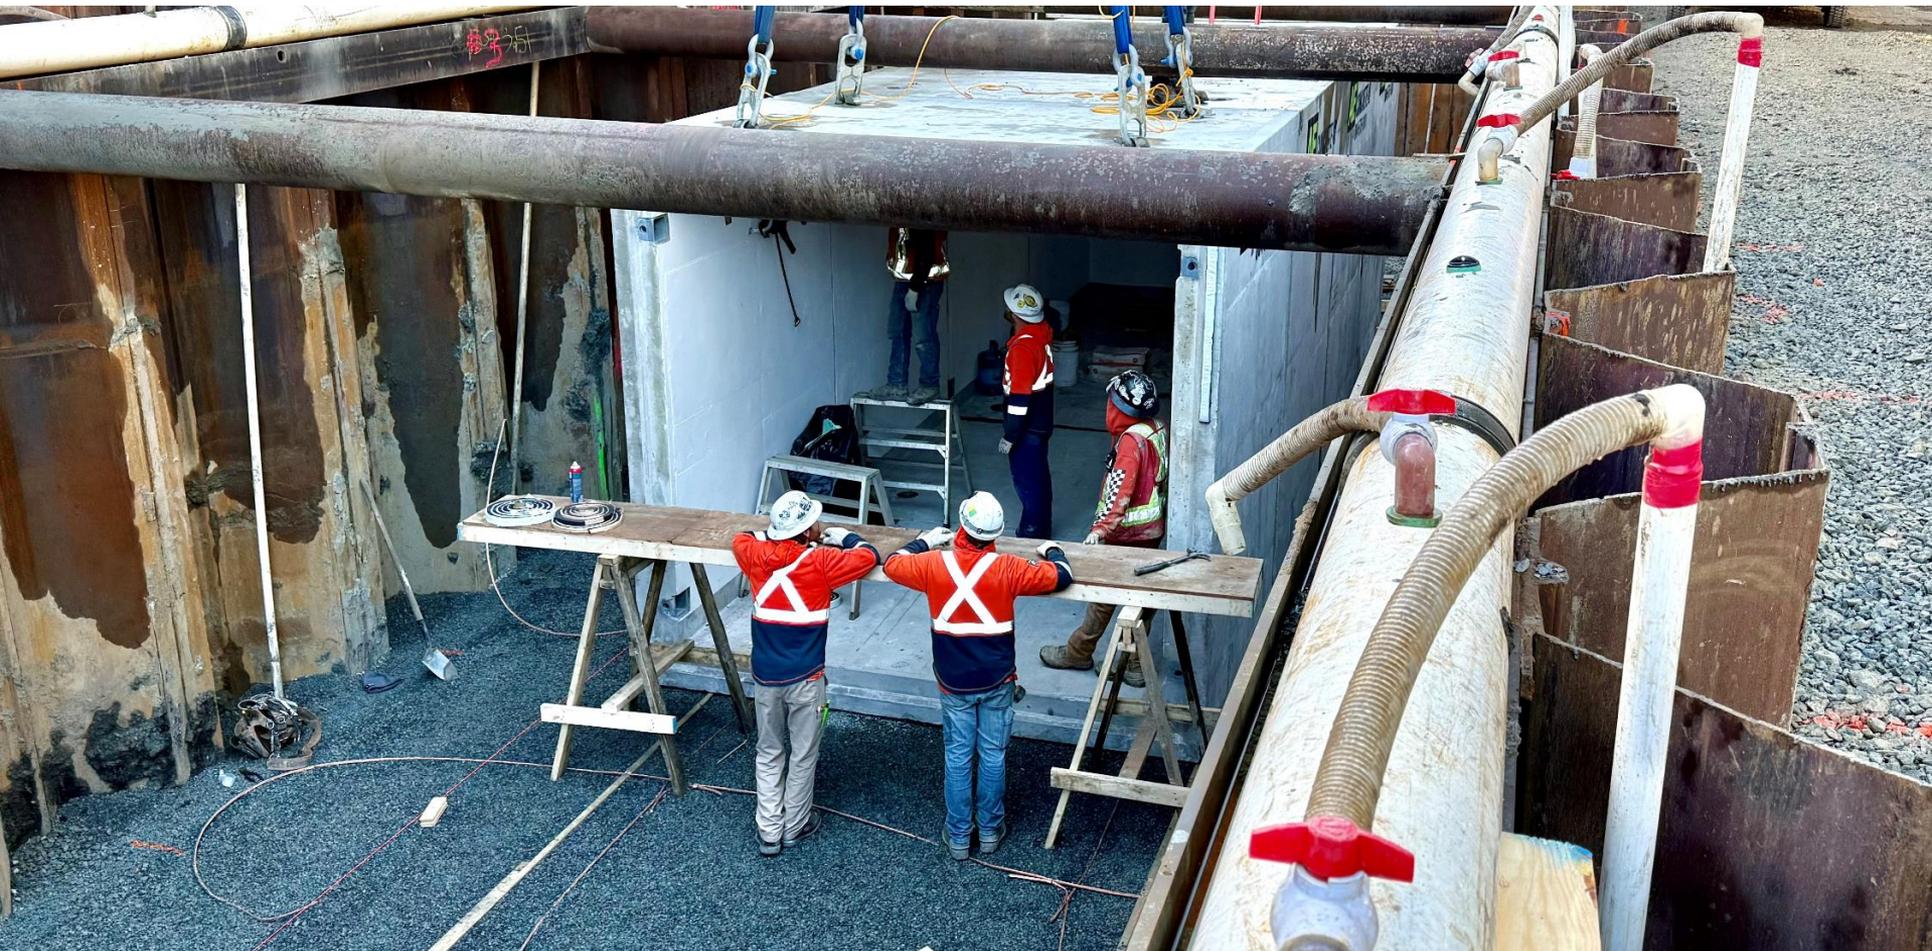
February 11: Making the final alignment adjustments on the positioning of the vault section.
