# Victoria to Esquimalt Cable Replacement Project – Community Construction Report #10

**February 2026**

# Project status

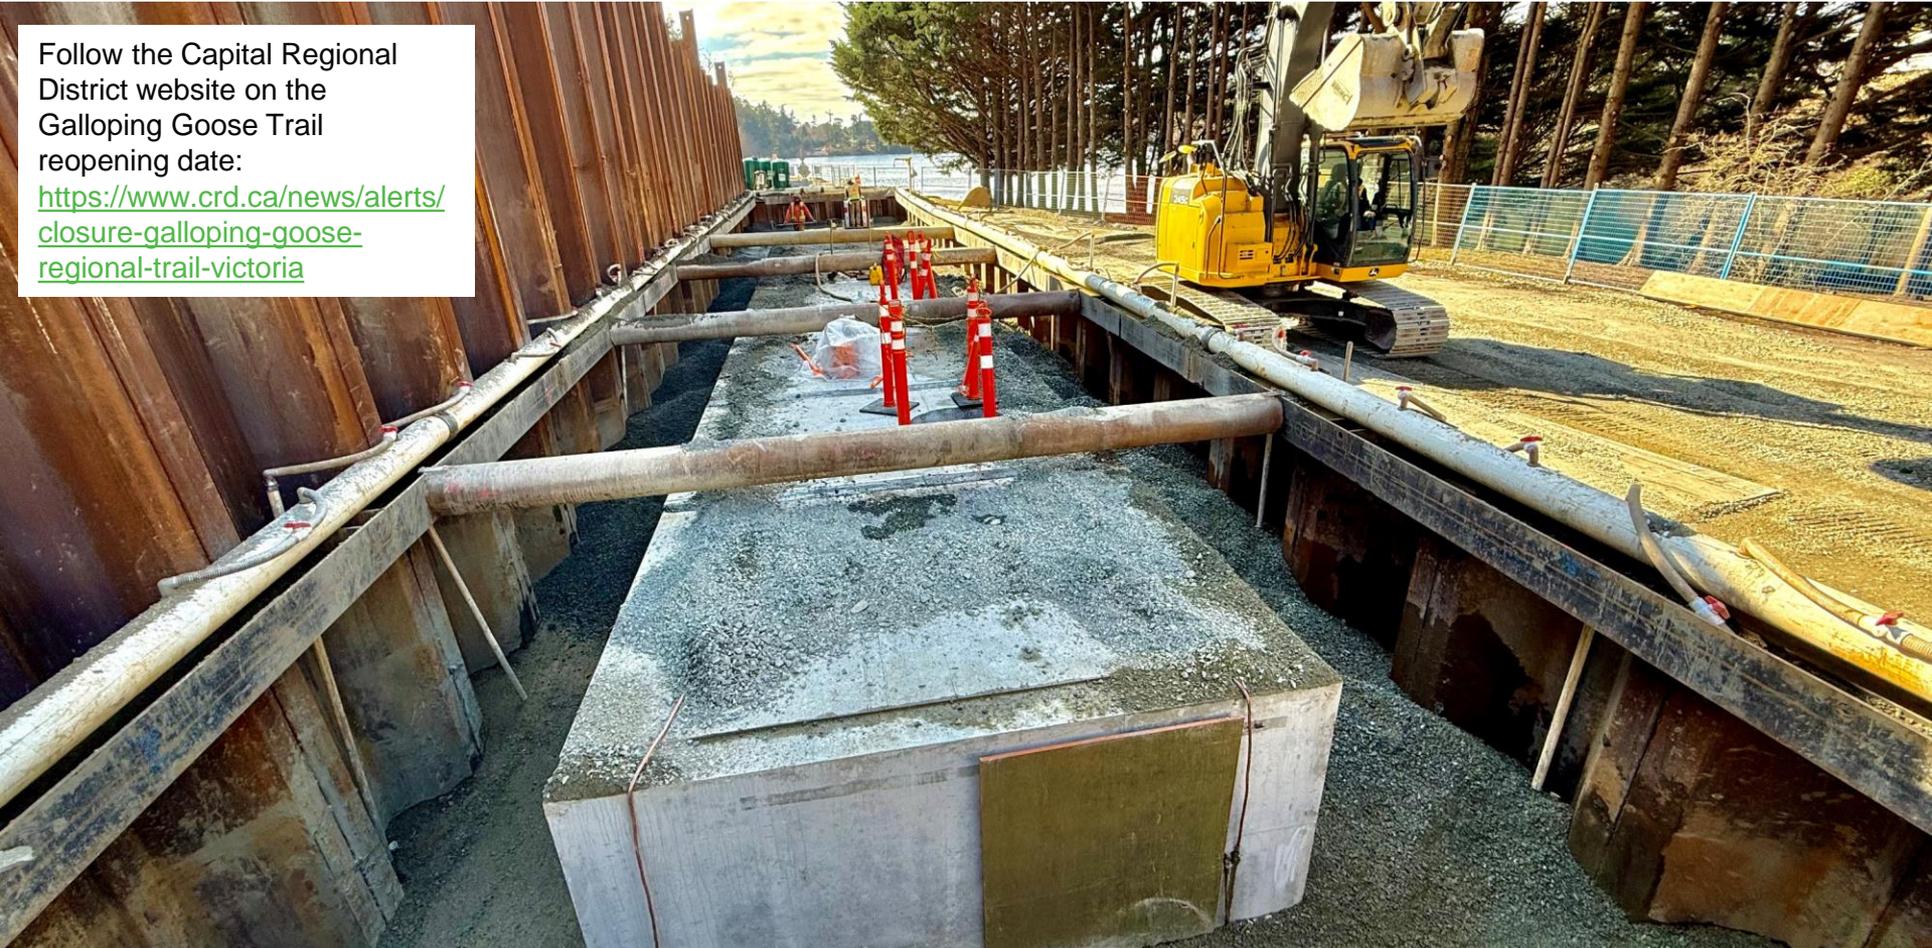
February 19: Filling in the area around the vault. The sheet piles around the area are being removed February 24 through March 6.

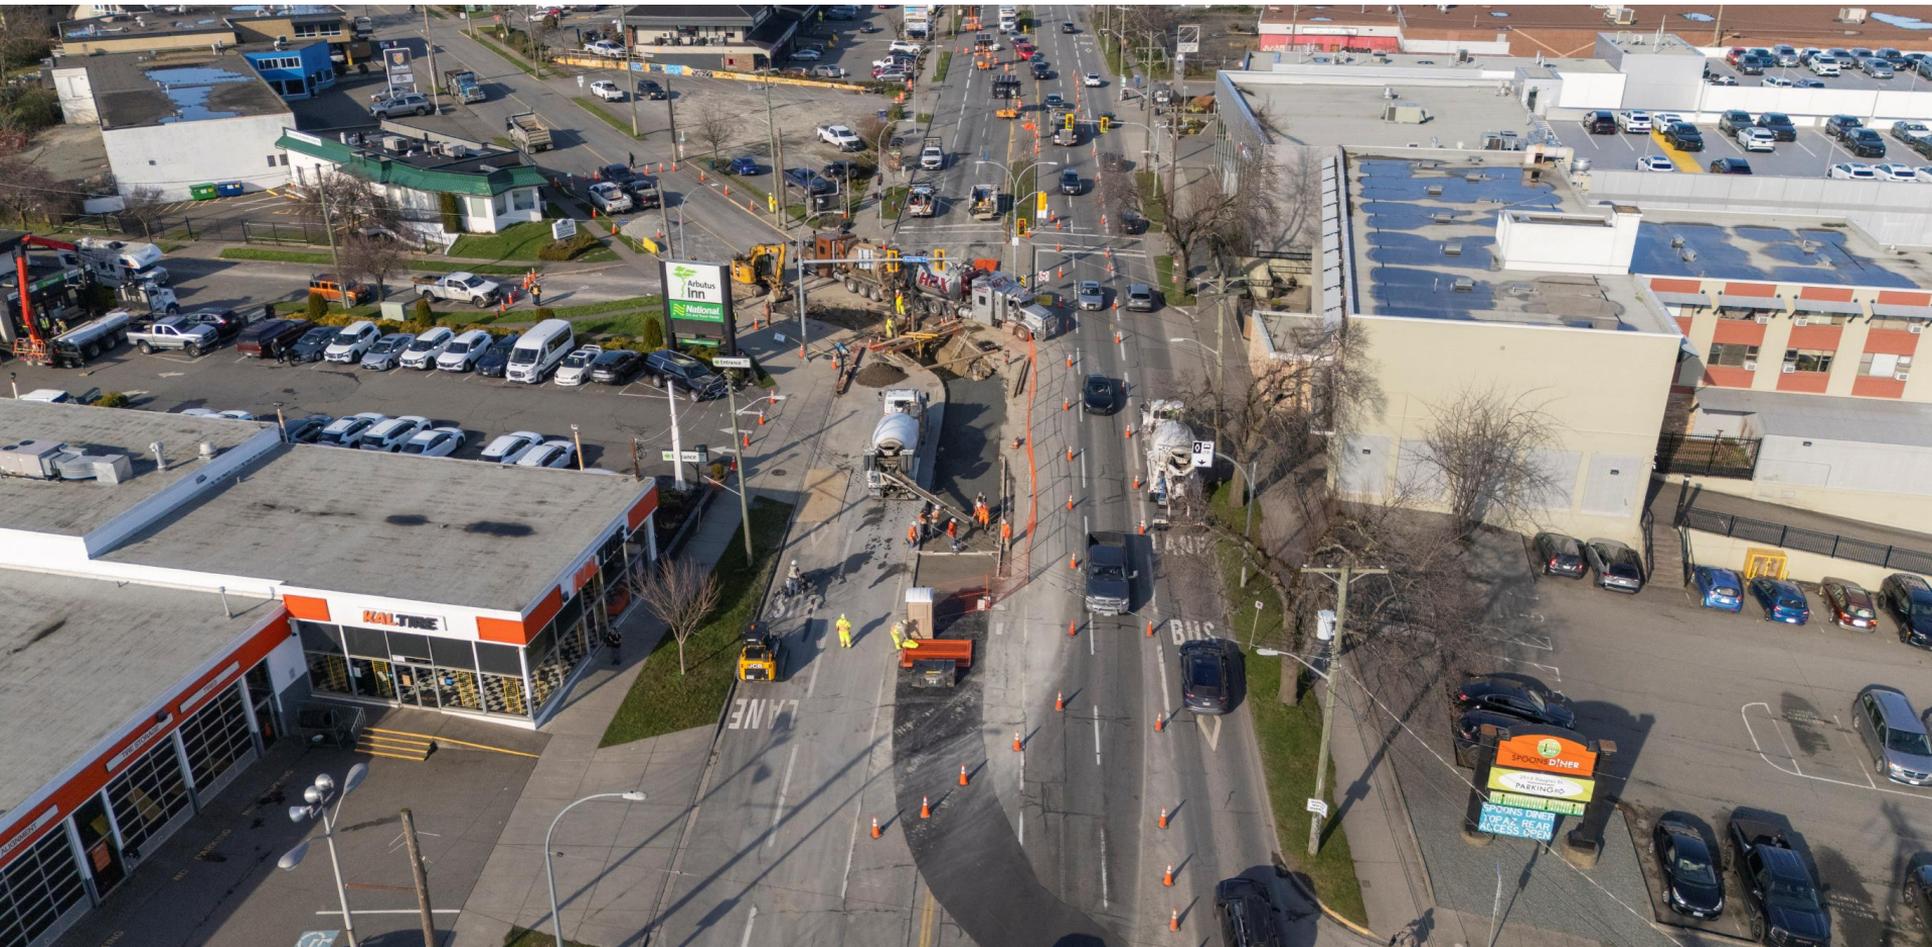
February 5: Comprehensive view of the work area and the duct bank work going across Douglas Street from Topaz Avenue.

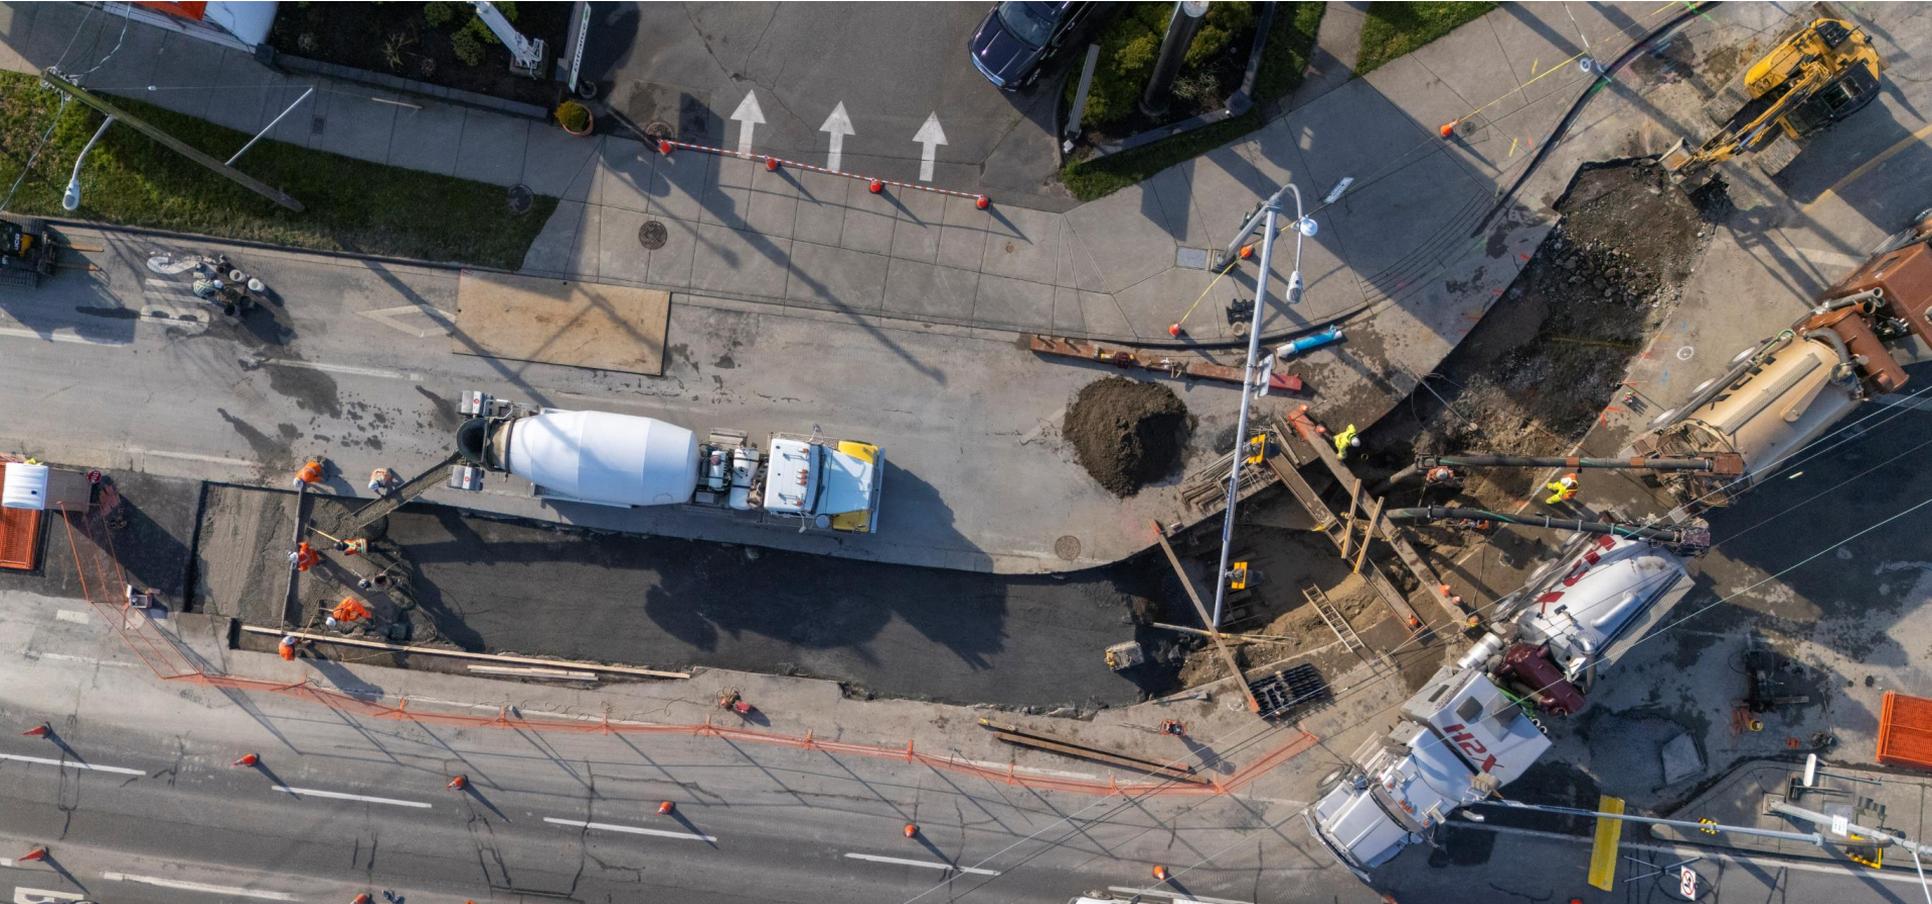
February 5: Duct bank work showing two Hvac Trucks removing soils and clay between numerous underground utilities on the right, and on the left, the placement of the concrete road base in advance of asphalt placement.

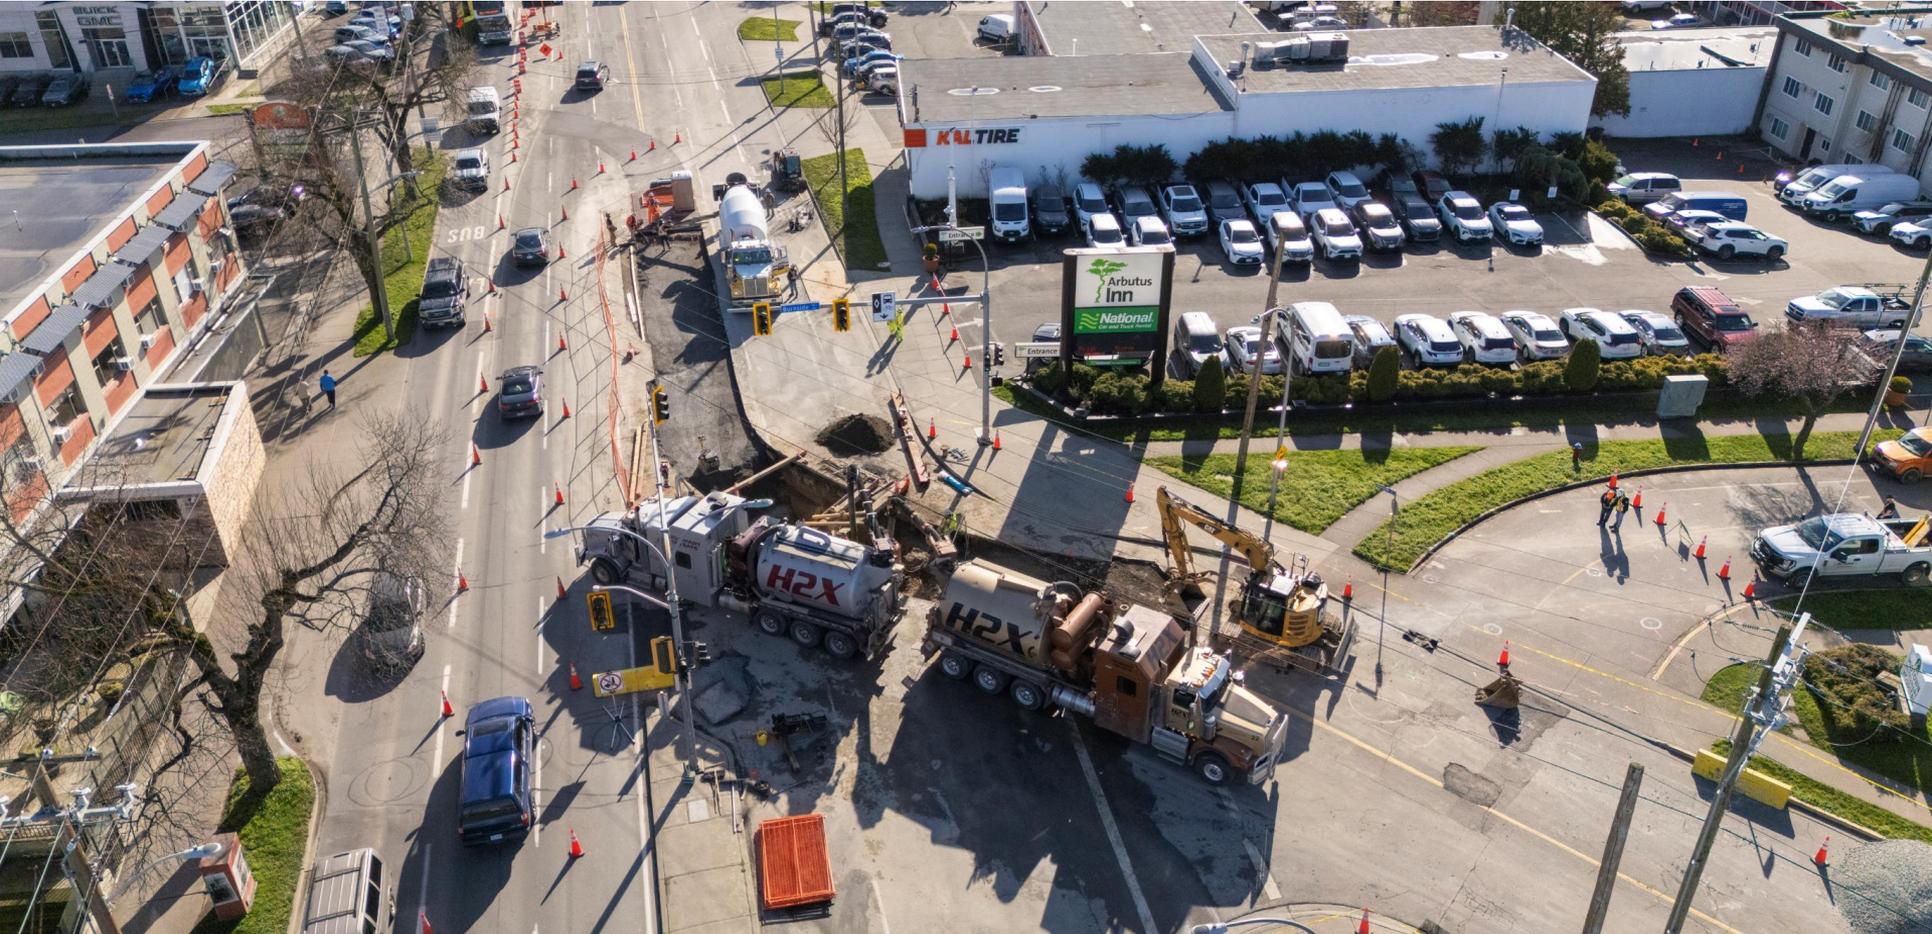
February 5: Douglas Street work area.

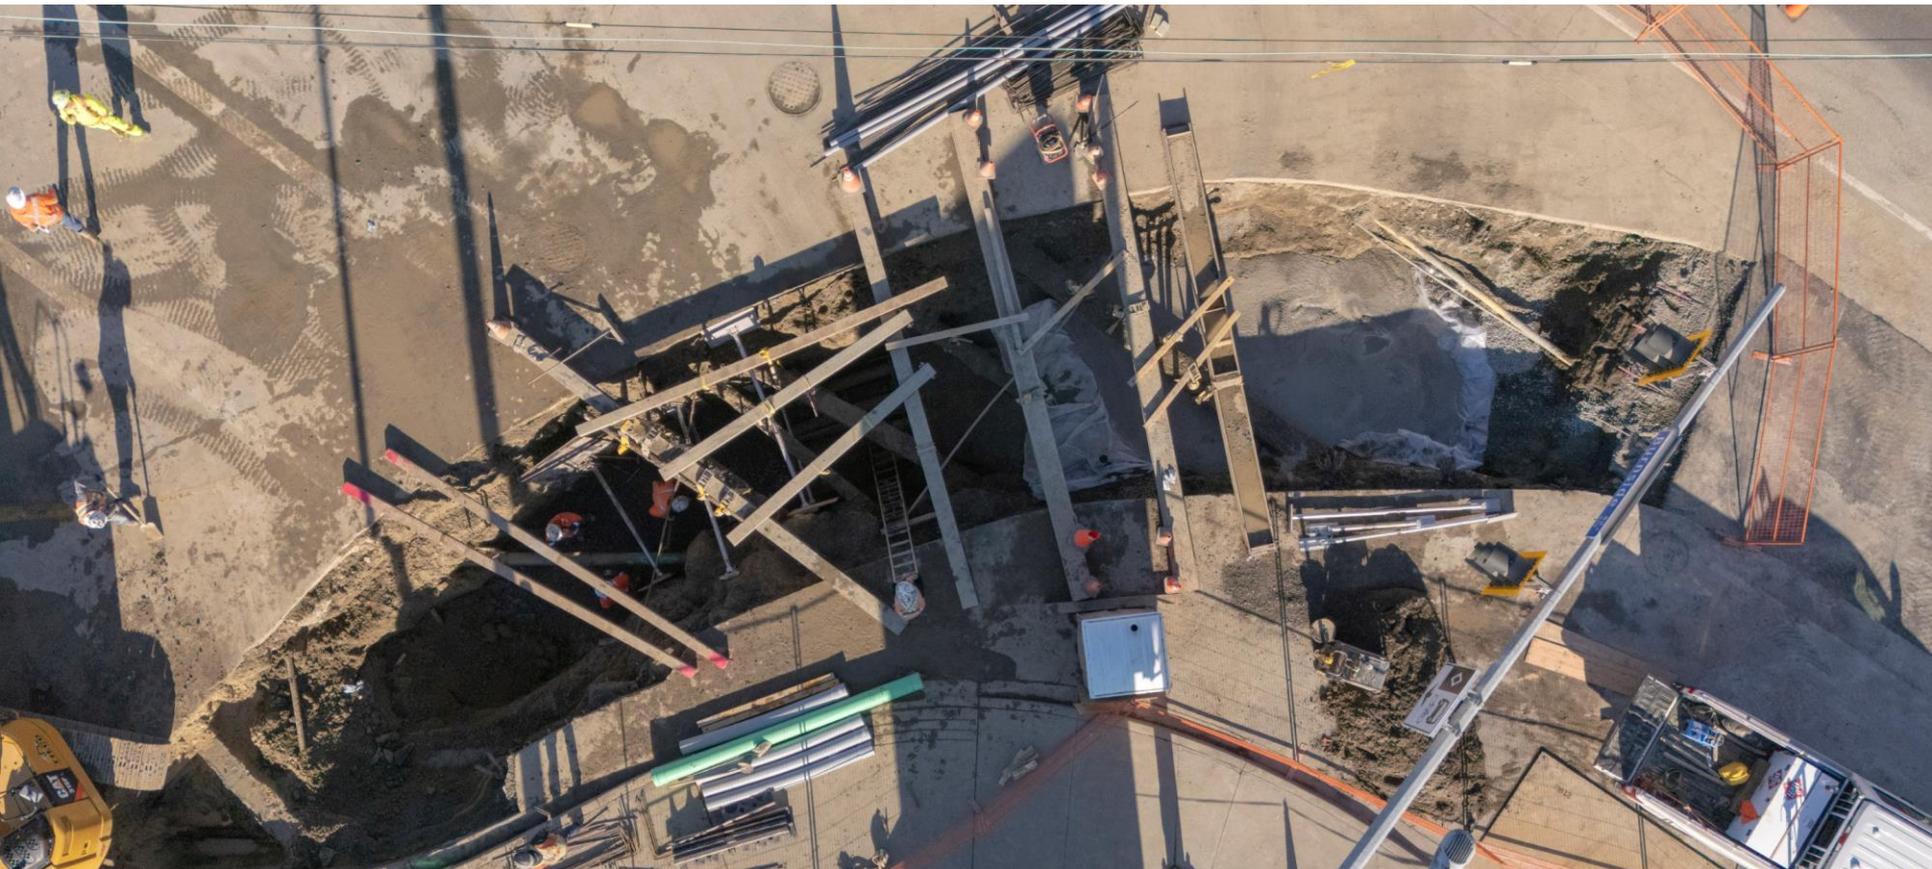
February 11: Bird's-eye view of the complexity of the duct bank work going under the many utilities and turning towards Burnside Road. The work in this area included three concrete placements: one for the duct bank conduit; one for a special concrete mix (shown on the right of the photo) to keep the cables cool given the lower ground depth; and one for the road base.

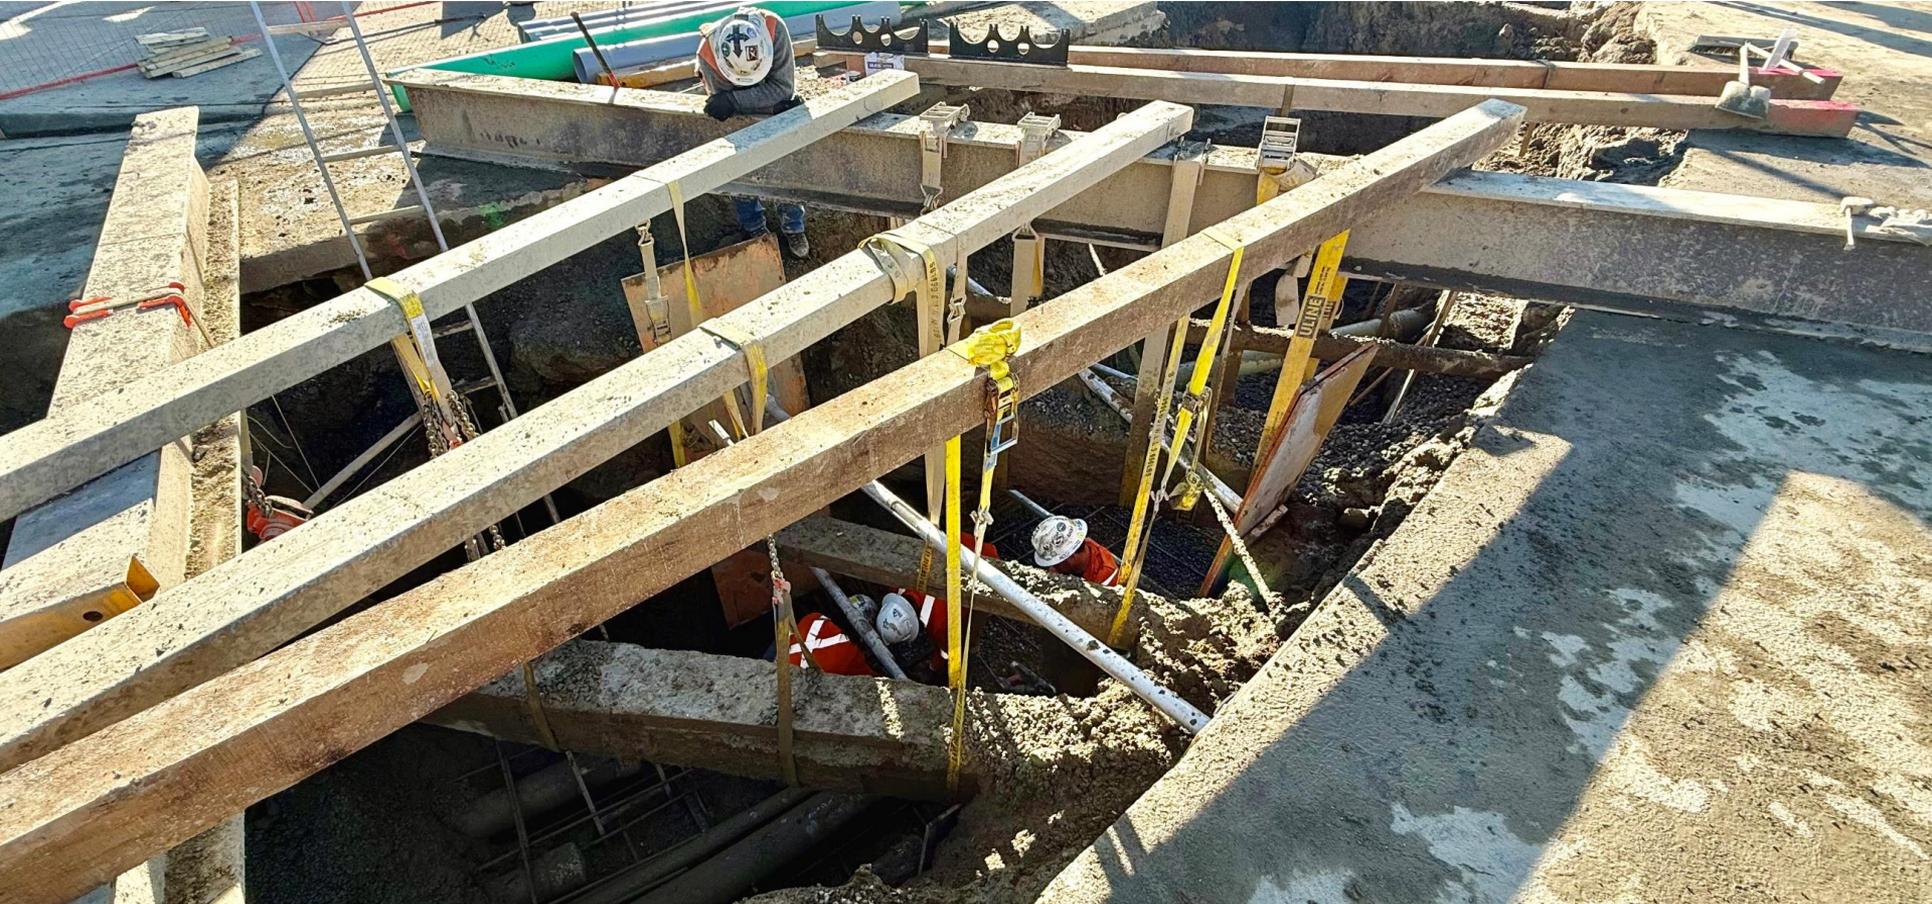
February 11: Crews placing the duct bank works under the numerous braced utilities. The soil in this area, up to 3 metres deep, was removed by Hvac Trucks as the utilities were too close together to safely place an excavator bucket.

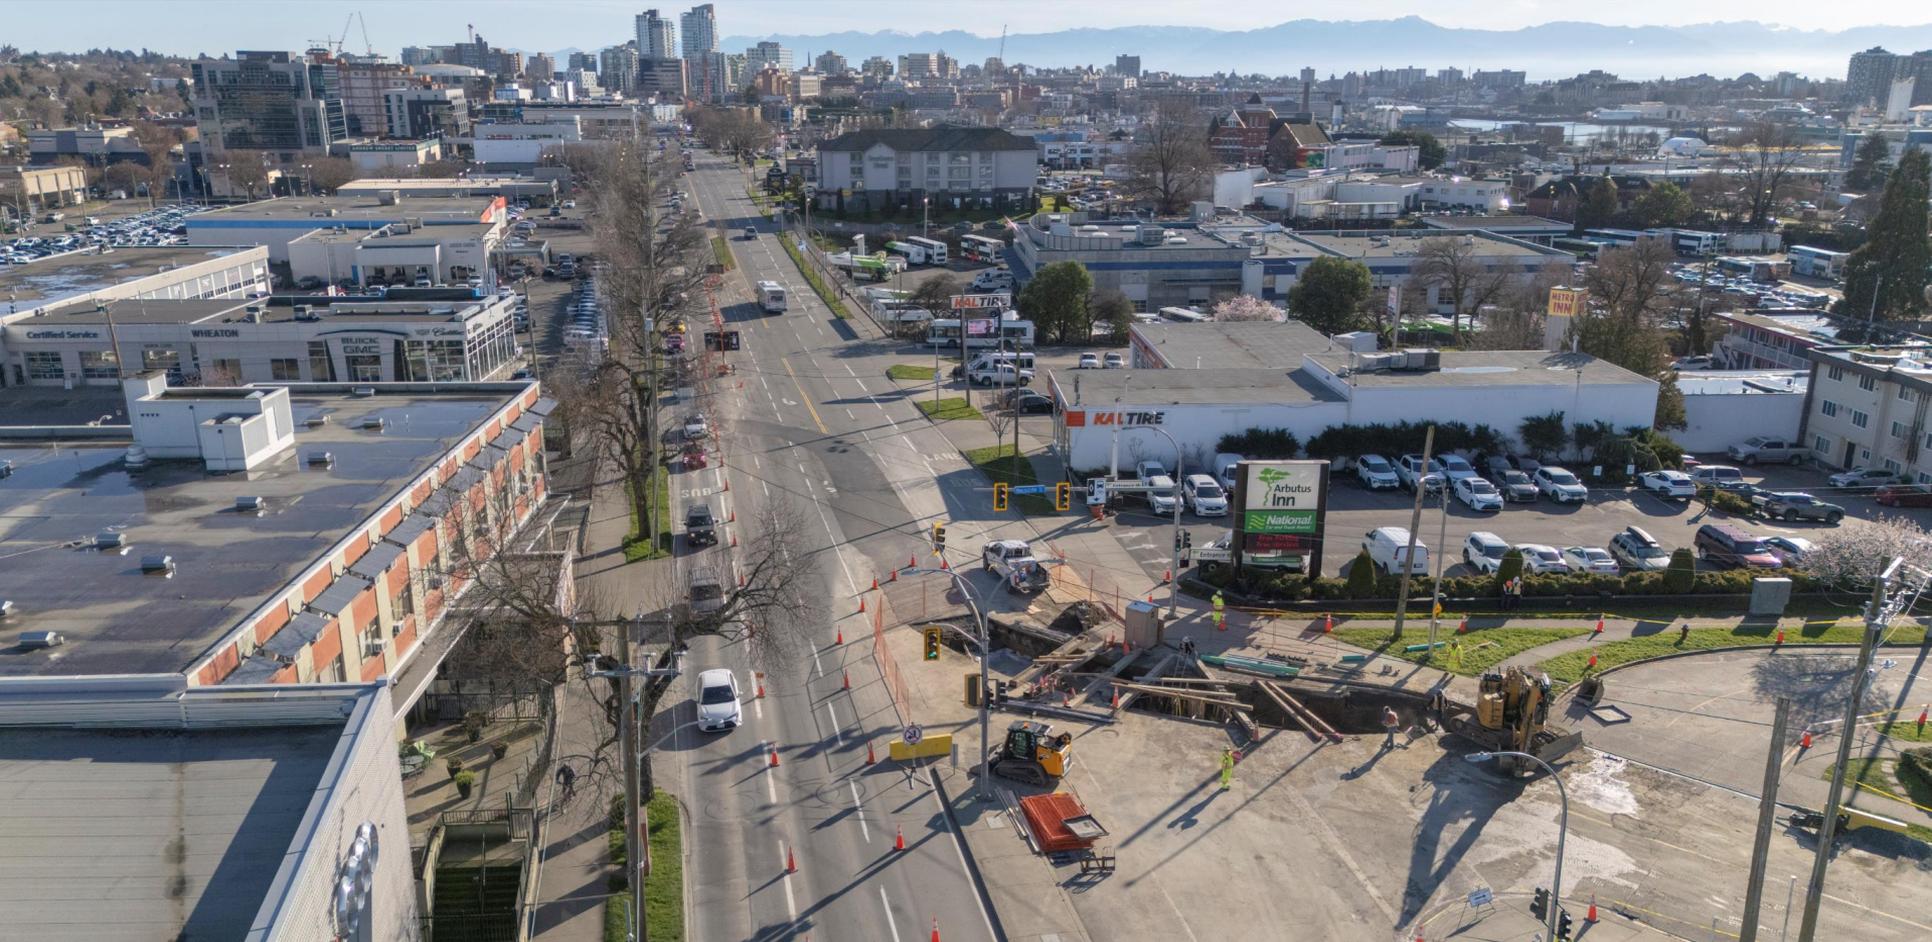
February 11: Panoramic view of the duct bank work and the traffic management, with downtown Victoria in the background.

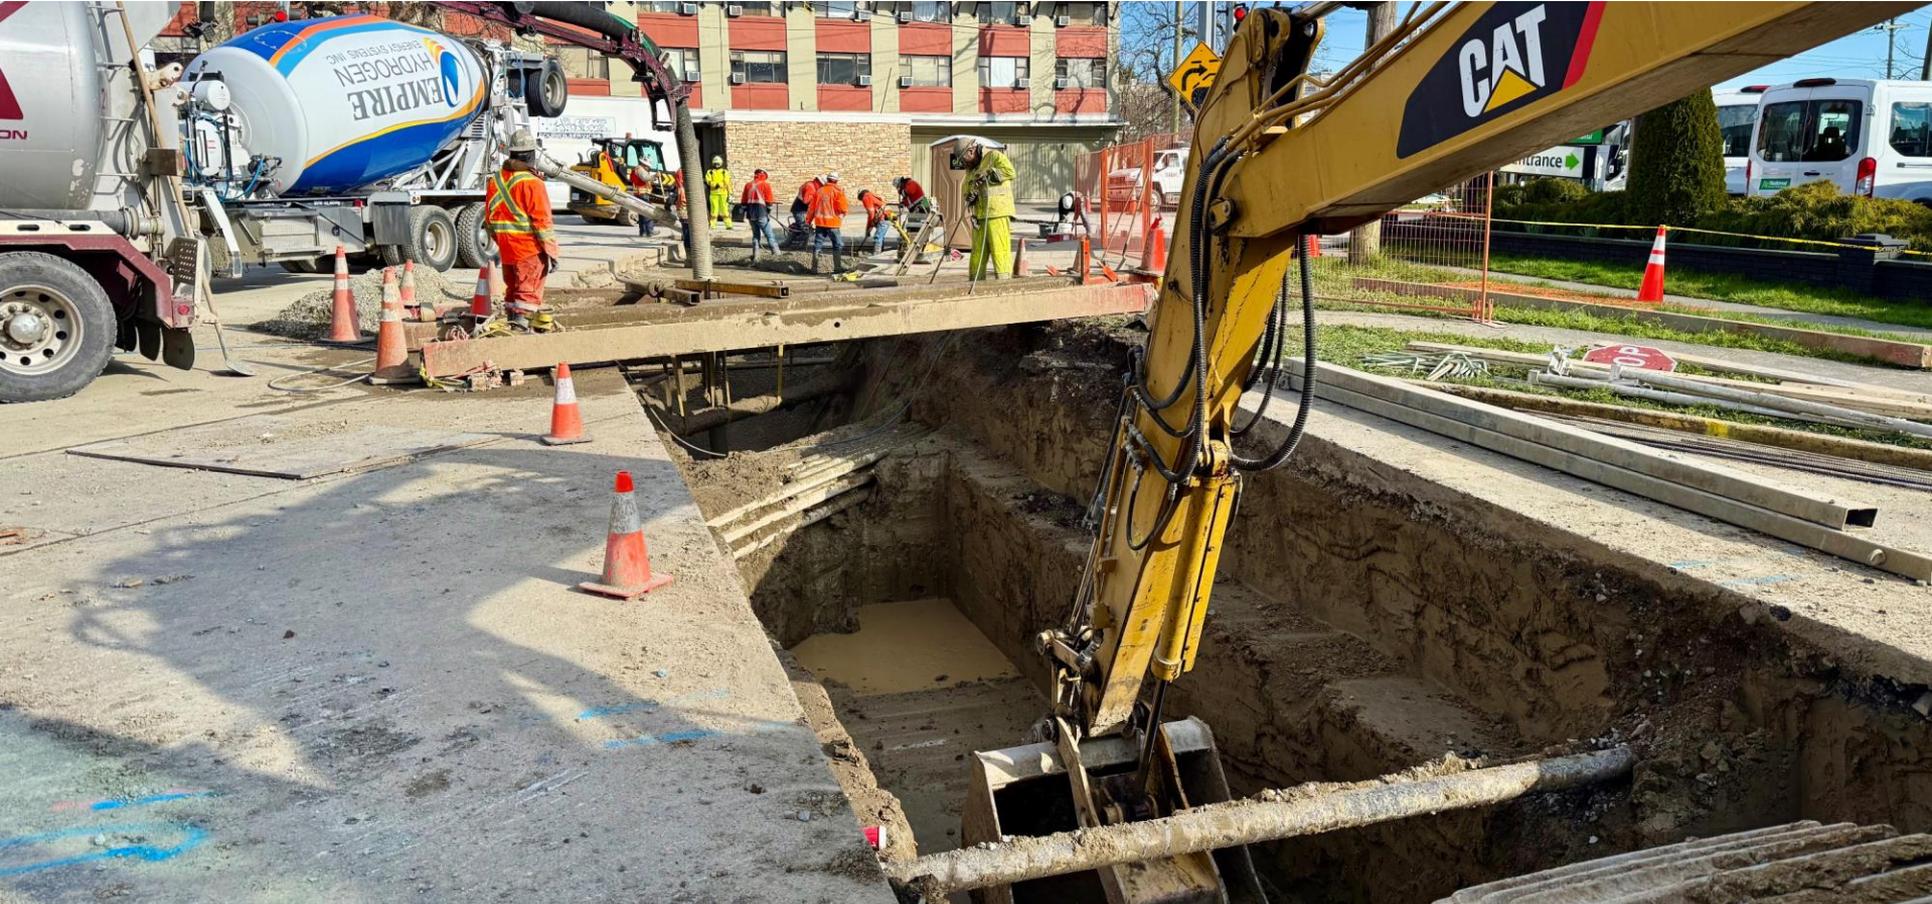
February 19: Concrete base placement in the background, and in the foreground, excavation work as the duct bank moves off Douglas Street onto the end of Burnside Road and down Dunedin Street.

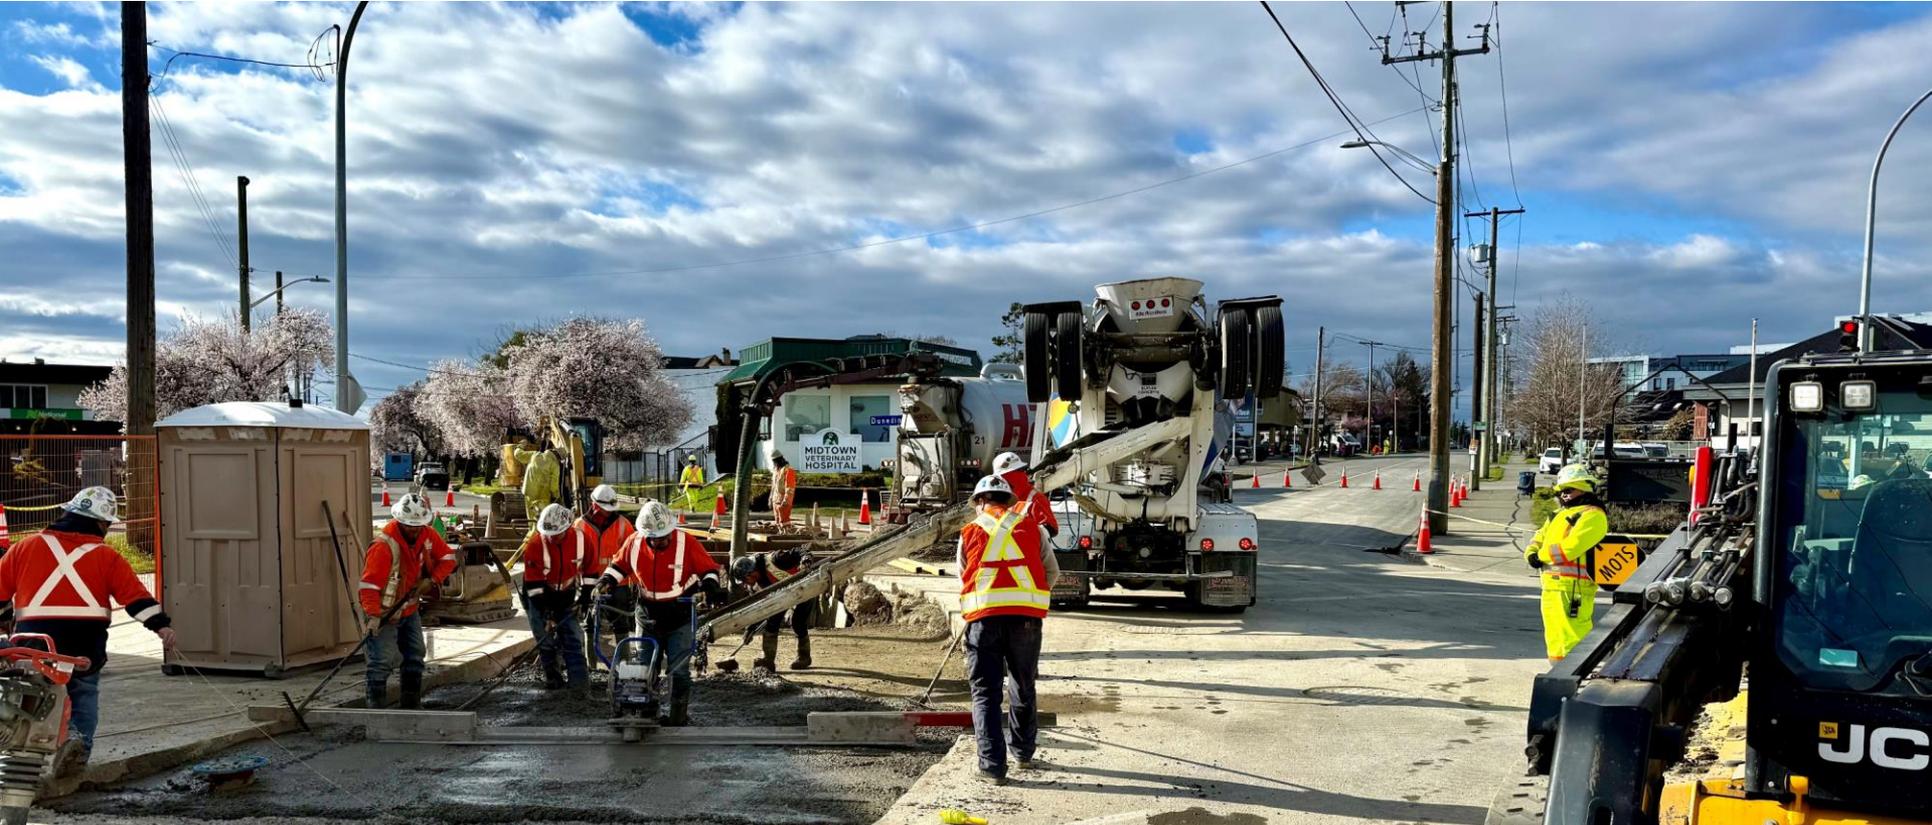
February 19: Crews placing the concrete base before asphalt was placed as the final street surface the next day. Douglas Street fully reopened in the morning of February 20. The northbound lane of Burnside Road (right side of photo) also opened on that same day. It was one week later than expected, though a significant achievement given the underground challenges. The southbound lane of Burnside Road opened February 27. Thank you to all the businesses and commuters for their patience.

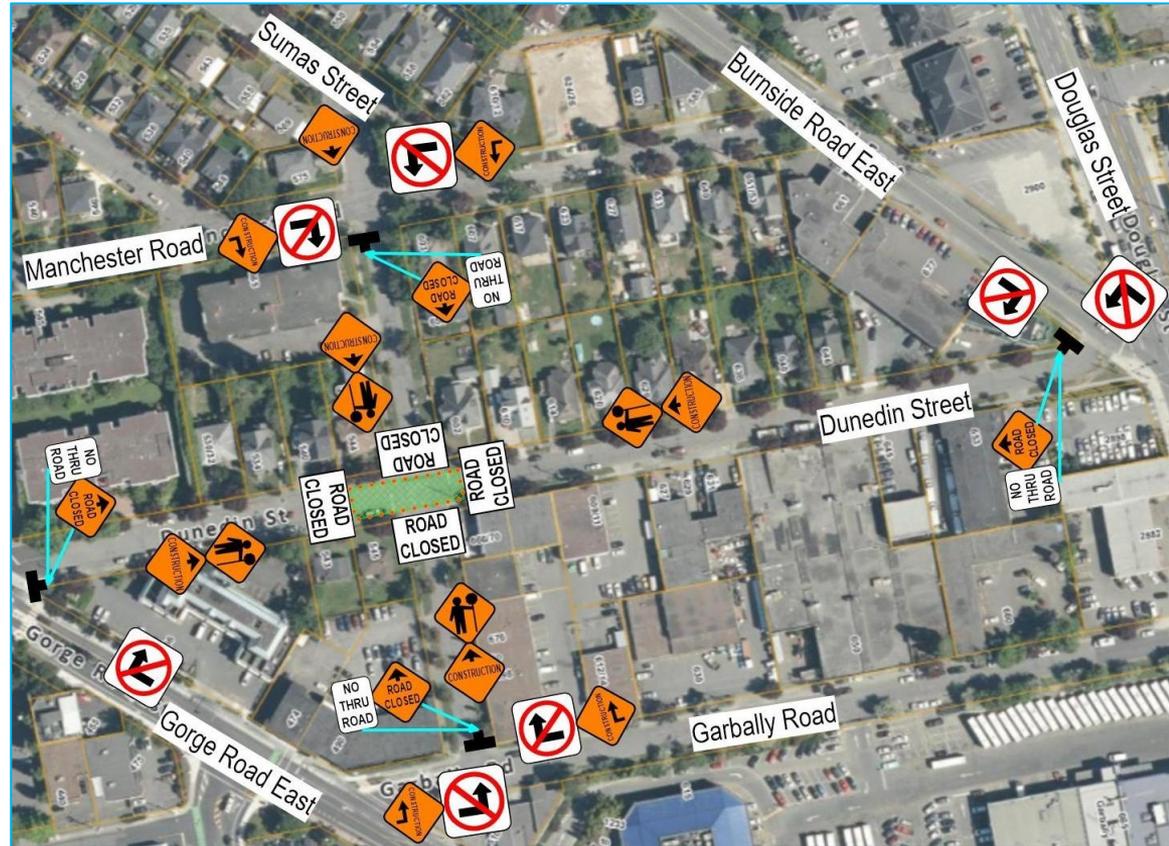
# Traffic management plan – Dunedin Street

## Sumas Street and Dunedin Street intersection

- Duct bank work began the third week of February and is moving westward, stopping on the western edge of the Sumas Street intersection.
- The work in the 600-block will be done in different construction sections.
- Repaving of the work area.
- Estimated completion of all construction and restoration work is end of March.

- Intersection closed for one to two weeks starting as early as mid-March. See traffic management plan.
- Please use alternative routes.
- No parking on either side of the street within the designated work zone.
- Follow flaggers and detour signs.
