# Victoria to Esquimalt Cable Replacement Project – Community Construction Report #16

**August 2026**

# Project status

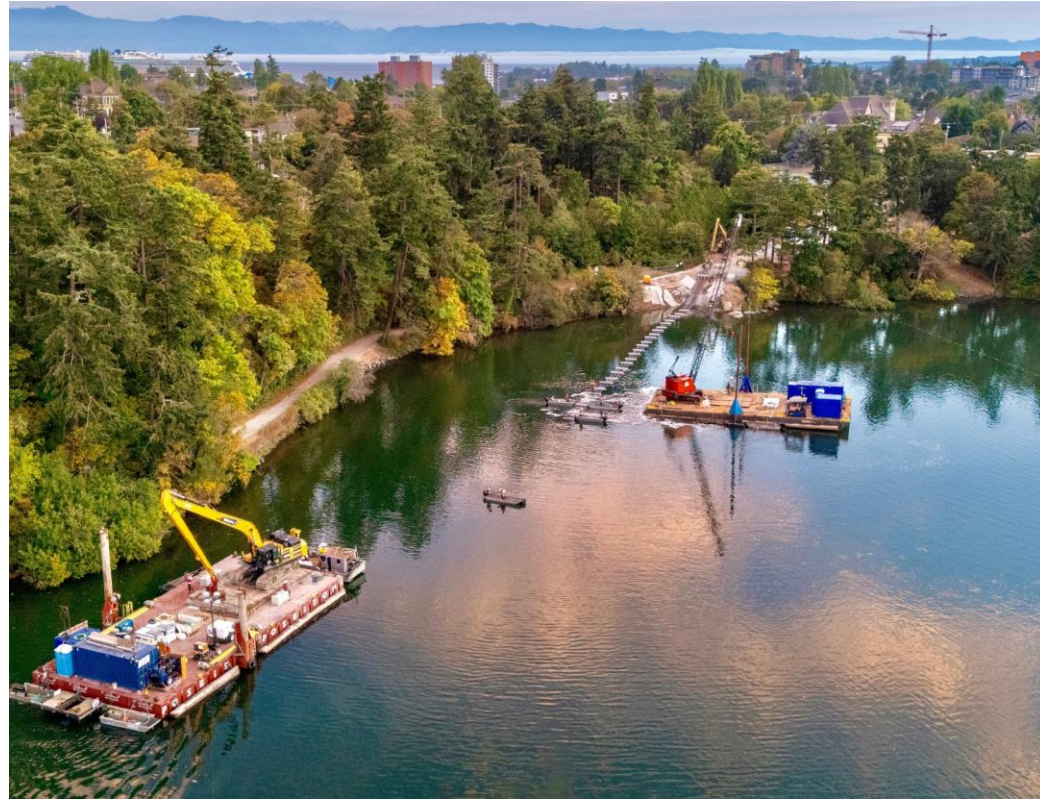
August 21: Evening view of the successful sinking of the conduits into the marine trench. Only five days of the possible ten-day marine navigation closure was required.

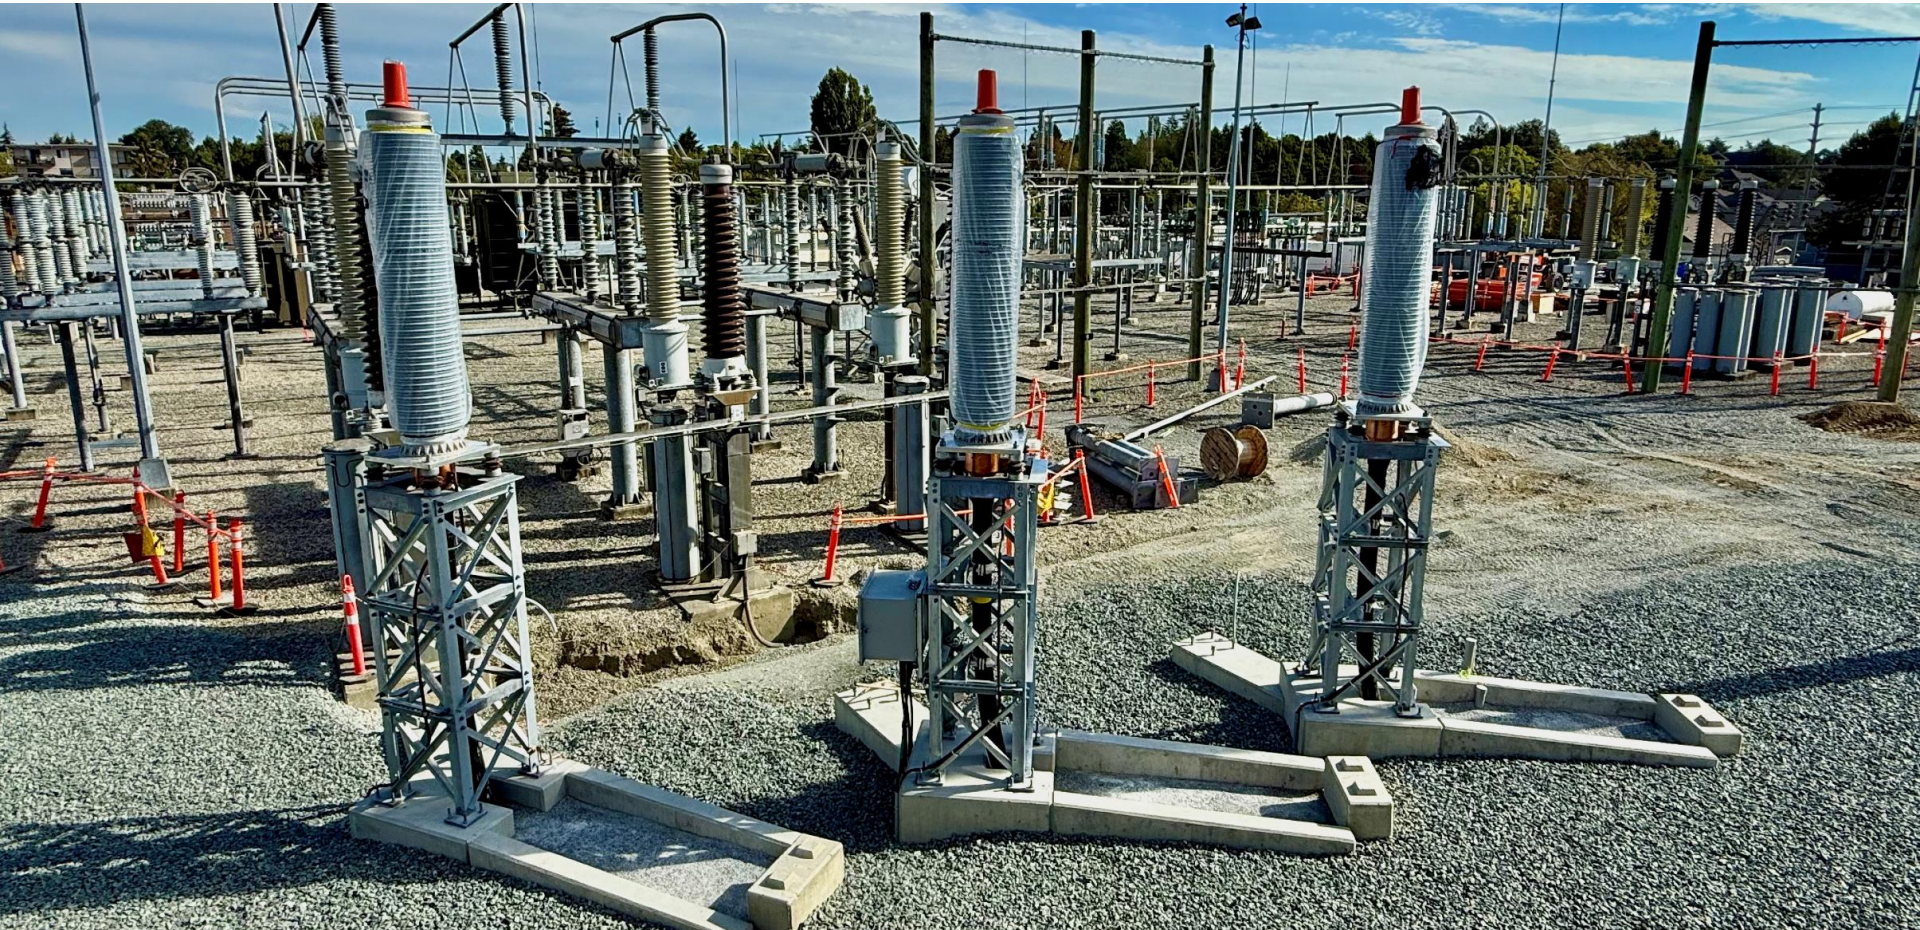
August 19: Equipment (three potheads) transitioning the underground cables to overhead and into the wider BC Hydro power grid.

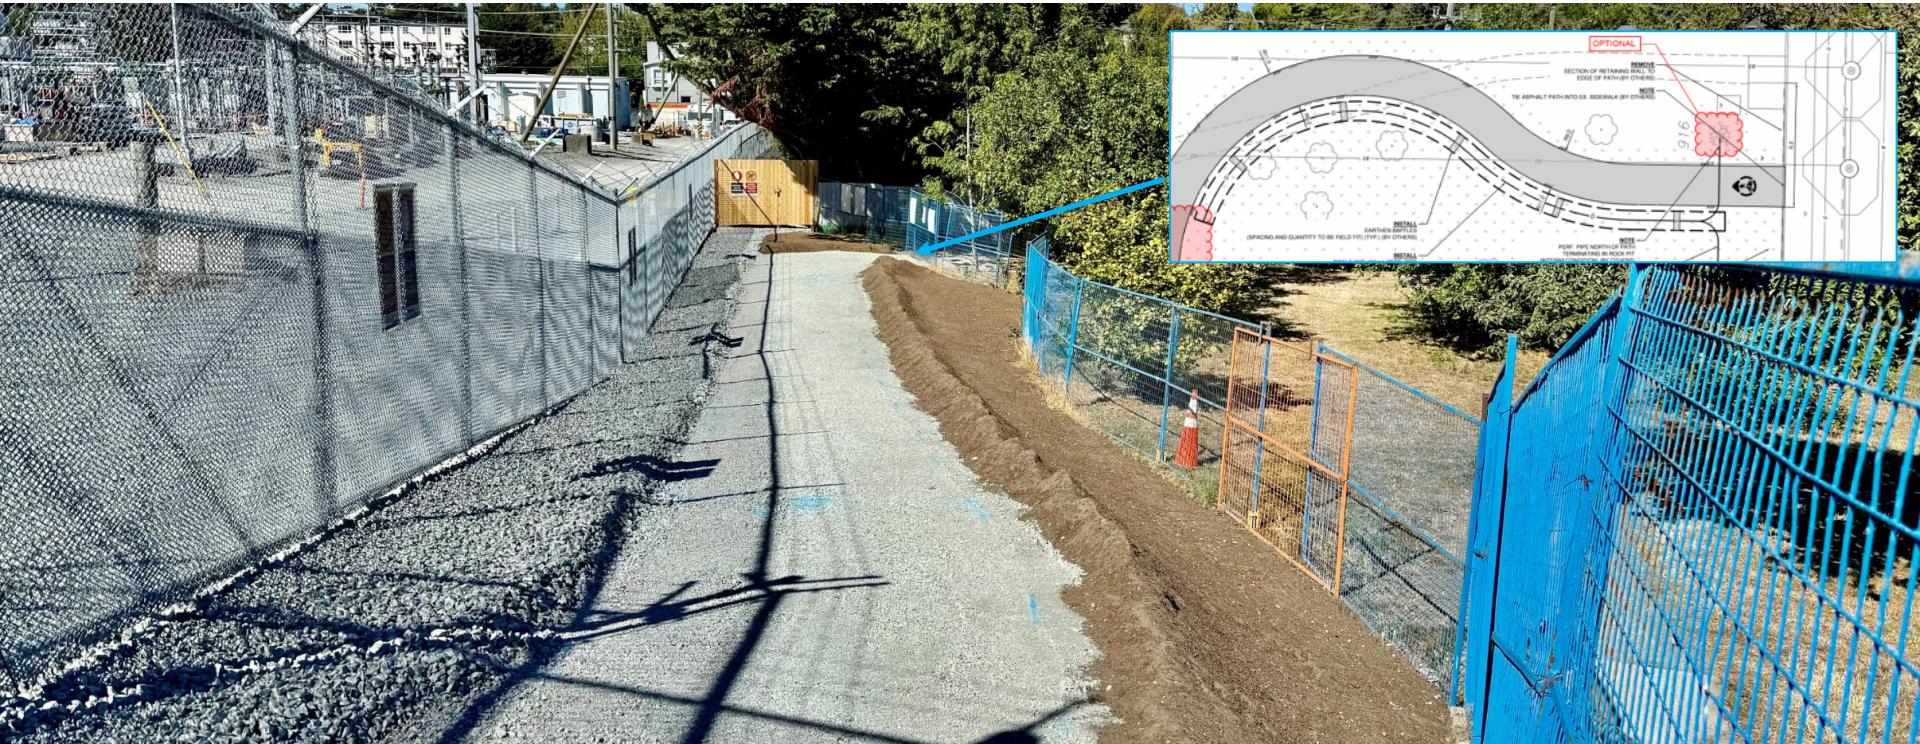
August 26: Work on a new 2-metre-wide bike path that will connect the E&N Trail to Hereward Road. The pathway will be paved with asphalt. Inset diagram shows the draft pathway connecting to Hereward Road with that work being done in September or October. BC Hydro and the City of Victoria will develop a use agreement as the trail is almost all on BC Hydro substation lands, including the land where the trail turns to connect to Hereward Road.

The new bike trail, at BC Hydro's cost, was put in place as a community benefit to replace a now closed informal and narrow dirt trail that connected the E&N Trail to Hereward Road.

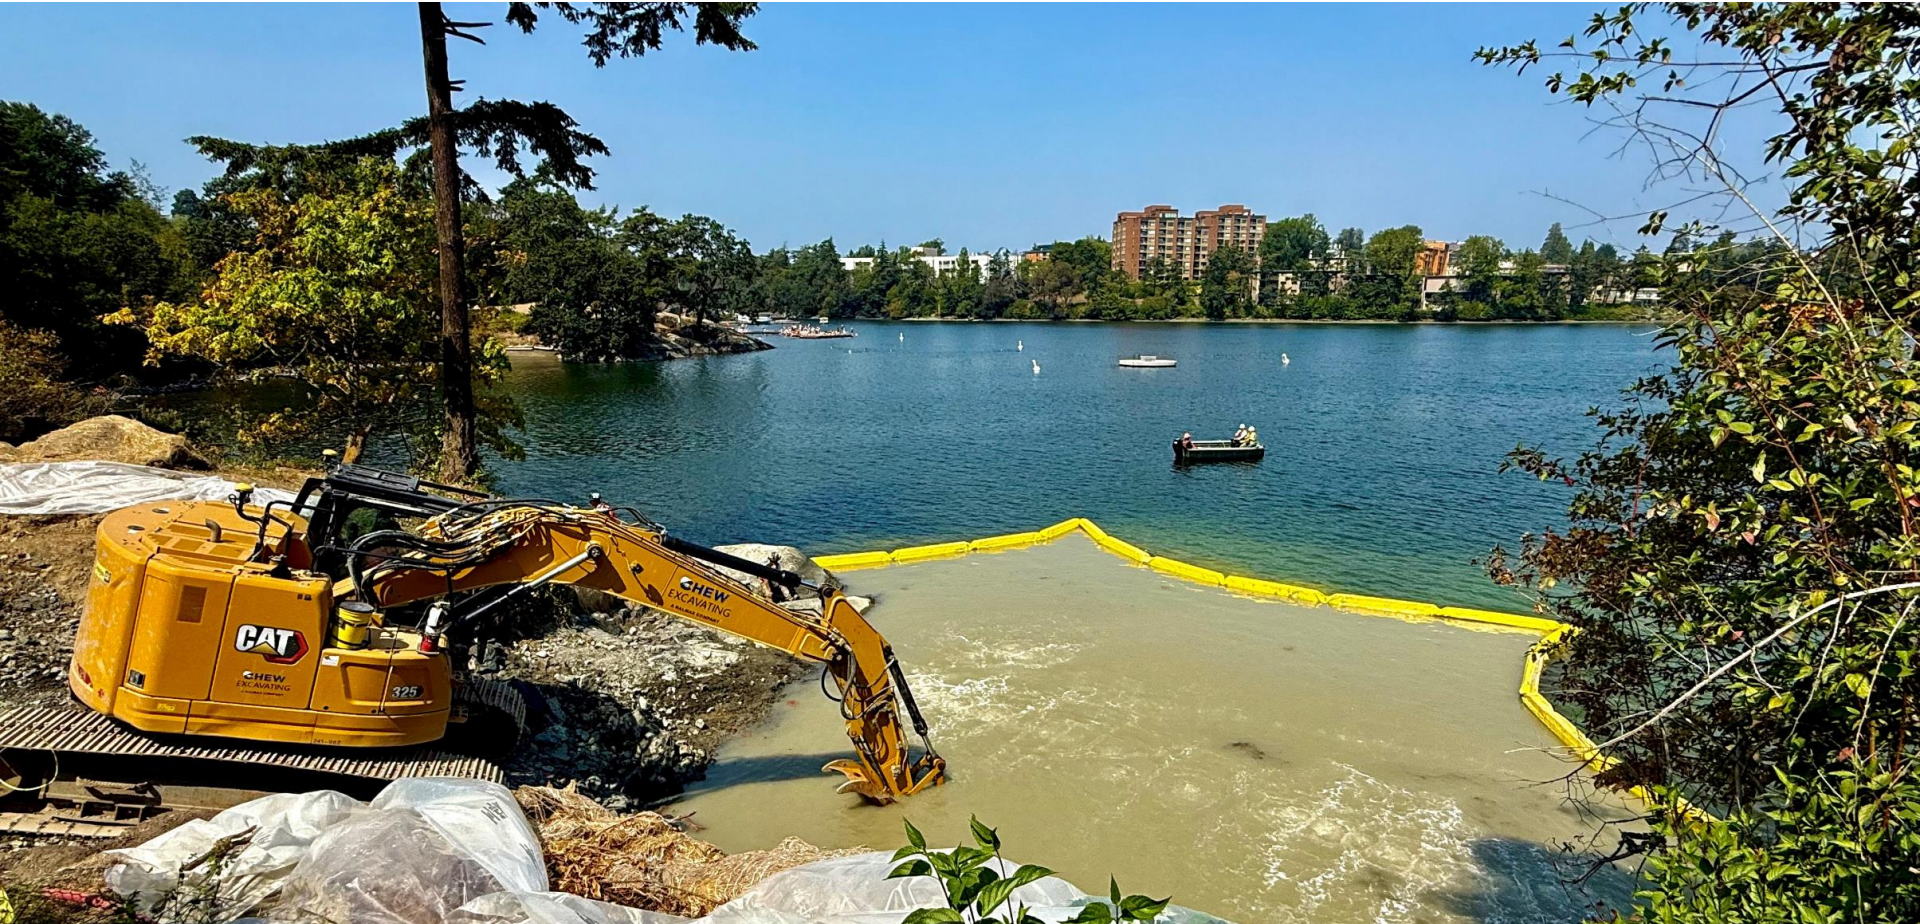
August 5: Sediment and rock removal work for the marine trench in preparation of the conduit placement on August 17.

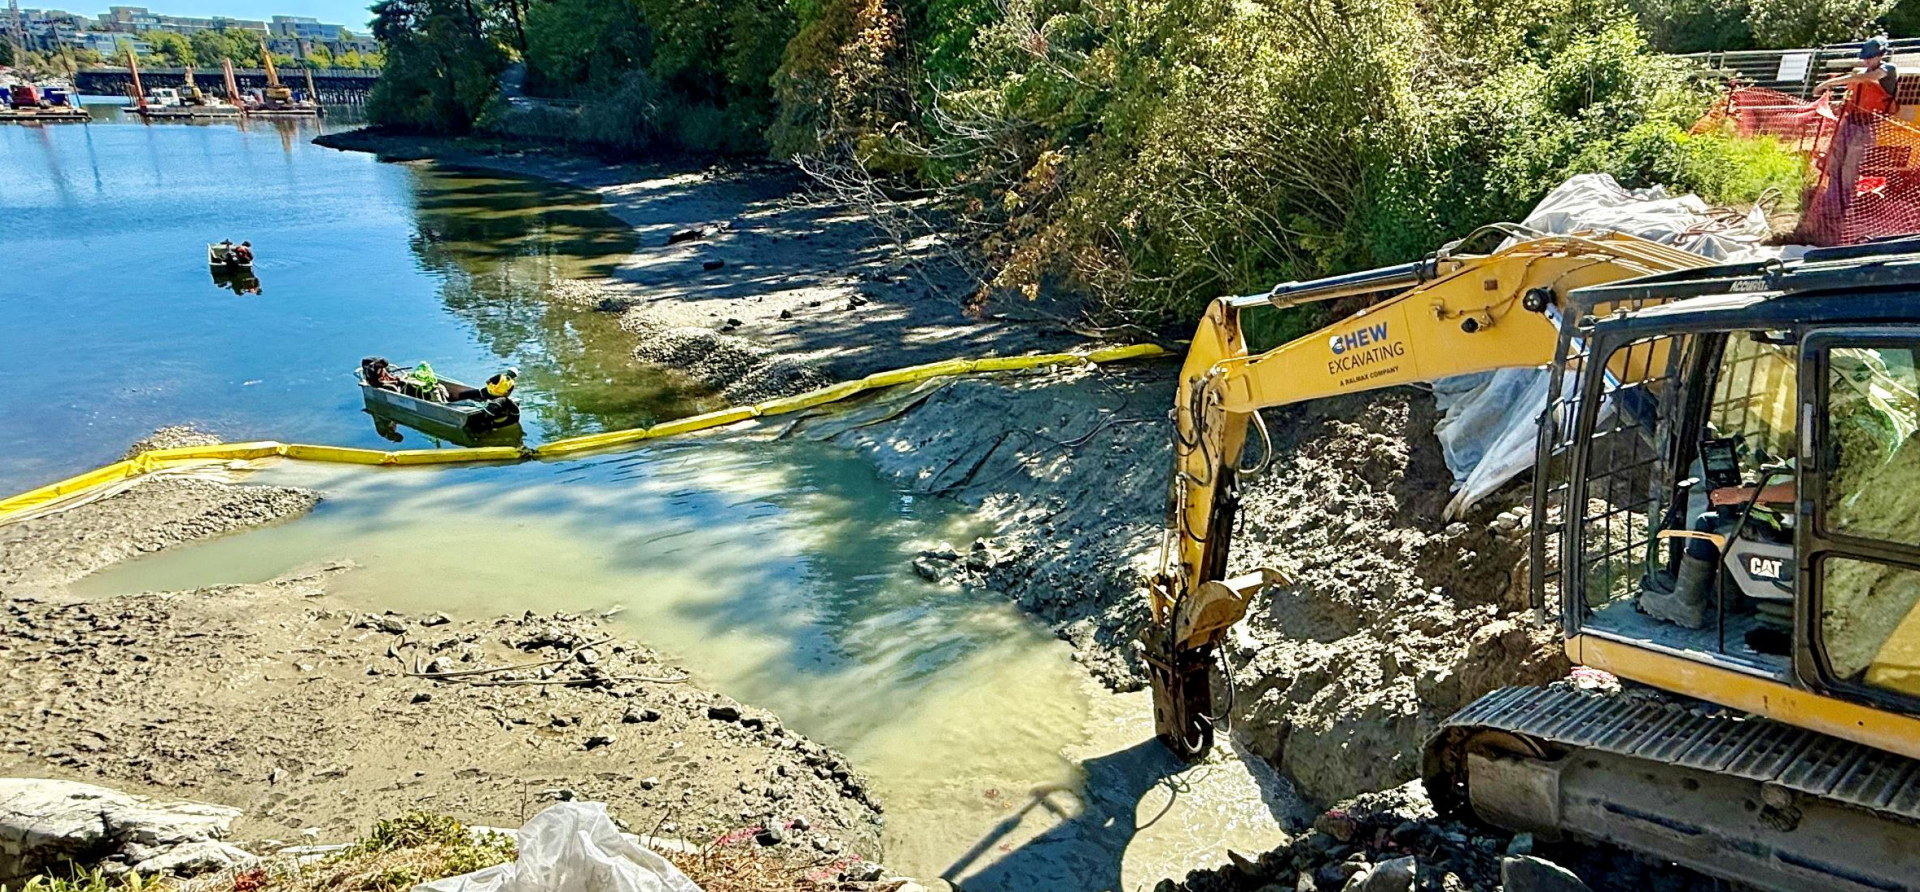
August 11: Breaking out the last section of rock for the concrete anchor block placement to hold the cables in place. The two boats are environmental monitors.

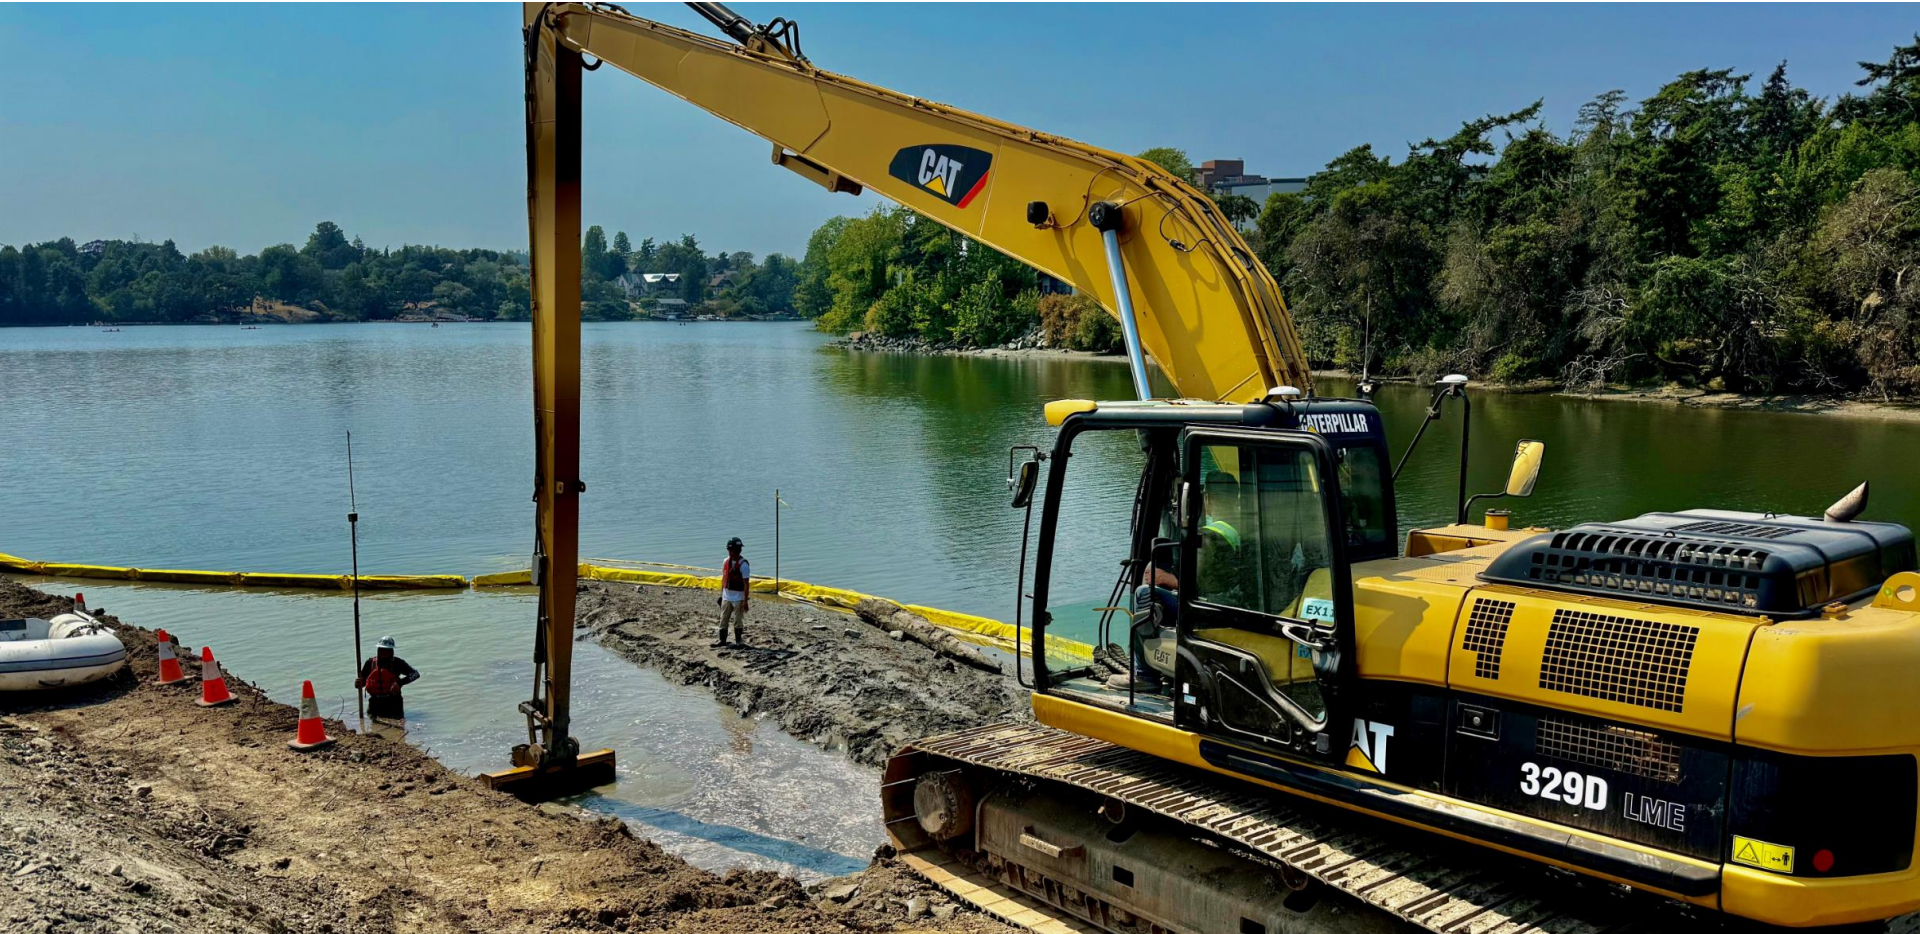
August 5: Trench excavation and measurement.

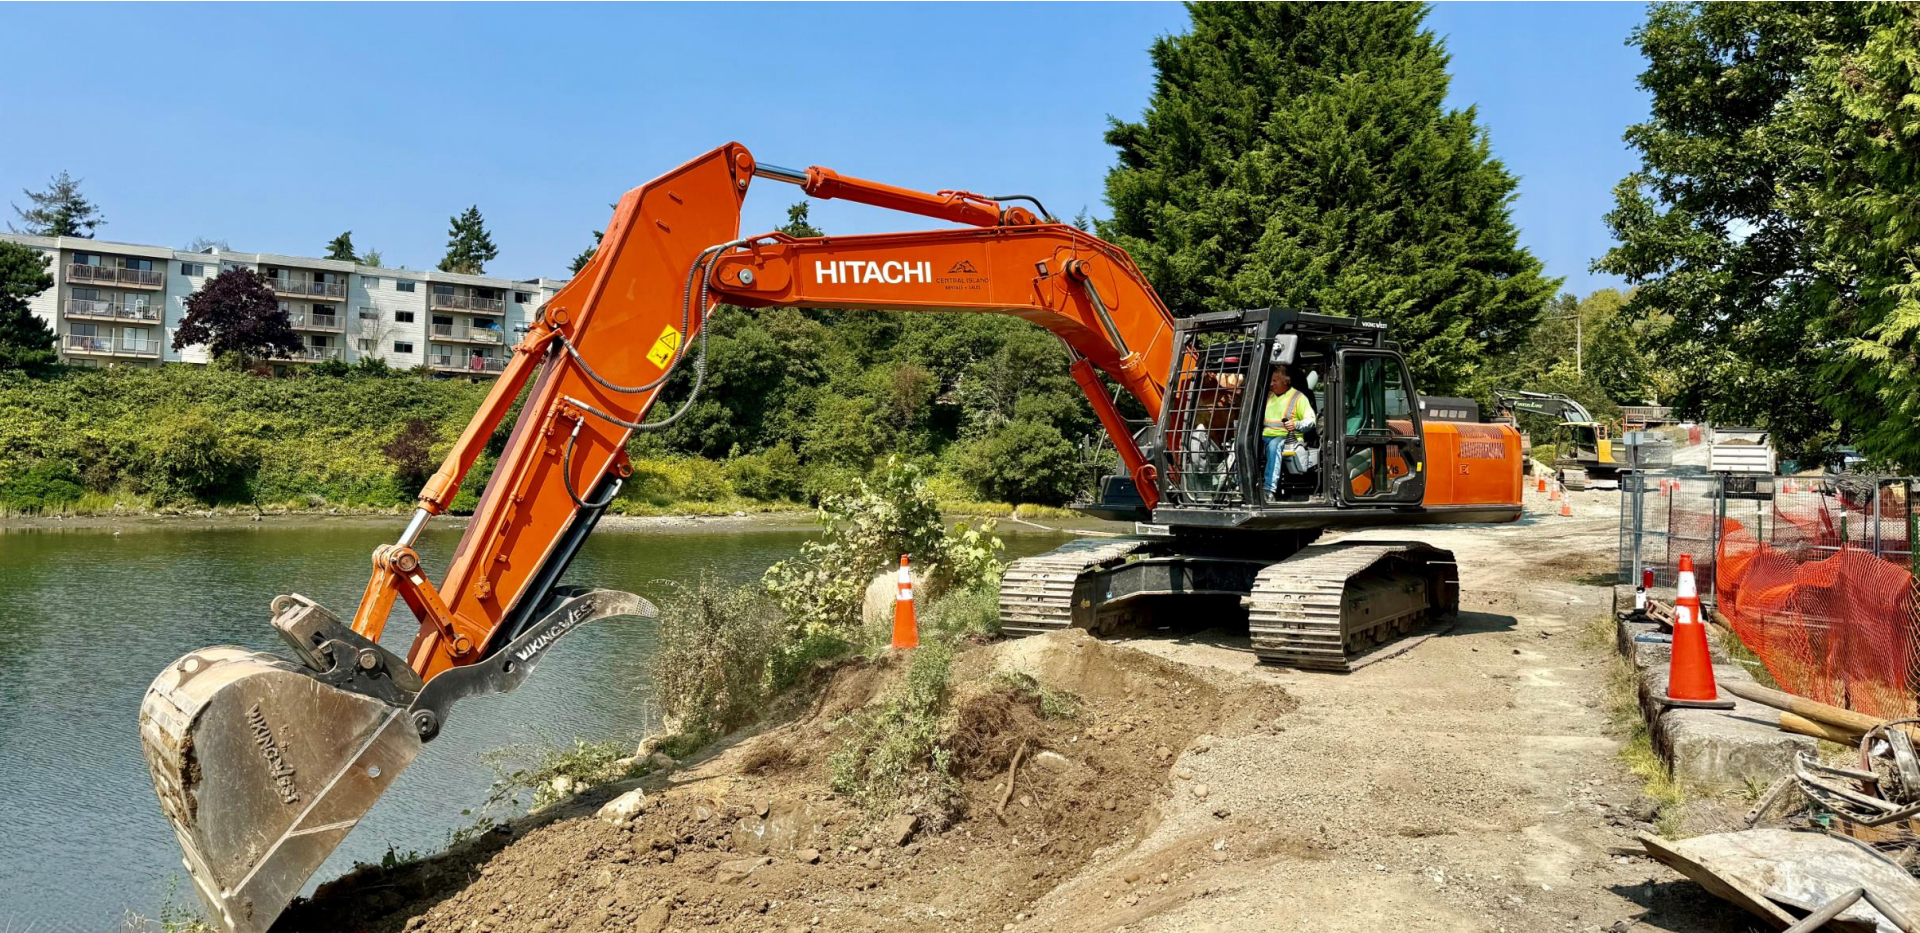
August 5: Removing material for the trench in the upper slope area and under Galloping Goose Regional Trail.

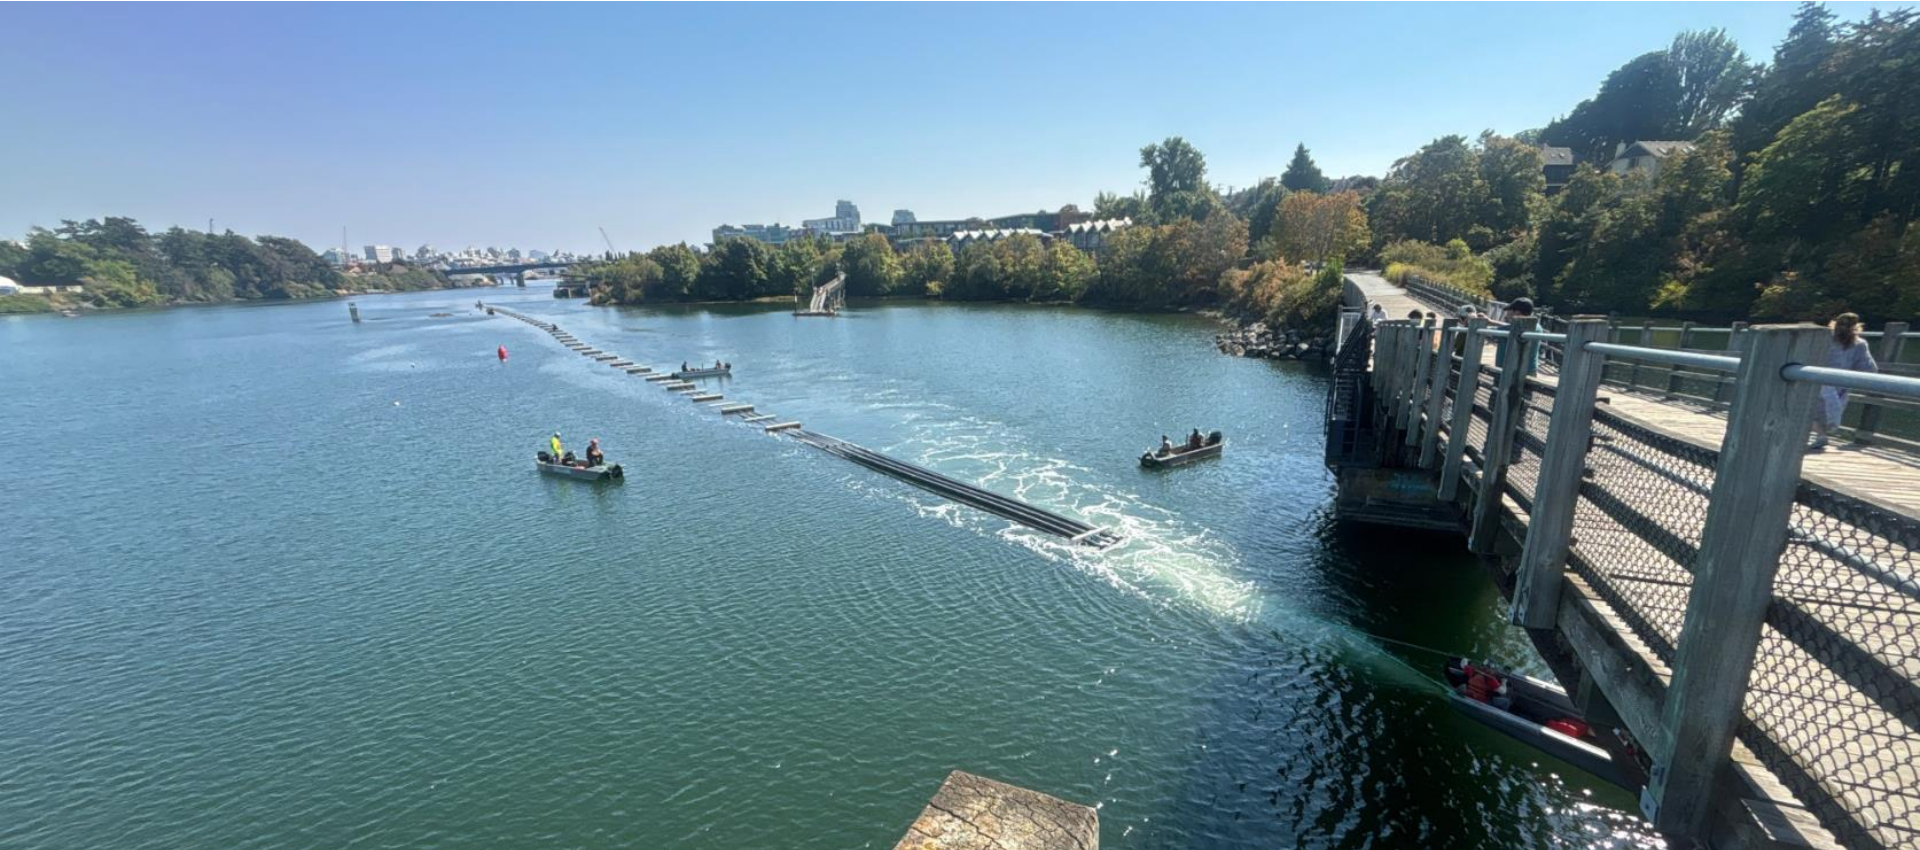
August 6: Moving in a 440-metre-long section under the Selkirk Trestle from the docks off Harbour Road. Two sections were moved in advance of the marine closure that started August 17. The third and final section was moved in on August 11. This was done to increase efficiencies at the site and remove potential marine closure delay risk.

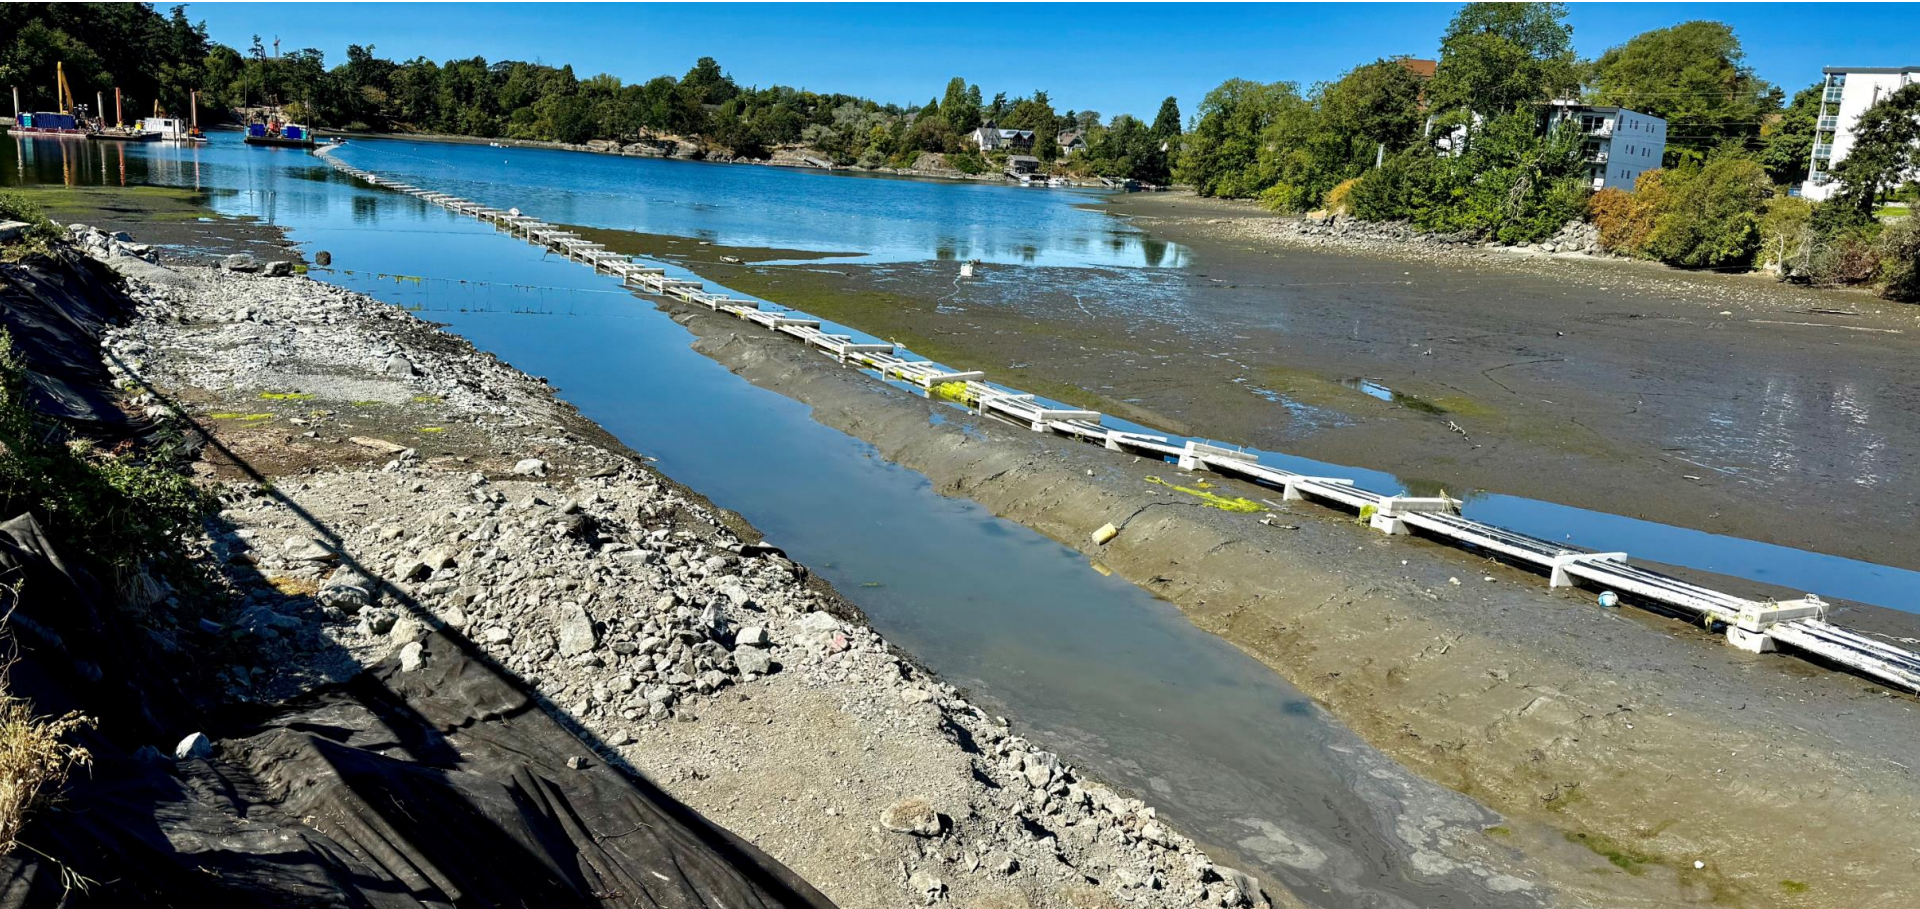
August 11: Completed trench shown at a lower tide and the cable conduit getting prepared to be placed into the trench.

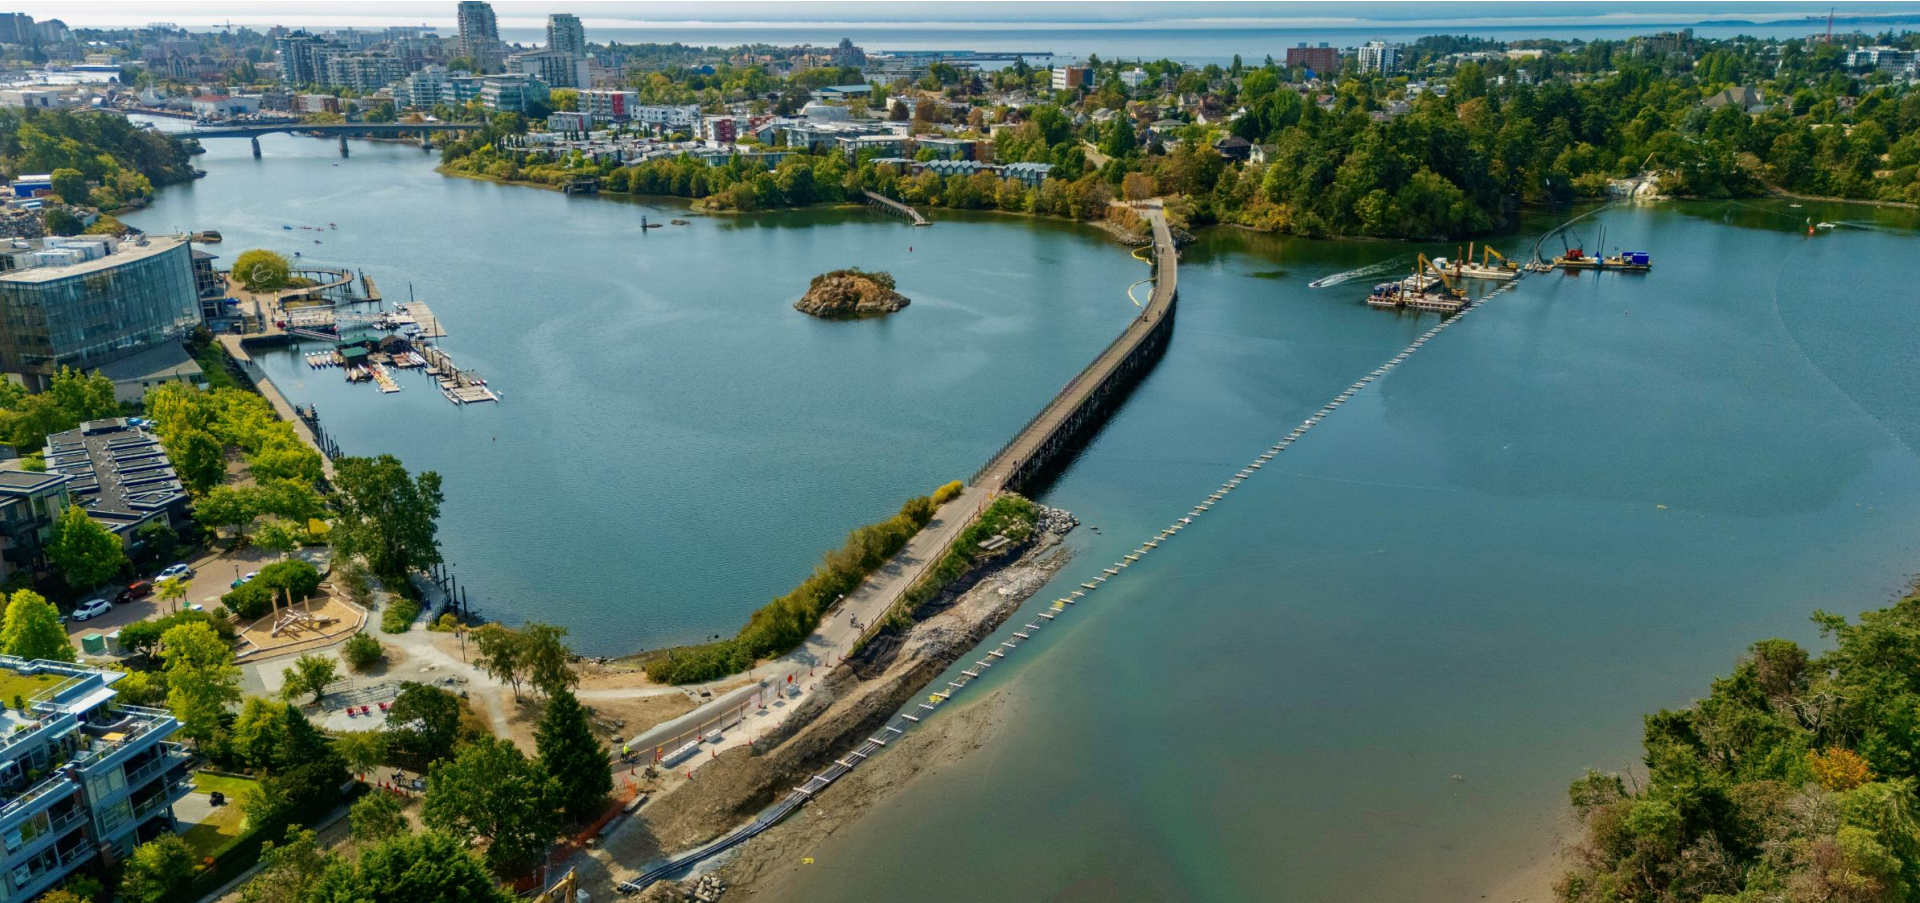
August 17: The third 220-metre-long section of conduit is moved into place on the Banfield Park side and attached to the 440-metre-long section, and combined, the conduits floated above the water surface from foreshore to foreshore and blocked marine navigation.

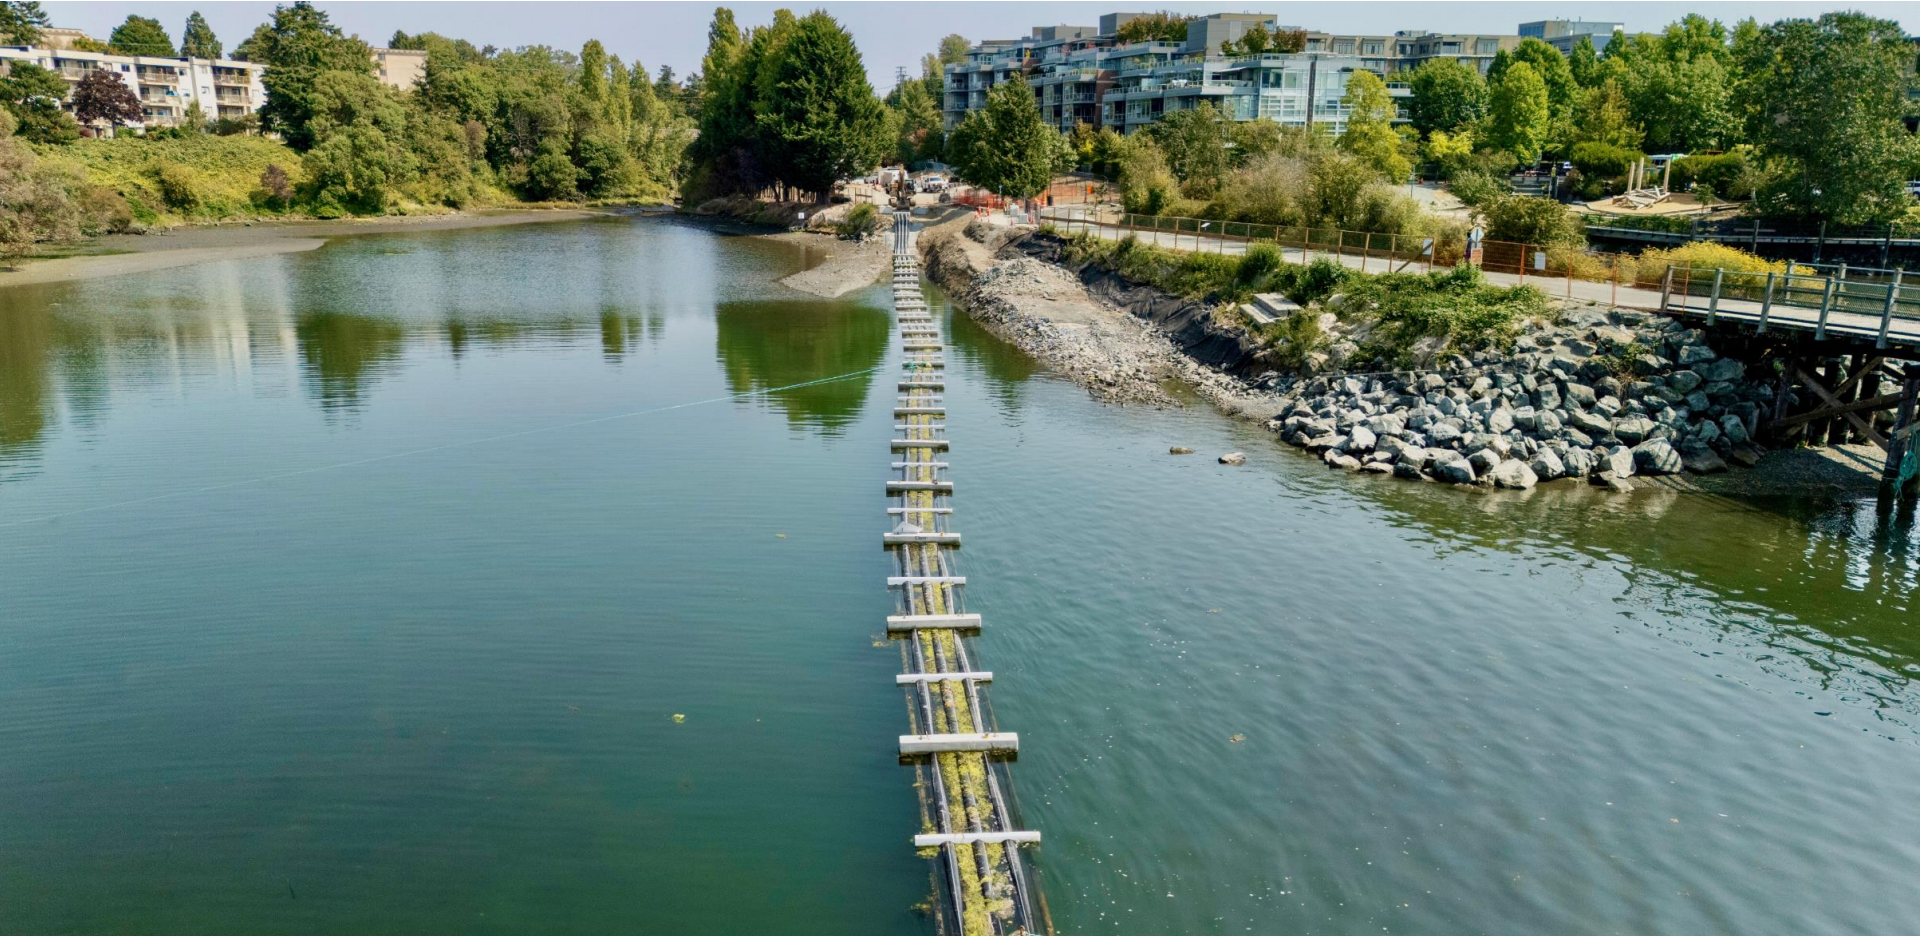
August 17: Floating conduits by Viaduct Park. Plastic spacers alternative with concrete anchor blocks.

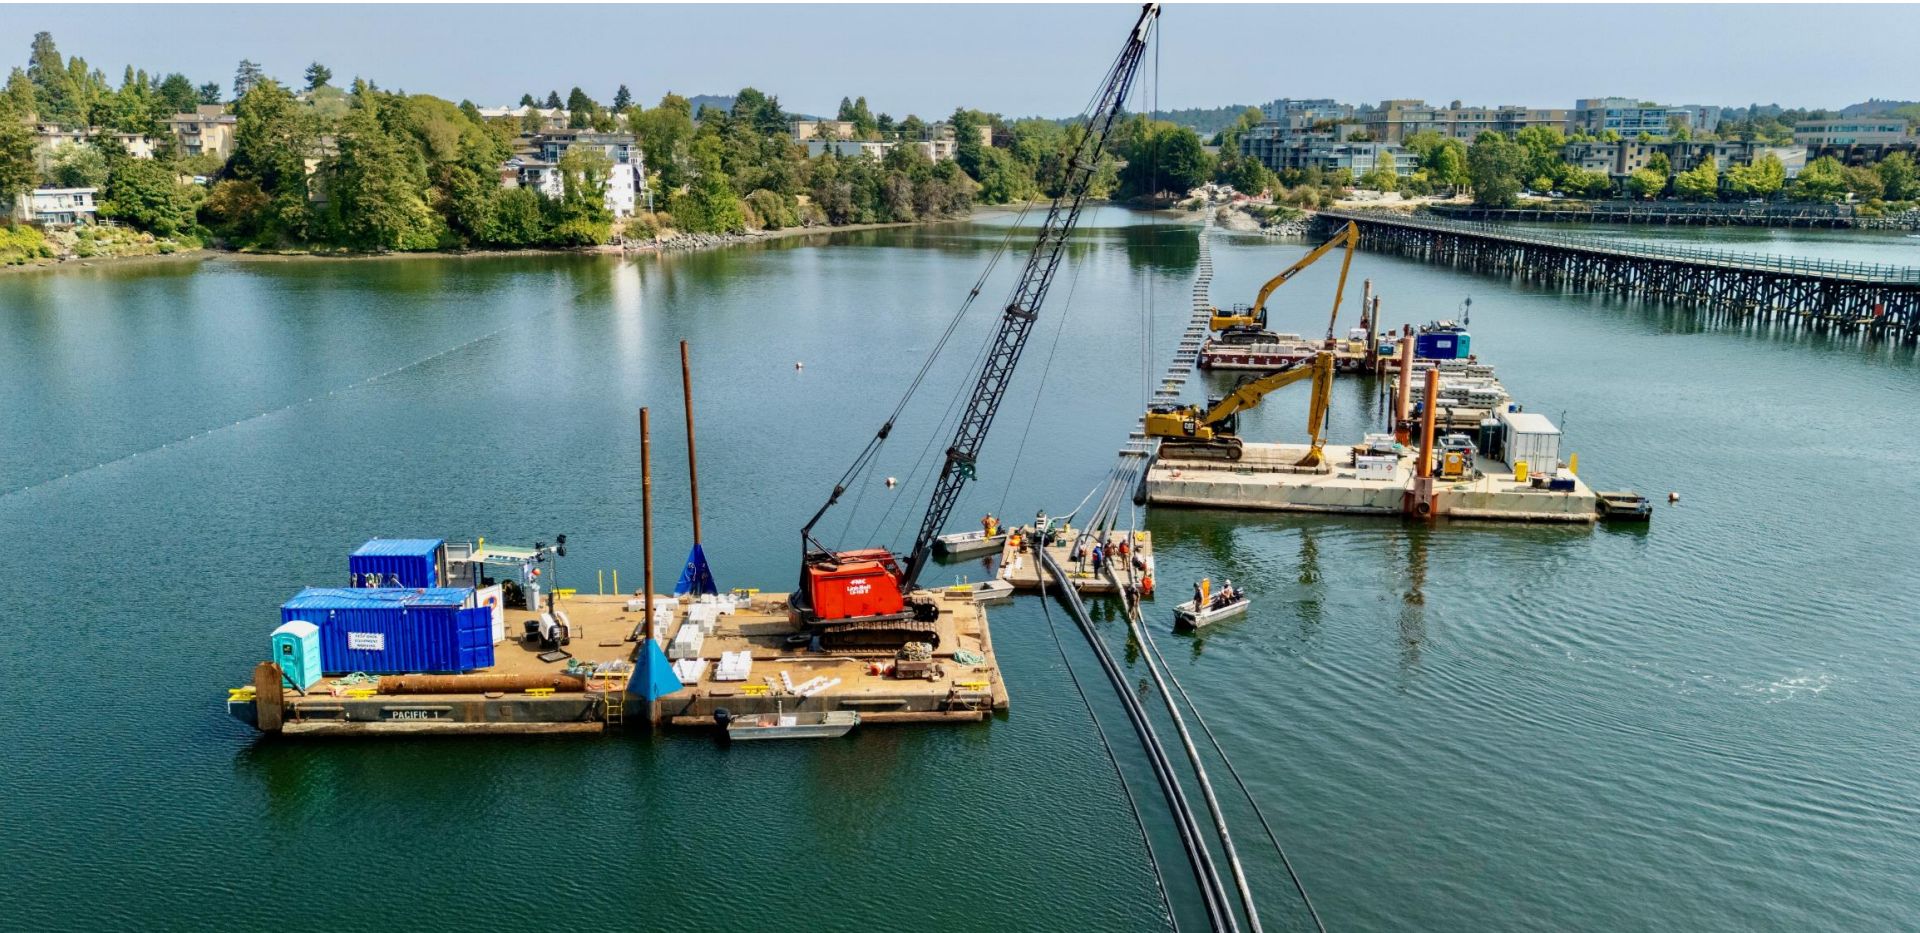
August 17: Cranes and equipment connect the five conduits together – three for the power cables and two for fibre-optic communication cables.

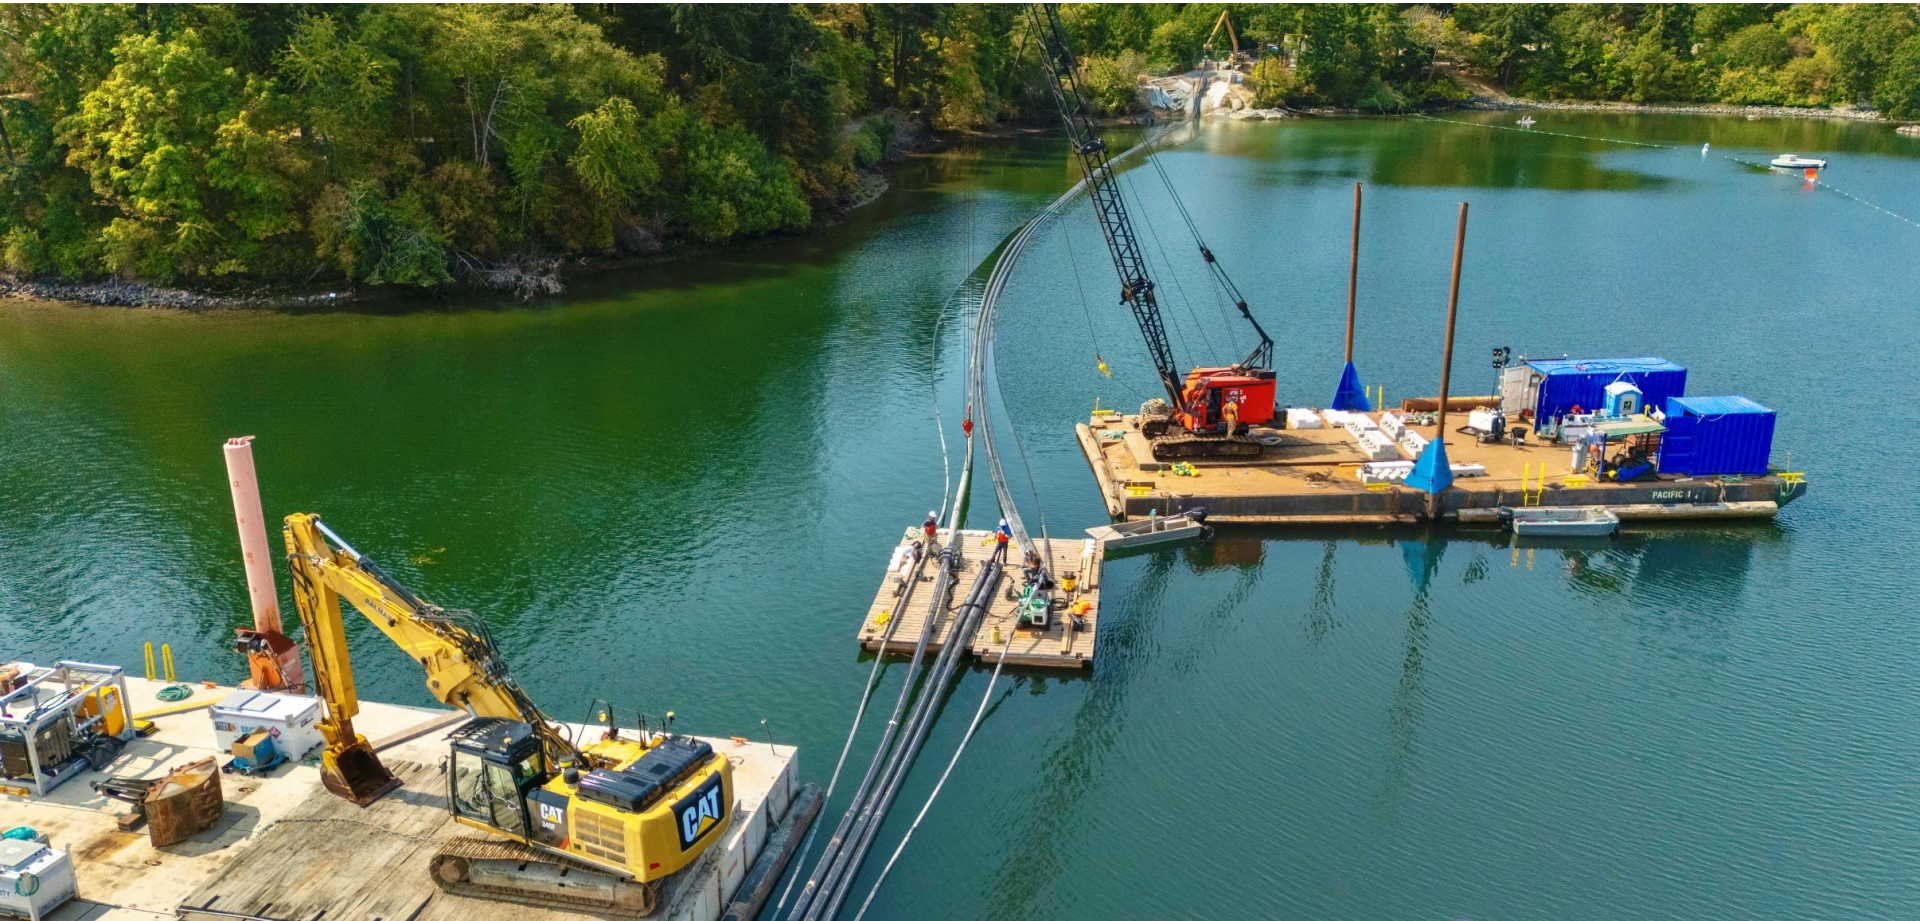
August 17: Closer view of the fusing work.
