# Victoria to Esquimalt Cable Replacement Project – Community Construction Report #16

**August 2026**

# Project status

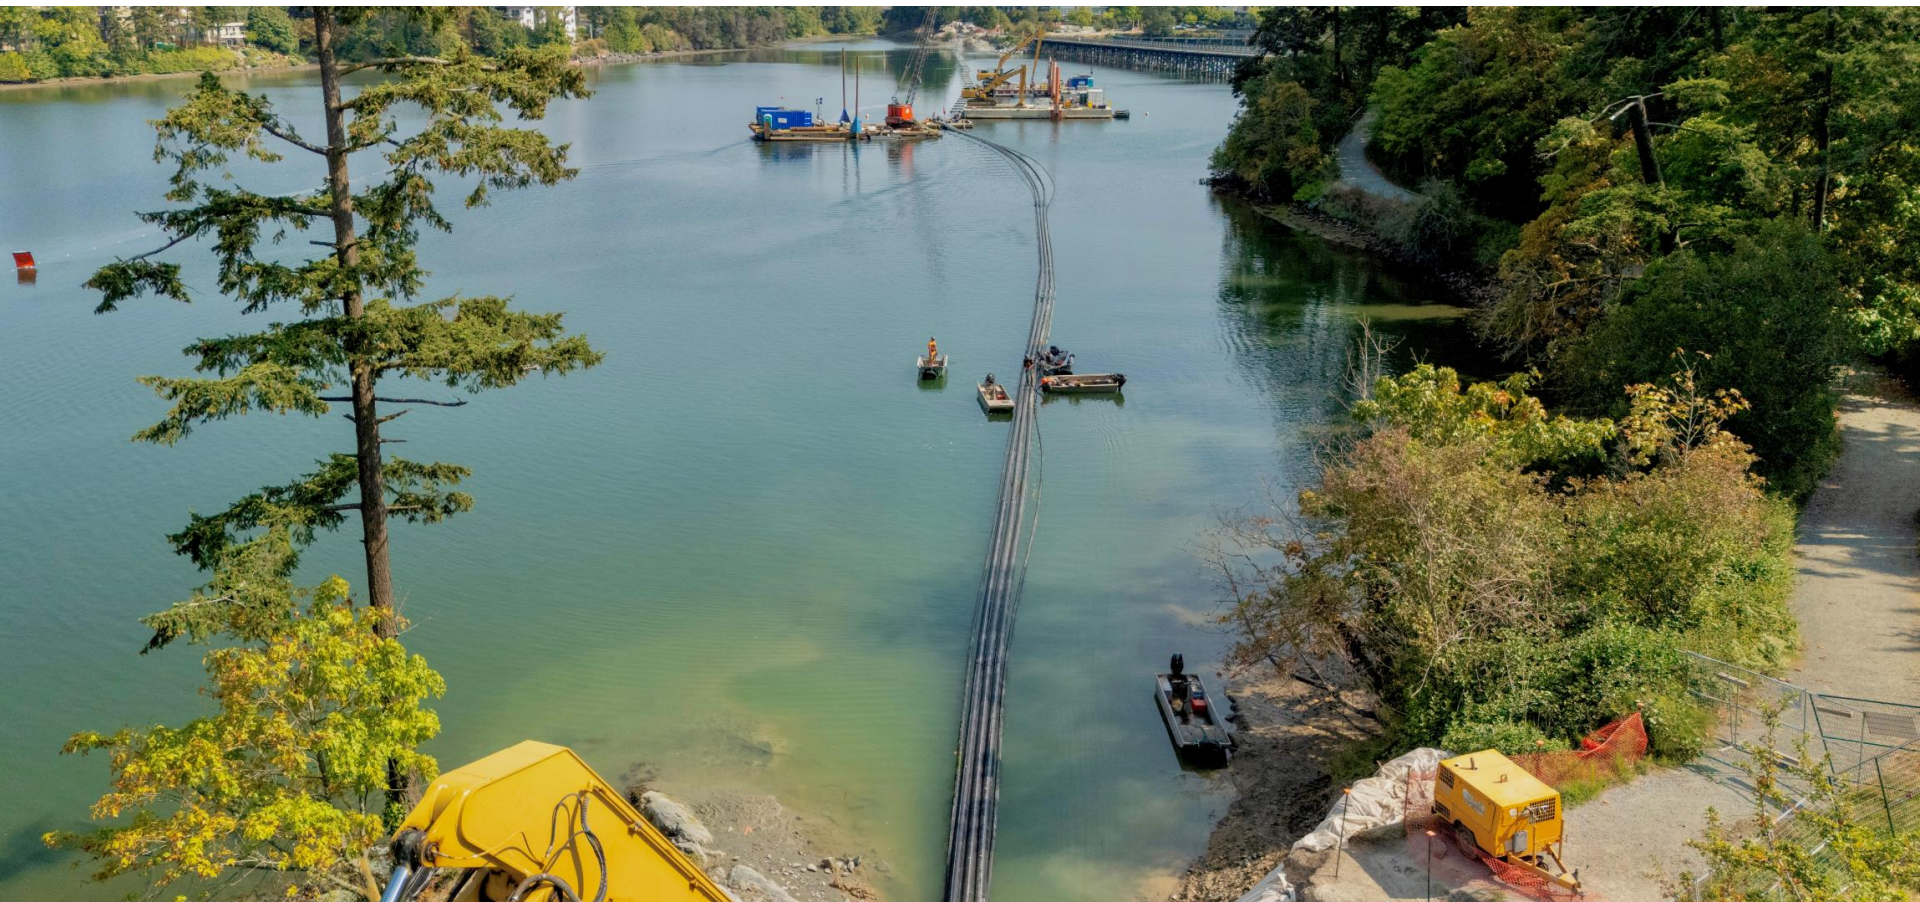
August 17: Floating conduits by Banfield Park. Signs and floating buoys/ropes/barriers were placed on both sides of the work area, including a pilot boat, to warn marine users of the navigation closure. Numerous project updates were issued to water recreation users.

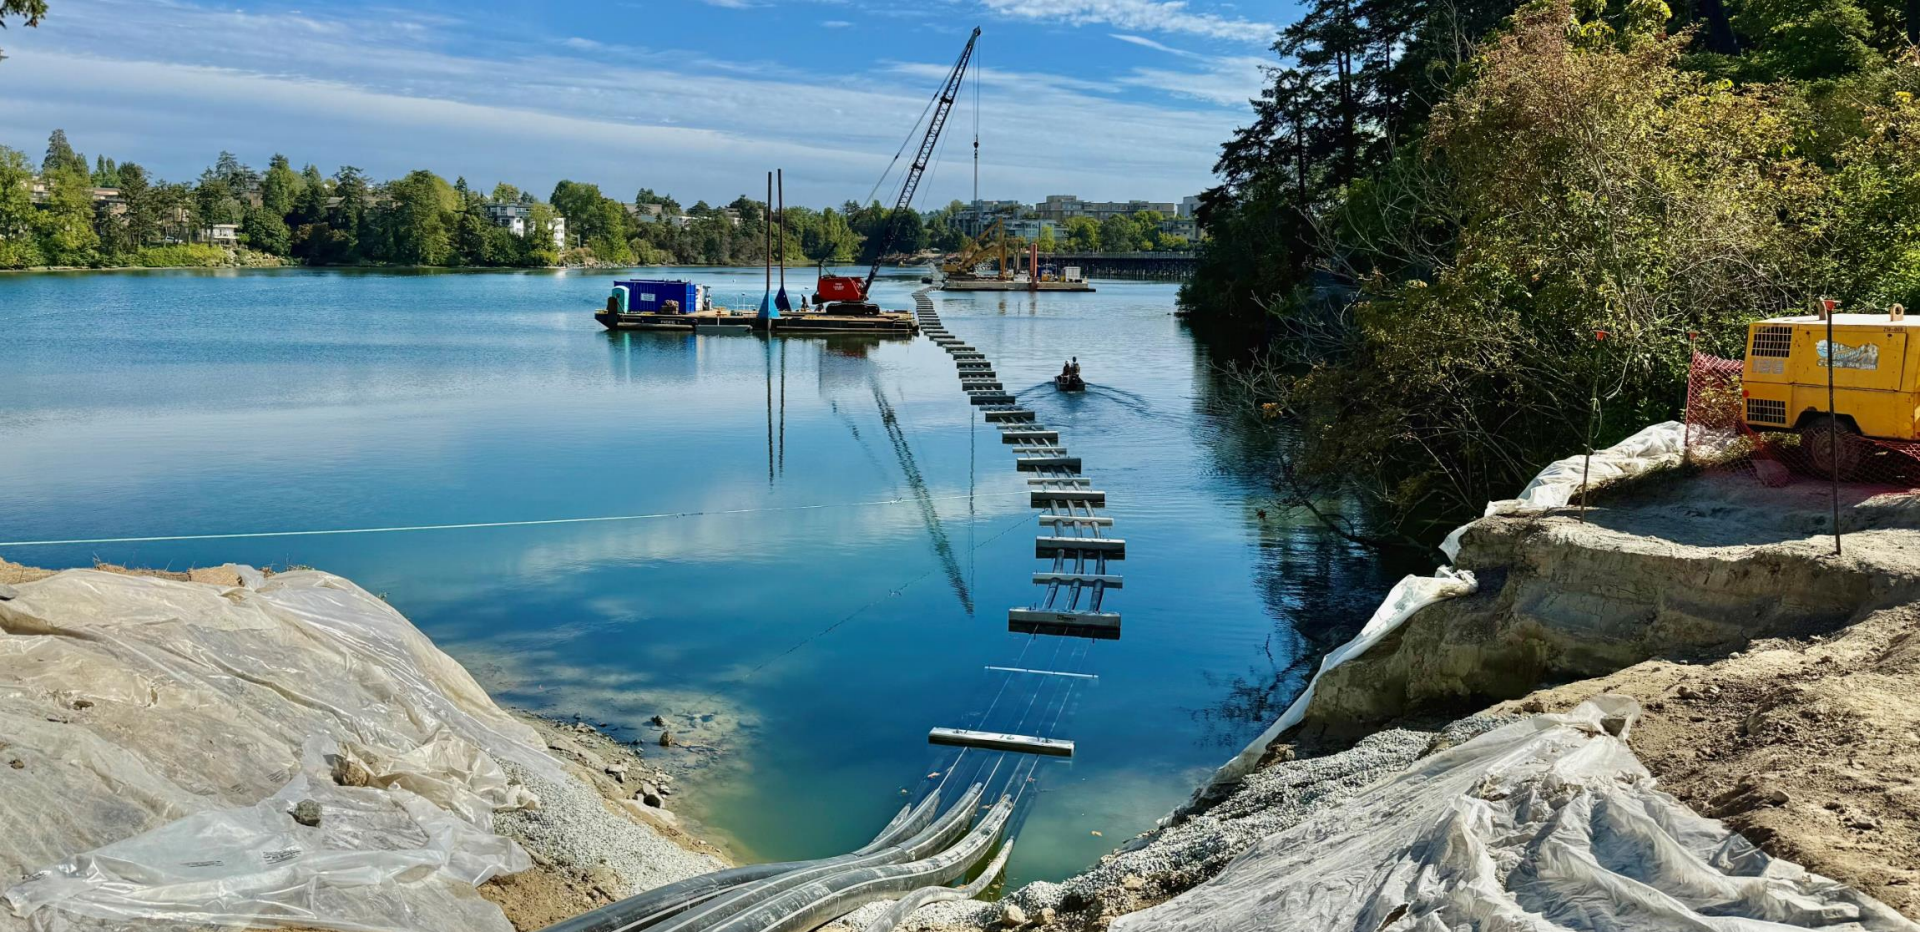
August 19: Installed plastic spacers and concrete anchor blocks attached to the last conduit section via a moving barge.

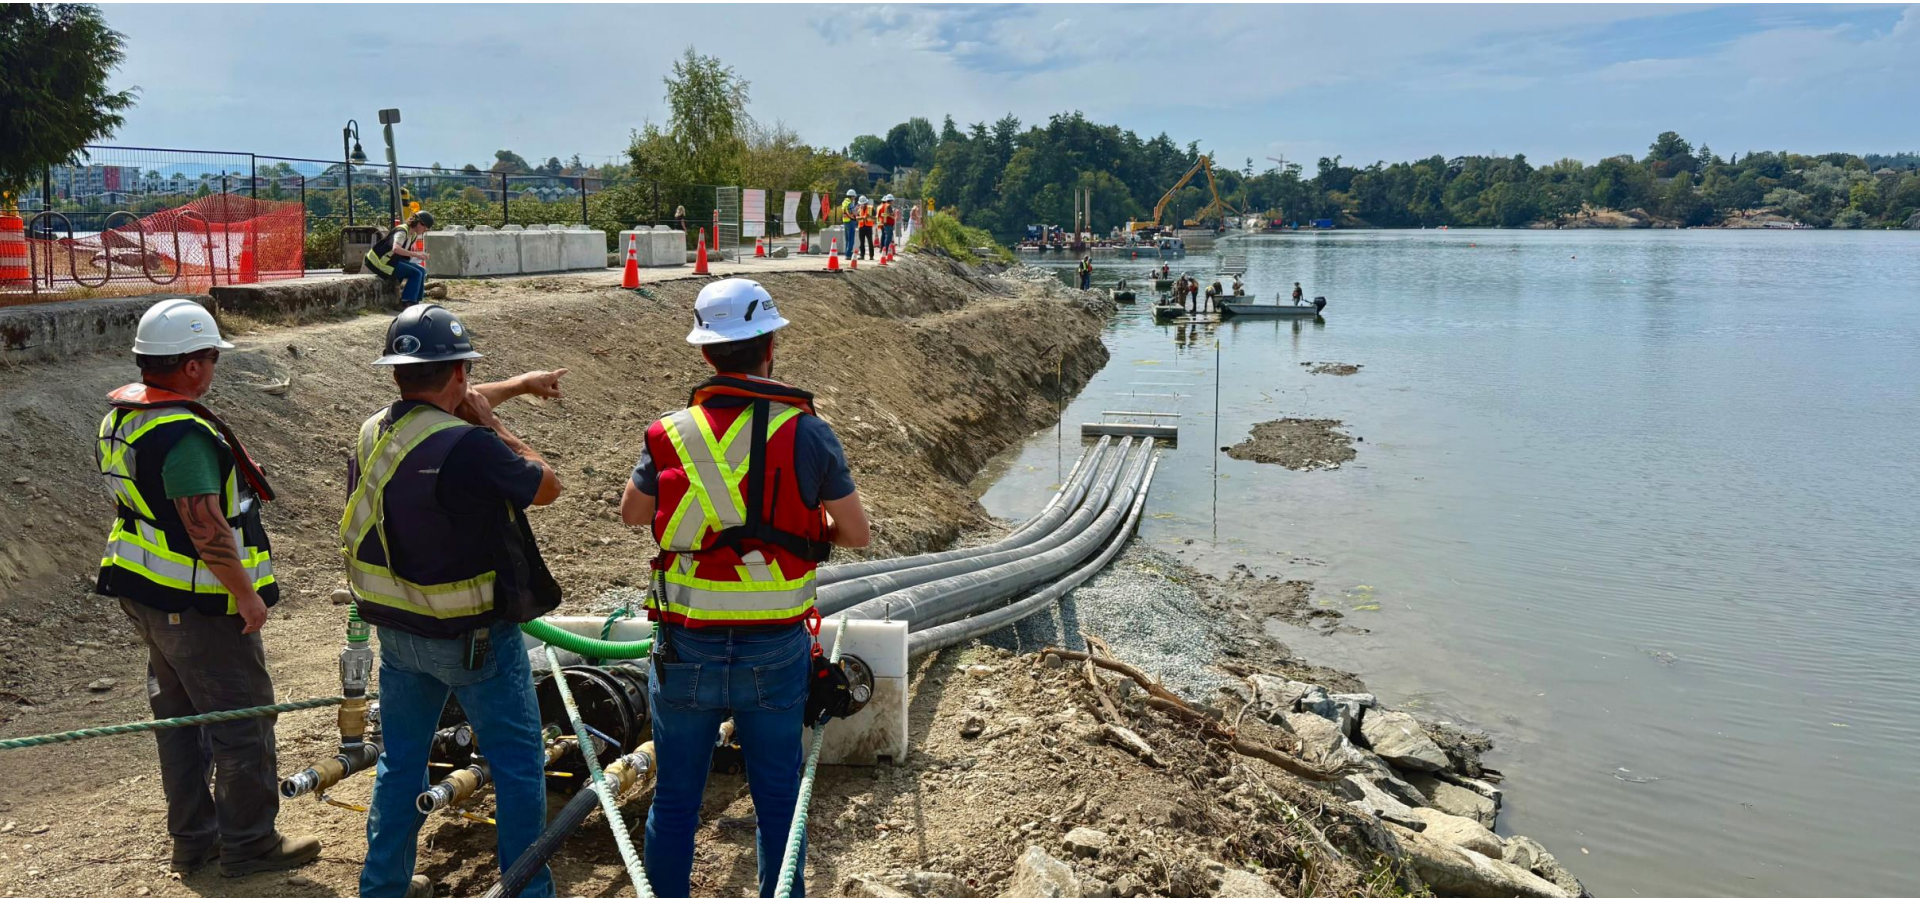
August 21: Conduit sinking began in the morning. Water was slowly added while air was released from the conduits thru valves to maintain equilibrium and allow the conduits to slowly sink from Viaduct Park towards Banfield Park.

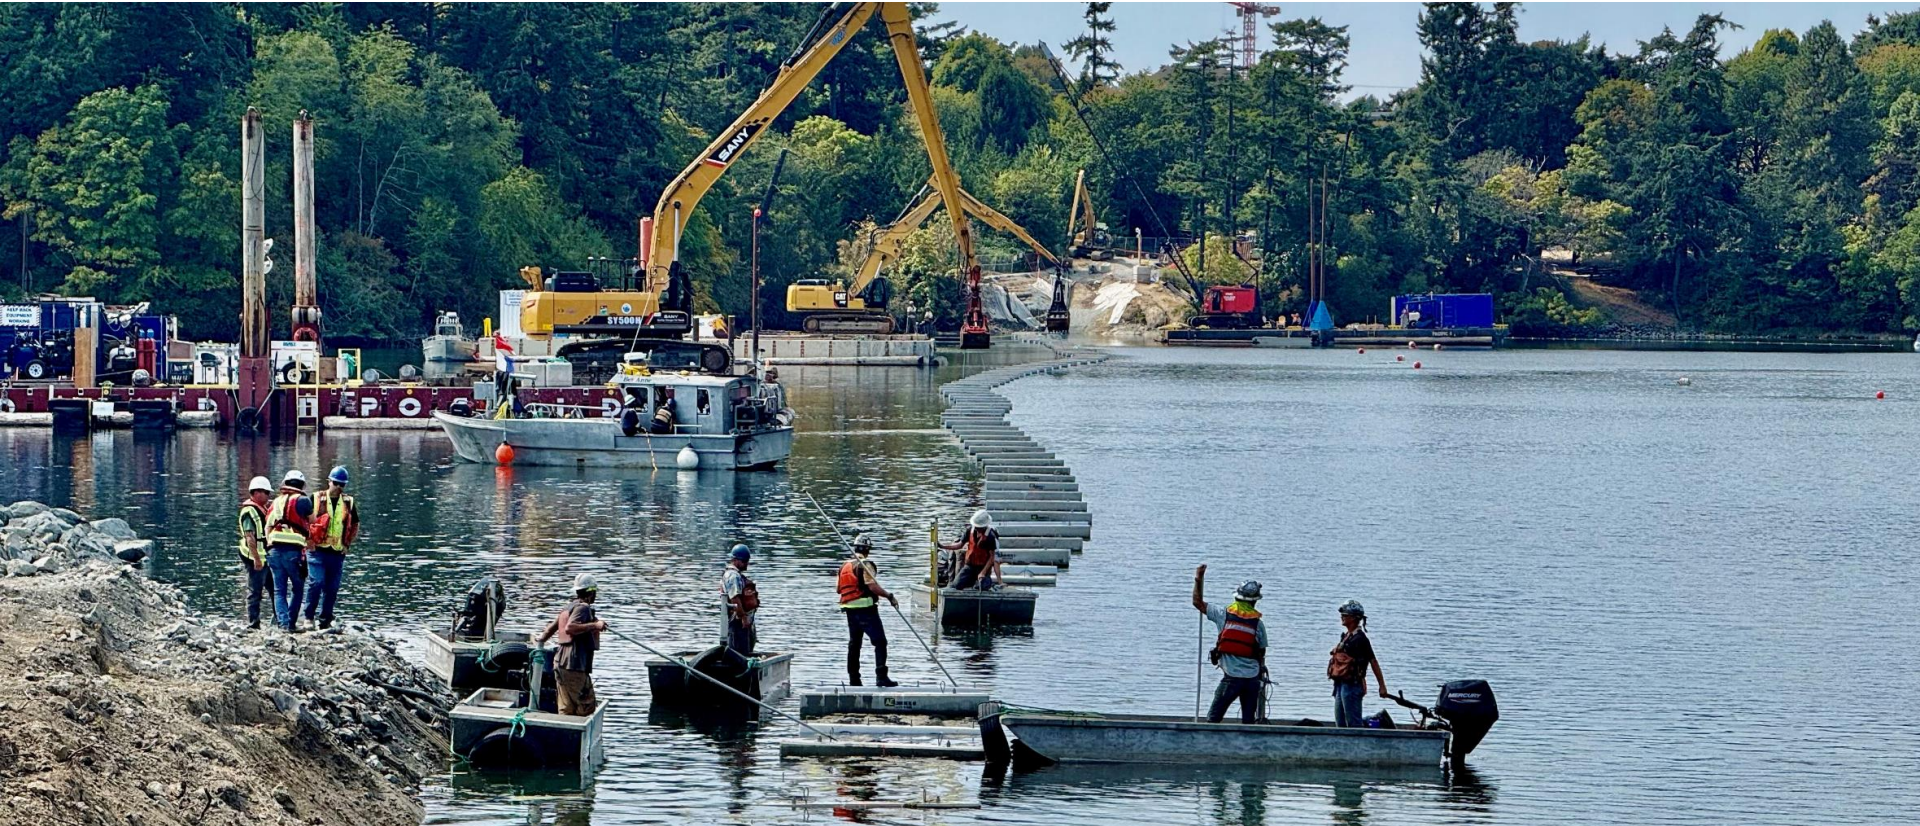
August 21: Surveyors, divers, excavators, boats, and other people and equipment worked in tandem, in combination with crews adjusting the water filling and air releases, to ensure the conduits landed exactly within the middle of the trench. Near the bottom, each concrete anchor block was shifted 5-10 cm in either direction as needed and then placed in the trench. This provided for a straight alignment from foreshore to foreshore.

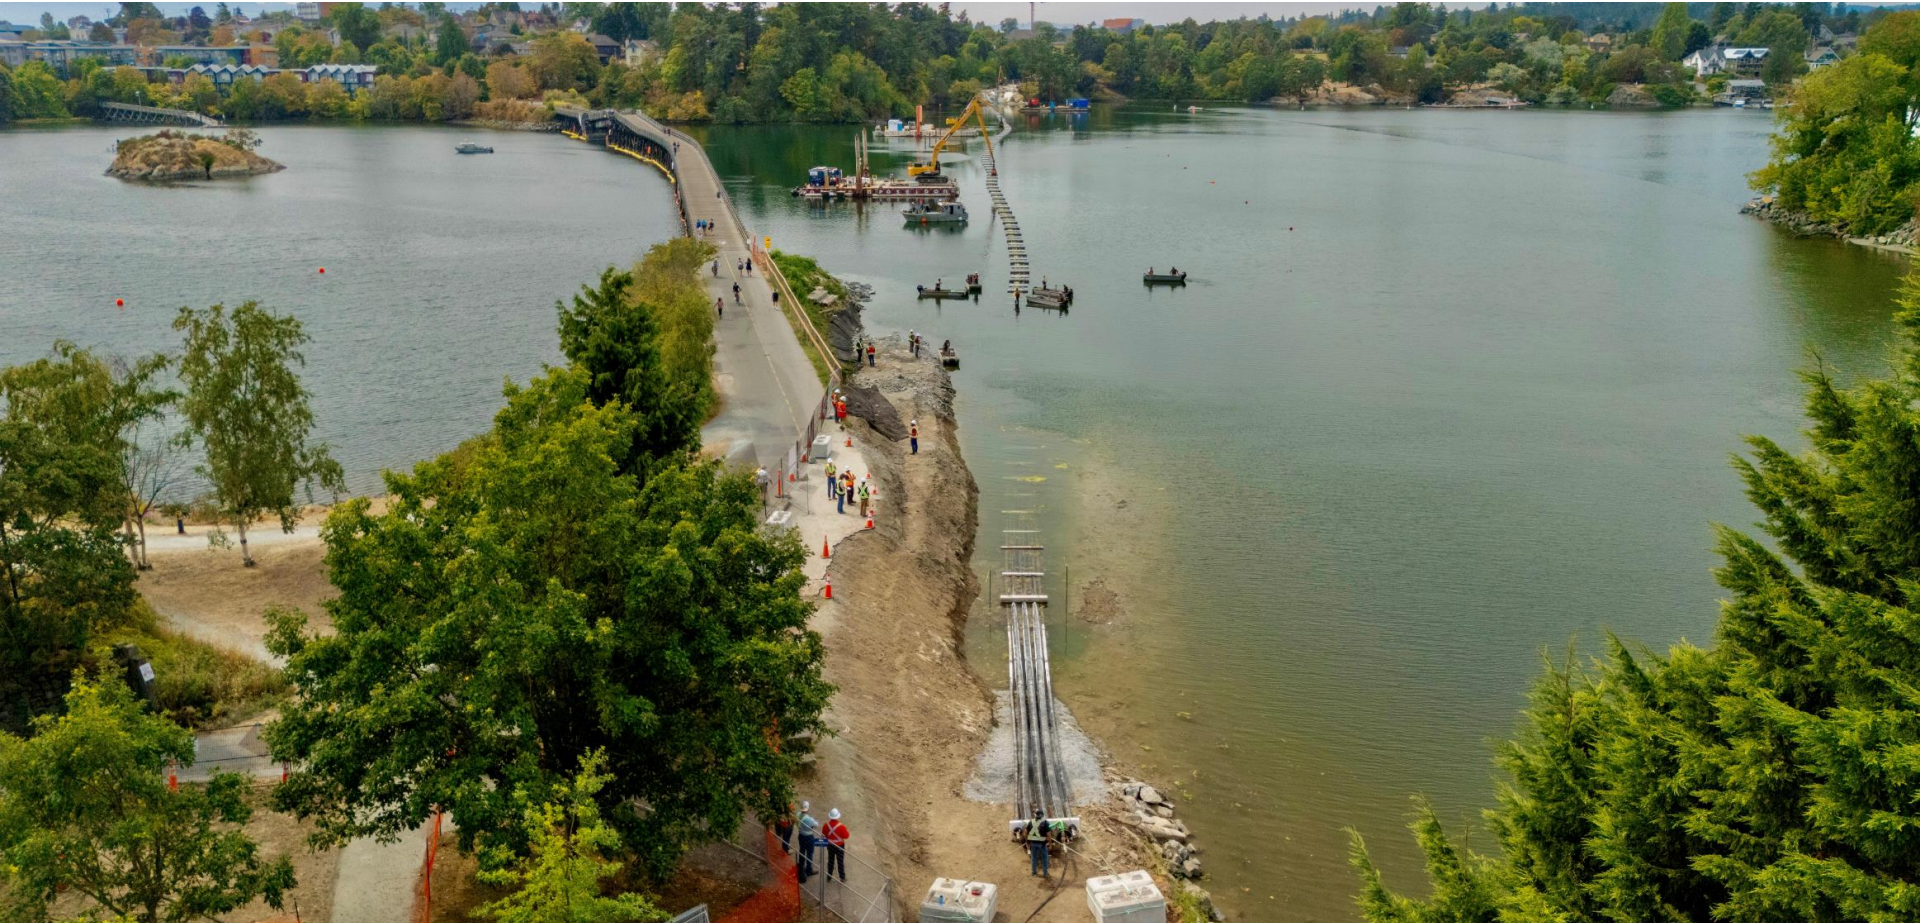
August 21: Looking over Viaduct Park towards the conduit sinking work. Galloping Goose Regional Trail and Selkirk Trestle on the left.

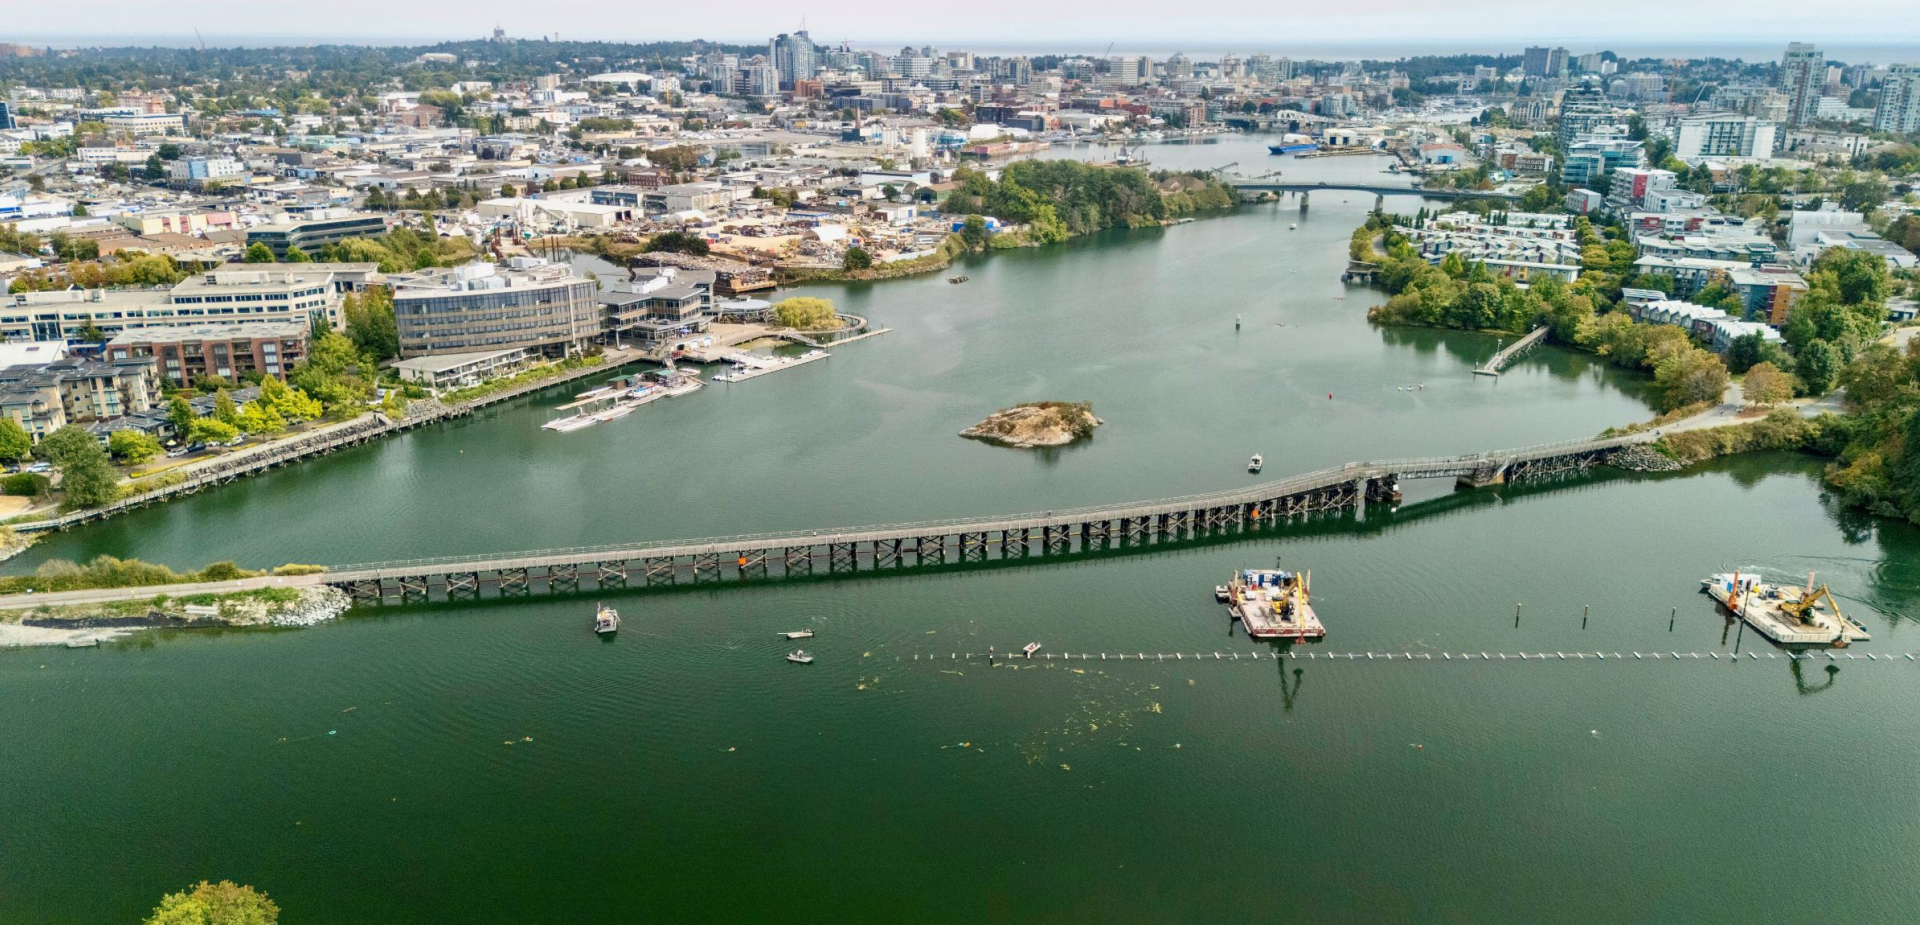
August 21: Progress in the conduit sinking.

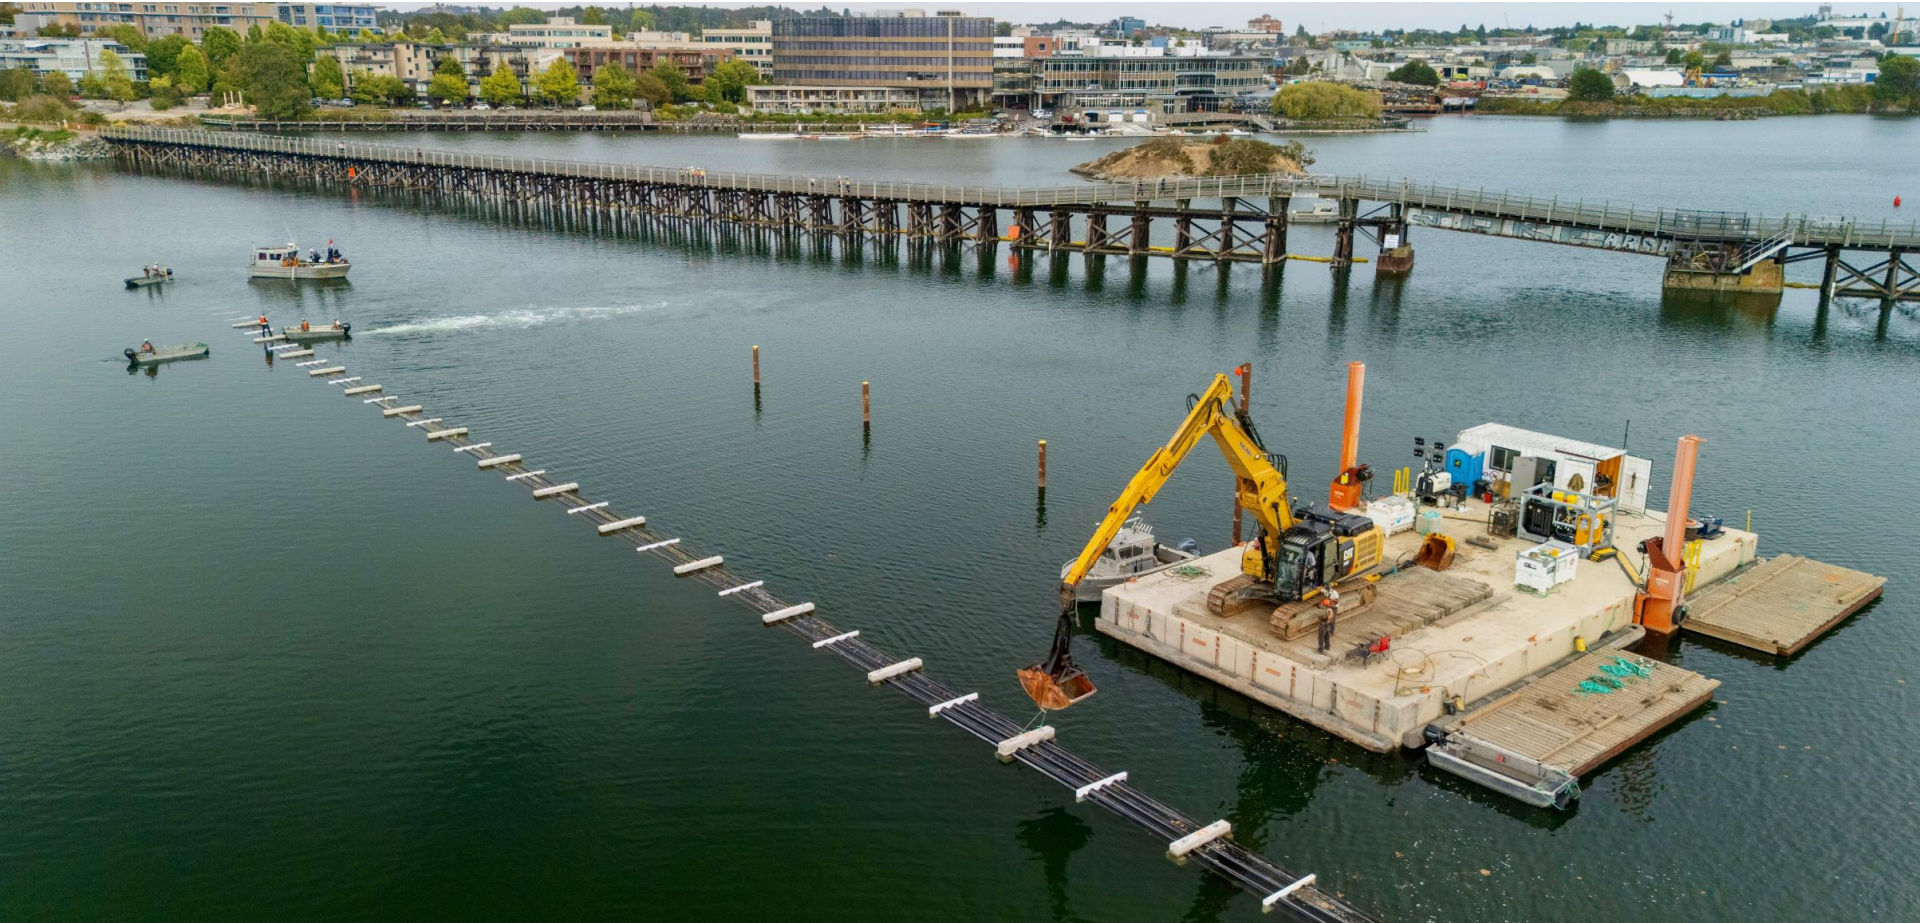
August 21: Diligently placing the conduits under the Gorge Waterway.

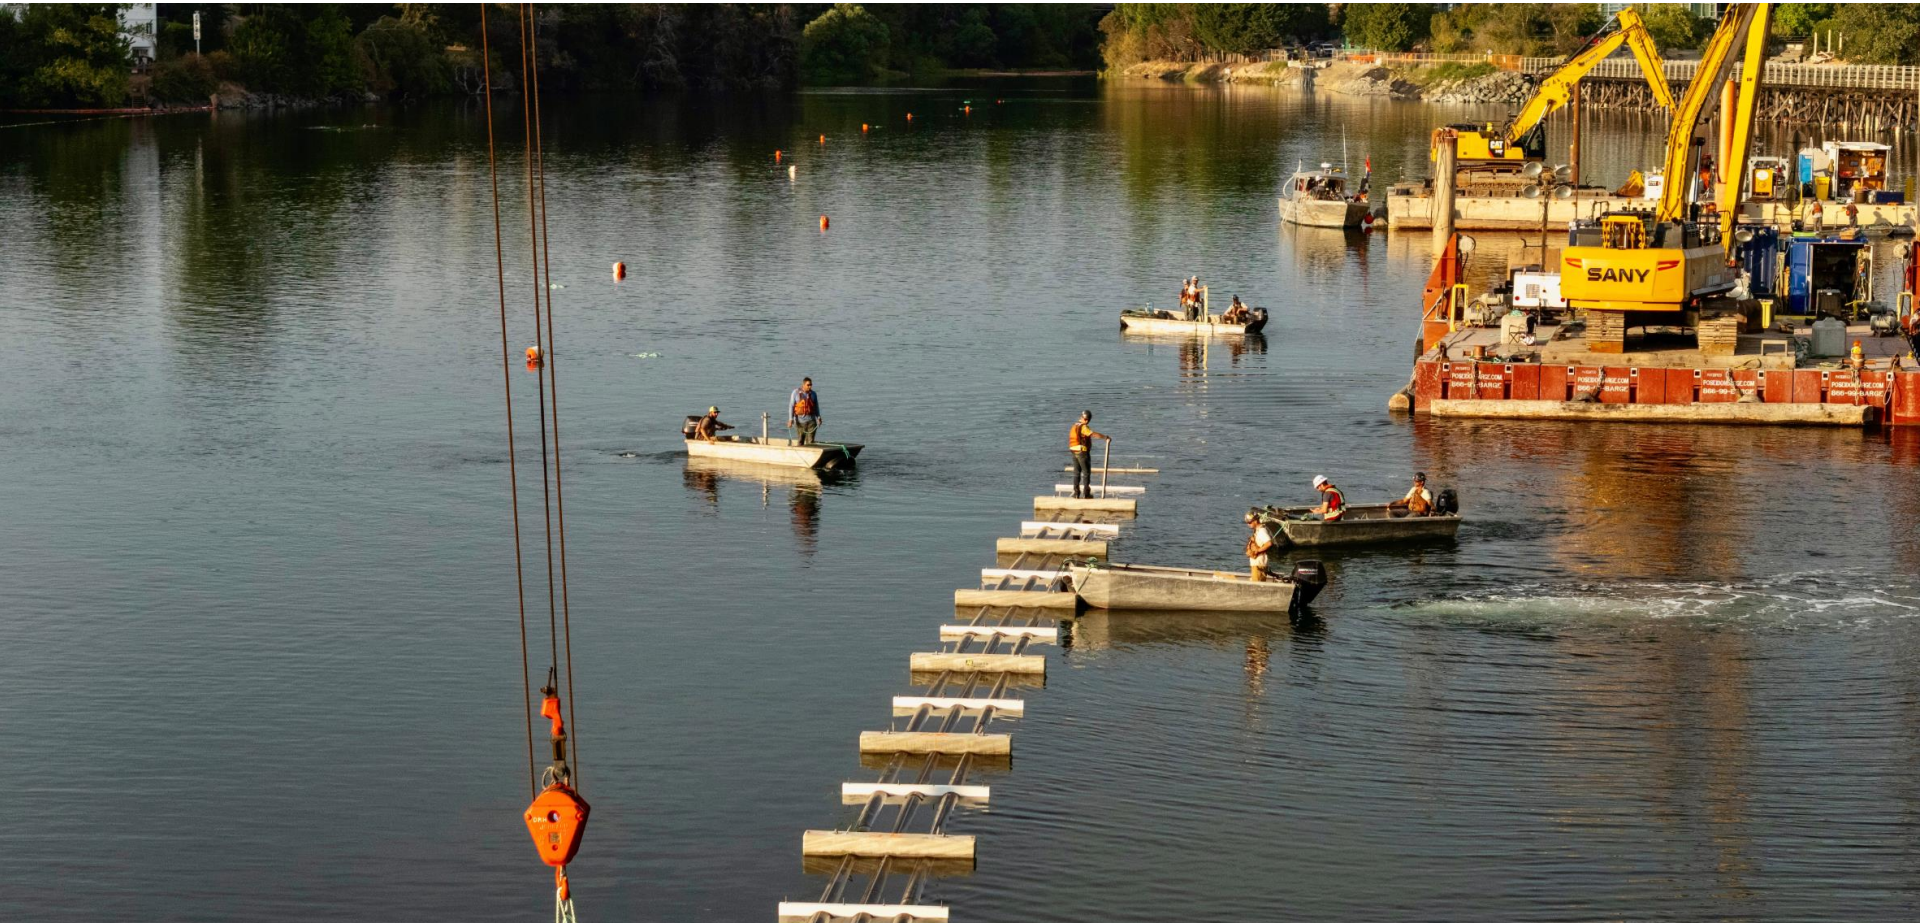
August 21: Good coordination with crews to carefully lower the conduits into the trench.

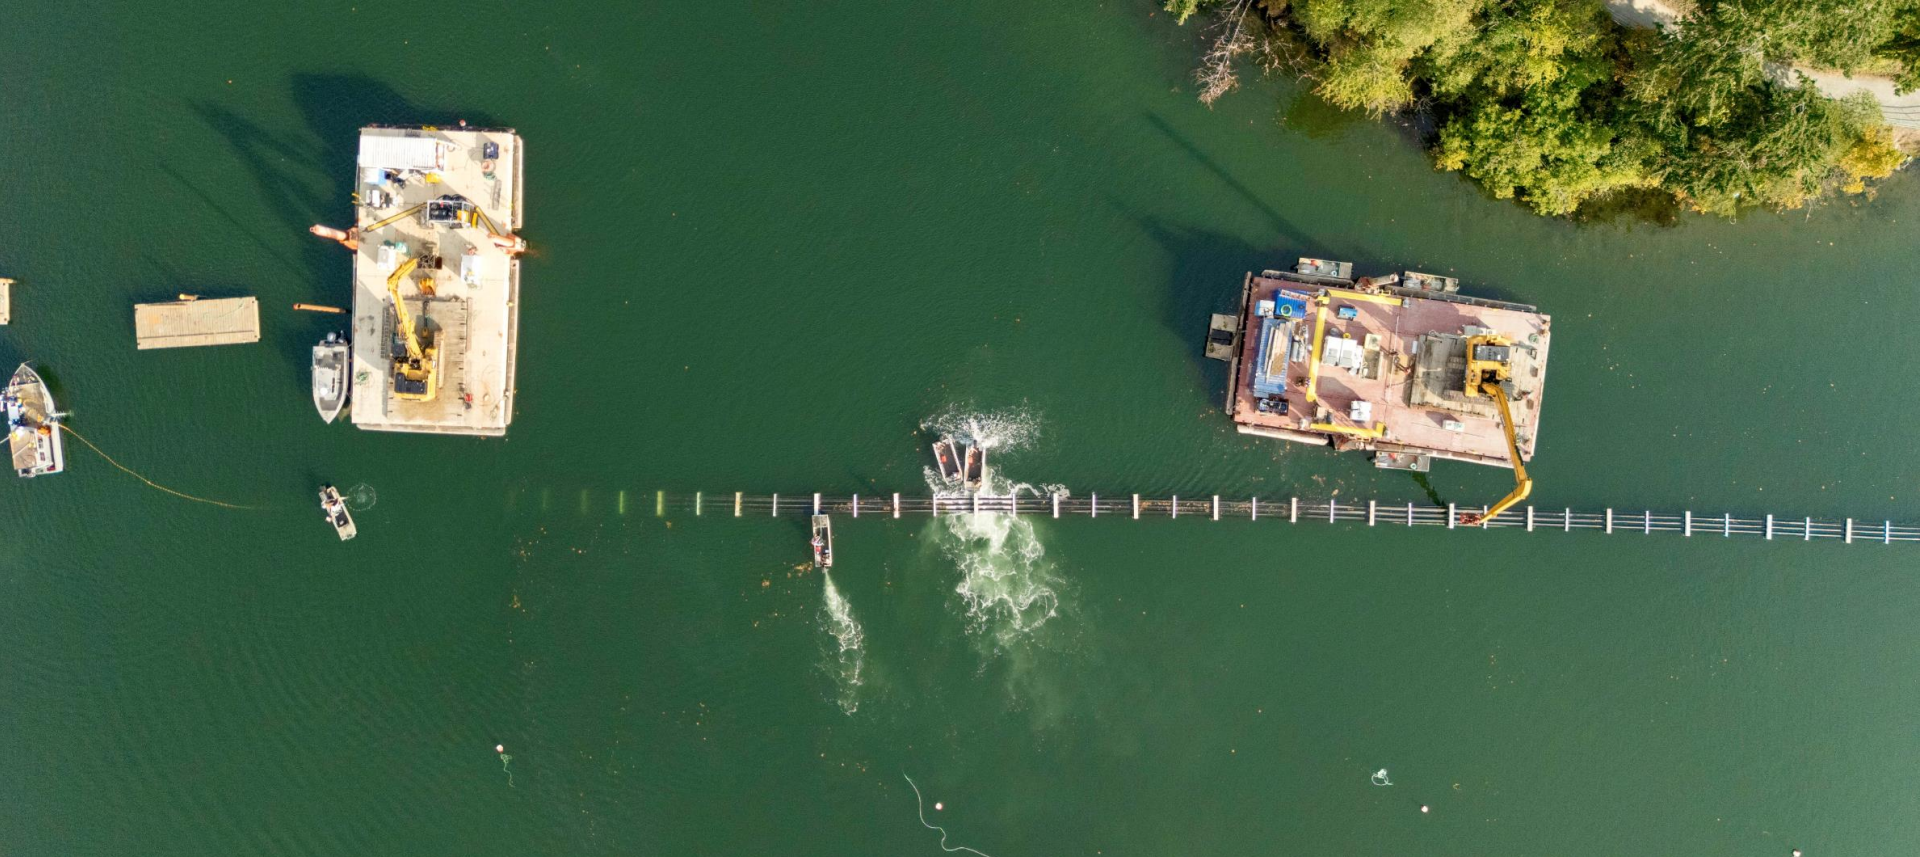
August 21: From left to right, diver boat with an air line to a diver near the small boat. The diver coordinates with crews with a survey stick to ensure conduit placement is accurate while three boats and an excavator arm push the conduits left or right to ensure proper alignment after sinking.

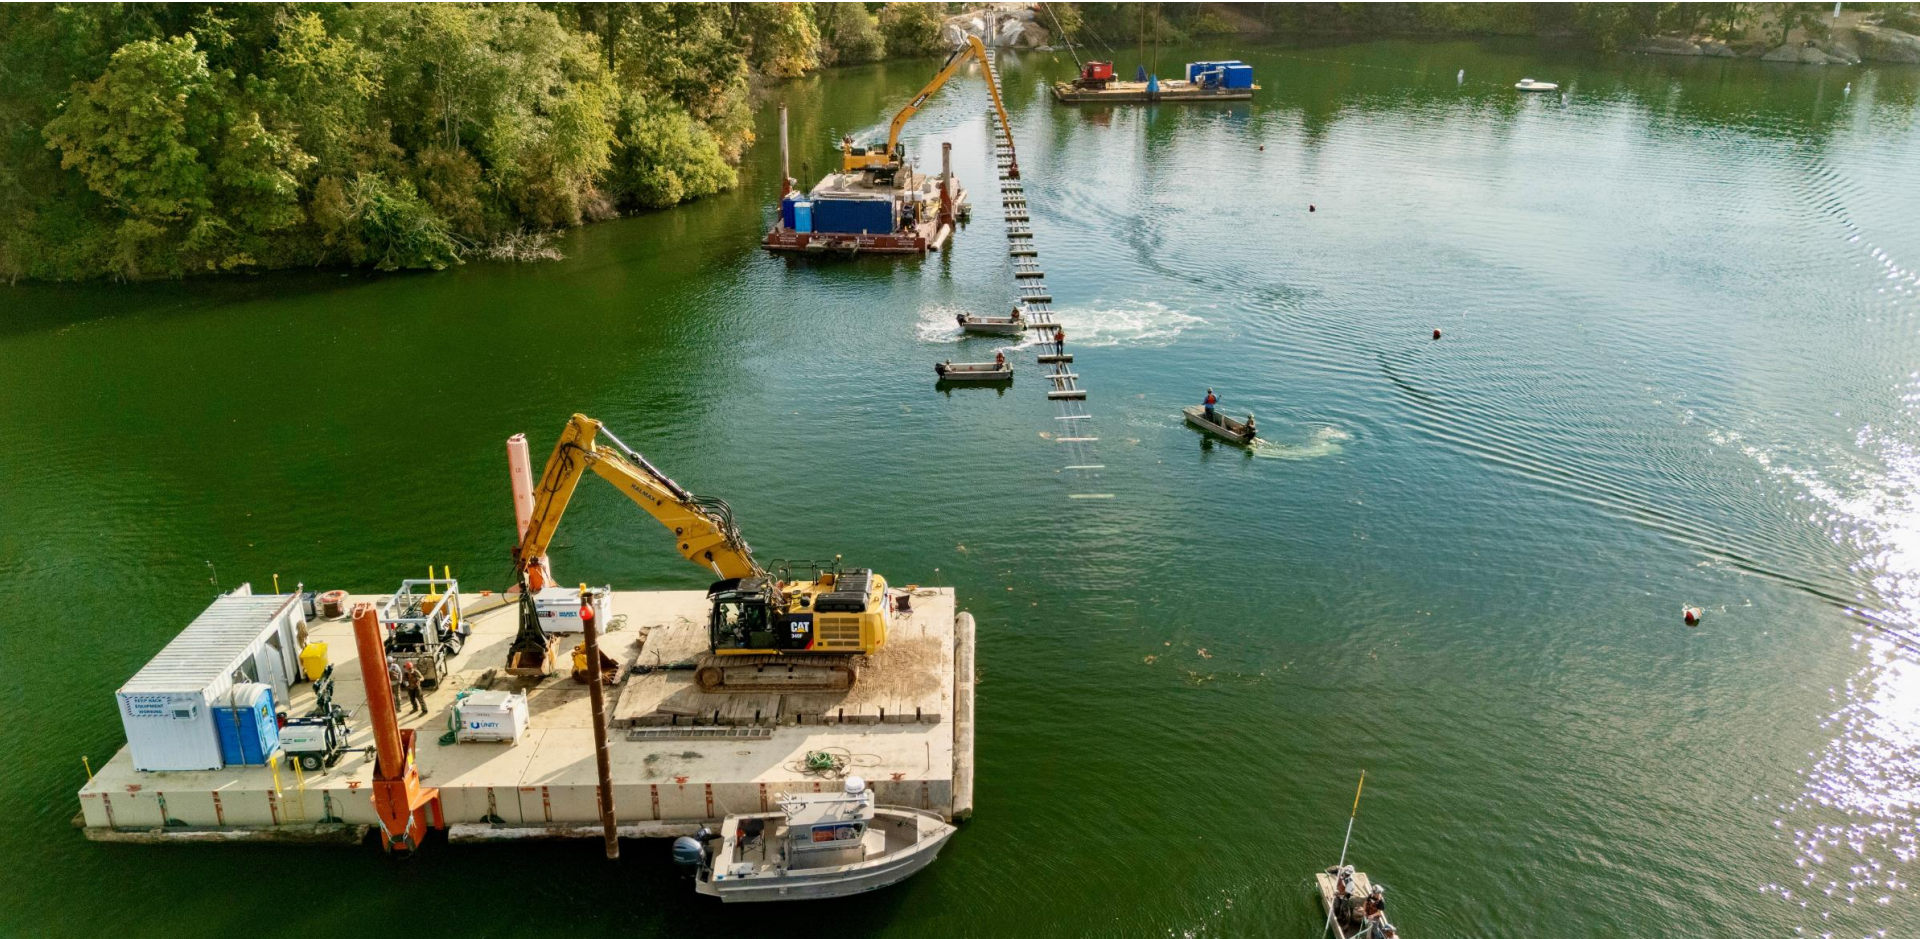
August 21: Another view of the same bird's-eye view from the previous page. Banfield Park in the background.

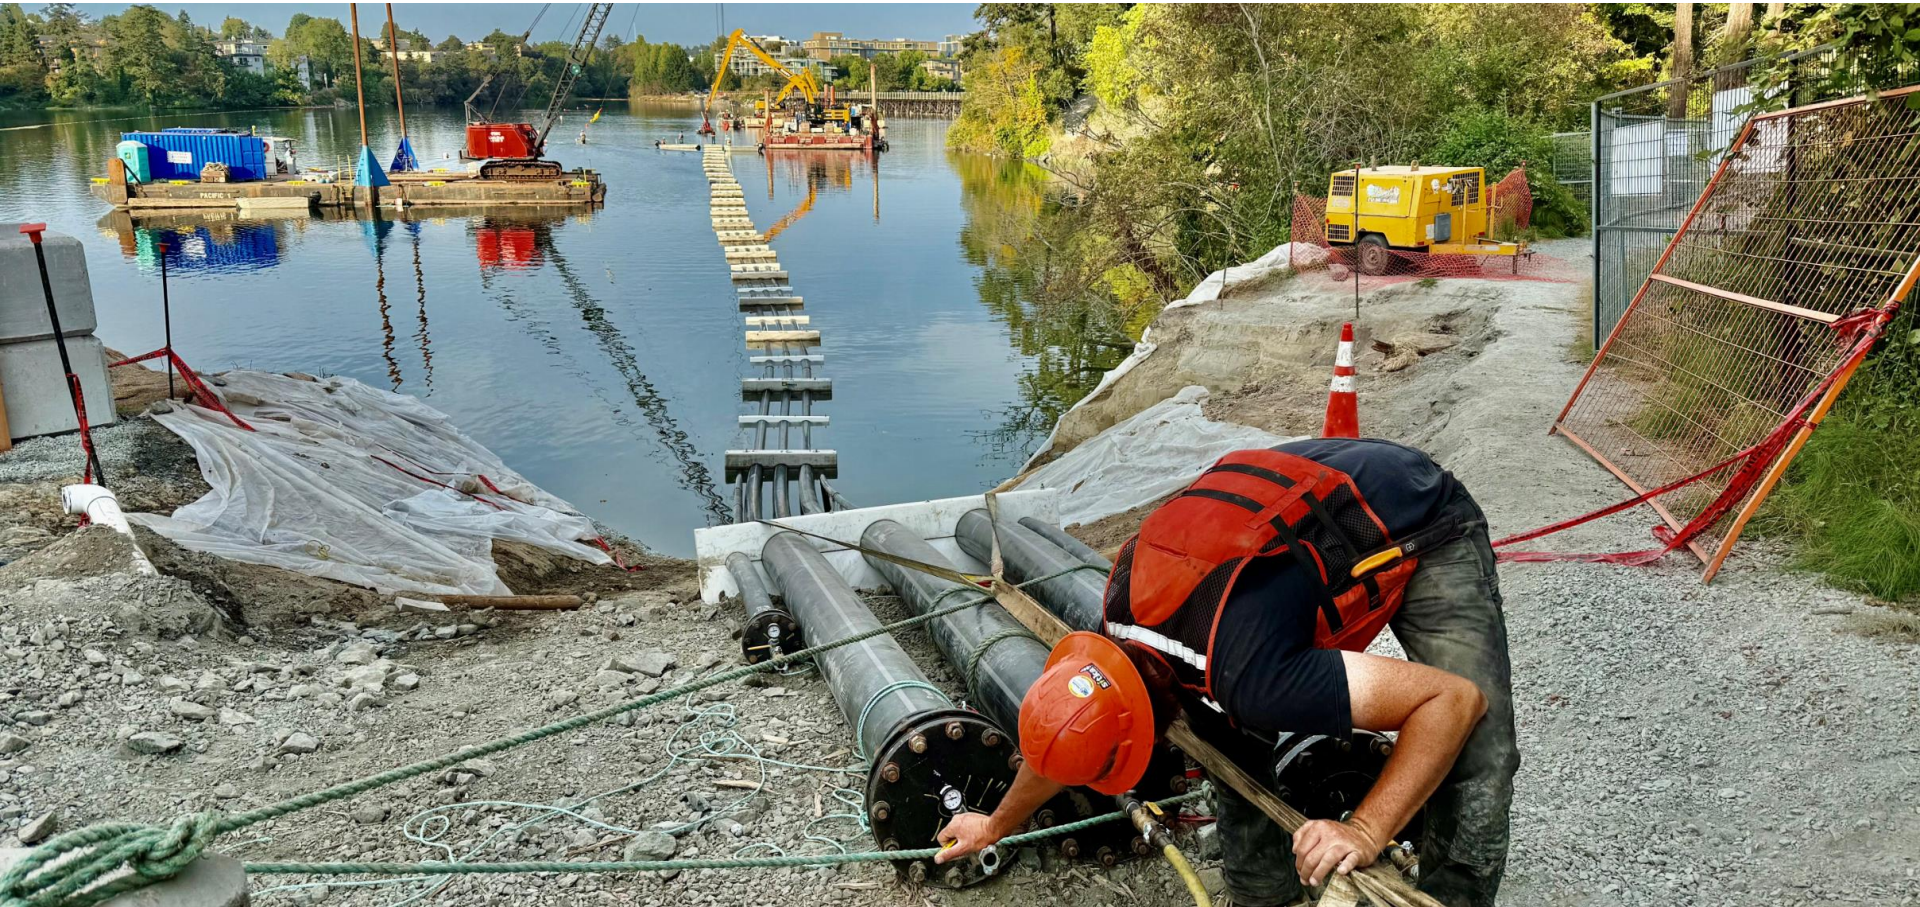
August 21: Adjusting the conduit air pressure on the Banfield Park side. It was an ongoing effort to adjust and ensure the conduits were balanced.

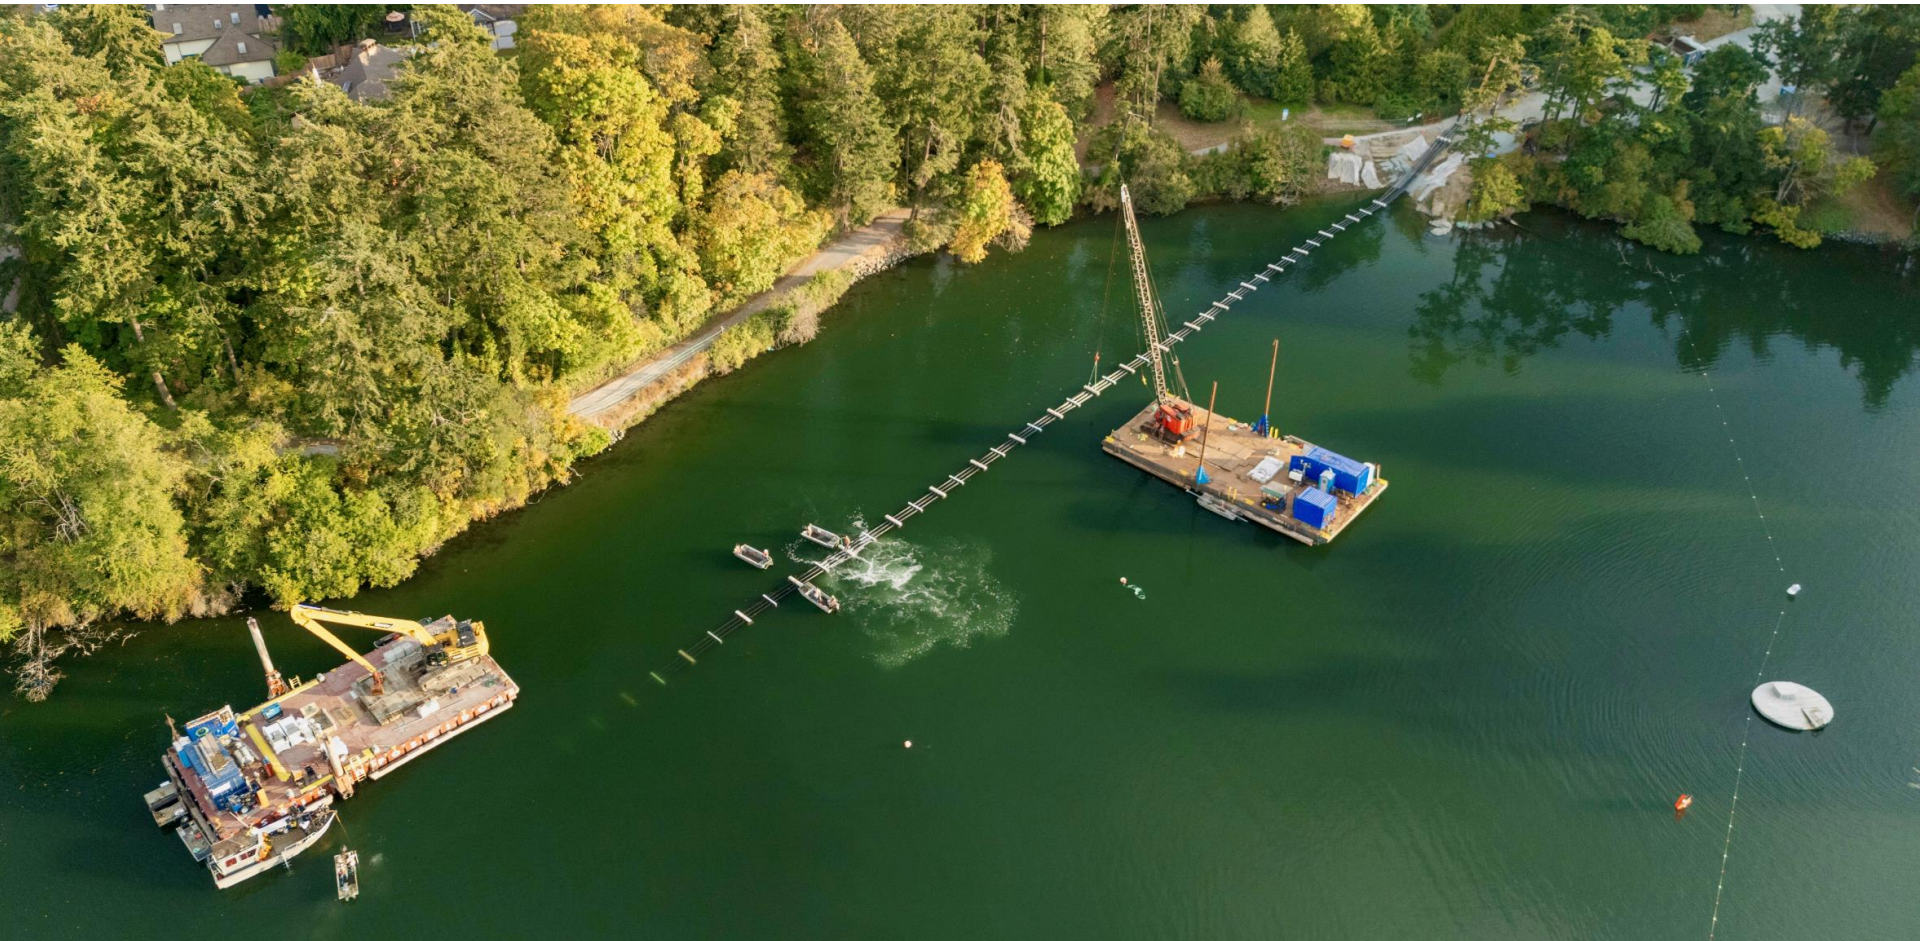
August 21: Progression in the conduit sinking as crews work towards Banfield Park.

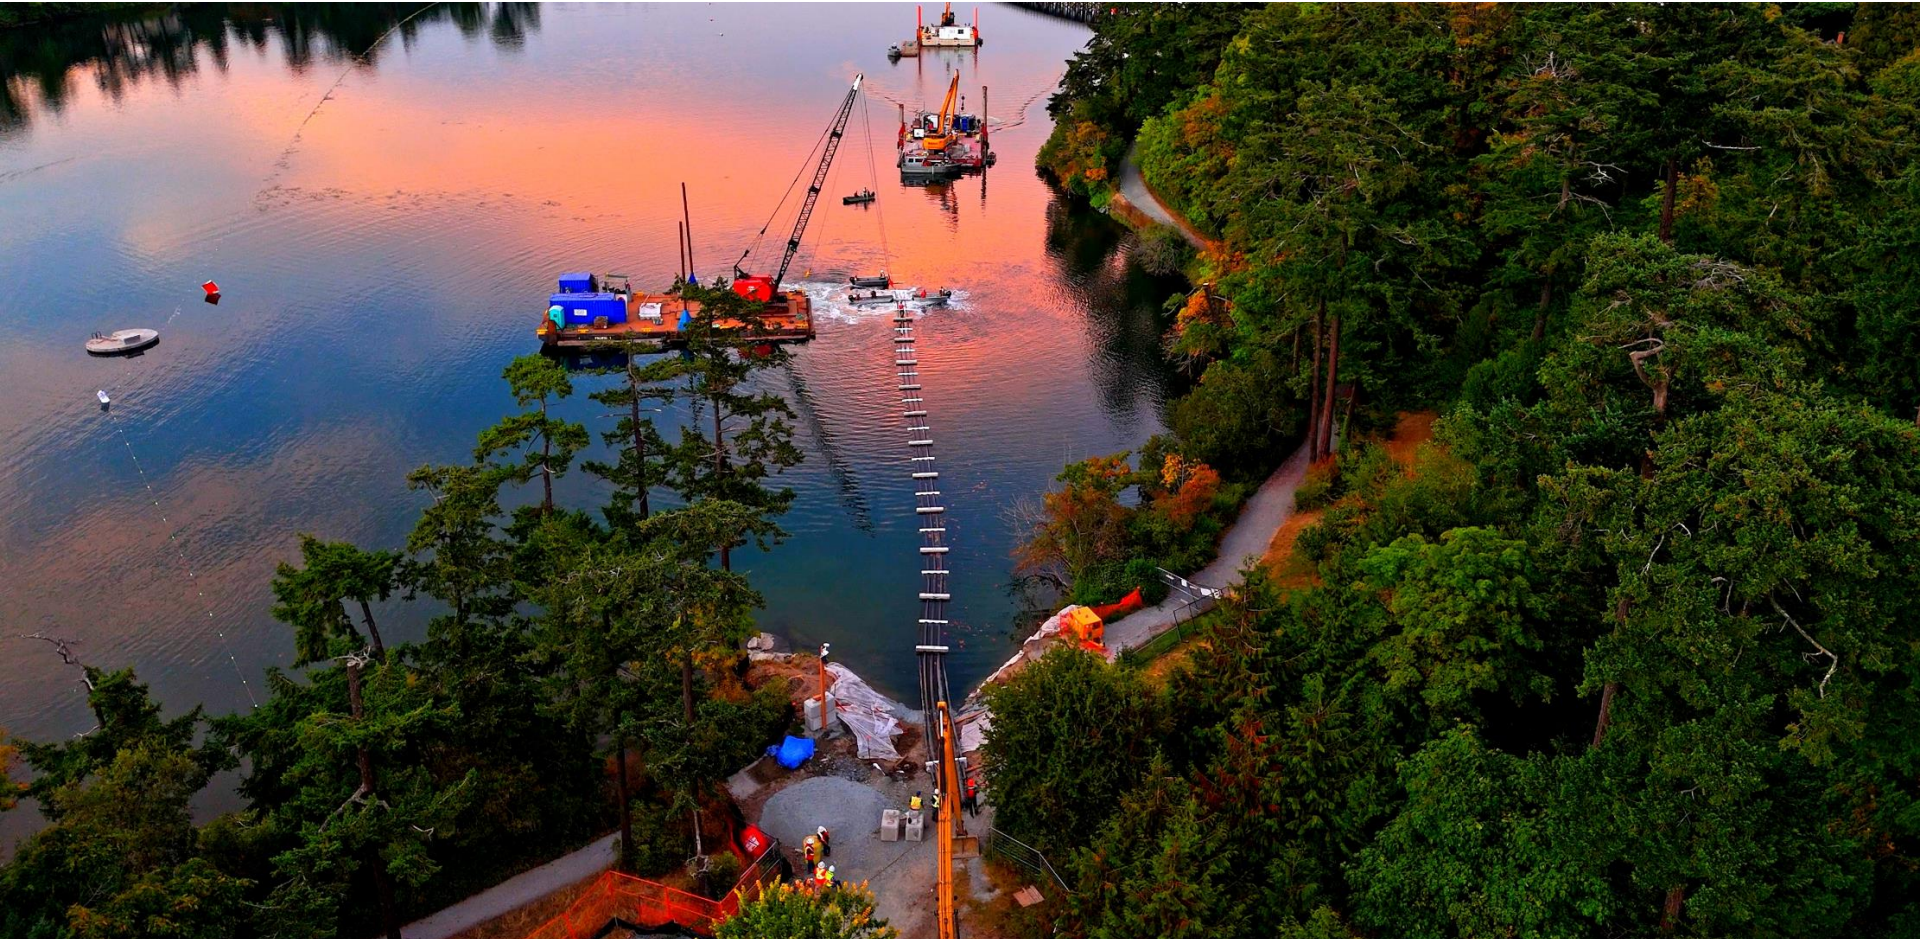
August 21: Work going into the evening. Incredible dusk coloured reflection off the water. The work was completed around 10:00 pm.
