# Victoria to Esquimalt Cable Replacement Project – Community Construction Report #16

**August 2026**

# Project status

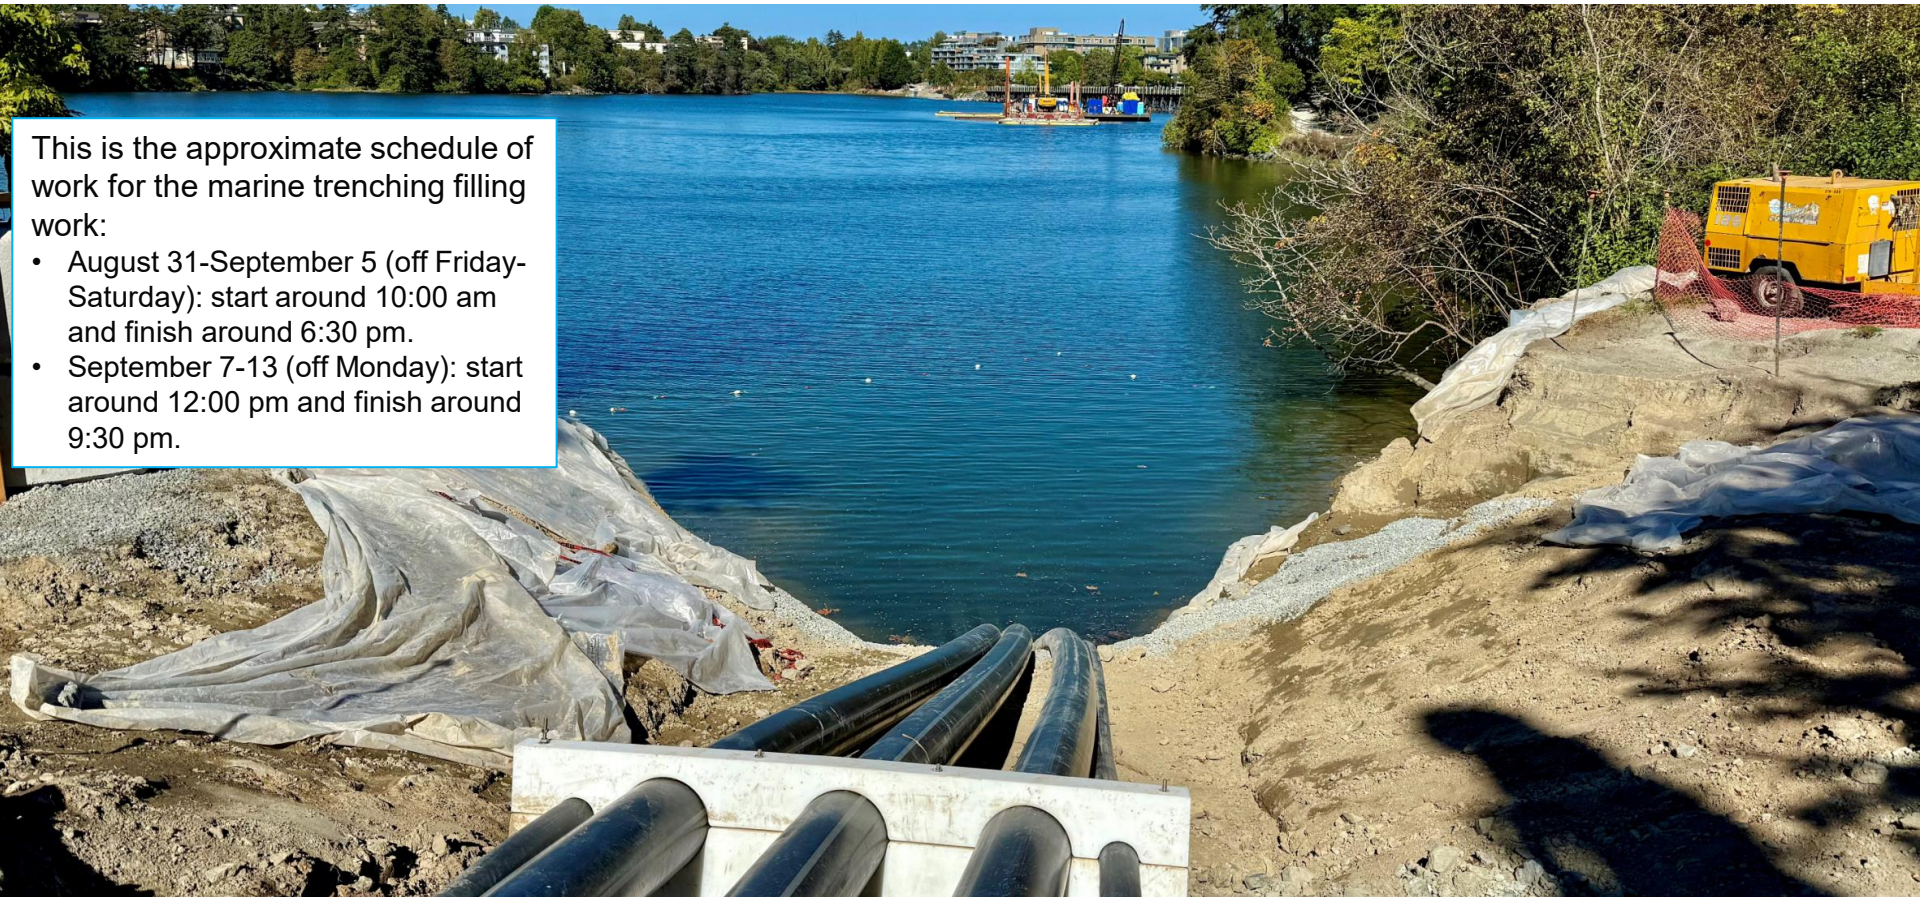
August 26: Conduits within the Gorge Waterway. Testing of conduits were completed, with good results, and crews began to place material over the conduits and fill in the trench on August 27. The placement of material within the trench may take up to three weeks.

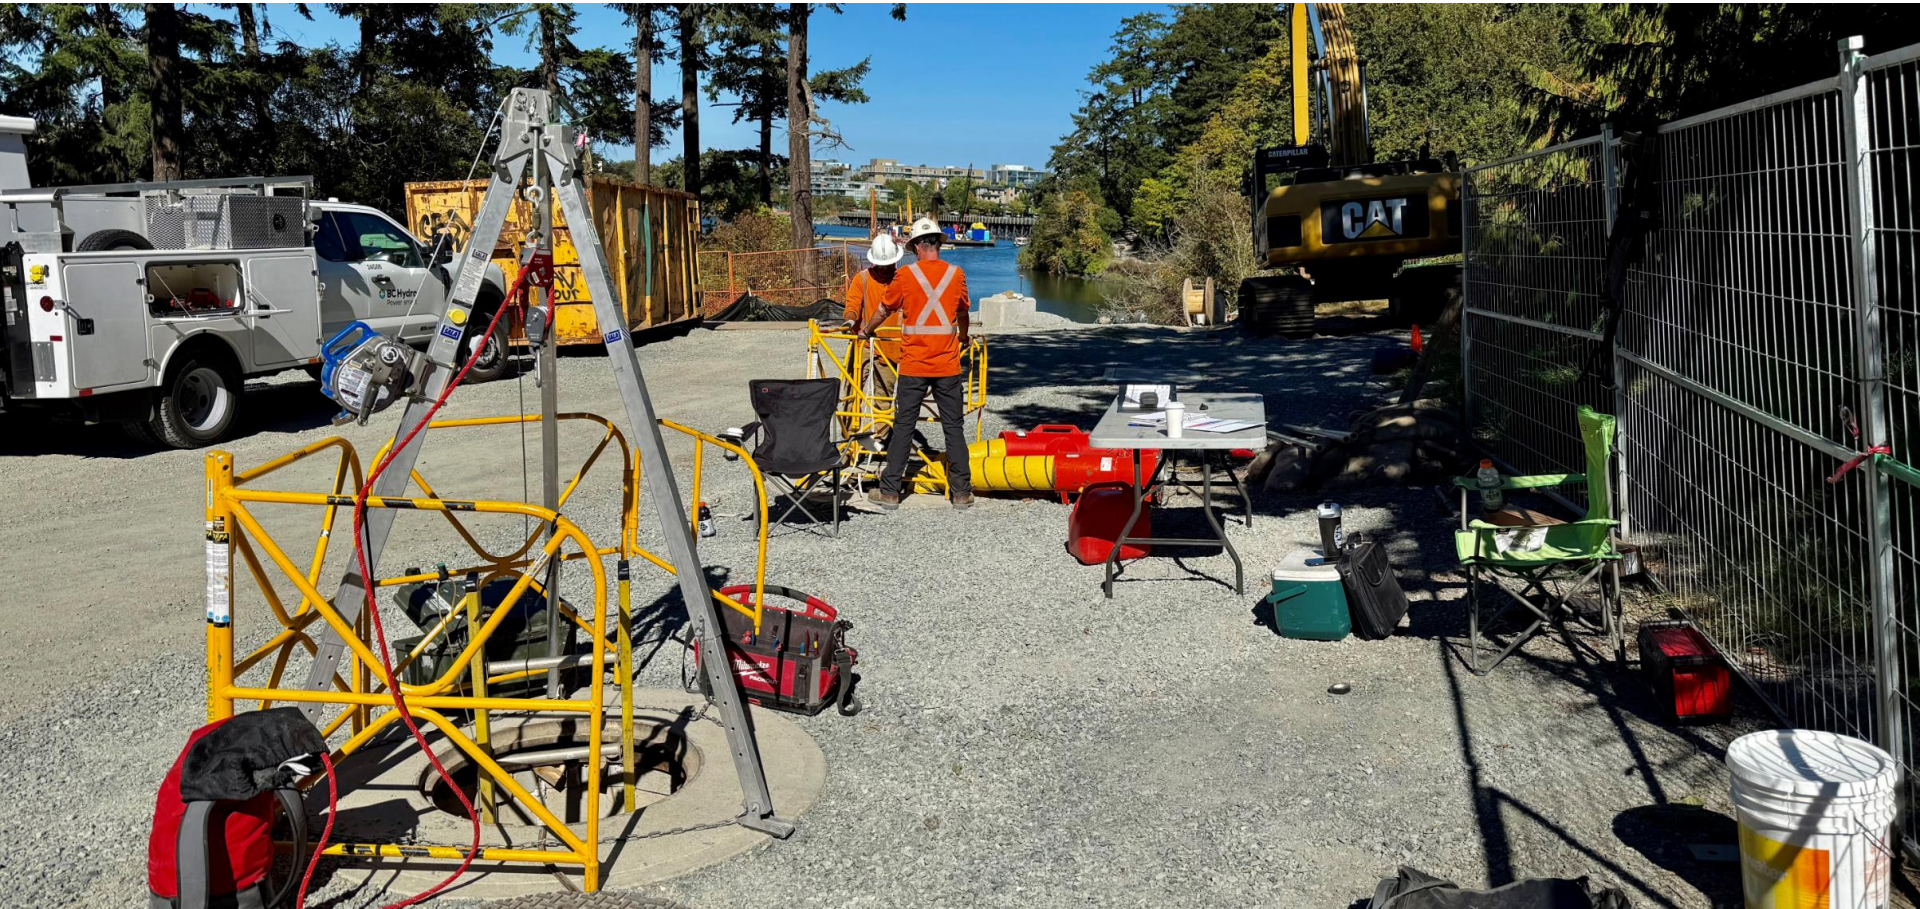
August 26: Crews preparing the concrete vault for the cable pulling, from Banfield Park to Viaduct Park, in September.
