# Victoria to Saanich Cable Replacement Project – Investigative Works Report #1

## August 2026

# Background: Victoria to Saanich Cable Replacement Project

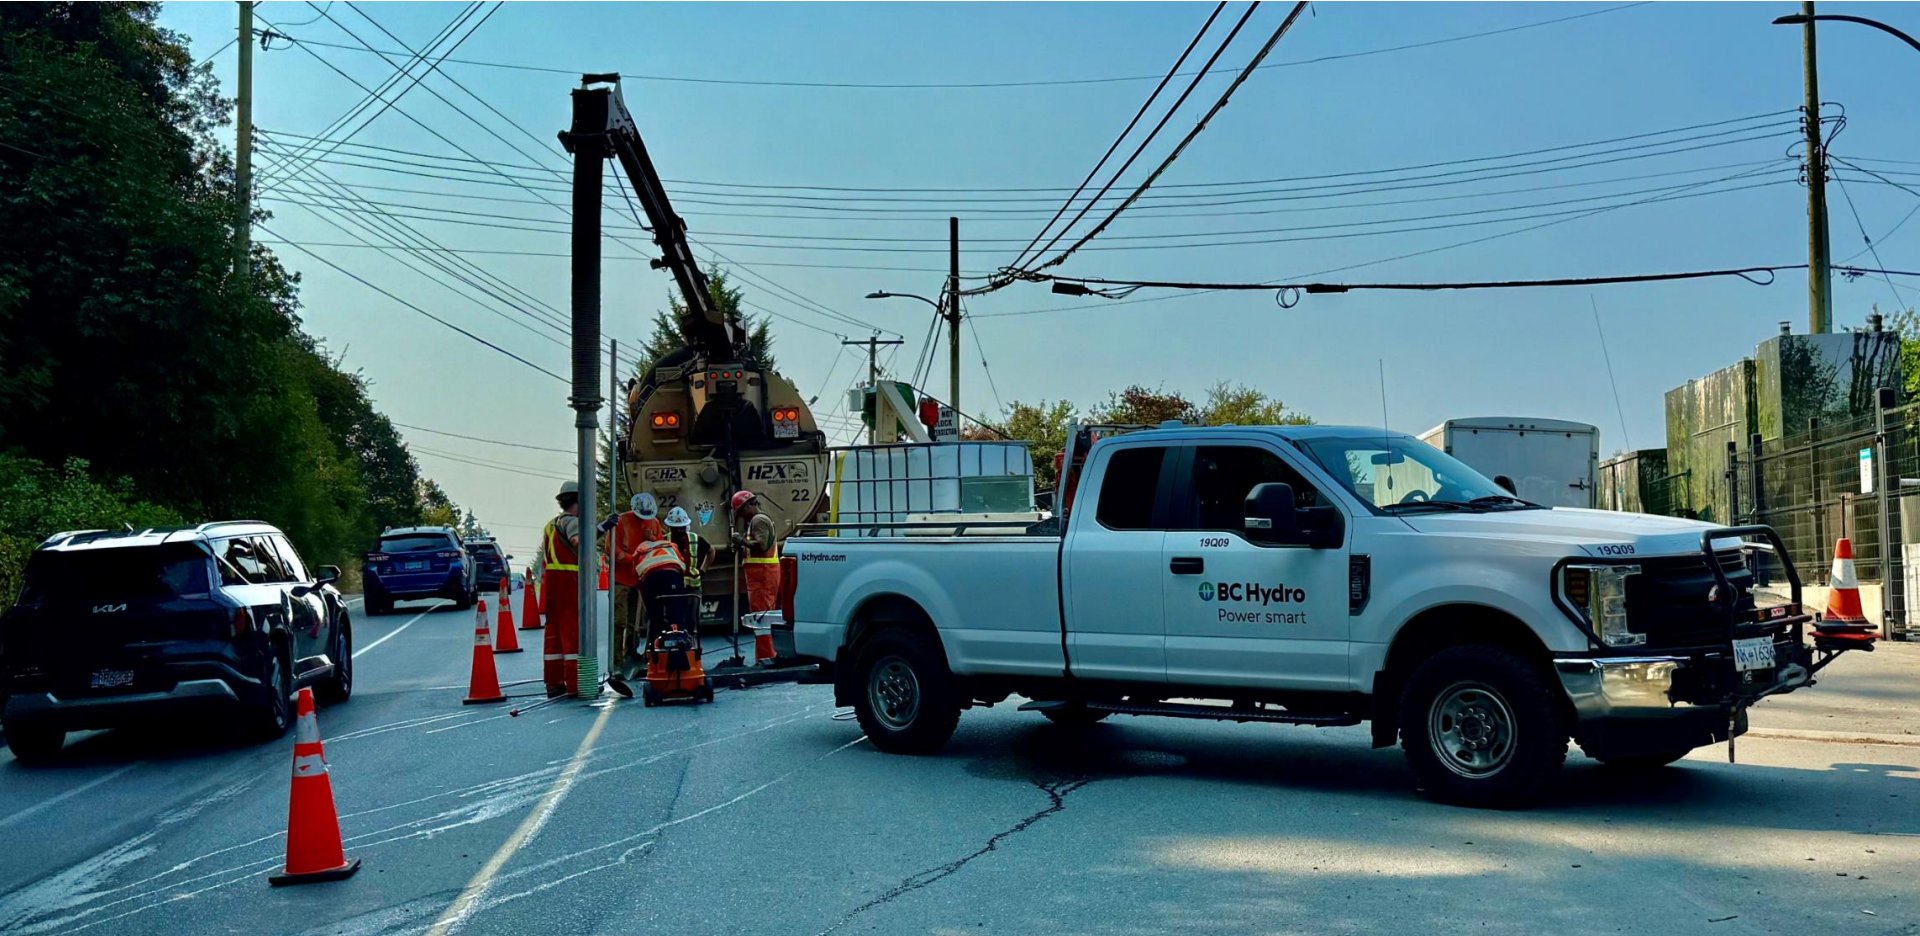
August 5: Traffic management with single-lane alternating traffic and the confirmation of the depth of a sewer line.

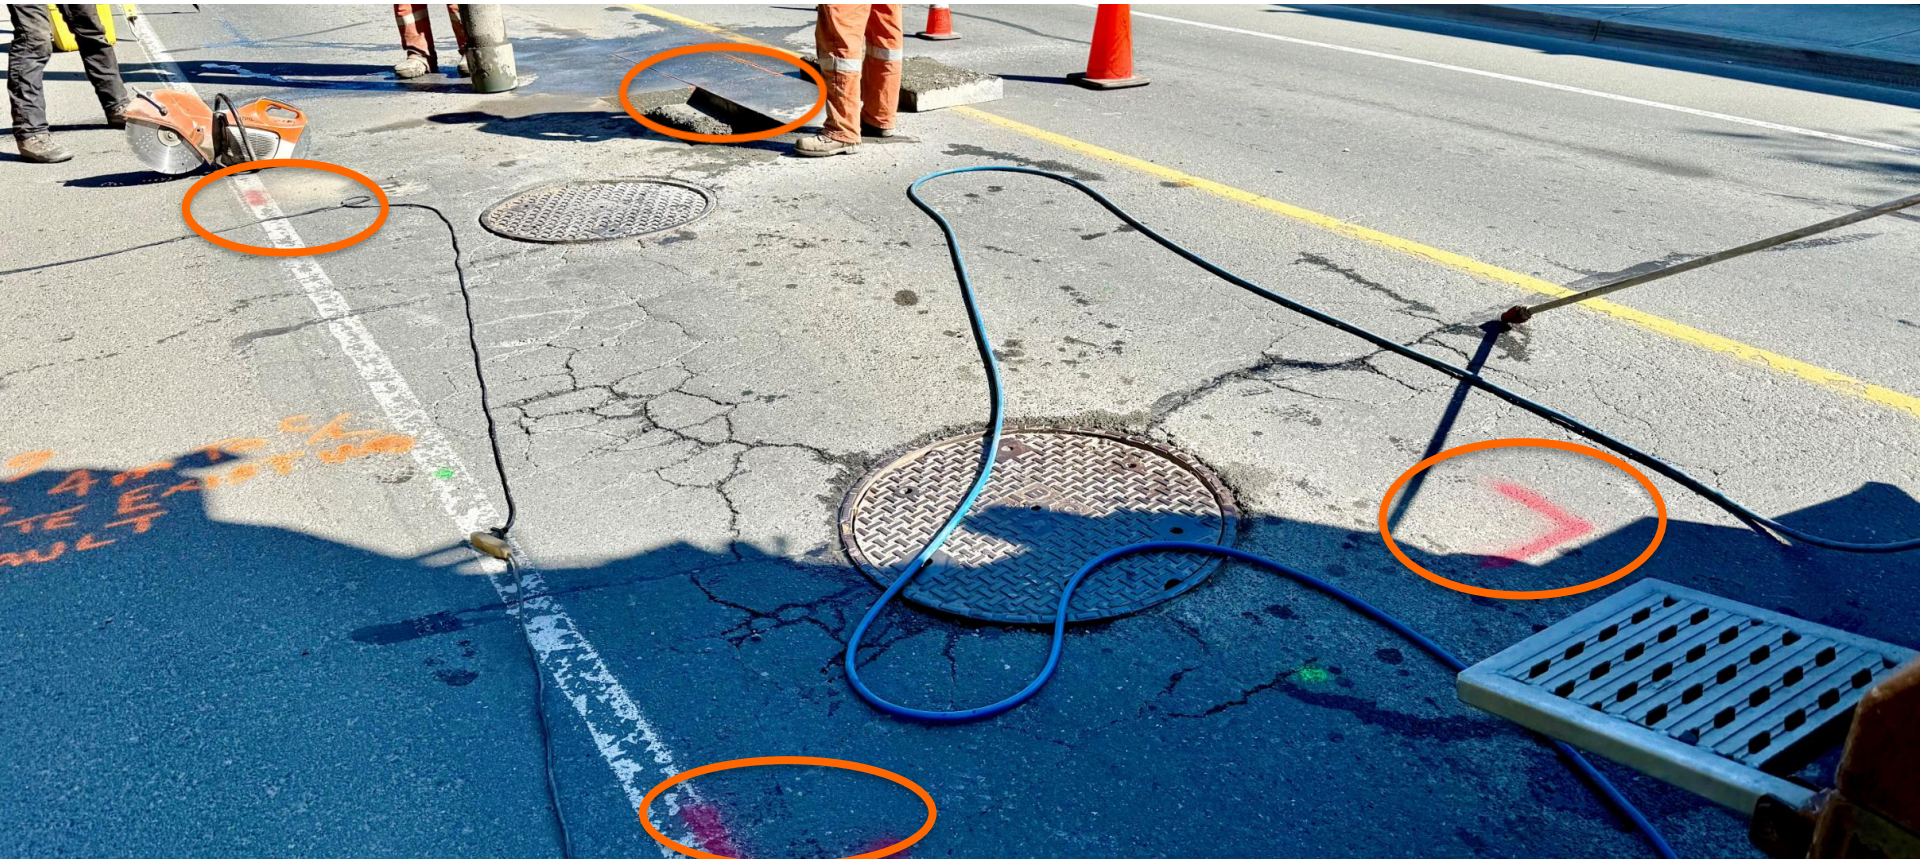
August 11: The existing street vaults along the route are 2.4 metres, by 2.7 metres, and 6 metres long. These vaults are where the existing cables are spliced together to make one long 7.4 km transmission line. Here, the four corners of the vault are shown with the orange ellipses. This work helps confirm the location and dimensions of existing infrastructure.

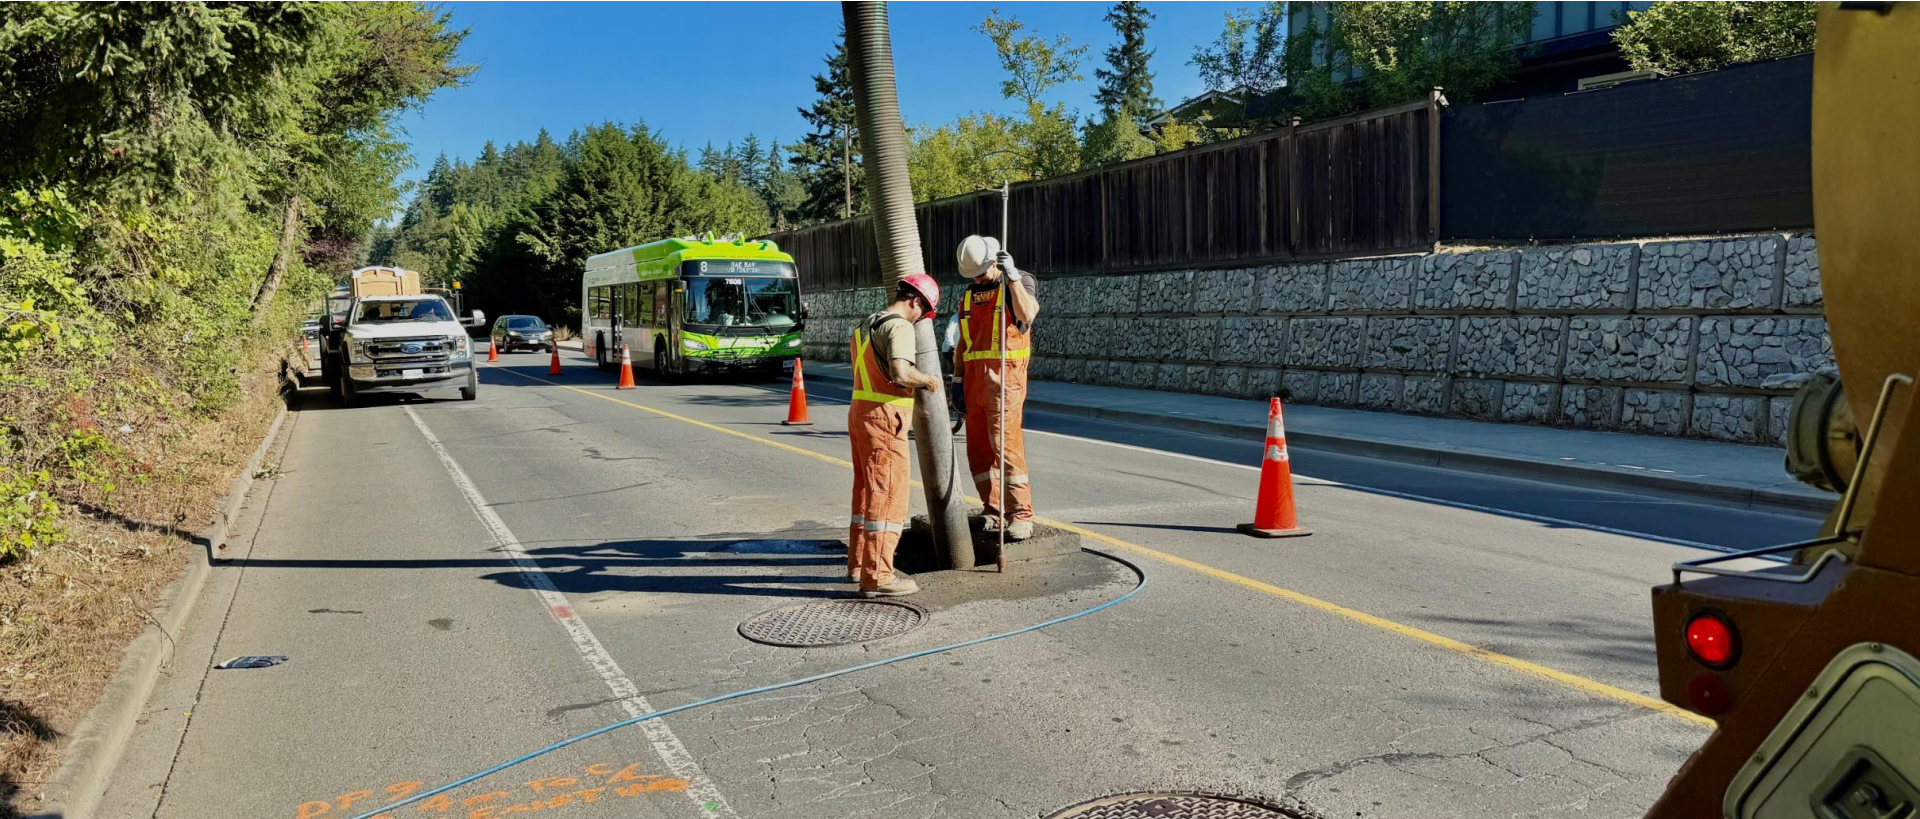
August 11: H-Vac trucks have been used for the investigative work. Soils are dislodged by high-pressure water and then vacuumed into the truck. This process prevents damage to underground utilities. Crews are confirming the corner of the concrete cable vault shown on the previous page. We coordinated the work activities with BC Transit thru bi-weekly meetings.

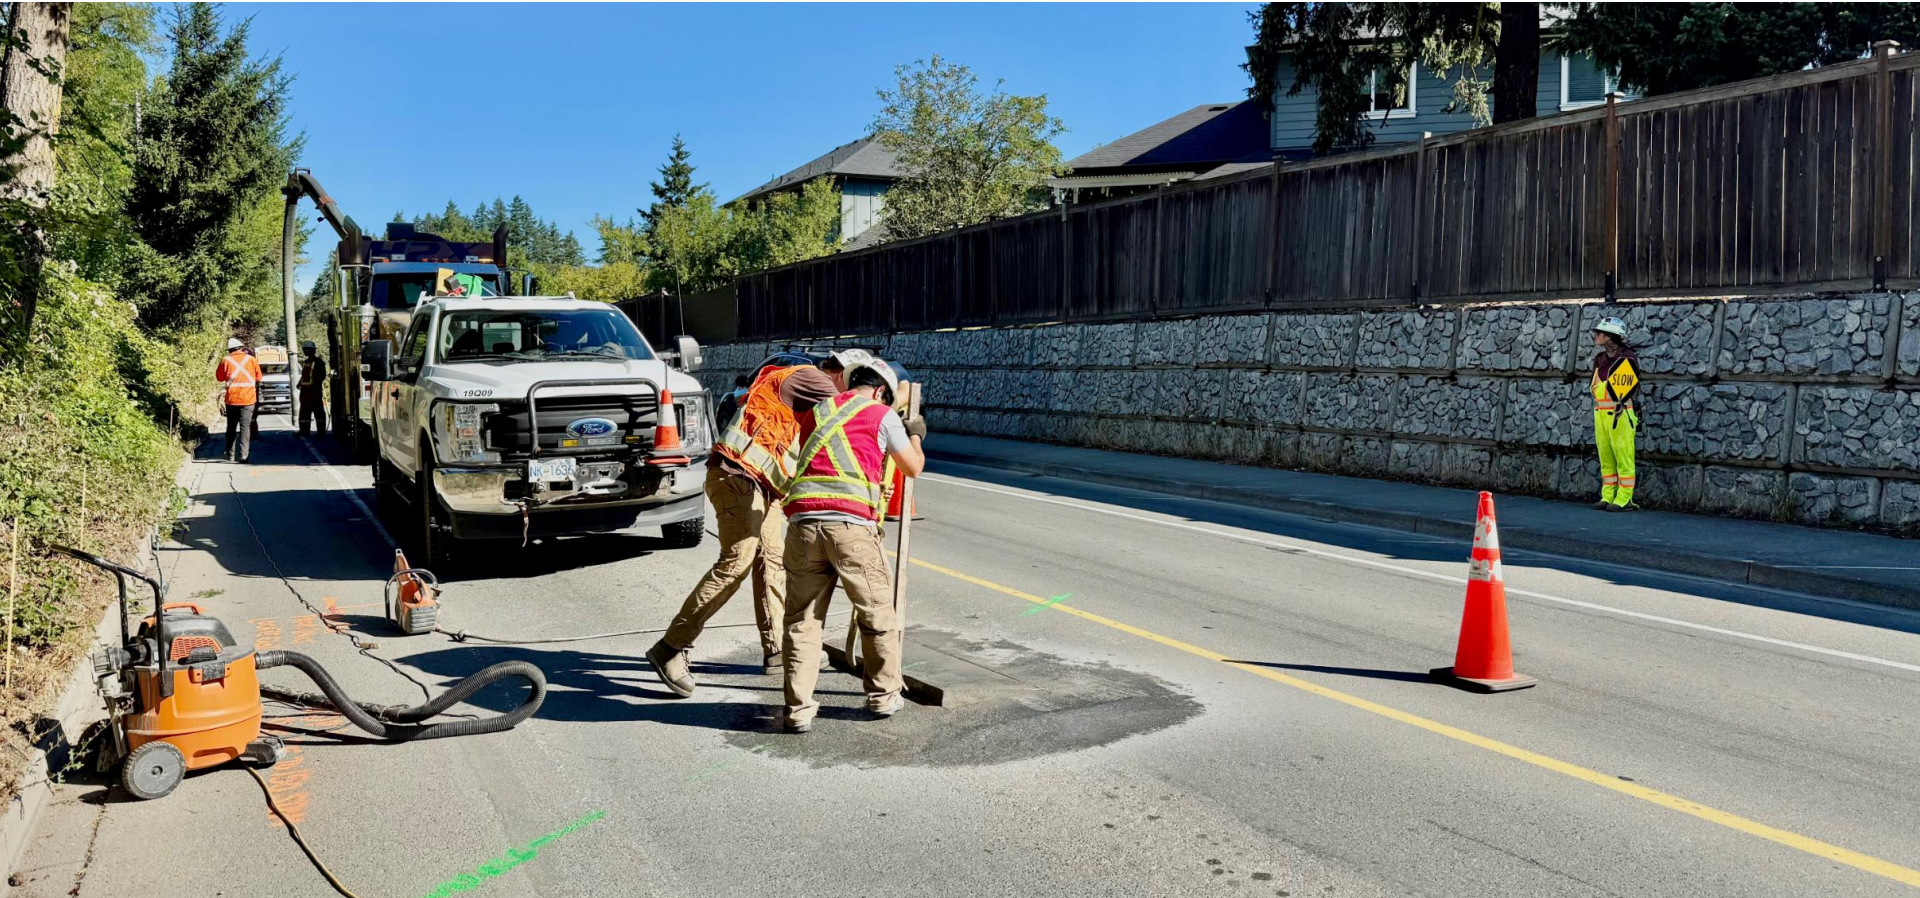
August 11: Crews cutting the asphalt and then prying it up to investigate the depth of a storm drain. The portable vacuum was there to remove water used by the saw.

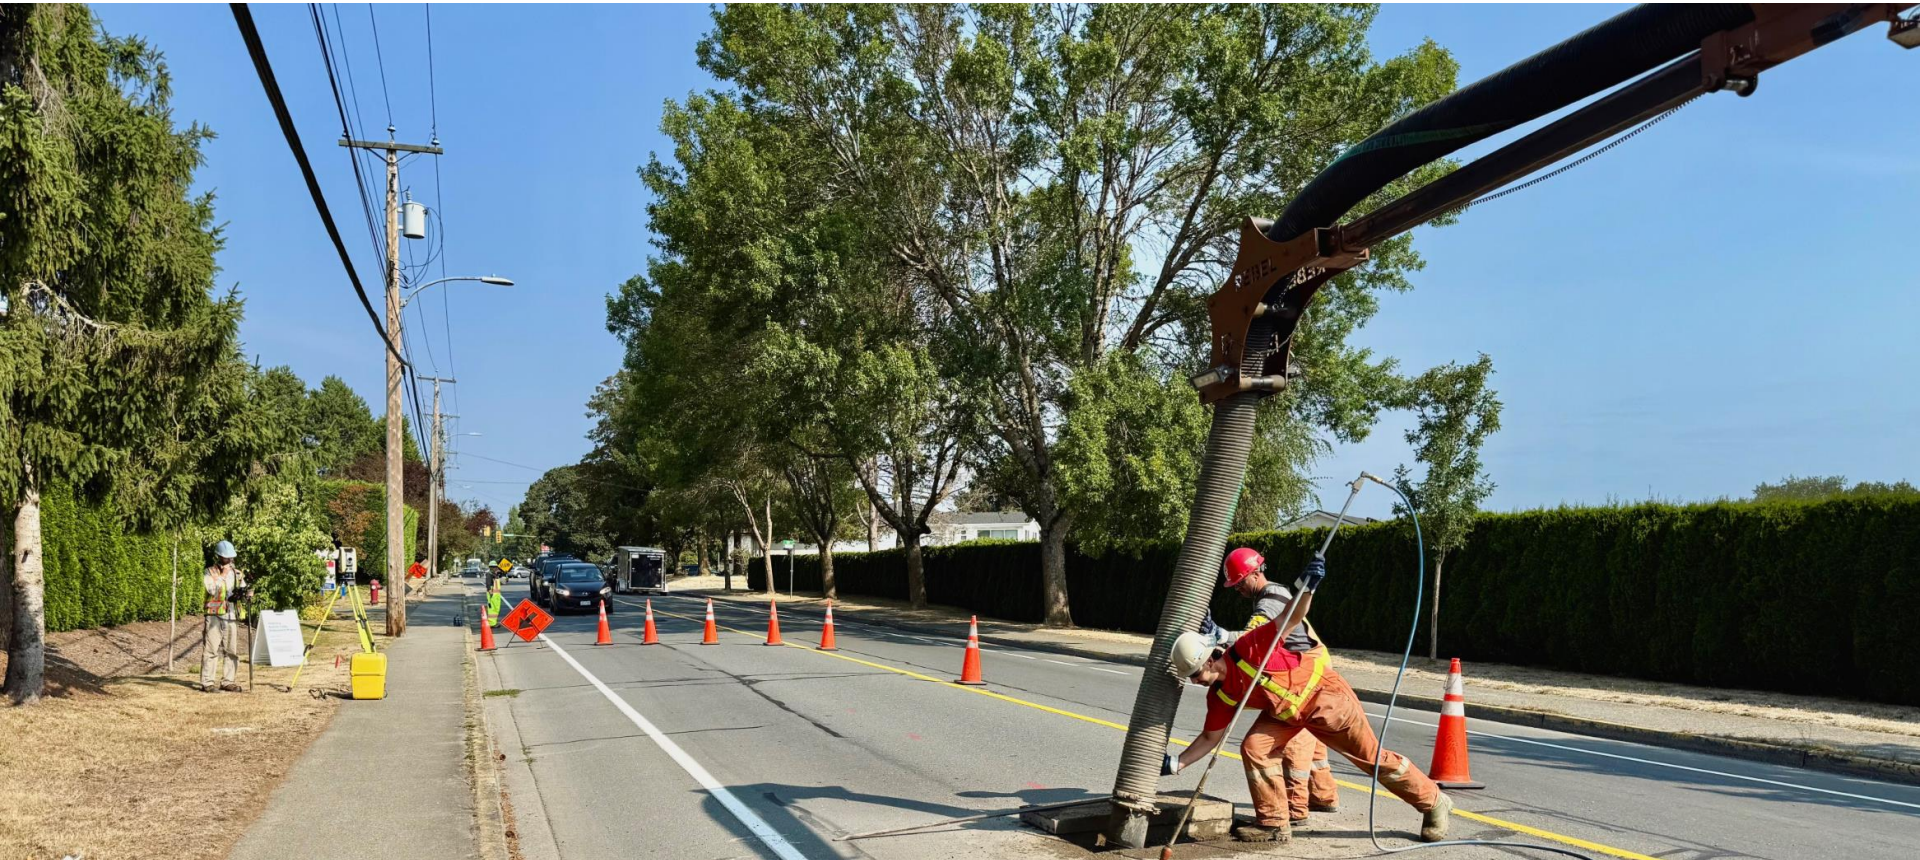
August 17: Crews removing material to expose an underground utility. This work is done to verify horizontal and vertical clearances as generally the new cables must be 1 metre away from other utilities. Information collected during daylighting helps reduce construction risk and supports final design development. Interurban and Wilkinson intersection is in the background.

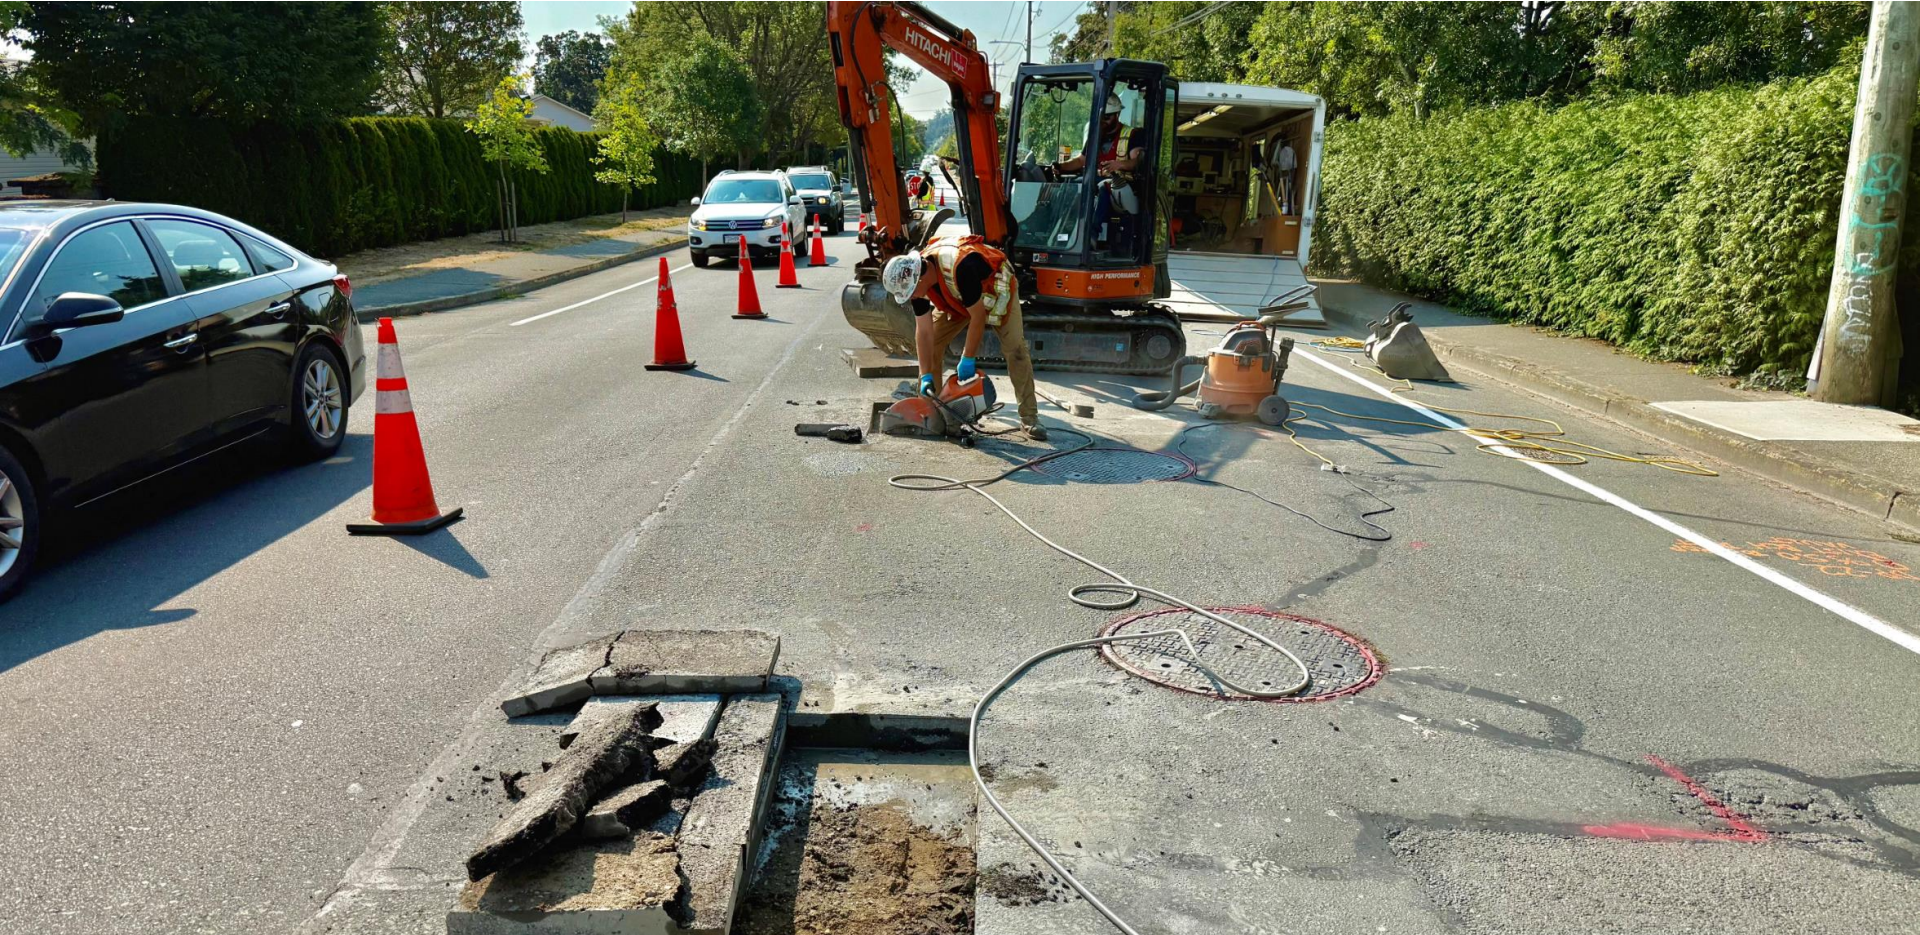
August 17: Crews cutting and removing asphalt to expose and confirm the limits of an existing transmission cable vault.

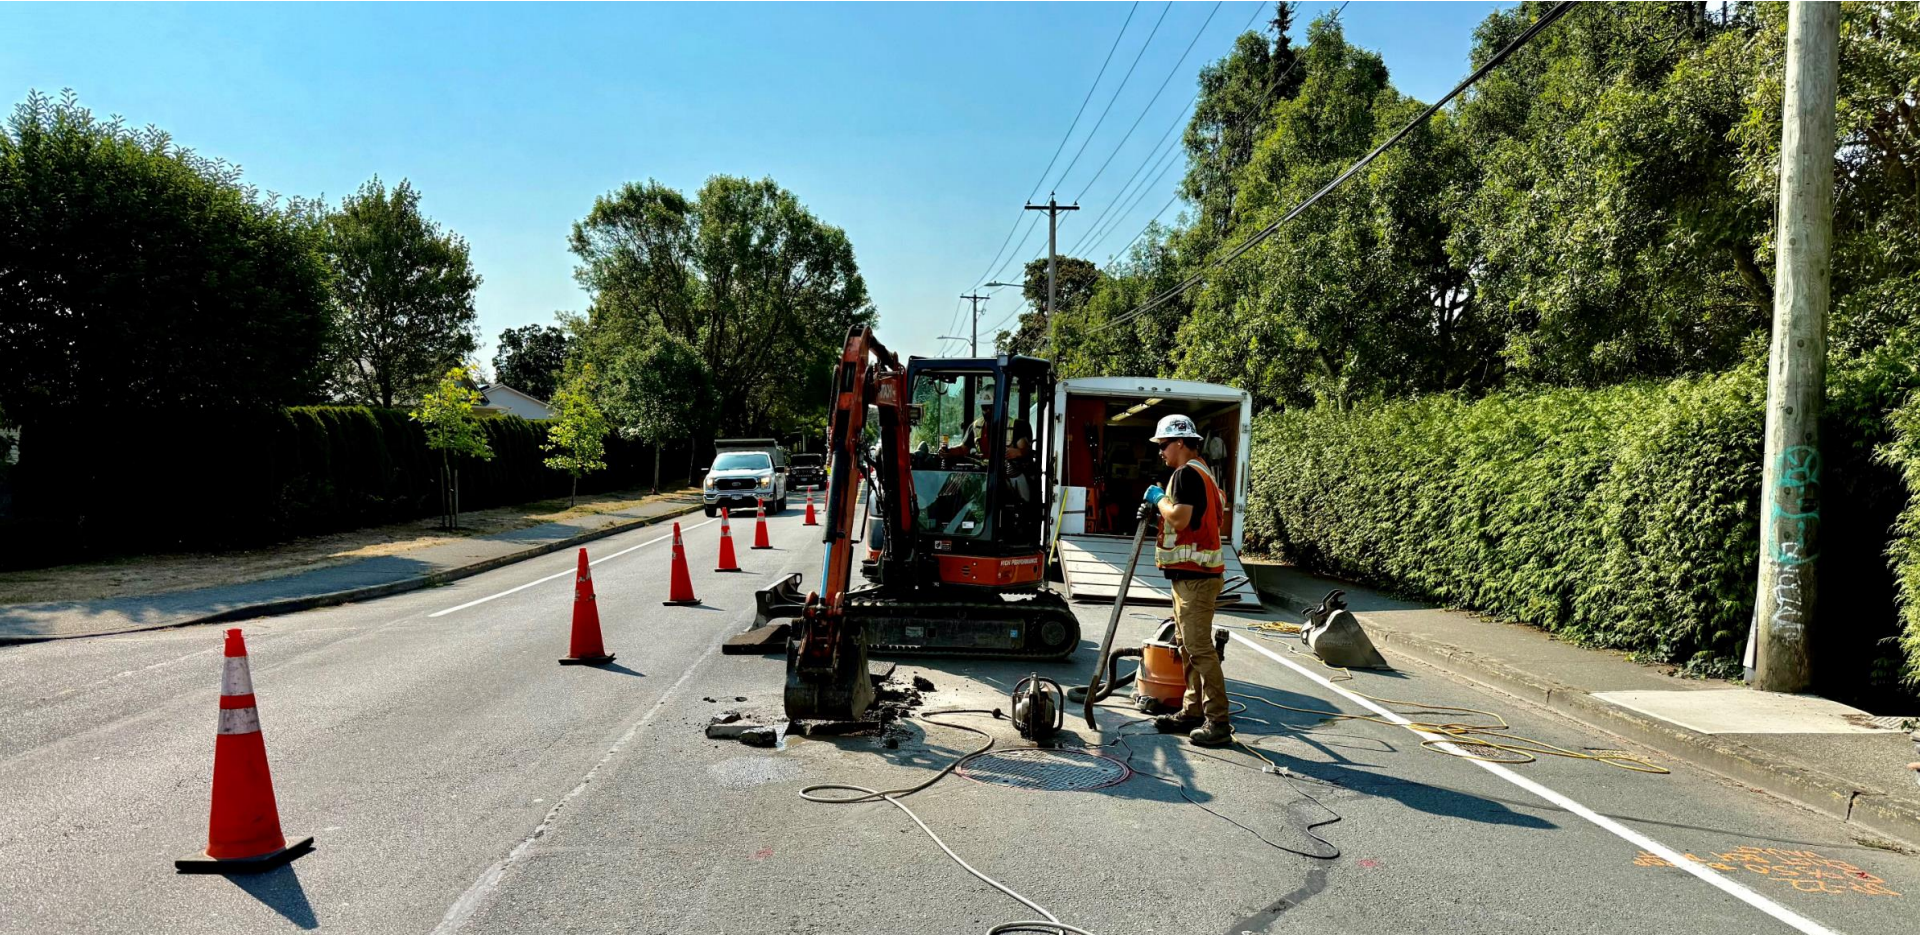
August 17: Two layers of asphalt were at this location with an excavator used to remove the second layer.

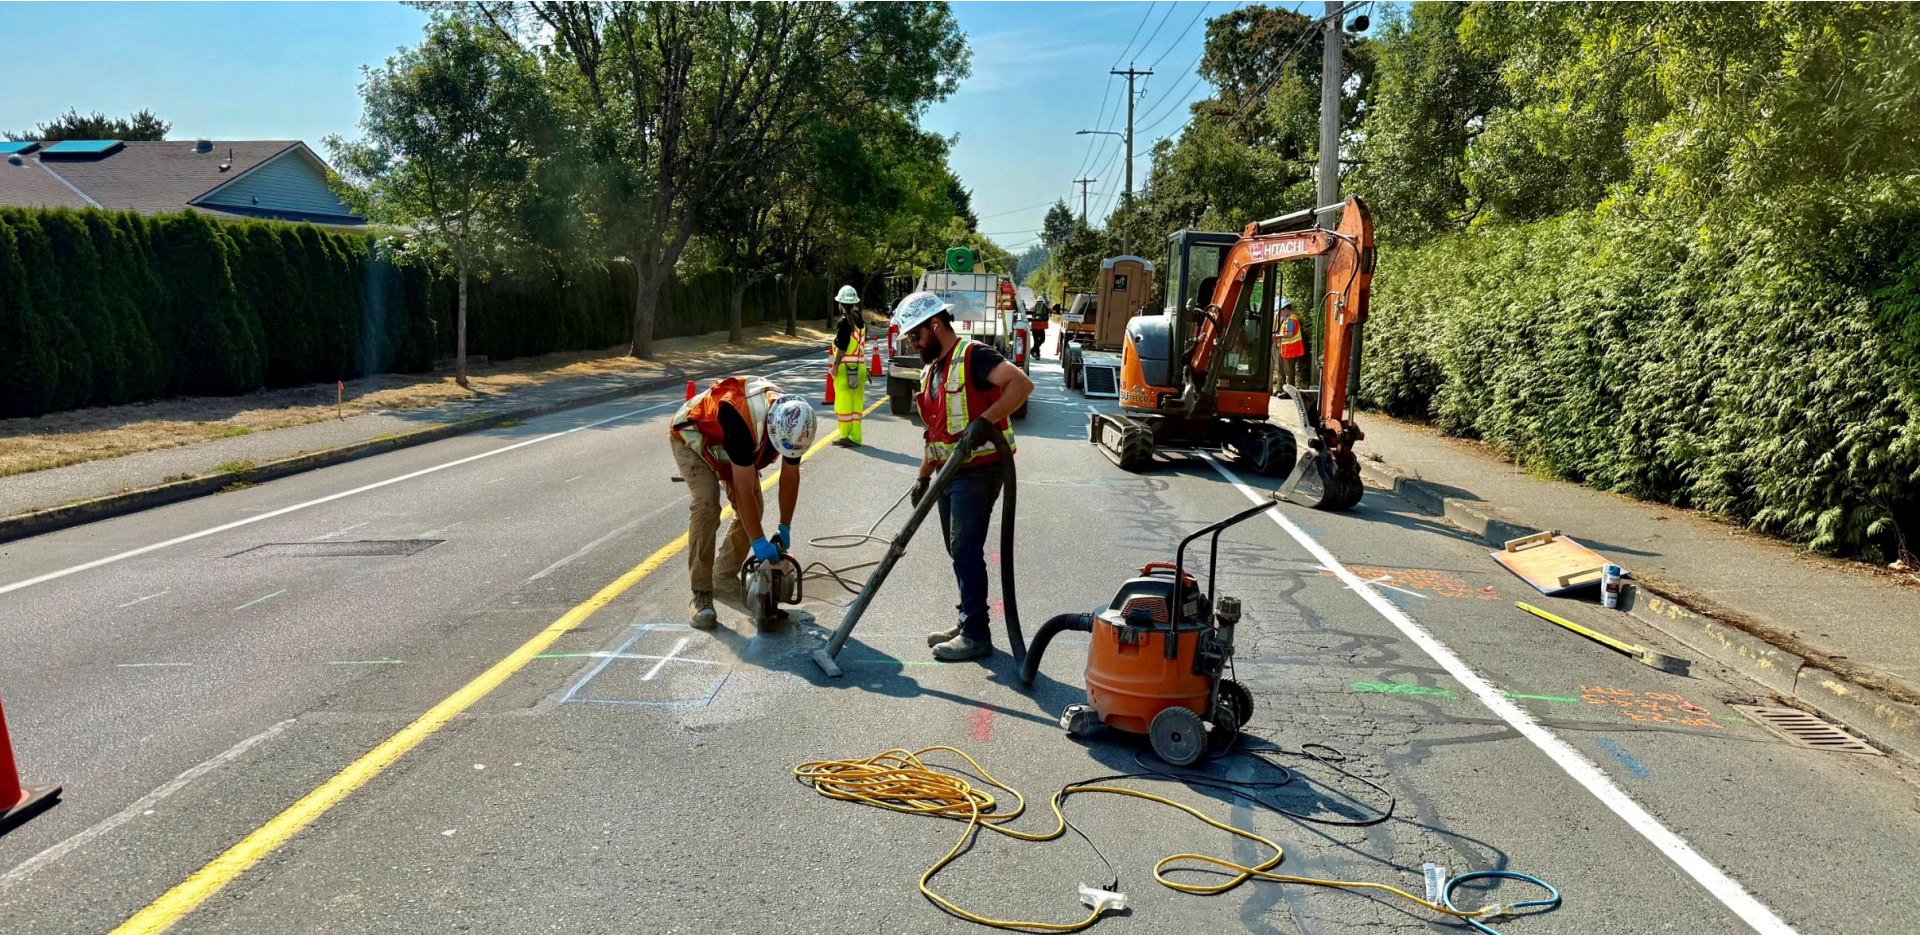
August 17: Moving down Interurban Road and road cutting to investigate a sewer line.

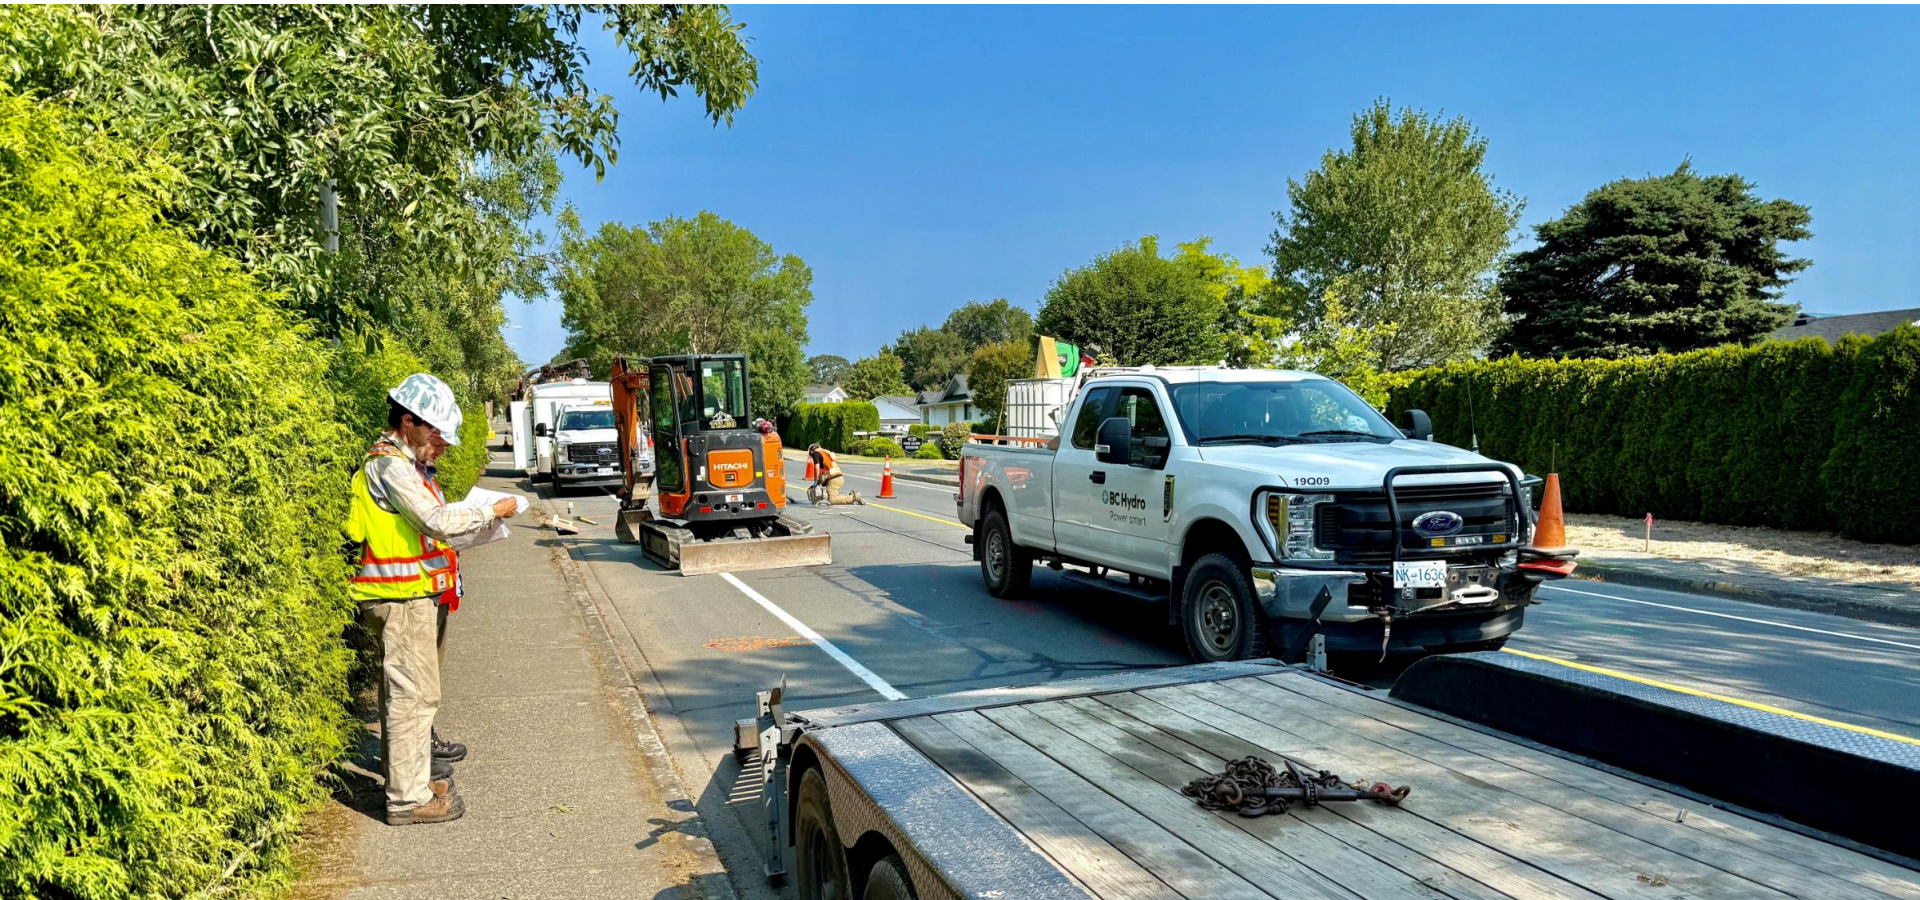
August 17: Engineers reviewing plans and drawings. The new cable will require a construction trench about 2.5 metres deep and wide. The new concrete vaults, for the larger cable, are about 4 metres wide and deep, and 12 metres long.

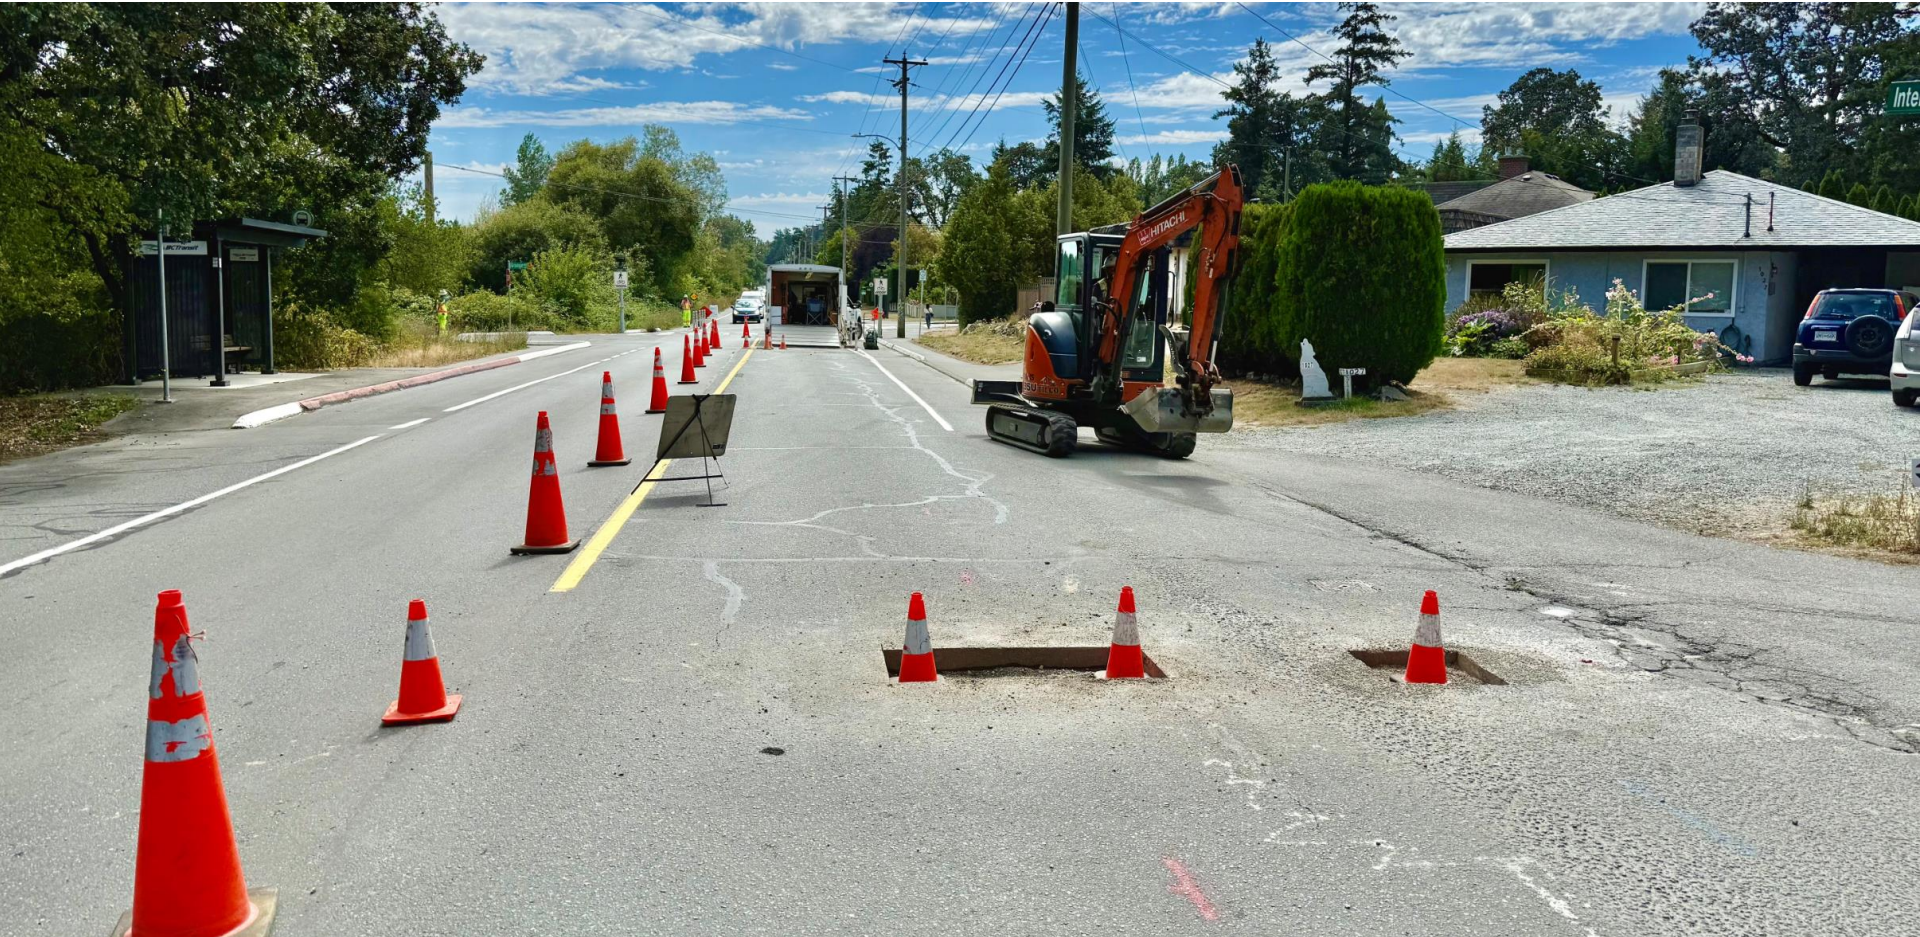
August 19: More underground utility exposures and back-filling. The two areas were about to be restored with asphalt placement.

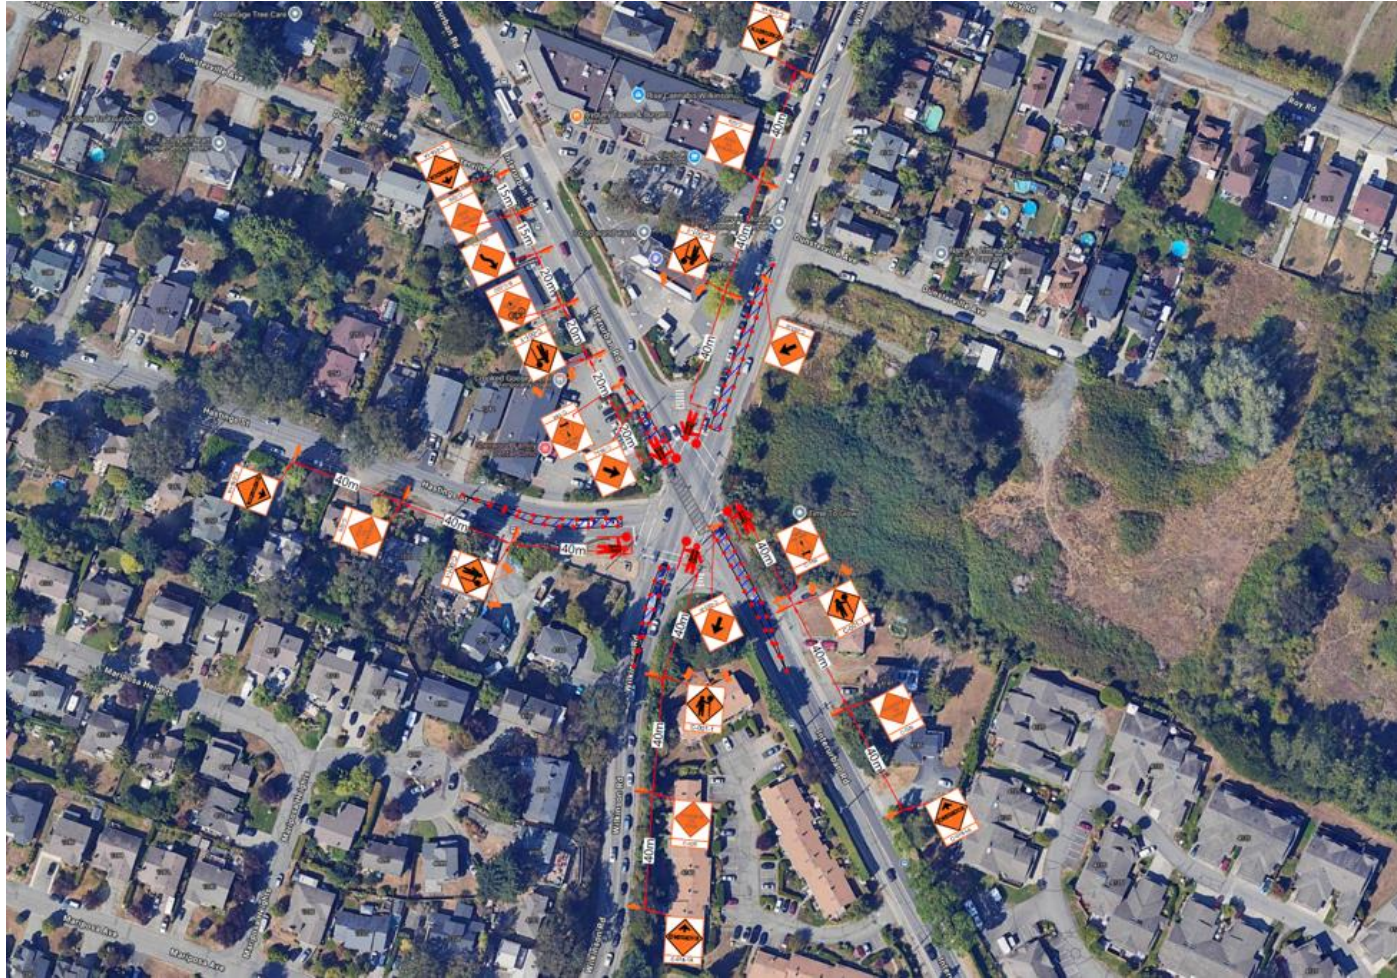
Traffic management plan during the August 24, 25 and 26 investigative work that went thru the Interurban Road and Wilkinson Road intersection.

The narrow investigative trench was up to 2 metres deep. The work was done over three nights from 6:00 pm to 6:00 am. Work just off the intersection, also at night, is planned for August 31 and September 1. There were no road closures and numerous flaggers efficiently direct traffic from the five roads that feed into the intersection.

The many utilities under the intersection were mapped and documented.

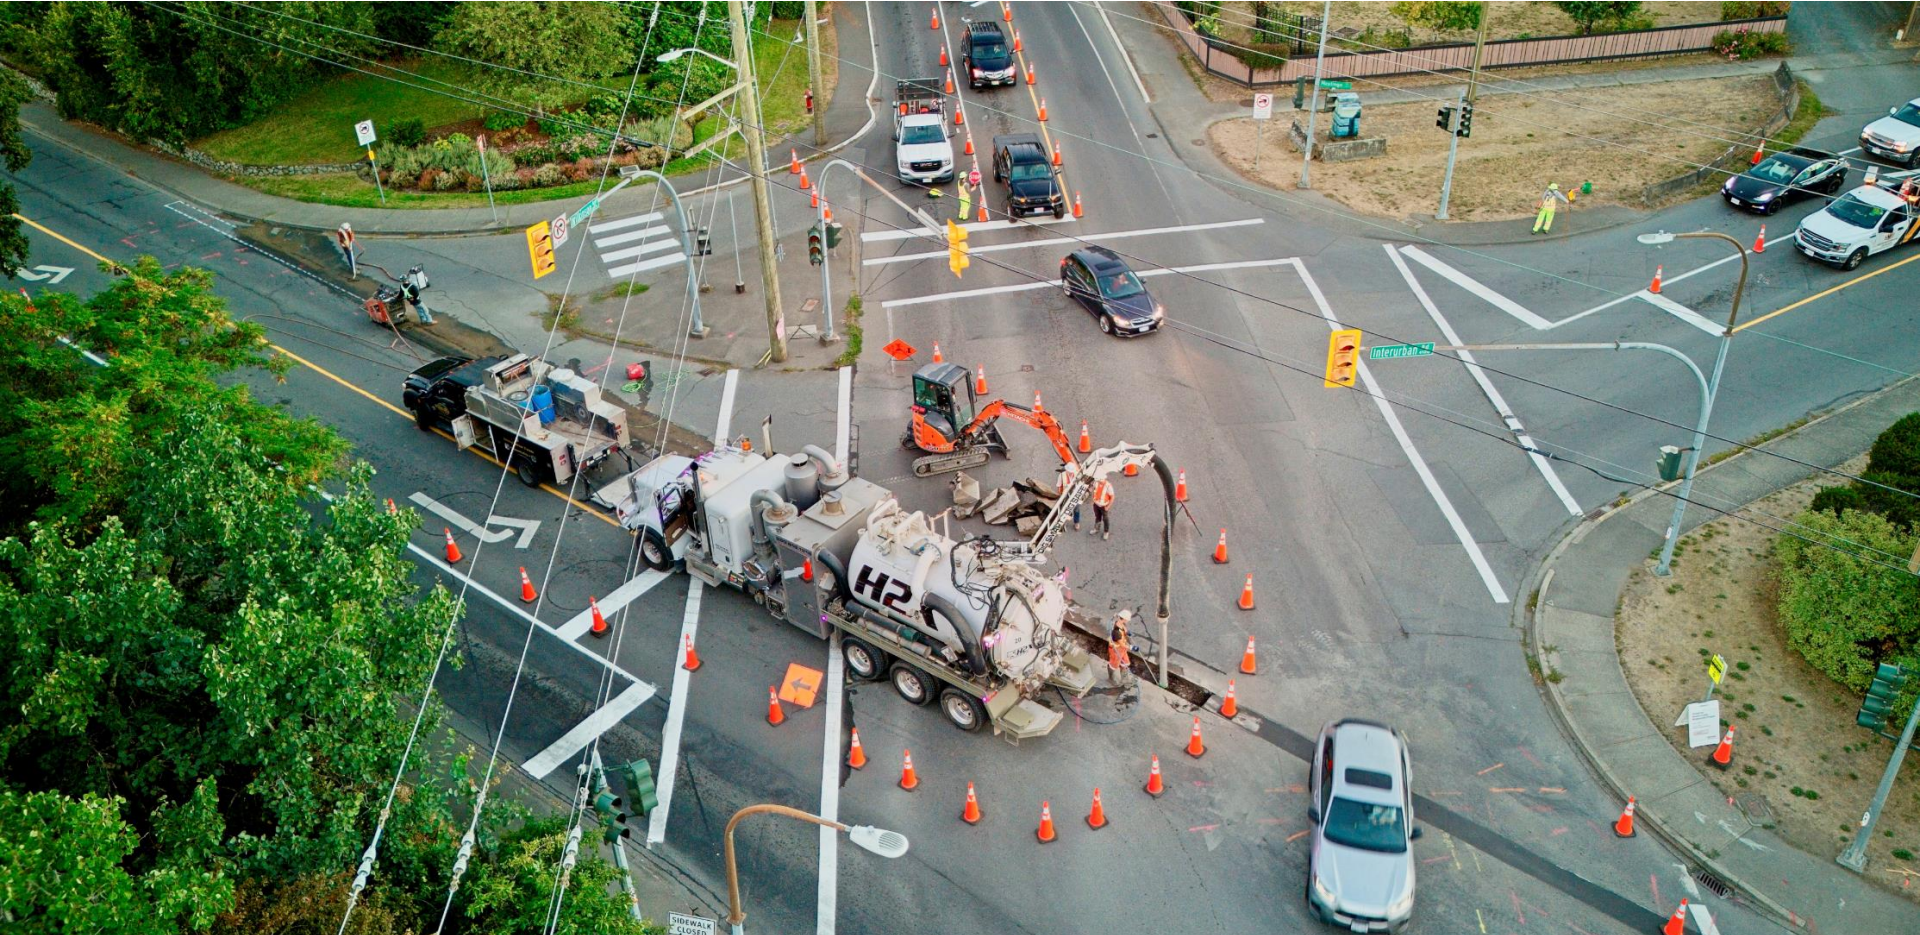
August 26: Removing soils within the investigation trench with the surrounding traffic management.

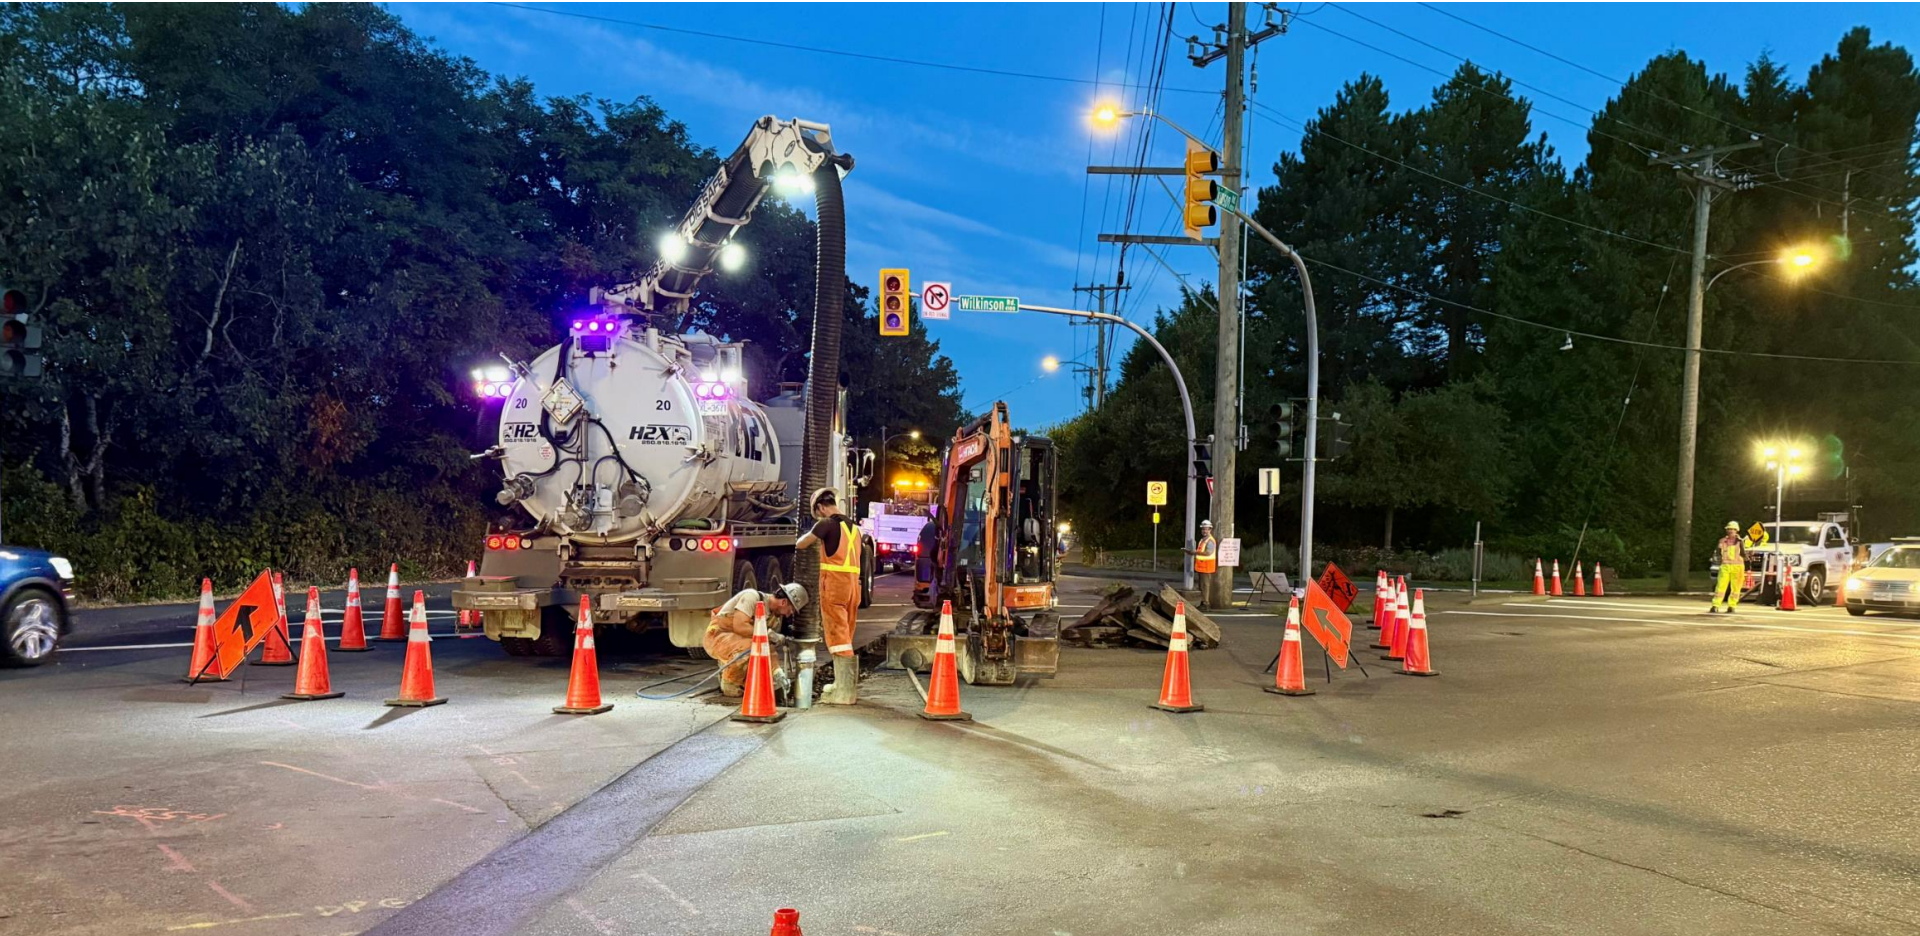
August 26: H-Vac crews exposing underground utilities. Half the intersection was completed and repaved the night of August 25.
