Board briefing – DAM SAFETY QUARTERLY REPORT

Quarterly Featured Damsite – Wilsey Dam

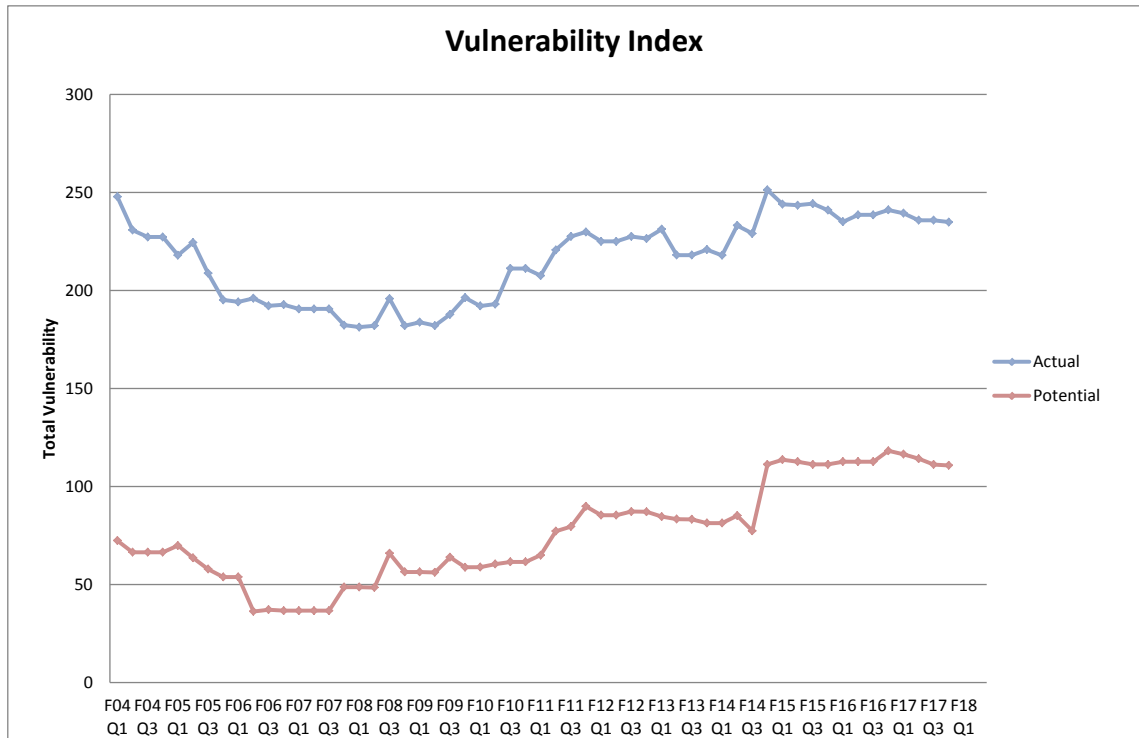
Figure 2 – Change in Actual and Potential Vulnerability Indices

Changes in Vulnerability Index for actual and potential deficiencies, as outlined in Figure 1, are tracked on a quarterly basis and shown on Figures 2 and 3. This is an indication of the changes in the understanding of the dam safety risk profile. In Figure 3, the total index is shown (sum of actual and potential deficiencies), as well as separate plots for decreases and increases in the total index. Decreases are due to remediation projects as per the Capital Plan and resolution of issues via Performance Investigations. Increases in the index are due to the recognition of new issues. Existing issues are re-examined on a regular basis, and re-rated as required.
