Board briefing – DAM SAFETY QUARTERLY REPORT

Quarterly Featured Damsite – Whatshan Dam

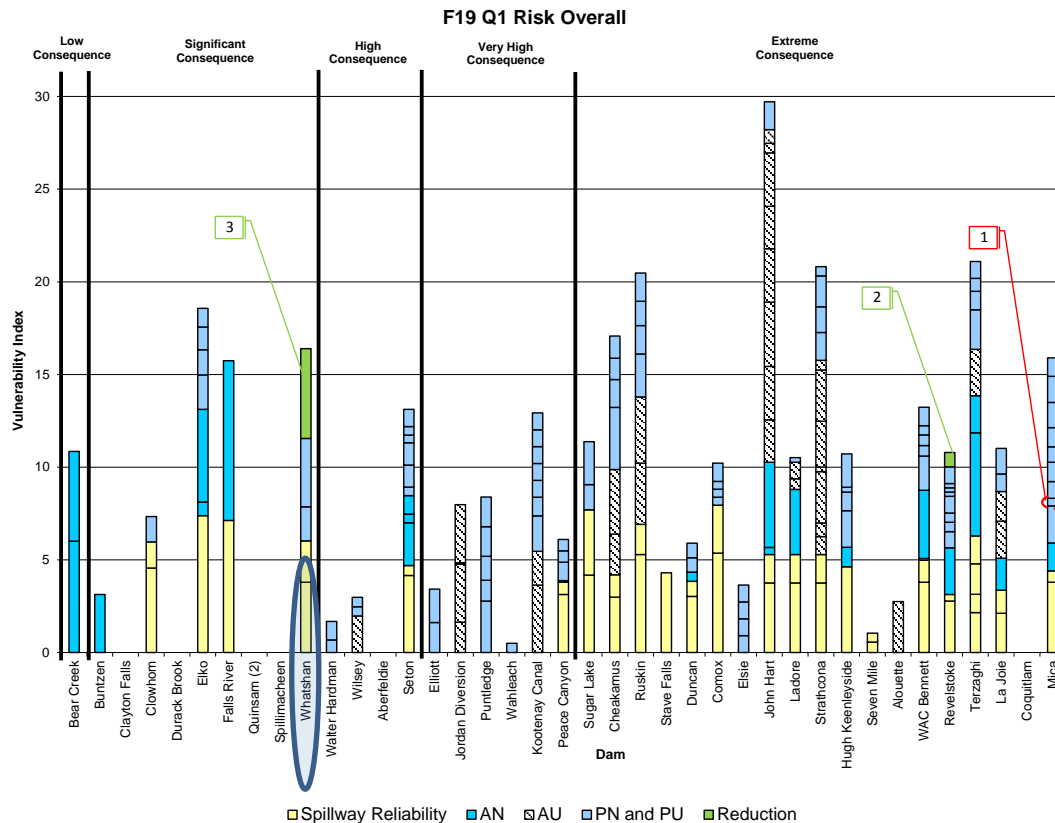
Figure 1 - Dam Safety: Overall Risk Profile

The Dam Safety Program has been carried out consistent with its stated objectives throughout the reporting period. The overall Dam Safety risk profile is shown in Figure 1. There has been an overall decrease in risk this quarter with the repair of the downstream left abutment at Whatshan Dam and completion of the issue related to the Revelstoke Marble Shear Block. There has been an increase at Mica Dam due to the addition of an issue into the database regarding the capacity of the downstream shell to manage high flows should an earthquake cause cracking within the dam's core.

- Vulnerability Index (Rating) is a qualitative assessment of future dam performance from all causes – the higher the rating the higher the likelihood of poor performance.
- 33 dam sites as identified have reportable risk at present
- This Risk Profile represents only currently known and rated issues. Changes do not necessarily indicate a physical change to BC Hydro assets that increase or decrease risk; rather they often represent a change in knowledge and understanding of the risk. Additionally, many known deficiencies (those without a direct impact on potential dam failure) have yet to be rated.

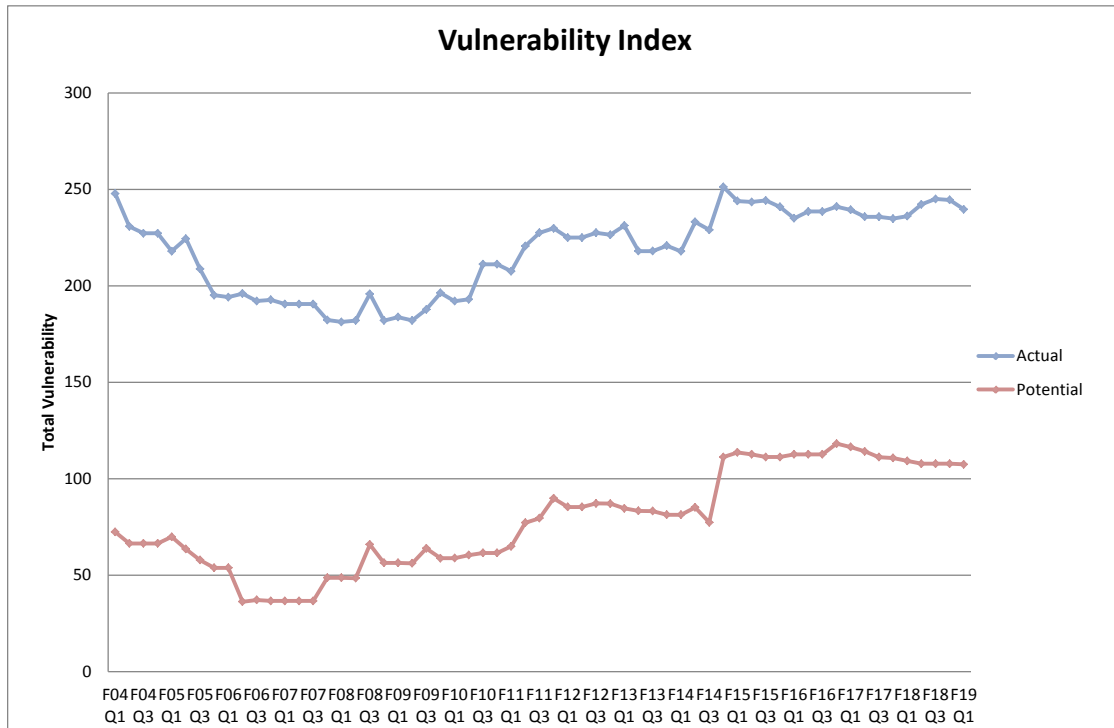
Figure 2 – Change in Actual and Potential Vulnerability Indices

Changes in Vulnerability Index for actual and potential deficiencies, as outlined in Figure 1, are tracked on a quarterly basis and shown on Figures 2 and 3. This is an indication of the changes in the understanding of the dam safety risk profile. In Figure 3, the total index is shown (sum of actual and potential deficiencies), as well as separate plots for decreases and increases in the total index. Decreases are due to remediation projects as per the Capital Plan, completed repairs and corrective maintenance, and resolution of issues via Performance Investigations. Increases in the index are due to the recognition of new issues. Existing issues are re-examined on a regular basis and re-rated as required.
