### Board briefing – DAM SAFETY QUARTERLY REPORT

### Quarterly Featured Dam Site

# Comox Dam

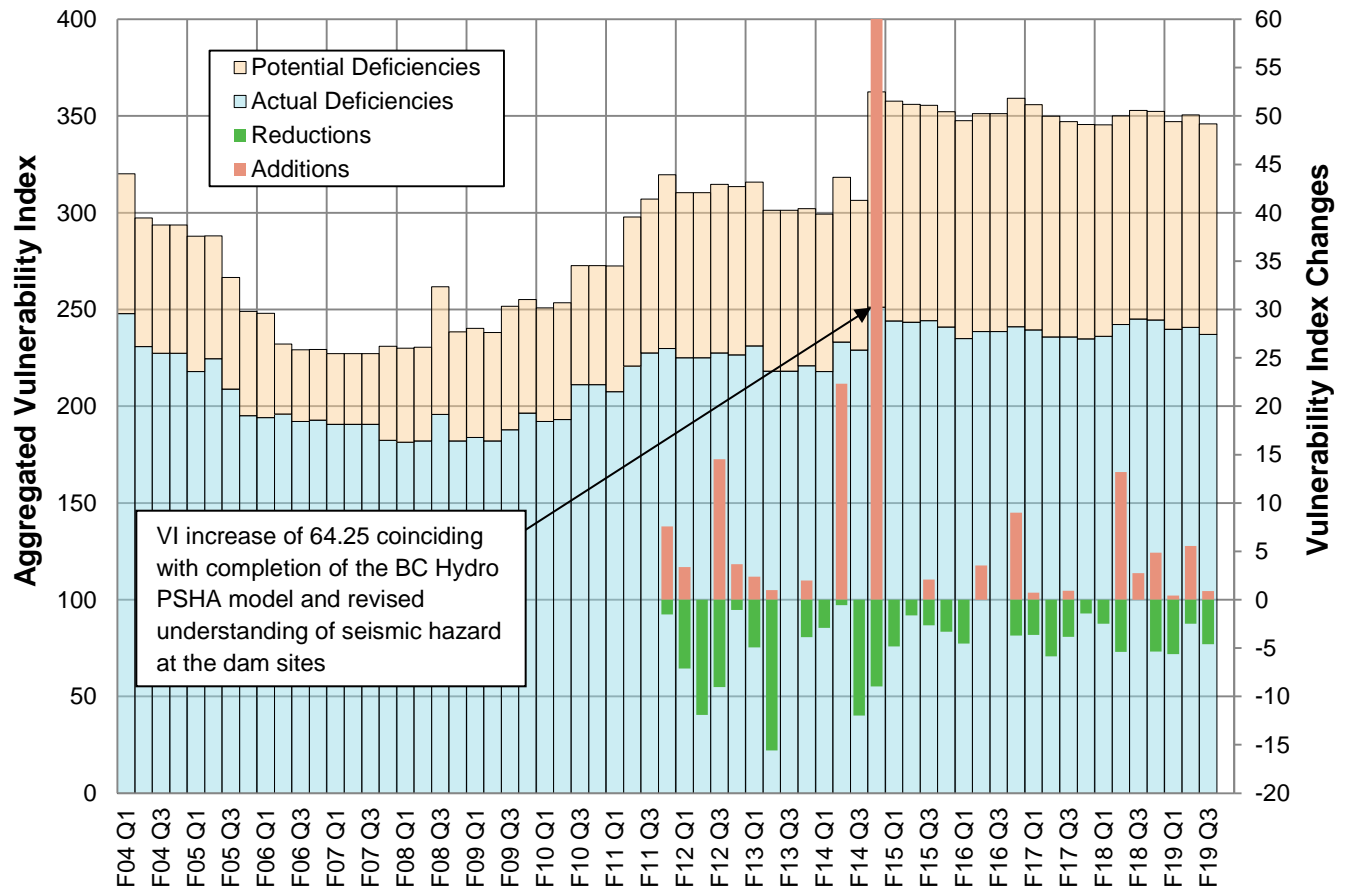
**Figure 2** Changes and trends in the Vulnerability Index aggregated across the BC Hydro system. Note: the bars are “stacked” such that total aggregated VI is given by the top of the Potential Deficiencies bar.

Changes in Vulnerability Index for actual and potential deficiencies, aggregated across the entire fleet of dams, are tracked on a quarterly basis and shown in Figure 2. This is an indication of the changes in the understanding of BC Hydro’s dam safety risk profile. Additions are due to the development or recognition of new issues. Reductions are due to risk remediation projects delivered through the Capital Plan, completed repairs and corrective maintenance, and resolution of issues via Dam Safety Investigations. Existing issues are re-examined on a regular basis and re-rated as required. These changes—additions and reductions—have been tracked since the end of Fiscal Year F2011.

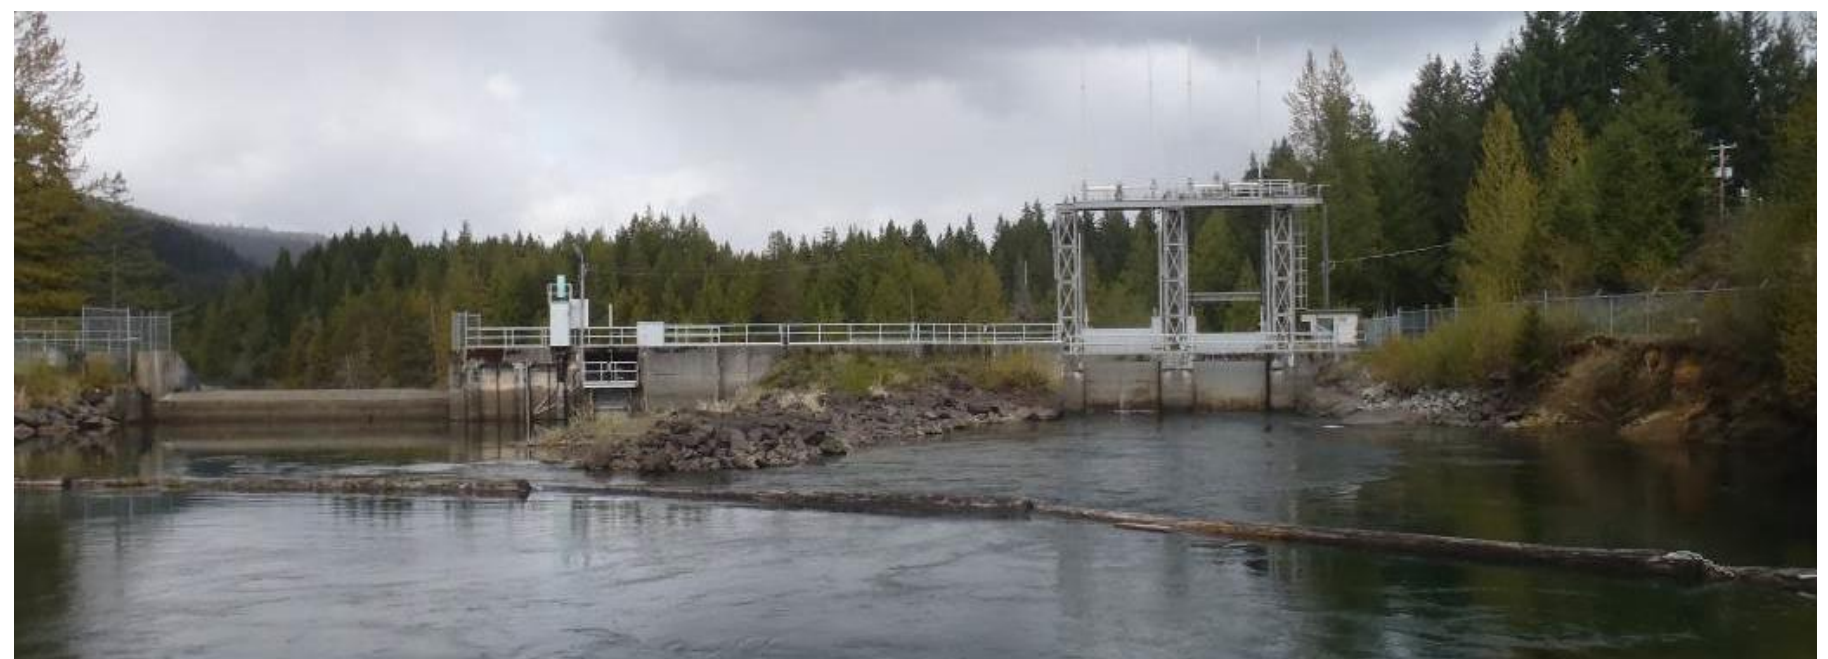
Photo 1 – Upstream face of Comox Dam

Both the Comox Dam and the downstream Puntledge Diversion Dam have potential seismic deficiencies which are being managed in the interim through public education. Initial high level assessments indicate that the Comox seismic withstand is below expectations and a more detailed review will be carried out. There are a number of flood-related issues in the system related to the reliability of the gates and the potential for overtopping the abutment at Comox Dam. Initial high level assessments also indicate there may be stability concerns for floods greater than a 1/1,000 Annual Exceedance Frequency. Flood related deficiencies associated with the Comox-Puntledge system are considered a lower priority since recreational users are not expected to be using the river during large floods.
