### Board briefing – DAM SAFETY QUARTERLY REPORT

#### Quarterly Featured Damsite – SEVEN MILE DAM

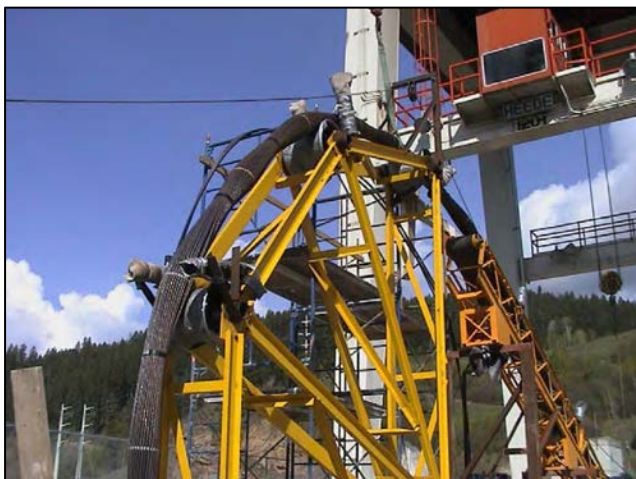
Dam stability was considerably improved with the installation of 57 post-tensioned, large capacity foundation anchors, carried out in 2 phases between 2002 and 2003. The anchors are post-tensioned 92 strand, fully corrosion protected, load testable and restressable. The anchors are oriented vertically and located near the upstream face of the gravity dam in four spillway blocks, four power intake blocks and seven gravity blocks. The two abutment blocks did not require anchoring. At the time of installation, the anchors had the largest capacity of any such anchors in the world. All 57 anchors were retested between 2003 and 2011 to determine if they were maintaining load capacity. All anchors achieved at least 2% above design loads.

Anchor Installation 2002-2003

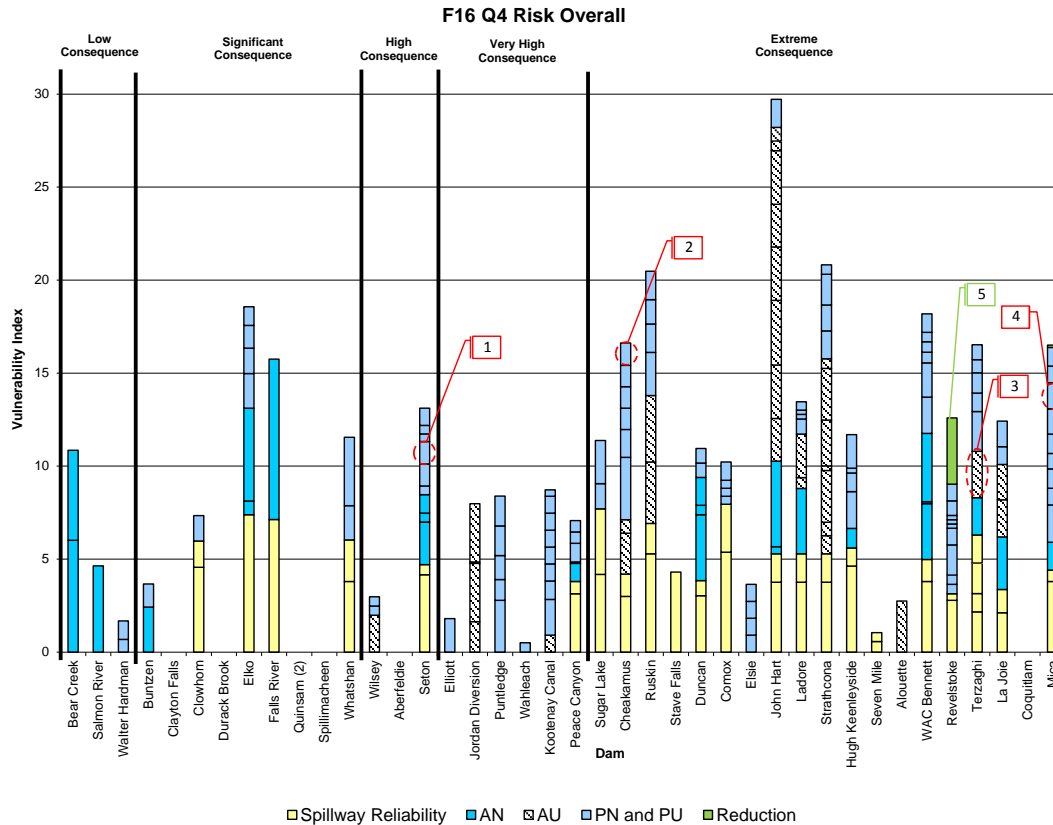
Figure 1 - Dam Safety: Overall Risk Profile

The Dam Safety Program has been carried out consistent with its stated objectives throughout the reporting period. The overall Dam Safety risk profile is shown in Figure 1. There has been a slight increase in the risk profile this quarter due to estimates of the vulnerability of Mica, Seton and Cheakamus Dams to overtopping waves from landslides, as well as the vulnerability associated with the lack of a means to cutoff flow from the Bridge River 1 penstocks in the event of a penstock breach.

Little Chief Slide is a landslide located upstream of Mica Dam. The possibility of an overtopping wave caused by failure of the Little Chief Slide was identified and accounted for in the original dam design. The issues associated with the long-term stability of the Little Chief Slide has always been noted in the dam safety issues database, but without a numerical rating. The vulnerability of Mica Dam to this hazard was rated in Q4 as part of an annual reservoir slopes review meeting, following comments from the recent external dam safety review. Similar ratings were also developed for landslides at Seton and Cheakamus Dams. These vulnerability ratings have been added to overall risk profile (Figure 1), for comparison with other rated vulnerabilities at these sites.

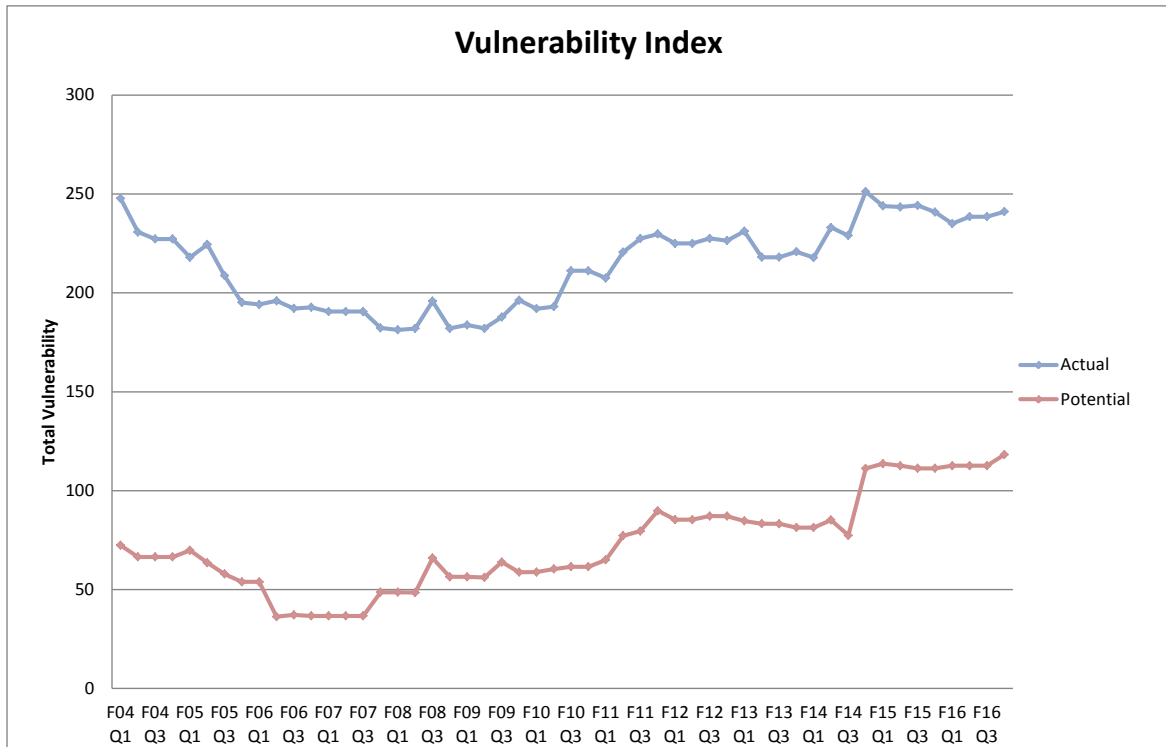
Figure 2 – Change in Actual and Potential Vulnerability Indices

Changes in Vulnerability Index for actual and potential deficiencies, as outlined in Figure 1, are tracked on a quarterly basis and shown on Figures 2 and 3. This is an indication of the changes in the understanding of the dam safety risk profile.

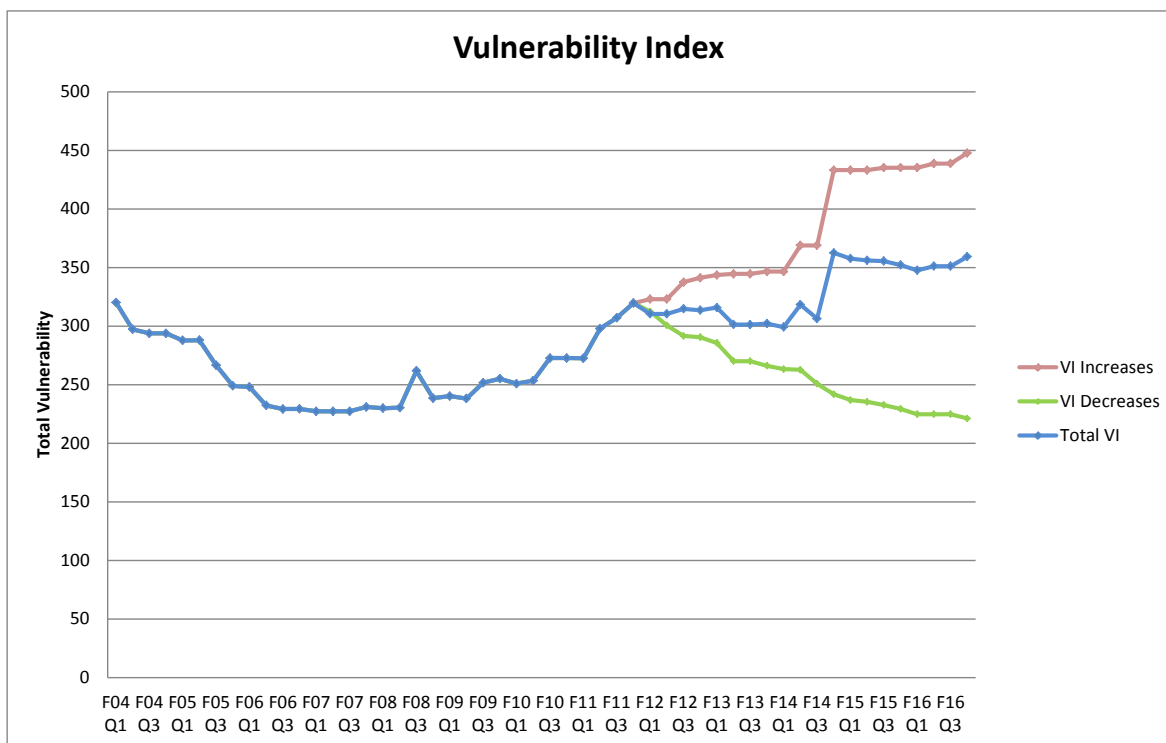
Figure 3 – Change in Total Vulnerability Index Components

In Figure 3, the total index is shown (sum of actual and potential deficiencies), as well as separate plots for decreases and increases in the total index. Decreases are due to remediation projects as per the Capital Plan and resolution of issues via Performance Investigations. Increases in the index are due to the recognition of new issues. Existing issues are re-examined on a regular basis, and re-rated as required.
