Board briefing – DAM SAFETY QUARTERLY REPORT

Quarterly Featured Damsite – Seton Dam

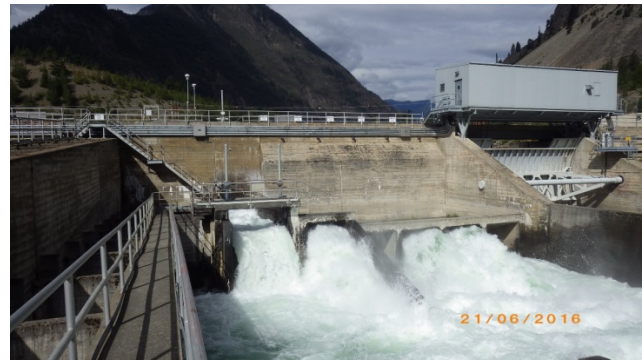
Seton Dam fishwater release gate and siphons in operation

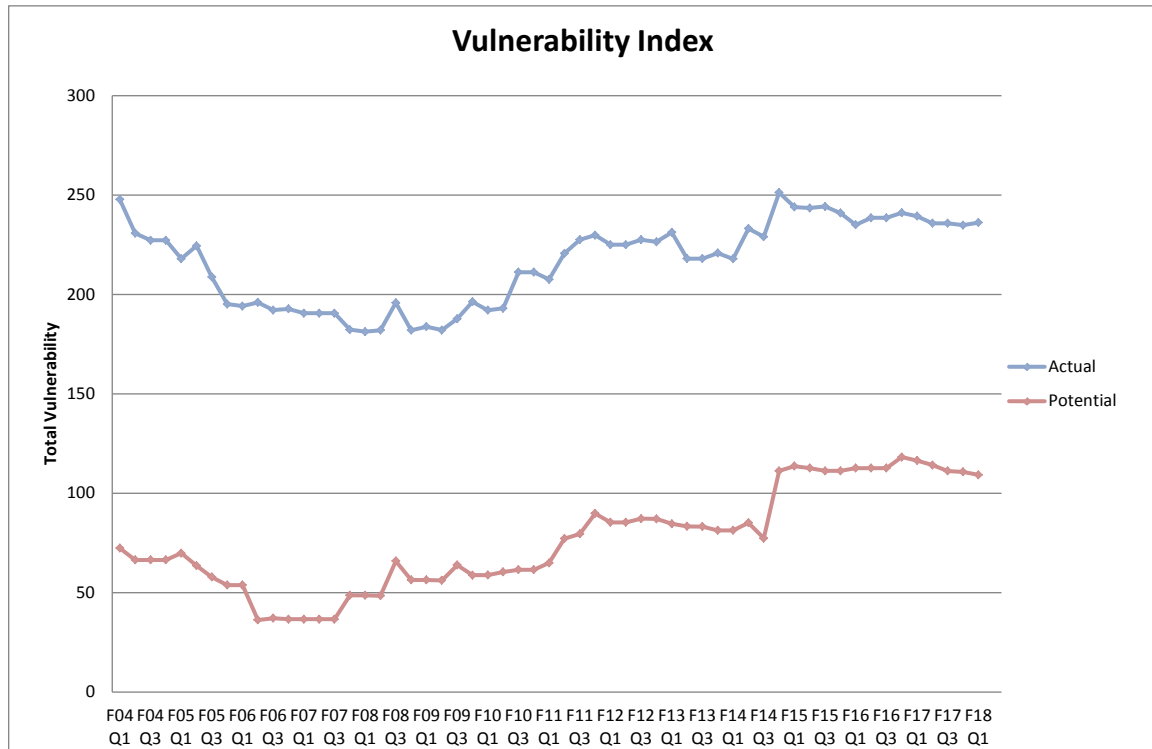
Figure 2 – Change in Actual and Potential Vulnerability Indices

Changes in Vulnerability Index for actual and potential deficiencies, as outlined in Figure 1, are tracked on a quarterly basis and shown on Figures 2 and 3. This is an indication of the changes in the understanding of the dam safety risk profile. In Figure 3, the total index is shown (sum of actual and potential deficiencies), as well as separate plots for decreases and increases in the total index. Decreases are due to remediation projects as per the Capital Plan and resolution of issues via Performance Investigations. Increases in the index are due to the recognition of new issues. Existing issues are re-examined on a regular basis, and re-rated as required.
