Board briefing – DAM SAFETY QUARTERLY REPORT

Quarterly Featured Damsite – Aberfeldie Dam

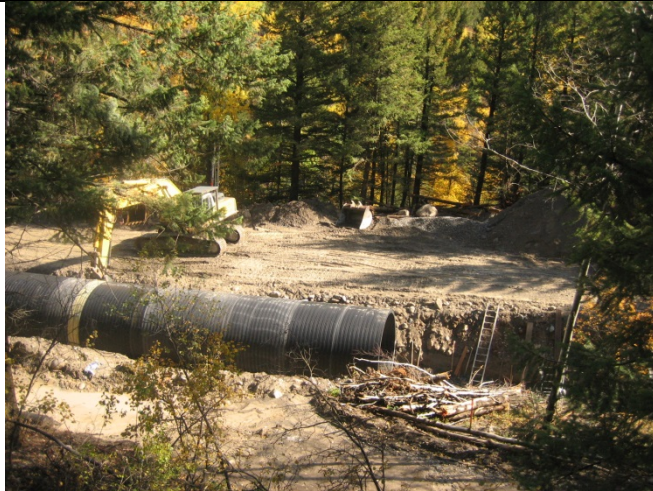
Construction of the new penstock

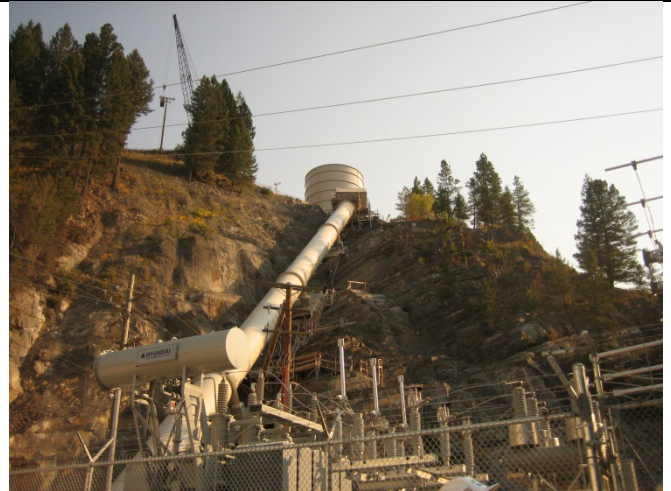
New steel penstock and surge tower

There are no identified deficiencies at Aberfeldie Dam. However, flowing water in the range of 1 to 5 liters/minute has been recently noticed adjacent to the buried plastic penstock during a dam safety inspection. As there is no indication of groundwater recharge or any obvious source, the possibility that this flow indicates penstock leakage will be investigated.

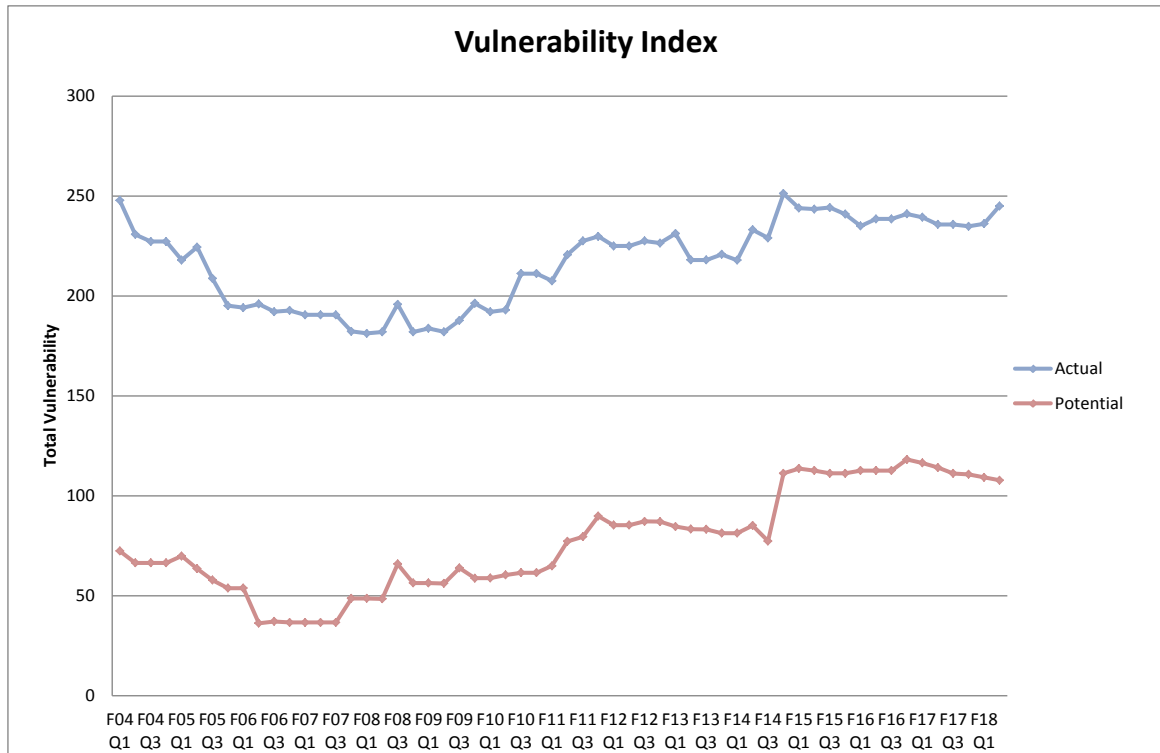
Figure 2 – Change in Actual and Potential Vulnerability Indices

Changes in Vulnerability Index for actual and potential deficiencies, as outlined in Figure 1, are tracked on a quarterly basis and shown on Figures 2 and 3. This is an indication of the changes in the understanding of the dam safety risk profile. In Figure 3, the total index is shown (sum of actual and potential deficiencies), as well as separate plots for decreases and increases in the total index. Decreases are due to remediation projects as per the Capital Plan and resolution of issues via Performance Investigations. Increases in the index are due to the recognition of new issues. Existing issues are re-examined on a regular basis, and re-rated as required.
