Board briefing – DAM SAFETY QUARTERLY REPORT

Quarterly Featured Damsite – Falls River Dam

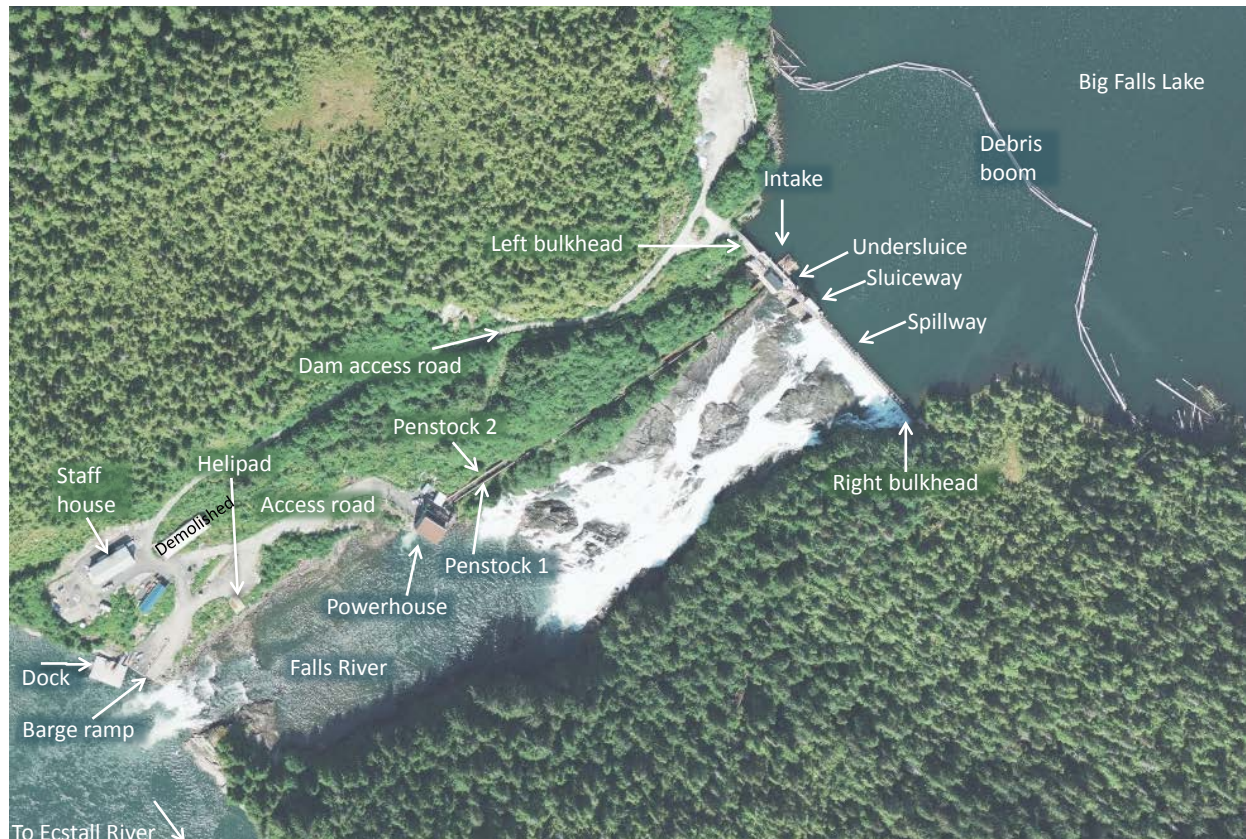
Falls River Facility

The facility intake structure consists of four intakes and a gated undersluice. The undersluice can only be operated by local manual control and is not currently used for normal operation. The penstocks are connected to intakes No. 1 and No. 2 while intakes No. 3 and No. 4 remain unused and are blocked with timber stoplogs.

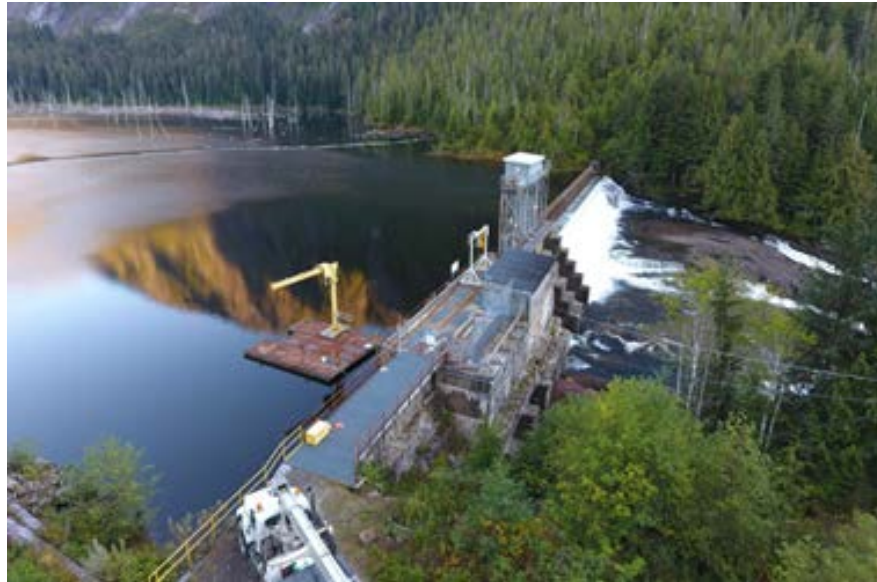
Falls River Dam looking across towards the left abutment

High inflows at Falls River are managed with the two spillway gates and the free overflow spillway. The vulnerability of the Falls River spillway gates has been given a very high rating in the Dam Safety Database due to their age, poor condition, and lack of reliability. There is also a vulnerability associated with these gates due to their potential inability to open when the reservoir level is above the crest of the free overflow spillway. For this reason, although the facility was designed to have flashboards installed along the free overflow spillway to store additional water in the reservoir, these are no longer used, so that a crew must be dispatched to site if the reservoir exceeds a certain elevation. The existing flood discharge gate system requires comprehensive review but this is not planned to be done prior to redevelopment as there is large capacity provided by the overflow spillway.
