Board briefing – DAM SAFETY QUARTERLY REPORT
Executive Summary

The purpose of this report is to update the Capital Projects Committee of the Board of Directors on key dam risk management activities during the period from April 1, 2019 to June 30, 2019, and to provide reasonable assurance that the safety of dams operated by BC Hydro continues to be managed to the established guidelines and criteria of the Dam Safety Program.

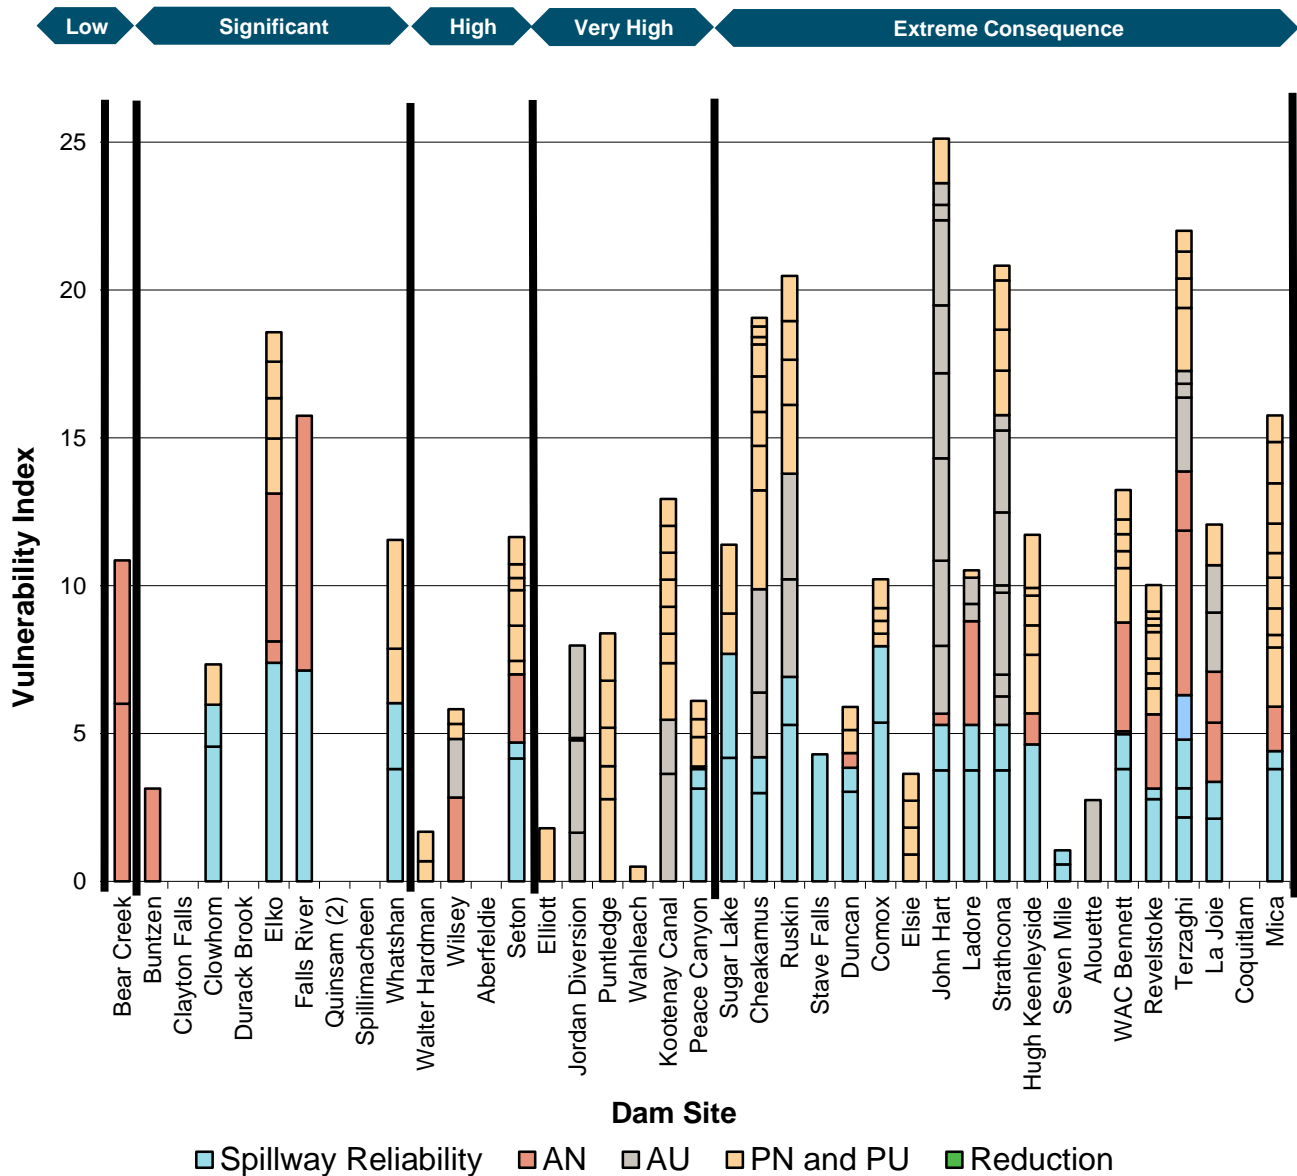
Figure 1 Dam Safety overall risk profile at the end of F2020 Q1, as represented by the Vulnerability Index. There were no changes in this quarter.

The Vulnerability Index for each currently identified issue at each dam site is shown in Figure 1. Dams are sequenced from left to right in order of increasing downstream consequences, per the BC Dam Safety Regulation. No Vulnerability Index changes were made in F2020 Q1.

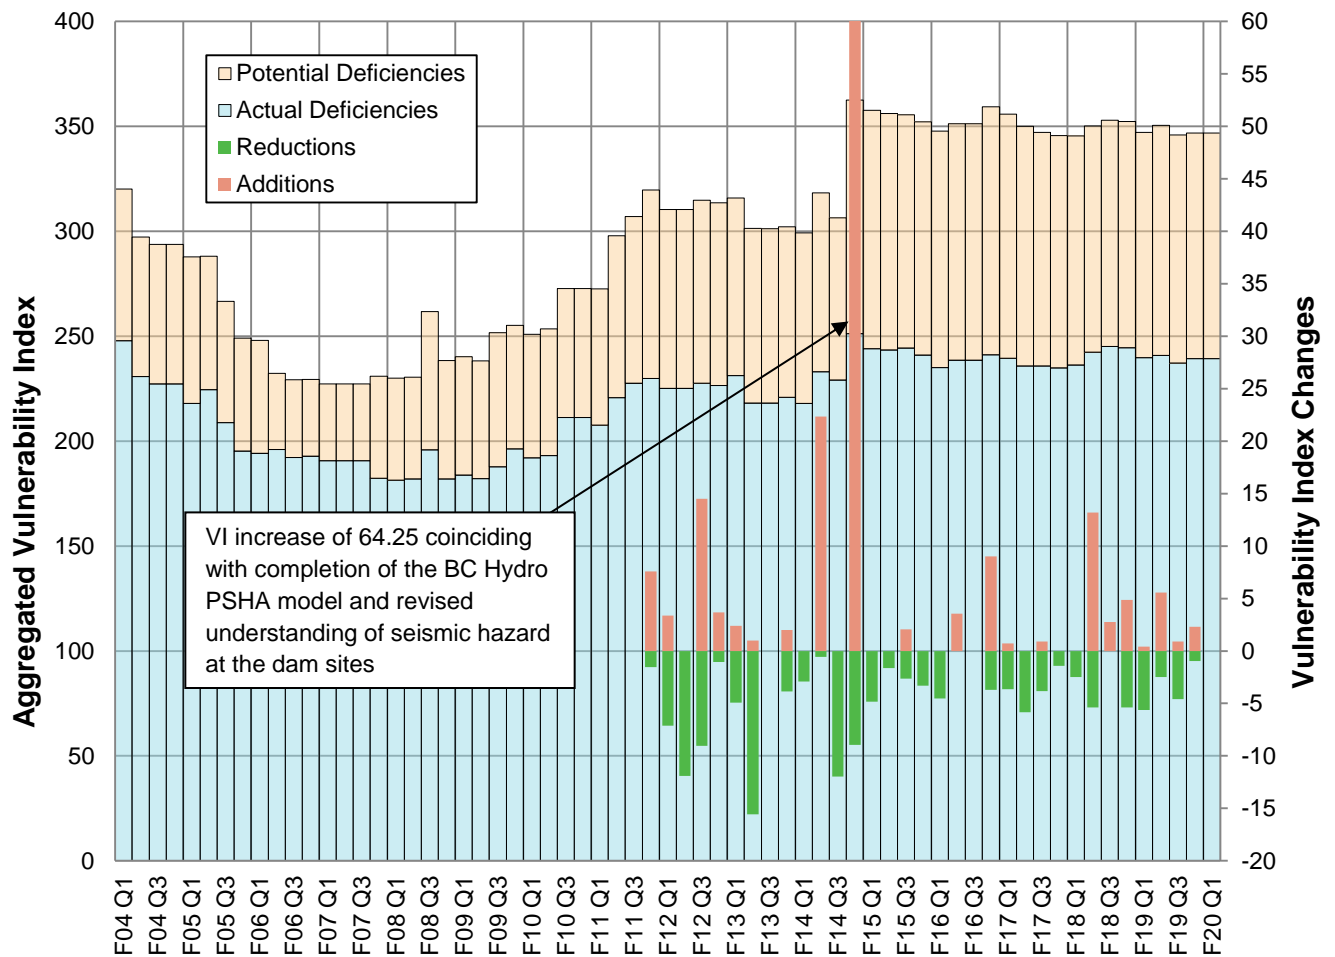
Figure 2 Changes and trends in the Vulnerability Index aggregated across the BC Hydro system. Note: the bars are “stacked” such that total aggregated Vulnerability Index is given by the top of the Potential Deficiencies bar.

Changes in Vulnerability Index for actual and potential deficiencies—including those related to spillway reliability—aggregated across the entire fleet of dams, are tracked on a quarterly basis and shown in Figure 2. This is an indication of the changes in the understanding of BC Hydro’s dam safety risk profile. Additions are due to the development or recognition of new issues. Reductions are due to risk remediation projects delivered through the Capital Plan, completed repairs and corrective maintenance, and resolution of issues via Dam Safety Investigations. Existing issues are re-examined on a regular basis and re-rated as required. As indicated by the uniformity of the height of the stacked blue and sand-coloured bars, the corporation’s intent to not allow an overall increase in the dam safety risk profile continues to be realized.

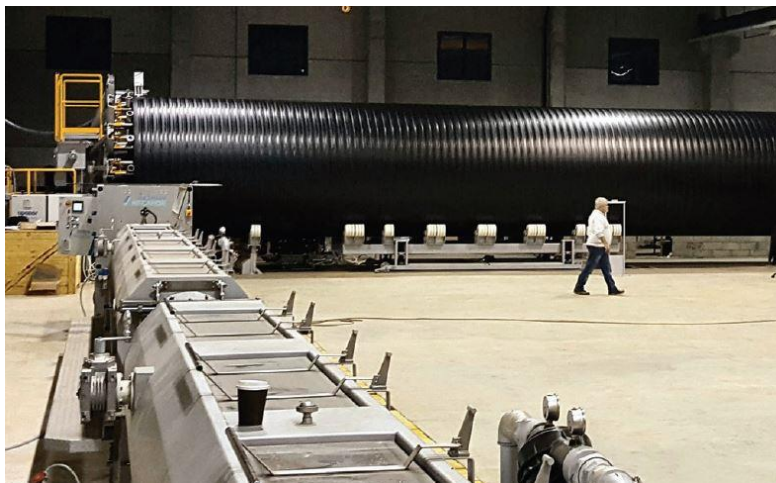
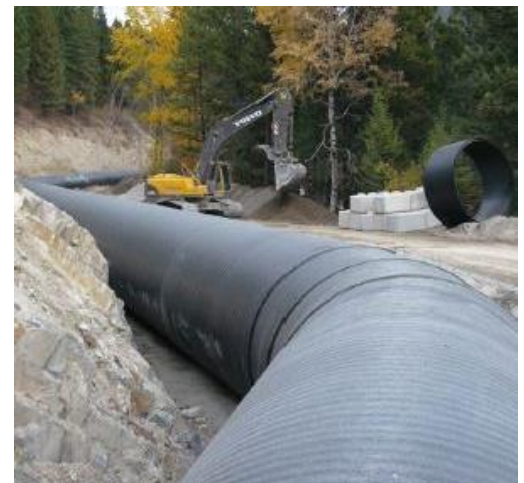
The Aberfeldie Generating Station is located on the Bull River, approximately 45 kilometers east of Cranbrook. The 25 MW powerhouse and penstock leading from the dam to the powerhouse were constructed between 2006 and 2008 as part of a general facility redevelopment project. The penstock includes approximately 800 metres of buried, high density polyethylene (HDPE), double-walled pipe. The pipe was manufactured by winding a rectangular tube into a spiral and welding the inner and outer surfaces together. Straight sections and factory-fabricated elbow sections were installed in a trench at site and welded together to form the penstock, which was then buried. This is the only HDPE penstock in BC Hydro's system.

Figure 3 Manufacturing (at left) and installation (at right) of the HDPE penstock at Aberfeldie.
