**BC HYDRO**  
**WAC BENNETT DAM**  
**EXPERT ENGINEERING PANEL**  
**APPENDICES - VOLUME 2**

*August 2012*

*Report No. N3405*

## **WAC Bennett Dam Expert Engineering Panel on Seepage Flow Control Characteristics**

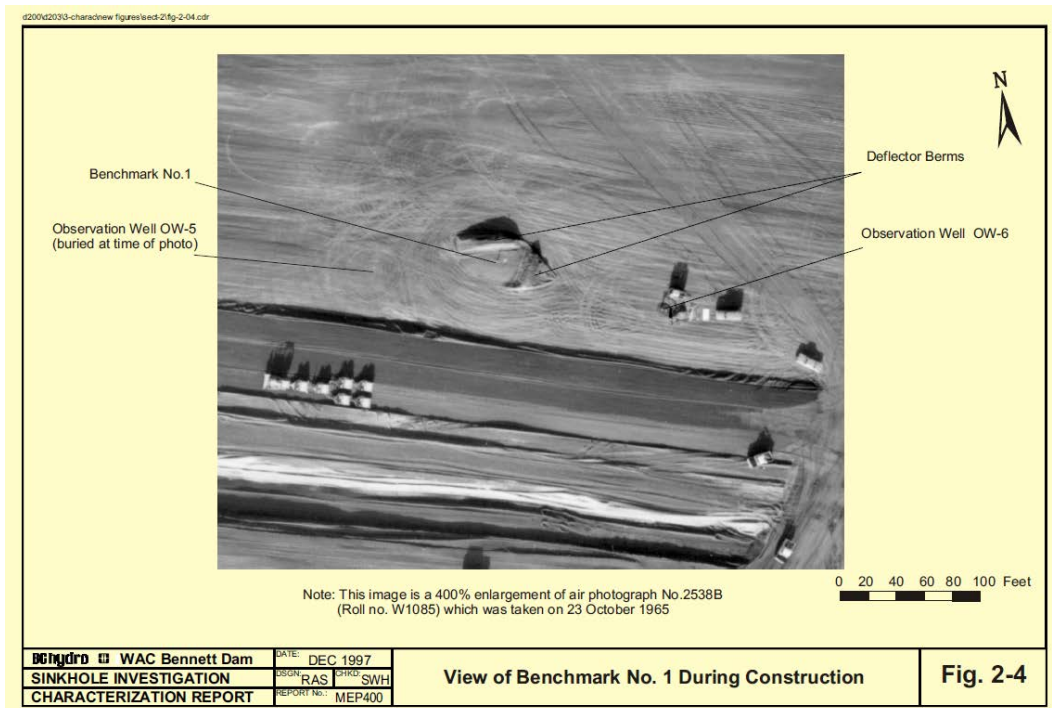
Section 2.4 of Report MEP 400 indicates that deflector berms were constructed around the Benchmarks to protect them from construction equipment. Figure H3 shows these for Benchmark 1 when the Core was at about EL 1895ft.

Section 2.4 of MEP 4000 indicates that “construction records indicate that the backfill in this diamond shaped area with estimated dimensions of 45ft by 30 ft was compacted by walk-behind equipment”. It is apparent from the tyre marks that the 100 ton roller used for the Core was not used within this area.

Figure H3. View of Benchmark No 1 during construction showing the “deflector berms”.

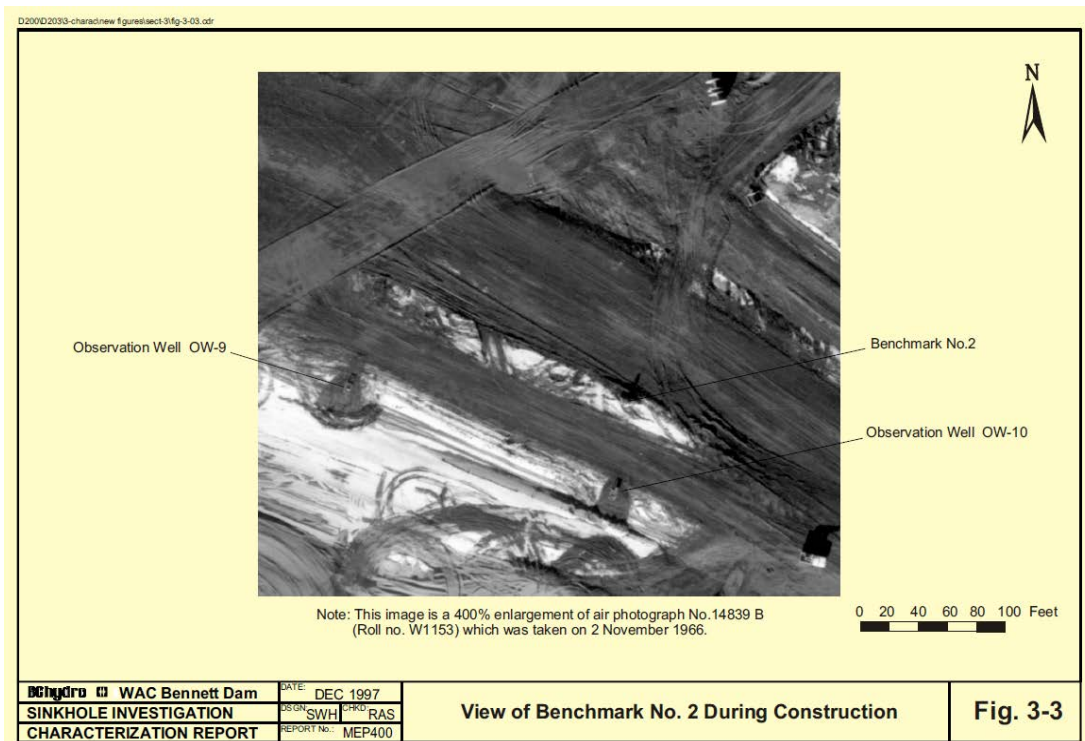
Figure H4 shows construction around Benchmark 2. The scale of the photograph makes it difficult to determine what measures were taken to protect the benchmark or compact around it. However the special treatment around the Observation Wells can be seen.

**Figure H4. View of Benchmark No 1 during construction.**

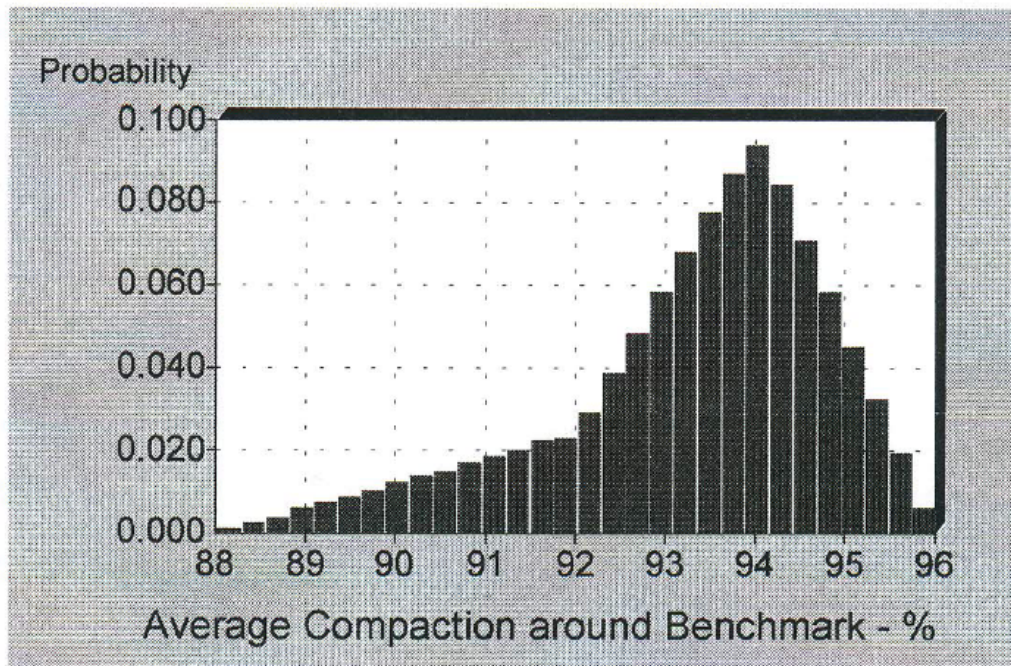
- (a) There were very few tests carried out to check the degree of compaction of the backfill. For Benchmark 1 there were only 5 tests close to the benchmark in 265 ten inch lifts. For Benchmark 2 there were none. There were only 3 other tests for each benchmark within the larger area.

- (b) For Benchmark 1 the lowest test result was 90.8%, not 93.8 % as assumed in the EP 400 report.

**Figure H5. Probability distribution of average compaction around Benchmark 1 as a % of standard maximum dry density.**

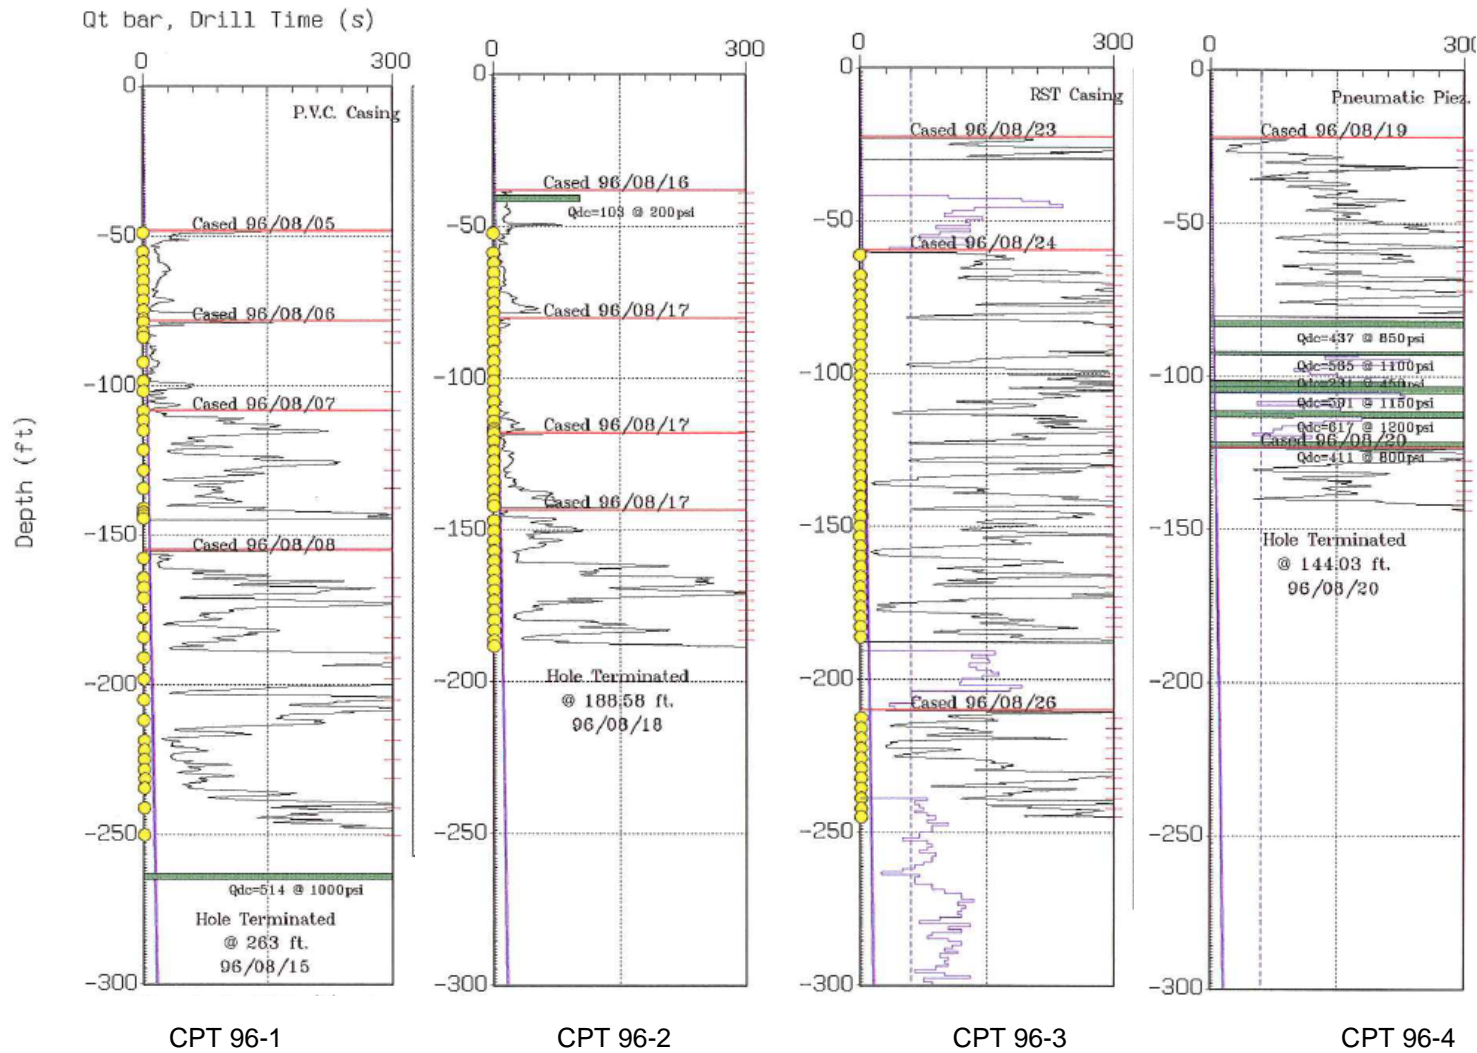
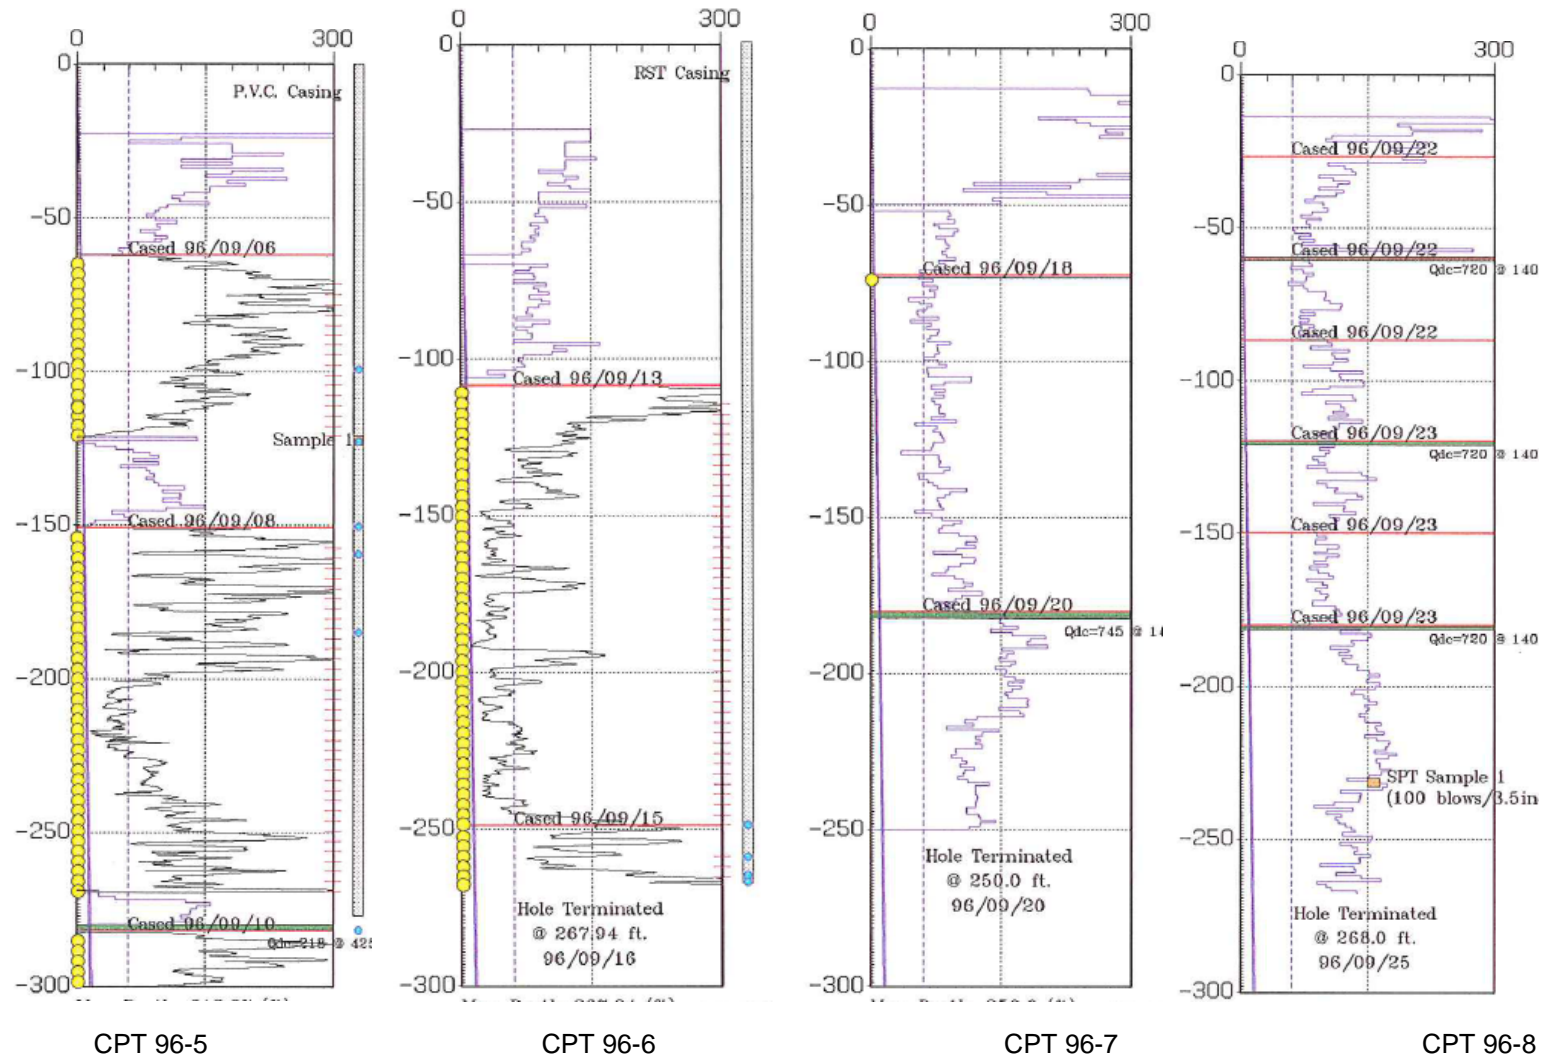
- (a) CPT 96-1 and CPT96-2 in the sinkhole show very low  $Q_t$  values to a depth of 110 and 130ft respectively. This is indicative of very loose conditions.

- (c) CPT 96-5 and CPT96-6 are within the 20 ft diameter zone downstream of the benchmark. They show quite high  $Q_t$  down to 125ft and 110 ft respectively indicating the Core is relatively dense. However at these levels there is a layer in each CPT of zero  $Q_t$  approx. This coincides with where the level of the maximum phreatic surface was, as discussed in H4.3 (b), and may represent a very loose zone or even voids at the top of the collapsed Core material.

- (d) Below this in CPT 96-5 there is a relatively high  $Q_t$  zone to 200ft depth, which has lower  $Q_t$  layers at about 10ft intervals. It is notable that mud loss was recorded at three of these low  $Q_t$  layers indicating they are susceptible to hydraulic fracture. From 200ft to 225 ft approx. there are low  $Q_t$  strata.

- (e) In CPT96-6 which is only about 10ft from CPT 96-5, the  $Q_t$  profile is quite different. There are low  $Q_t$  values from 150ft to 240ft. Much of this zone has  $Q_t$  values of about 1 to 1.5MPa, indicating very loose or loose conditions. There are strata at 170ft and 190ft with zero resistance. These conditions are looser than in CPT 96-1 and CPT 96-2 within the sinkhole.

- (f) CPT 96-3 and CPT 96-4 which are about 13ft to 14ft from the benchmark show distinctly different conditions with very high  $Q_t$  inter-layered with thin zones of 4MPa  $Q_t$  at regular intervals of about 5ft elevation. In CPT 96-3 there are three layers at 135ft, 160ft and 175 ft approx. with  $Q_t$  approaching zero.

- (g) CPT 96-7 and CPT 96-8 show different conditions again, with relatively uniform  $Q_t$  in the range 4 to 6 MPa from 50ft to 180 ft increasing to 10 to 15 MPa to the base of the tests. CPT 96-7 is about 14ft upstream of the benchmark and CPT96-8 is about 90 ft from the benchmark but near Observation Well OW-5.

Figure H9a. Cone resistance for CPTU tests at Benchmark No 1

Figure H9b. Cone resistance for CPTU tests at Benchmark No 1

- (d) The CPT data presents a more complex picture for this area. It shows variable conditions in the "moderately disturbed zone" with much lower  $Q_t$  values in CPT 96-6 than in CPT 96-5 and CPT 96-7 which are all within the 20 ft diameter area. This could be a result of poor compaction extending to CPT 96-6, or internal erosion resulting in effective loosening of the strata.

- (e) The inter-layering of dense high  $Q_t$  material with much lower  $Q_t$  strata at regular elevation intervals seems to indicate this is a result of placement compaction variations, possibly emphasised by wetting compaction of the looser strata as it saturates. The presence of three near zero  $Q_t$  layer in CPT 96-3 is consistent with wetting compaction of the saturated soil below this level leaving a very loose layer or void with a roof of dense soil above it. The layering is at about 5 ft intervals, or a week's placement. It may be that there was a shift or day when there was no work and the surface desiccated by sunshine or freezing or that the deflector berms were raised in 5 ft lifts.

- (g) The presence of zero CPT  $Q_t$  resistance at the 110ft / 130 ft depth is consistent with collapse settlement of the saturated soil below this level leaving a very loose layer or void with a roof of partially saturated soil above it.

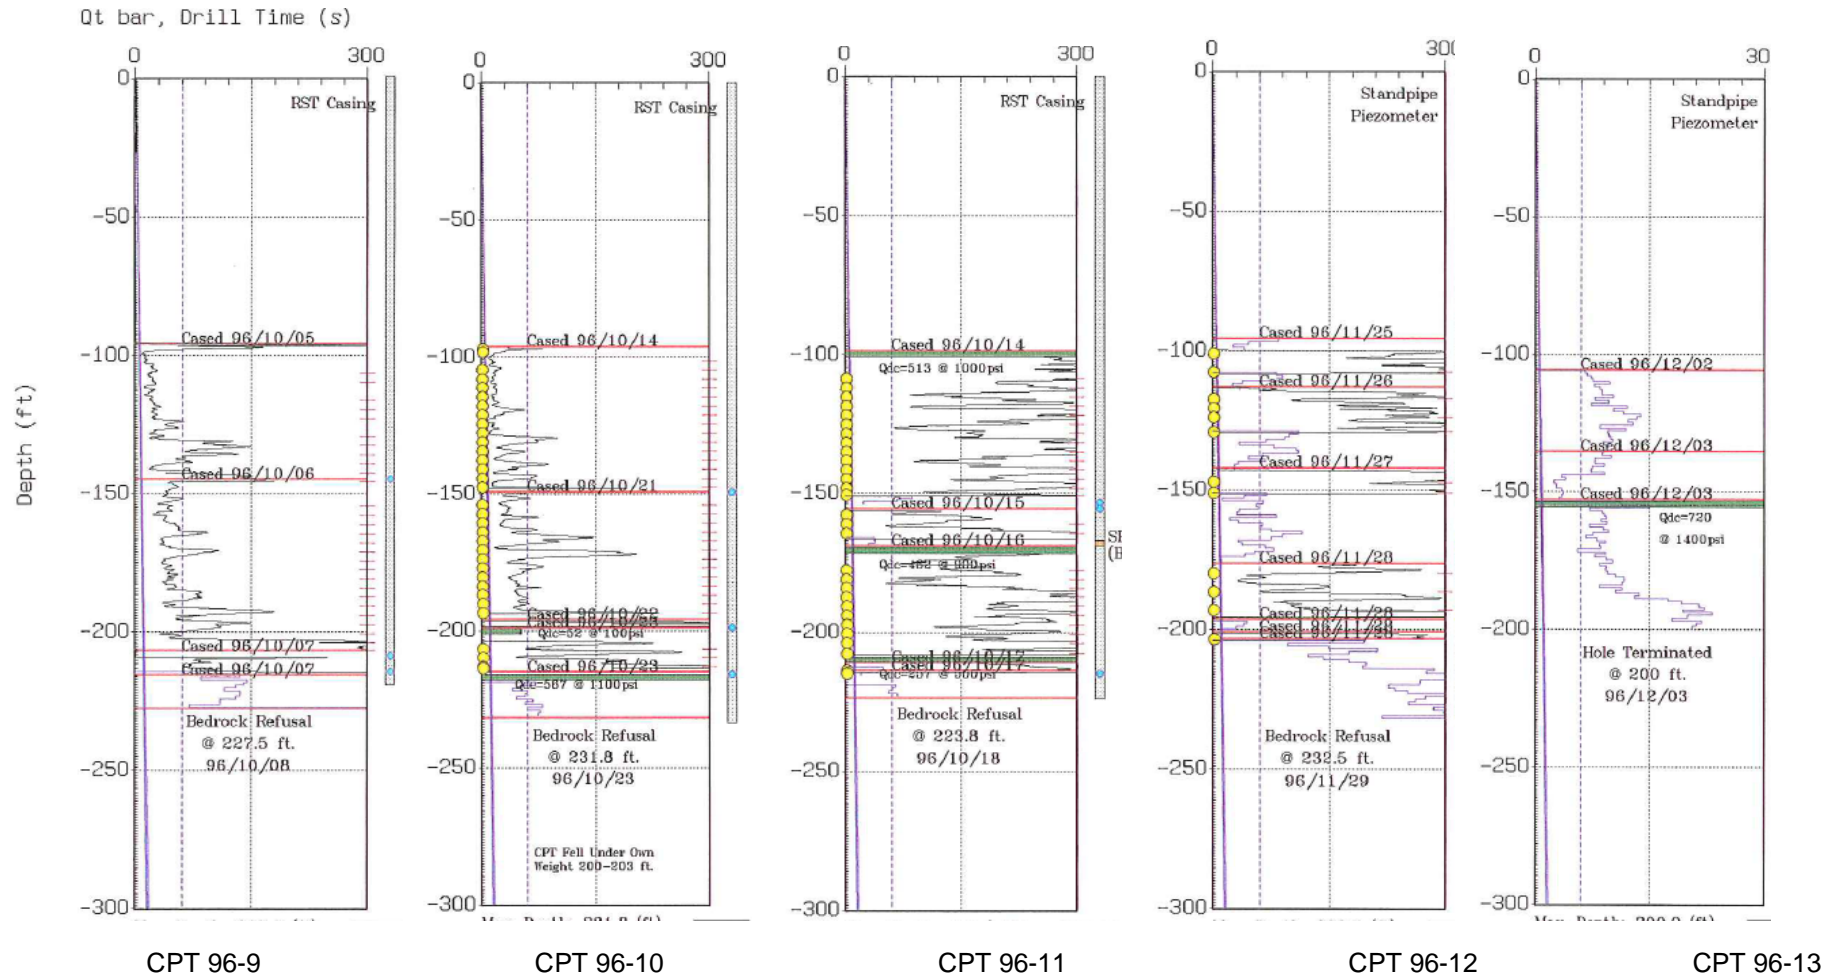
- (a) The probes were all cased to 100ft through the Shell so there is no data in the top 100ft.
- (b) CPT 96-9 and CPT 96-10 are in the "sinkhole". They show  $Q_t$  of about 1 MPa from 100ft to 125ft and generally 1 MPa to 3 MPa, or very loose conditions from that level to the base of the hole. In CPT 96-10 there is distinct layering at regular 5ft intervals and this may reflect that the method of placement and compaction around the benchmark was in 5 ft layers with little compaction.

- (c) CPT 96-11 and CPT 96-12 which are 13ft and 17ft respectively from the benchmark show conditions from 100 ft to 150 ft in CPT 96-11 and 130 ft in CPT 96-11 which are similar to CPT 96-5, with dense strata inter-layered at about 10 ft intervals with  $Q_t$  3 MPa strata. This continues to the base of the probe in CPT 96-11 but in CPT 96-12 there is quite low  $Q_t$  from 130 ft to 200ft approx. CPT 96-13 which is about 11ft upstream of the benchmark has somewhat denser conditions than CPT 98-12, and is similar to the CPT upstream of Benchmark No 1. It does have a 5 ft section centred on 150ft with  $Q_t$  about 1.5 MPa.

- The grout takes are lower in the upper 75ft. This may be due to the significantly lower grout pressures used and to this part being in Shell, not Core material
- Grout takes below this are similar to Sinkhole No 1 despite the CPT data indicating sinkhole No 1 was lower density than sinkhole No 2 (Figure H12). From this it seems that the grout take is significantly controlled by the strata around the 10 ft diameter sinkhole rather than those in the sinkhole.

Figure H10. Cone resistance plots for CPTU tests at Benchmark No 2

- (a) There is a low density / high void ratio zone in the 10 ft approx diameter centring on the benchmark, and quite low density / high void ratio at some depths up to 17ft from the benchmark.
- (b) There is distinct layering in loose to very loose strata at regular 5ft intervals in CPT 96-10 and this may reflect the method of placement and compaction around the benchmark was in 5 ft layers with little compaction.

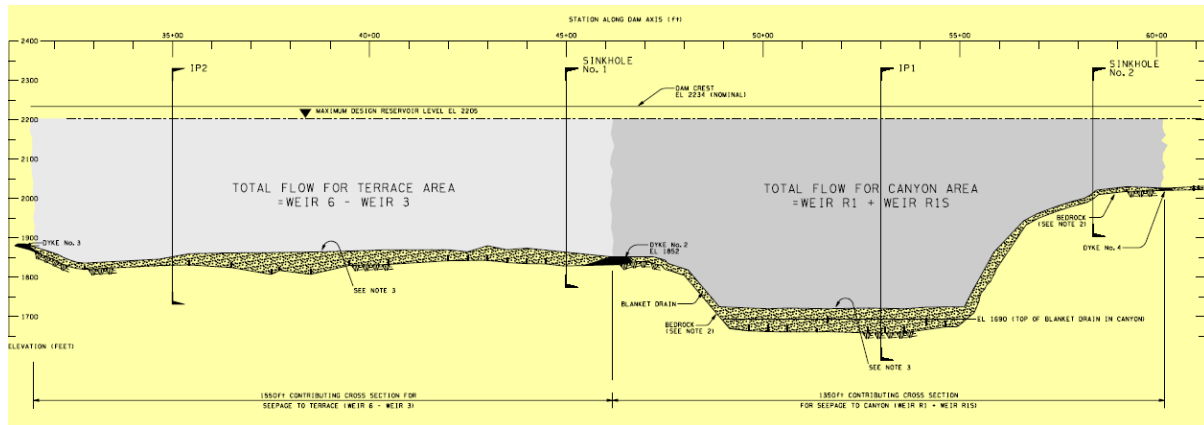
Figures H14 shows the longitudinal profile of the foundation along the dam centreline at Sinkholes No 1 and No 2. Figures H15 and H16 show the foundation profiles in upstream-downstream cross-sections at Sinkhole No 1 and Sinkhole No 2 respectively.

The longitudinal profile at Sinkhole No 2 is such that extension strains are highly likely at the Sinkhole. At Sinkhole No 1 the cross section profile would also make extension strains highly likely.

These could have a significant part to play in whether concentrated leak erosion occurs through cracks or hydraulic fractures in low stress zones subject to hydraulic fracture.

Figure H14. Longitudinal profile along dam axis

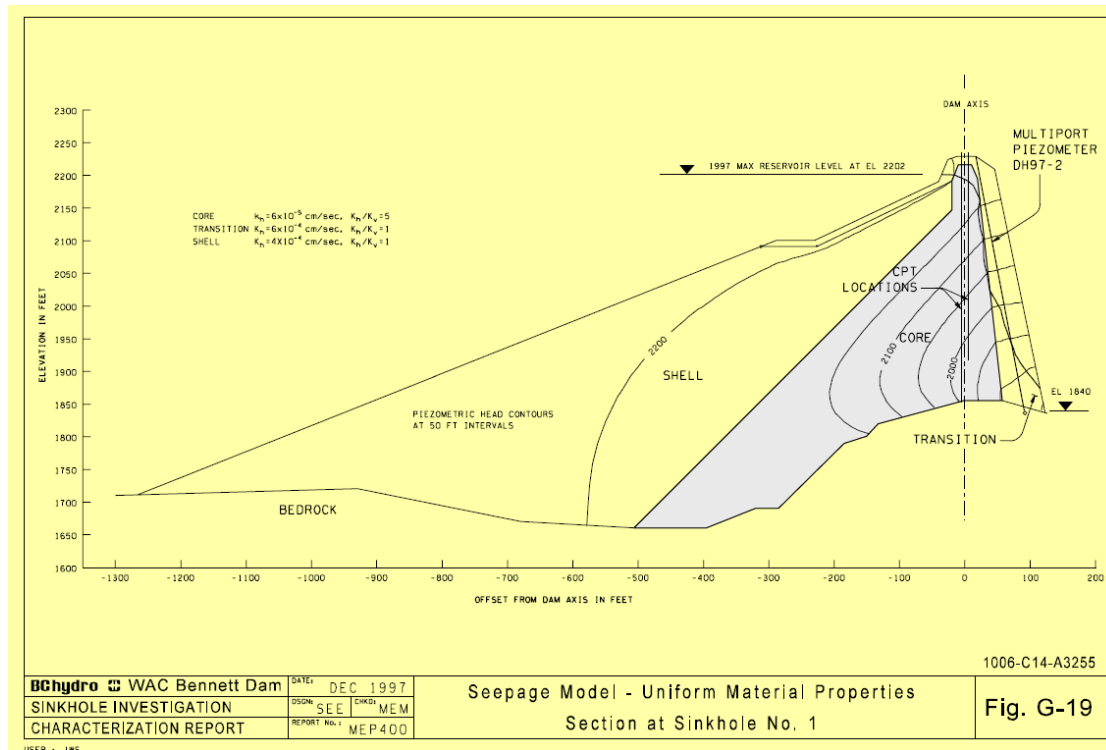
Figure H15. Cross section at Sinkhole No 1

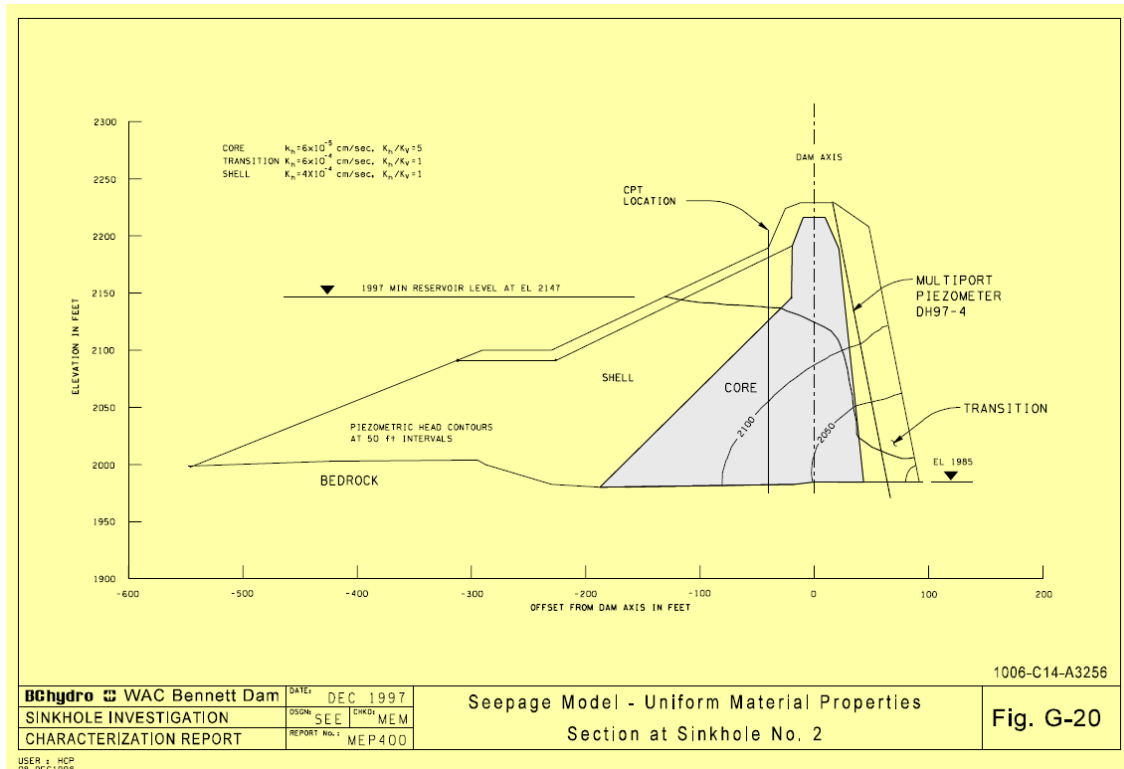
**Figure H16. Cross section at Sinkhole No 2**
