**02SH35**

**IRELAND CREEK SIDETCHANNEL**

**FINAL REPORT**

Date: April 12, 2003

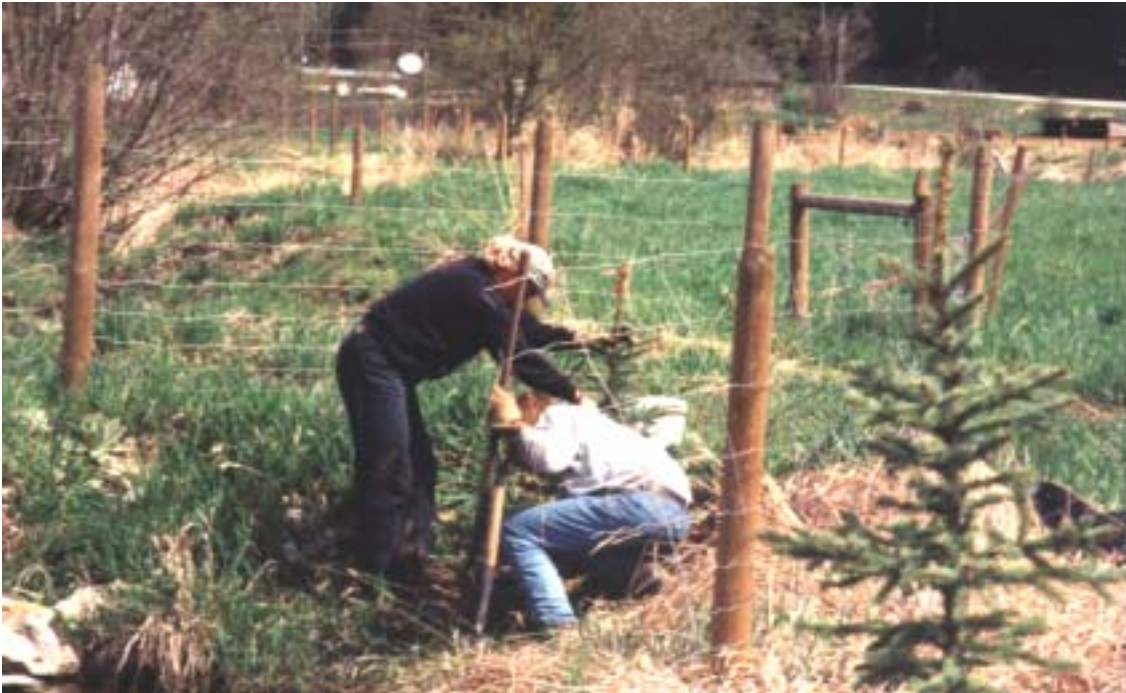
Planting began in spring as soon as funding was confirmed and again in the fall along both sides of the channel. In May, bare-root stock totaling of 86 trees and 37 shrubs were planted. The trees varied from 2 to 6 feet. A mixture of spruce, cedar, fir, paper birch and water birch were planted. The shrubs included hawthorn, rose, chokecherry and Saskatoon.

When planting, peat soil mixed with bone meal was mixed with the soil used to fill the holes around the root balls to encourage root growth. The holes were dug slightly deeper and wider than the root ball so that when backfilled the tree would be in a slight depression. This was done to allow the trees to be watered by hand. All plants were protected with vole guards. Birch, hawthorn and chokecherry were also protected from browsing with stucco wire held in place with wooden stakes or rebar (Figure 3). The cage also helps support the plants from being smothered by the reed canary grass during the fall and winter. All the trees on the lower half to the channel were staked to prevent uprooting by floodwaters.

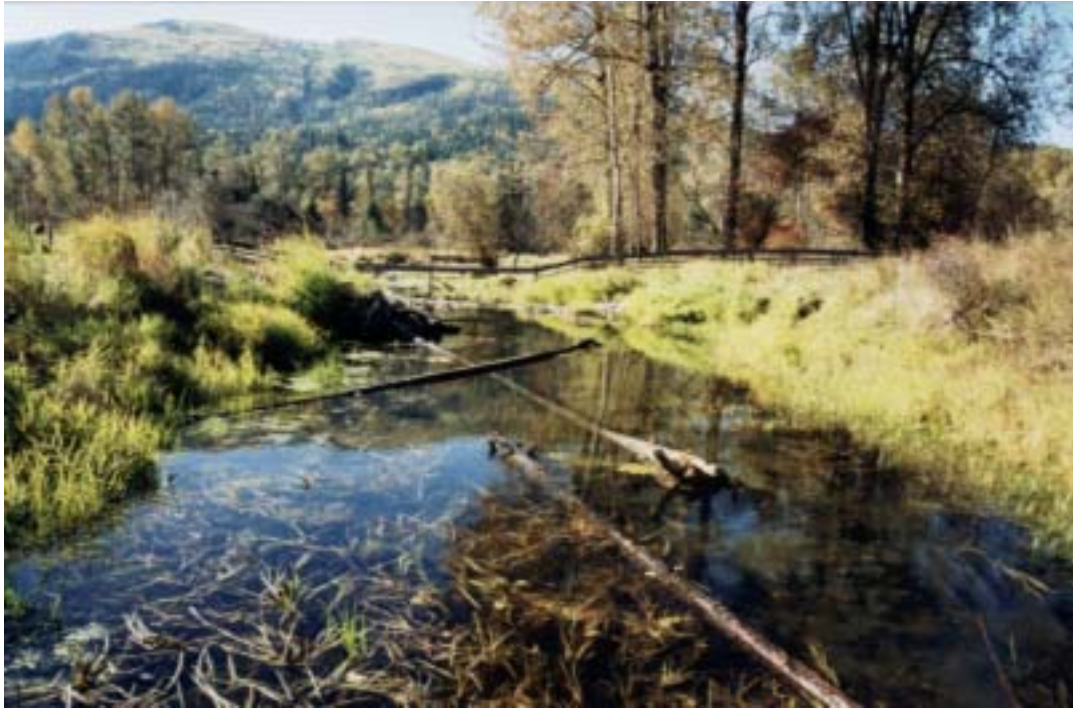
The channel was complexed with both wood and rock. Seventy-six fir and larch trees were placed in the channel. The trees averaged 25 cm at the base and 10 m long. The trees had been topped at approximately 10 cm to fit on the truck but the roots were kept on. The trees were traded with a landowner for some consultation (in-kind) regarding some bank erosion on a creek on his property. The only cost was for the excavator to collect and pile the trees (\$535).
