2015–2016 Dam Safety Report

Dam Safety Program Report 2015 – 2016 (F2016)

Prepared by:

June 2016

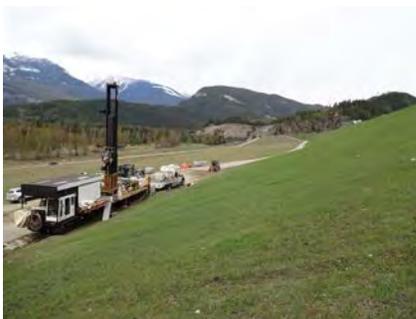
Sonic rig drilling standpipe piezometer

As part of the design and construction of Duncan Dam, a number of relief wells and piezometers were originally installed near the toe of the dam to control and monitor seepage. Over the intervening years, more than a third of these piezometers ceased to function or became inaccessible. The dam was under instrumented for its consequence classification in relation to modern monitoring expectations and other BC Hydro extreme consequence dams. In addition, the outlets for the relief wells and weirs are below tailwater during a portion of the year.

This project was initiated to install new instrumentation and connect instrumentation to the Automatic Data Acquisition System (ADAS). In F2015 instrumentation to monitor concrete cracking at the low-level outlet and surface drainage improvements at the left abutment was installed.

The instrumentation has been put in service and preparation of the construction report is in progress.

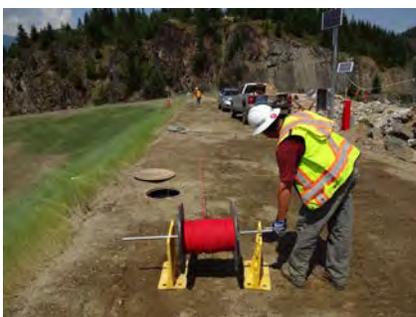
Pulling instrumentation cable

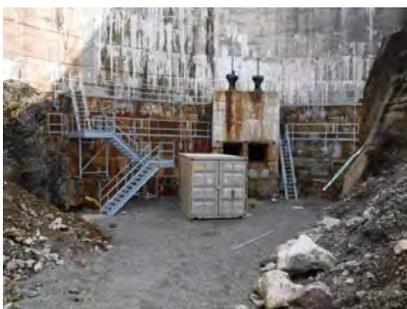
Wilsey Dam-Access and Safety Improvement

- provide monitoring capability for existing drains in the foundation of the arch dam,
- re-establish piezometric monitoring capabilities in the left abutment, and
- establish safe access to the lower part of the dam for inspection purposes.

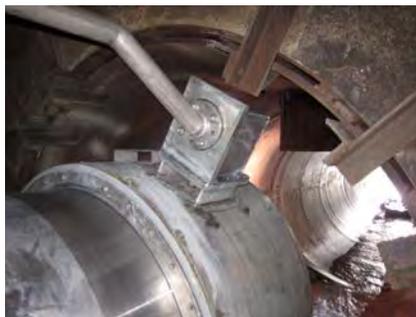
Following the failure of the pressure relief valve discharge at the South Conduit in February 2012, a reliable alternative water passage was required via the North water passage.

North Conduit drain improvements

Construction work in F2016 to provide North Conduit drain improvements have now completed the planned upgrades. Project documentation is in progress.

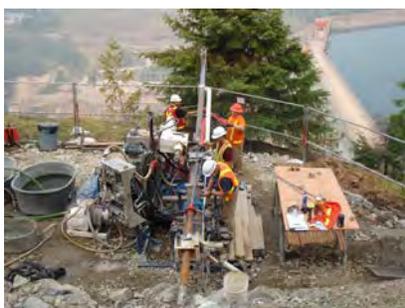
There are seven slopes of interest on the Left Bank of Revelstoke Dam. The study recommended further stabilization work for one slope, which will be carried out under a future project. However, the investigation also concluded that for another two slopes, the geology was poorly understood, and there was insufficient instrumentation to make a definite stability assessment. The investigation recommended that instrumentation be installed and additional geological information be collected to provide a technical basis for whether or not stabilization is required for these slopes.

Left Bank Slopes-Instrumentation Installation

This project was initiated in F2015 to gain a greater understanding of the stability through the installation of instrumentation. The following activities were included in the scope of work and were carried out in F2016:

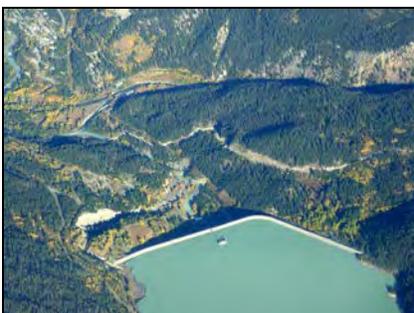
The existing shotcrete facing of La Joie Dam installed in 1972 has deteriorated, resulting in increased leakage through the dam. Some of the leakage is currently managed through maintenance of the shotcrete panels accessible during low reservoir periods. A previous study to understand the performance of the dam has concluded that the dam requires significant upgrades to ensure safe performance following the design earthquake.

An update to the La Joie Operation, Maintenance and Surveillance Manual was issued in F2015 in the form of an Interim Dam Safety Risk Management Plan. Repairs to the upstream face of the dam will continue to be carried out as required (annually or bi-annually).

Following the discussions with First Nations and the Comptroller of Water Rights and addressing a number of their concerns, the updated Interim Dam Safety Risk Management Plan was issued in January 2016, providing clarity on the need to reduce the reservoir to manage dam safety risk. The new lower normal maximum operating level was achieved in early February 2016.

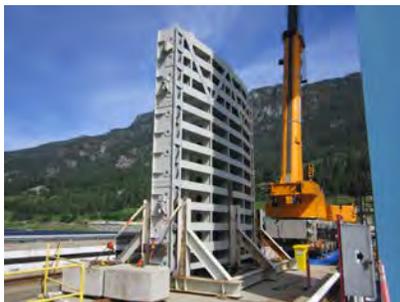
Hugh Keenleyside gates

Construction work is now substantially complete in F2016 at Hugh Keenleyside Dam to improve the power supply and distribution, gate controls, strengthen the tower at the spillway, and replace drives and hoist at the spillway and the low level outlets.

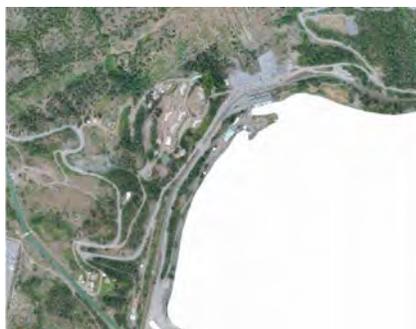
Bridge River 1 has a history of geotechnical issues. The powerhouse is situated on soils subject to artesian uplift pressures. Extensive remedial measures were required early in the plant's life to arrest rotational movement between the powerhouse and the Bridge River 1 penstocks. The upper portions of the penstocks are founded on a more stable rock foundation on the side of Mission Mountain above the powerhouse.

Aerial view of the Bridge powerhouses and penstock slopes

This project is installing appropriate instrumentation to monitor for penstock leakage and differential movement between the penstocks and powerhouse; detect elevated powerhouse foundation pore pressures and provide appropriate relief of excess artesian pressures.

Installation and alarming of flowmeters on penstocks 2 and 3 were completed prior to F2016. In F2016, installation of flowmeters on penstocks 1 and 4 was completed; alarm levels were set to detect significant leaks; and procedures for manual closure of the valves were included in the site operating orders.

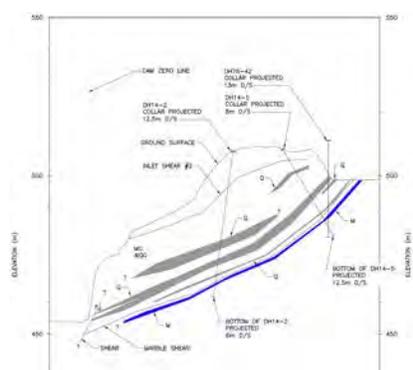
The Marble Shear Block is a large rock mass located on the right bank of the canyon at the Revelstoke Concrete Dam. At the time of construction, some movement of the block occurred during excavation for the dam and powerhouse. Extensive stabilization measures were implemented, and no significant movement has occurred since in the area of the dam and powerhouse. However, downstream of the powerhouse, the Marble Shear is still considered potentially unstable and water levels must be maintained to reduce the likelihood of slope movement.

Significant work was carried out in 1998/99 to reduce water levels but they have since increased. In 2012, a number of drains were cleaned by high pressure jetting and six existing drains were reamed. Ten new drains were also installed at the head of the Marble Shear Block Drainage Adit. The drainage trenches on top of the Marble Shear Block were cleared to reduce ponding. While these measures did impact water levels slightly, the average water level is still above the originally defined acceptable limit.

Geological Model Output

In F2016, the new information obtained in F2015 was used to update the geological model of the slope and to re-assess the stability of Marble Shear Block. New thresholds have been established for the previously installed instruments to monitor the Marble Shear Block stability into the future.

It was concluded that in order to assist in monitoring these thresholds, two additional in-place inclinometers should be installed within the Marble Shear Block and a detailed LiDAR surveying of the spillway chute should be completed. This work will be carried out in F2017.

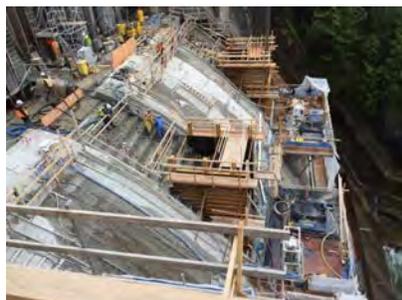
Construction of New Piers 4 and 5

- Installation and commissioning of the first two spillway gates (Spillway Gates No. 1 and No. 2)
- Successful completion of the removal and transfer of the bulkhead to the new location, in front of old Gates 4 to 6
- Removal of existing Gates 4 to 6
- Removal of the existing Piers 4, 5 & 6
- Construction of new Piers 4 and 5, in progress
- Construction of the Left Abutment reverser filter berm and seepage flow measuring instruments; and
- Partial relining of critical sections in Tunnel 3.

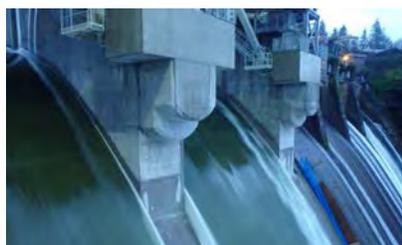
Flow from new Spillway Gates No. 1 and No. 2. Remaining old spillway gates can be seen in the background.

Analyses of the overall dam performance are in progress. These analyses will determine the number and design of additional anchors required.

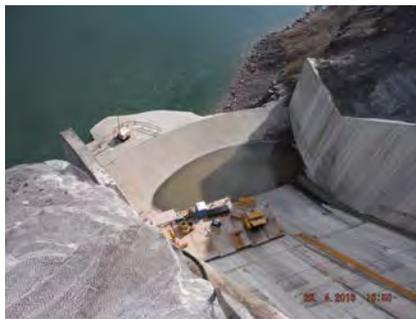
This project is carrying out repairs to the spillway chute concrete surface at the W.A.C. Bennett Dam. Safe access to the chute was achieved in August 2011 following completion of rock slope stabilization works which allowed for a complete chute inspection.

WAC Bennett Dam Spillway Chute - Working Platform Construction

- installation of waterstops in the upstream construction and contraction joints,
- repairs of significant cracks by removal of the cracked concrete and replacement with new concrete, and
- minor patching of other cracks.

The contract to carry out the resurfacing work on the inclined portion of the spillway was awarded in late F2014. The surface concrete was removed by hydro-demolition. Additional dowels / anchors / rebar were installed, and new concrete was placed meeting the tight tolerance requirements. About three quarters of the planned concrete removal / resurfacing work was completed in F2015. The plan is to complete the remainder of the upper portion and the entire lower portion of the chute in the 2nd year of construction. Due to the high risk of spill, a decision was made in late F2015 not to proceed with construction in 2015.
