Peace Project Water Use Plan

WILLISTON TRIAL TRIBUTARIES

Implementation Year 9

Final Report Year 9 (2019)

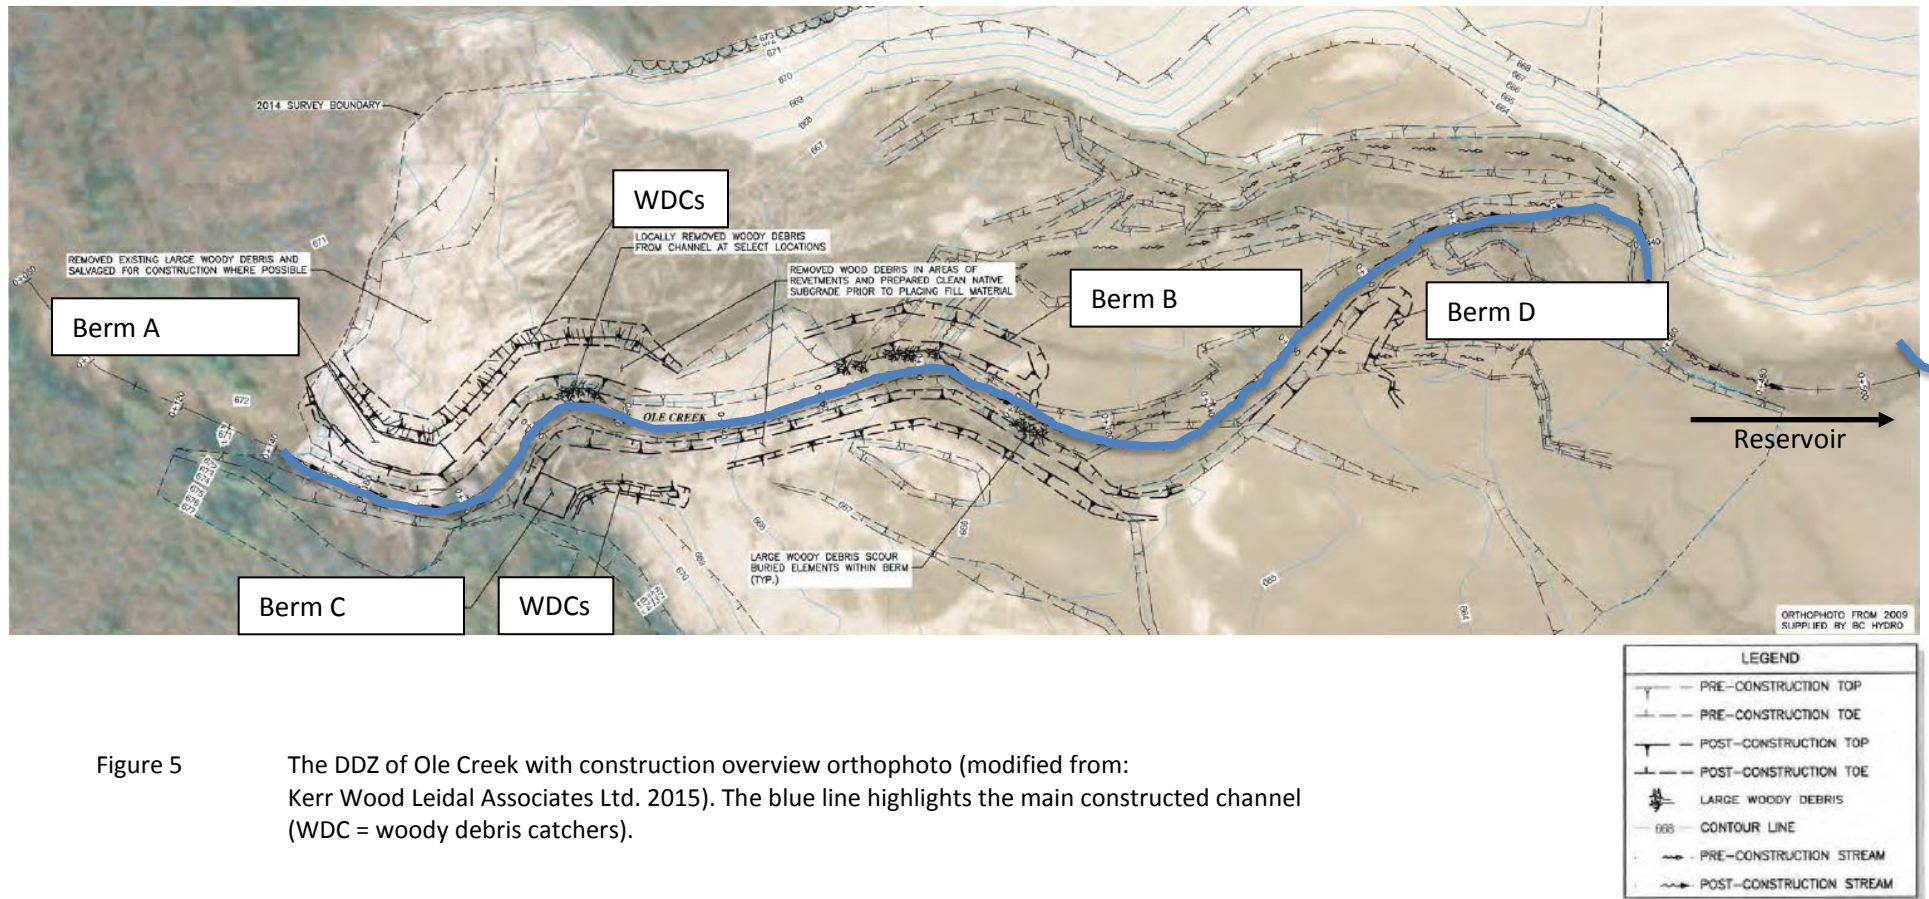
Detailed and Structure-Specific Assessment Results: Detailed May 29, 2019 inspection results for all Ole Creek structures are shown in Table 4 and Table 5 and related photographs are shown in Figure 6 and Figure 7.

Figure 5 The DDZ of Ole Creek with construction overview orthophoto (modified from: Kerr Wood Leidal Associates Ltd. 2015). The blue line highlights the main constructed channel (WDC = woody debris catchers).

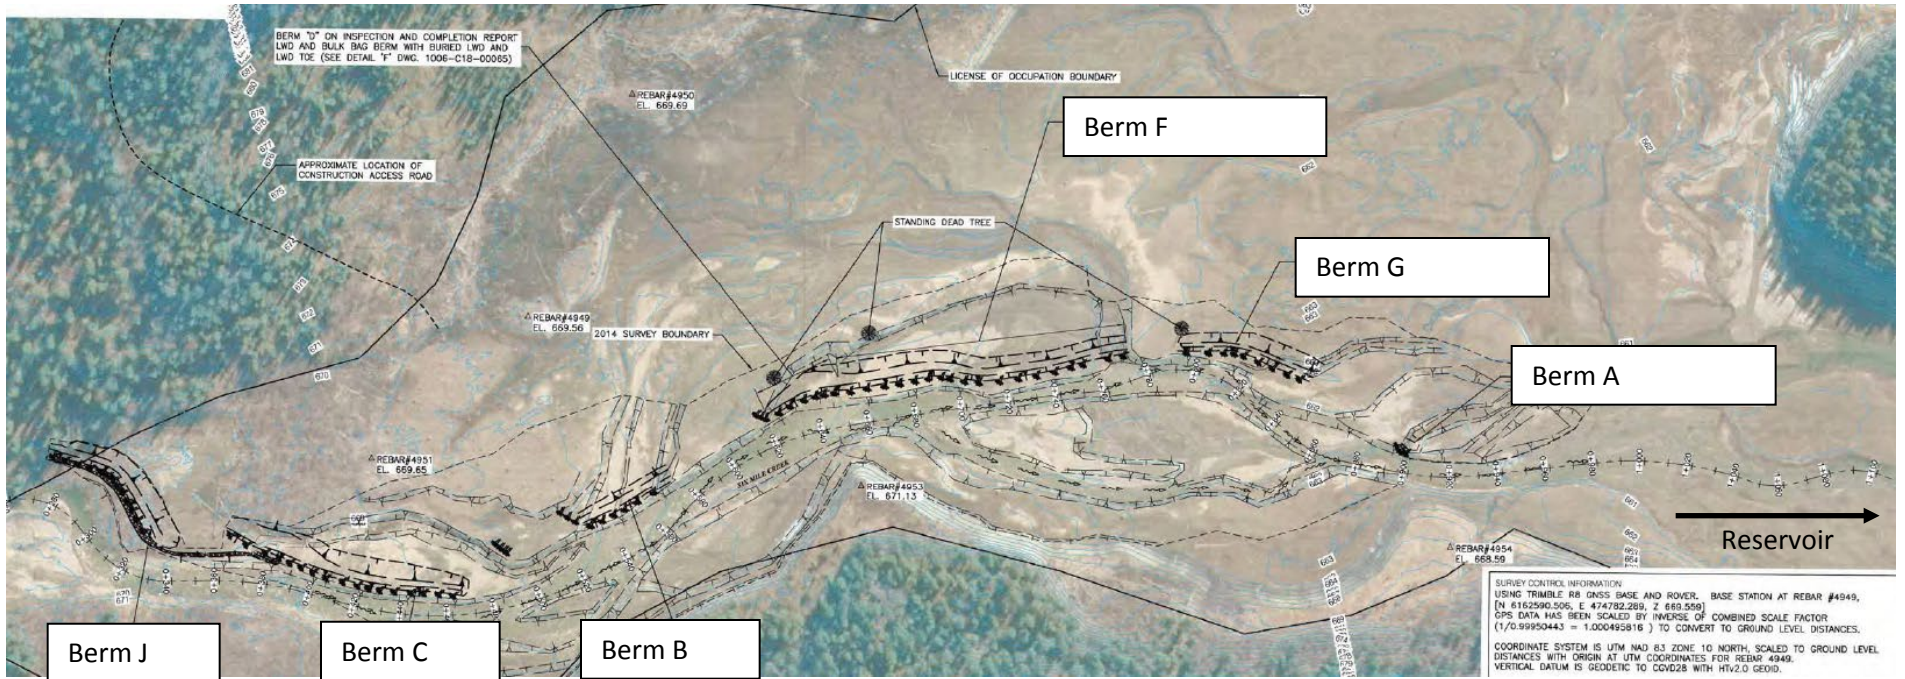
LWD Structures: The embedded LWD structures were still stabilizing the toe of the constructed berms but the LWD structures were neither creating scour pools, nor did they provide fish cover or shading at the creek level. It appeared as if Six Mile Creek may have lowered its thalweg through erosion, leaving the LWD structures elevated above creek levels at all but the highest discharges. The observation that the creek thalweg has been lowered, will need to be confirmed through a detailed elevational survey.

Figure 8 The DDZ of Six Mile Creek with construction overview orthophoto (modified from: Kerr Wood Leidal Associates Ltd. 2015). WDC = woody debris catchers

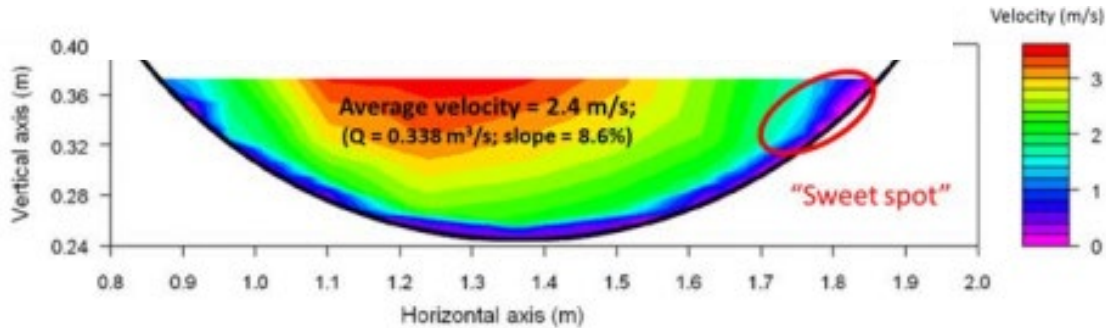
the water depth where current velocities are typically much higher than close to the bottom as can be seen in Figure 12 on an example of a culvert where currents at one third of the water depth were approximately 2 m/s while the current velocity close to the culvert bottom was much slower at 0.3-0.8 m/s. In a natural creek with rougher bottom substrate the differences between one third depth and bottom current velocity are likely even more pronounced. We therefore assume that in addition to using the creek margins for migration in depth of 10-15 cm, migration may also have been possible in slightly deeper water close to the bottom.

Figure 12 Current velocities measured in a culvert at different depths and distance from the bottom (from: Katopodis and Gervais 2016).

Nevertheless, additional scour pools created by adding LWD structures, which are either anchored in the stream channel or embedded in the berms at an elevation that allows them to be in the water, are recommended for any future installations. These added LWD structures would create additional low current and resting areas between the long runs and rifles that may pose physical exhaustion for smaller fish.
