Peace Project Water Use Plan

WILLISTON TRIAL TRIBUTARIES

PEACE PROJECT WATER USE PLAN

Final Report Year 8 (2018)

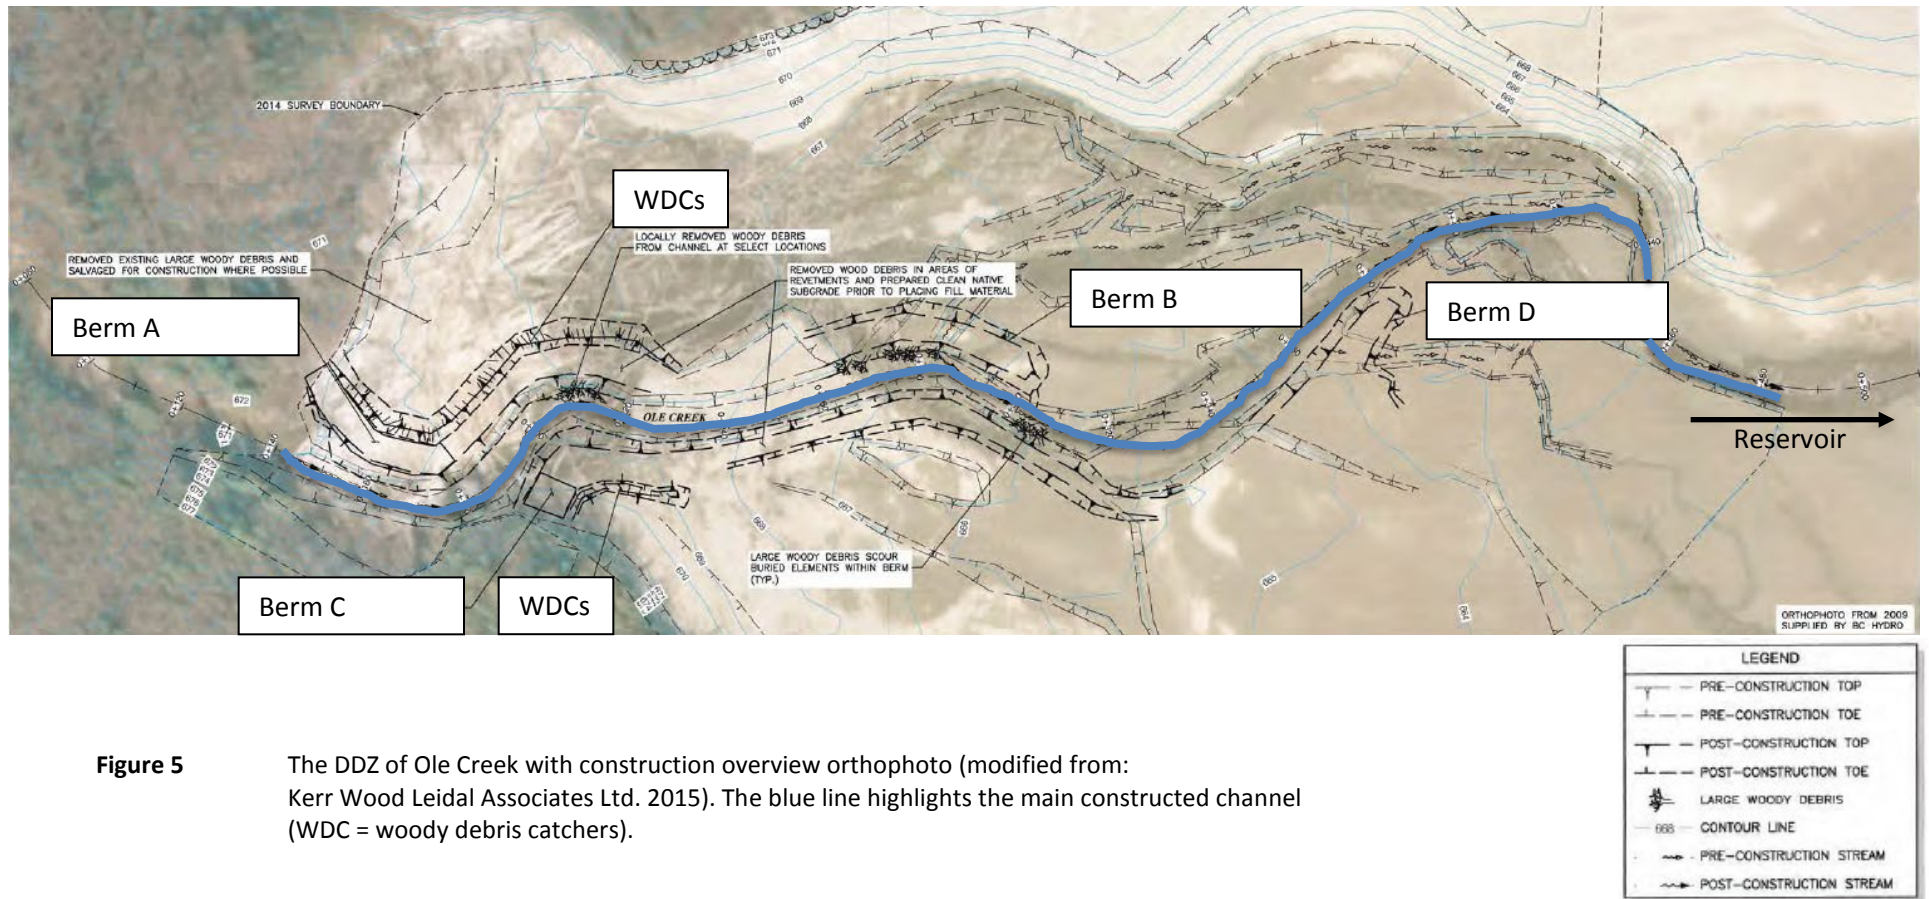
Figure 5 The DDZ of Ole Creek with construction overview orthophoto (modified from: Kerr Wood Leidal Associates Ltd. 2015). The blue line highlights the main constructed channel (WDC = woody debris catchers).

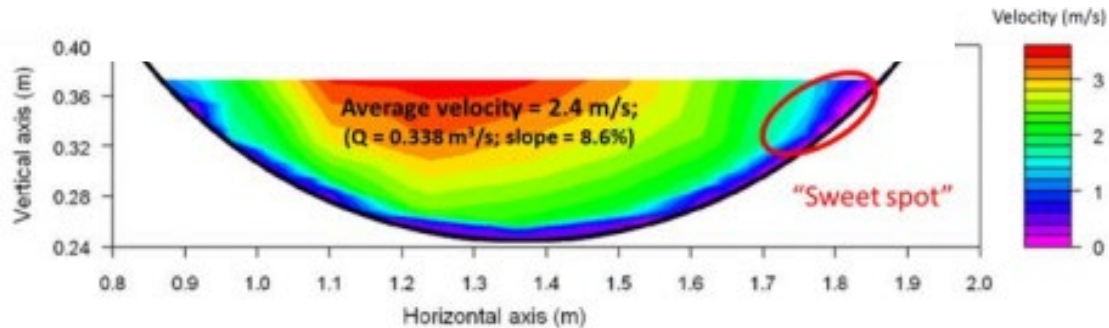
depth of 10-15 cm should have been possible at the discharges measured in June of 2018. Discharge measurements as per Resource Inventory Standards are carried out at one third of the water depth where current velocities are typically much higher than close to the bottom as can be seen in Figure 12 on an example of a culvert where currents at one third of the water depth were approximately 2 m/s while the current velocity close to the culvert bottom was much slower at 0.3-0.8 m/s. In a natural creek with rougher bottom substrate the differences between one third depth and bottom current velocity are likely even more pronounced. We therefore assume that in addition to using the creek margins for migration in depth of 10-15 cm, migration may also have been possible in slightly deeper water close to the bottom.

Figure 12 Current velocities measured in a culvert at different depths and distance from the bottom (from: Katopodis and Gervais 2016).

Nevertheless, additional scour pools created by adding LWD structures, which are either anchored in the stream channel or embedded in the berms at an elevation that allows them to be in the water, are recommended for consideration. These added LWD structures would create additional low current and resting areas between the long runs and rifles that may pose physical exhaustion for smaller fish.
