Peace Project Water Use Plan

Williston Reservoir Trial Tributaries Implementation Year 9

2019 - 6 Mile Creek Engineering Inspection Report

Site Inspection Report

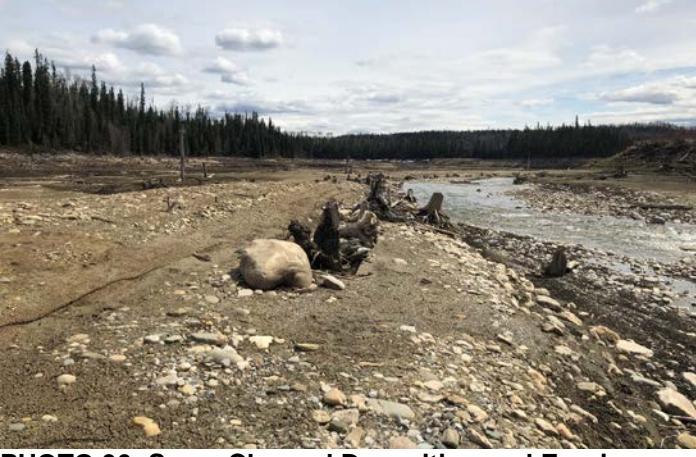
- Berm in good condition. No significant settlement or erosion observed in the field or noted in the survey (see Profile on DWG 1000-C1800063-R3, and Sections 0+540 and 0+560 on DWG 1000-C1800067-R1)
- LWD is in good condition and is not displaced.
- There appears to be some erosion near the toe and deposition mid-channel, which is confirmed on Section 0+540.
- The coir material in the soil wraps is in good condition.
- ECM is deteriorating where exposed (not covered with sand/cobble to prevent floating).
- Overland flow blockage / roughness (buried LWD) are not disturbed and in good condition (See Photos 37 and 38).

PHOTO 37: Downstream line of buried LWD

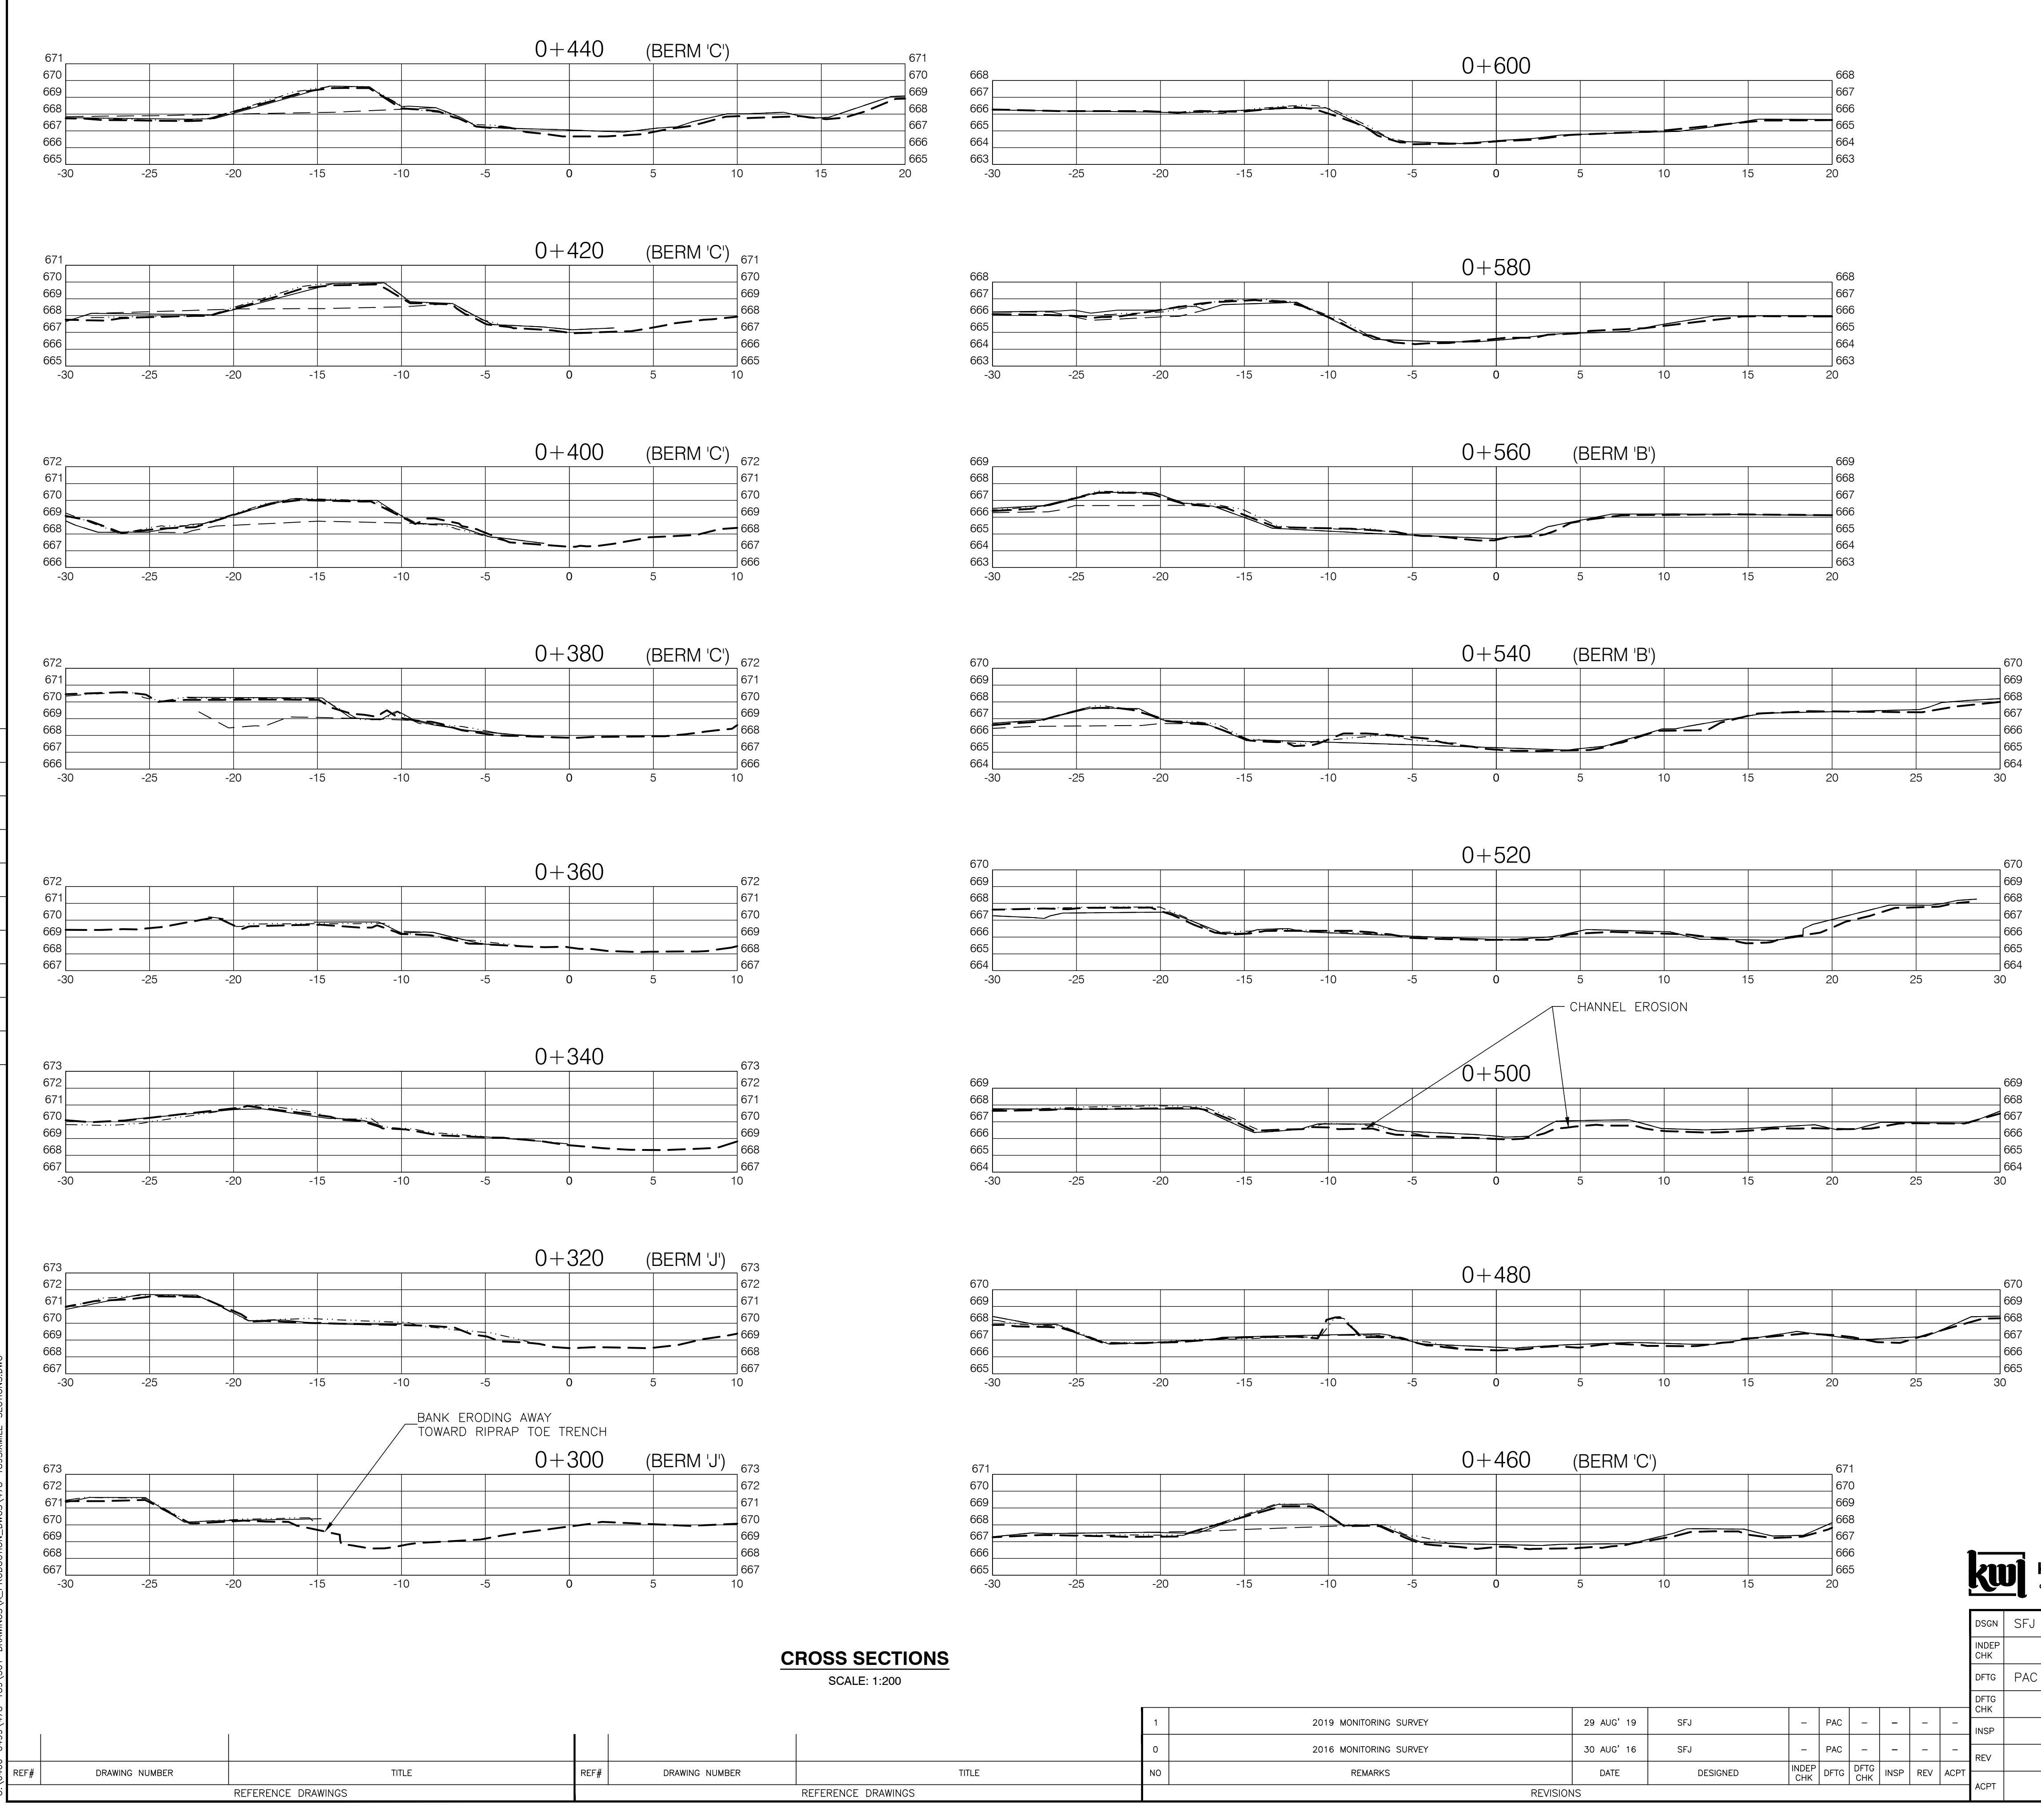
GMS WORKS #19 WILLISTON RESERVOIR TRIAL TRIBUTARIES SIX MILE CREEK CROSS SECTIONS (1 OF 2) DWG NO DATE SIZE 1006-C18-00067 D 2019-08 NOT TO BE REPRODUCED WITHOUT THE PERMISSION OF BC HYDRO

- Berm 'C' is in good condition with no significant settlement or erosion observed in the field or noted in the survey (see Profile on DWG 1000-C1800063-R3, and Sections 0+380 and 0+460 on DWG 1000-C1800067-R1)

- Berm 'J' has effectively protected the bank and kept the creek from eroding behind the works. The berm is in good condition. No significant settlement or erosion observed in the field or noted in the survey (see Profile on DWG 1000-C1800063-R3, and Sections 0+300 and 0+320 on DWG 1000-C1800067-R1)
