Peace Project Water Use Plan

Williston Reservoir Trial Tributaries

2019 - Ole Creek Engineering Inspection Report

Site Inspection Report

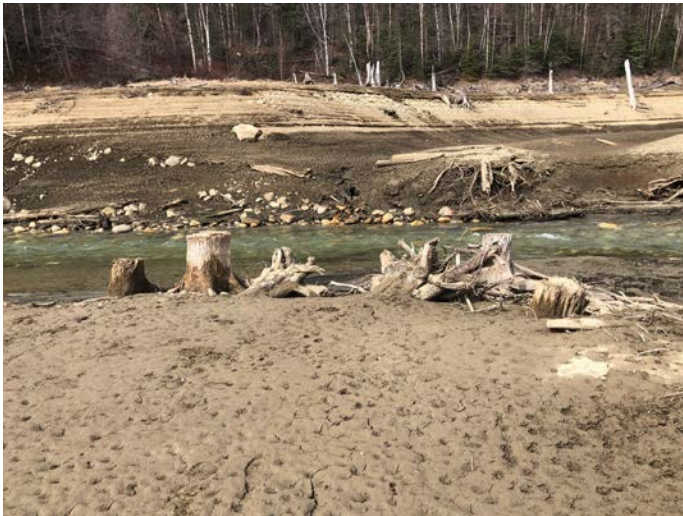
PHOTO 8: Looking at Berm 'A' from Left Bank

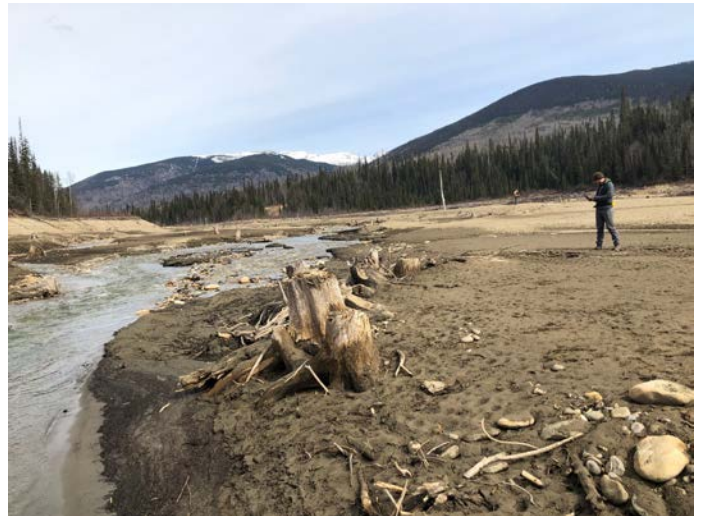
PHOTO 9: Looking Upstream at Berm 'A'

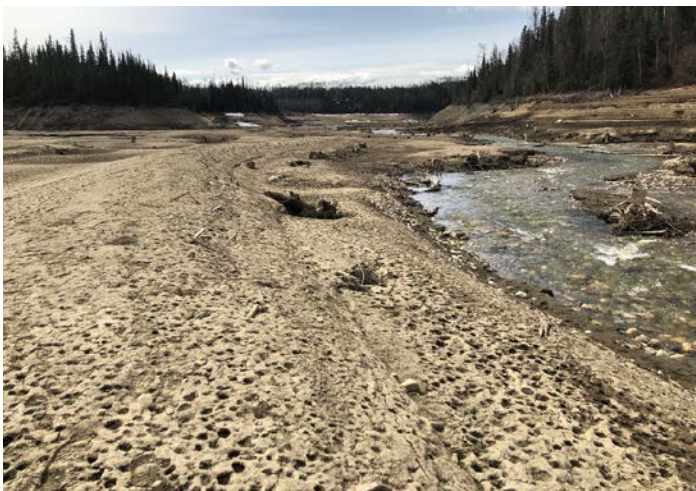
PHOTO 13: Survey of Toe of Berm 'G' on Creek Side (repeat of 2016 Ph#9)

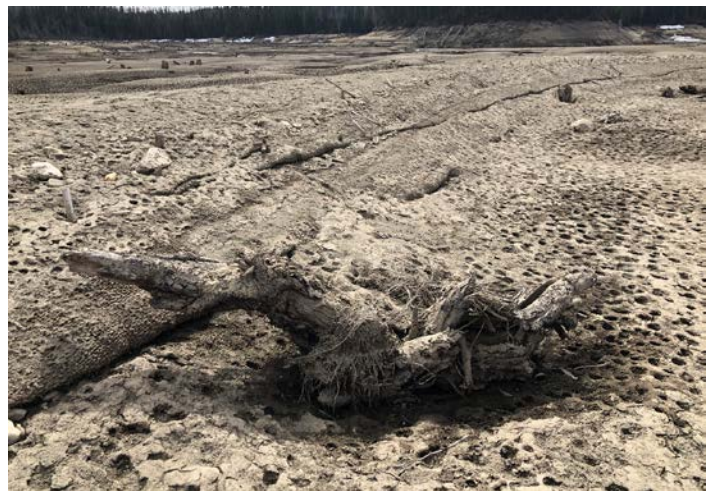
- The coir geogrid fabric is still intact and in good condition where visible.
- The large woody debris (LWD) was in good condition and is protecting the berm, however some sections of the LWD have become partially buried by sediment and so appear to not be providing fish habitat in the active creek with water levels at the time of site visit.

PHOTO 14: Berm 'G' Coir Geogrid & LWD, and sedimentation (repeat of 2016 Ph#10)

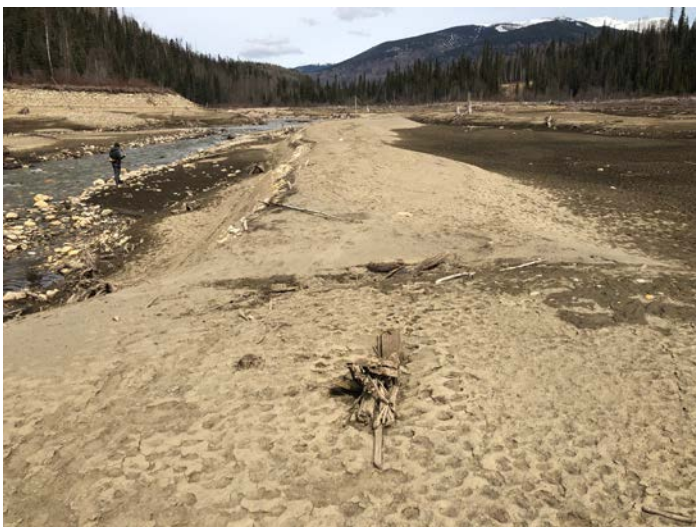
- Exposed coir geogrid material used in the soil wraps is in good condition and functioning well.
- Erosion appears to have occurred downstream of the berm where the ground is 'natural' (see Photo 17).

PHOTO 17: Downstream End of Berm 'F' Looking Upstream. Possible Erosion Downstream of Berm in 'Natural' Area (wet area in centre of Photo) (repeat of 2016 Ph#12)

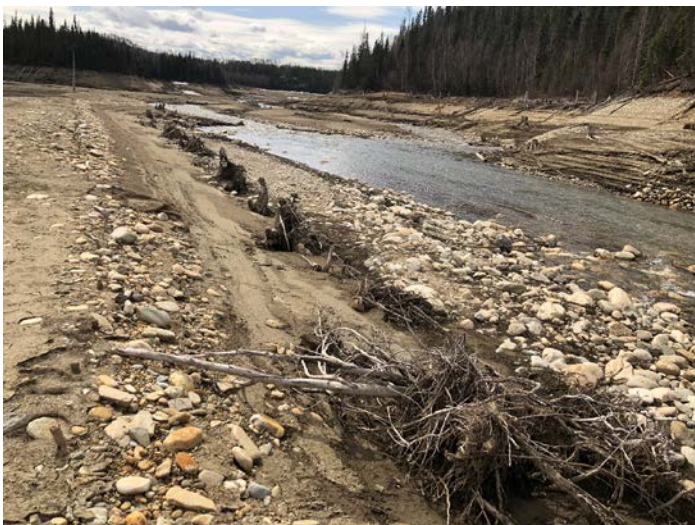
PHOTO 23: LWD and Channel Erosion and Deposition Looking Downstream (repeat of 2016 Ph#16)

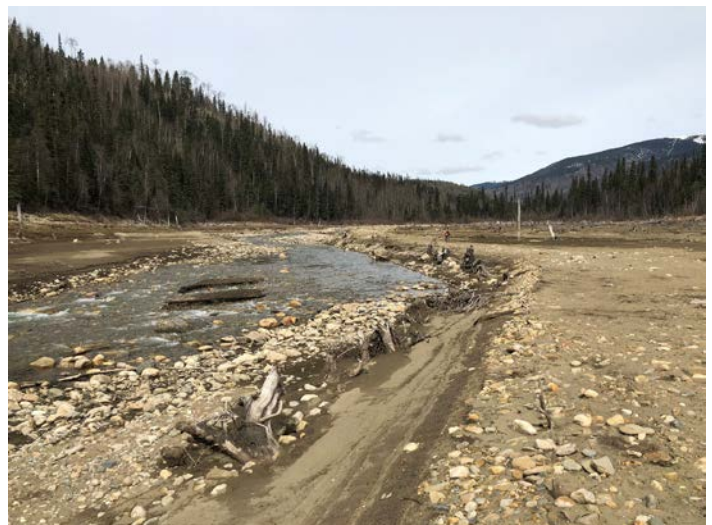
PHOTO 24: LWD and Channel Erosion and Deposition Looking Upstream (repeat of 2016 Ph#17)

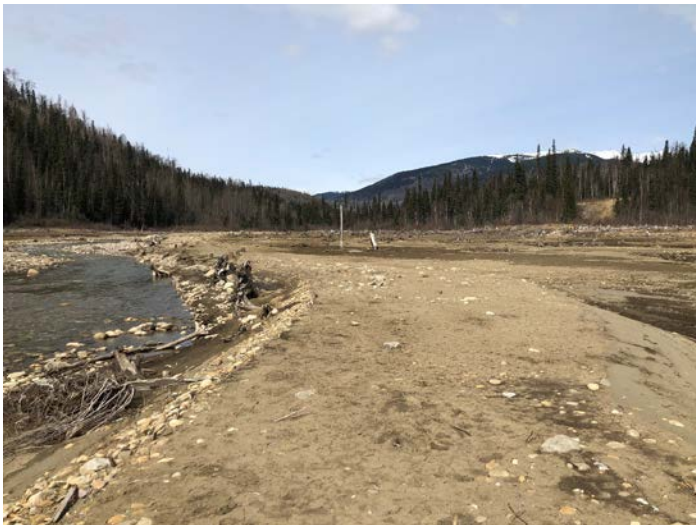
PHOTO 29: Looking Upstream at Berm 'D' (repeat of 2016 Ph#22)

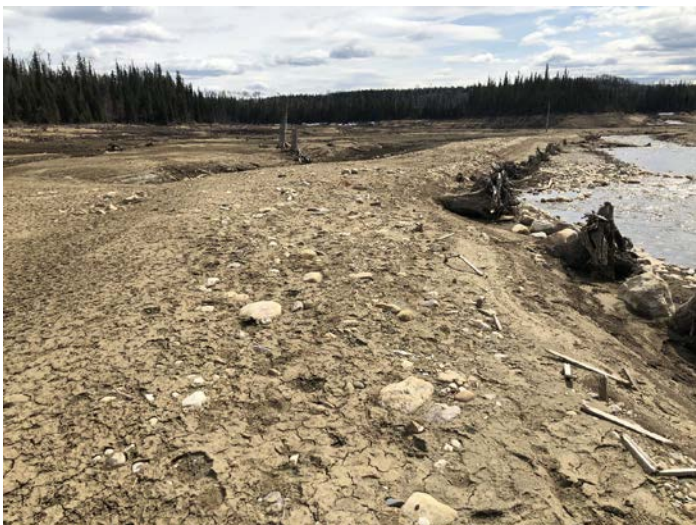
PHOTO 31: Material Used to Cover ECM When it Became Buoyant Still in Place, also Deposition (repeat of 2016 Ph#24)

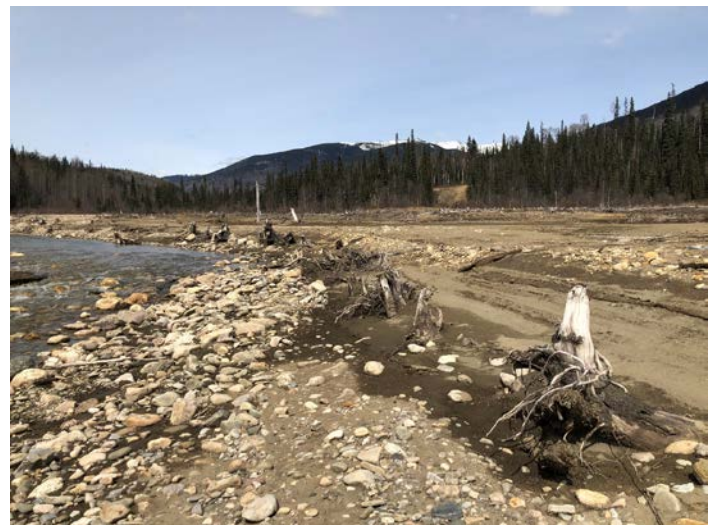
PHOTO 32: Deposition and Erosion Near LWD (repeat of 2016 Ph#25)

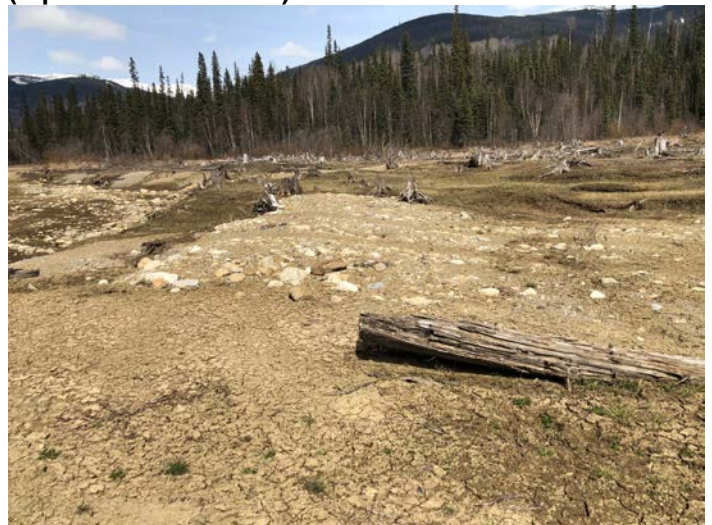
PHOTO 38: Upstream line of buried LWD

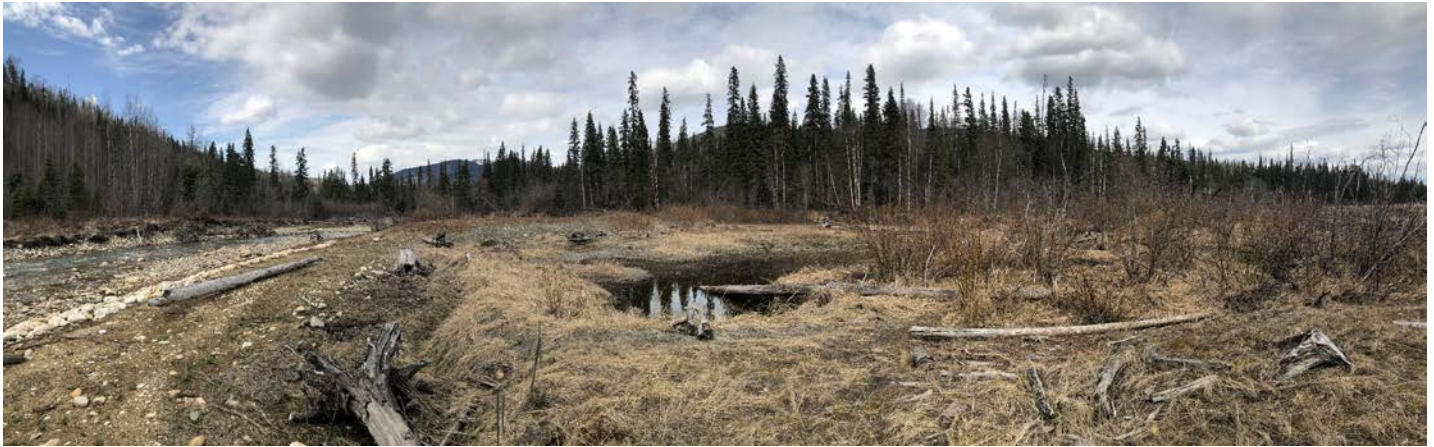
- The ECM, where exposed, has significantly deteriorated.
- The rock spur at the downstream end is still intact (see Photo 43).
- The upstream tie-in location for Berm 'C' to the beaver pond is stable and has not changed since construction.

PHOTO 42 (Panoramic): Intact beaver/habitat pond upstream of Berm 'C' (repeat of 2016 Ph#33)

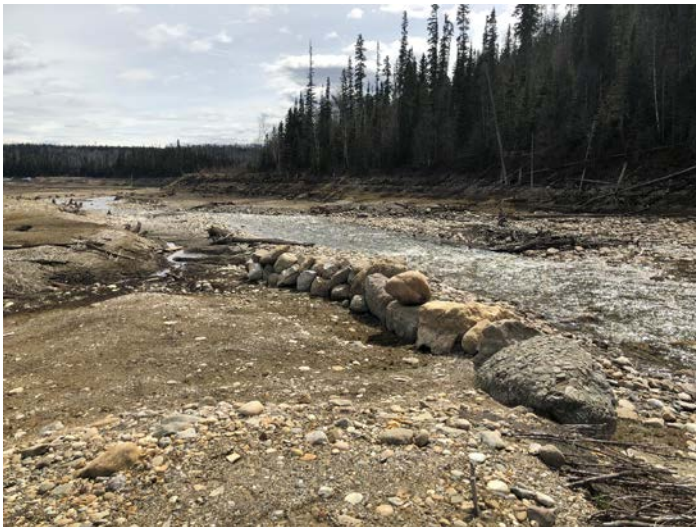
PHOTO 43: Downstream end of Berm 'C' looking downstream (repeat of 2016 Ph#34)

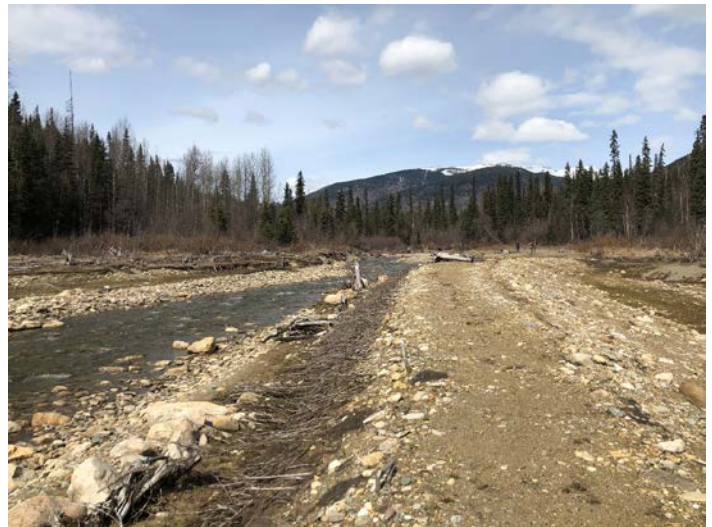
PHOTO 44: Downstream end of Berm 'C' looking upstream (repeat of 2016 Ph#35)

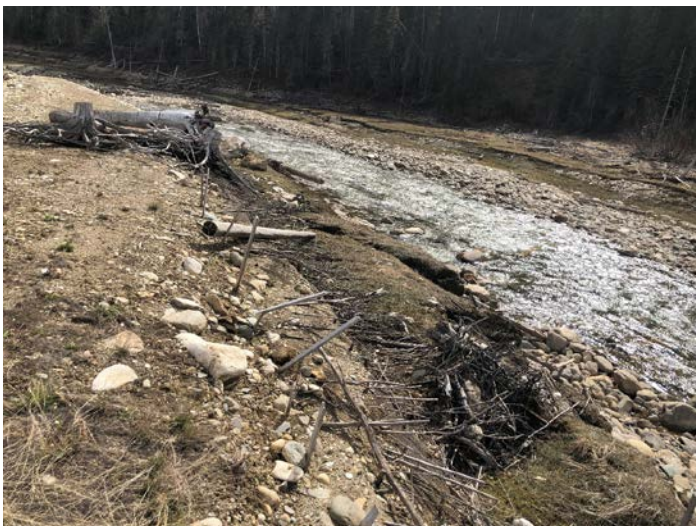
PHOTO 45: Coir soil wraps, willow brush layers along berm and native grasses/reeds at toe (repeat of 2016 Ph#36)

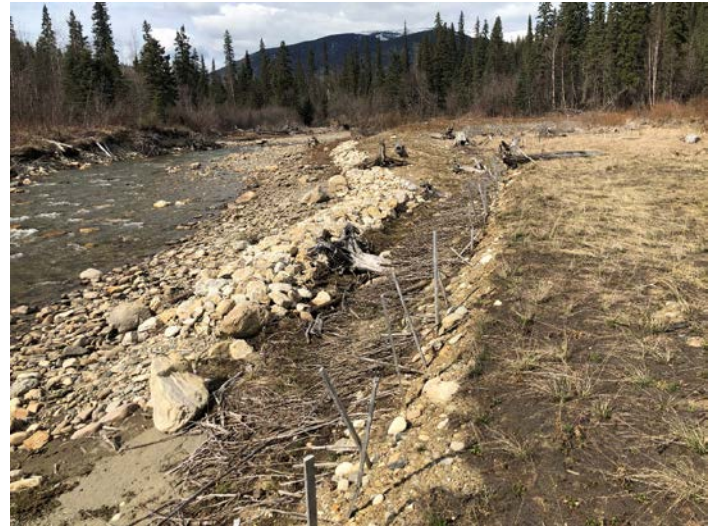
PHOTO 48: Looking upstream at willow layers in the lower berm and grasses on crest (no active growth given time of site visit) (repeat of 2016 Ph#39)

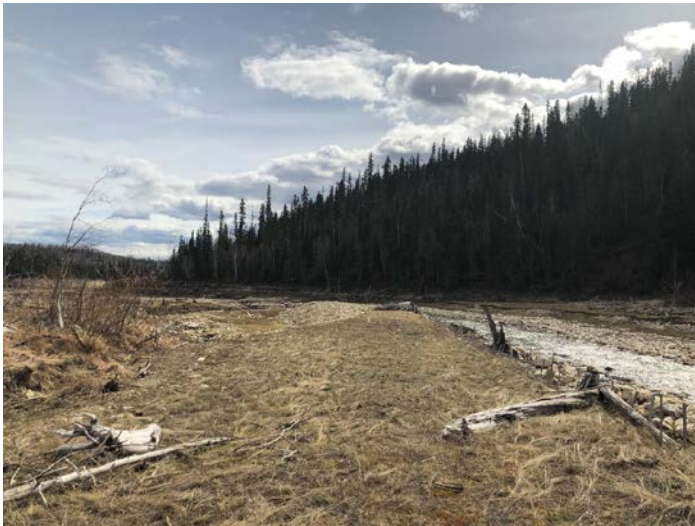
- The upstream half of the berm had good grass growth on the crest (see Photos 49 & 50).
- The coir geogrid is generally in good condition, however there is a section of damaged coir approximately 5 m long 3 to 4 m upstream from the downstream end of Berm 'C' (See Photo 46). The damage is potentially from ice, wave action, or debris. The damaged coir is considered to still be stable and it is not an issue at this time, however it should be monitored in future inspections.

PHOTO 49: Looking downstream along Berm 'C' (repeat of 2016 Ph#40)

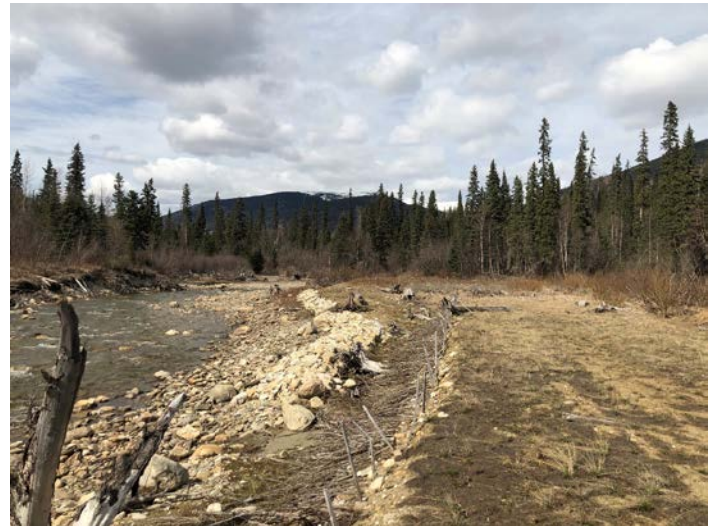
PHOTO 50: Looking upstream at upstream end of Berm 'C' (repeat of 2016 Ph#41)

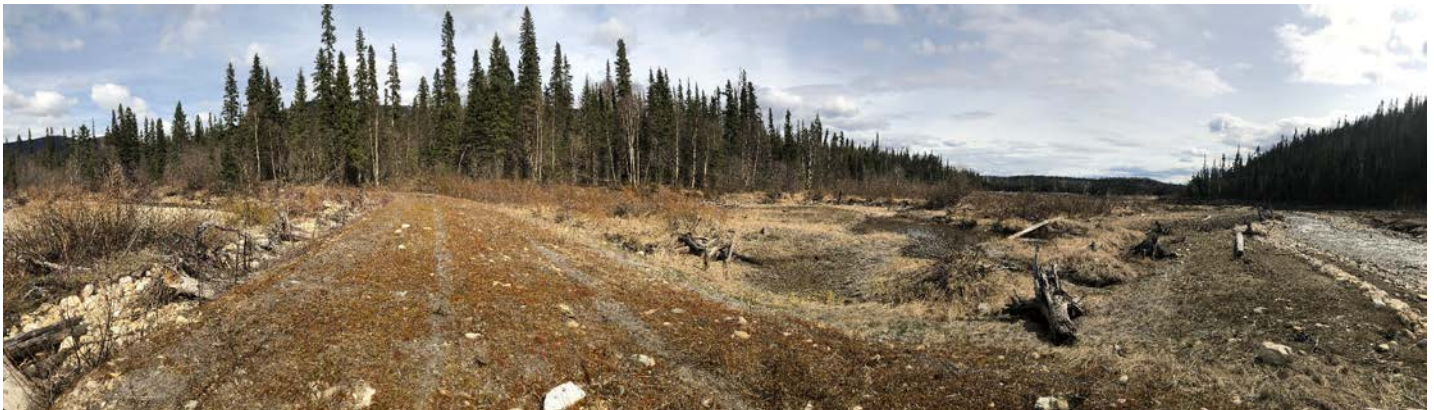
PHOTO 52 (Panoramic): Berm 'J' looking upstream. Beaver / habitat pond at right of the photo. (repeat of 2016 Ph#43)

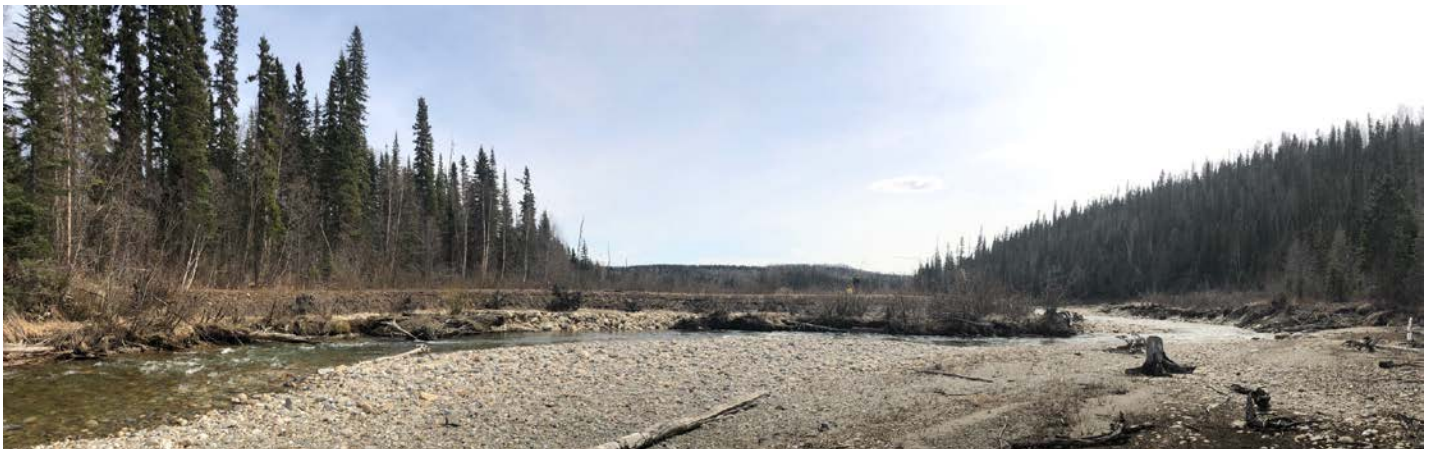
PHOTO 56 (Panoramic): Looking Downstream at Berm 'J' from Right Bank Bar

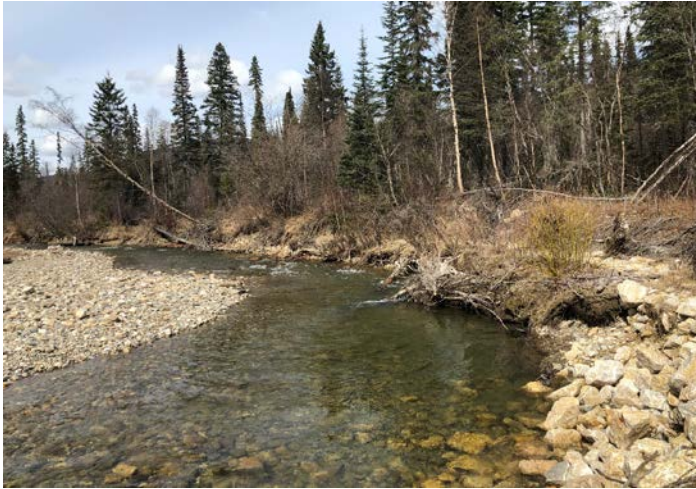
- The LWD is in good condition and has been not displaced.
- The creek has eroded away the bank in front of the berm and there is now an approximately 10 m long section of riprap exposed to the water (see Photos 57, 58 & 65).

PHOTO 57: Eroding Bank and ‘launching’ riprap toe trench looking upstream (repeat of 2016 Ph#46)

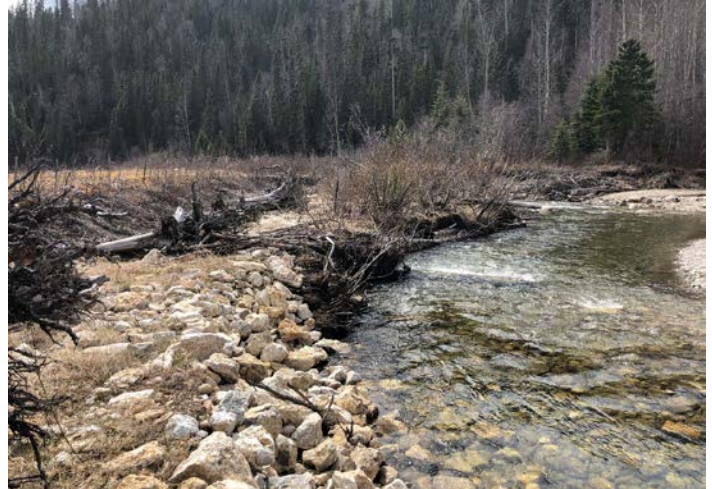
PHOTO 58: Eroding bank and ‘launching’ riprap toe trench looking downstream (repeat of 2016 Ph#47)

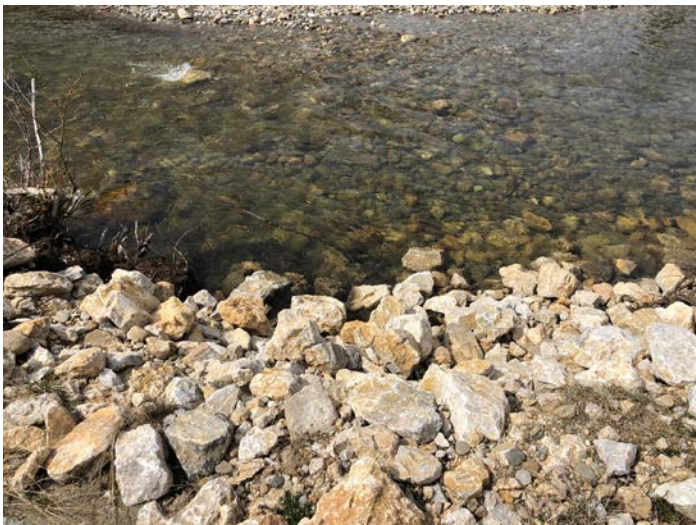
- Riprap launching toe trench has begun to 'launch' into eroded creek bank as expected and designed protecting the toe of Berm 'J' (see Photo 59).
- Willows are starting to come up and establish well all along berm at the time of the site visit (see Photo 63).

PHOTO 59: Launching riprap toe (repeat of 2016 Ph#48)

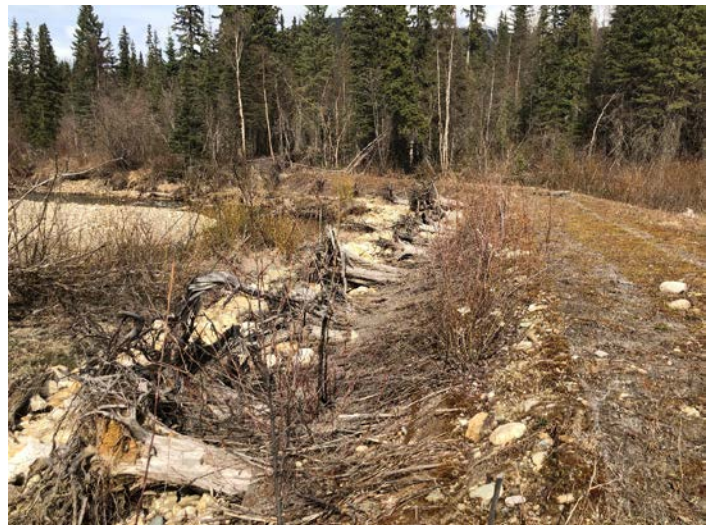
PHOTO 60: Coir Geogrid “Soil Wraps”, willow, LWD, and riprap toe looking upstream (repeat of 2016 Ph#49)

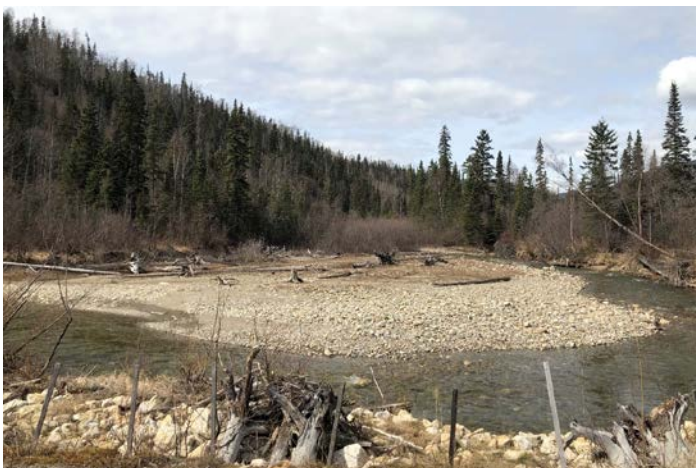
PHOTO 61: Gravel bar across from Berm ‘J’ (repeat of 2016 Ph#50)

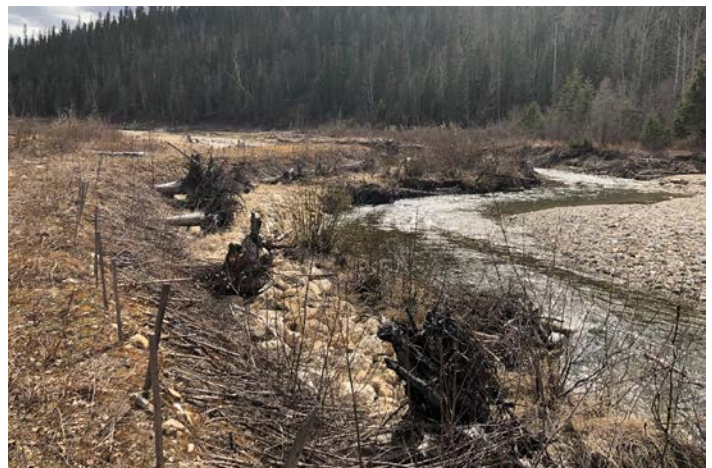
PHOTO 62: Soil wraps, willow brush layers, LWD and riprap looking downstream (repeat of 2016 Ph#51)

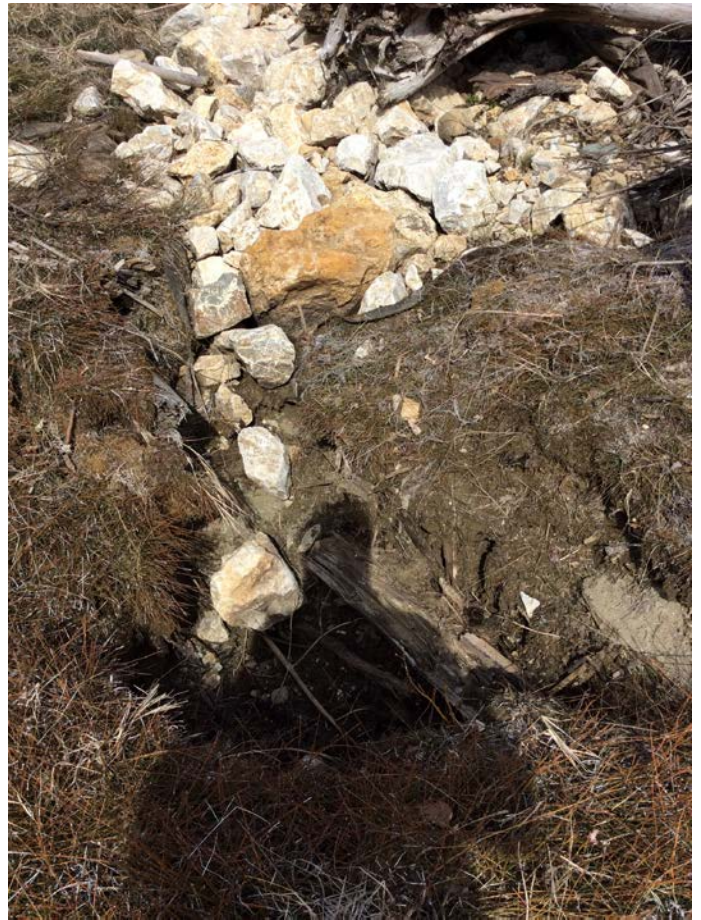
- Grass and other vegetation growing on top and on back side of berm.
- The ECM has almost completely deteriorated as expected.
- Some erosion was noted just downstream of the riprap on Berm 'J' (See Photo 64).

PHOTO 64: Erosion at downstream end of riprap toe protection

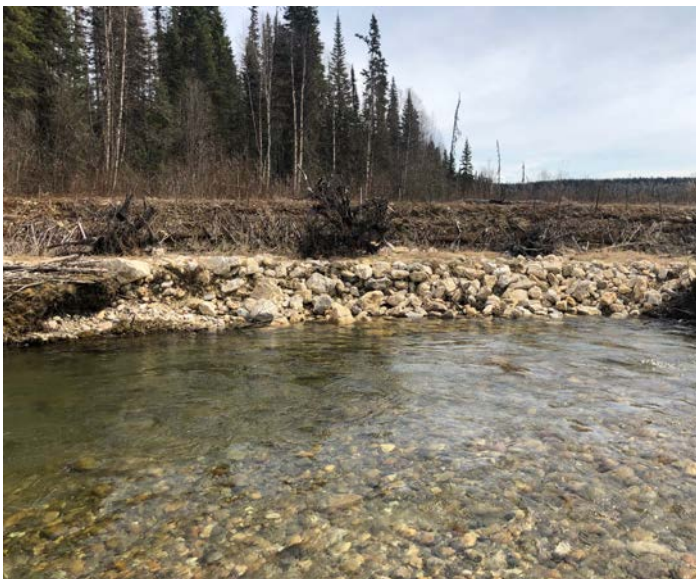
PHOTO 65: Launched Toe Riprap at Berm 'J'
