Construction Completion Report

BC Hydro – Williston Reservoir Wetland Demonstration Site 34 Beaver Pond Completion Report

BC HYDRO - WILLISTON RESERVOIR WETLAND DEMONSTRATION SITE 34 BEAVER POND

1414340003-001-R-Rev0

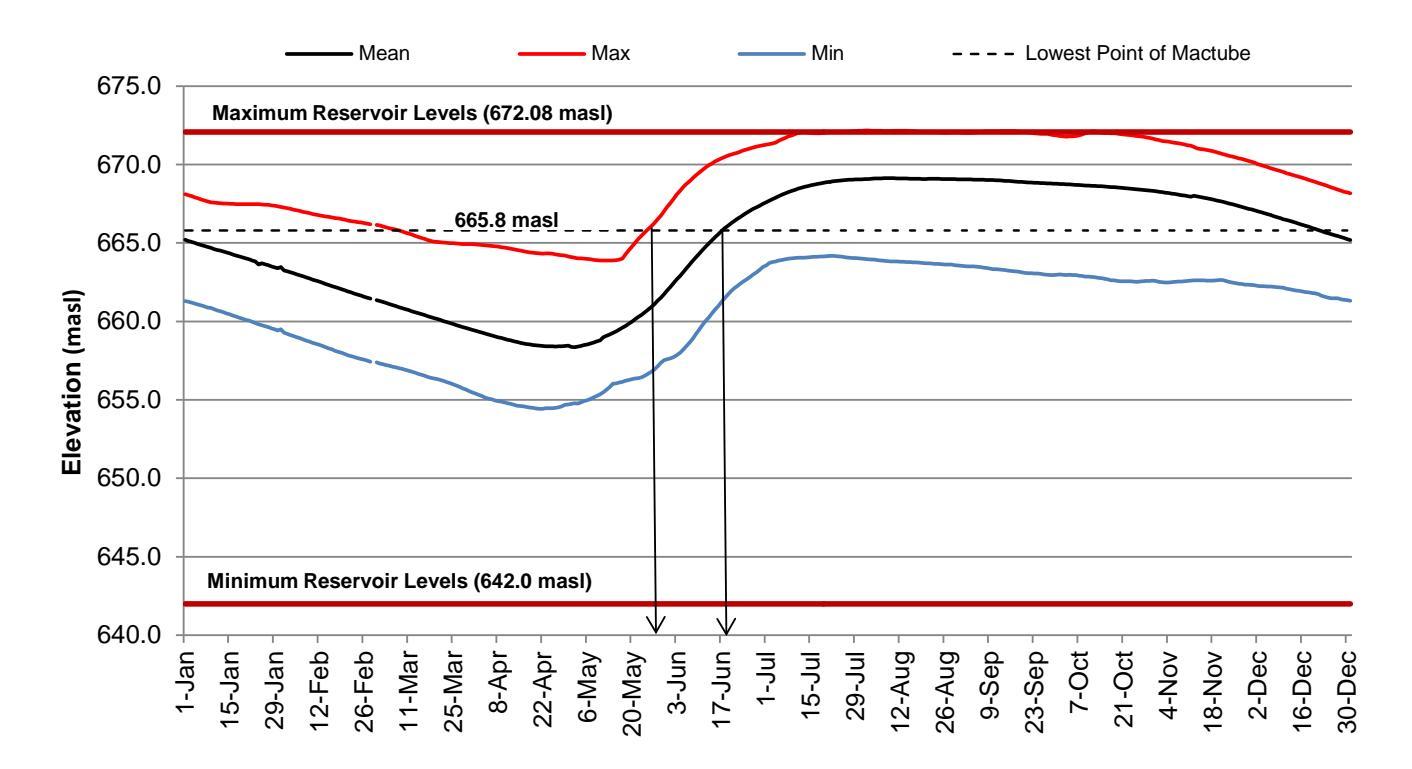
Figure 1: Average of maximum, minimum and mean annual water levels in Williston Reservoir for the period 1984 to 2010 showing minimum and maximum supply elevations relevant to the approximate elevation (metres above sea level) of the lowest point of the Mactubes. Arrows show a possible range of dates the base of the Mactubes may be reached in any given year of operation of the Williston Reservoir.

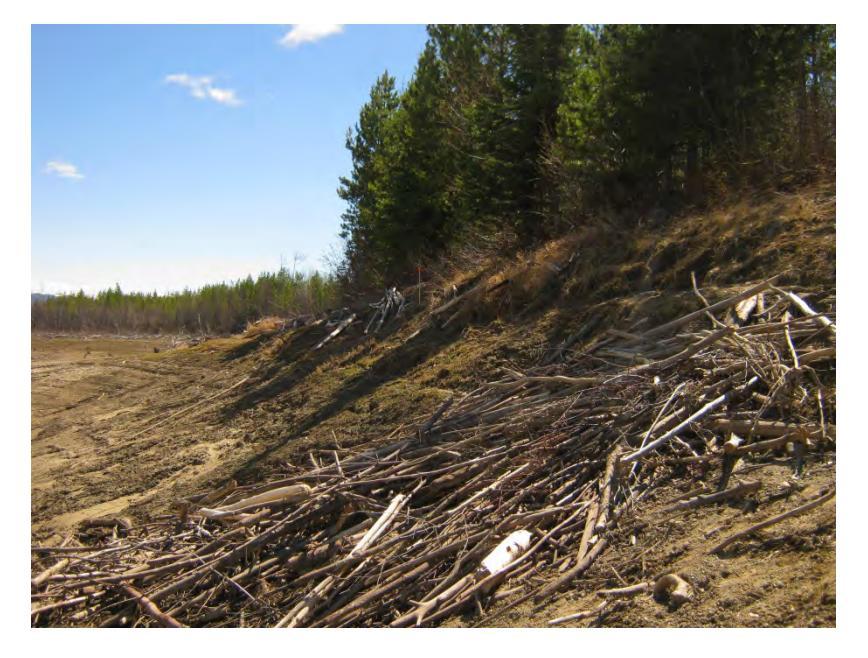
Sloughing side slope along proposed road alignment.

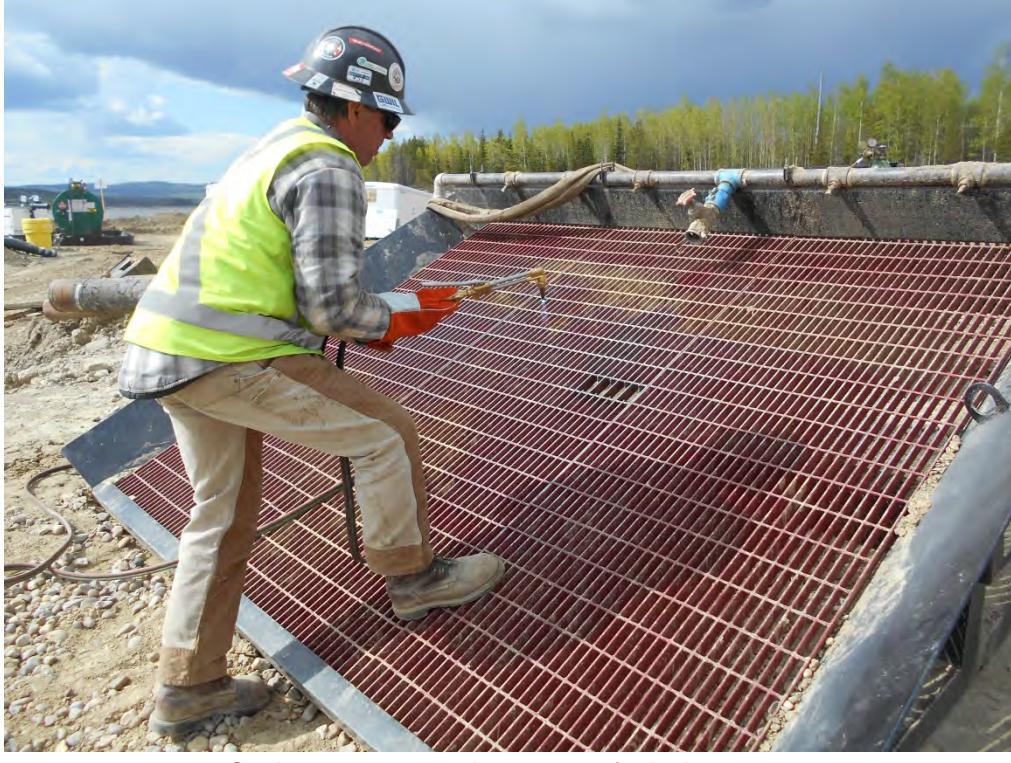
Daily Comment: Held daily tailboard safety meeting. Continued hauling sand to mud tank filling mud tank and filling Mac Tubes. Began cutting grizzly to allow bigger pieces of material to fall through. DWB continued monitoring activates on site. Cut out every second grate on Grizzly Screen to allow more material to pass into mud tank.

Cutting every second grate out of grizzly screen

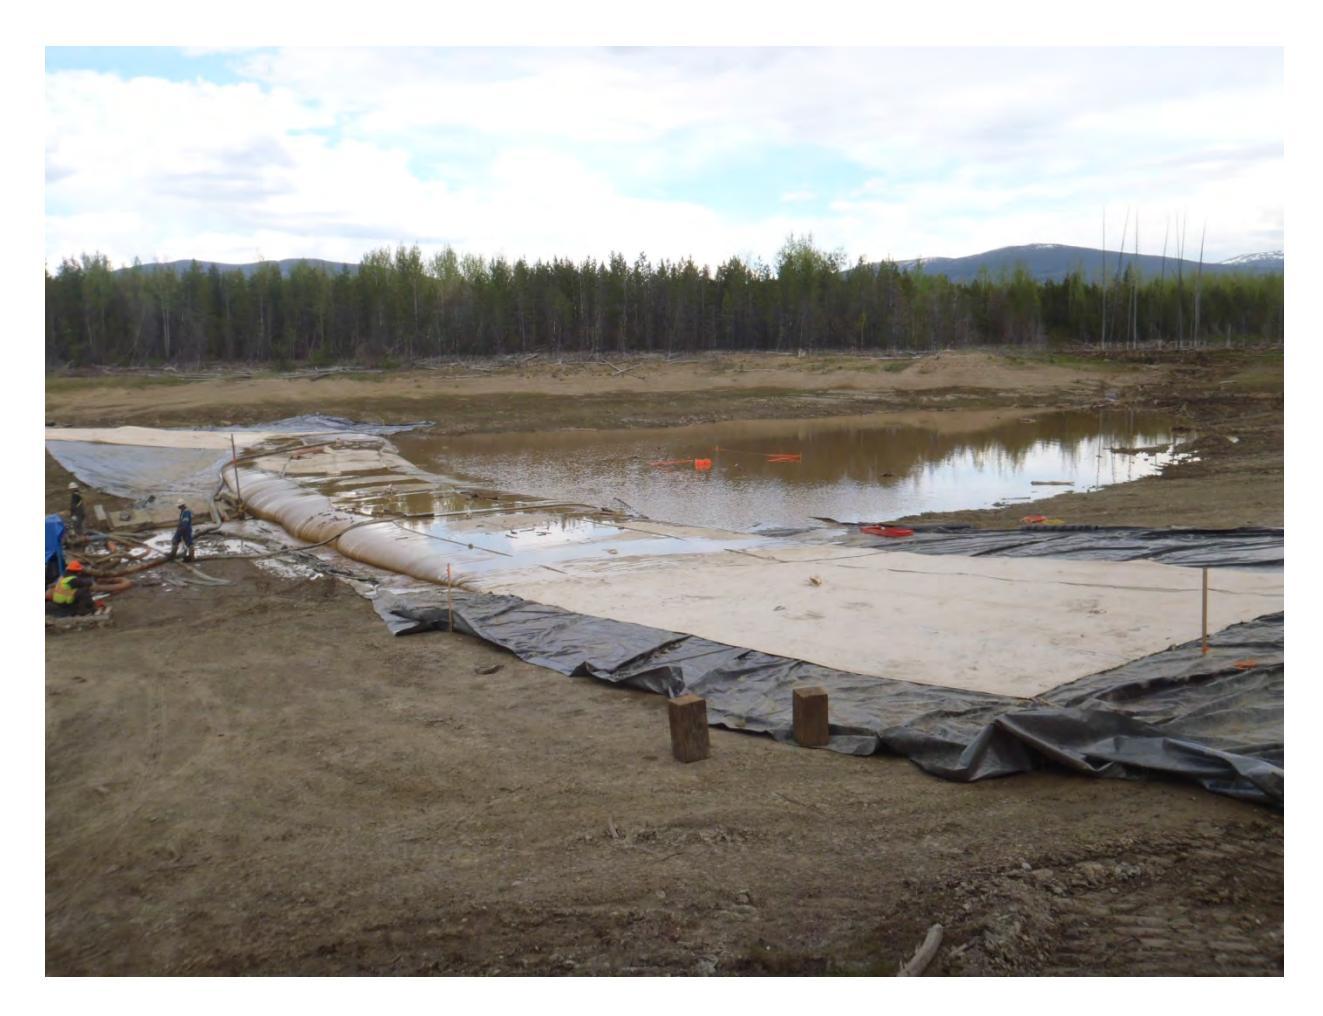
<u>Daily Comment</u>: Held daily tailboard safety meeting. Got approval from Golder to continue filling bag but at a lower elevation. Continued hauling material and filling bag.

Filling of bag.

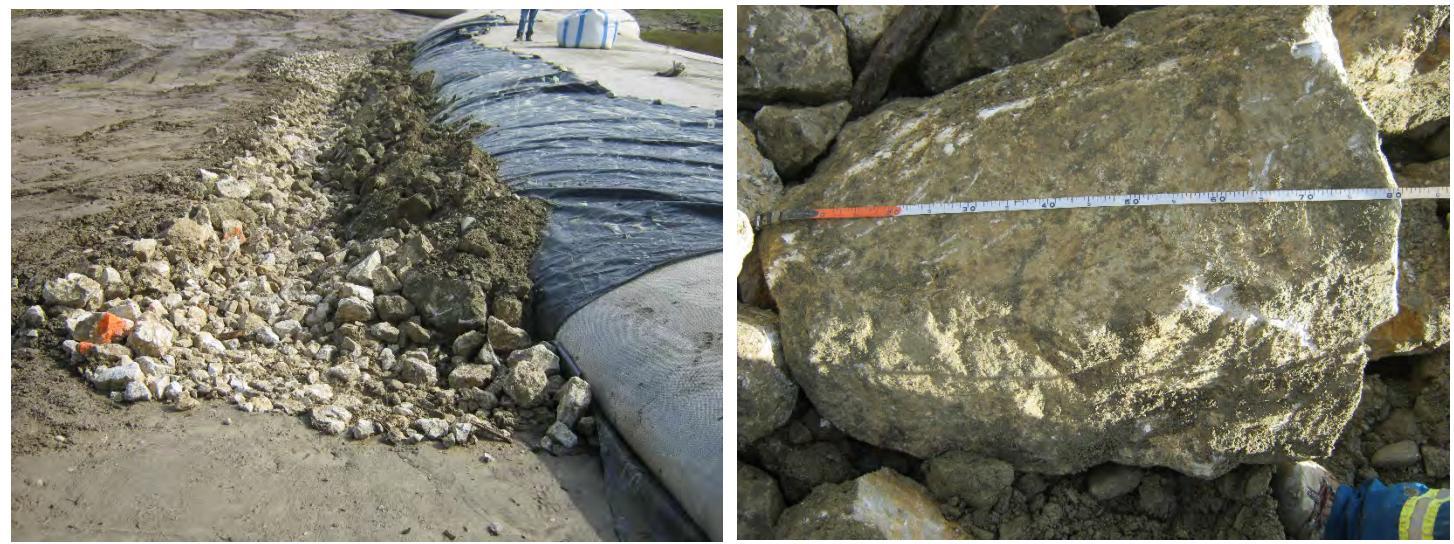
50 kg rip rap placed over filter stone

Larger piece of rip rap (80 cm)

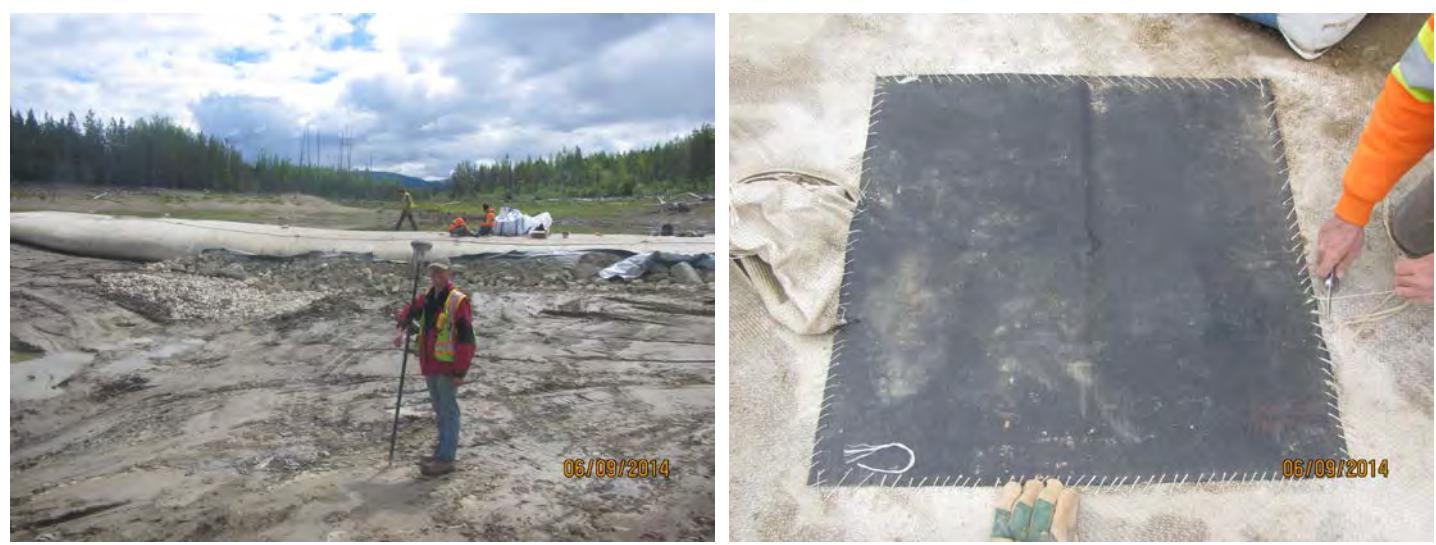
Daily Comment: Held daily tailboard safety meeting. Finished patching hole in bag. Final inspection was completed. Demobilization and separating out BCH and 3rd party supplies and equipment continued at the barge landing in Mackenzie.

Patched bag

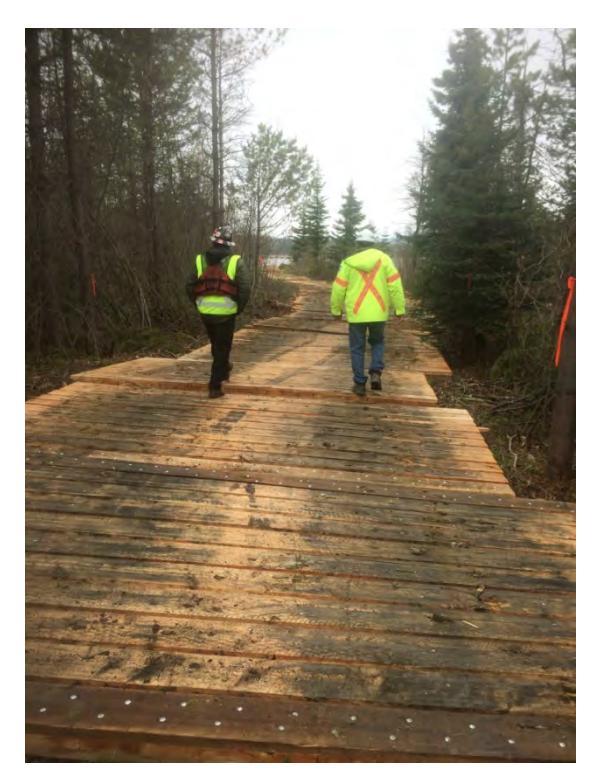
Photo 1: Access to the site required an overland route through the forest, opposed to following the shoreline into the small embayment where WDS 34 is located.

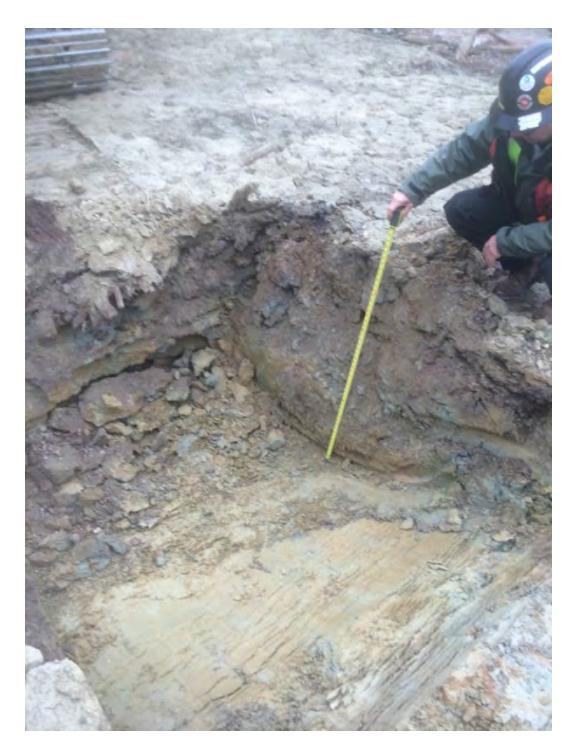
Photo 2: Test pit to determine depth of suitable material for filling Mactubes prior to reaching clay.

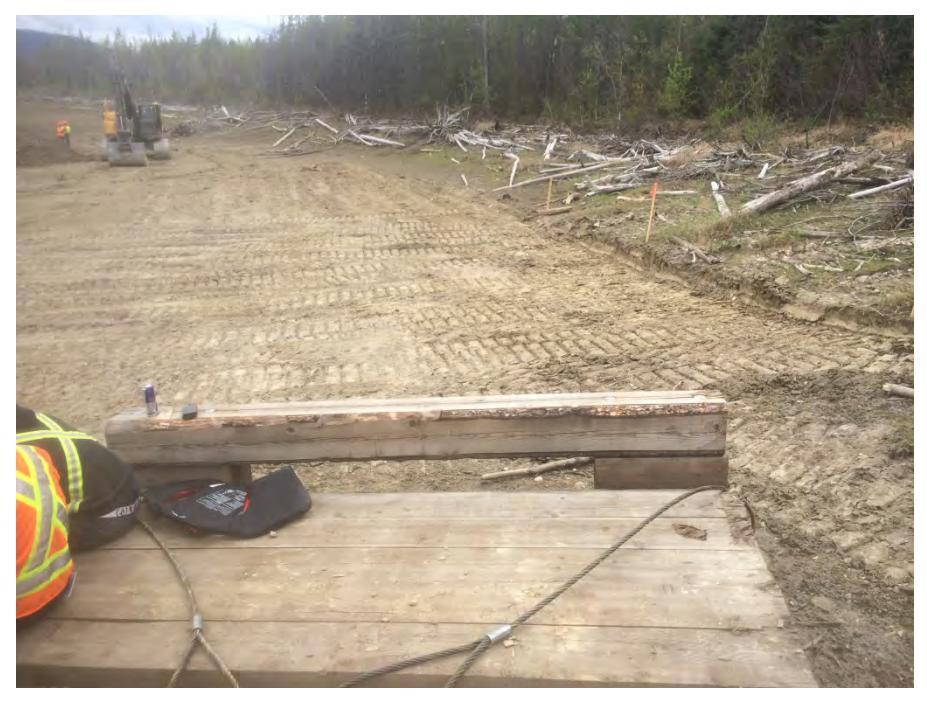
Photo 3: Ground preparation of the bedding plane for the Mactubes was limited to removal of woody debris and other sharp objects that could puncture the bags.

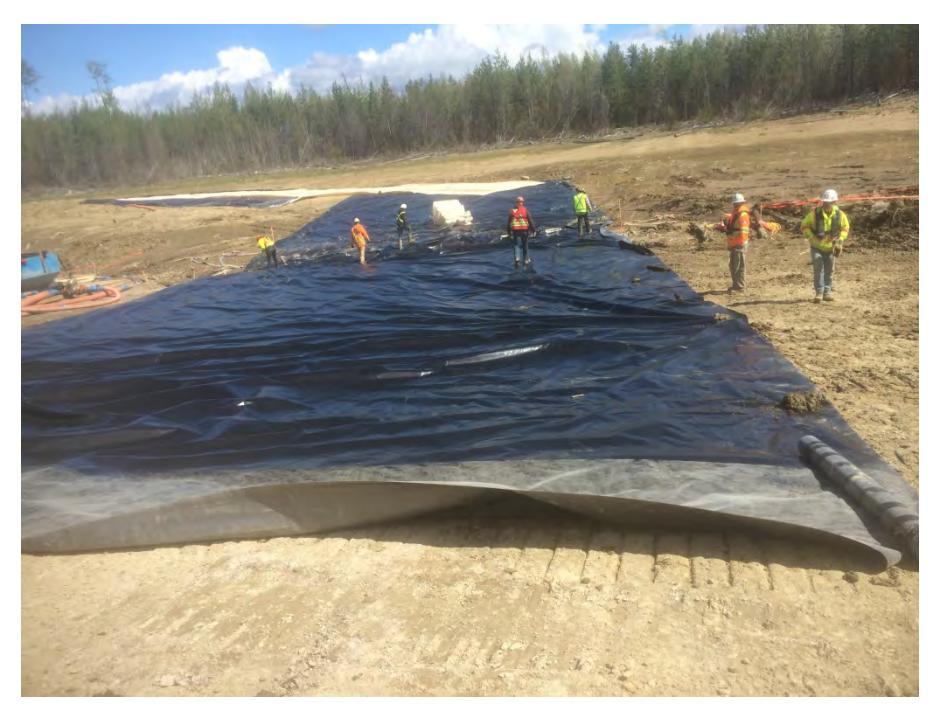
Photo 4: Placement of the RPE liner for Mactube 1. Mactube 2 at the north end of WDS 34 has already been laid out over the liner.

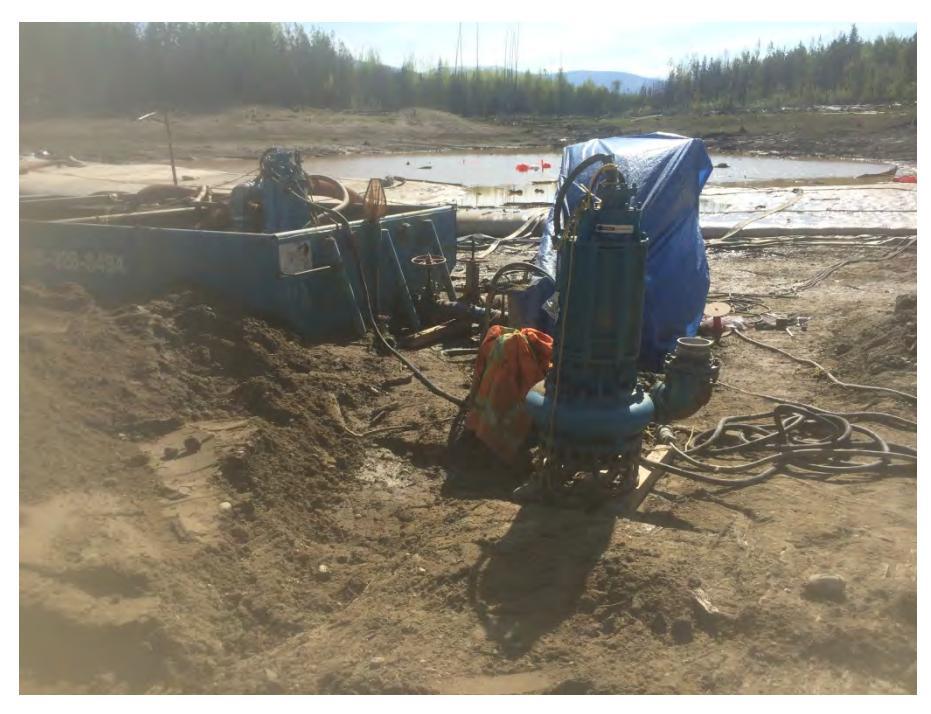
Photo 5: Box and pump system, showing the mud tank in the back ground and Toyo electric dredge pumps (one in the tank and the spare in the foreground).

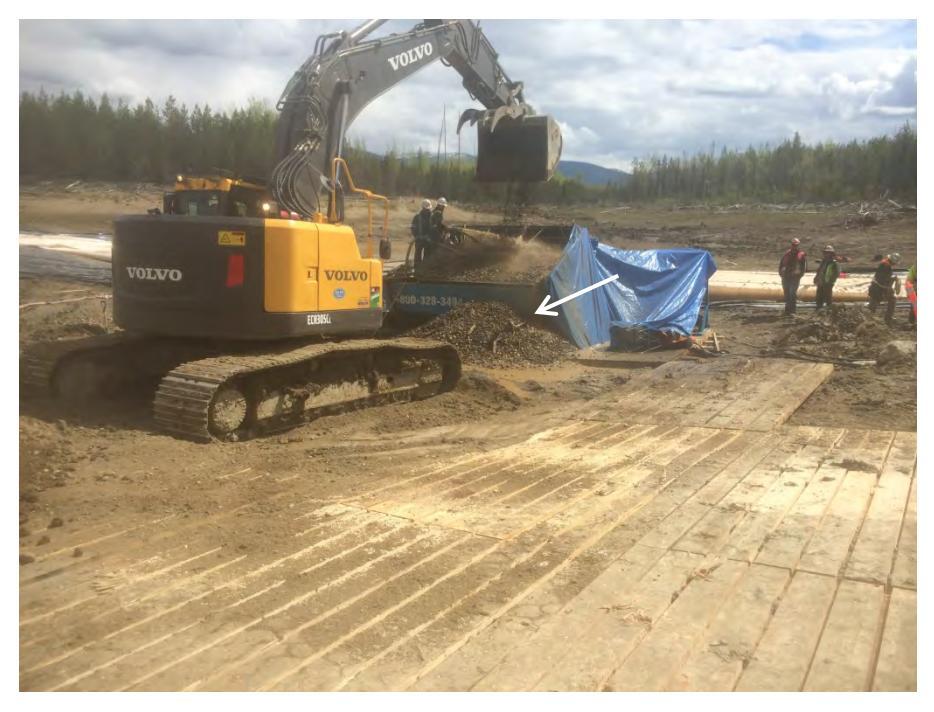
Photo 6: Material being fed through the 1 inch grizzly and washed into the mud tank. Note the gravel/cobble (arrow) at the base of the grizzly. The grate size of the grizzly was eventually cut to 2 inch size to facilitate passage of larger particle sized material into the tank, increasing Mactube filling production.

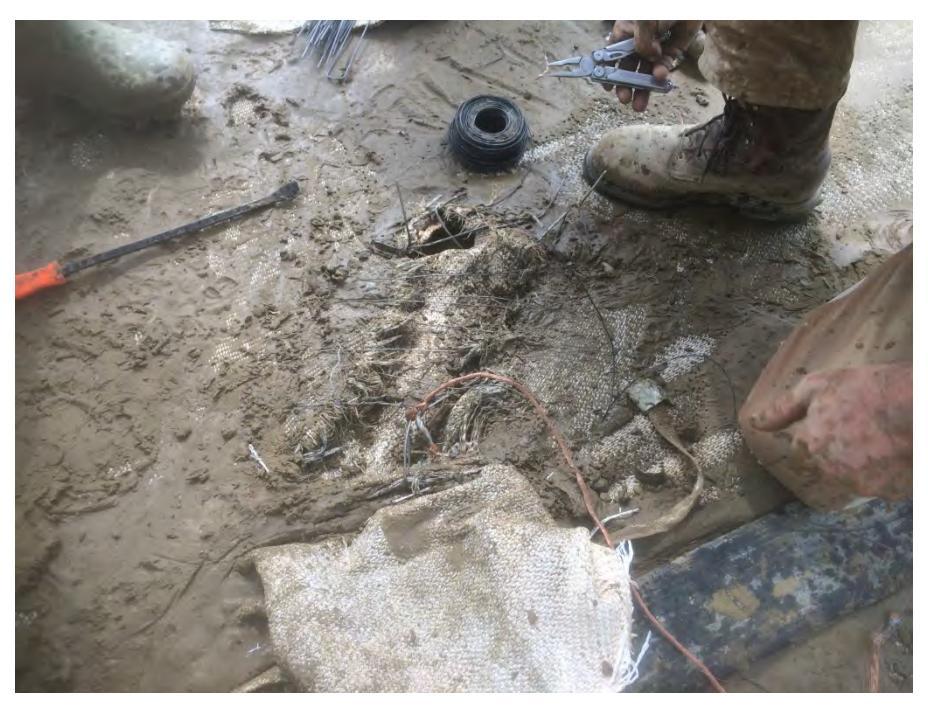
Photo 9: An attempt to sew the holes together was unsuccessful, as the material ripped and the two holes became one.

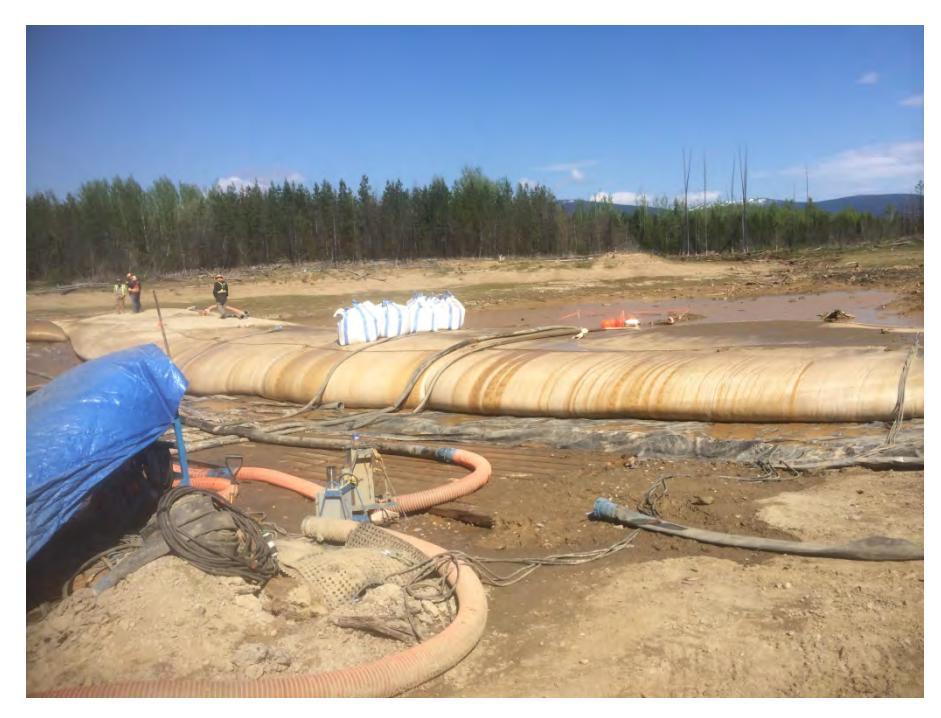
Photo 10: Weighted rock bags filled with silt were not sufficient to form a barrier to prevent slurry from flowing into the area designated as a spillway.

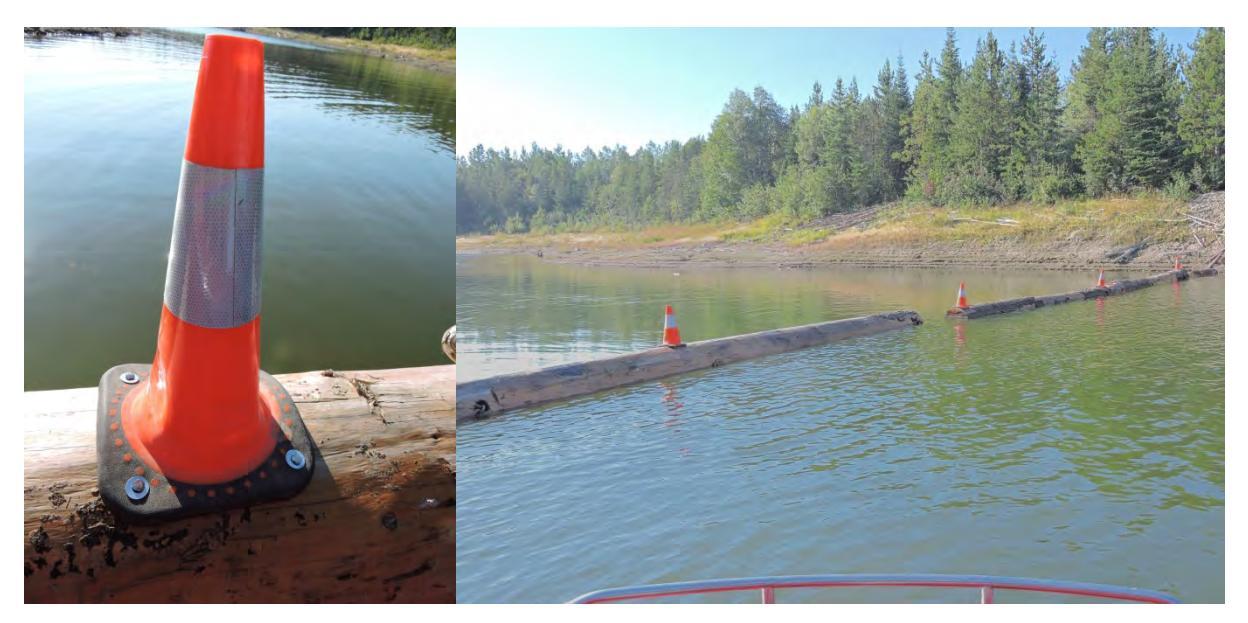
Photo 11: Log boom markers identifying location of the log boom for boaters that may enter the area. (Photo Courtesy of N. Vanderkwaak).

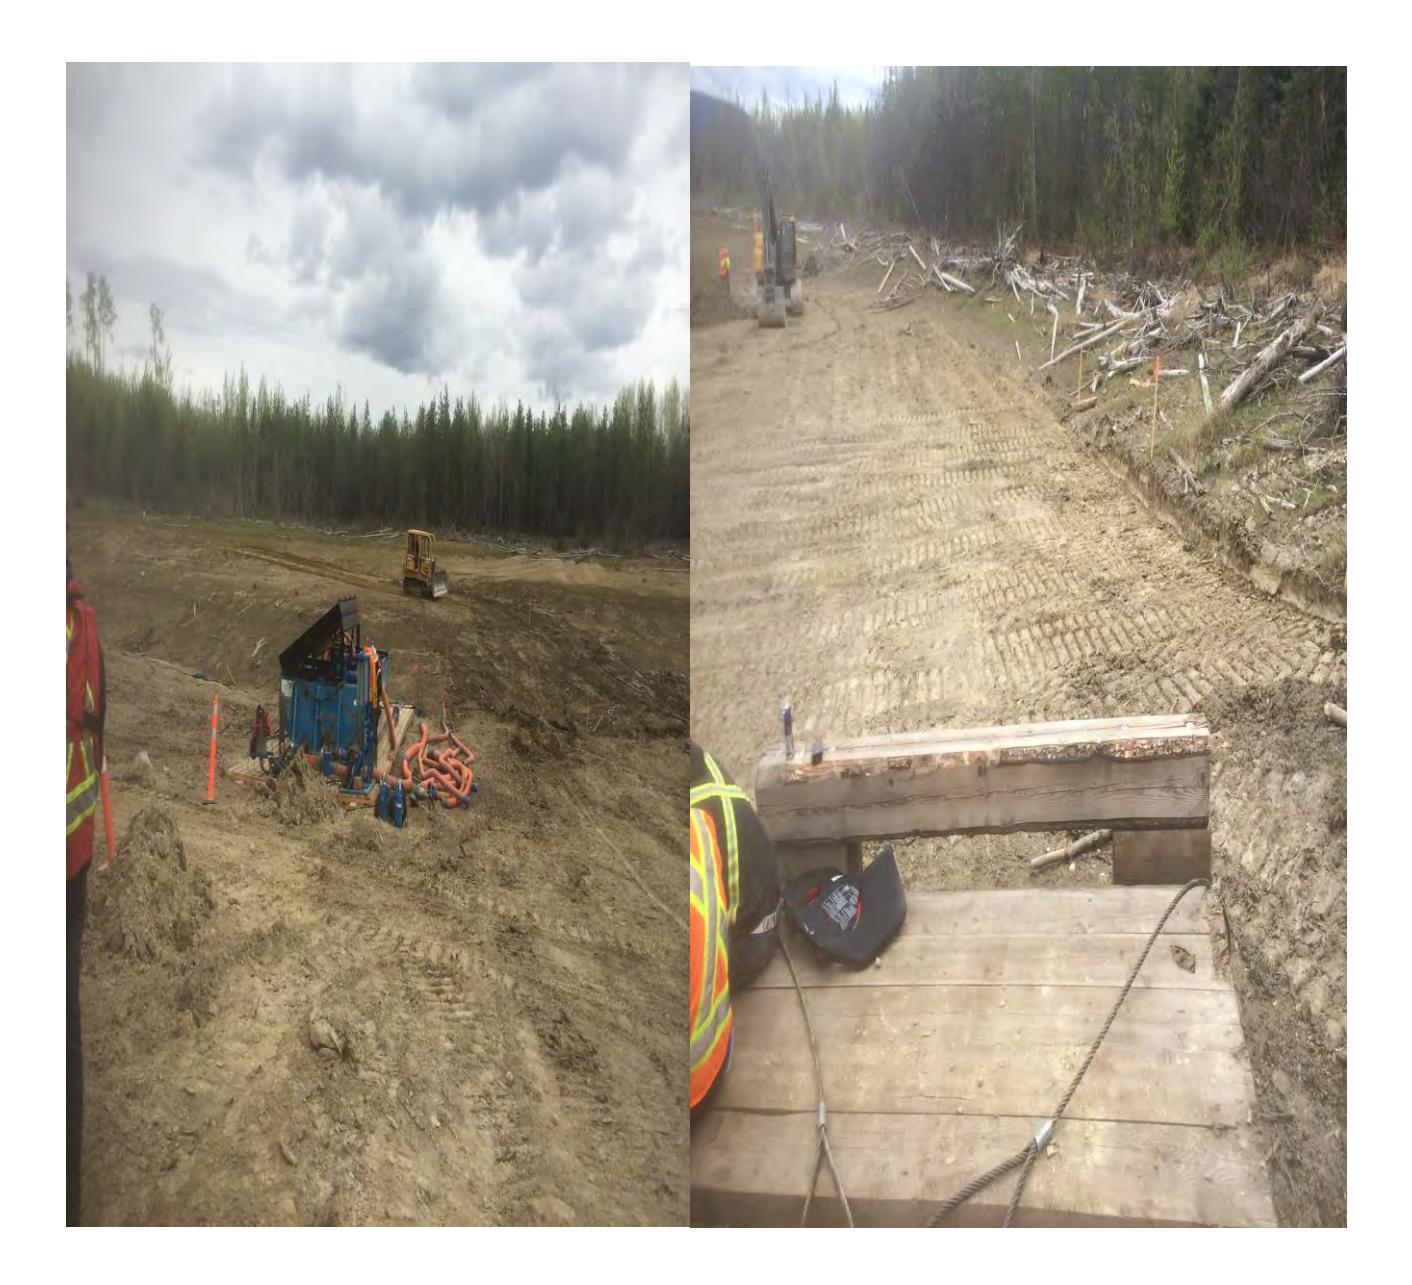
Stripping under BAG 1

Under BAG 2 after stripped

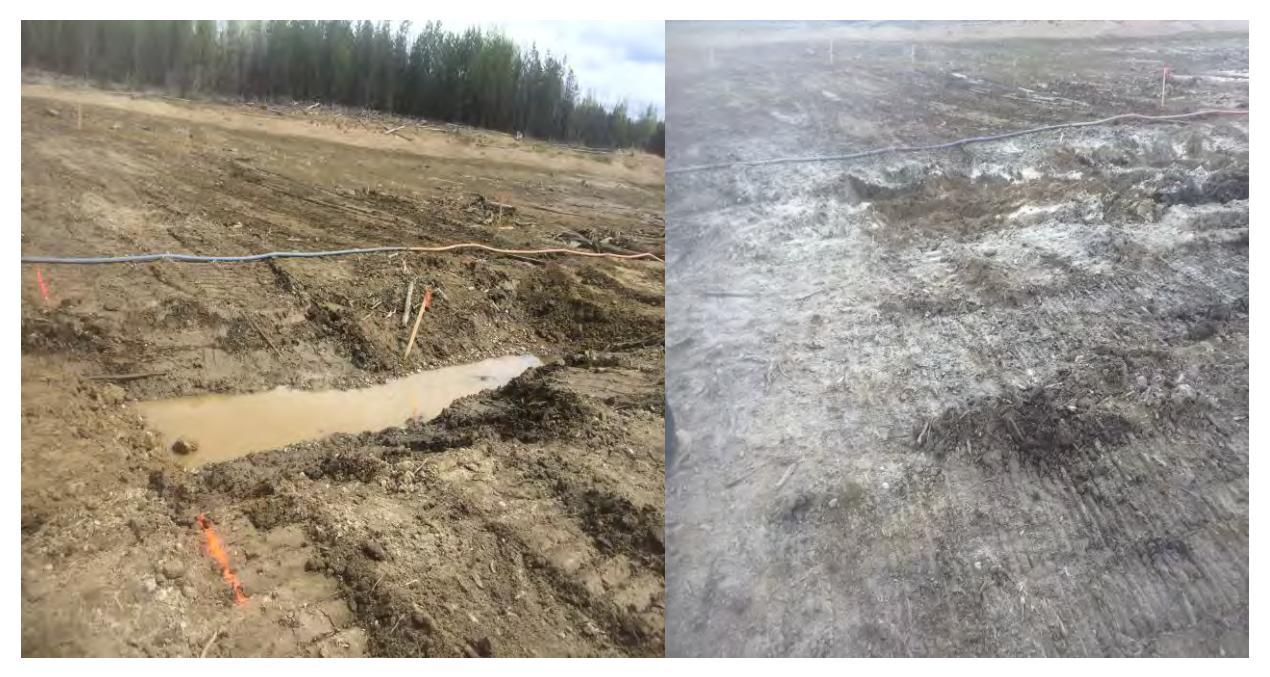
The creek section under Mac Tubes was filled with soil mixed with grout powder.

Soil from both sides to act like forms for the grout

Grout mixed with soil filled the creek

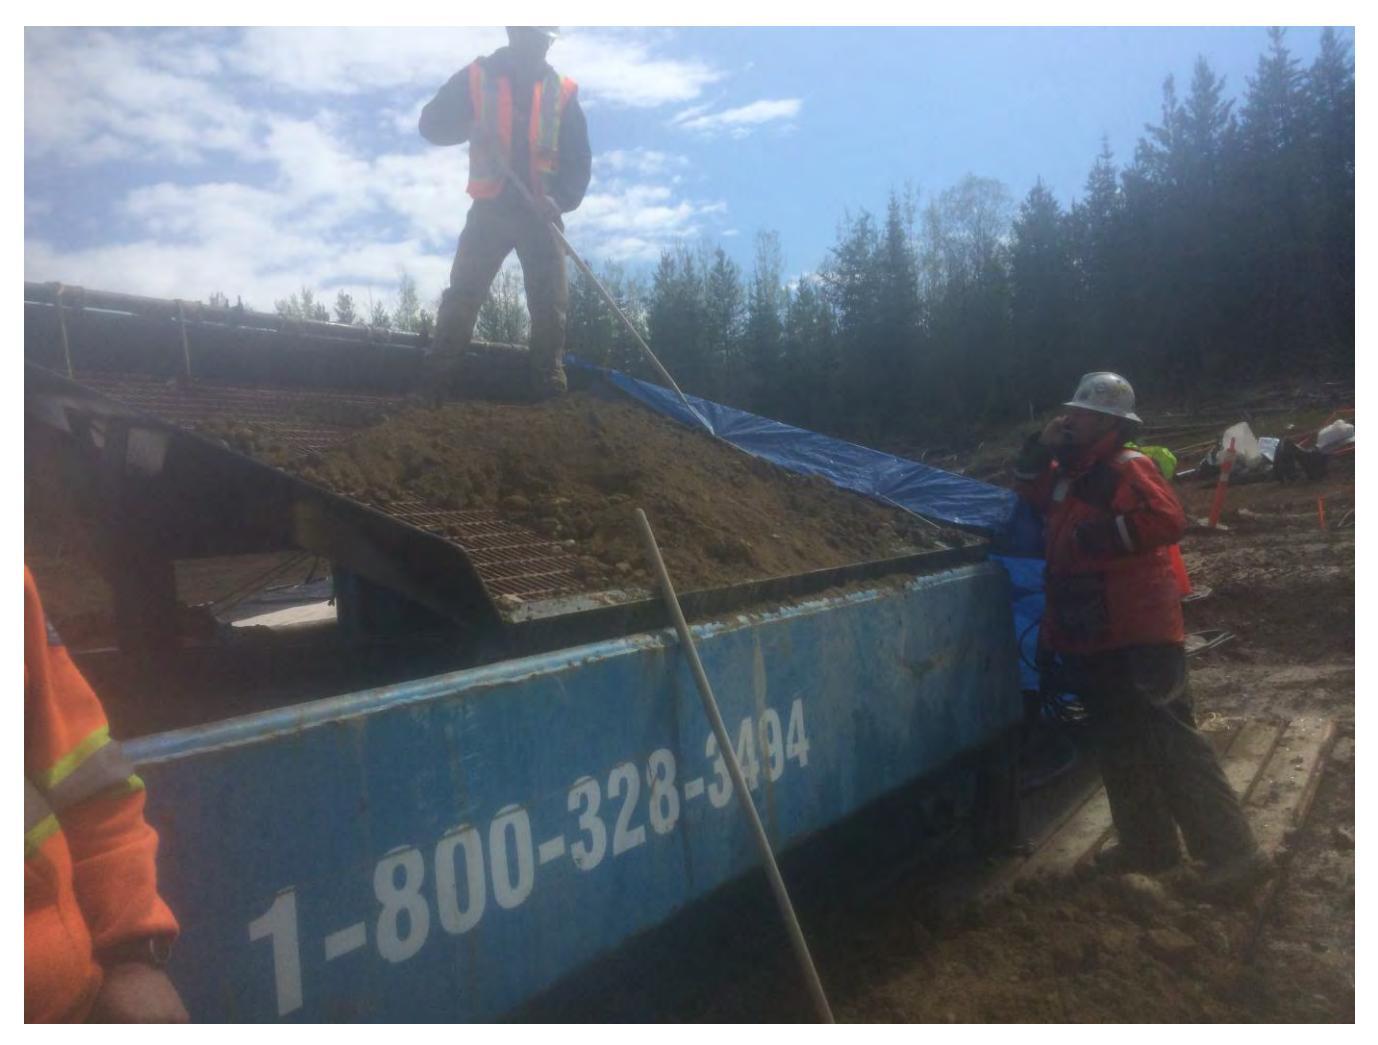
Photo 15

Contractor had a challenge when trying feeding material through the grizzly screen, doesn't pass more than 1". It took longer than what was anticipated for each load (excavator bucket). (See photo 15)

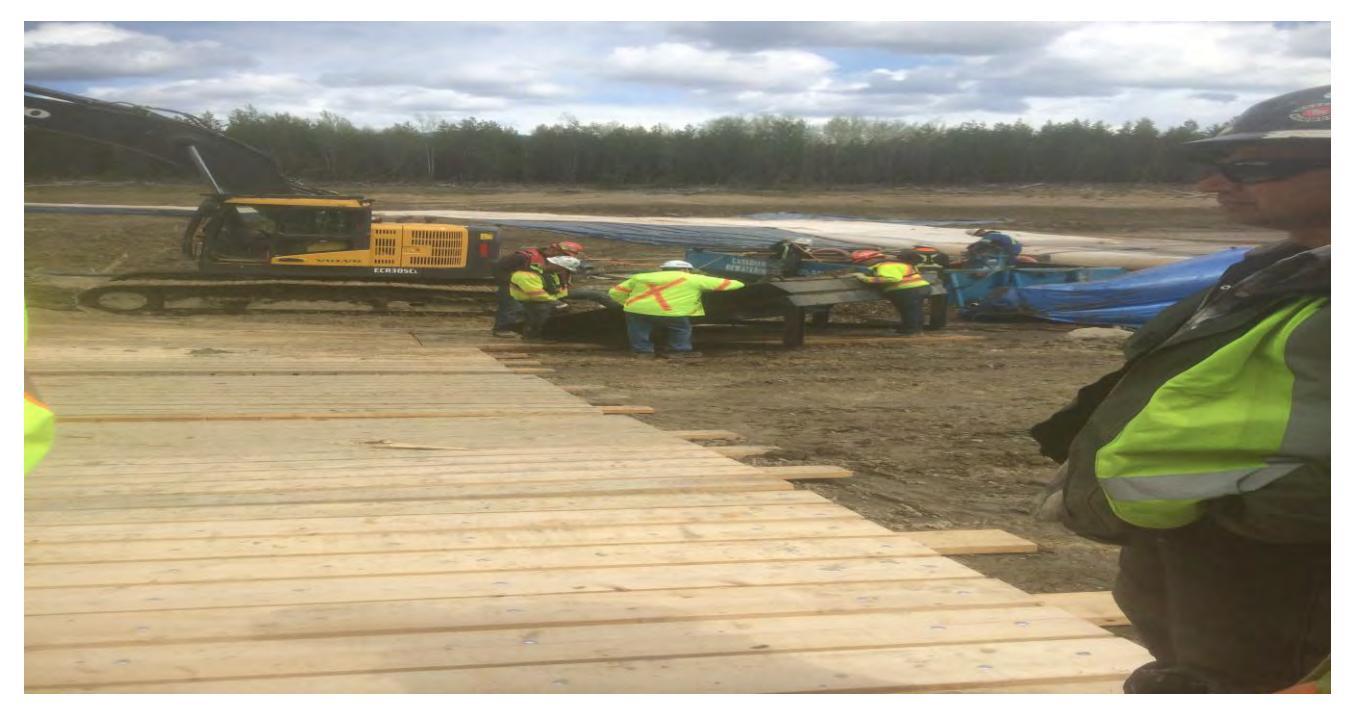
Photo 5

Grizzly was removed (Photo 5)

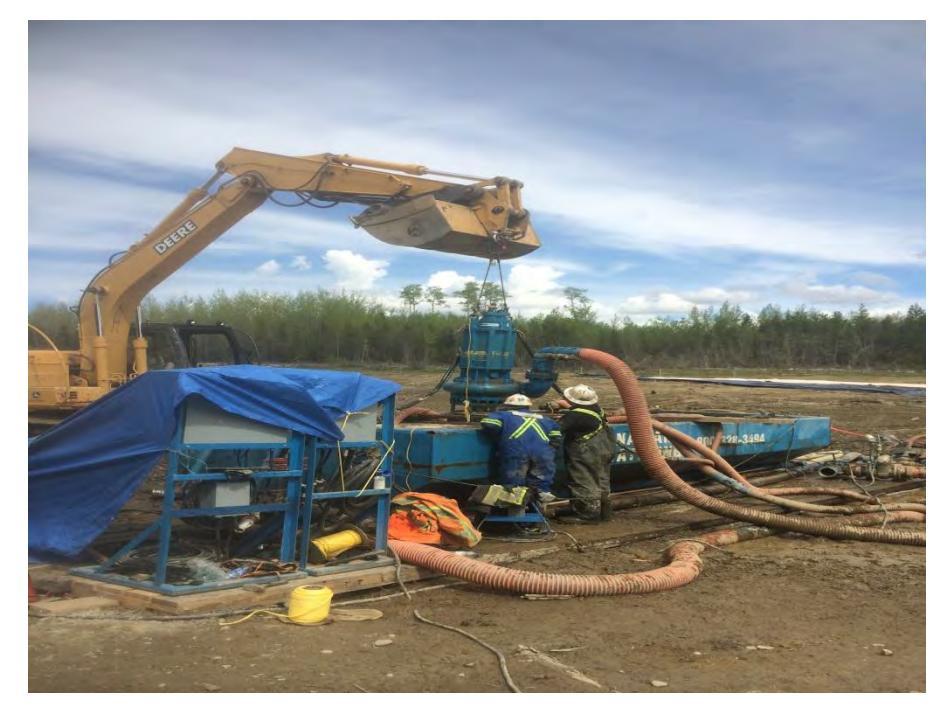
Photo 5

Occasionally pump was plugged and needed service/cleaning. (Photo 5)

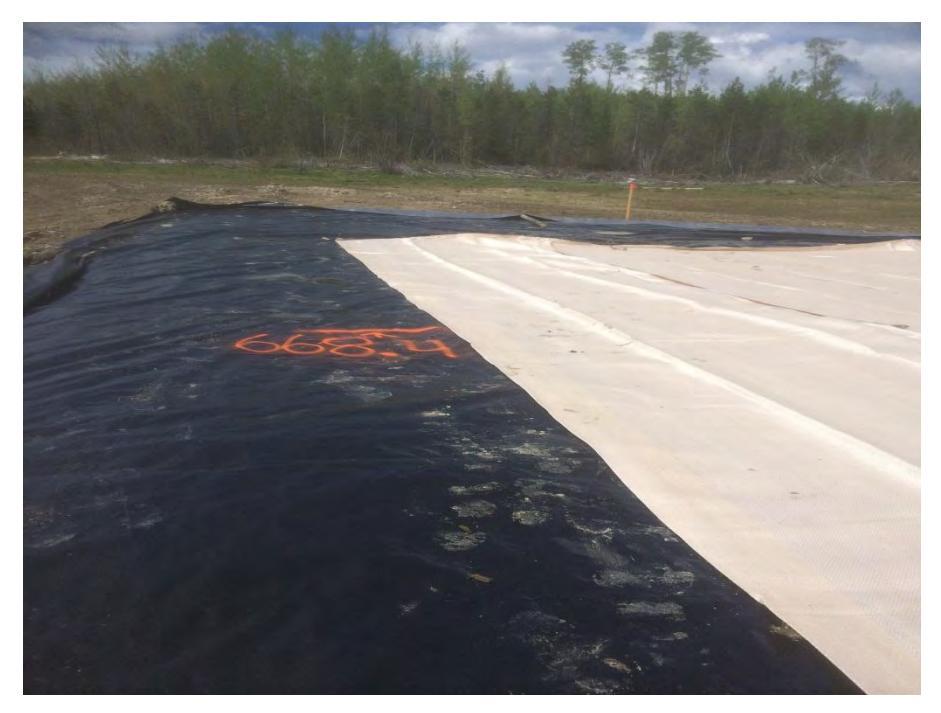
Photo 9 – North Bag (# 2) is longer than what needed.

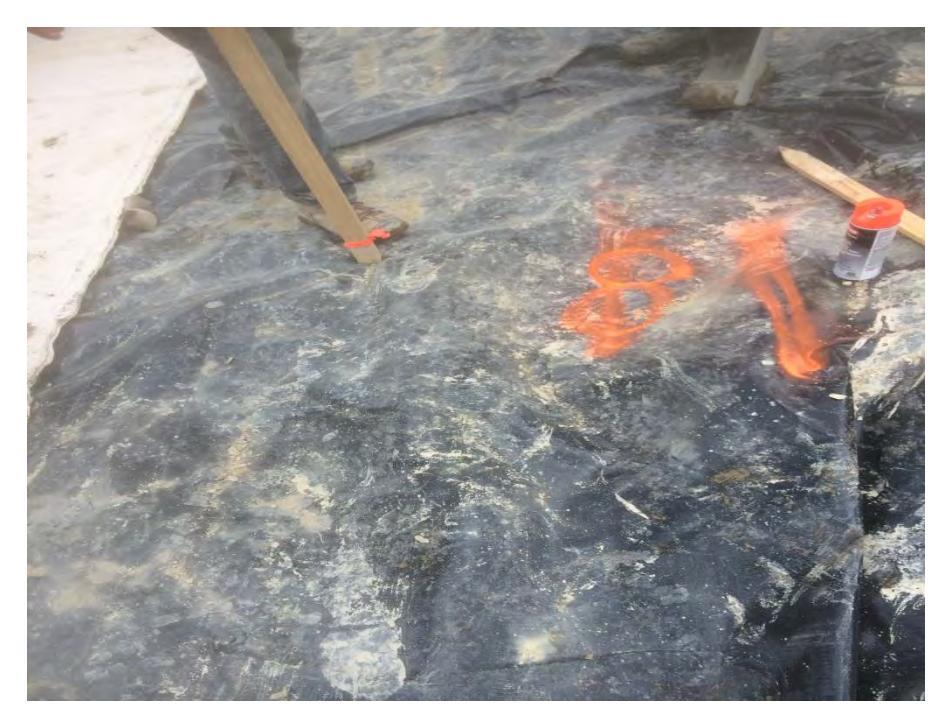
Photo 10 – South Bag (# 1) is shorter than what needed (soil was trimmed for getting better slope).

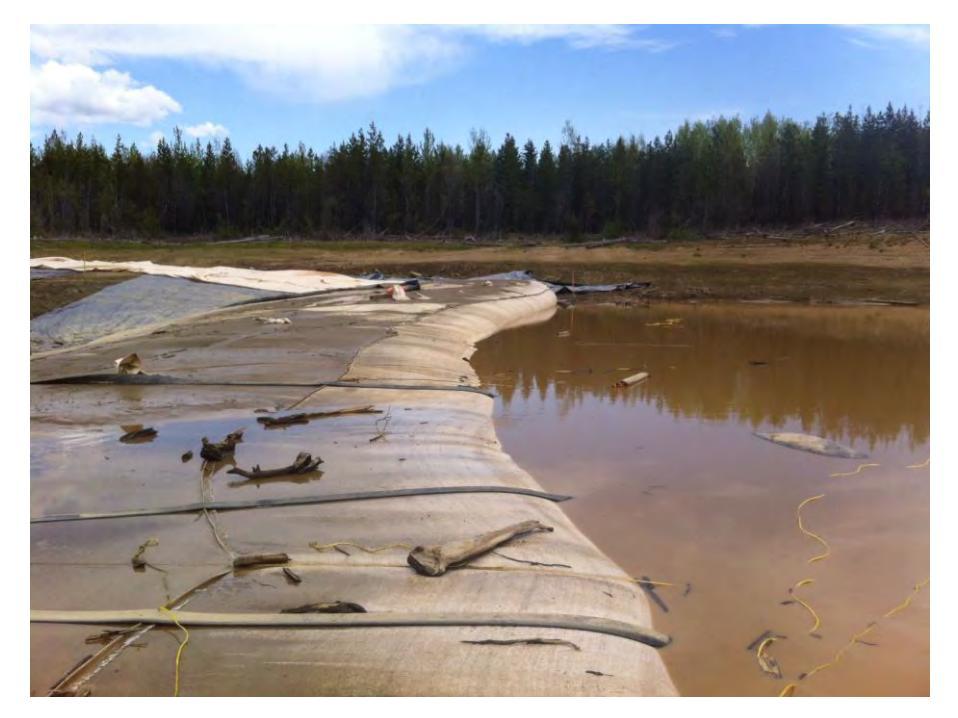
Photo 4

The South Bag (#1) started to curve towards the downstream as getting filled up. (Photos 4 - 5)

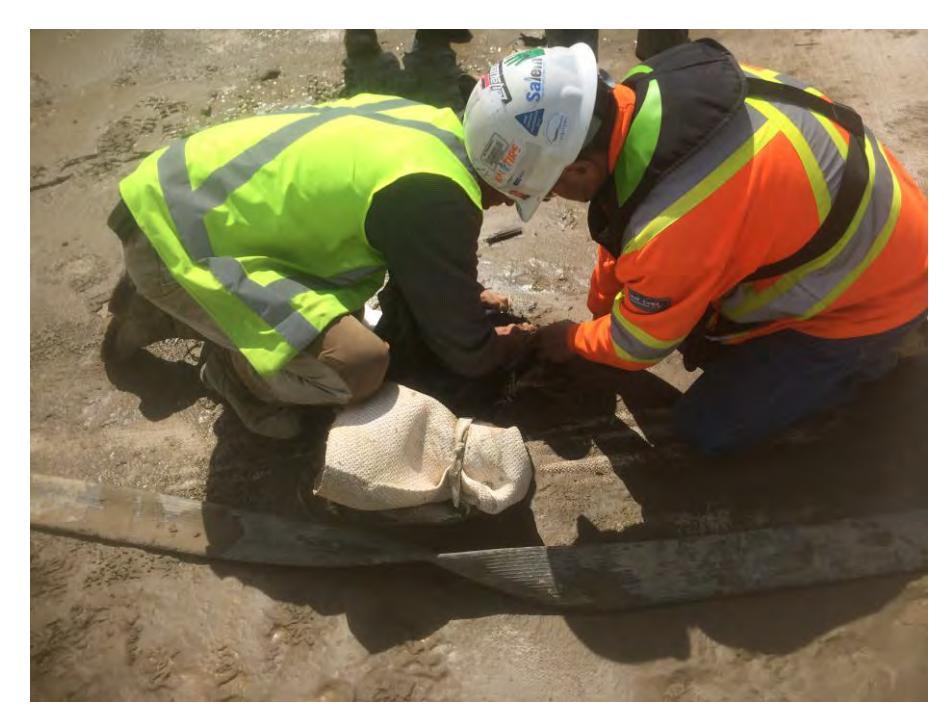
Ian Clarke tried pulling the pieces together and left site at 4:00 pm; later contractor called for more assessment on the situation since the ripped part was getting bigger as the bag was pressured. The ripped part started with 2 holes approx. 200 mm diameter each. During Ian's attempt to repair, the two holes took a square shape 400 mm X 200 mm. (Photos 3 - 9)

Photo 3 – Ian trying to fix the rip

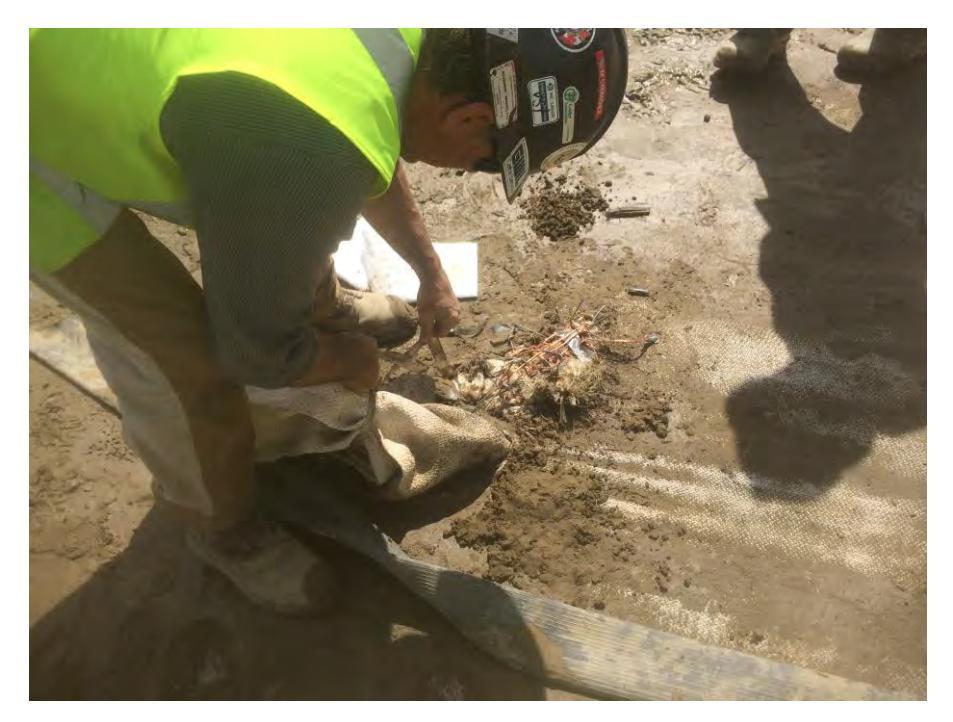
Photo 5 – Ian trying to pull ripped pieces together.

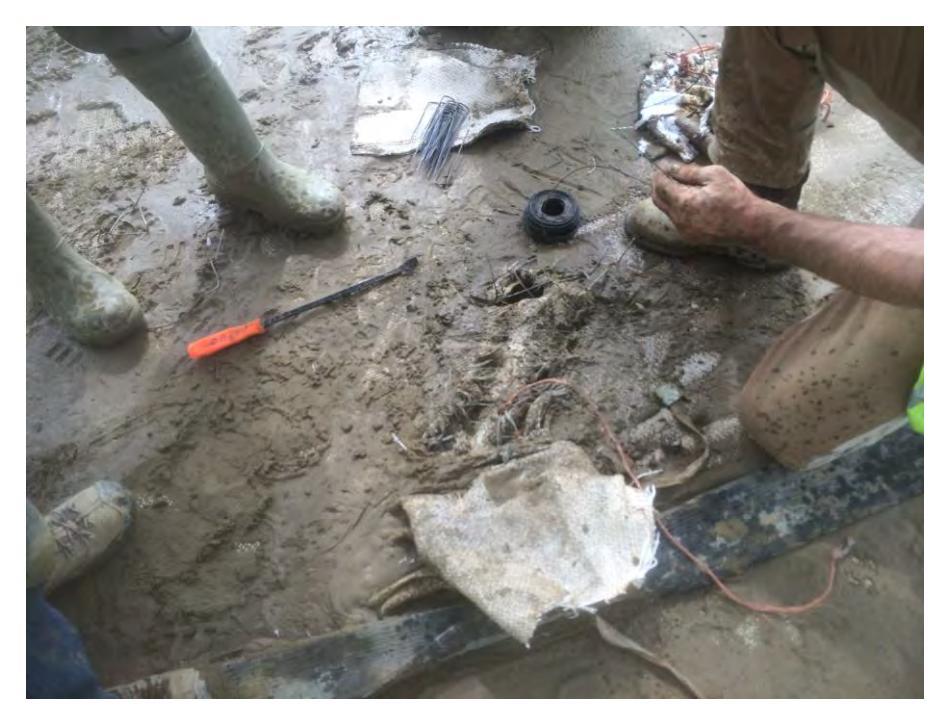
Photo 6 – trying pulling ripped pieces together.

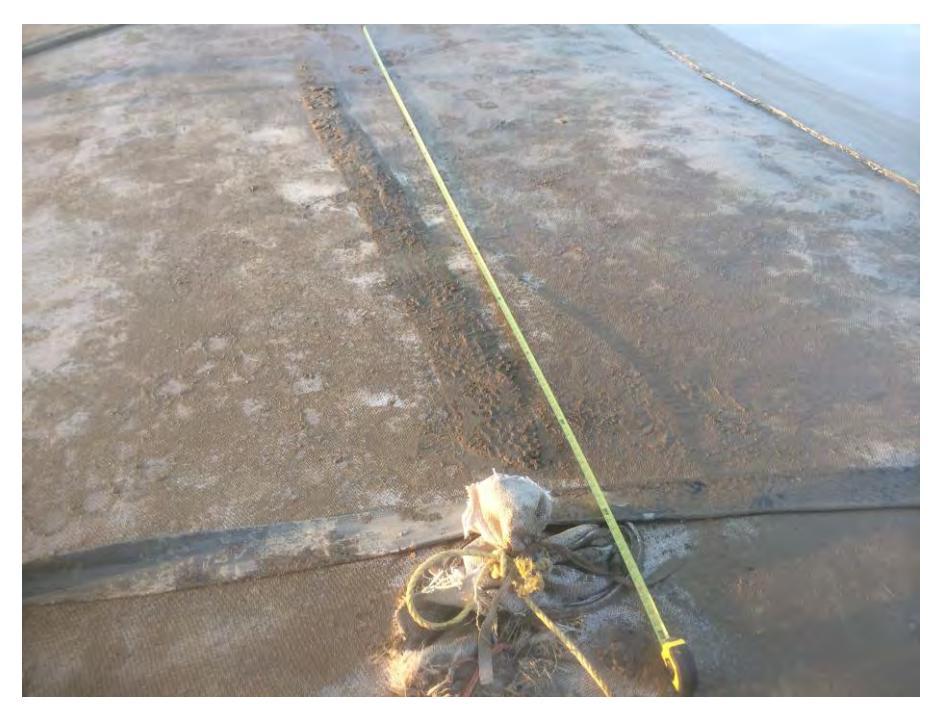
Photo 8 – Distance to centre line of the spillway. (See Photo 9)
