Construction Completion Report

BC Hydro – Williston Reservoir Wetland Demonstration Site 34 Beaver Pond Completion Report

BC HYDRO - WILLISTON RESERVOIR WETLAND DEMONSTRATION SITE 34 BEAVER POND

1414340003-001-R-Rev0

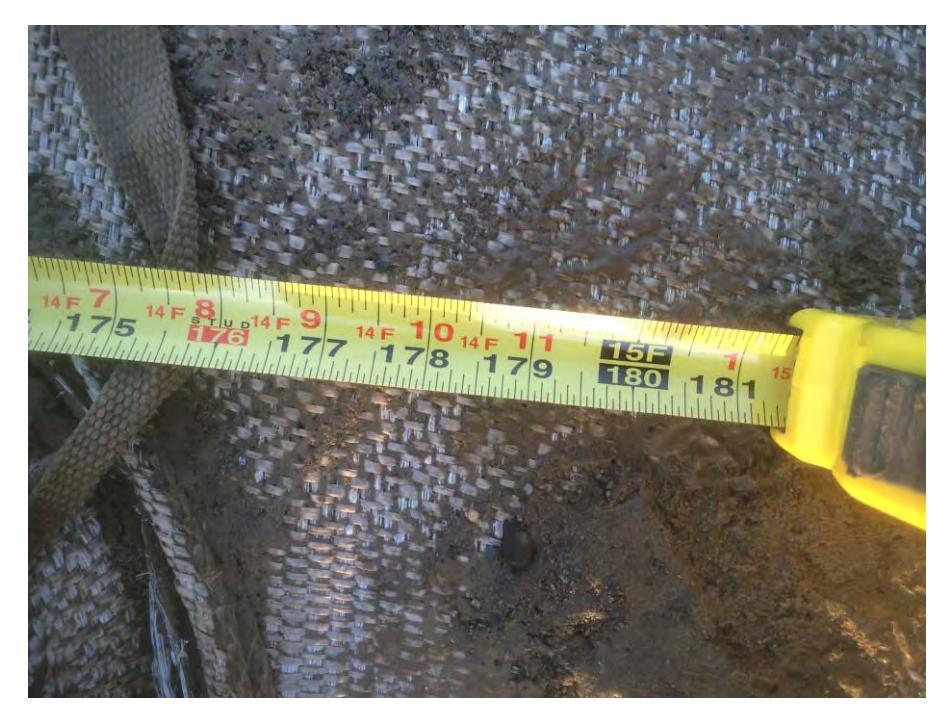
Ian Clarke tried pulling the pieces together and left site at 4:00 pm; later contractor called for more assessment on the situation since the ripped part was getting bigger as the bag was pressured. The ripped part started with 2 holes approx. 200 mm diameter each. During Ian's attempt to repair, the two holes took a square shape 400 mm X 200 mm. (Photos 3 - 9)

Photo 9 – Distance from the ripped part to centre line of the spillway

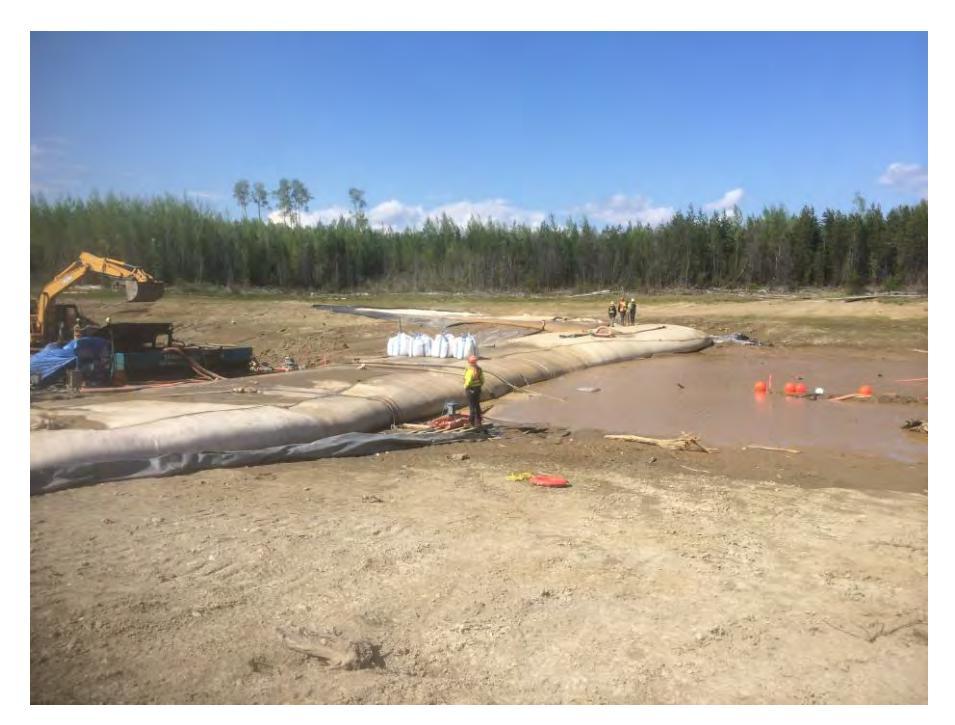
Smaller Bags were filled with soil and placed, on top of the South Bag (#1), to create a lower elevation for the spillway. (Photos 2, 3)

Photo 2 – South Bag (#1) is filled to desired elevation. Also showing small bags filled with soil placed on top.

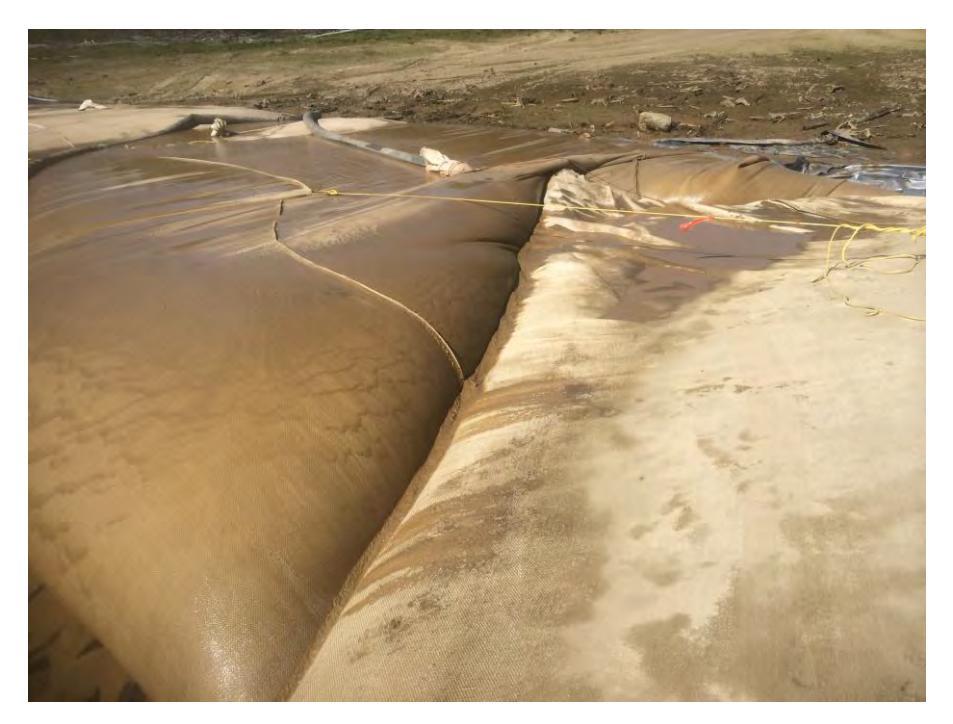
Photo 3 – Closer view of smaller bags filled with soil and placed on top of South Bag (#1) to creat spill way Elev.

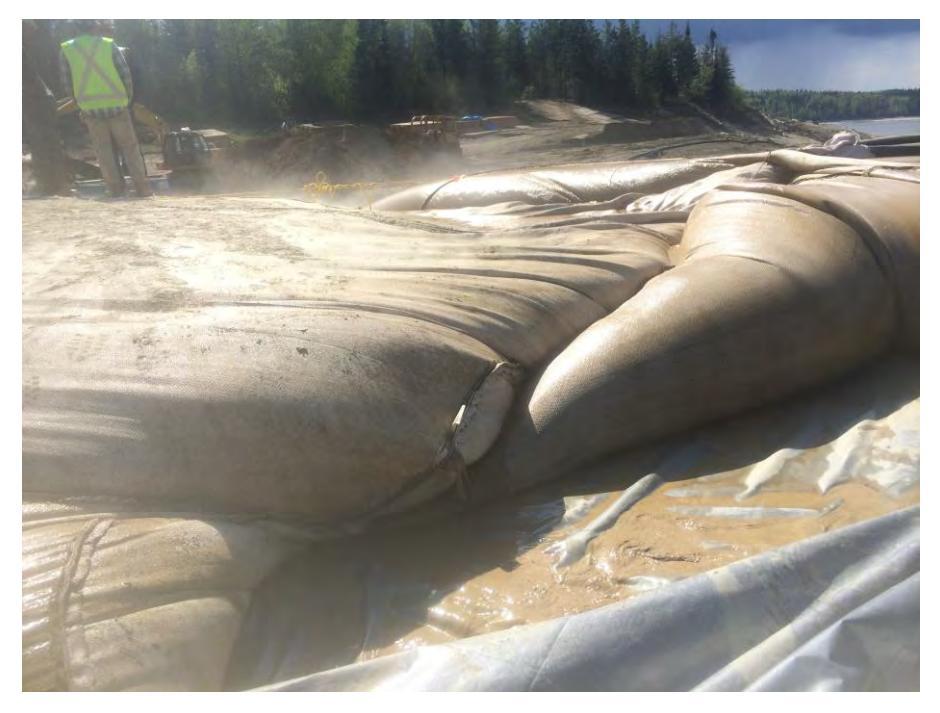
Photo 4 – Showing the seam between the two bags – Standing on South Bag (#1) looking North.

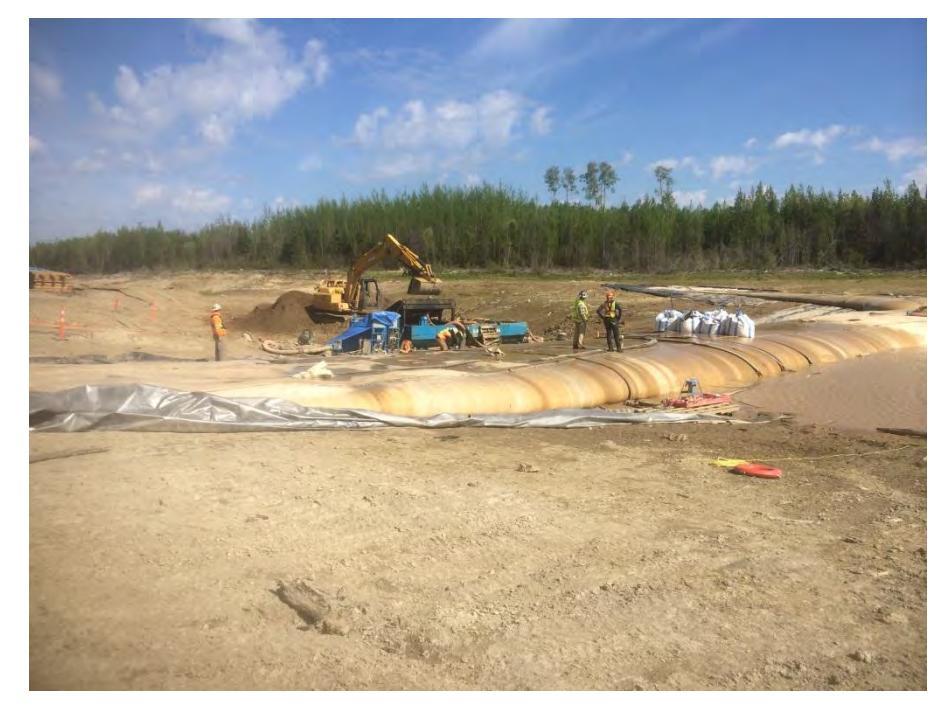
The small bags on top of the South Bag (#1) did not keep the slurry from filling along the bag. Spillway would be identified according to surveyed elevations on Monday. Golder and Duz Cho (Rob Wallin) agreed to locate the spill way by finding the lowest elevation along South Bag (#1) – The lowest elevation is to be the centre line of the spill way; Duz Cho will measure 5m on each side of the identified centre line to mark the boundaries of where riprap will be placed. The total length of riprap layer is 10m along the bag, will extend 2m far from the bag and it is 0.5m thick. Duz Cho will fold the existing linear, that is under the bag, to the top of the bag; a non-woven geotextile will lay on the ground (minimum 10m X 2m along the bag) then riprap will be placed on top of the geotextile. (Photo 8)

Photo 1 – These small bags on top could not keep slurry from filling along the bag

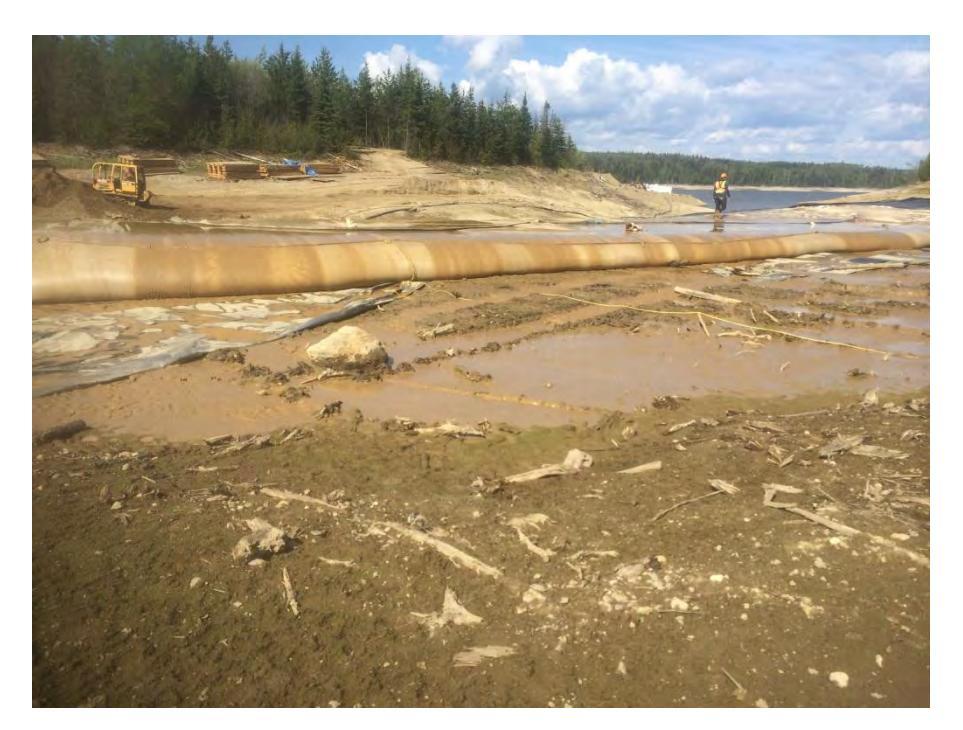
Photo 2 – North Bag (#2) was pumped few centimetres above designed elevation and dewatering (will settle to designed elevation after dewatering)

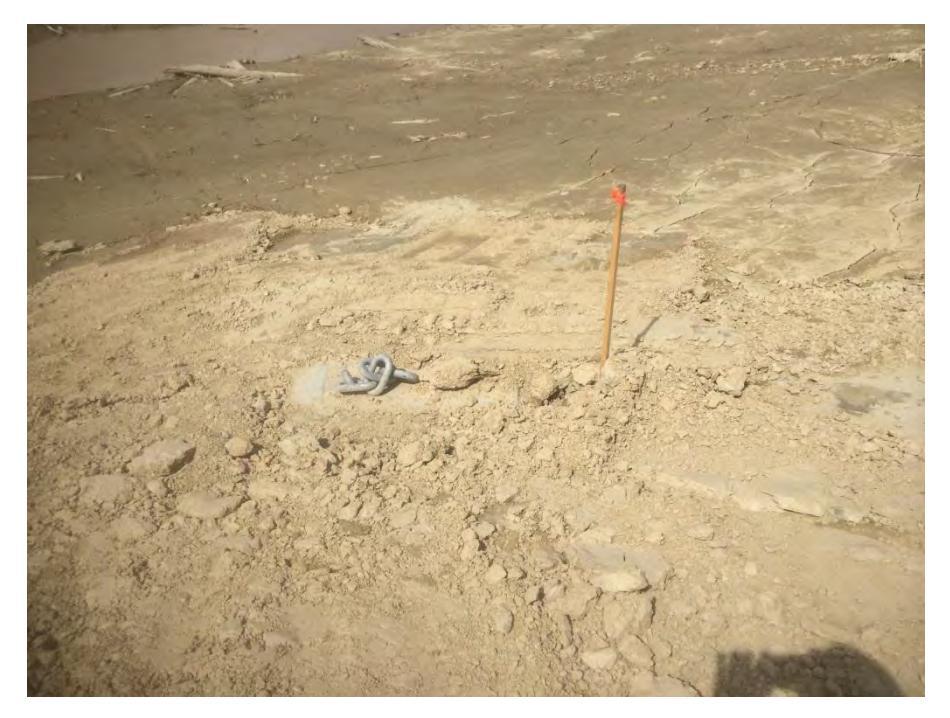
Photo 3 – Anchors for the Log Booms are in place (downstream)

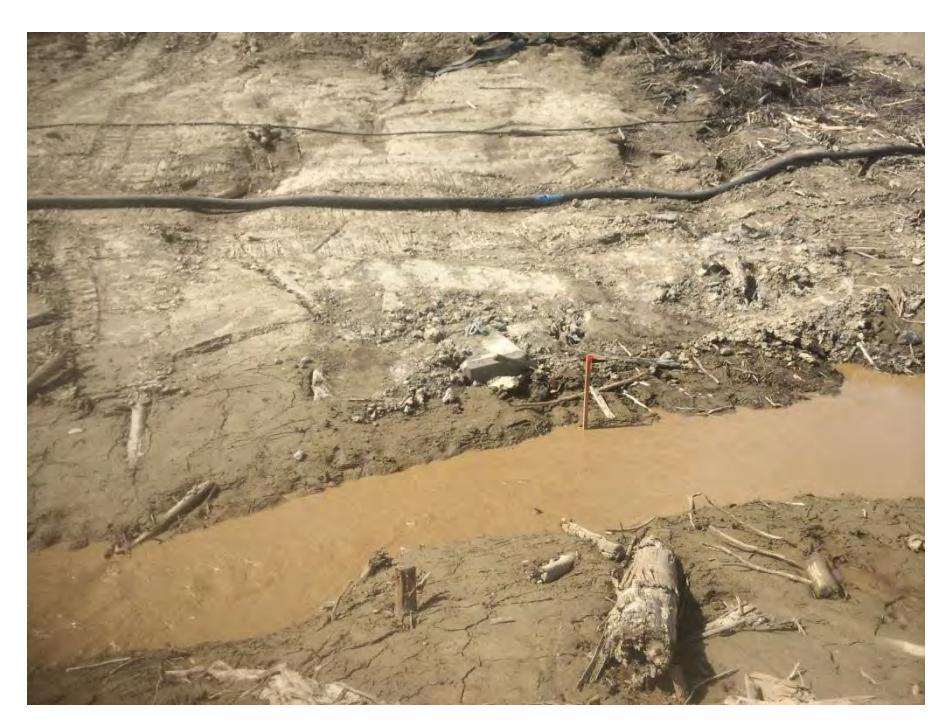
Photo 4 - Anchors for the Log Booms are in place (downstream)

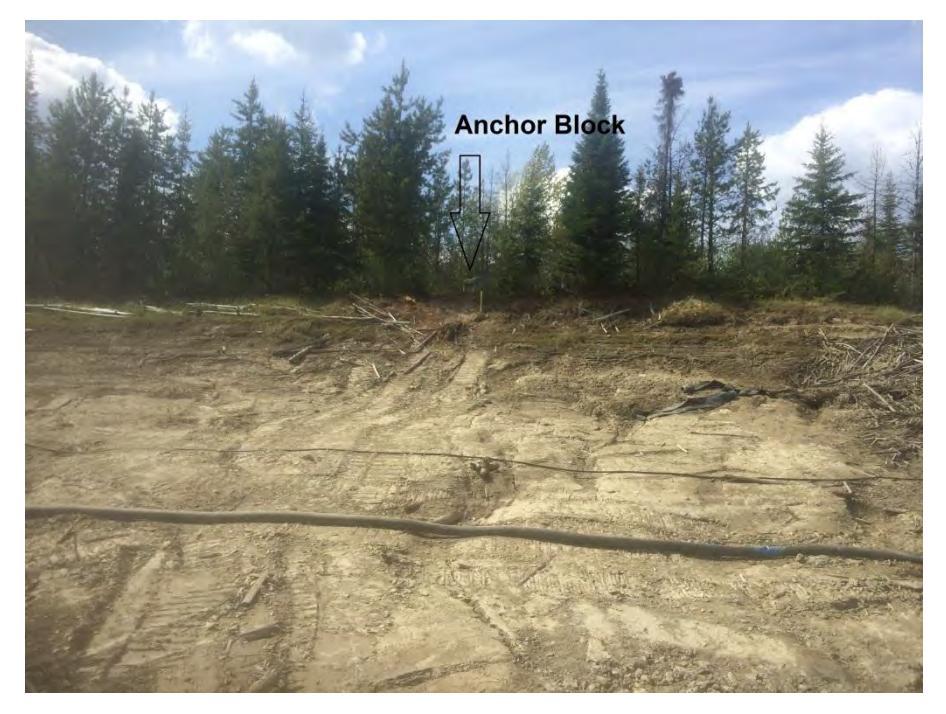
Photo 5 – This Anchor Block will be placed where the surveyed stick shows in the photo (2 m from where the block is placed in this photo)

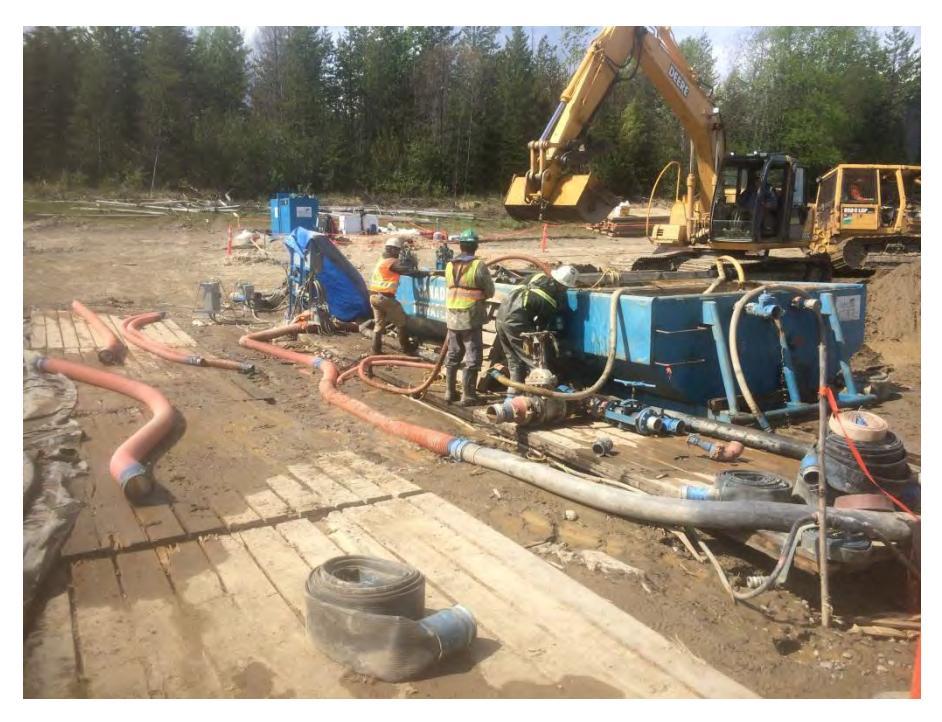
Photo 6 – Contractor is demobbing

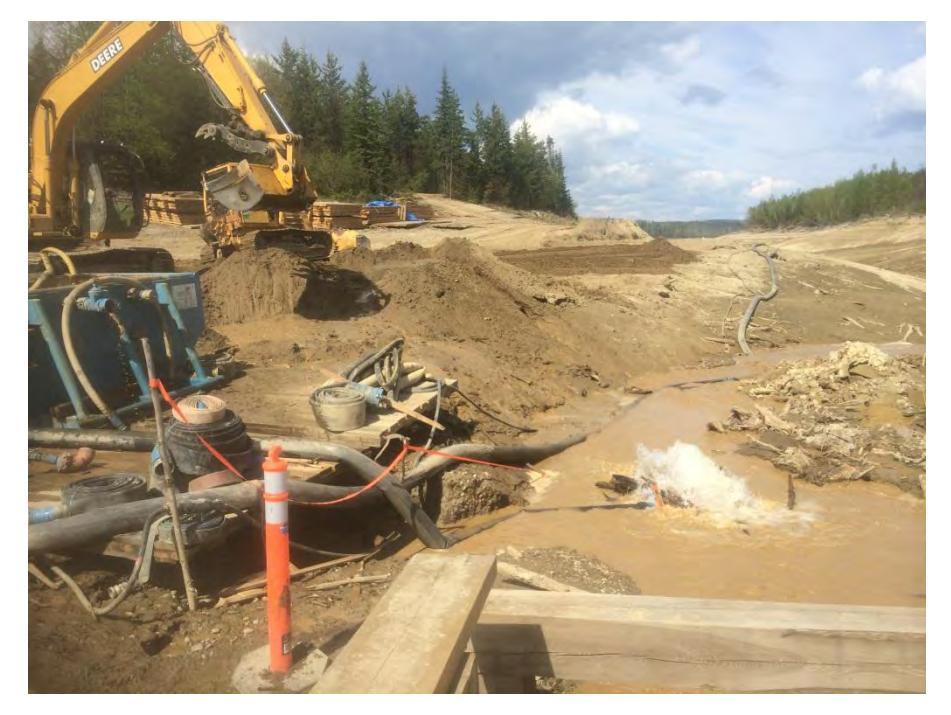
Photo 7 – spreading extra material that was not used to fill the bags
