Peace River Project Water Use Plan

*Williston Reservoir Wetland Demonstration Site 6-2 Airport
Lagoon. Final Report*

BC HYDRO - WILLISTON RESERVOIR WETLAND DEMONSTRATION SITE 6-2 AIRPORT LAGOON

Completion Report BC Hydro Report # N3589

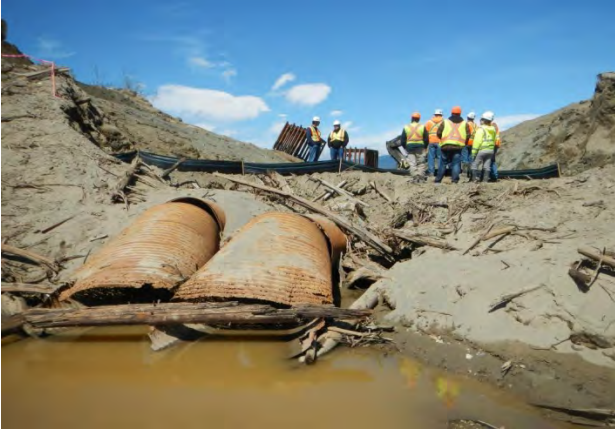
Photo 1 – Excavation & removal of old culverts.

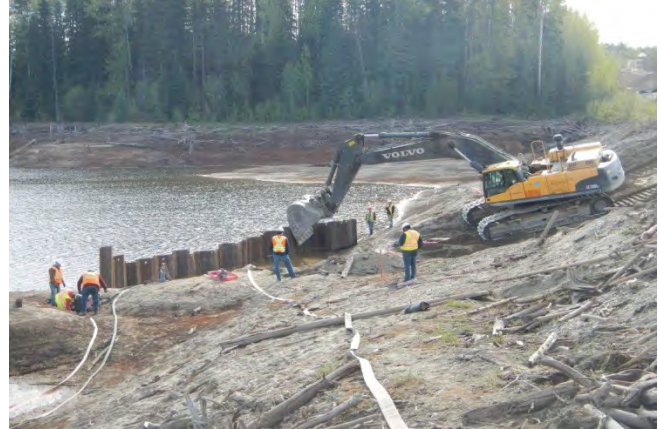
Due to rising water levels in Williston reservoir, temporary sheet pile coffer dams were installed by the Contractor at both the upstream (Wetland) and downstream (Reservoir) sides of the causeway road embankments to allow construction to proceed in the dry. These temporary structures were removed at the end of the construction period.

Photo 2 – Placement of sheet pile coffer dam.

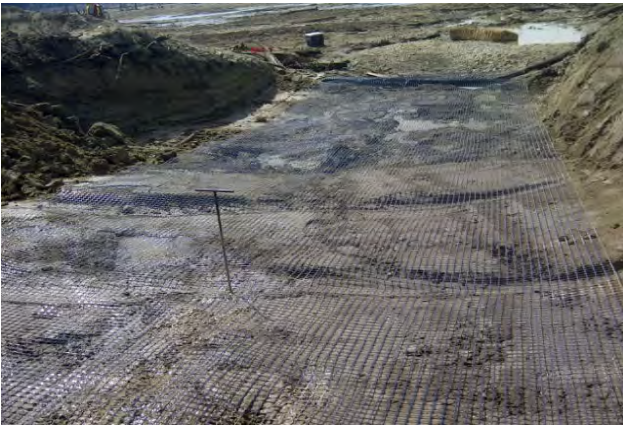
Photo 3 – Placement of geogrid.

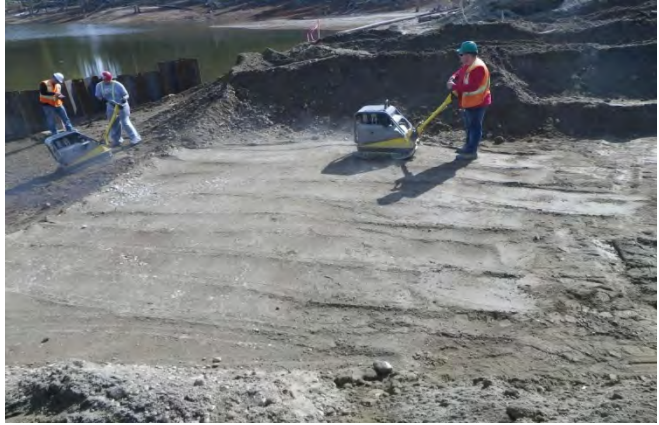
Native backfill material was then placed in 300 mm lifts and compacted to a minimum of 95% of the Standard Proctor Maximum Dry Density (SPMDD) up to the proposed invert elevations of the new culverts. The design drawings specified that the backfill was to be compacted to 98% SPMDD, however, based on site conditions the on-site geotechnical engineer agreed that compacting to a minimum of 95% SPMDD was sufficient. Free draining well graded 75 mm minus compacted sand and gravel was placed in the area underneath the ends of the proposed culverts as specified on the design drawings.

Photo 4 – Placement of fill material and compaction.

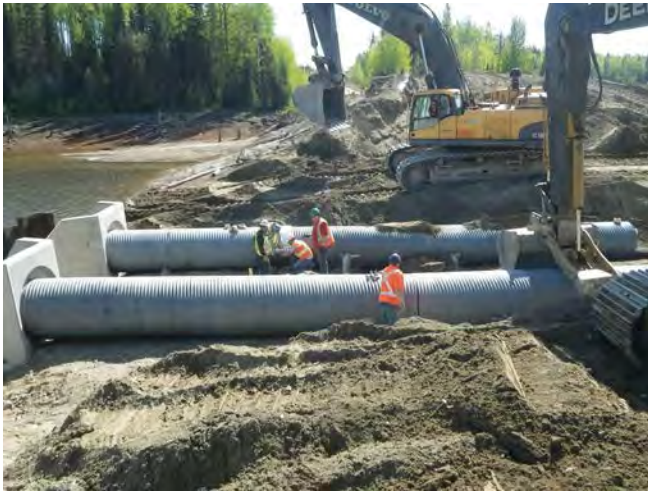
Photo - 9 Twin culvert installations.

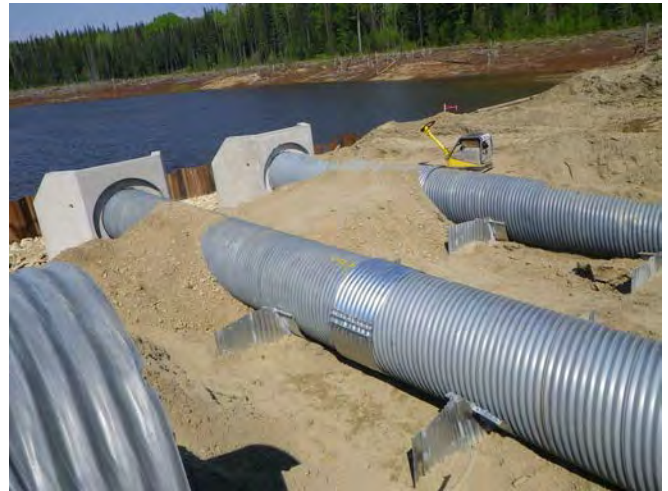
Photo 10 – Twin culvert installation.

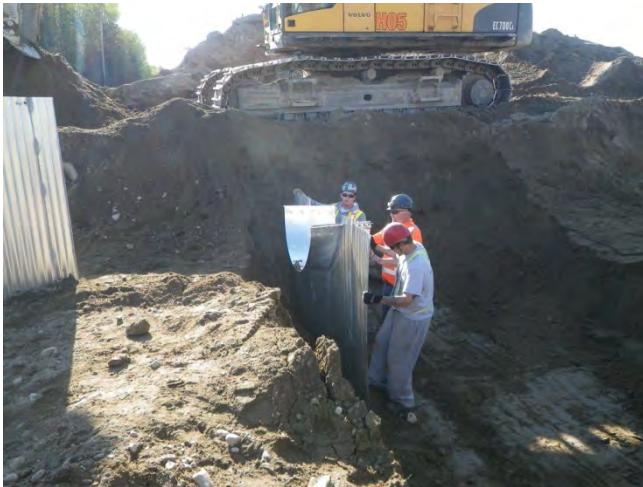
The previously compacted native backfill that had been placed along the alignment of the culverts and in the immediate vicinity of each of the anti-seepage collars were then excavated out to allow for the installation of the anti-seepage collars. Once the anti-seepage collars were installed, the backfill was replaced and compacted.

Photo 11 – Anti-seepage collar installation.

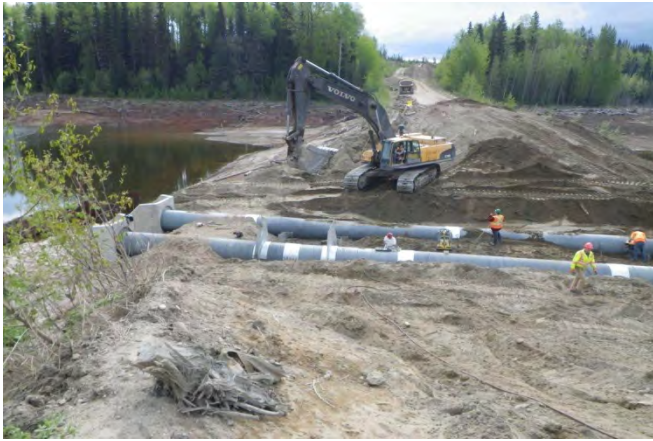
Photo 13 – Culvert installation – north side – lagoon.

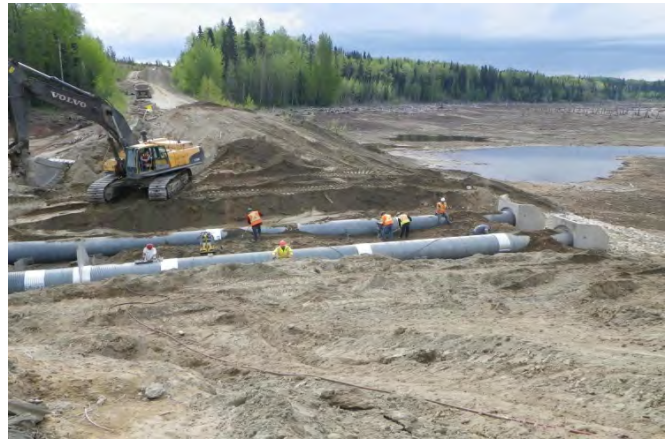
Photo 14 – Culvert installation, south side – Williston Reservoir.

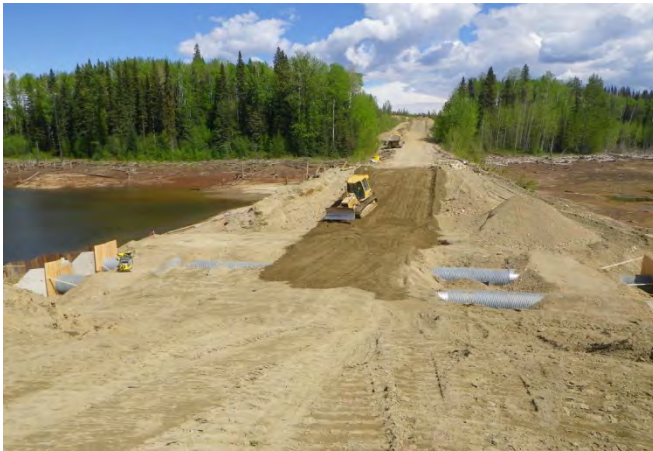
Photo 15 – Backfill around culverts and embankment.

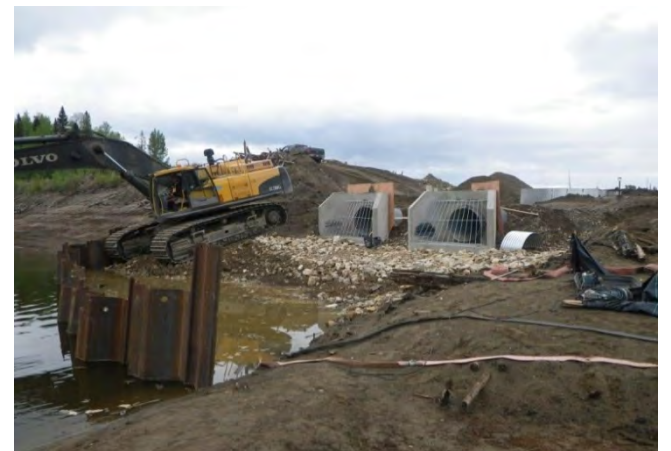
Photo 16 – Grillage installation on upstream headwalls.

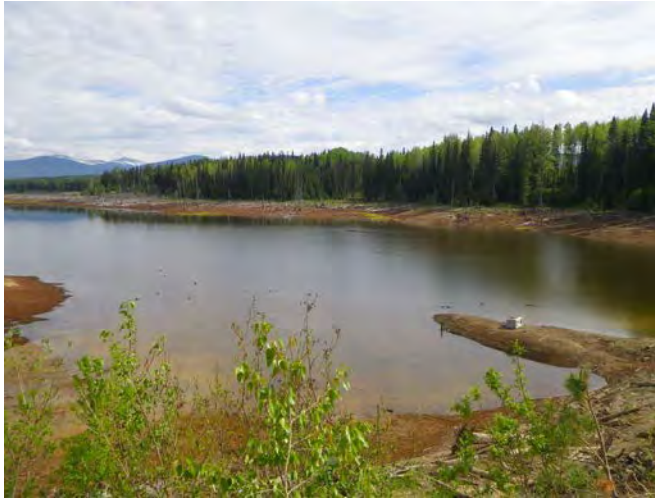
A modification to the design of the concrete anchor blocks was requested by the Contractor to replace the proposed 25 mm (1") diameter galvanized steel coil rod that was to be cast into the block with 37.5 mm (1.5") diameter stud link anchor chain that was cast into the anchor block. The 37.5 mm anchor chain extended 1.5 m from the face of the concrete block for the embankment anchors and each link was welded together to form a rigid 1.5 m long chain from which a shackle could be installed for connection to the log boom chain. This request was reviewed and approved by Golder as the service life with the thicker chain was expected to be similar to the galvanized material specified.

Photo 17 – Log boom anchor block placement lagoon.

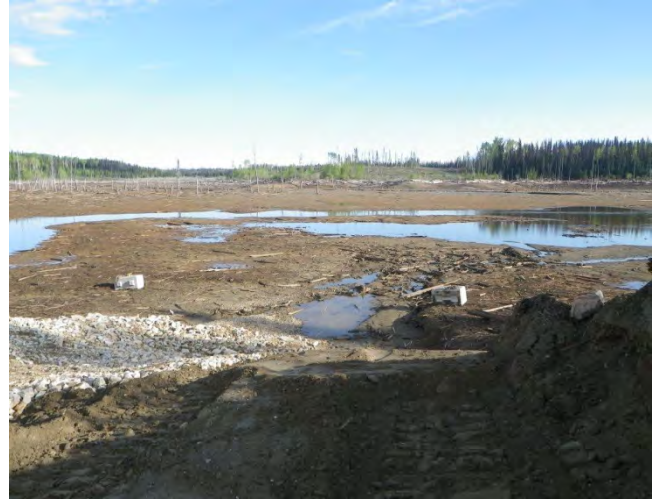
Photo 18 – Log boom anchor block placement reservoir.

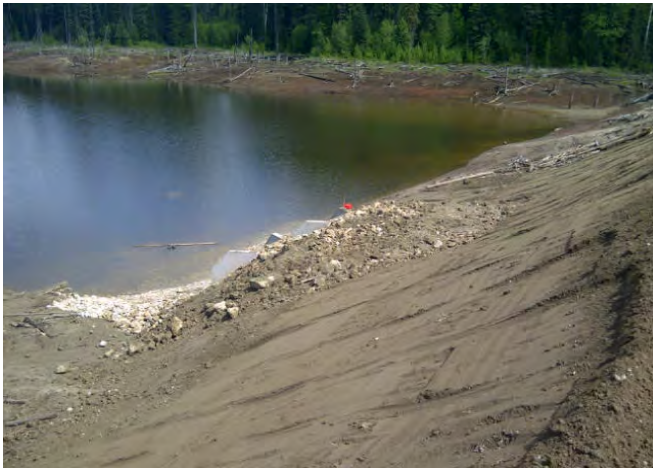
Photo 19 – Fill placement & view of headwalls, Lagoon.

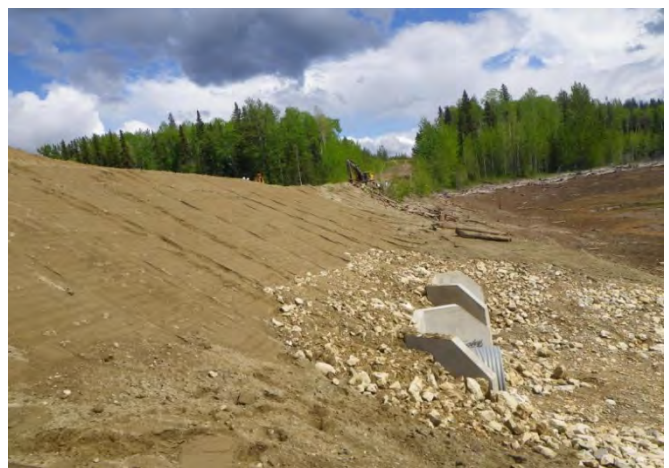
Photo 20 – Fill placement & view of headwalls, reservoir.

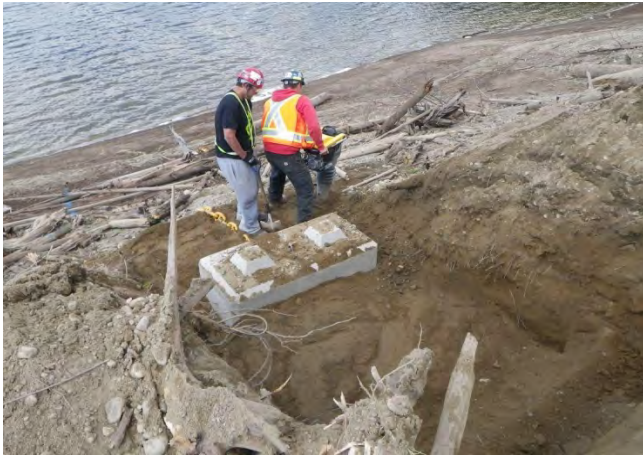
Photo 21 – Embankment anchor installation.

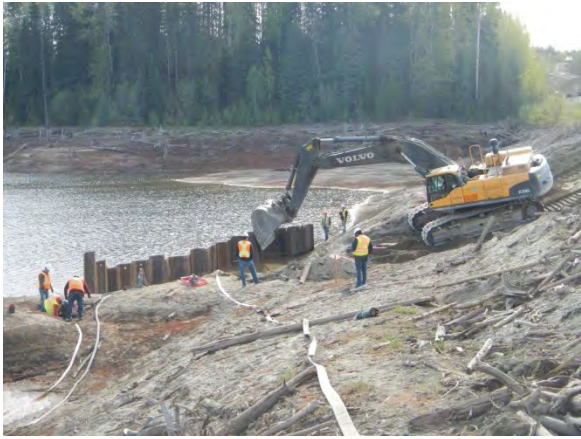
Building Sheet Pile Wall

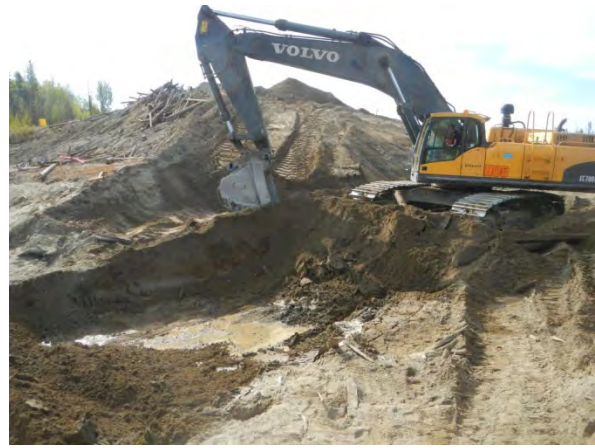
Excavating debris for Culvert base pre.

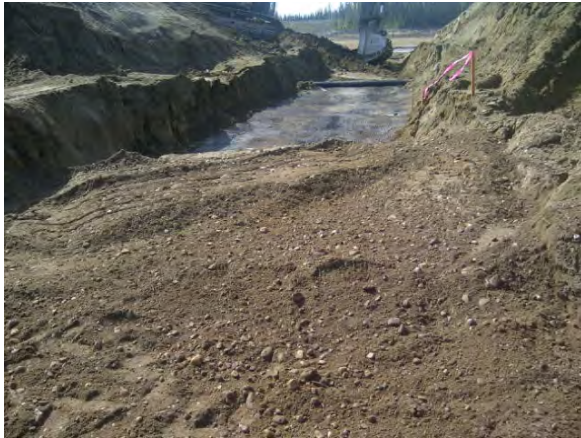
Placing Geo-grid and soil, upstream

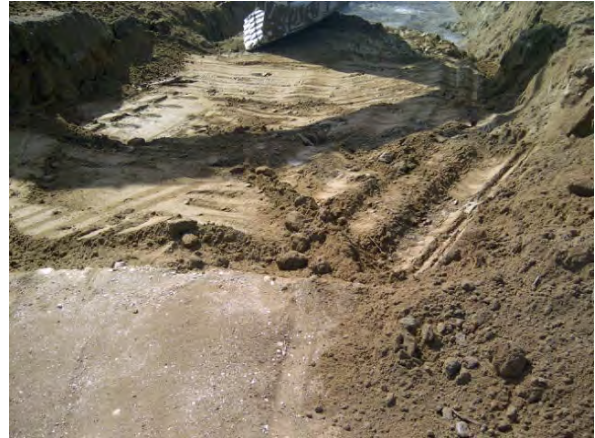
Culvert base excavation

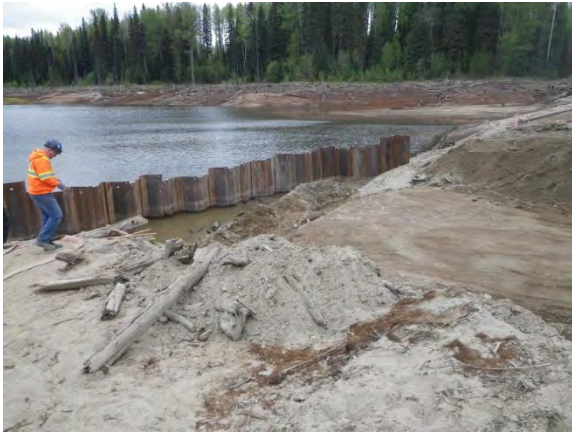
Progressing compaction, upstream

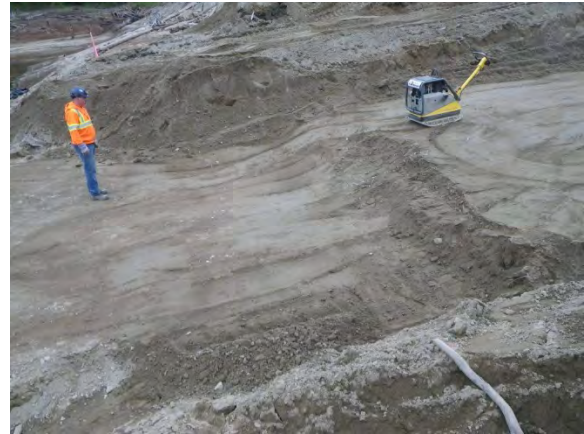
Progressing compaction mid-section

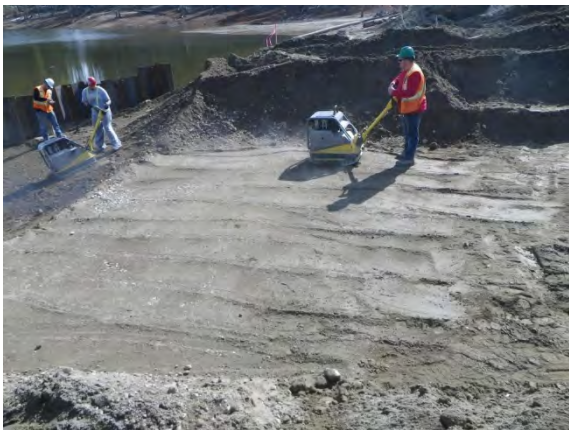
Progressing compaction, upstream

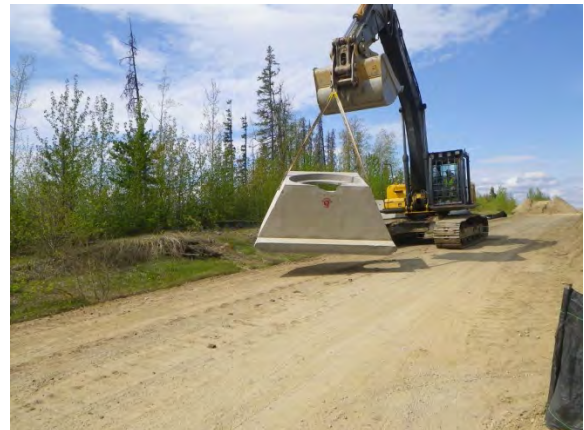
Transforming Culvert Concrete Head

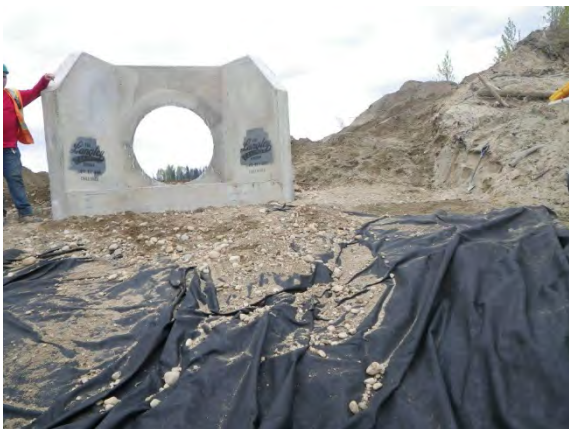
Placing Culvert Concrete Head

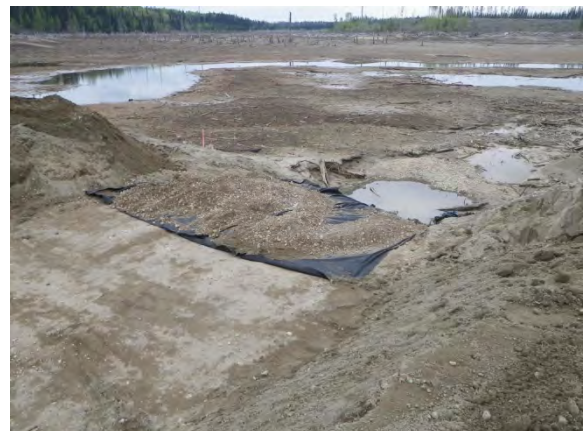
Placing Geo-textile, downstream.

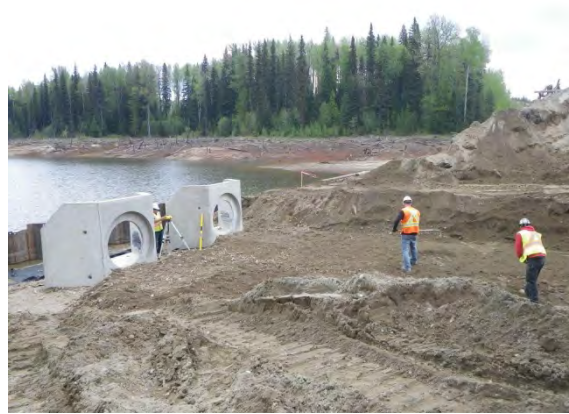
Prep. Culvert base, upstream

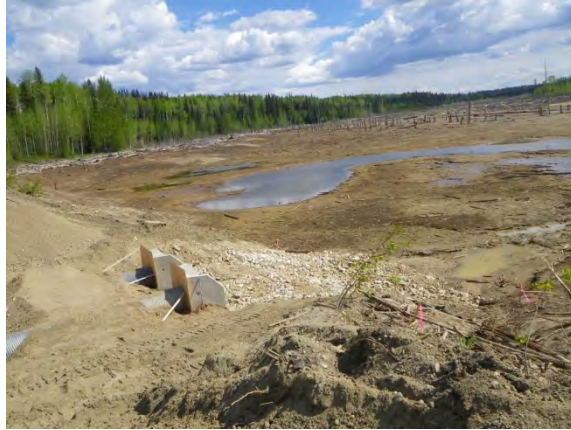
Culverts against concrete heads, downstream

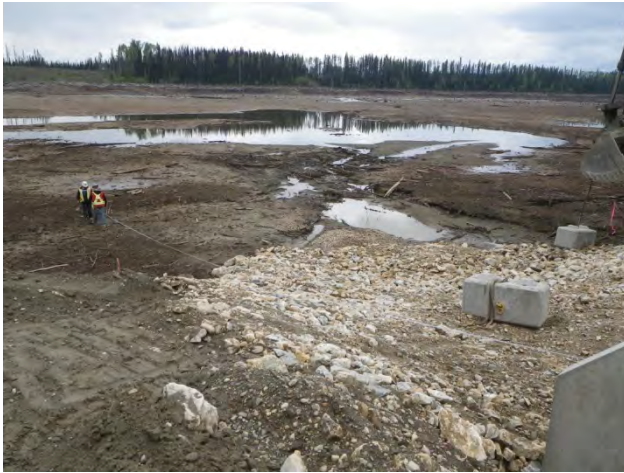
Placed concrete blocks downstream

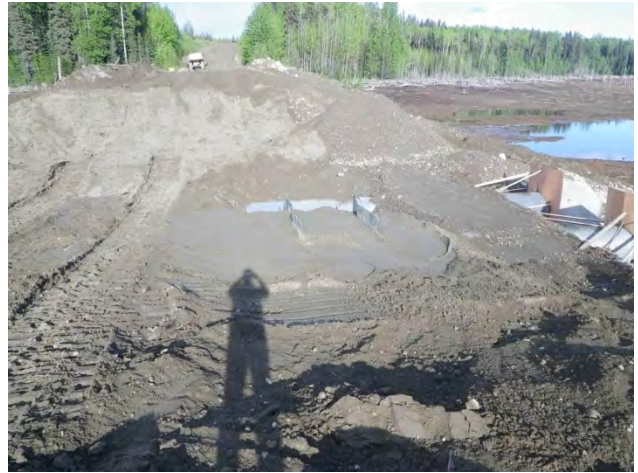
Compaction progress for road above culvert

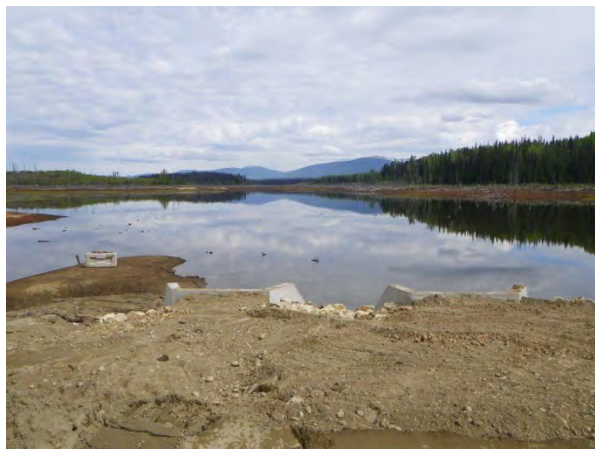
Upstream during construction

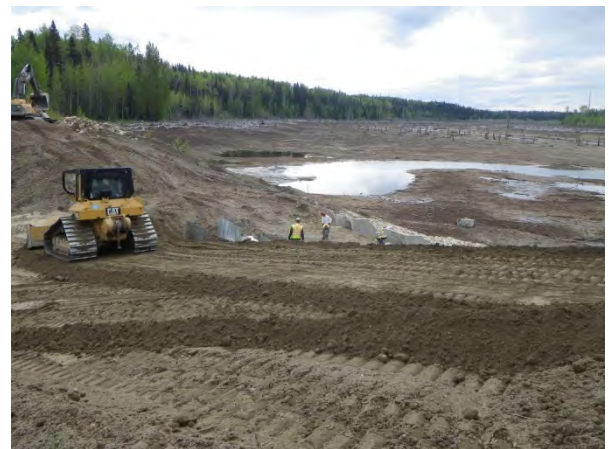
Downstream during construction

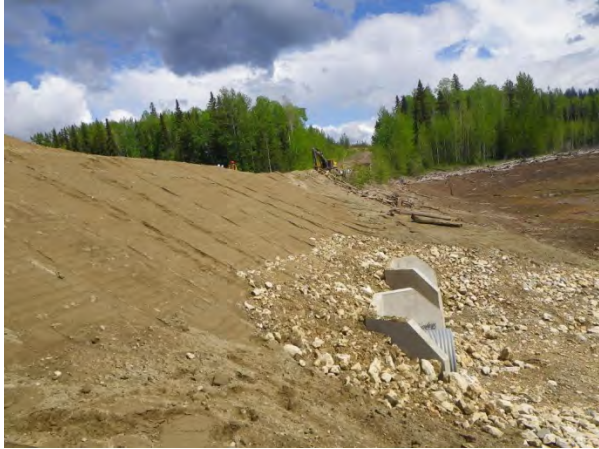
Slopes close to finishing, downstream

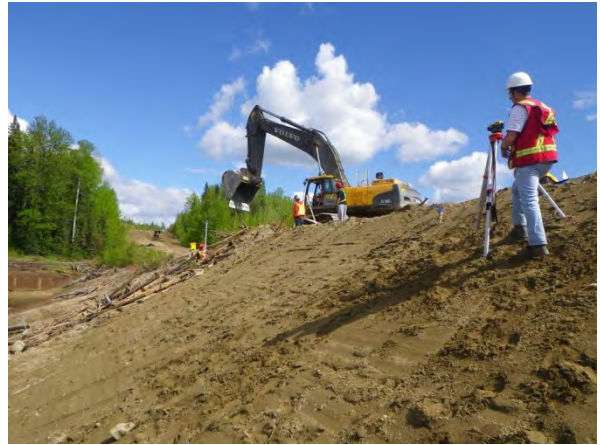
Slopes close to finishing, downstream

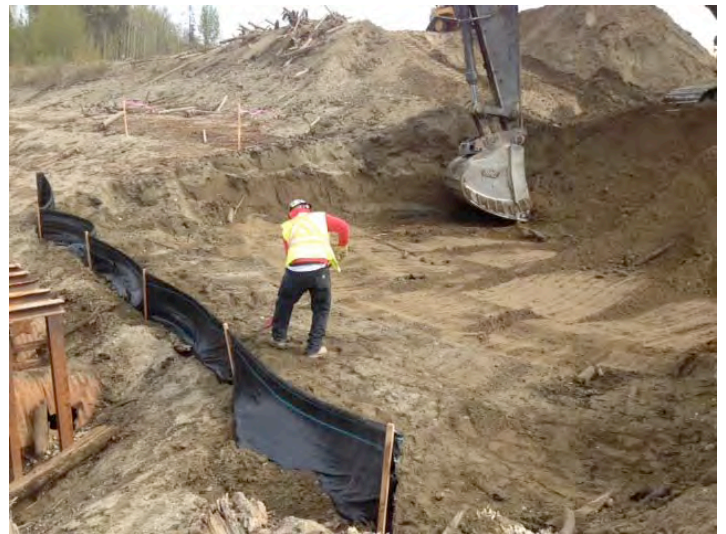
Installing silt fence

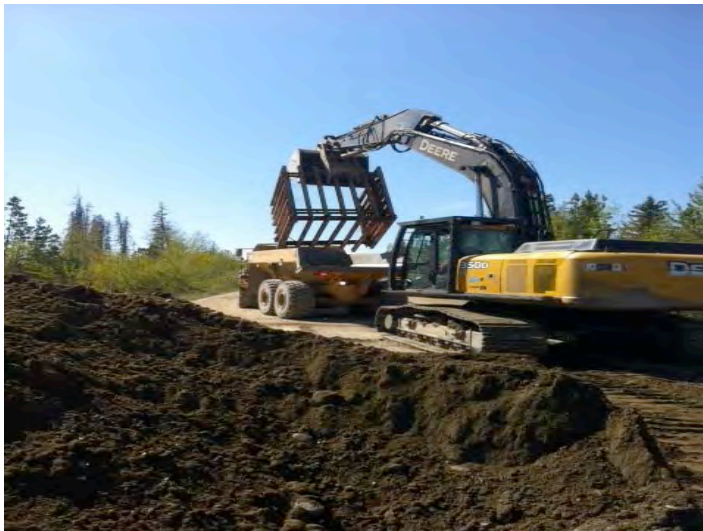
Loading out steel grates

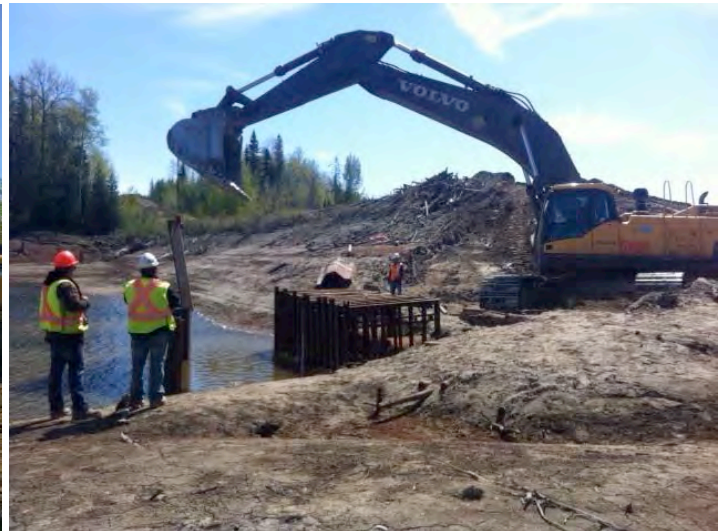
Installing coffer dam

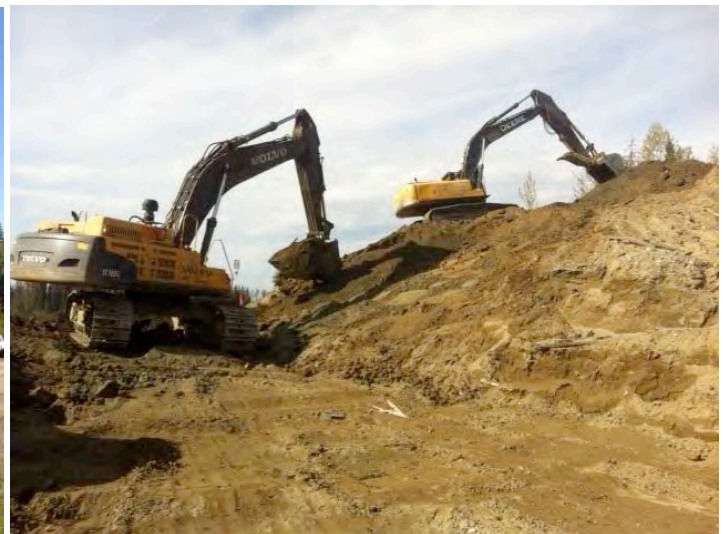
Safe sloping excavation

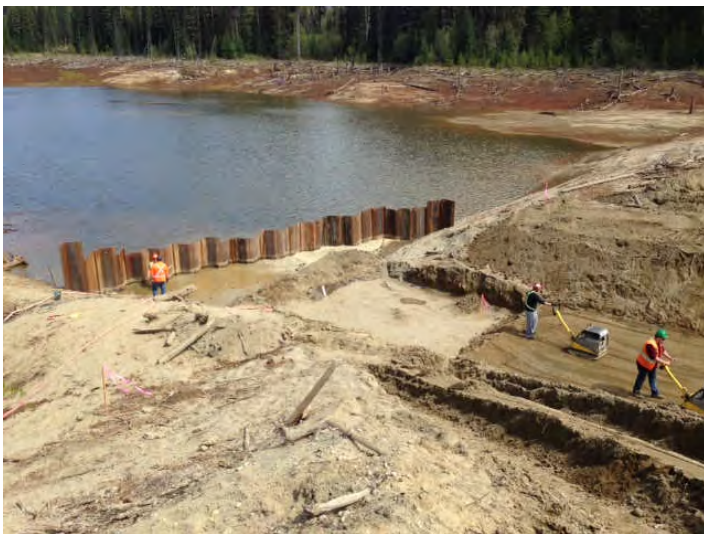
Levelling and packing lifts

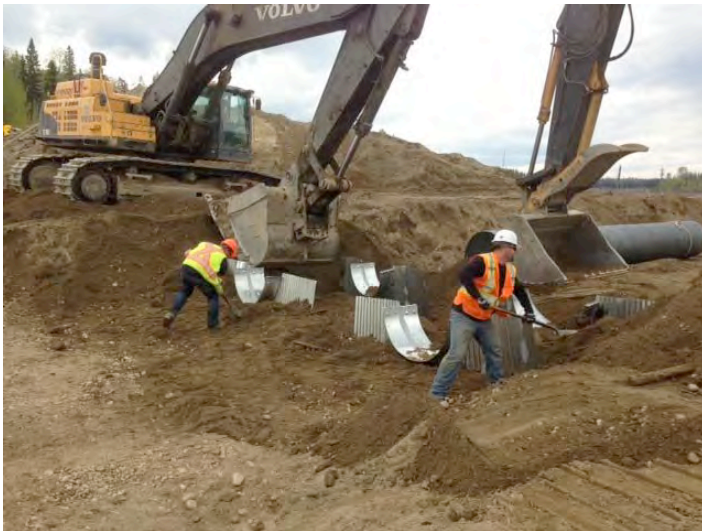
Installing anti-seepage collars

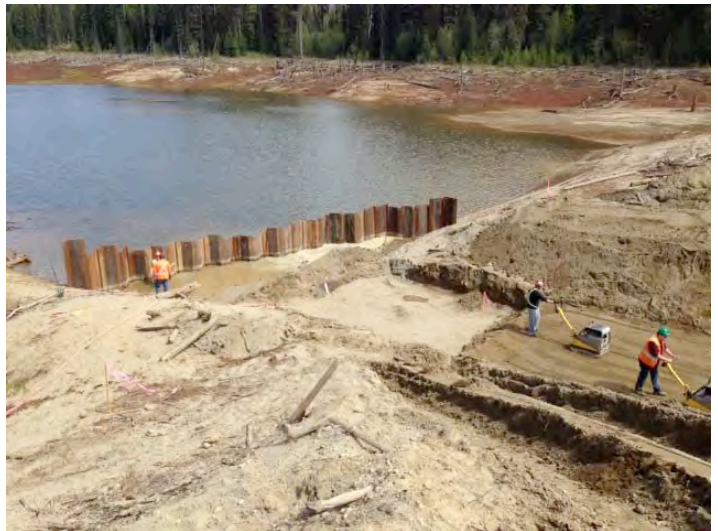
Compacting the culvert beds

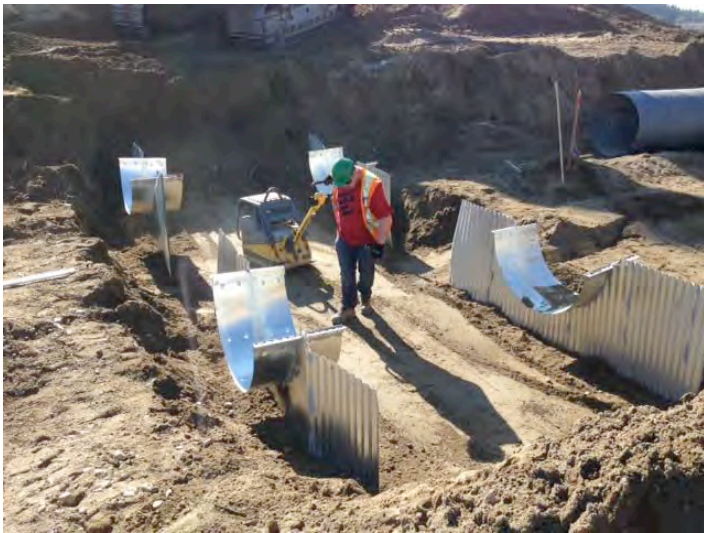
Compacting around anti-seepage collars

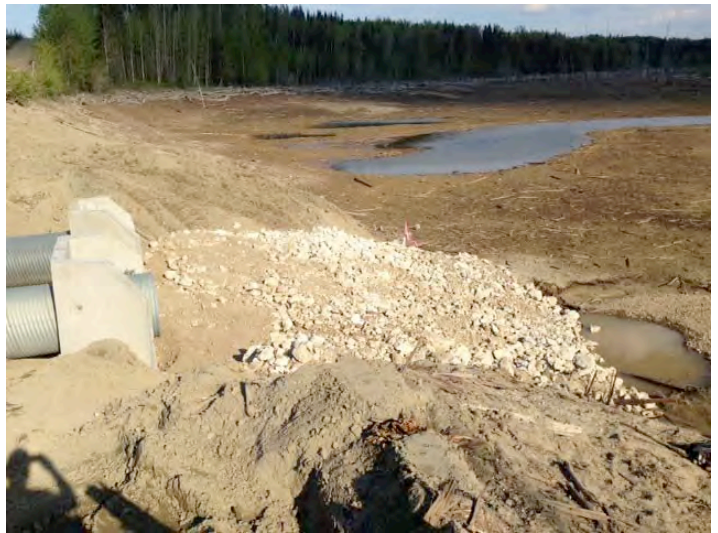
Installing rip-rap on downstream end

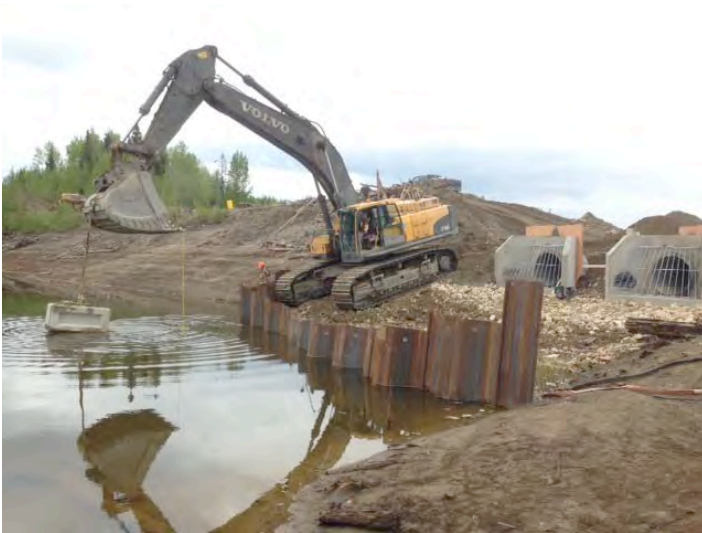
Placing Anchor Blocks

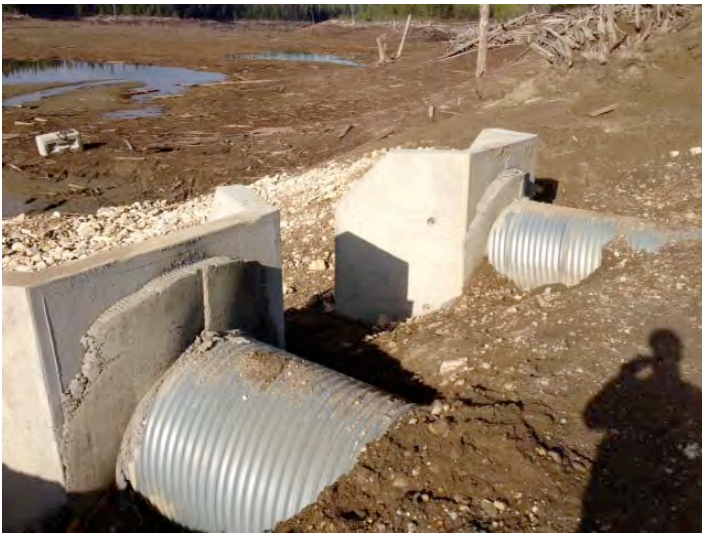
Concrete around culverts

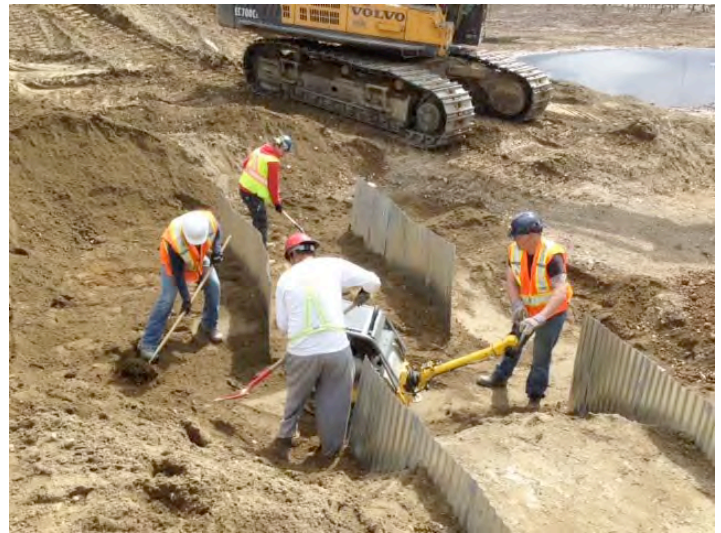
Backfilling final anti-seepage collar

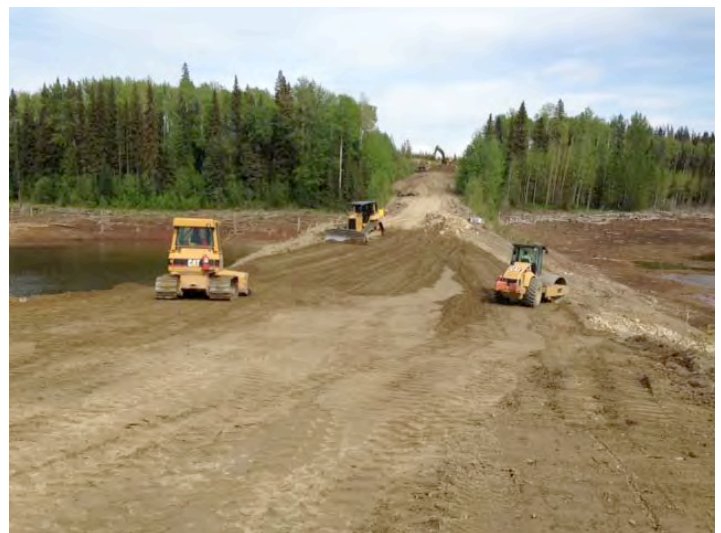
Spreading and compacting even lifts

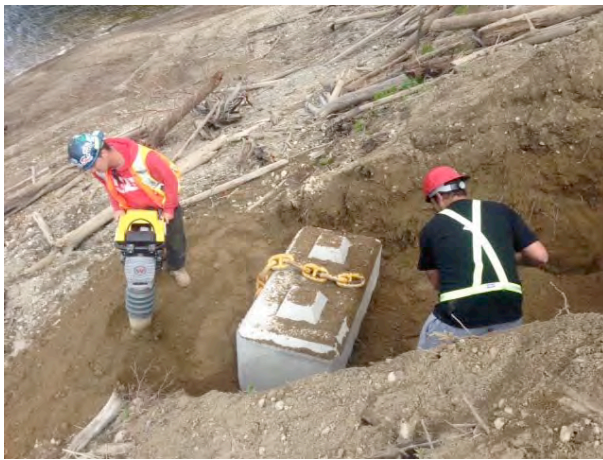
Backfilling embankment anchors

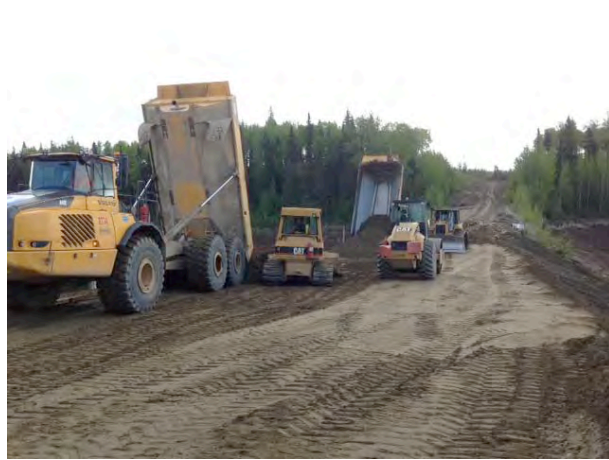
Spreading and compacting lifts

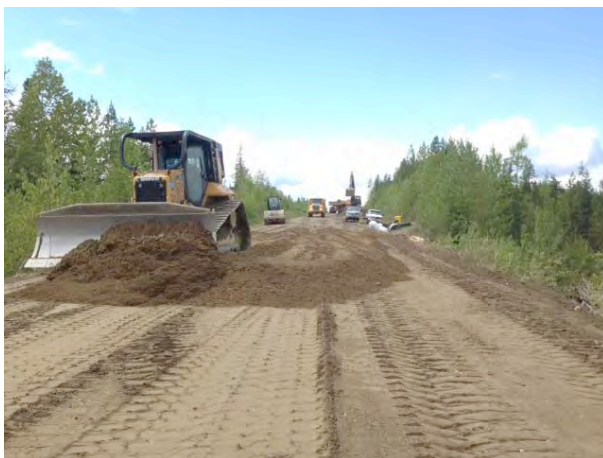
Spreading gravel base

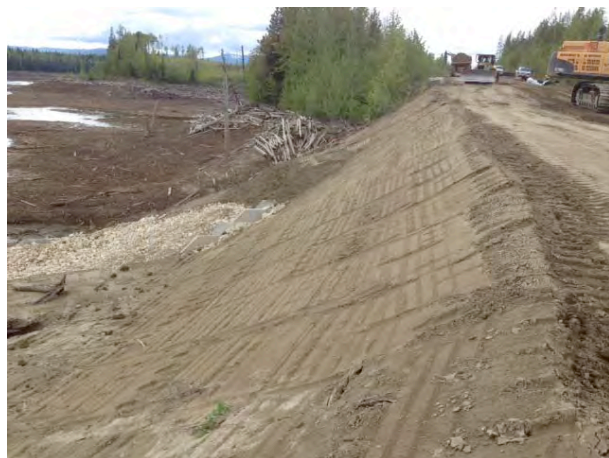
Slope on downstream side

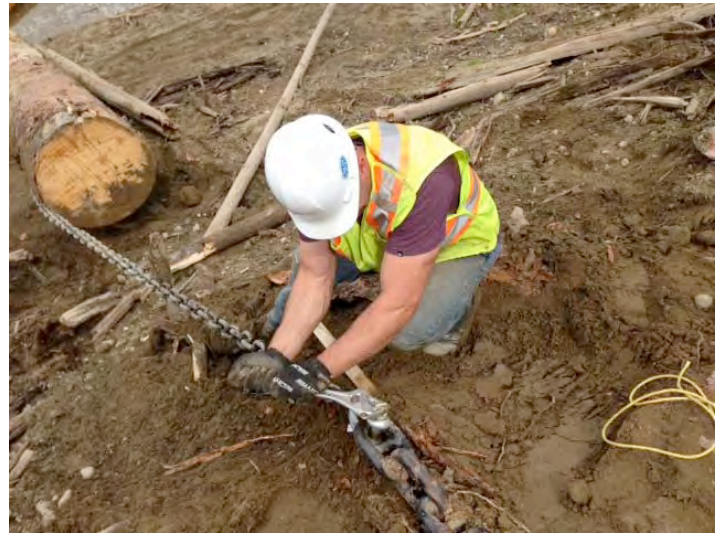
Fastening log boom to embankment block

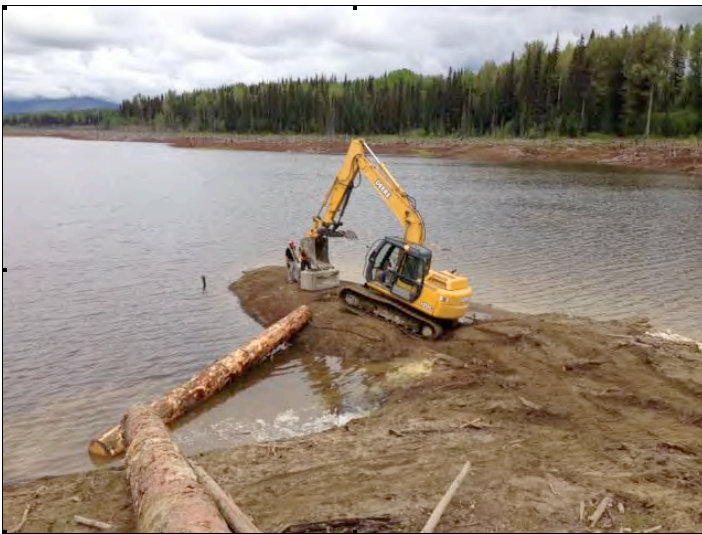
Placing upstream log boom

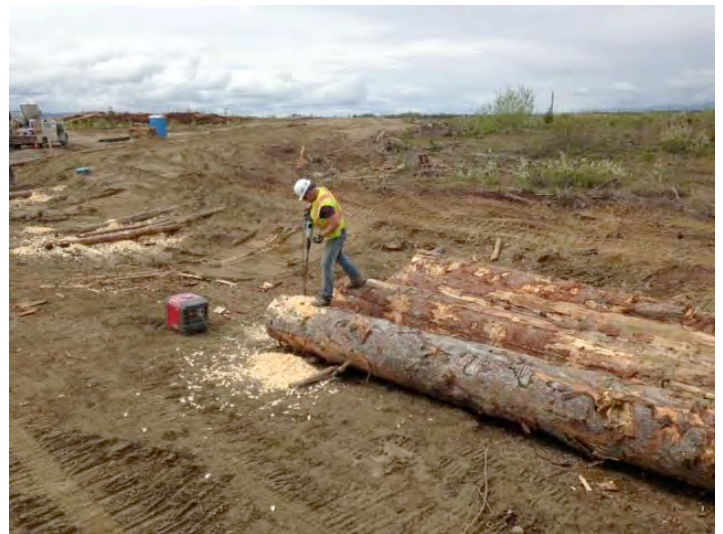
Drilling boom chain holes

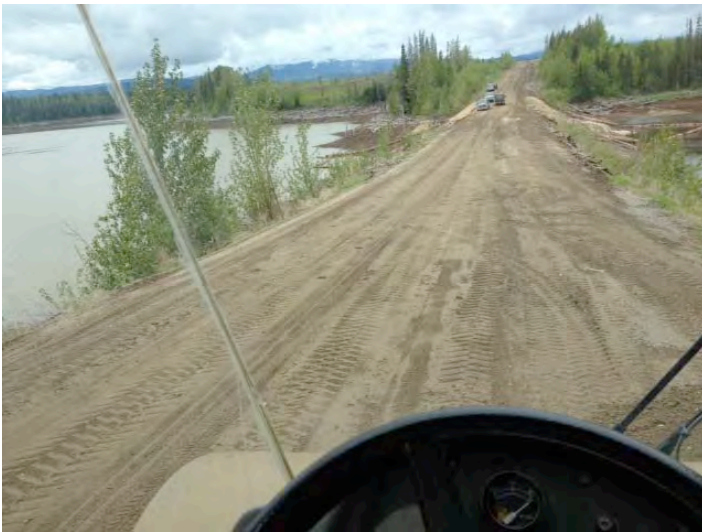
Grading and packing the Causeway
