Peace Project Water Use Plan

Williston Reservoir Trial Tributaries

Ole Creek 2016 Engineering Inspection Report

Site Inspection Report

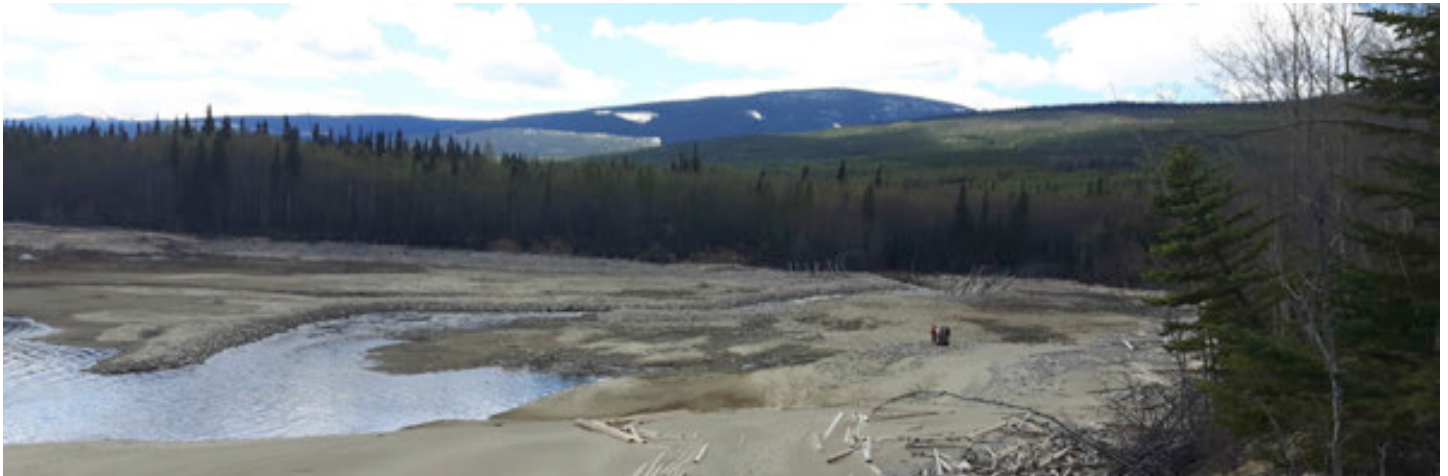
PHOTO 1 (Panoramic): Ole Creek works looking upstream from downstream left bank

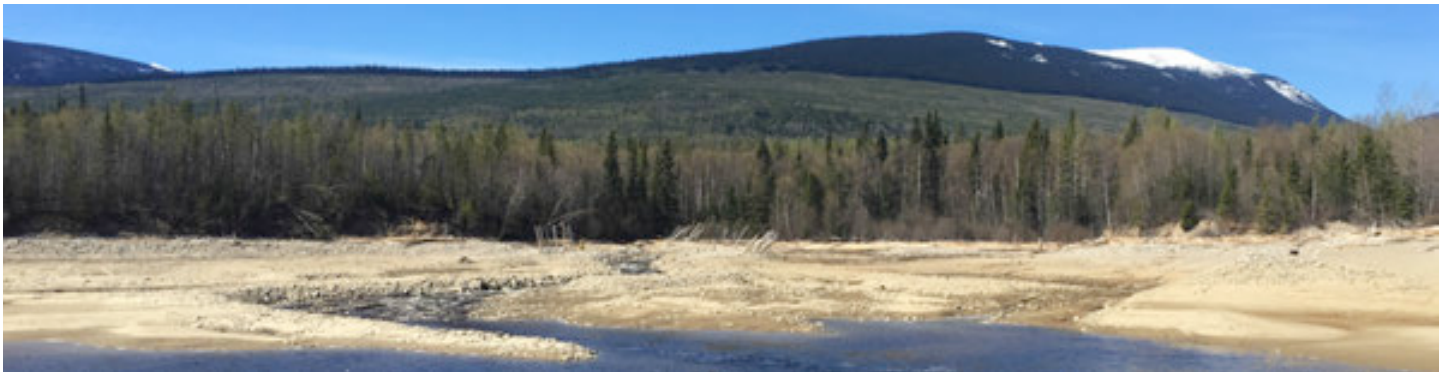
PHOTO 2 (Panoramic): Ole Creek works looking upstream from downstream left bank

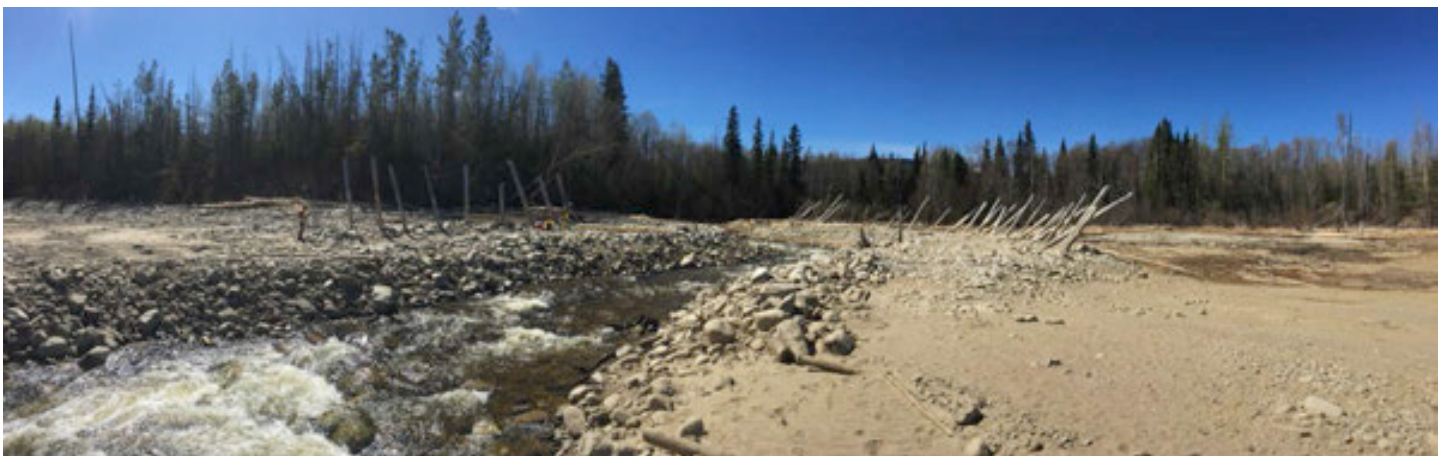
PHOTO 3 (Panoramic): Ole Creek works looking upstream at upper berms and debris catchers

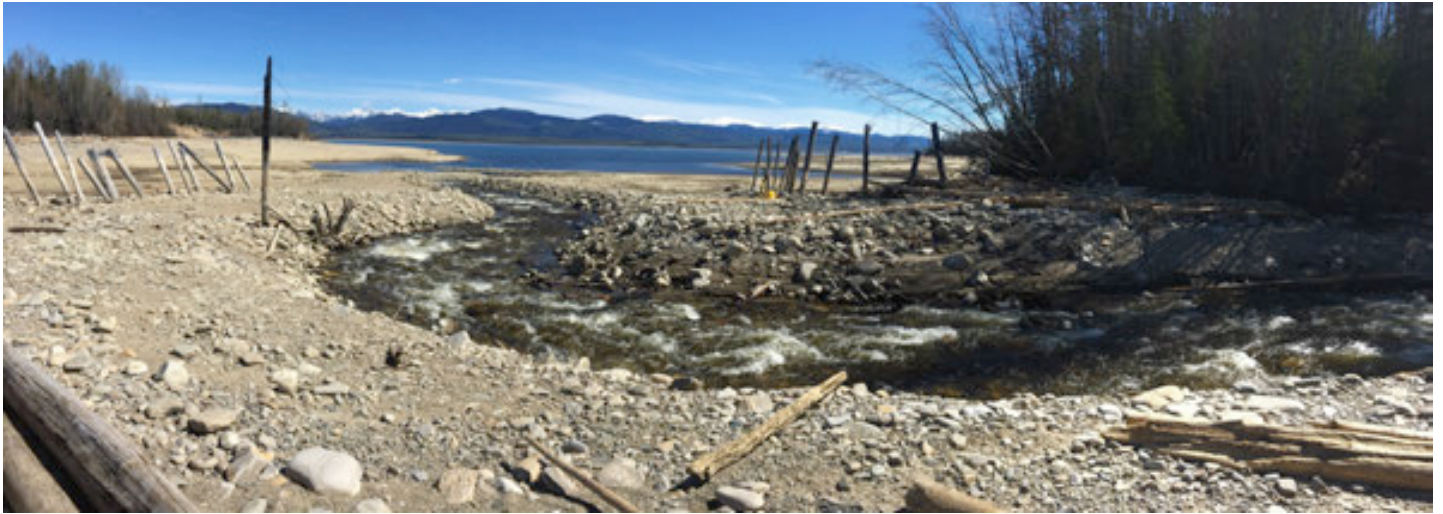
PHOTO 4 (Panoramic): Ole Creek looking downstream along Berm 'A' just upstream of Berm 'C'

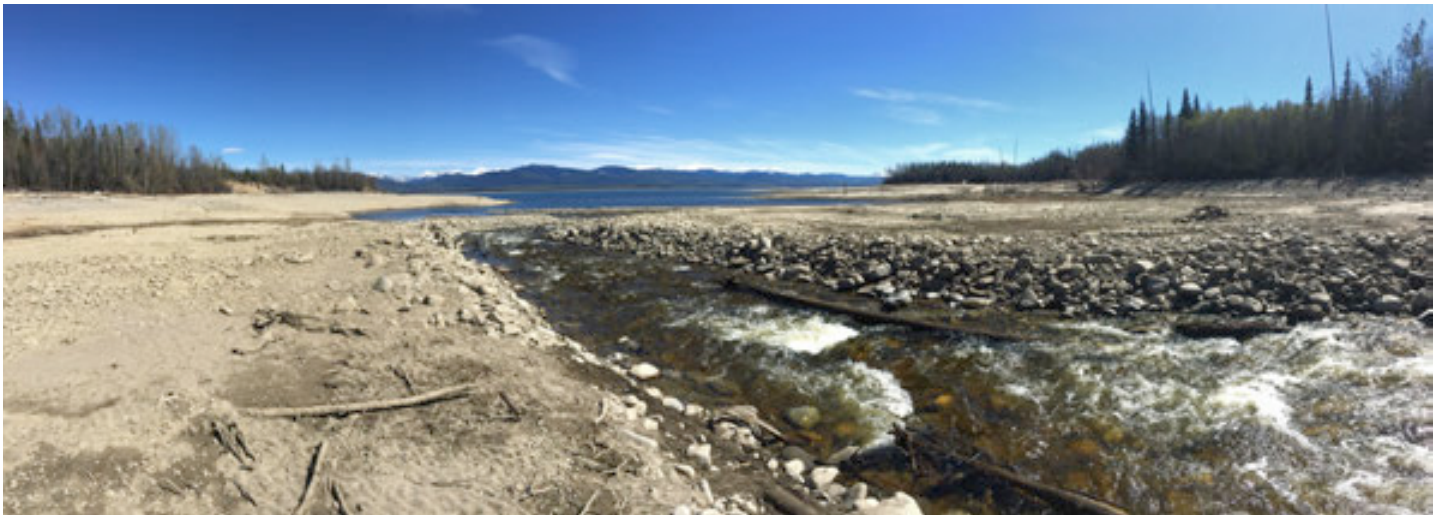
PHOTO 5 (Panoramic): Ole Creek looking downstream from below Berm 'A'

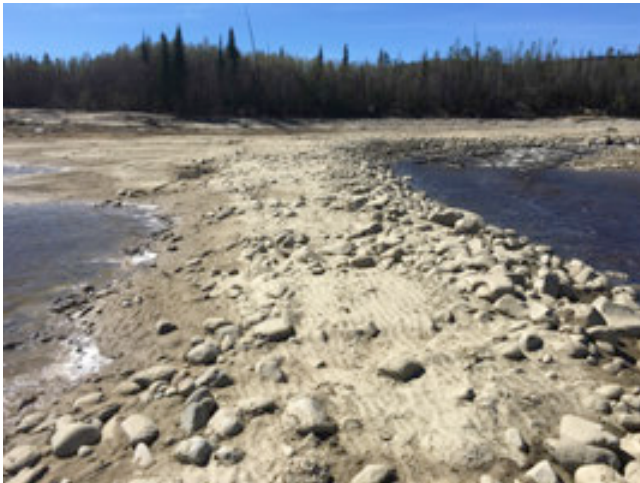
- The berm is generally in good condition; however, there has been some settlement/displacement and erosion of the finer fraction of material from the berm crest based on visual observations and the survey (see Profile on DWG 1000-C1800061-R2, and Sections 0+360 and 0+380 on 1000-C1800066-R0).

- The top of berm is slightly uneven in some locations with some large cobble proud of crest.
- The erosion, settlement and displacement of some material could be caused by large woody debris movement, wave action, ice movement, and creek flow over the berm as the reservoir level rises.

PHOTO 10: Looking upstream at Berm 'D' from downstream end of berm. Note erosion of fine fraction of the berm crest.

- The settlement/displacement on Berm 'D', should be monitored during the annual monitoring work. It is possible that the settlement / erosion could have been greatest in the first season, and may lessen with time. If the berm height becomes less than 0.8 m above the creek, then repairs should be considered.

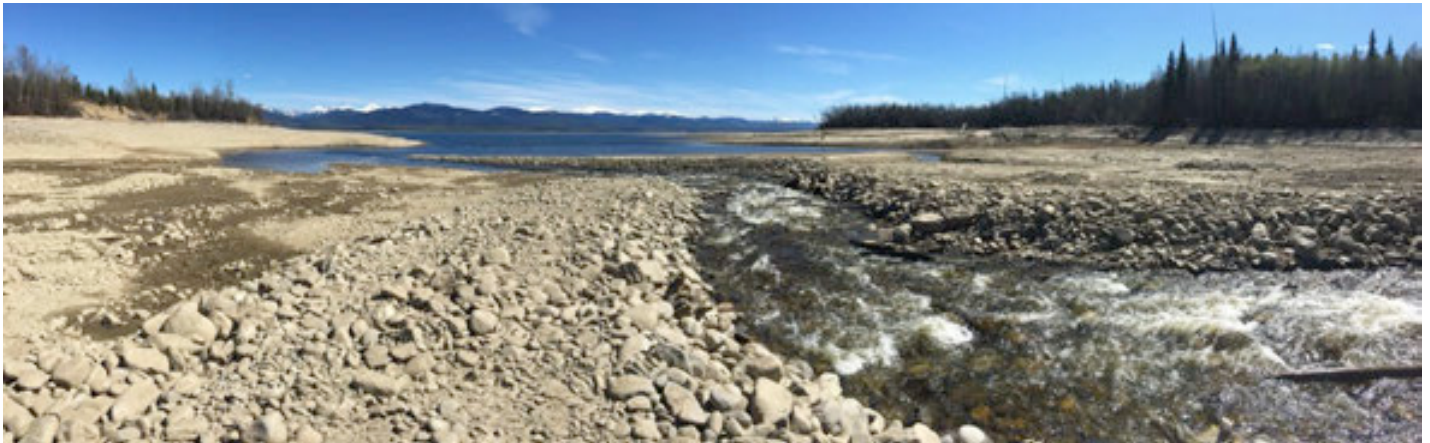
PHOTO 12 (Panoramic): Berm 'B' looking downstream on left side of photo and Berm 'D' at right side

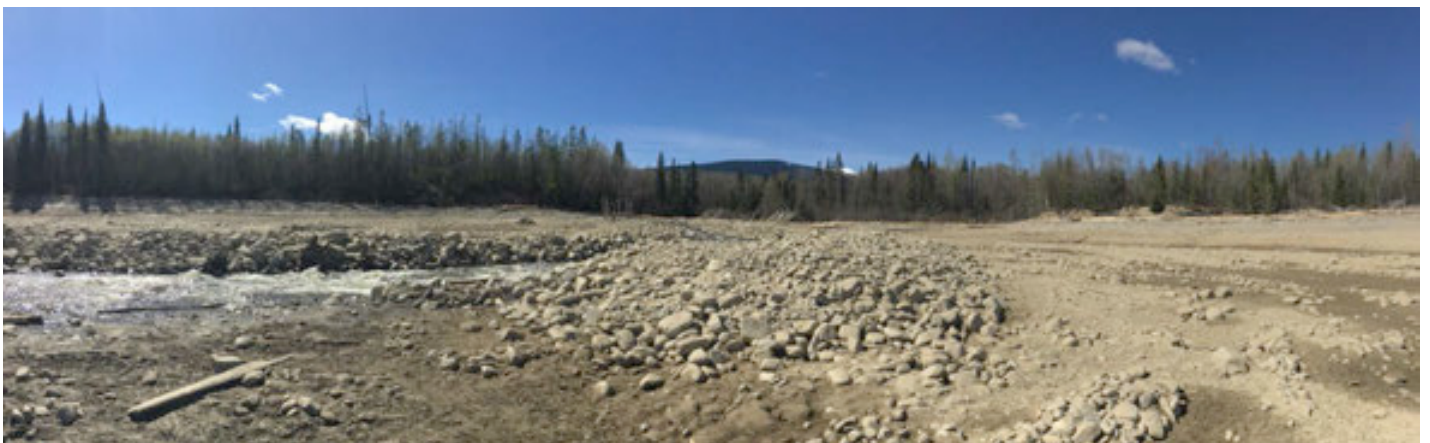
PHOTO 13 (Panoramic): Berm 'B' looking upstream at lower end (in centre of photo)

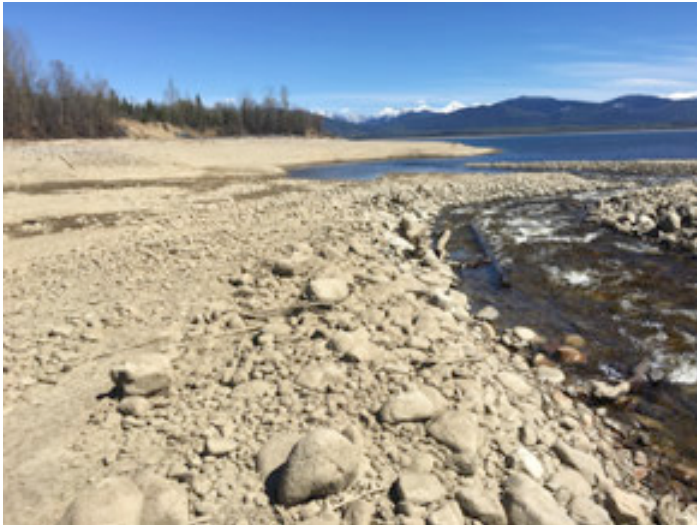
PHOTO 15: Looking downstream along Berm 'B'

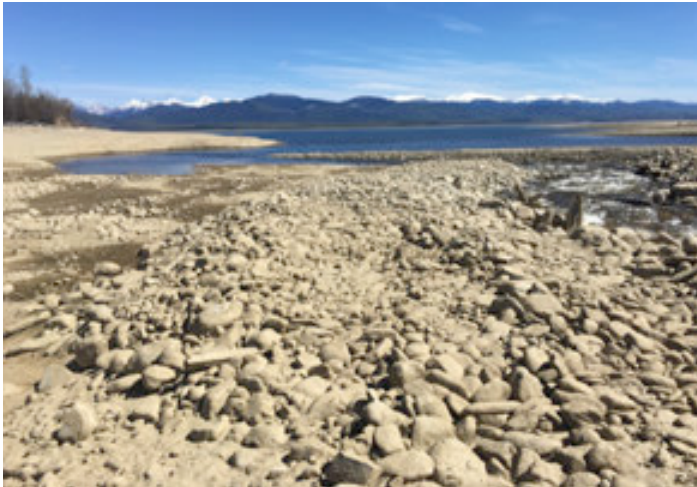
PHOTO 17: Looking downstream along Berm 'B'

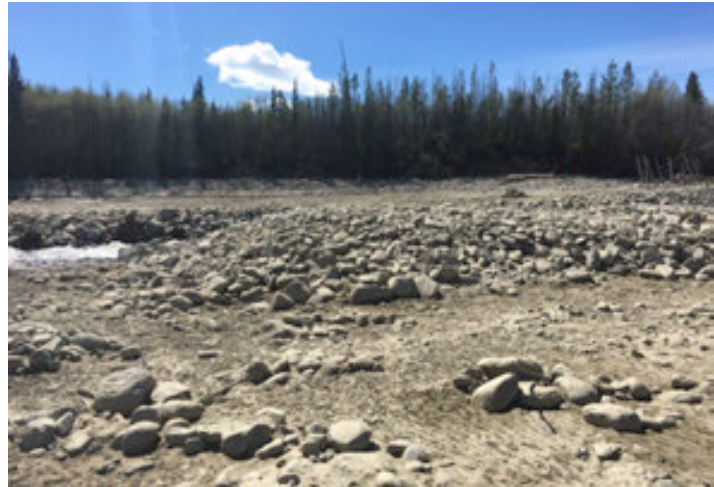
PHOTO 18: Downstream end of Berm 'B'

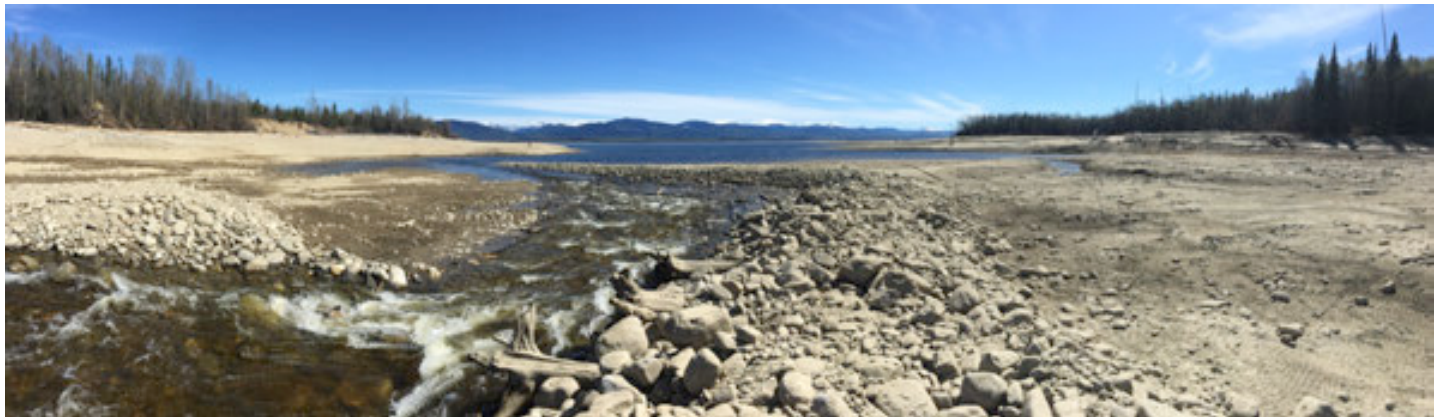
PHOTO 19 (Panoramic): Looking downstream along the lower section of Berm 'C' at LWD location

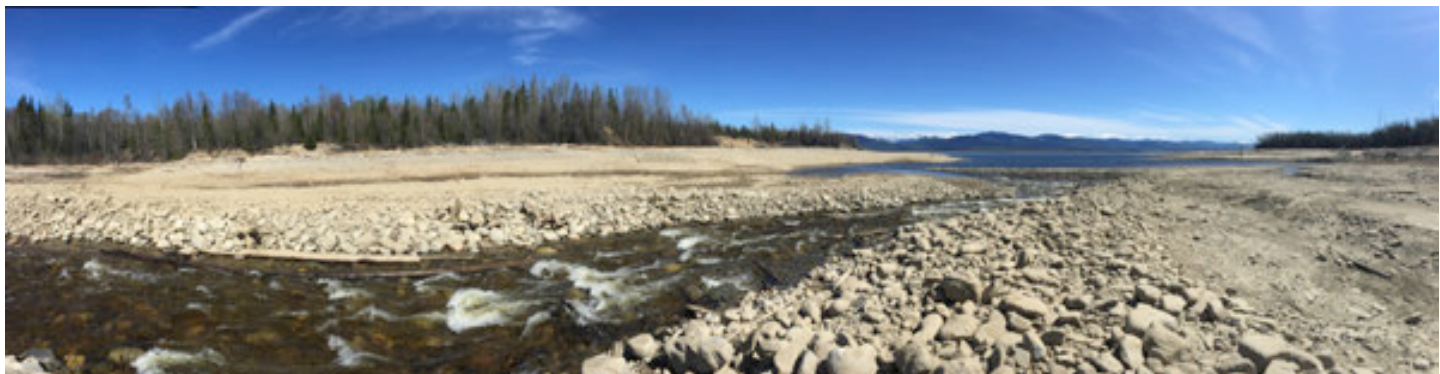
PHOTO 20 (Panoramic): Looking downstream along Berm 'C' from just downstream of woody debris catcher

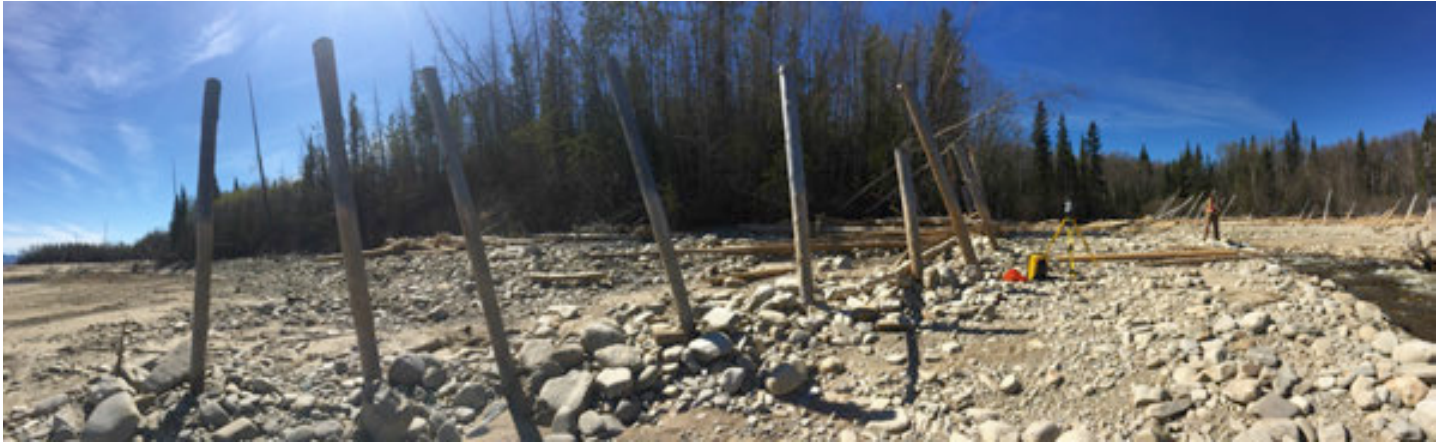
PHOTO 21 (Panoramic): Looking upstream at Berm 'C' and woody debris catcher

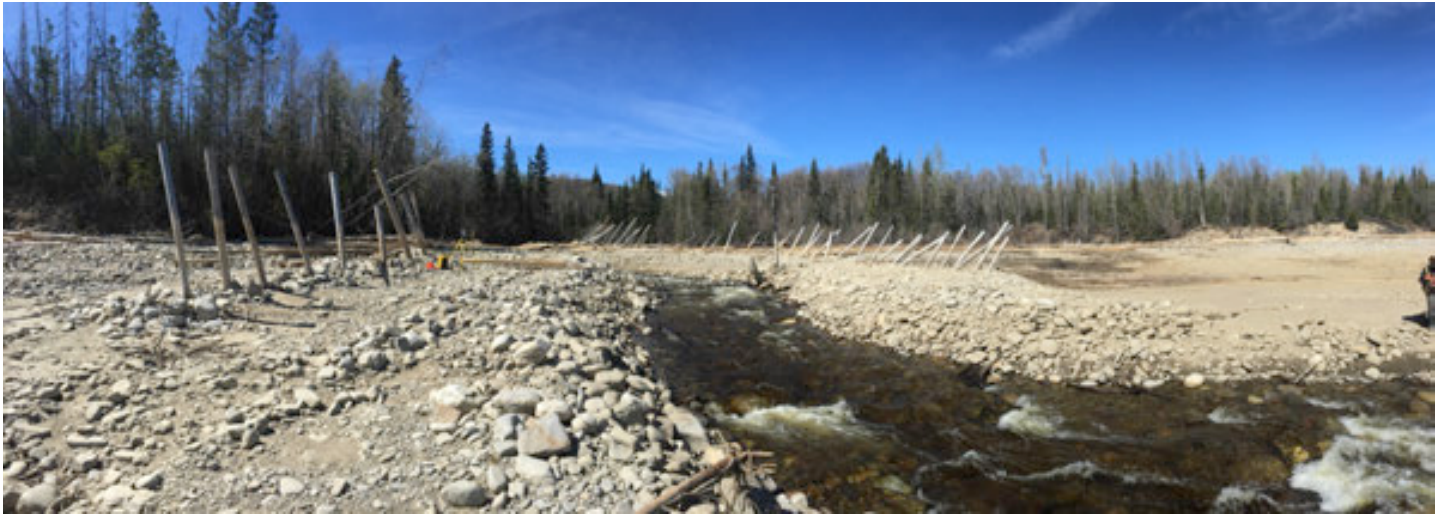
PHOTO 22 (Panoramic): Looking upstream along Berm 'C' and woody debris catcher (on left in photo)

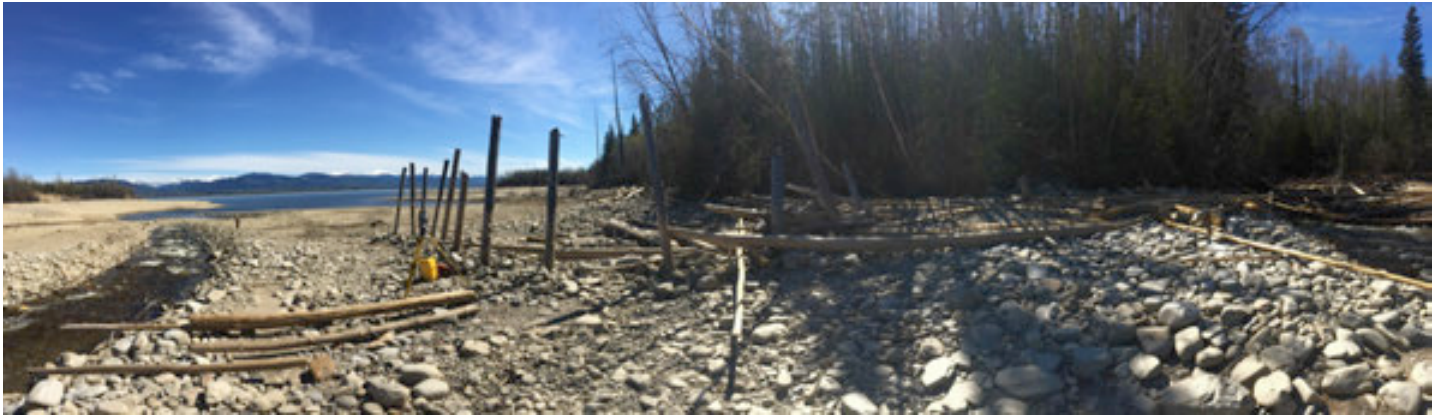
PHOTO 23 (Panoramic): Looking downstream at Berm 'C' and woody debris catcher

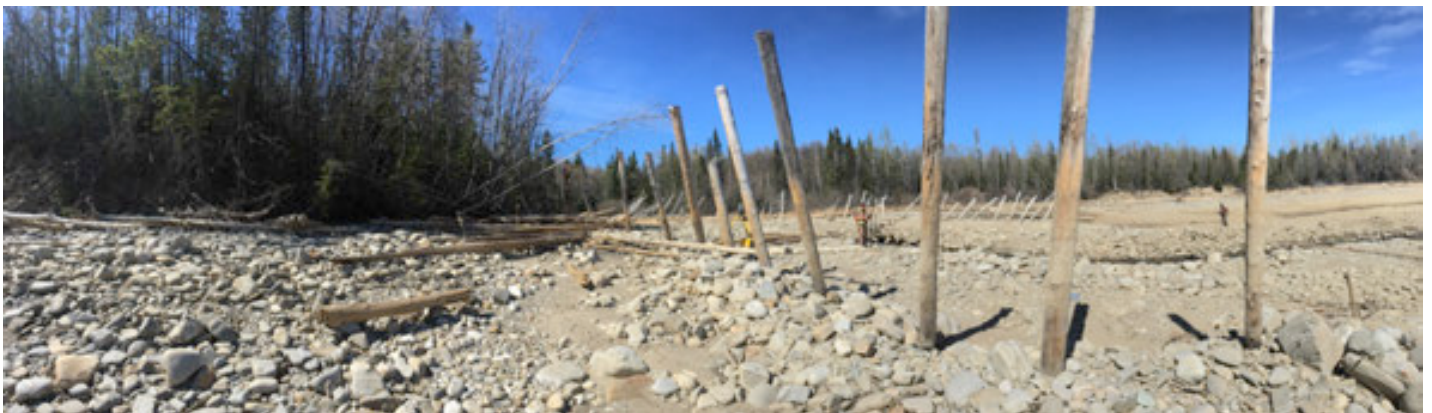
PHOTO 24 (Panoramic): Looking upstream at Berm 'C' and woody debris catcher

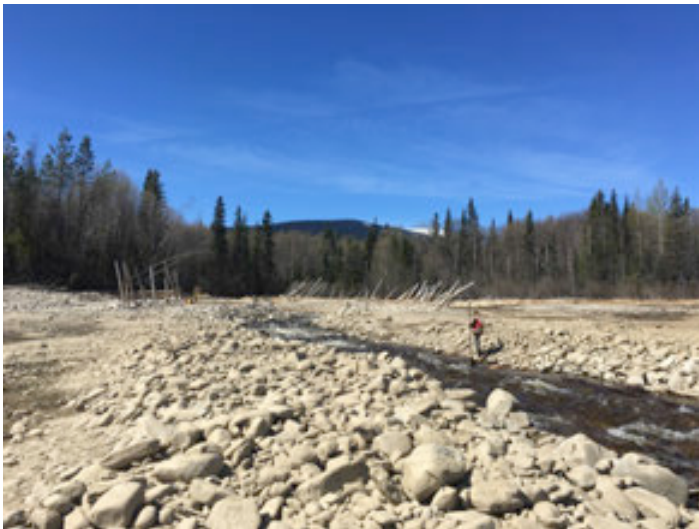
PHOTO 29: Looking upstream at Berm 'C' from downstream end of berm.

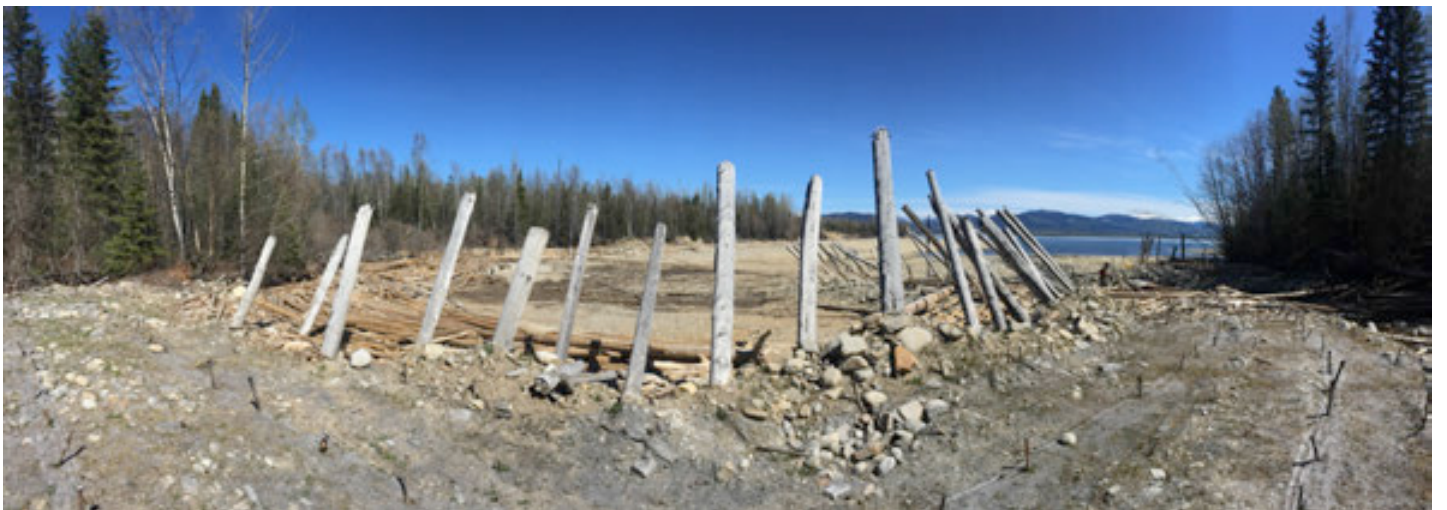
PHOTO 32 (Panoramic): Berm 'A' and left bank woody debris catcher (note bend is exaggerated)

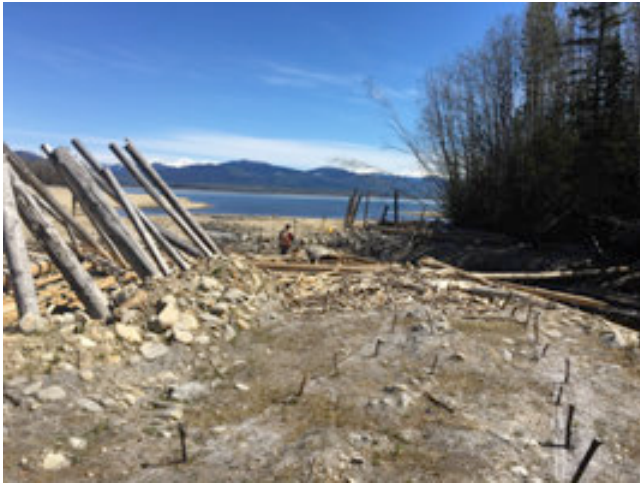
PHOTO 36: Downstream end of Berm 'A' looking downstream

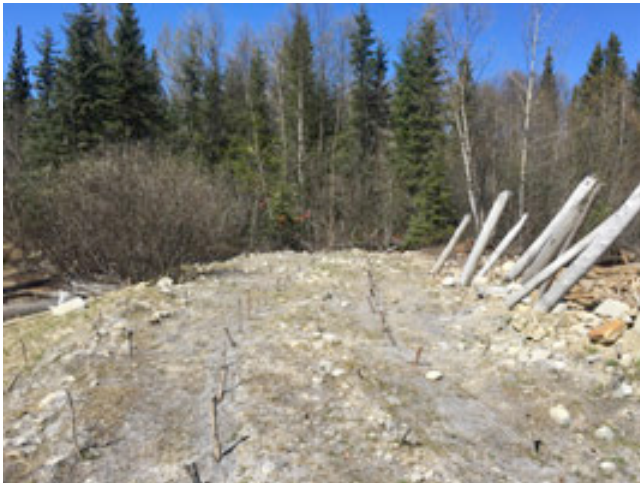
PHOTO 38: Upstream end of Berm 'A'

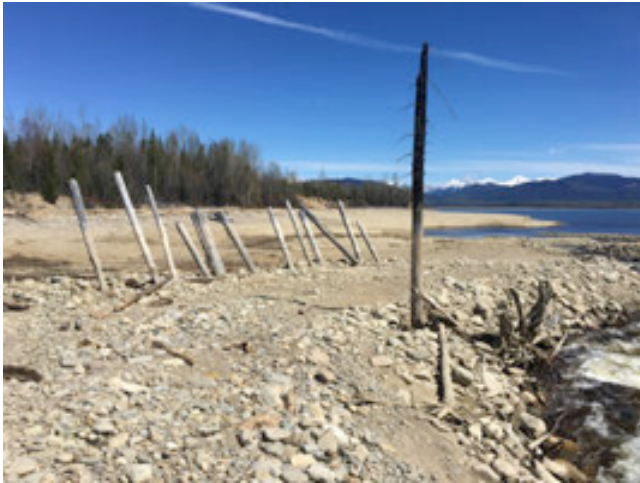
Photo 42: Downstream end of Berm 'A' and LWD embedded in berm (left side of photo)

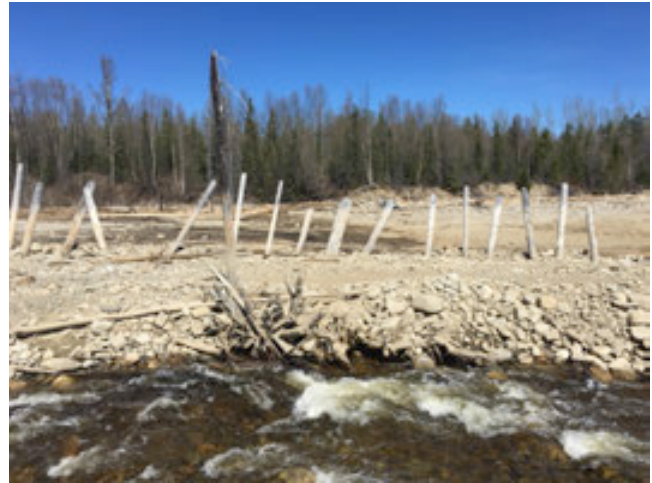
Photo 43: Embedded LWD in Berm 'A'

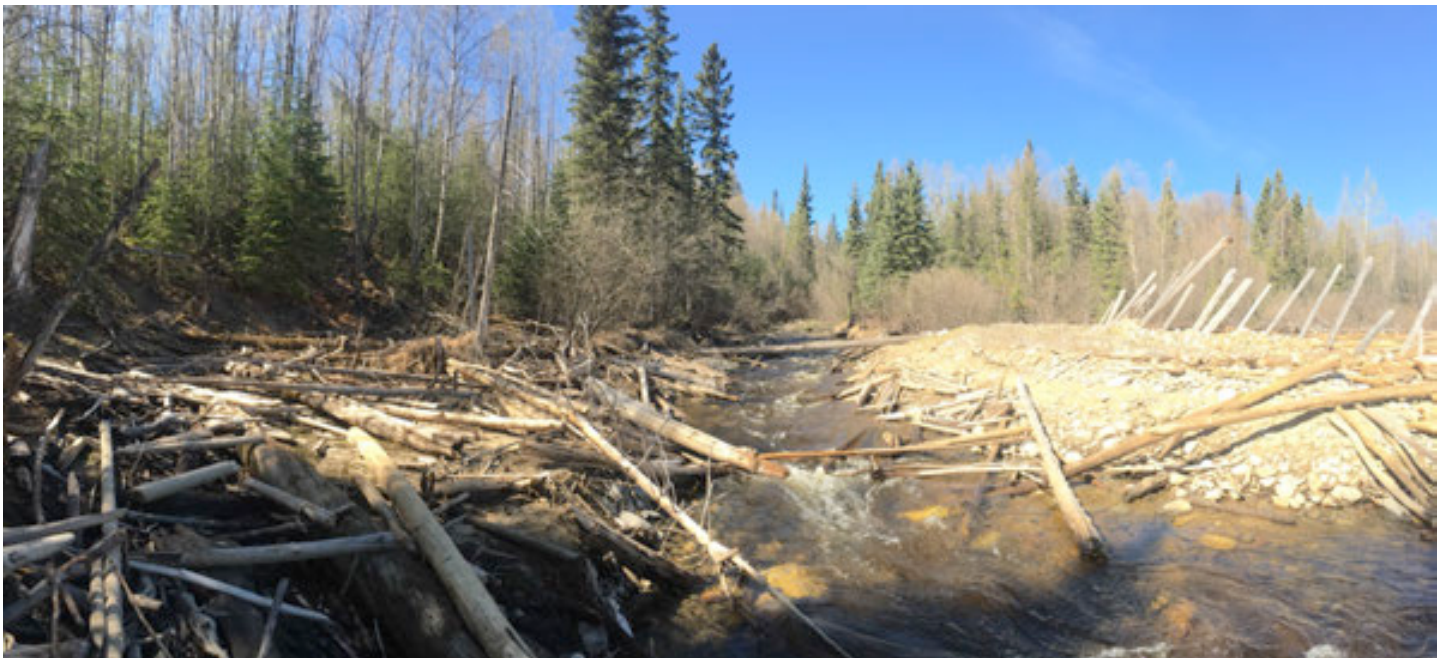
- There is a small logjam that has formed just upstream of Berm 'C' and along Berm 'A'. It is in the vicinity of where some log debris was able to pass between the woody debris catchers, so it is likely a combination of log debris transported by the creek and logs floated from the reservoir.

- The environmental monitoring contractor noted that the logjam is not presently a barrier to fish passage, but could become one if it accumulates material. This logjam should be monitored and could be removed if it becomes a barrier to fish passage.

PHOTO 46 (Panoramic): Looking at channel upstream of logjam from right bank, Berm 'A' at right
