Peace Project Water Use Plan

Williston Reservoir Trial Tributaries

6 Mile 2016 Engineering Inspection Report

Site Inspection Report

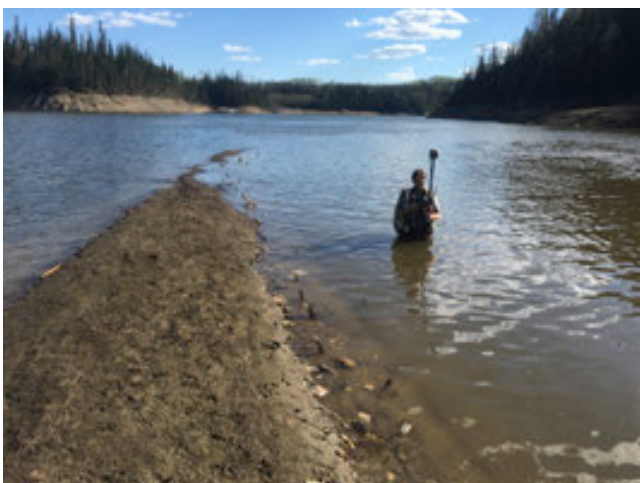
PHOTO 9: Survey of Toe of Berm 'G' on Creek Side

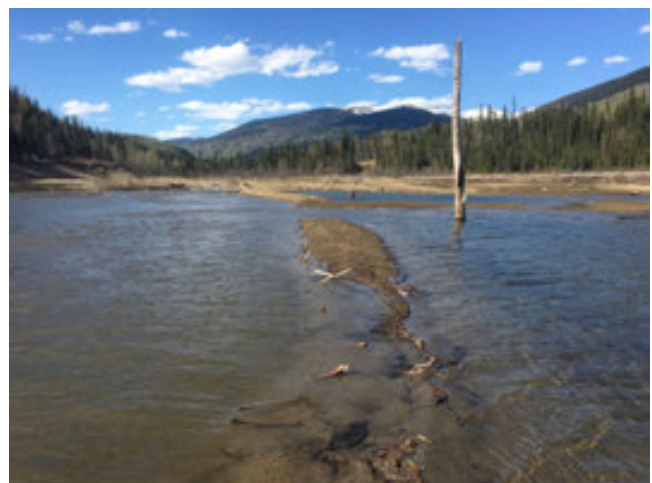
PHOTO 10: Berm 'G' Looking Upstream

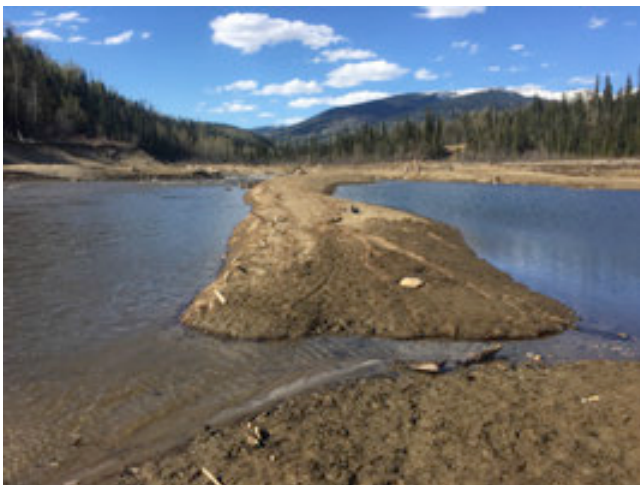
- There was a fine layer of sand/silt covering berm.
- Exposed coir material used in the soil wraps is in good condition and functioning well.
- Erosion appears to have occurred downstream of the berm where the ground is 'natural' (see Photo 12)

PHOTO 12: Downstream End of Berm 'F' Looking Upstream. Possible Erosion Downstream of Berm in 'Natural' Area (Note Water Flowing from Left to Right Side of Photo).

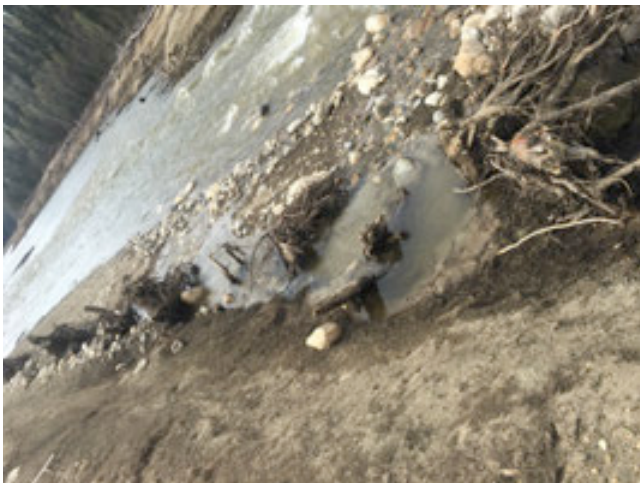
- The LWD is in good condition and has not displaced. There are some eroded pools and gravel deposition at the toe around the LWD (visible in Photo 16 below, and indicated on section 0+740), which was desired for habitat.

PHOTO 16: LWD and Toe Erosion and Deposition Creating Habitat Features in Channel

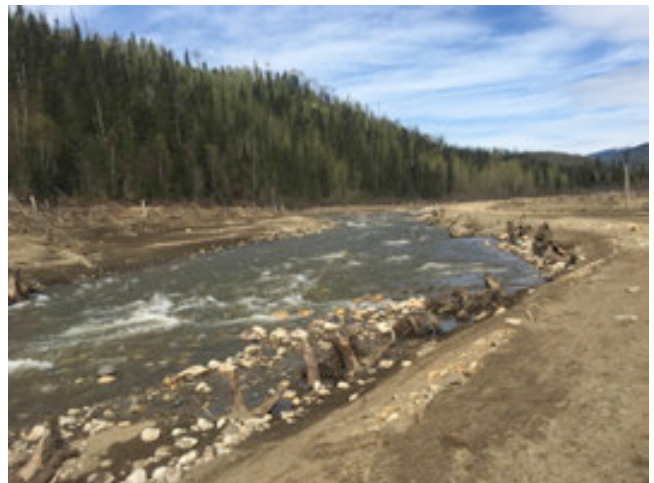
PHOTO 17: LWD, Deposition and Channel Scour/Deepening

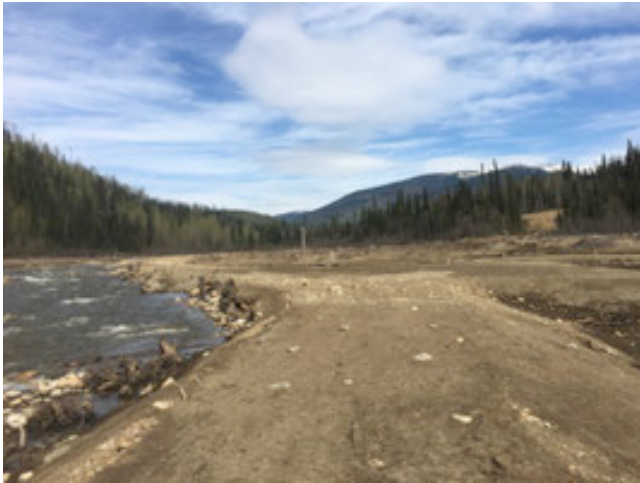
PHOTO 22: Looking Upstream at Berm 'D'

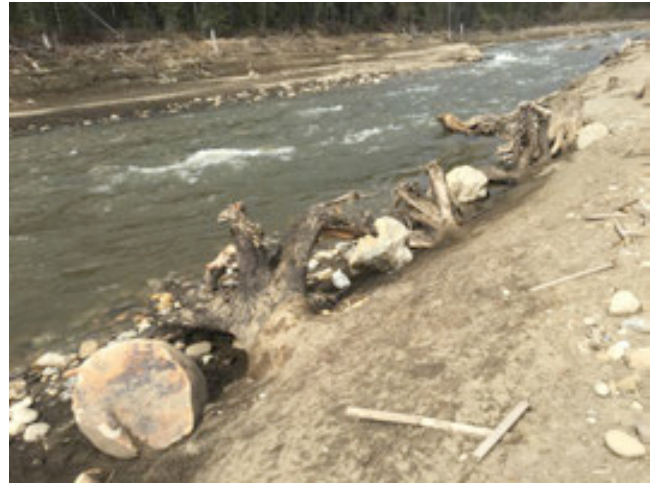
PHOTO 23: LWD at Berm 'D'.

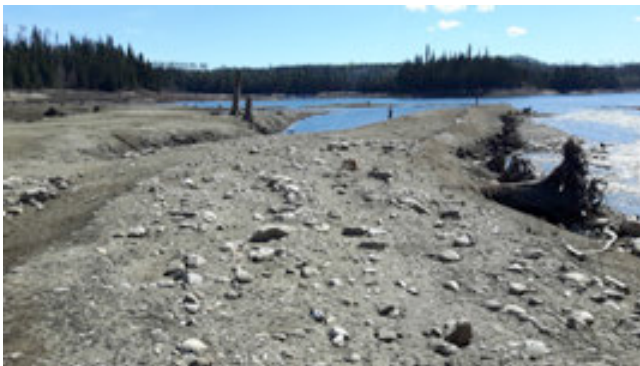
PHOTO 24: Material Used to Cover ECM When it Became Buoyant Still in Place.

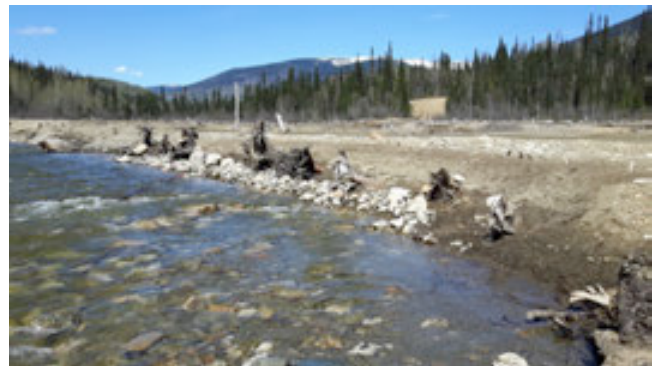
PHOTO 25: Deposition and Erosion Near LWD

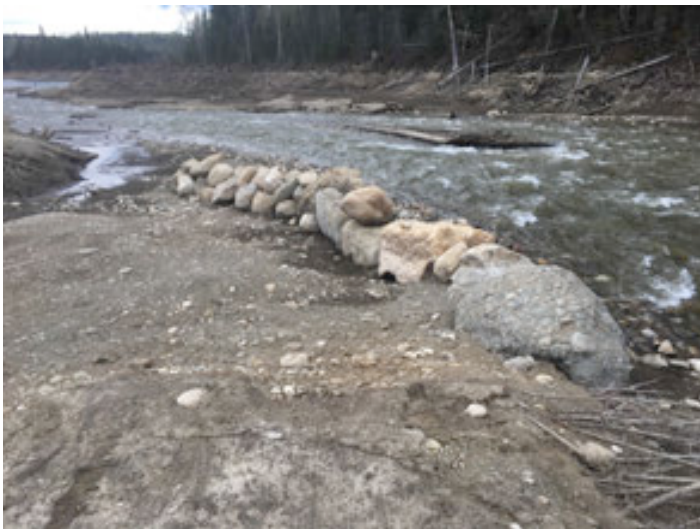
- The upstream half of the berm had good grass growth from 2015 on the crest (see Photo 40 & 41).
- The ECM, where exposed, is deteriorating.
- The rock spur at the downstream end is still intact (see Photo 34).

PHOTO 34: Downstream end of Berm 'C' looking downstream

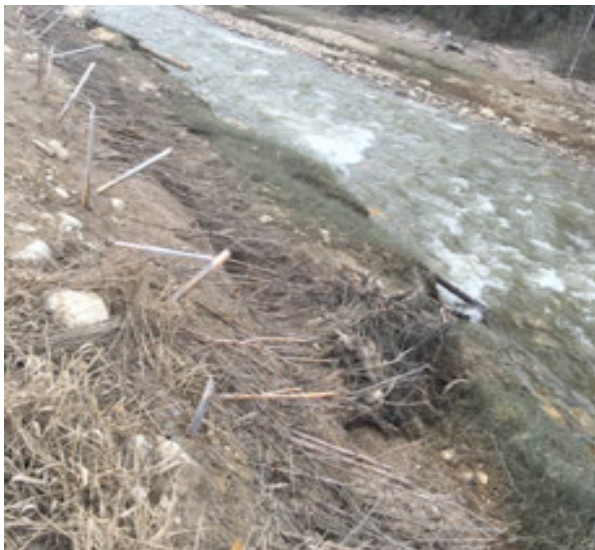
PHOTO 36: Coir soil wraps, willow brush layers along berm and native grasses/reeds at toe

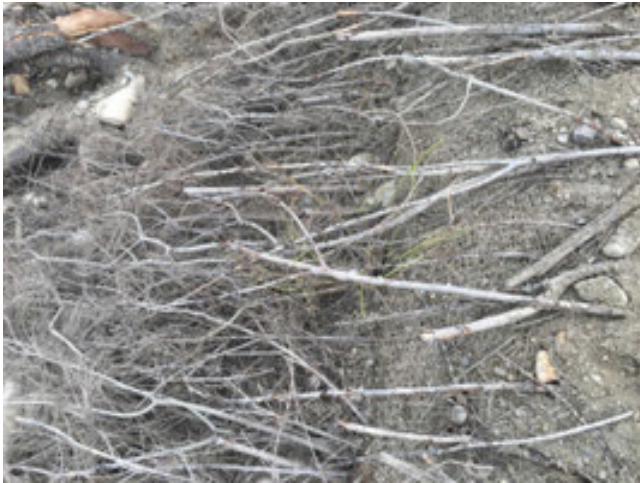
- The LWD is in good condition and has not displaced.
- Most of the willows (2014 live brush and stakes) do not appear to have survived however there are a few areas where the willow has taken (see Photo 38). It was also early in the season, so it is likely that additional growth will take hold above the reservoir this summer.

PHOTO 38: Few willow stakes took hold in downstream berm area (lower elevation), however there is some limited new growth. Willow was likely submerged as indicated in photos below.

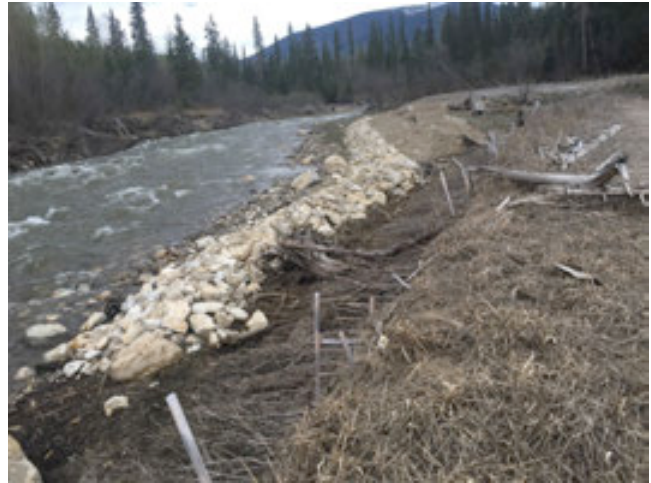
PHOTO 39: Looking upstream at willow layers (mostly dead) in the lower berm and grasses in the upper berm that had grown (not active growth yet this year given time of site visit).

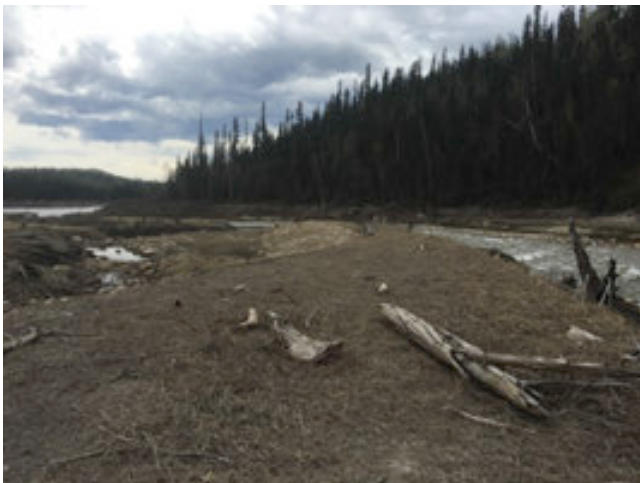
- Flotsam deposited on berm crest provides evidence of the high reservoir level and or wave action in 2015 to an elevation of approximately 670 m (see Photos 40 & 41 and DWG 1000-C1800063-R2). Much of Berm 'C' appears to have been submerged in 2015, which is likely why much of the willow does not appear to have survived.

PHOTO 40: Looking downstream along Berm 'C', note flotsam in foreground.

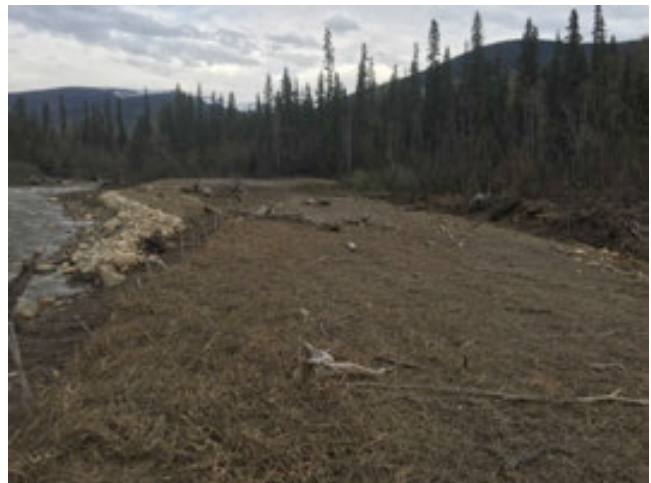
PHOTO 41: Looking upstream at upstream end of Berm 'C', note flotsam deposition from reservoir in 2015 indicating that the berm was likely mostly submerged in 2015. Note 2015 grass growth.

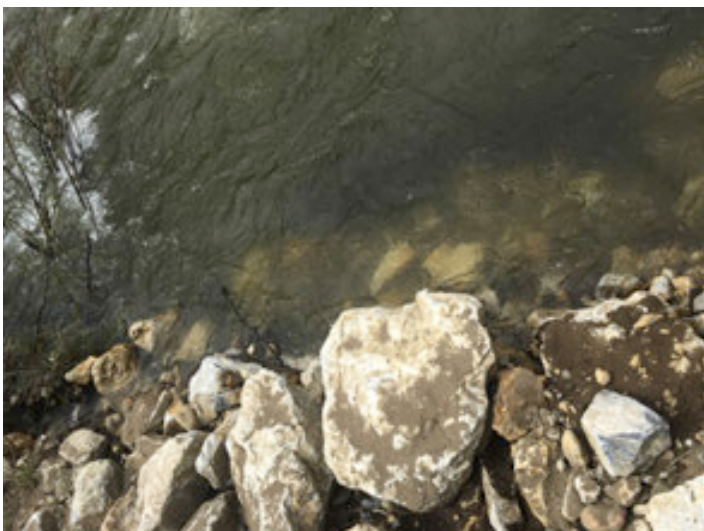
- Riprap launching toe trench has begun to 'launch' into eroded creek bank as expected and designed protecting the toe of Berm 'J' (see Photo 48).
- Willow shoots were thinly spread out, but were starting to come up all along berm at the time of the site visit (see Photo 52).

PHOTO 48: Launching riprap toe.

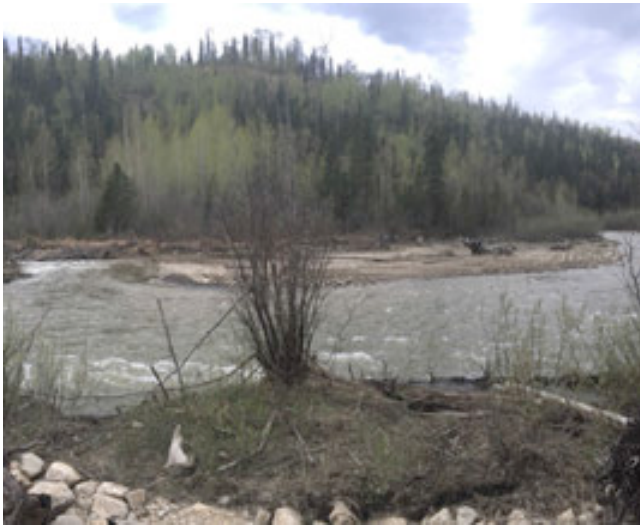
PHOTO 50: Gravel bar across from Berm 'J'

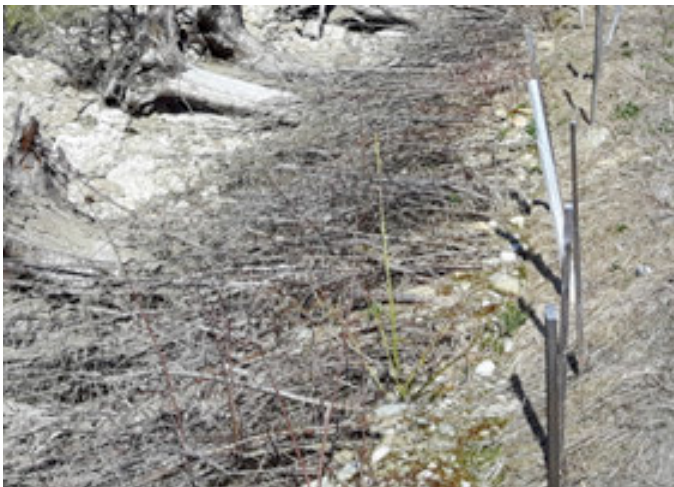
PHOTO 52: Willow starting to take in brush layers

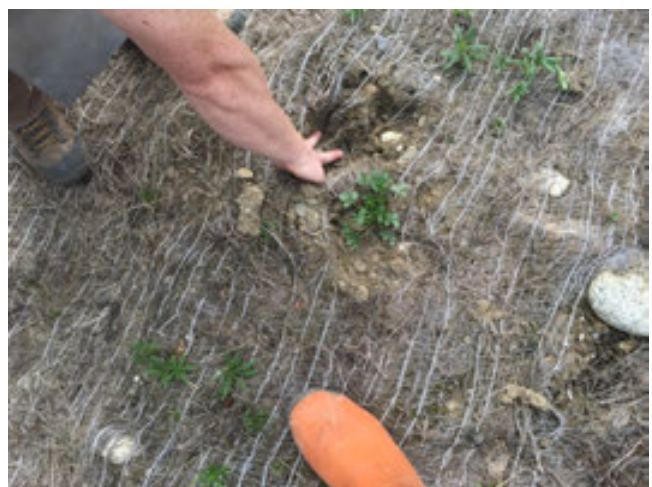
- Grass and other vegetation growing on top and on back side of berm.
- The ECM has deteriorated as expected.
- Evidence of moose damage to crest of berm (hoof prints observed, see Photos 53, 54 & 55).

PHOTO 53: Moose tracks in berm crest and ECM.

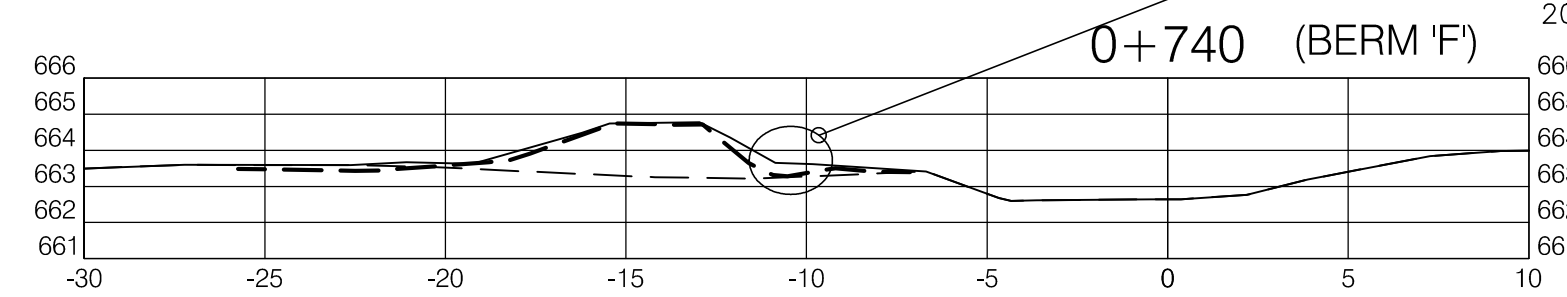
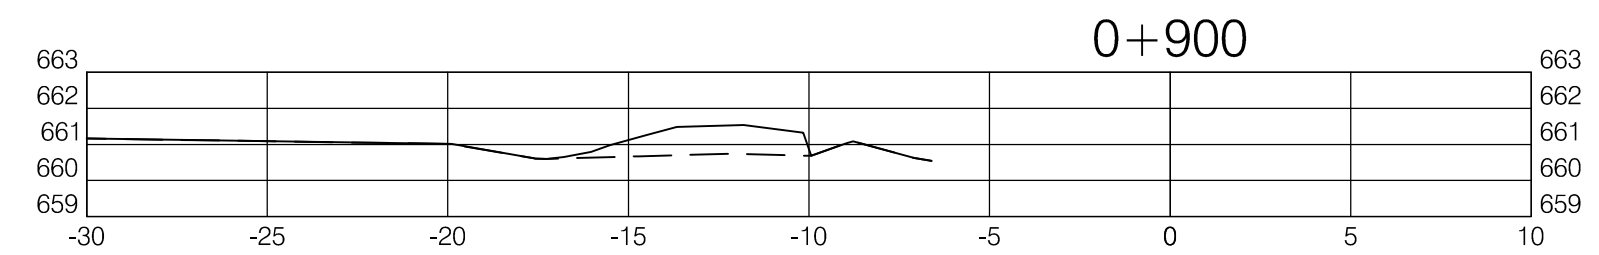
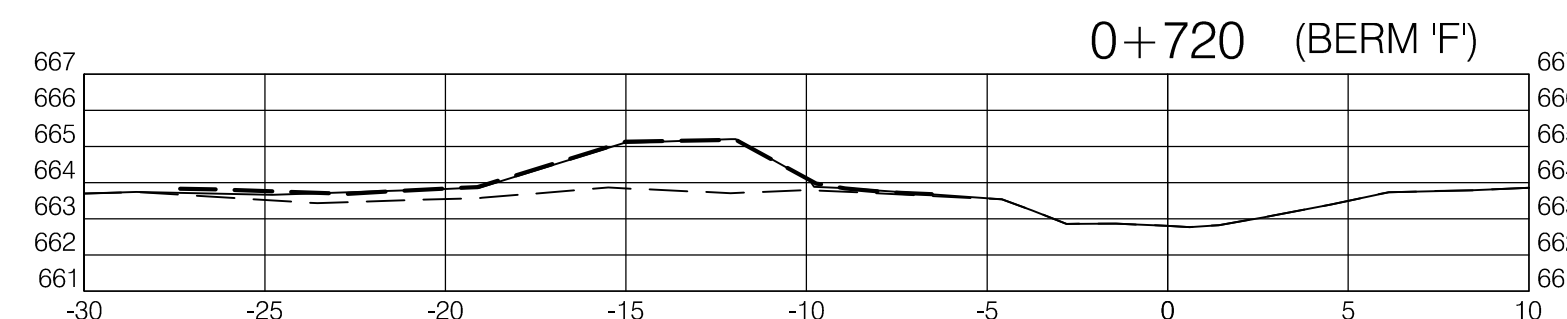
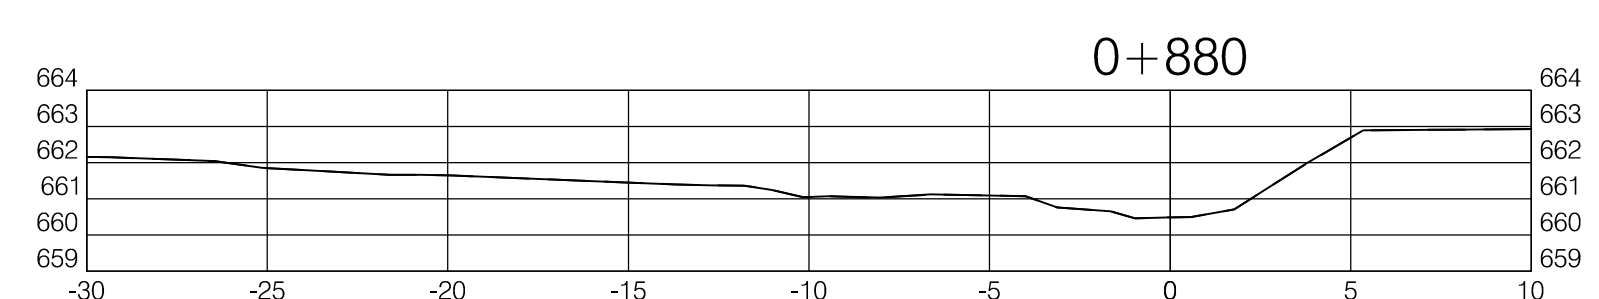
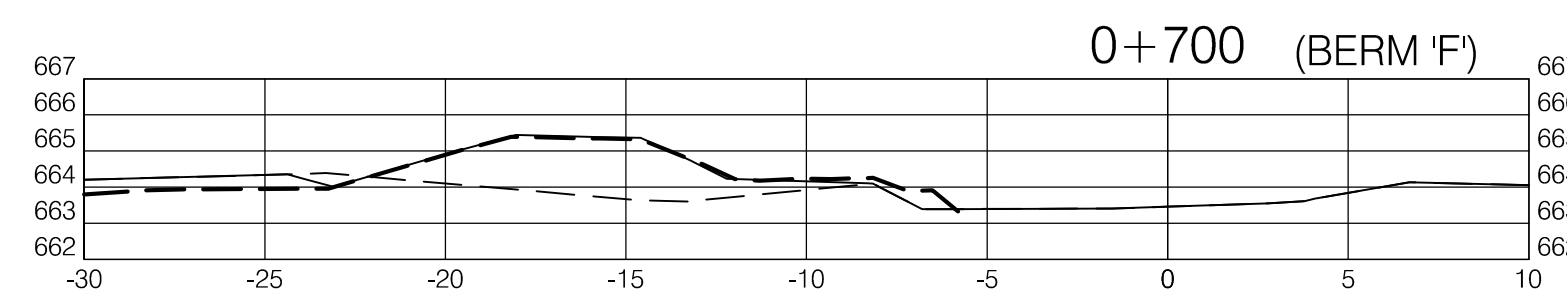
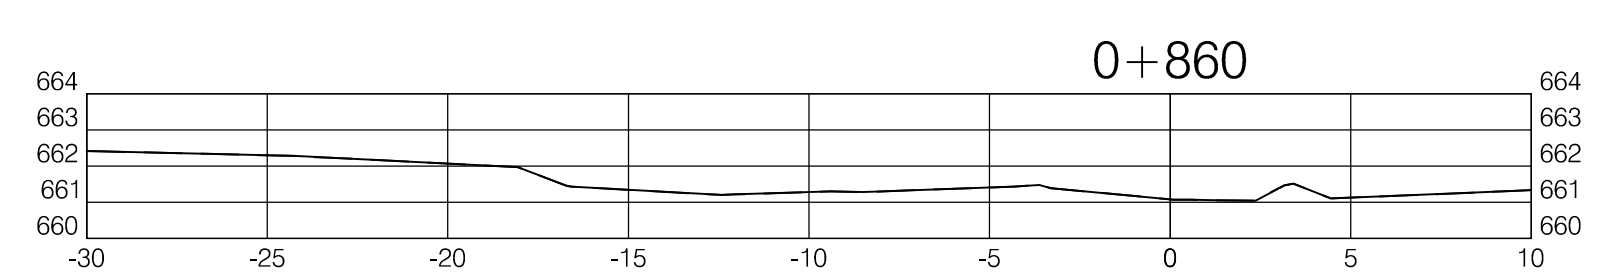
POSSIBLE LOCAL EROSION OR SETTLEMENT. VISUAL CONFIRMATION NOT POSSIBLE AS MUCH OF THE BERM WAS SUBMERGED DURING 2016 INSPECTION

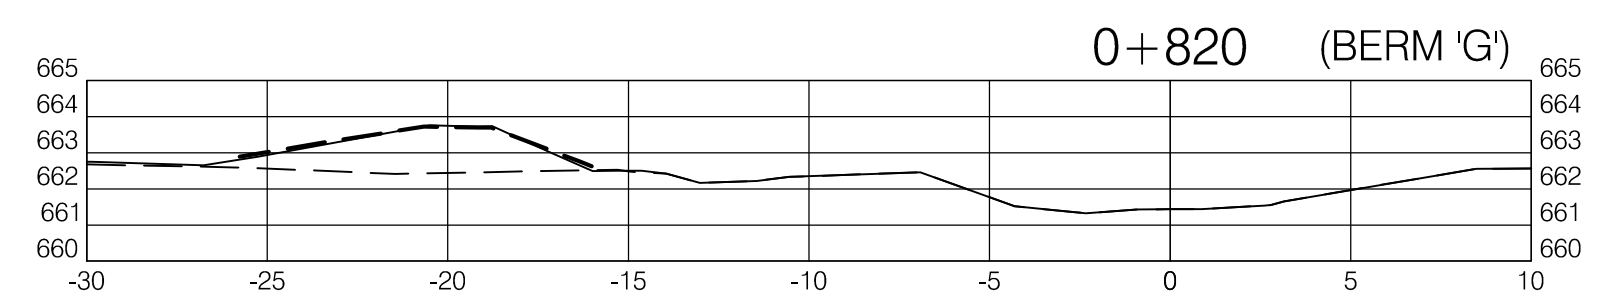
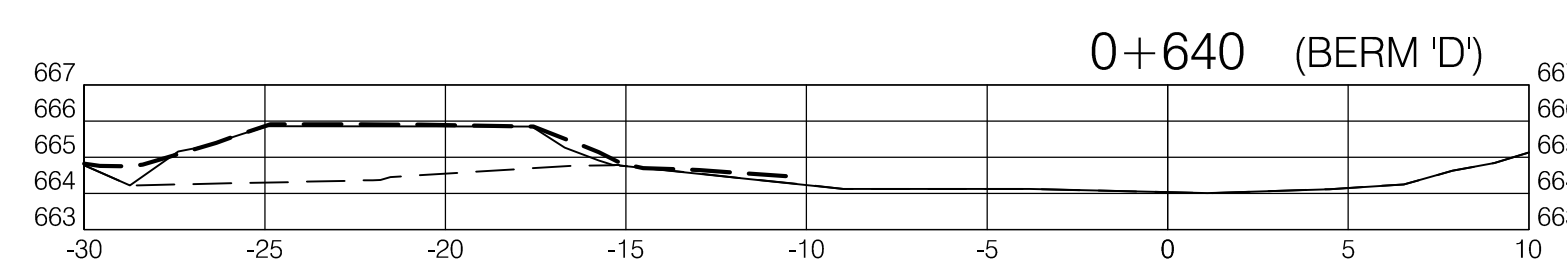
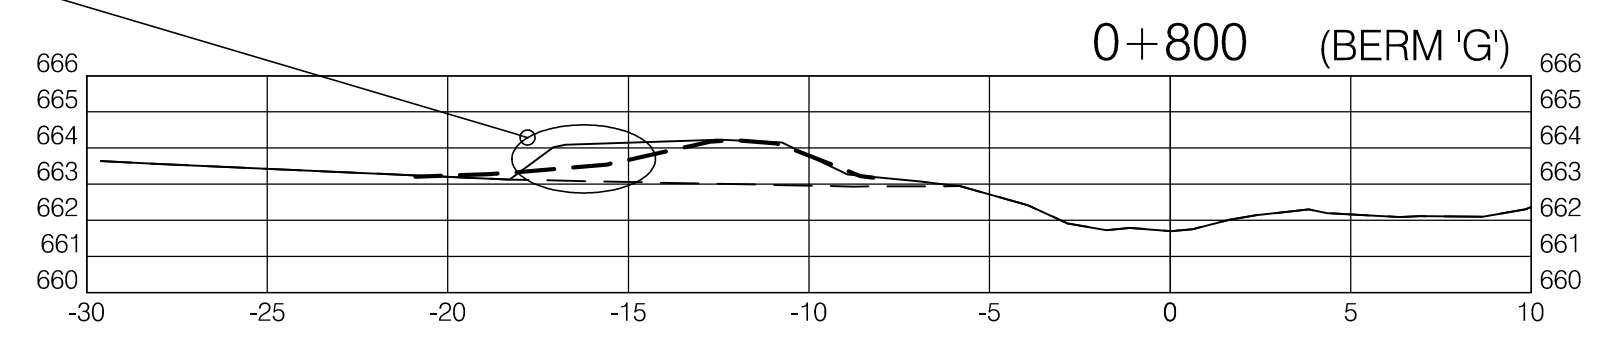
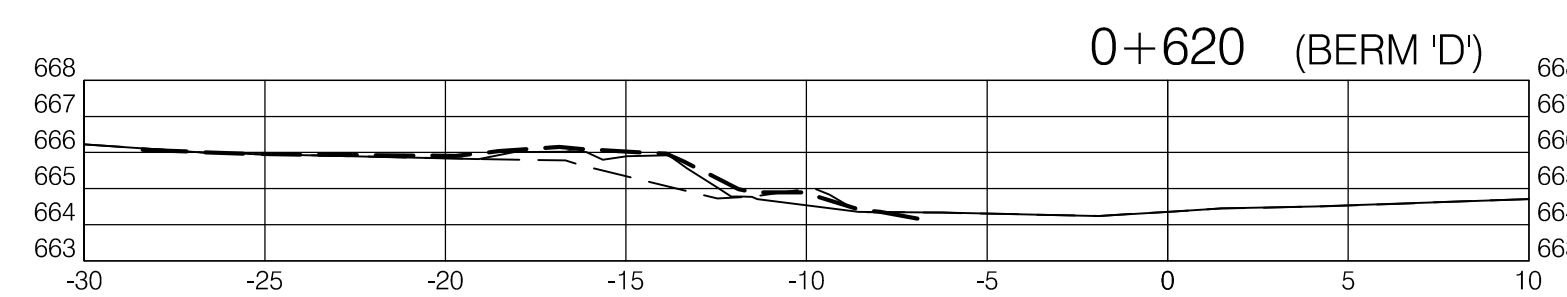
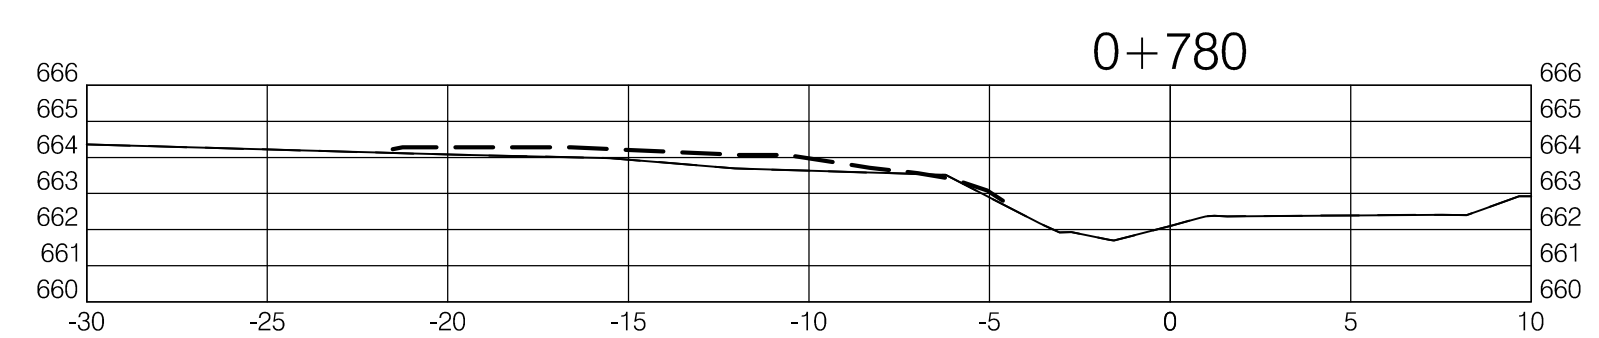
POSSIBLE LOCAL EROSION OR SETTLEMENT. VISUAL CONFIRMATION NOT POSSIBLE AS MUCH OF THE BERM WAS SUBMERGED DURING 2016 INSPECTION
